**REPORT NUMBER: R&D-CAL-15-004**

**MOVING BARRIER TO VEHICLE CRASH TEST IN SUPPORT OF NHTSA'S  
FRONTAL OBLIQUE OFFSET PROGRAM  
OBLIQUE MOVING DEFORMABLE BARRIER INTO RIGHT FRONT OF A**

**2015 Volvo S60**

**90.1KPH, 15 DEGREE ANGLE, 35% OVERLAP**

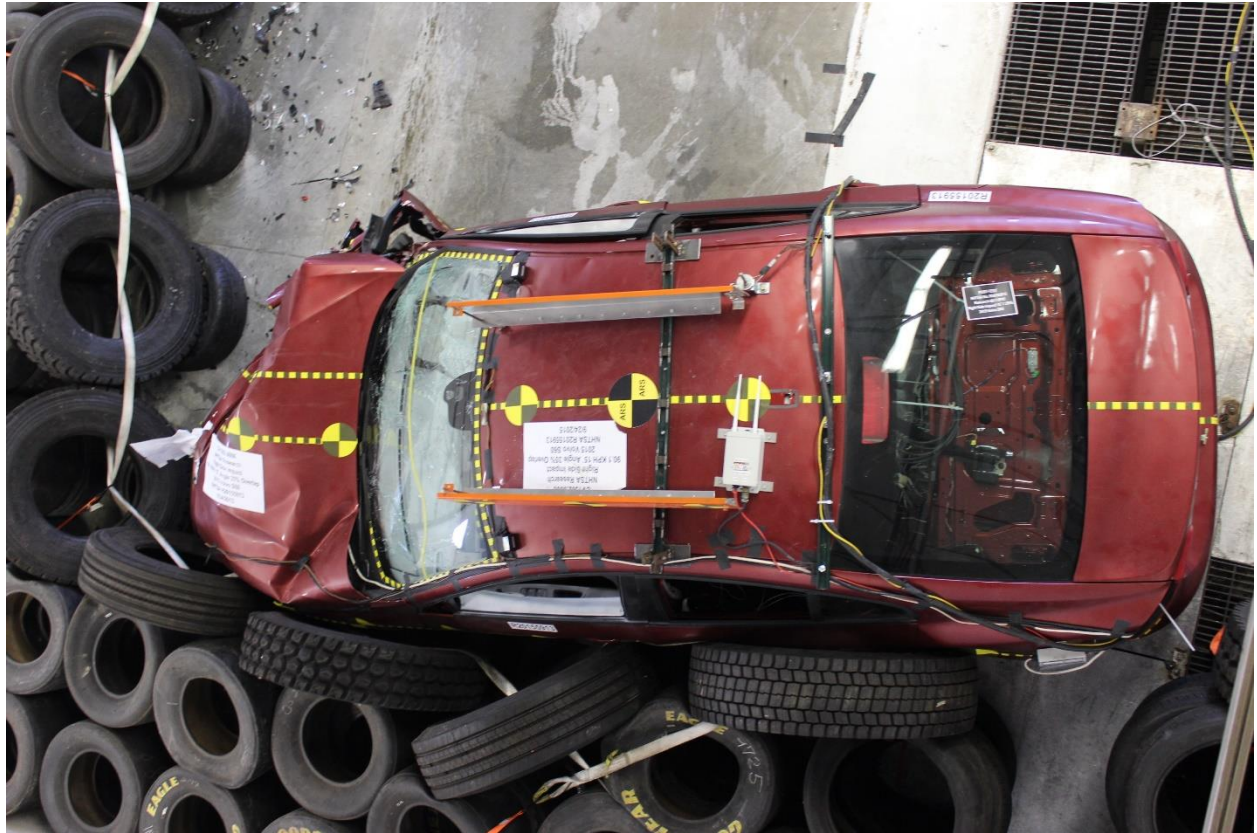
**No. 027 Post-Test Vehicle Overhead View**

Collision Deformation Classification: 12FREE4  
Midpoint of Damage: C5  
Damage Region Length (mm): 1373  
Impact Mode: Frontal 15° Angle, 35% Right Offset

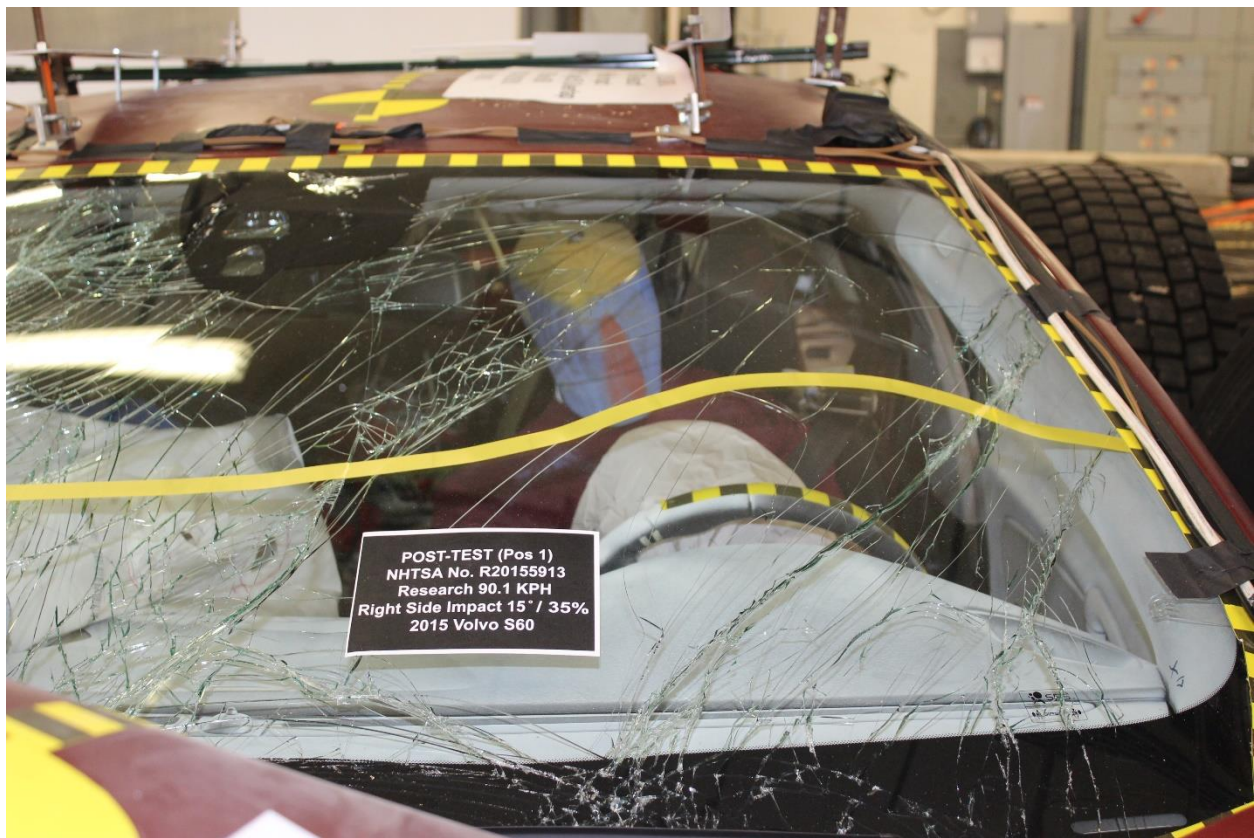
**No. 051 Post-Test Driver Front Windshield View**

| Critical Areas of Performance | Observations and Conclusions | Photo Taken (Y/N) |
|---|---|---|
| Windshield Damage | Crack throughout with separation along bottom edge | Y |

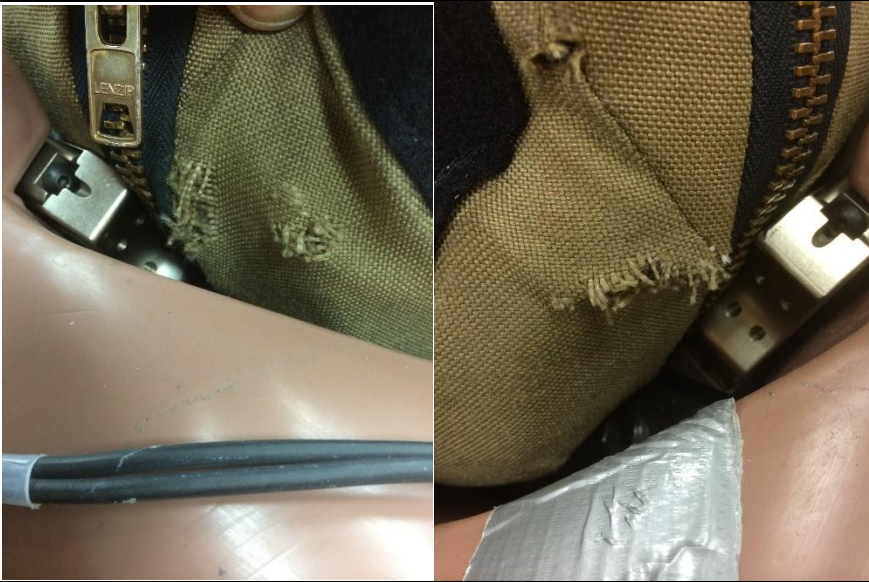
| HEAD | |
|---|---|
| Y / N | No evidence of tearing, cuts, or broken stitches in lower abdomen bag and zipper<br><b>Multiple tears and broken stitches in lower abdomen bag.</b> |

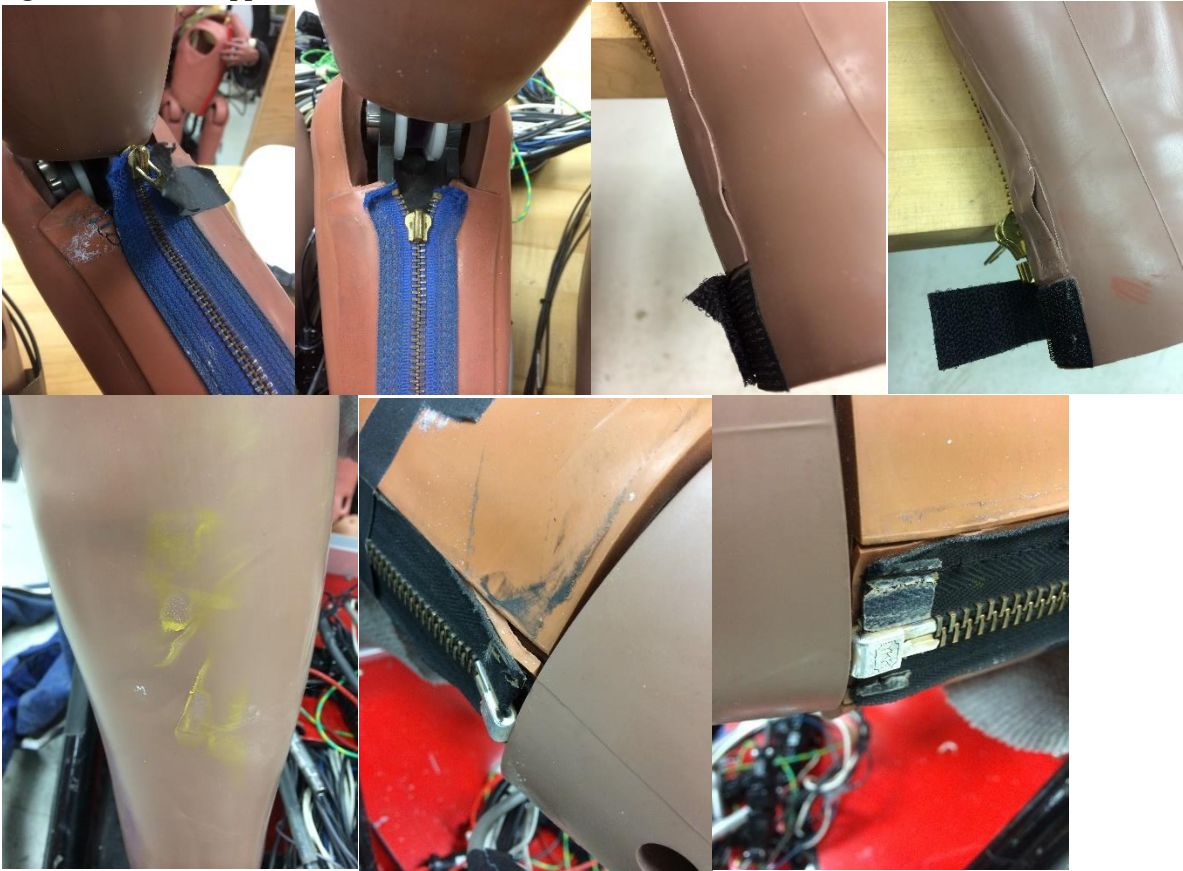
| OTHER | <p><b>Heavy scuffing on front of right calf. Both thigh zippers detaching from flesh. Zippers detaching on left and right calves. Torn zippers/flesh on L &amp; R forearms.</b></p> | |

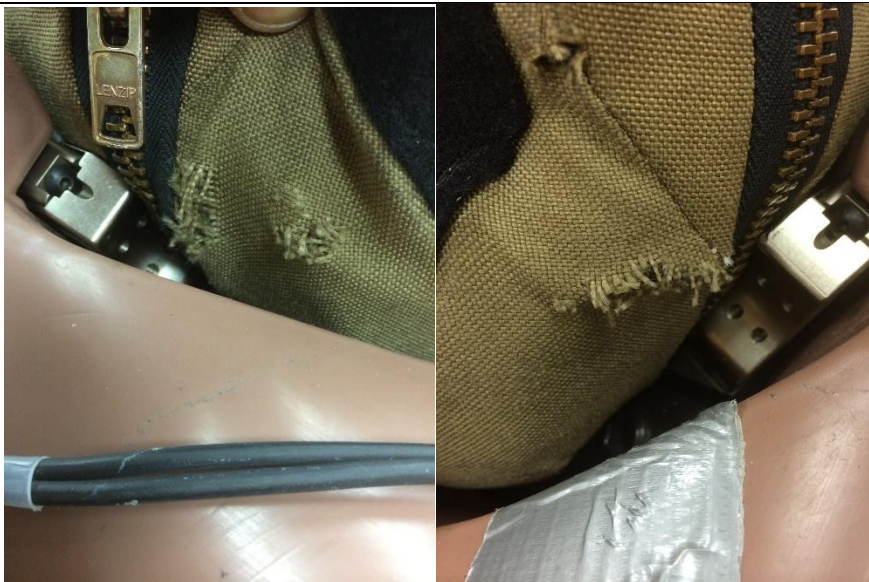
| HEAD | |
|---|---|
| Y / N | No evidence of tearing, cuts, or broken stitches in lower abdomen bag and zipper<br><b>Multiple tears and broken stitches in lower abdomen bag.</b> |

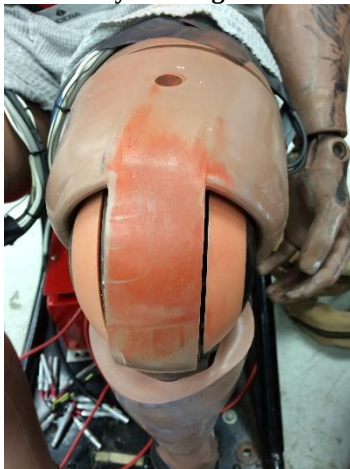
| OTHER | New heavy scuffing on left knee skin. | |

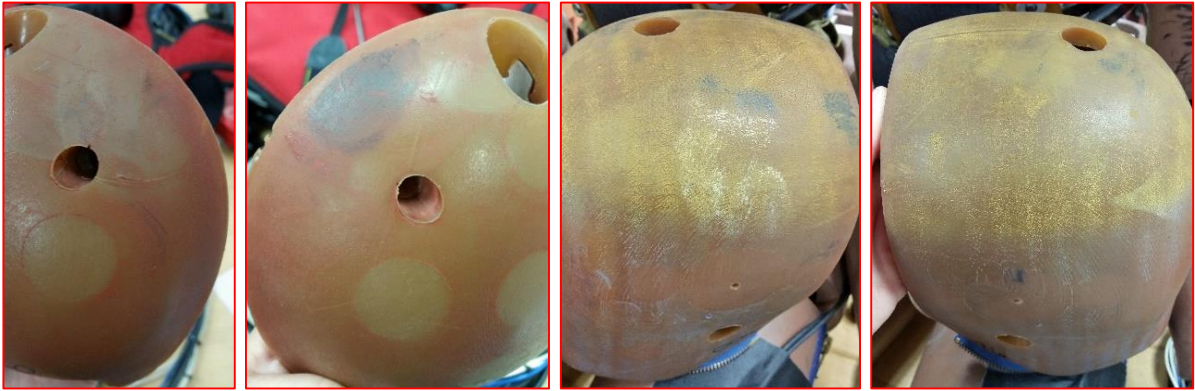
| HEAD | |
|---|---|
| OTHER | <p>Rear head cap has a superficial cut and some scuffing. Head skin has scuffing.</p> |

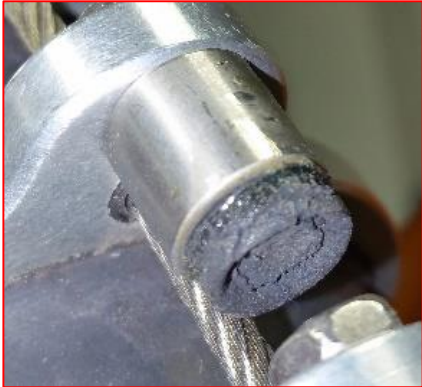
| HEAD | |
|---|---|
| Y / N | <p>No evidence of de-bonding or permanent compression in neck soft stop assemblies</p> <p>Permanent compression of the first neck soft stop</p> |

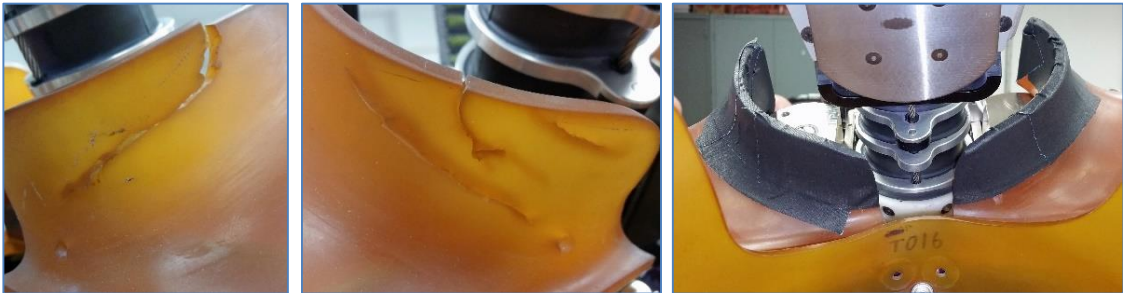
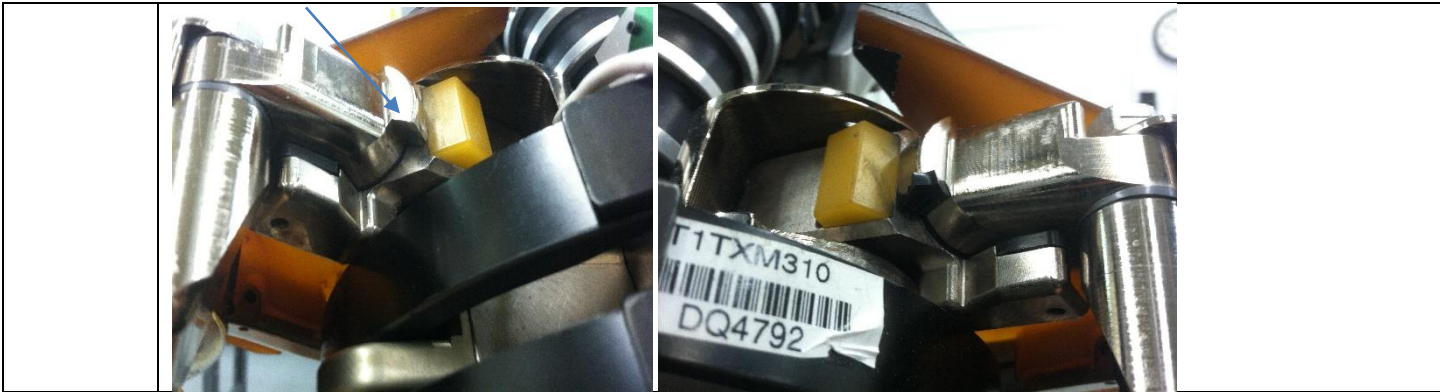
| HEAD | |
|---|---|
| OTHER | <p>Urethane Pads are both torn, completely through, near the neck. We put Gaffer's tape over the tears to protect.</p> <p>LH shoulder bumper missing. RH shoulder bumper deformed</p> |

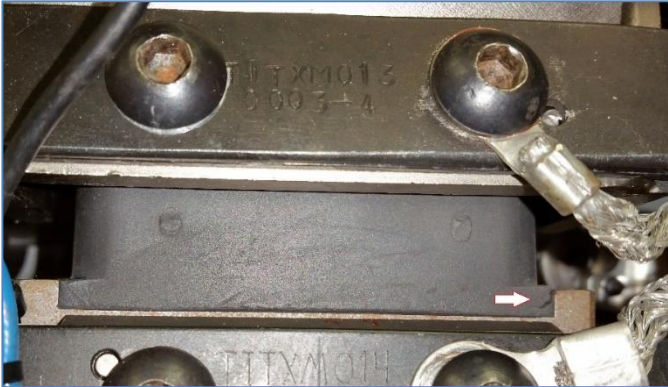
| OTHER | <p>Small cut on the thoracic spine</p> <p>Tears and rubbing damage to the front left Lumbar Spine. Tears also on rear sides – right side is pictured.</p> <div style="display: flex; justify-content: space-around;"> </div> <p>Damage is present on the surrounding metal structures of the Lumbar Spine</p> <div style="display: flex; justify-content: space-around;"> </div> |

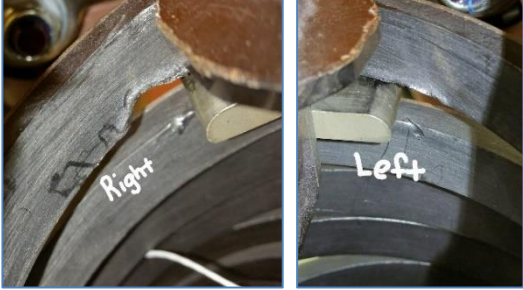
| THORAX | |
|---|---|
| Y / N | <p>No evidence of contact at top, bottom, or interior faces of rib damping material<br/>Both of the top two ribs, left and right, have contact damage</p> |

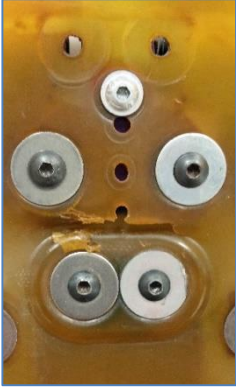
| THORAX | |
|---|---|
| Y / N | <p>Urethane bib is securely attached to ribs with no sign of tearing or washer penetration<br/>Urethane bib has signs of washer penetration repair and a tear</p> |

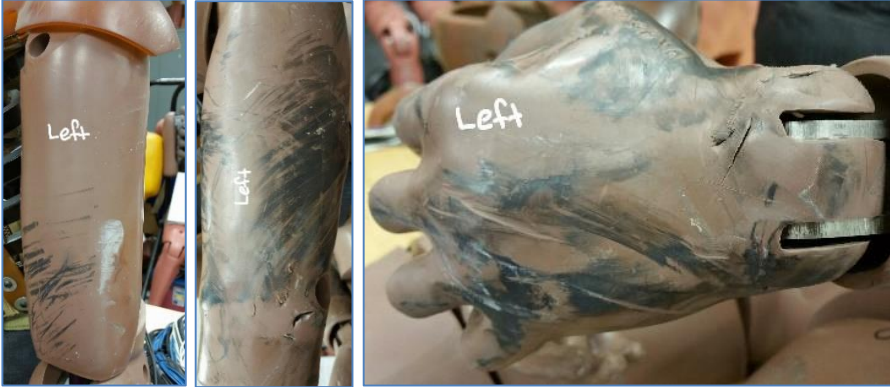
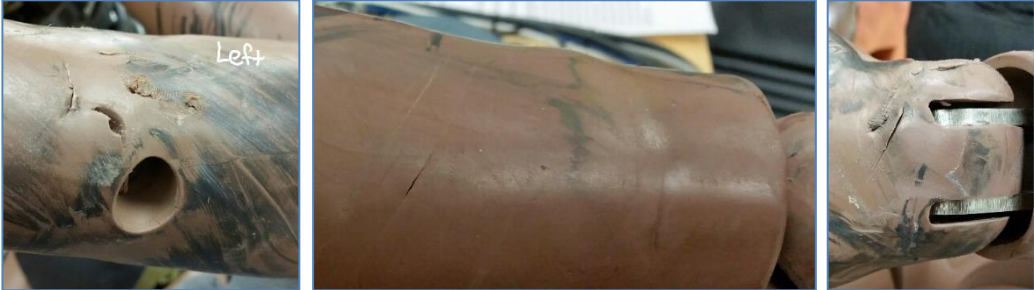
| THORAX | |
|---|---|
| OTHER | <p>There is heavy scuffing to the left upper arm, lower arm, and hand</p> <p>The left hand and lower arm (inside and out) have cuts/punctures</p> |

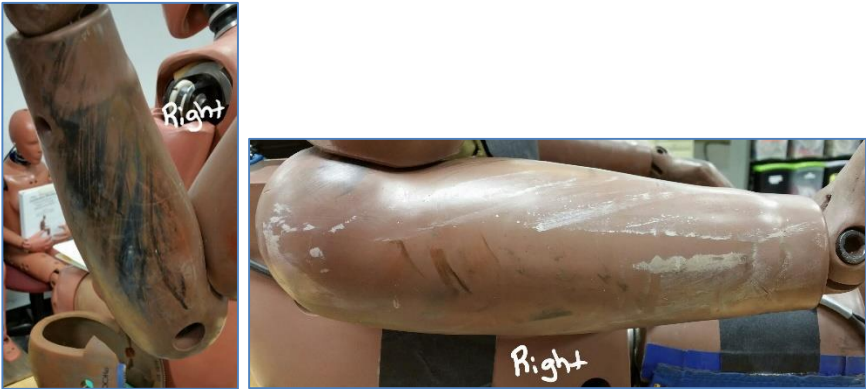
| | <p>The right lower arm (inside and out) has scuffing</p> <p>The inside of the right hand has cuts and the thumb is tearing</p> <p>The back of the right elbow has a small tear</p> |

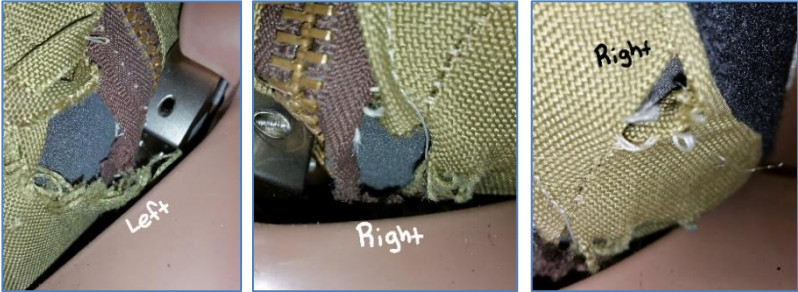
| Y / N | <p>No evidence of tearing, cuts, or broken stitches in lower abdomen bag and zipper</p> <p>Both sides have tears on the lower portion of the bag, and right side is torn near top</p> |

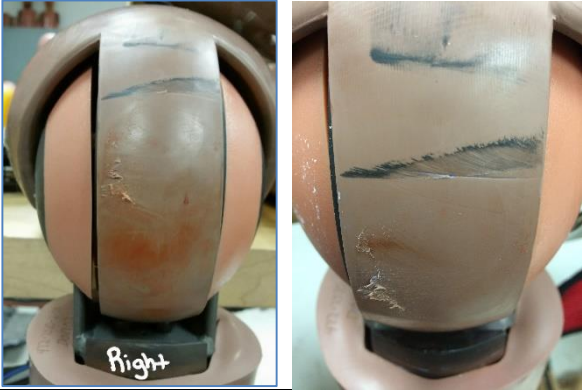
| Y / N | <p>No cuts, tears, or scuffing of knee flesh</p> <p>Scuffing to the right knee</p> <p>Slice on Right knee</p> |

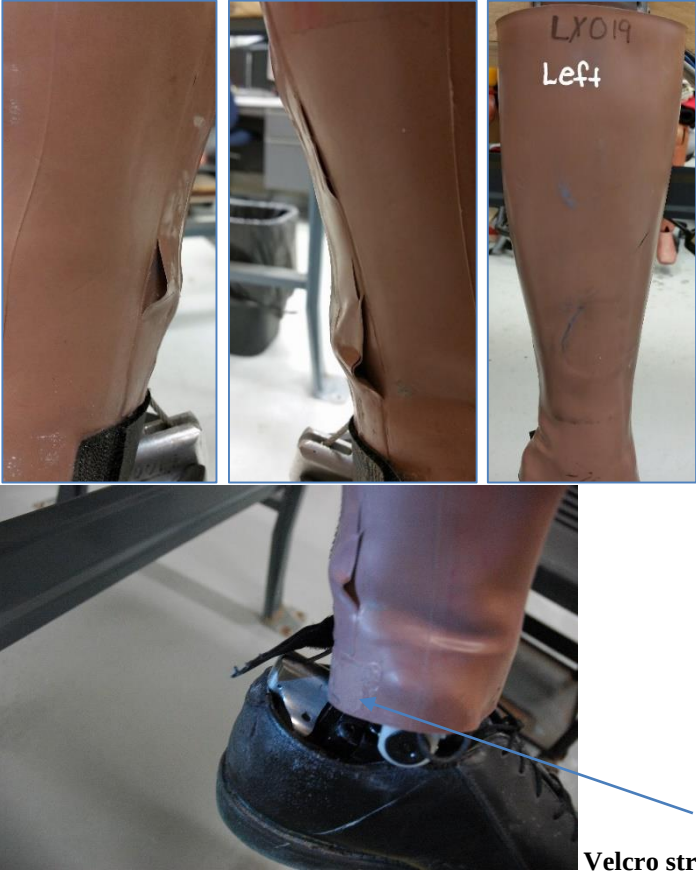
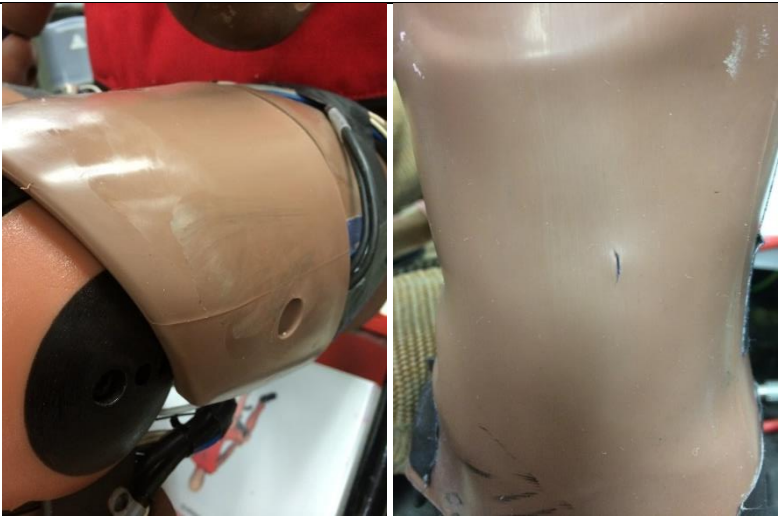
| Y / N | No cuts, tears, or scuffing of leg flesh<br><b>Zipper pulling away from lower leg flesh of the left leg on both sides, and the front is scuffed.</b> | |
| | | Velcro strap torn from LH tibia flesh at ankle. |

| OTHER | front on left calf. | Heavy scuffing on left thigh. Puncture in |

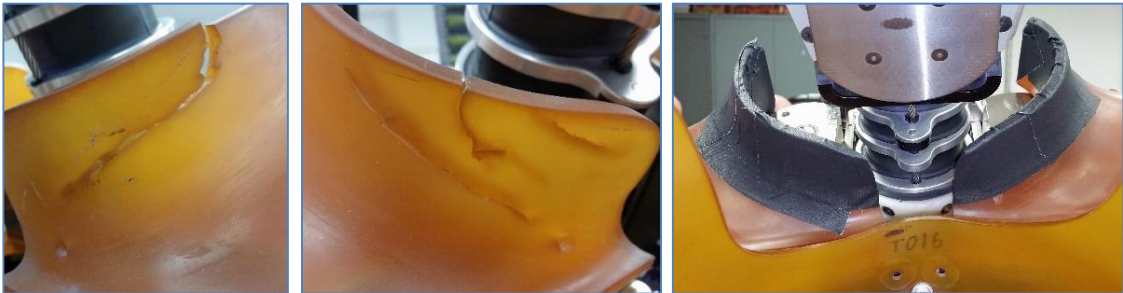
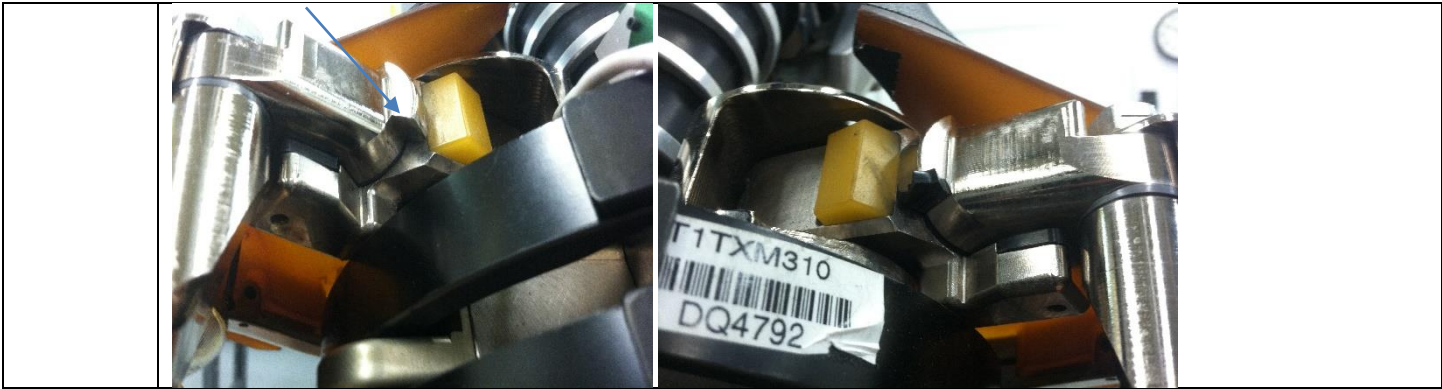
| HEAD | |
|---|---|
| OTHER | <p>Urethane Pads are both torn, completely through, near the neck. We put Gaffer's tape over the tears to protect.</p> <p>LH shoulder bumper missing. RH shoulder bumper deformed</p> |

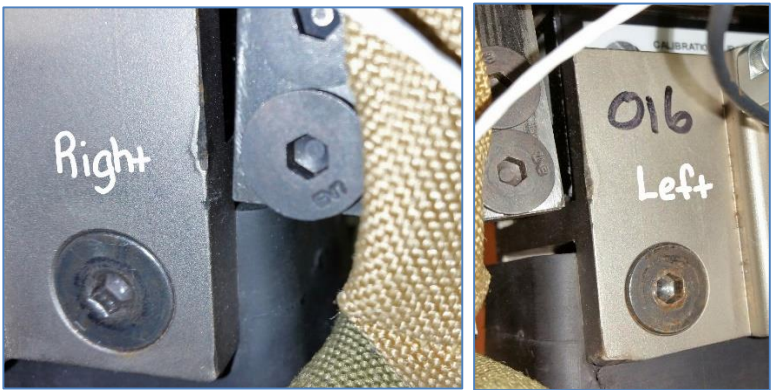
Damage is present on the surrounding metal structures of the Lumbar Spine

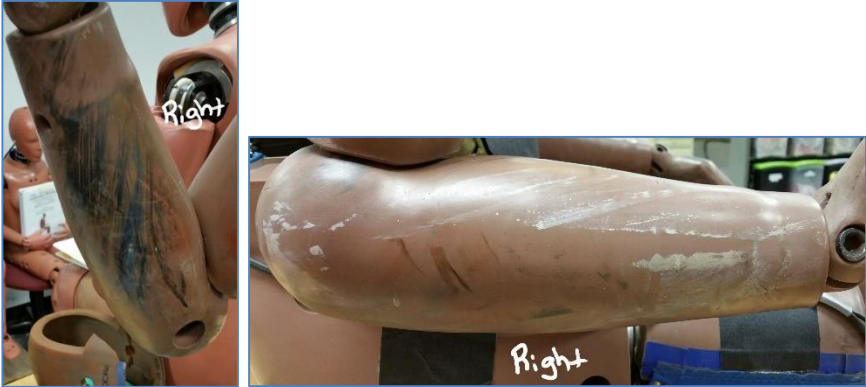
| THORAX | |
|---|---|
| OTHER | <p>There is heavy scuffing to the left upper arm, lower arm, and hand</p> <p>The left hand and lower arm (inside and out) have cuts/punctures</p> |

| | <p>The right lower arm (inside and out) has scuffing</p> <p>The inside of the right hand has cuts and the thumb is tearing</p> <p>The back of the right elbow has a small tear</p> |

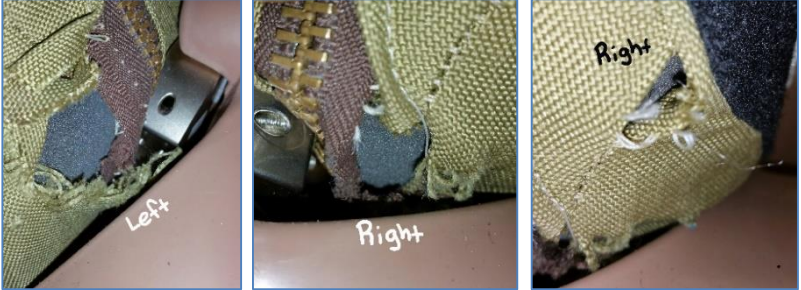
| Y / N | <p>No evidence of tearing, cuts, or broken stitches in lower abdomen bag and zipper</p> <p>Both sides have tears on the lower portion of the bag, and right side is torn near top</p> |

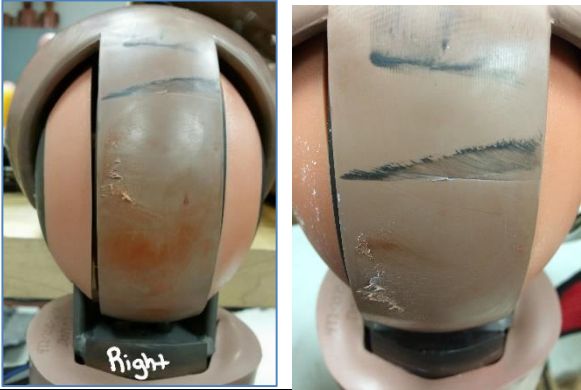
| Y / N | <p>No cuts, tears, or scuffing of knee flesh</p> <p>Scuffing to the right knee</p> <p>Slice on Right knee</p> |

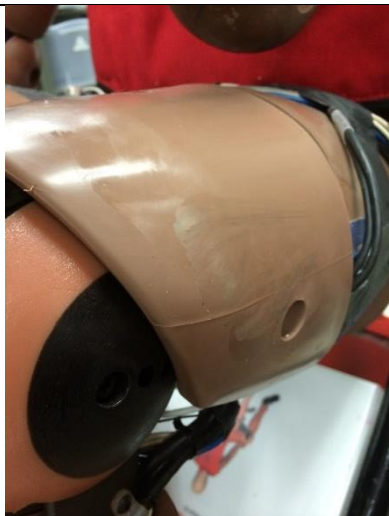
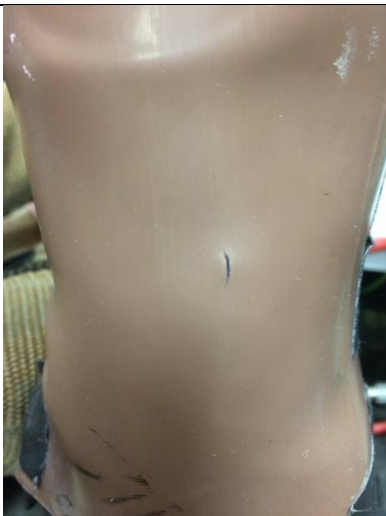
| Y / N | No cuts, tears, or scuffing of leg flesh<br><b>Zipper pulling away from lower leg flesh of the left leg on both sides, and the front is scuffed.</b> | |
| | | Velcro strap torn from LH tibia flesh at ankle. |

| | front on left calf. | Heavy scuffing on left thigh. Puncture in |
