REPORT NUMBER: SPNCAP-CAL-16-001

**NEW CAR ASSESSMENT PROGRAM (NCAP)
SIDE IMPACT POLE TEST**

**Ford Motor Co.
2016 Ford Explorer
SUV**

NHTSA No: M20160206

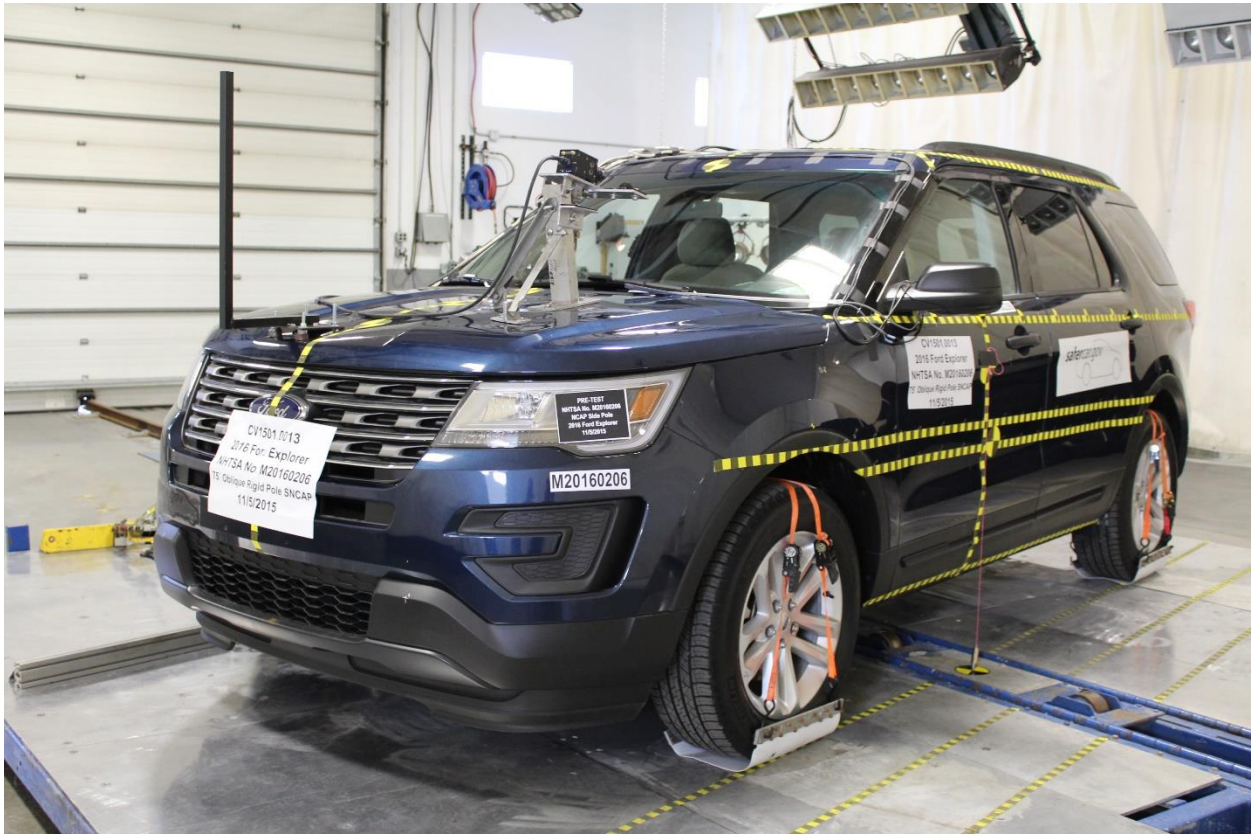
Figure A-4: Post-Test Frontal View of Test Vehicle

Critical Areas of Performance	Observations and Conclusions
Pillar Performance	A-Pillar and B-Pillar buckled inward.
Sill Separation	Bent inwards where pole impacted
Windshield Damage	Shattered throughout with separation along Driver A-Pillar
Side Window Damage	Driver window shattered during impact event
Other Notable Effects	None
