REPORT NUMBER: NCAP-KAR-16-003

**NEW CAR ASSESSMENT PROGRAM (NCAP)
FRONTAL BARRIER IMPACT TEST**

**TOYOTA MOTOR CORPORATION
2016 LEXUS ES 350 4-DOOR SEDAN**

NHTSA NUMBER: M20165100

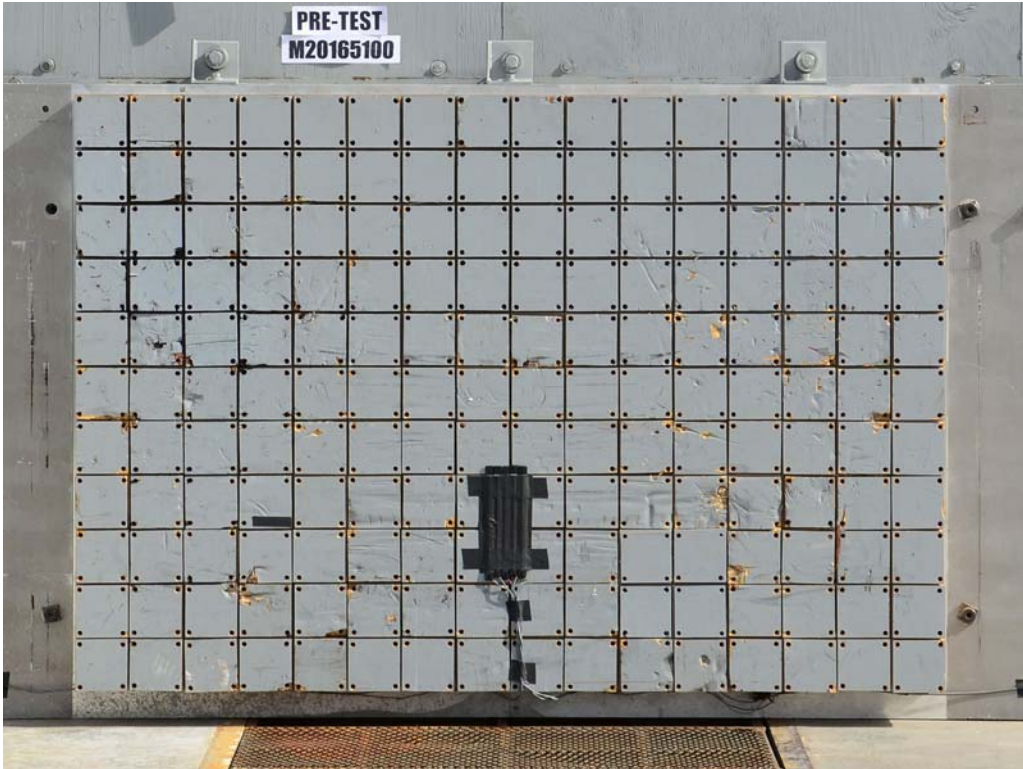
FIGURE 2. Load Cell Wall

A load cell barrier consisting of 176 load cells was impacted by a 2016 Lexus ES 350 4-door sedan at a velocity of 56.52 km/h. The test was performed at KARCO Engineering, LLC. on November 9, 2015. Pre- and post-test photographs of the vehicle and dummies can be found in Appendix A of this report.

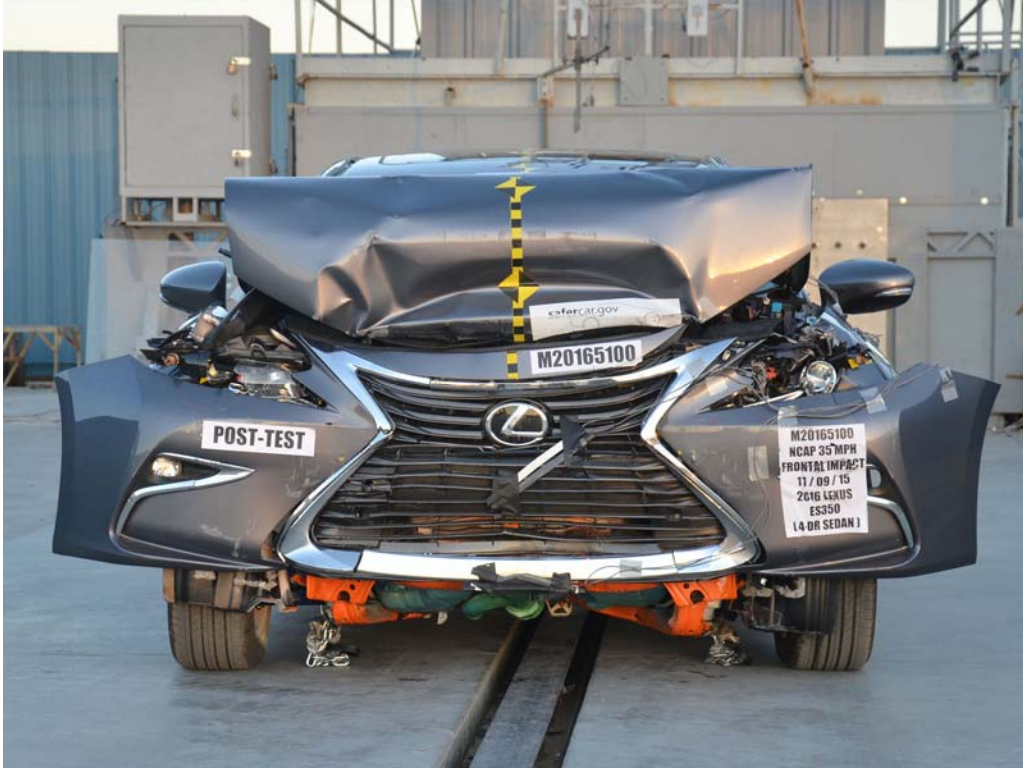
FIGURE 8. Post-Test Front View of Test Vehicle

Critical Areas of Performance	Observations and Conclusions
Windshield Damage	Broken
Window Damage	None
Other Notable Effects	None

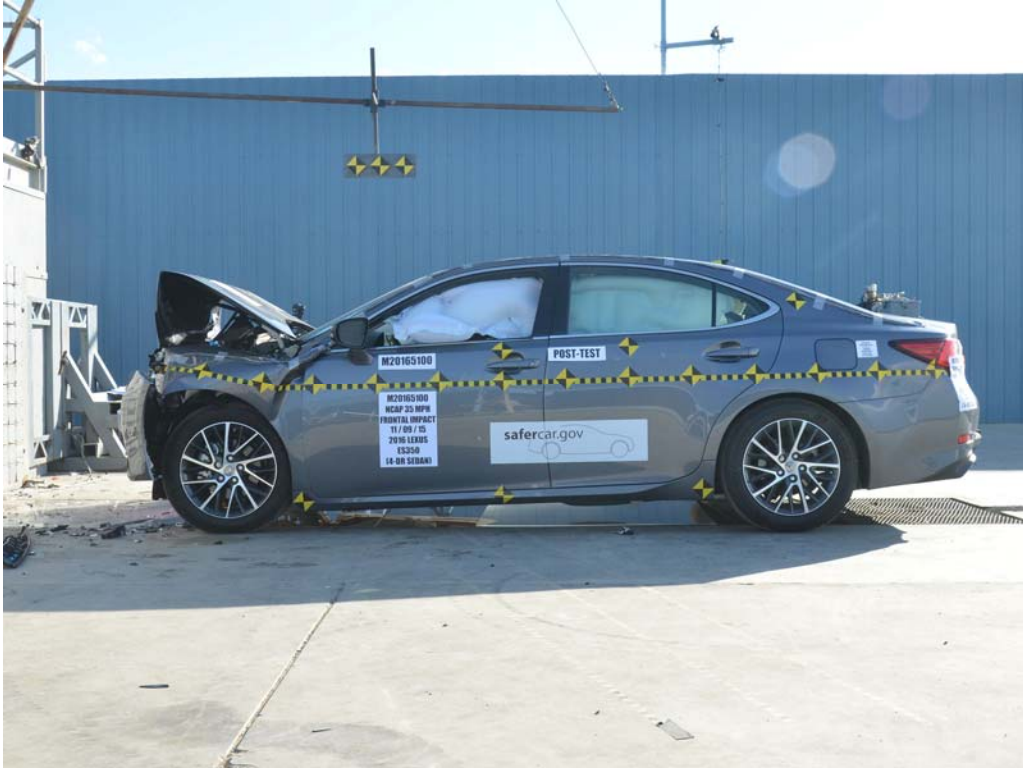
FIGURE 10. Post-Test Left View of Test Vehicle

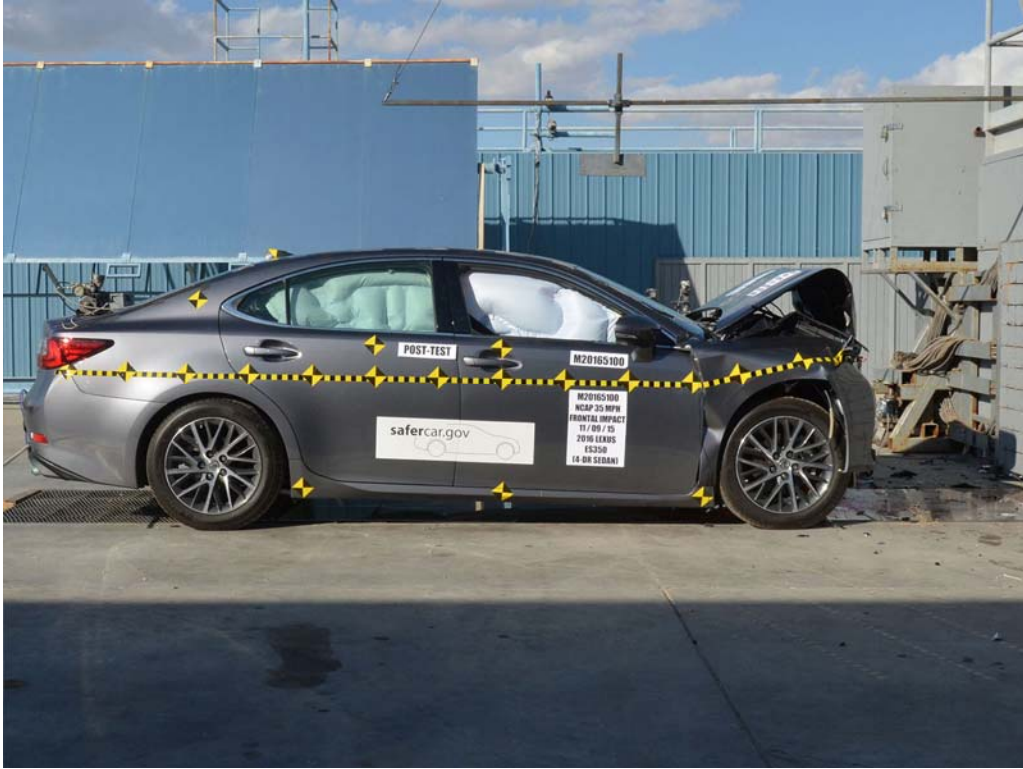
FIGURE 12. Post-Test Right View of Test Vehicle

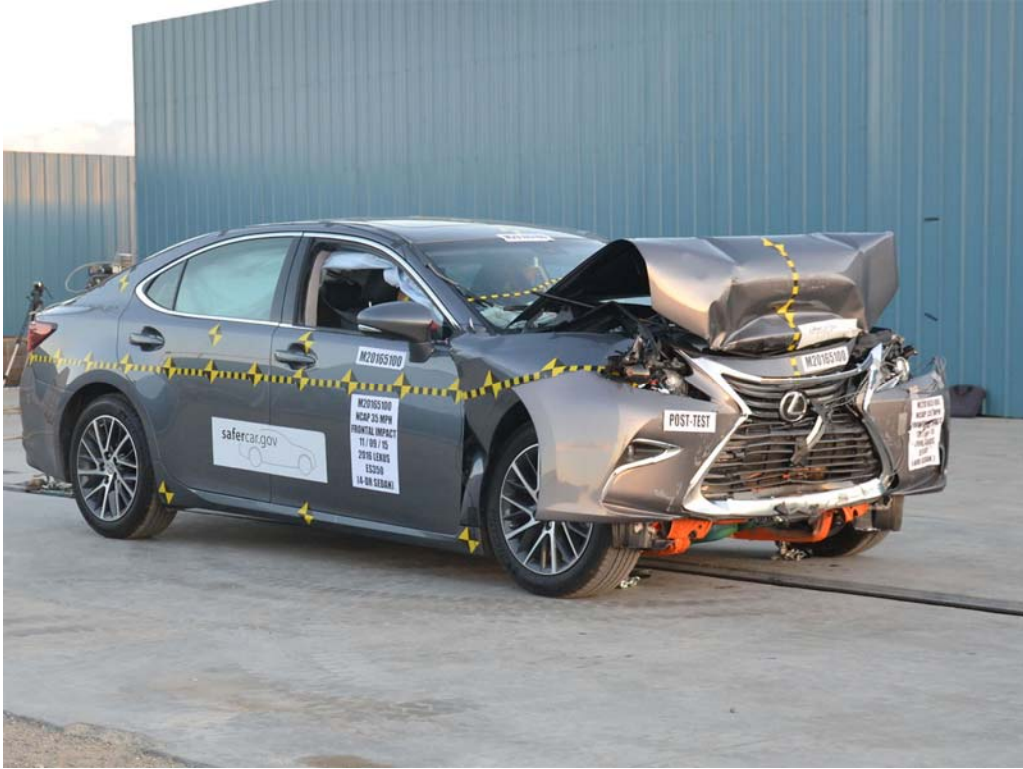
FIGURE 14. Post-Test Right Front $\frac{3}{4}$ View

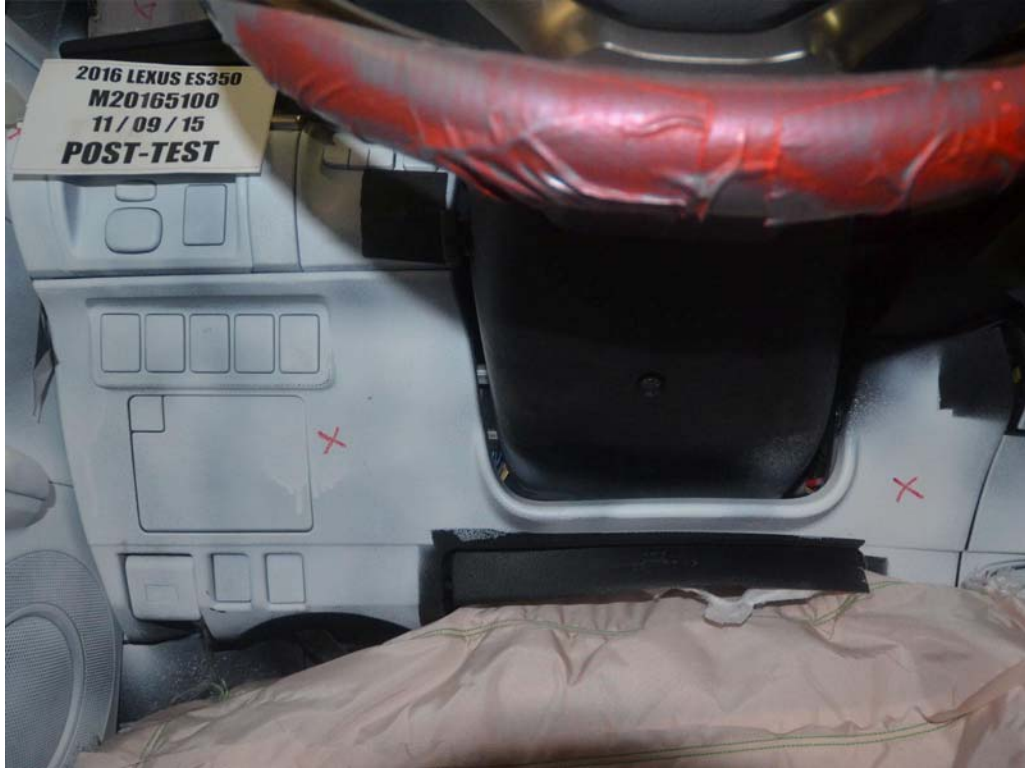
FIGURE 42. Post-Test Driver's Side Knee Bolster
