**REPORT NUMBER: SPNCAP-KAR-16-005  
NEW CAR ASSESSMENT PROGRAM (NCAP)  
SIDE IMPACT POLE TEST**

**TOYOTA MOTOR CORPORATION  
2016 LEXUS ES 350 4-DOOR SEDAN**

**NHTSA No: M20165101**

**FINAL REPORT**

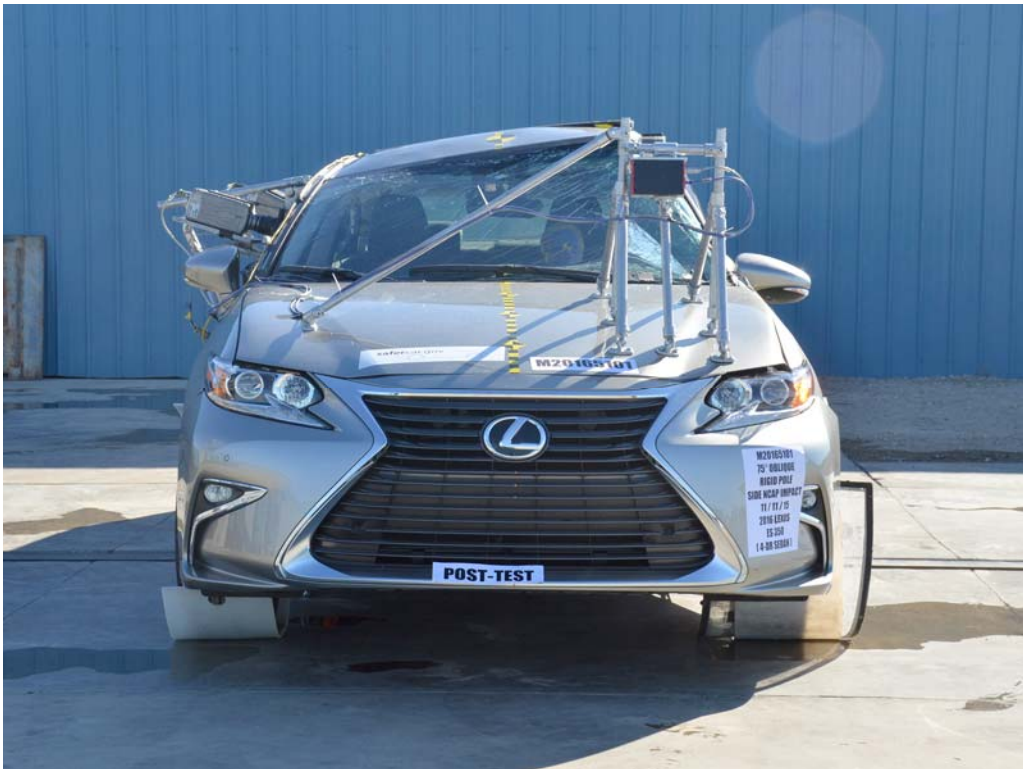
FIGURE 4. Post-Test Frontal View of Test Vehicle

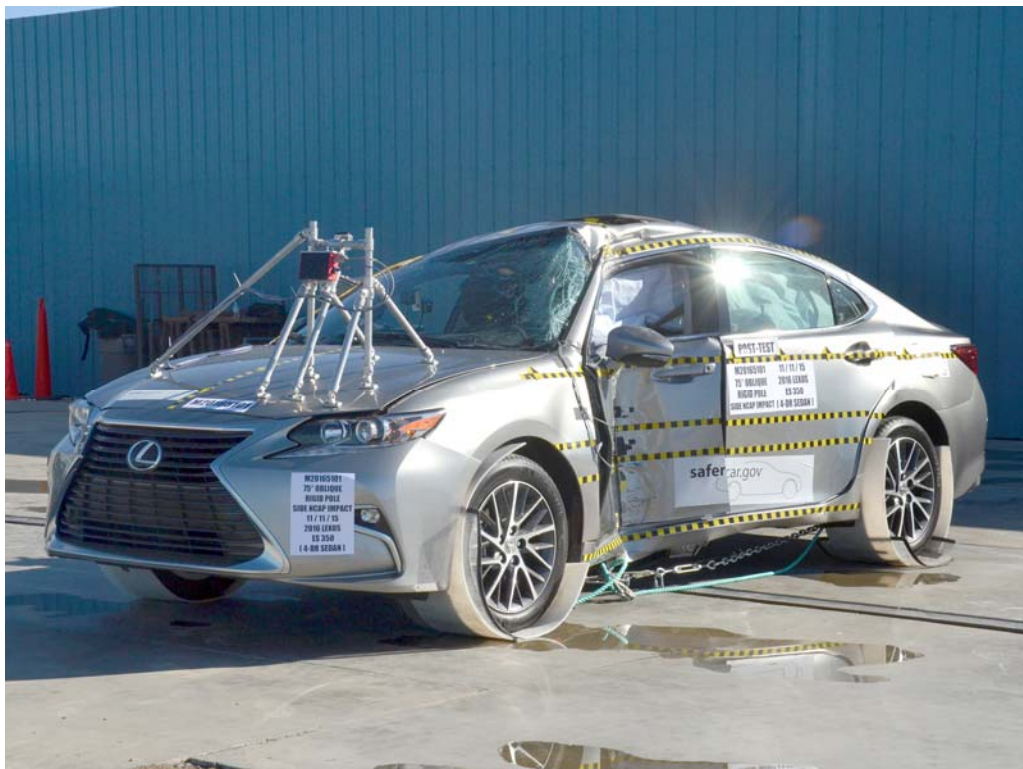
FIGURE 6. Post-Test Left Front  $\frac{3}{4}$  View of Test Vehicle

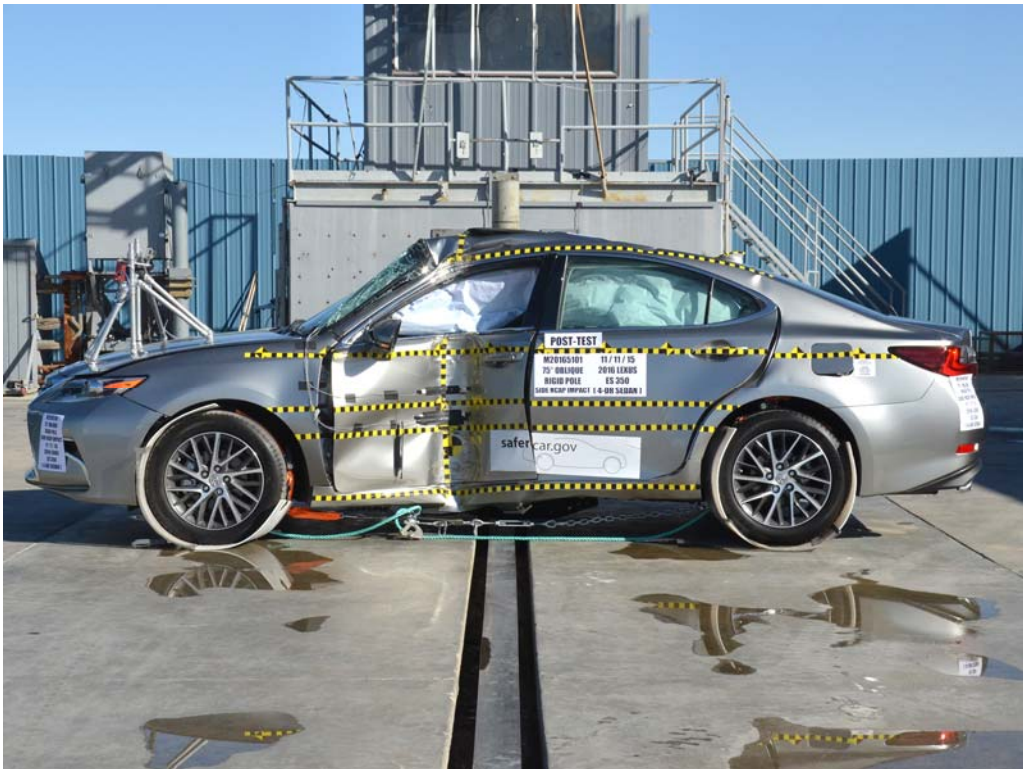
FIGURE 8. Post-Test Left Side View of Test Vehicle

Both the front and rear doors on the struck side of the vehicle were jammed shut while remaining closed and latched. There was no separation at the hinges or latches. Both doors on the non-struck side remained closed and latched. There were no ATD values that exceeded limits.

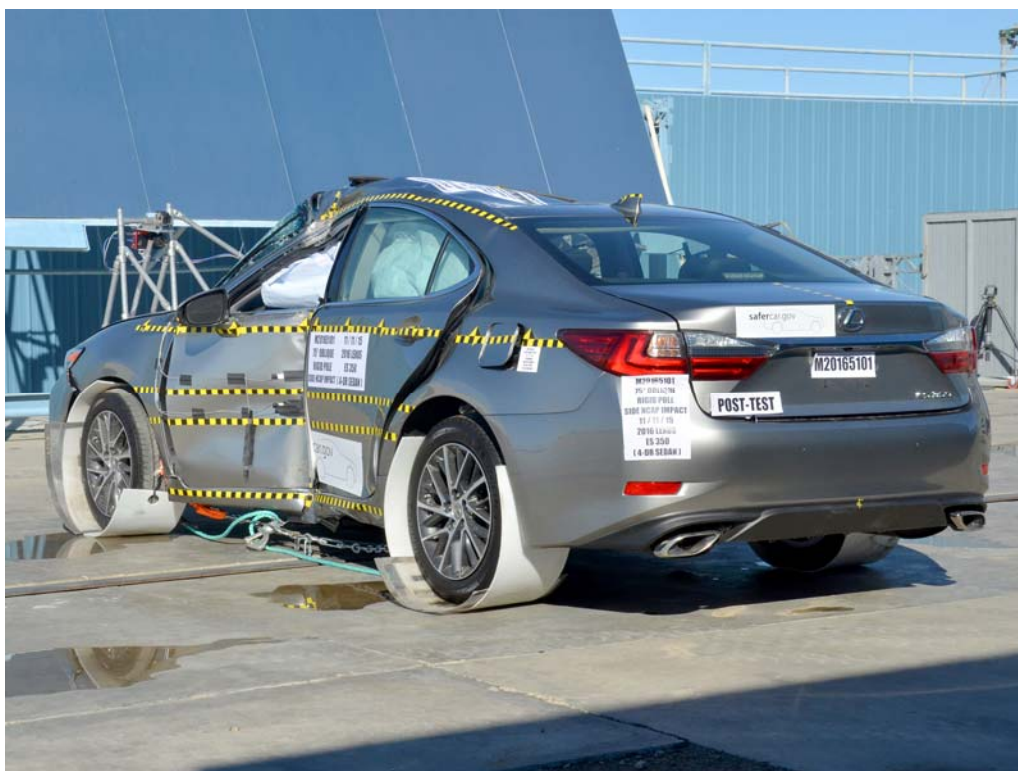
FIGURE 10. Post-Test Left Rear  $\frac{3}{4}$  View of Test Vehicle

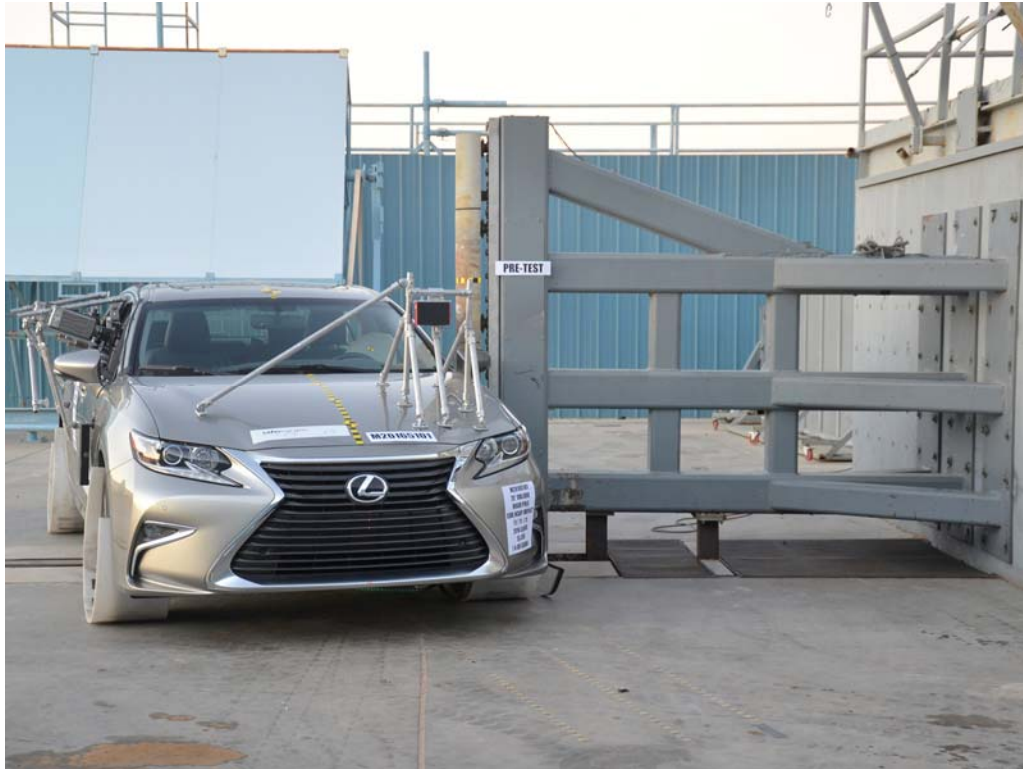
FIGURE 17. Pre-Test Left Side View of Pole  
Positioned Against Side of Vehicle

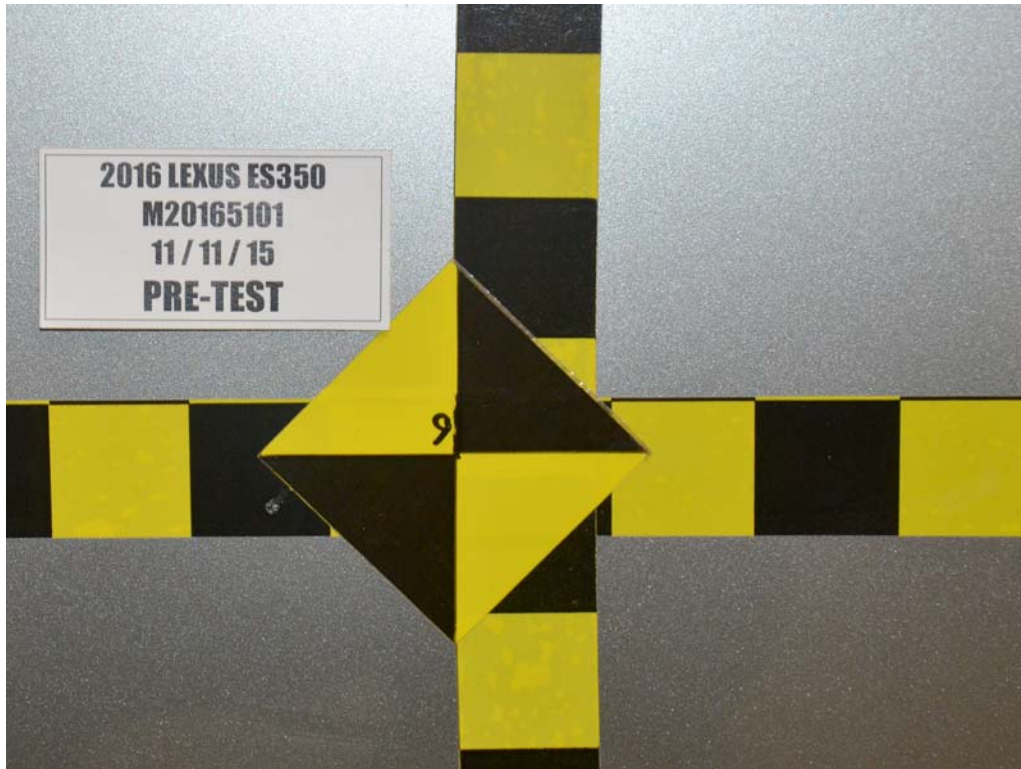
FIGURE 19. Pre-Test Close-Up View of Impact Point Target

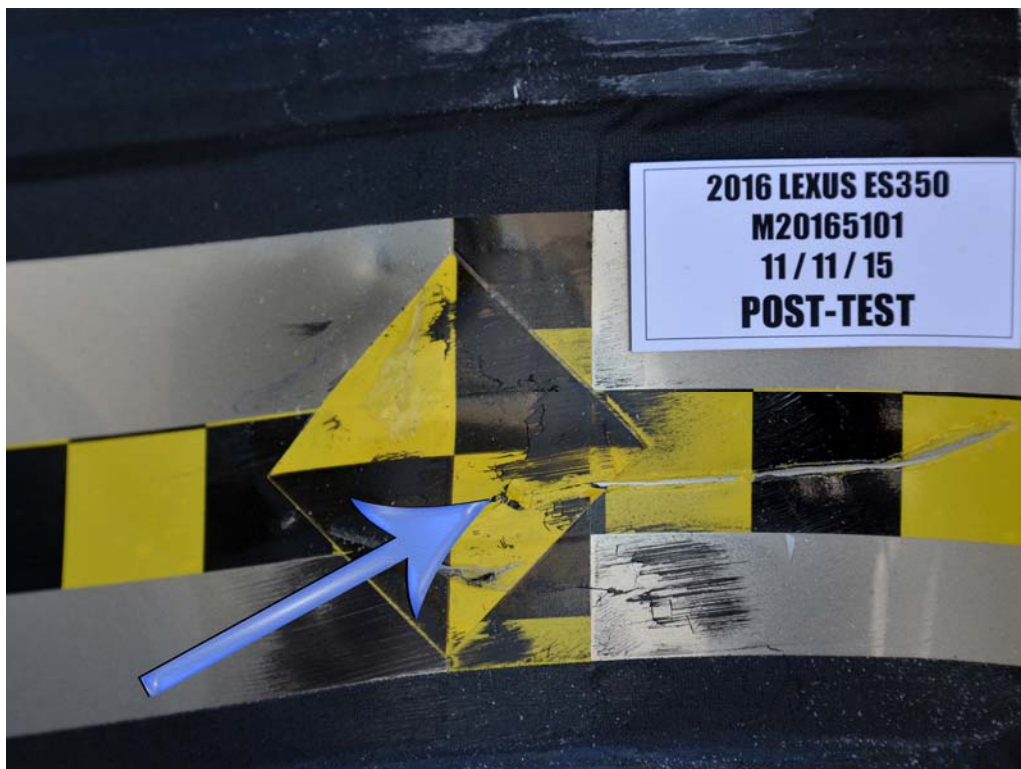
FIGURE 20. Post-Test Close-Up View of Impact Point Target  
Showing Impact Location

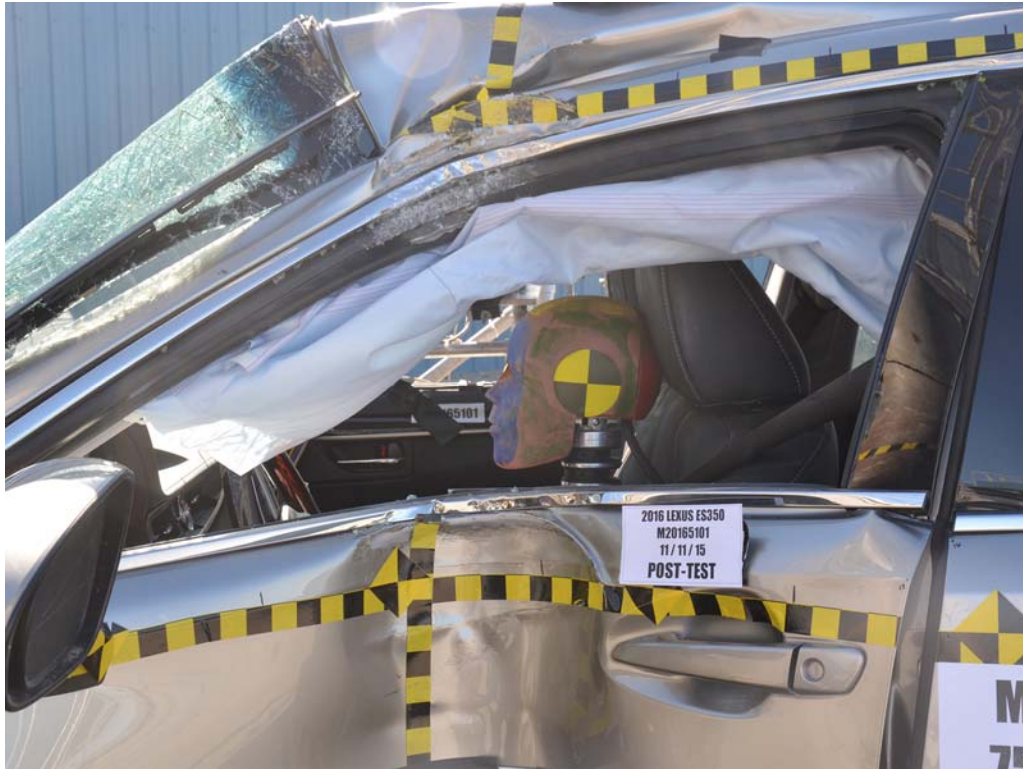
FIGURE 25. Post-Test Left Side View of Dummy Shoulder and Door Top View

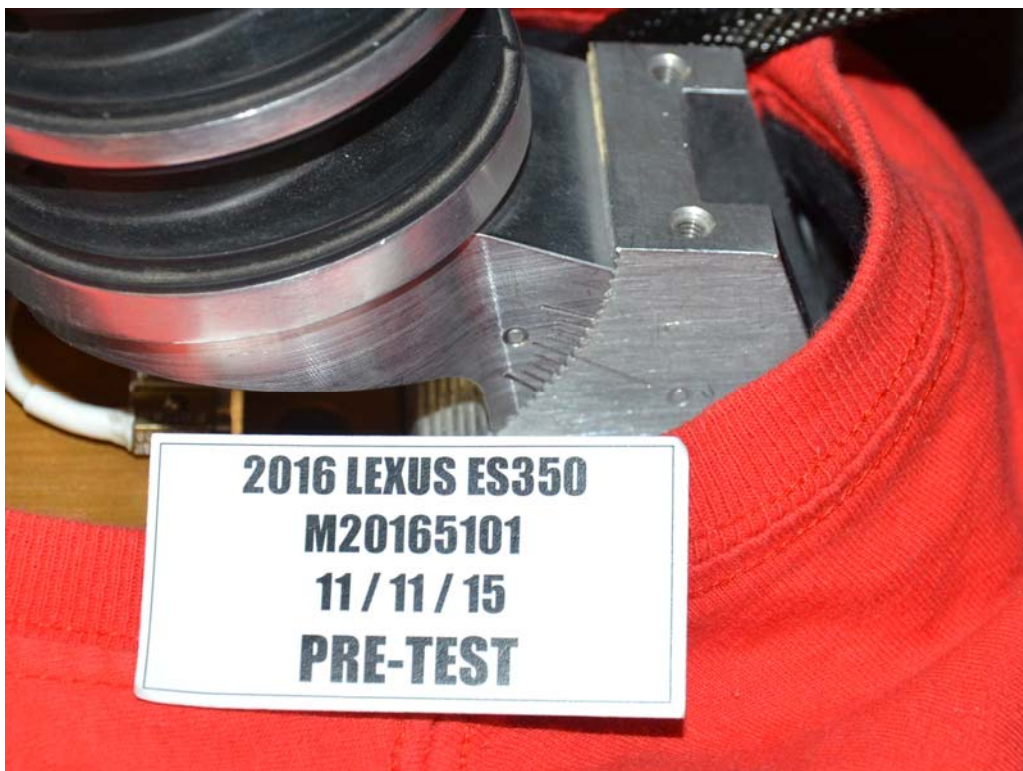
FIGURE 30. Pre-Test Left Side View of Dummy's Neck  
Showing Position of Adjustable Neck Bracket

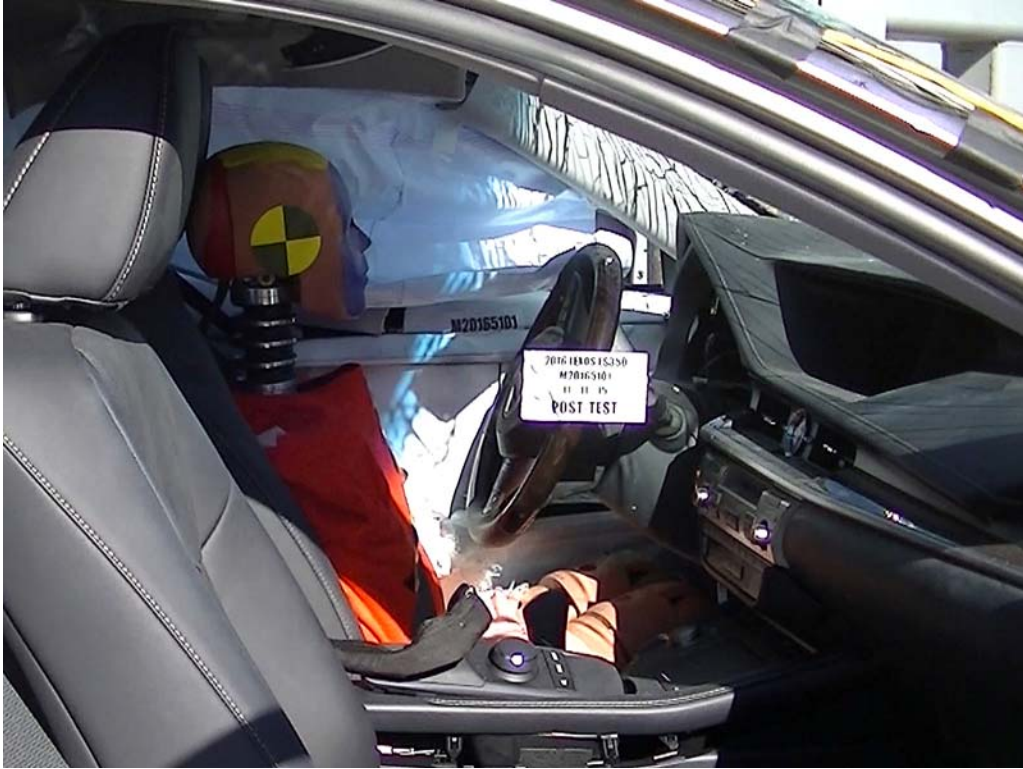
FIGURE 43. Post-Test Right Side View of Dummy and Front Seat of Occupant Compartment

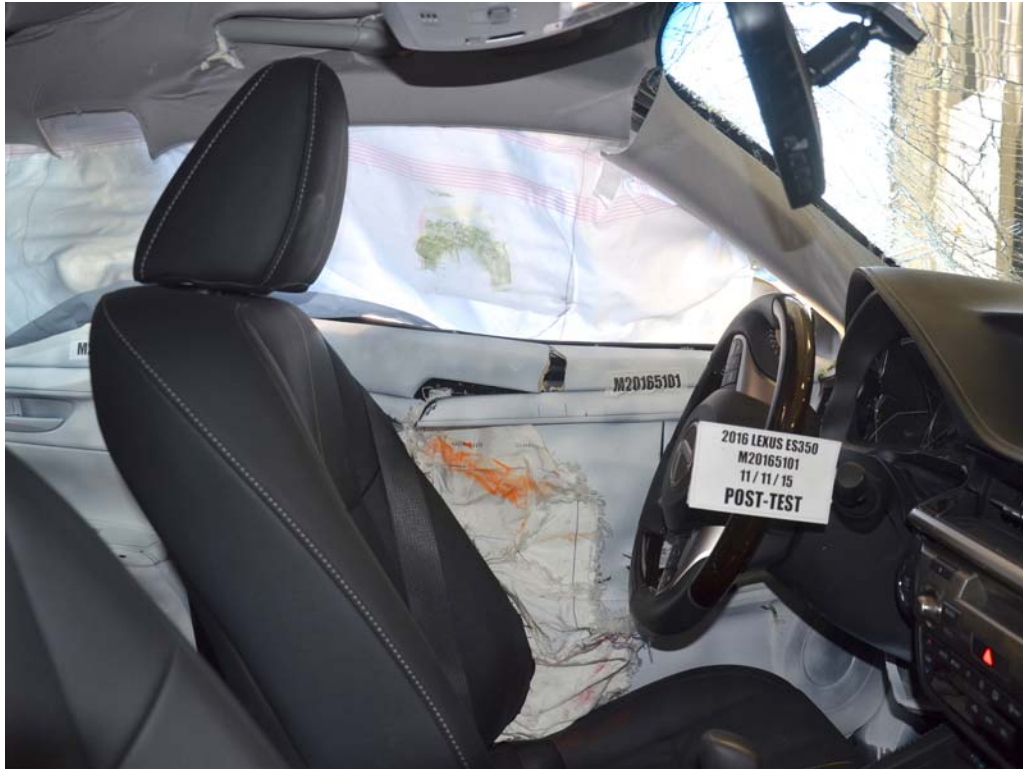
FIGURE 45. Post-Test Inner Door Panel View  
Showing Dummy Contact Locations

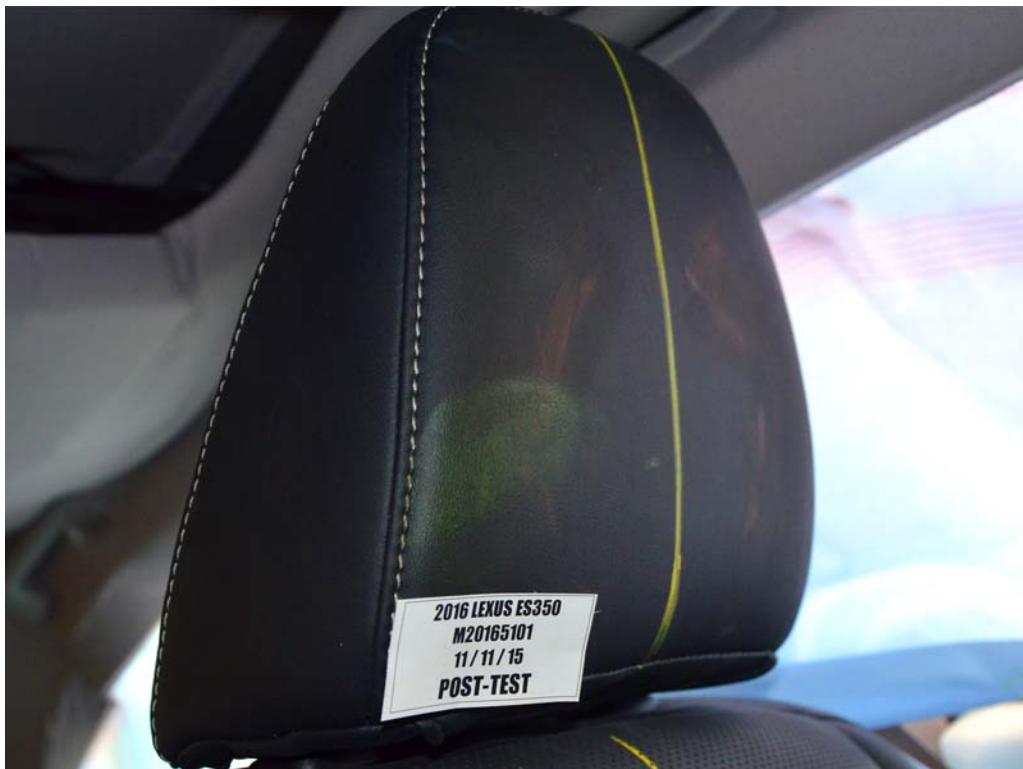
FIGURE 46. Post-Test Dummy Close-Up Head Contact with Vehicle Interior View

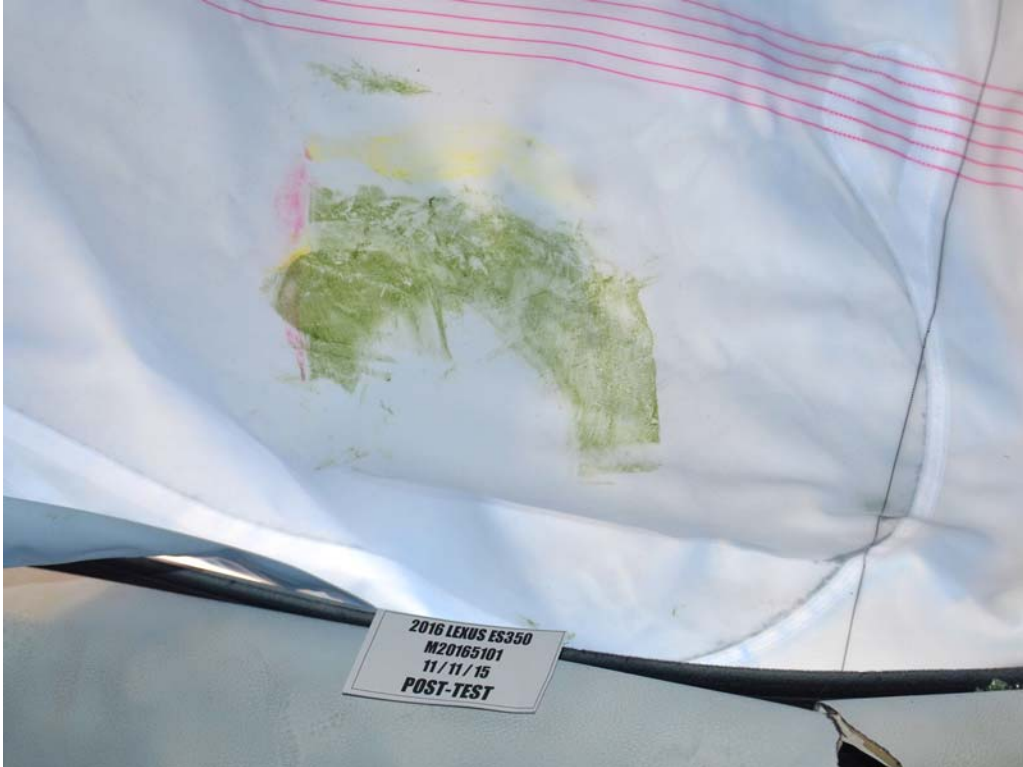
FIGURE 47. Post-Test Dummy Close-Up Head Contact With Side Airbag View

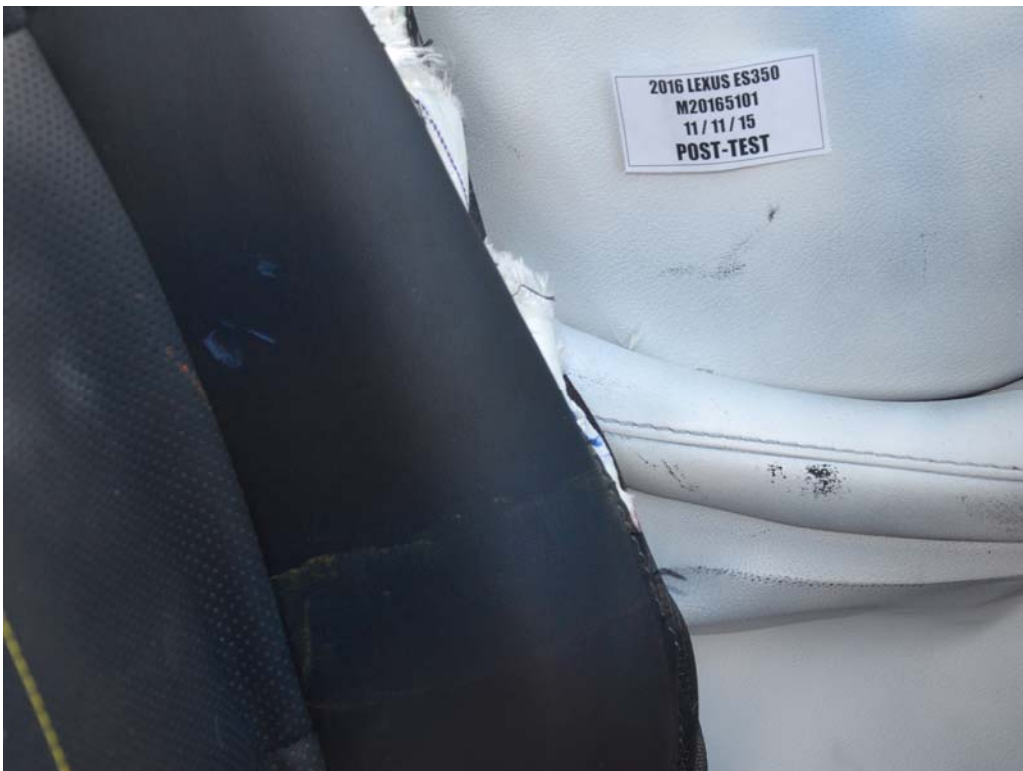
FIGURE 48. Post-Test Dummy Close-Up Torso Contact With Vehicle Interior View

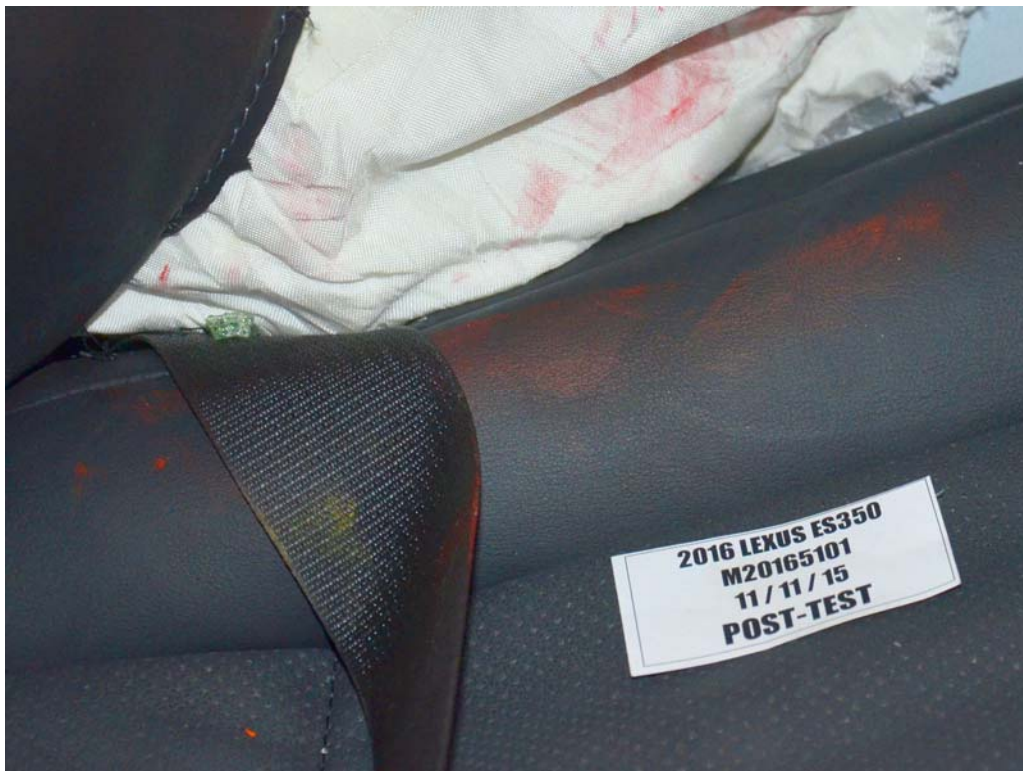
FIGURE 50. Post-Test Dummy Close-Up Pelvis Contact With Vehicle Interior View

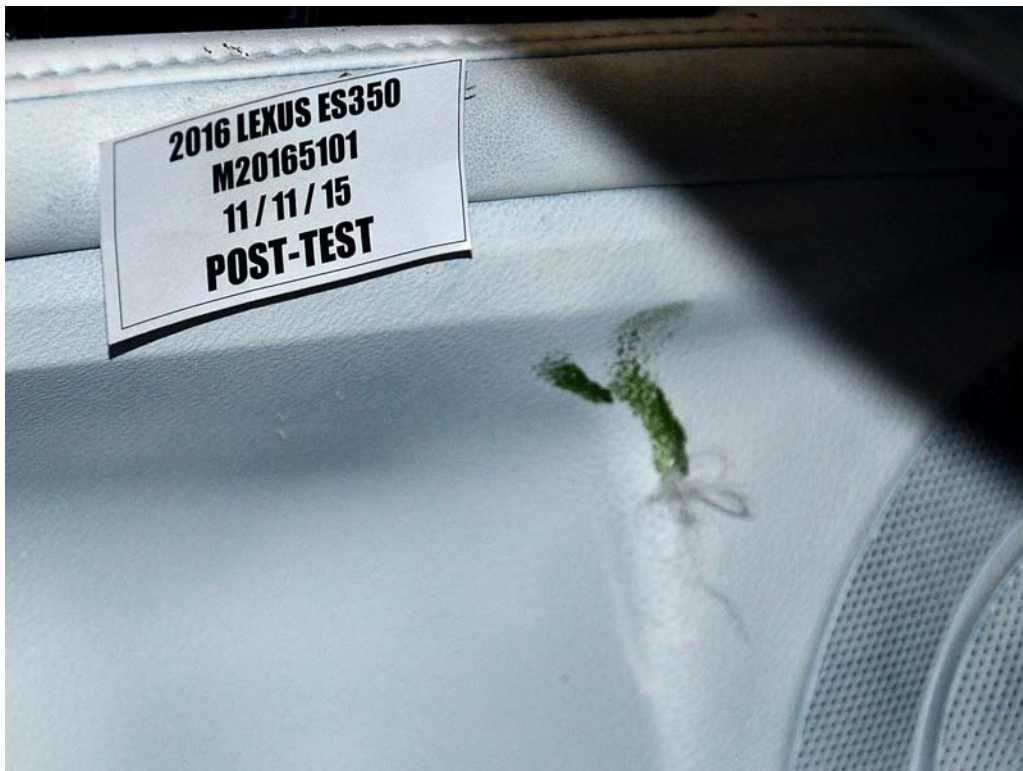
FIGURE 52. Post-Test Dummy Close-Up Knee Contact with Vehicle Interior View
