REPORT NUMBER: SINCAP-KAR-16-007

**NEW CAR ASSESSMENT PROGRAM (NCAP)
MOVING DEFORMABLE BARRIER SIDE IMPACT TEST**

**MAZDA MOTOR CORPORATION
2016 MAZDA CX-3 TOURING SUV**

NHTSA No: M20165402

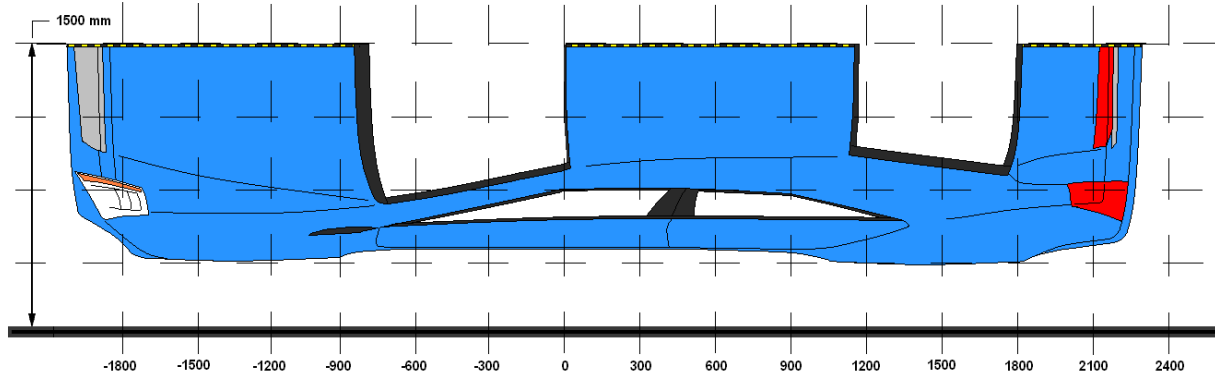
VEHICLE AND MDB DAMAGE PROFILE DISTANCES

VEHICLE DAMAGE PROFILE DISTANCES

MDB DAMAGE PROFILE DISTANCES

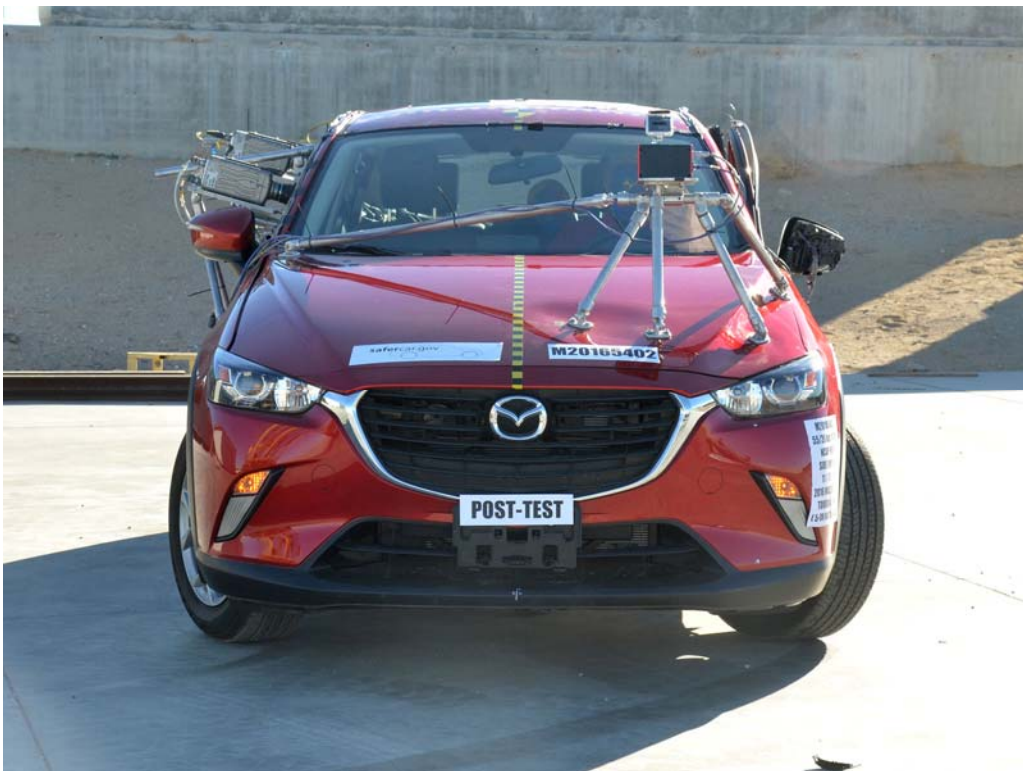
FIGURE 4. Post-Test Frontal View of Test Vehicle

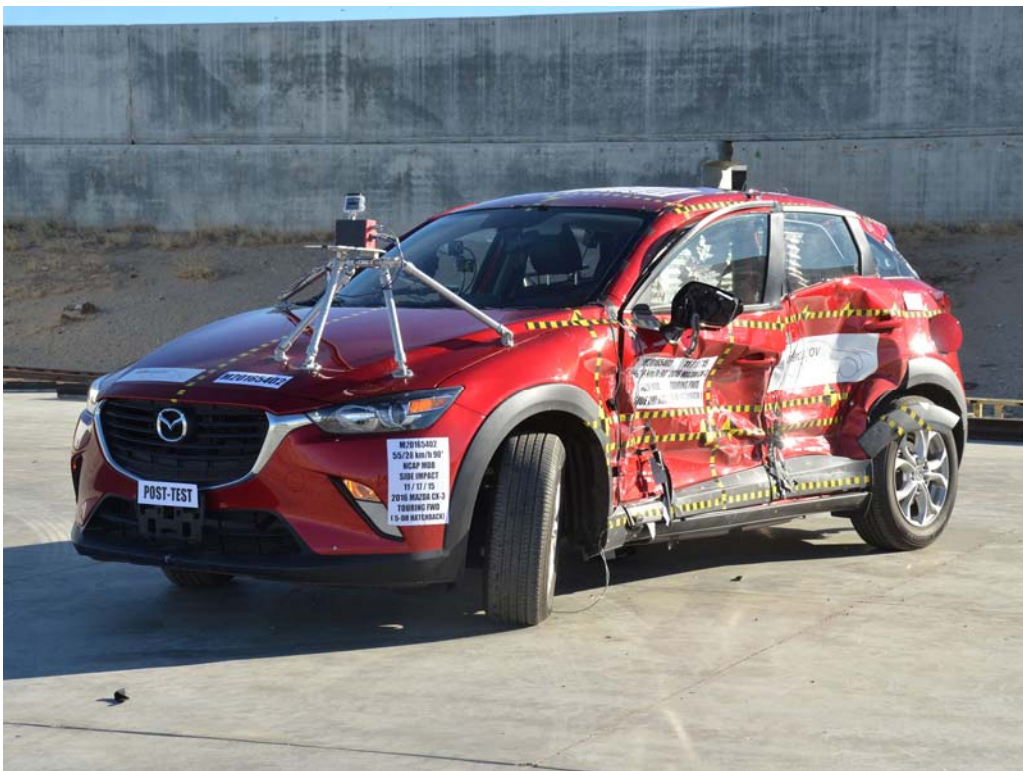
FIGURE 6. Post-Test Left Front $\frac{3}{4}$ View of Test Vehicle

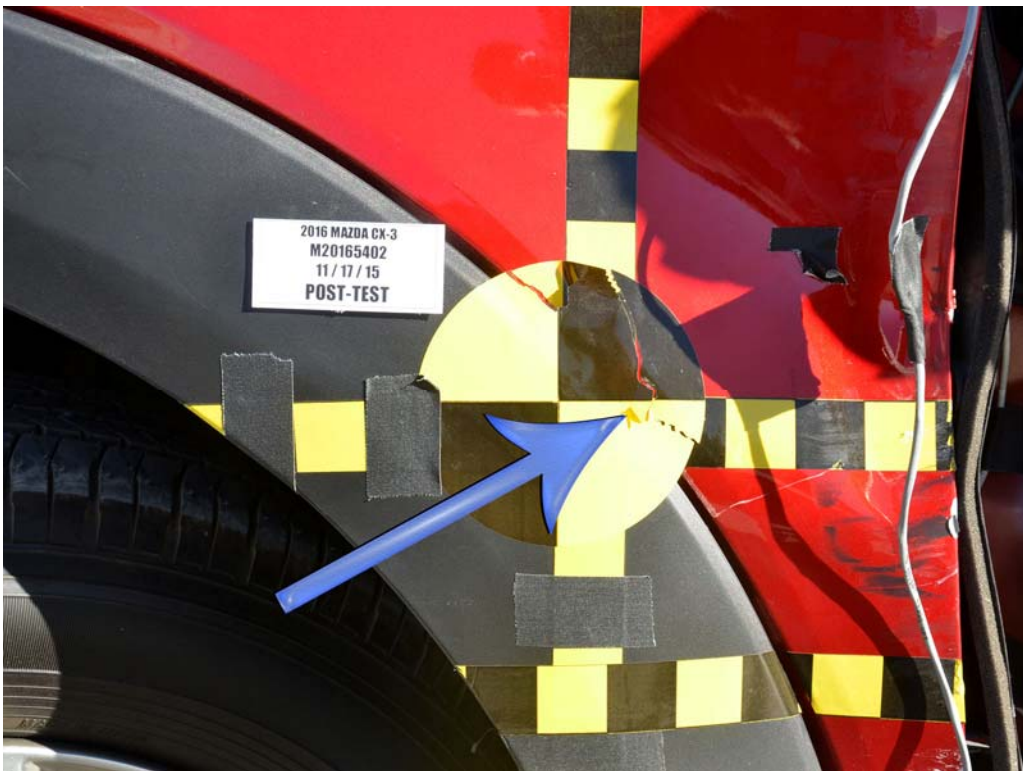
FIGURE 20. Post-Test Close-Up View of Impact Point Target

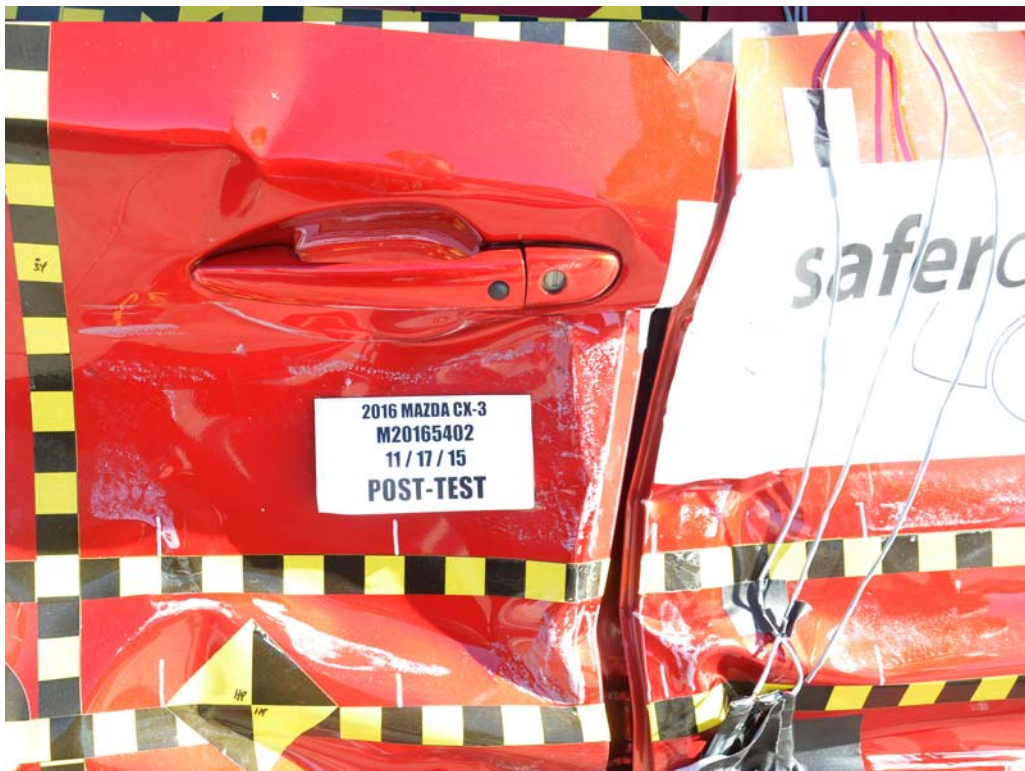
FIGURE 22. Post-Test Left Front Door Latch Close-Up

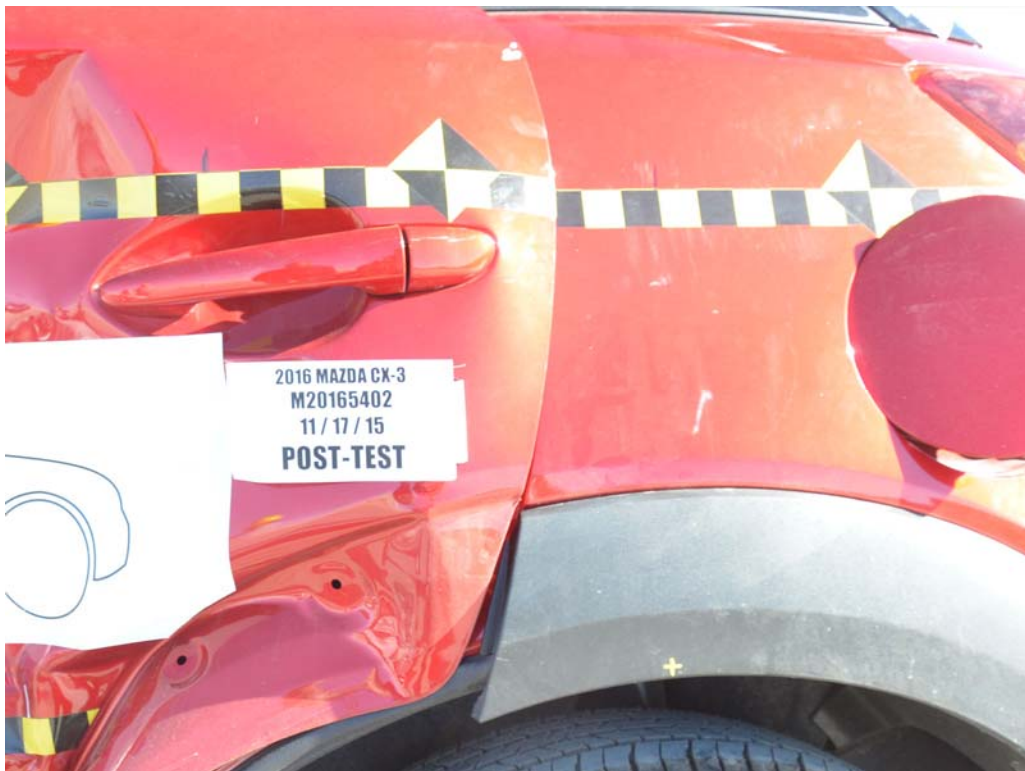
FIGURE 24. Post-Test Left Rear Door Latch Close-Up

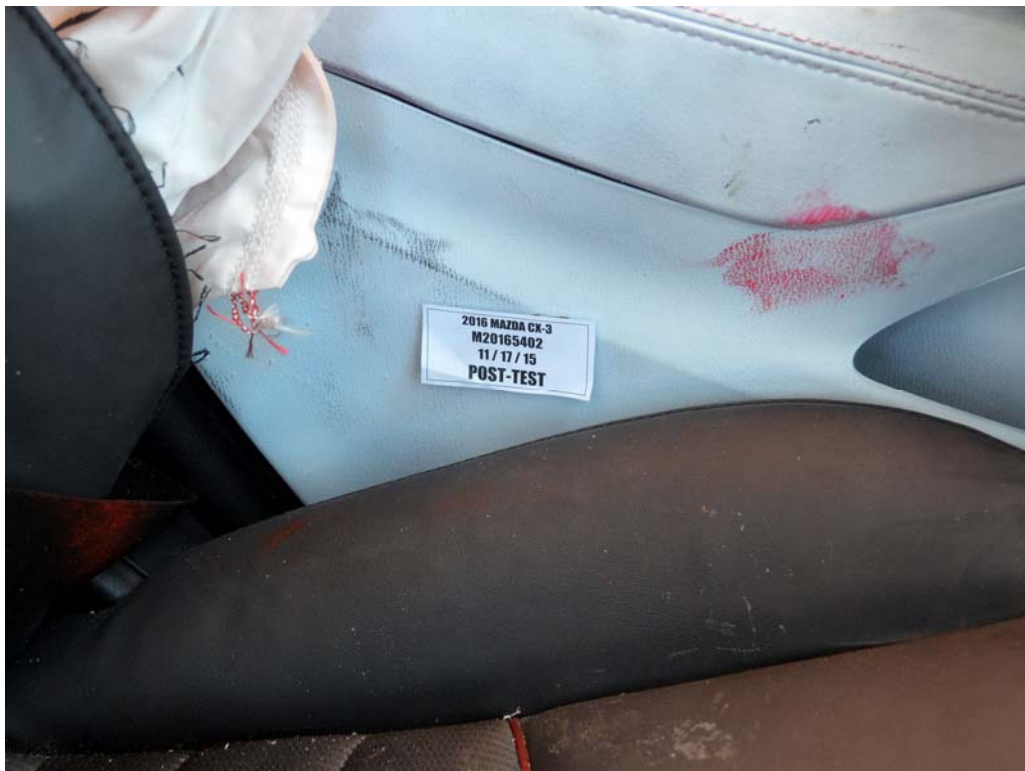
FIGURE 52. Post-Test Driver Dummy Close-Up Pelvis Contact with Vehicle Interior View

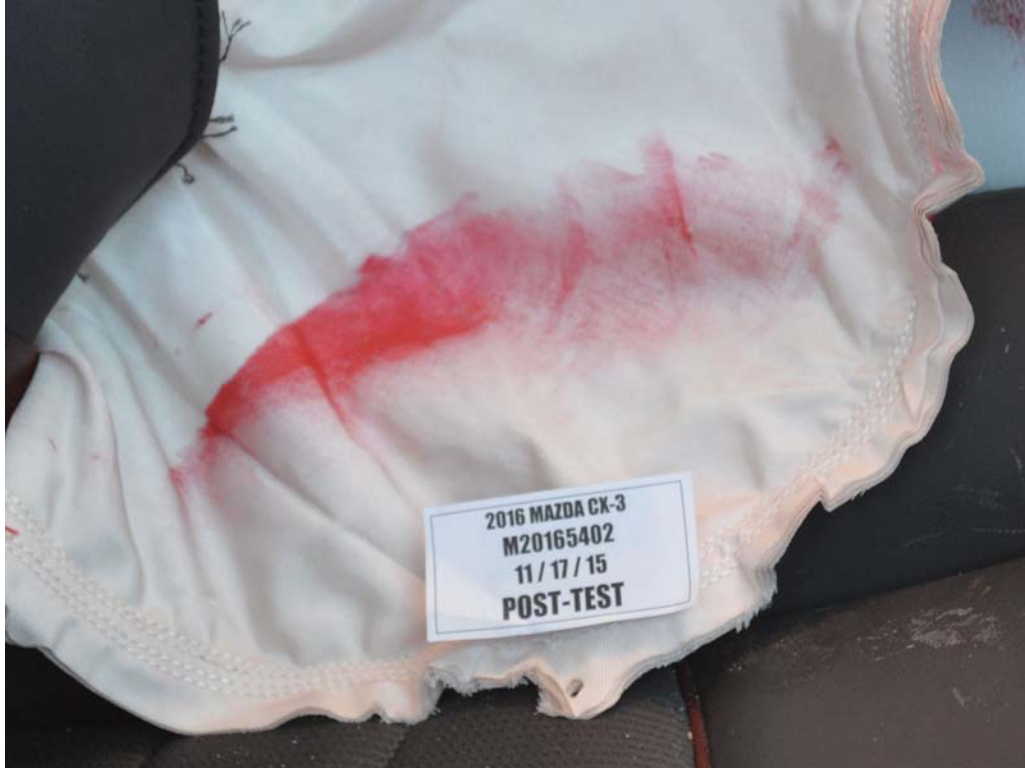
FIGURE 53. Post-Test Driver Dummy Close-Up Pelvis Contact with Side Airbag View

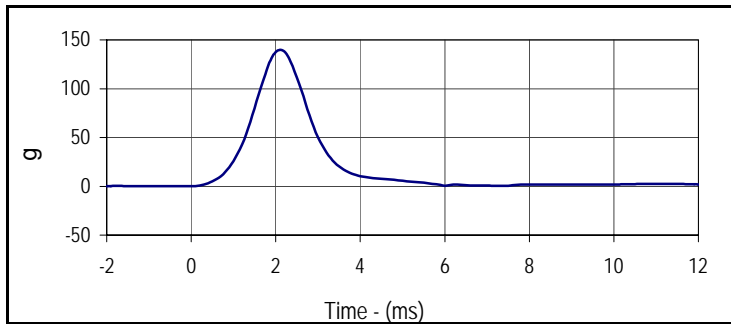
Curve Description			
Head Resultant			
Plot No.	Type	SAE Class	Units
001	RES	1000	g
Max	Time	Min	Time
140.0	2.1	0.1	0.0

Tested Parameter	Units	Specification	Result	Pass/Fail
Head Assembly Soak Time	Minutes	≥240	385	Pass
Temperature During Soak	Max	20.6 to 22.2	21.3	Pass
	Min		21.2	Pass
Humidity During Soak	Max	10.0 to 70.0	23.8	Pass
	Min		23.7	Pass
Laboratory Temperature During Test	°C	20.6 to 22.2	21.3	Pass
Laboratory Humidity During Test	%	10.0 to 70.0	23.8	Pass
Peak Head Resultant Acceleration	g	125 to 155	140.0	Pass
Peak Head X Acceleration	g	≤15	5.3	Pass
Is Acceleration Unimodal?	Yes/No	Yes	Yes	Pass
Oscillations After Main Pulse	%	<15	0.3	Pass
Overall Test Results				Pass

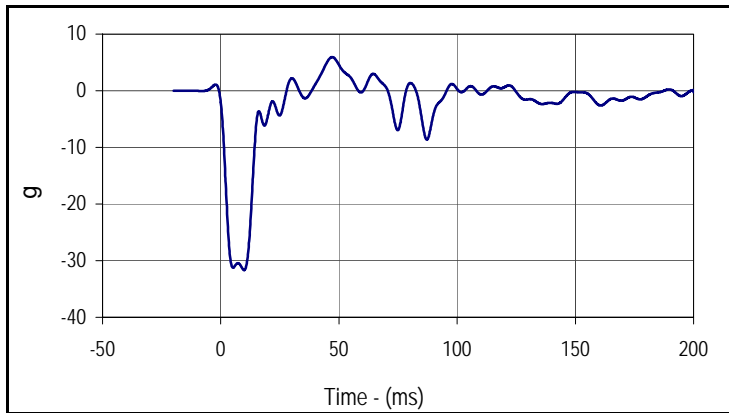
Curve Description			
Pendulum Deceleration			
Plot No.	Type	SAE Class	Units
001	FIL	60	g
Max	Time	Min	Time
5.9	47.1	-31.7	9.9

Tested Parameter	Units	Specification	Result	Pass/Fail
Neck Assembly Soak Time	Minutes	≥240	420	Pass
Temperature During Soak	Max	20.6 to 22.2	21.3	Pass
	Min		21.2	Pass
Humidity During Soak	Max	10.0 to 70.0	23.8	Pass
	Min		23.7	Pass
Laboratory Temperature During Test	°C	20.6 to 22.2	21.3	Pass
Laboratory Humidity During Test	%	10.0 to 70.0	23.8	Pass
Pendulum Velocity	m/s	3.3 to 3.5	3.35	Pass
Headform Flexion	Max	49 to 59	54.3	Pass
	Time	54 to 66	54.6	Pass
Headform Flexion Decay (Peak to Zero)	msec	53 to 88	62.6	Pass
Overall Test Results				Pass

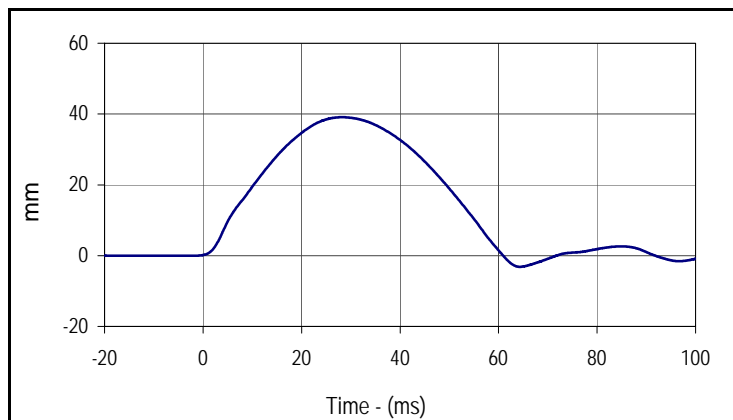
Curve Description			
Upper Rib Deflection (459 mm Drop Height)			
Plot No.	Type	SAE Class	Units
001	FIL	180	mm
Max	Time	Min	Time
39.1	28.2	-3.2	64.3

Tested Parameter	Units	Specification	Result	Pass/Fail
Rib Module Soak Time	Minutes	≥240	540	Pass
Temperature During Soak	Max	20.6 to 22.2	21.3	Pass
	Min		21.2	Pass
Humidity During Soak	Max	10.0 to 70.0	23.8	Pass
	Min		23.7	Pass
Laboratory Temperature During Test	°C	20.6 to 22.2	21.3	Pass
Laboratory Humidity During Test	%	10.0 to 70.0	23.7	Pass
Peak Rib Deflection at 459 +/- 5 mm Drop Height	mm	36 to 40	39.1	Pass
Peak Rib Deflection at 815 +/- 8 mm Drop Height	mm	46 to 51	50.7	Pass
Overall Test Results				Pass

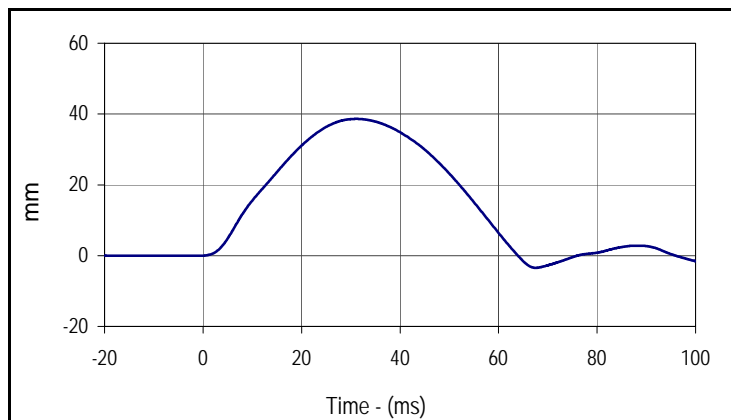
Curve Description			
Middle Rib Deflection (459 mm Drop Height)			
Plot No.	Type	SAE Class	Units
001	FIL	180	mm
Max	Time	Min	Time
38.6	31.2	-3.5	67.5

Tested Parameter	Units	Specification	Result	Pass/Fail
Rib Module Soak Time	Minutes	≥240	585	Pass
Temperature During Soak	Max	20.6 to 22.2	21.3	Pass
	Min		21.2	Pass
Humidity During Soak	Max	10.0 to 70.0	23.8	Pass
	Min		23.7	Pass
Laboratory Temperature During Test	°C	20.6 to 22.2	21.2	Pass
Laboratory Humidity During Test	%	10.0 to 70.0	23.7	Pass
Peak Rib Deflection at 459 +/- 5 mm Drop Height	mm	36 to 40	38.6	Pass
Peak Rib Deflection at 815 +/- 8 mm Drop Height	mm	46 to 51	50.0	Pass
Overall Test Results				Pass

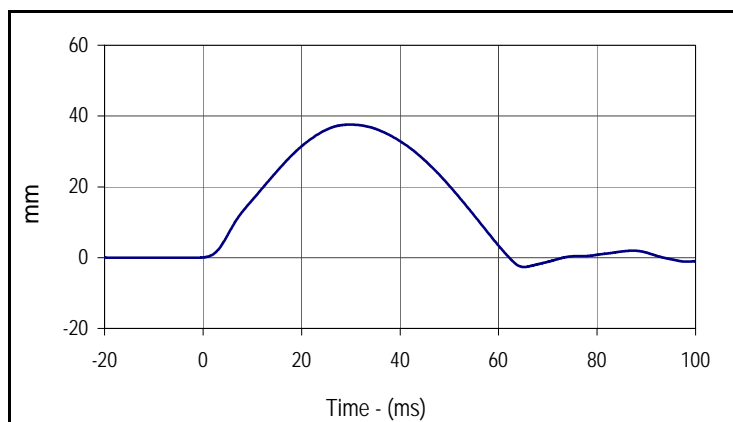
Curve Description			
Lower Rib Deflection (459 mm Drop Height)			
Plot No.	Type	SAE Class	Units
001	FIL	180	mm
Max	Time	Min	Time
37.6	29.8	-2.7	65.2

Tested Parameter	Units	Specification	Result	Pass/Fail
Rib Module Soak Time	Minutes	≥240	630	Pass
Temperature During Soak	Max	20.6 to 22.2	21.3	Pass
	Min		21.2	Pass
Humidity During Soak	Max	10.0 to 70.0	23.8	Pass
	Min		23.7	Pass
Laboratory Temperature During Test	°C	20.6 to 22.2	21.2	Pass
Laboratory Humidity During Test	%	10.0 to 70.0	23.7	Pass
Peak Rib Deflection at 459 +/- 5 mm Drop Height	mm	36 to 40	37.6	Pass
Peak Rib Deflection at 815 +/- 8 mm Drop Height	mm	46 to 51	47.8	Pass
Overall Test Results				Pass

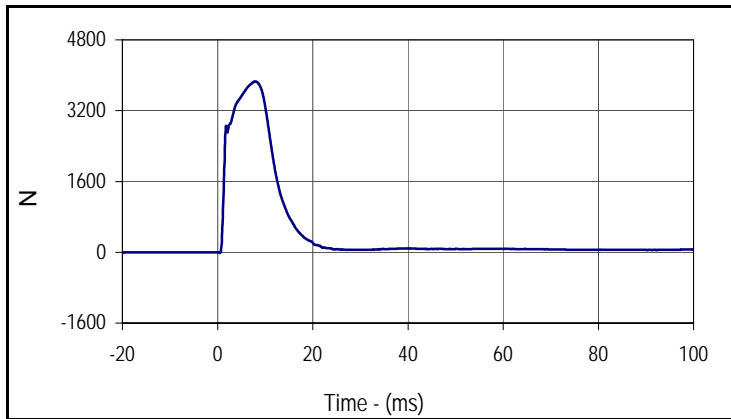
Curve Description			
Pelvis Acetabulum Force			
Plot No.	Type	SAE Class	Units
001	FIL	600	N
Max	Time	Min	Time
3859.9	8.0	-16.1	0.5

Tested Parameter	Units	Specification	Result	Pass/Fail
Dummy Soak Time	Minutes	≥180	707	Pass
Temperature During Soak	Max	20.6 to 22.2	21.6	Pass
	Min		21.1	Pass
Humidity During Soak	Max	10.0 to 70.0	23.0	Pass
	Min		22.4	Pass
Laboratory Temperature During Test	°C	18.9 to 25.6	21.4	Pass
Laboratory Humidity During Test	%	10.0 to 70.0	23.0	Pass
Impactor Velocity	m/s	6.6 to 6.8	6.64	Pass
Peak Acetabulum Force Y	N	3600 to 4300	3859.9	Pass
Peak Pelvis Y Acceleration After 6 msec.	g	34 to 42	41.3	Pass
Peak Impactor Acceleration	g	38 to 47	46.3	Pass
Overall Test Results				Pass

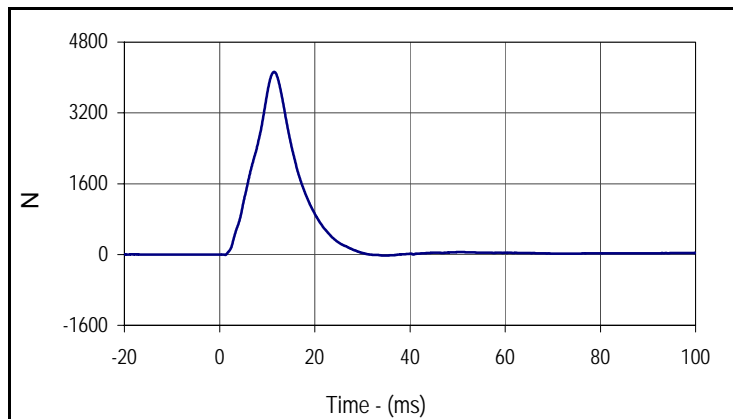
Curve Description			
Pelvis Iliac Force			
Plot No.	Type	SAE Class	Units
001	FIL	600	N
Max	Time	Min	Time
4125.8	11.4	-22.3	35.3

Tested Parameter	Units	Specification	Result	Pass/Fail
Dummy Soak Time	Minutes	≥180	762	Pass
Temperature During Soak	Max	20.6 to 22.2	21.6	Pass
	Min		21.1	Pass
Humidity During Soak	Max	10.0 to 70.0	23.0	Pass
	Min		22.4	Pass
Laboratory Temperature During Test	°C	18.9 to 25.6	21.1	Pass
Laboratory Humidity During Test	%	10.0 to 70.0	22.4	Pass
Impactor Velocity	m/s	4.2 to 4.4	4.31	Pass
Peak Iliac Force	N	4100 to 5100	4125.8	Pass
Peak Pelvis Y Acceleration	g	28 to 39	32.3	Pass
Peak Impactor Acceleration	g	36 to 45	37.6	Pass
Overall Test Results				Pass
