**REPORT NUMBER: NCAP-MGA-2016-025**

**NEW CAR ASSESSMENT PROGRAM (NCAP)  
Frontal Barrier Impact Test**

**Honda of America Mfg., Inc.  
2016 Honda CR-V AWD LX 5-Dr. SUV  
NHTSA No.: O20165311**

**MGA RESEARCH CORPORATION  
5000 Warren Road  
Burlington, WI 53105**

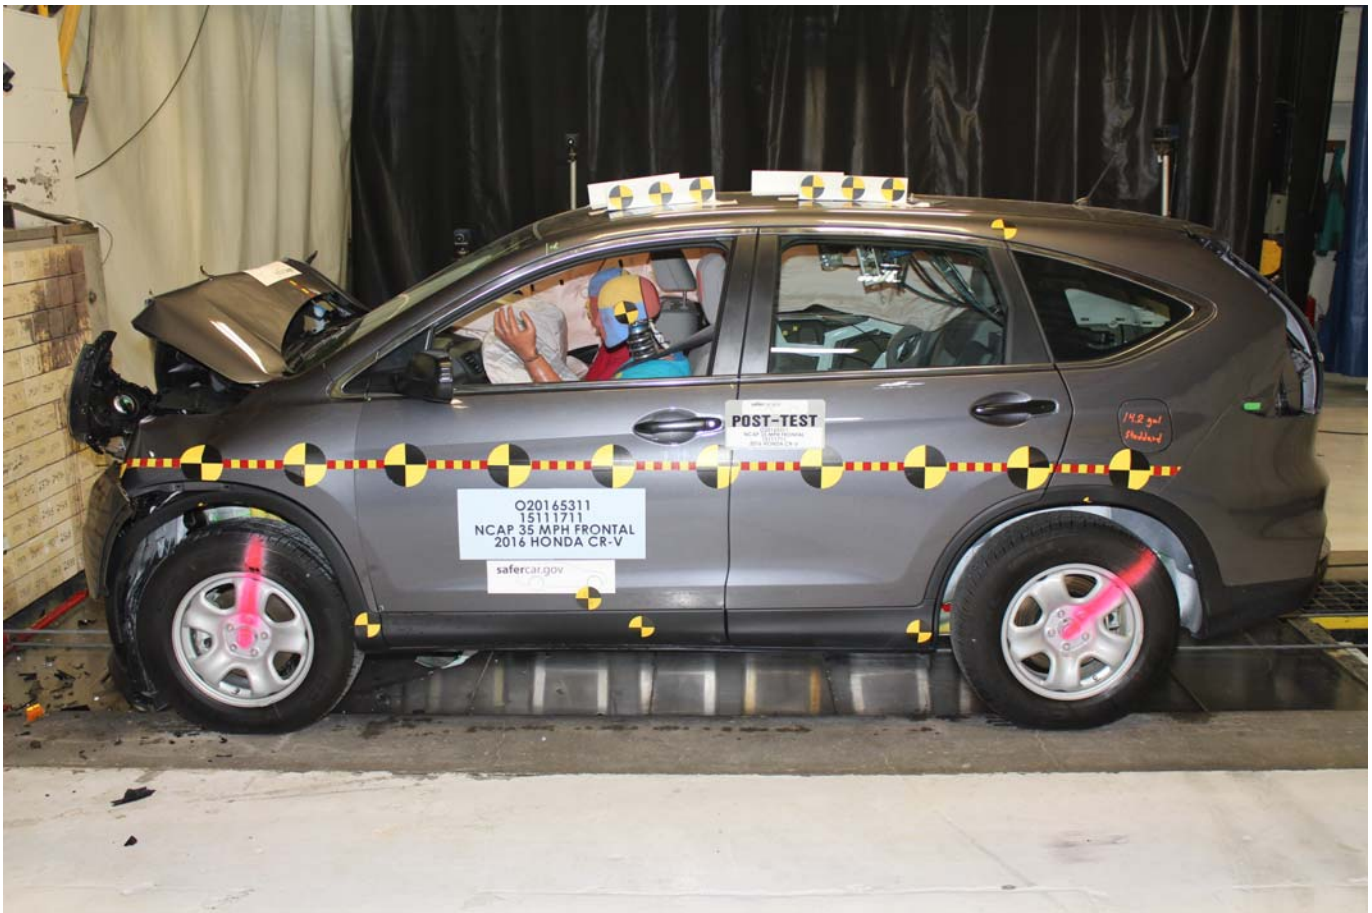
Photo No. 011 - Post-Test Left View of Test Vehicle

The maximum static crush of the vehicle was 521 mm and both the driver and passenger side doors remained closed during the impact event and were operable after the impact.

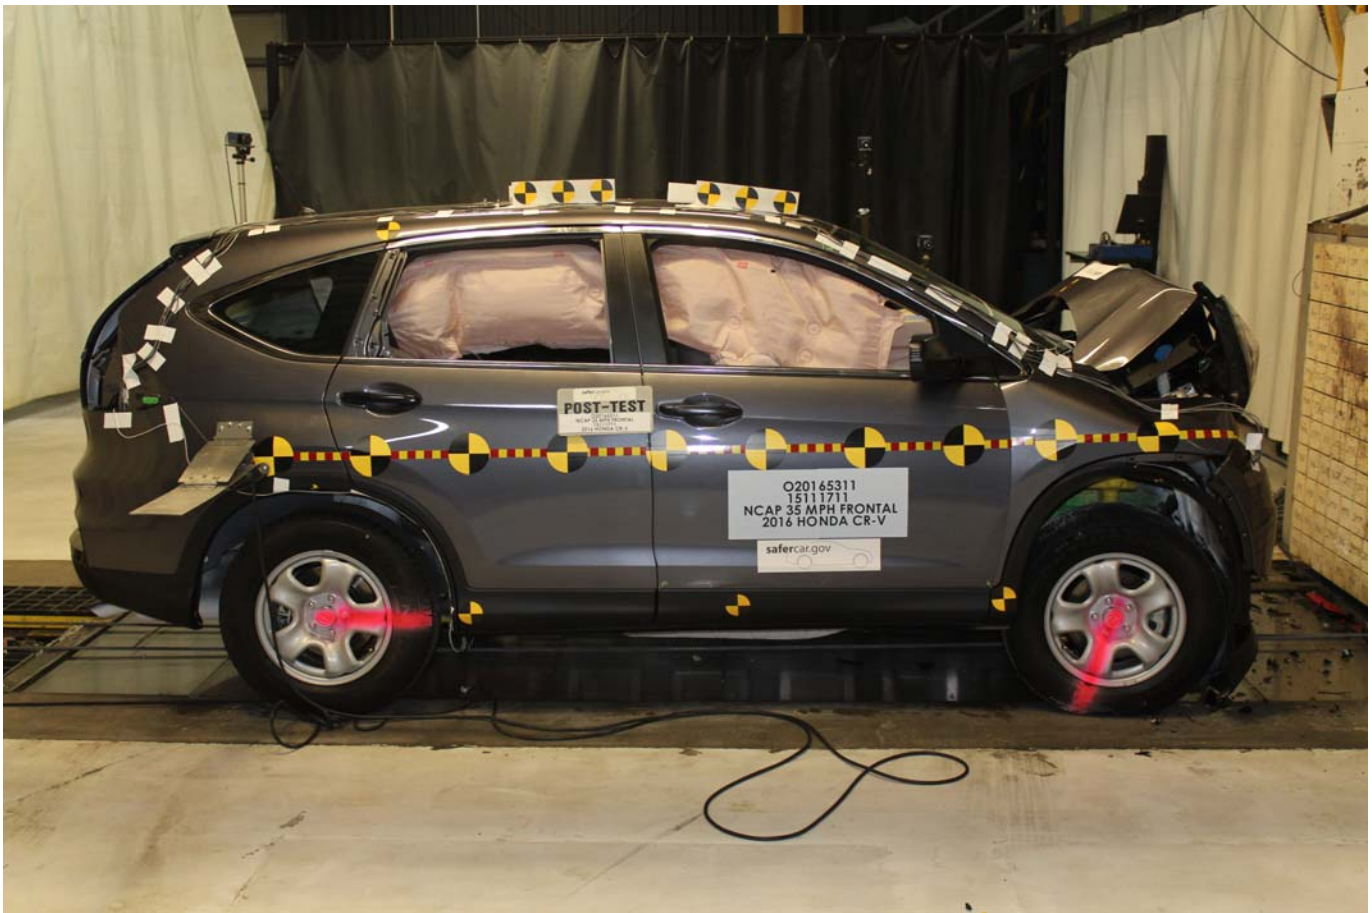
Photo No. 013 - Post-Test Right View of Test Vehicle

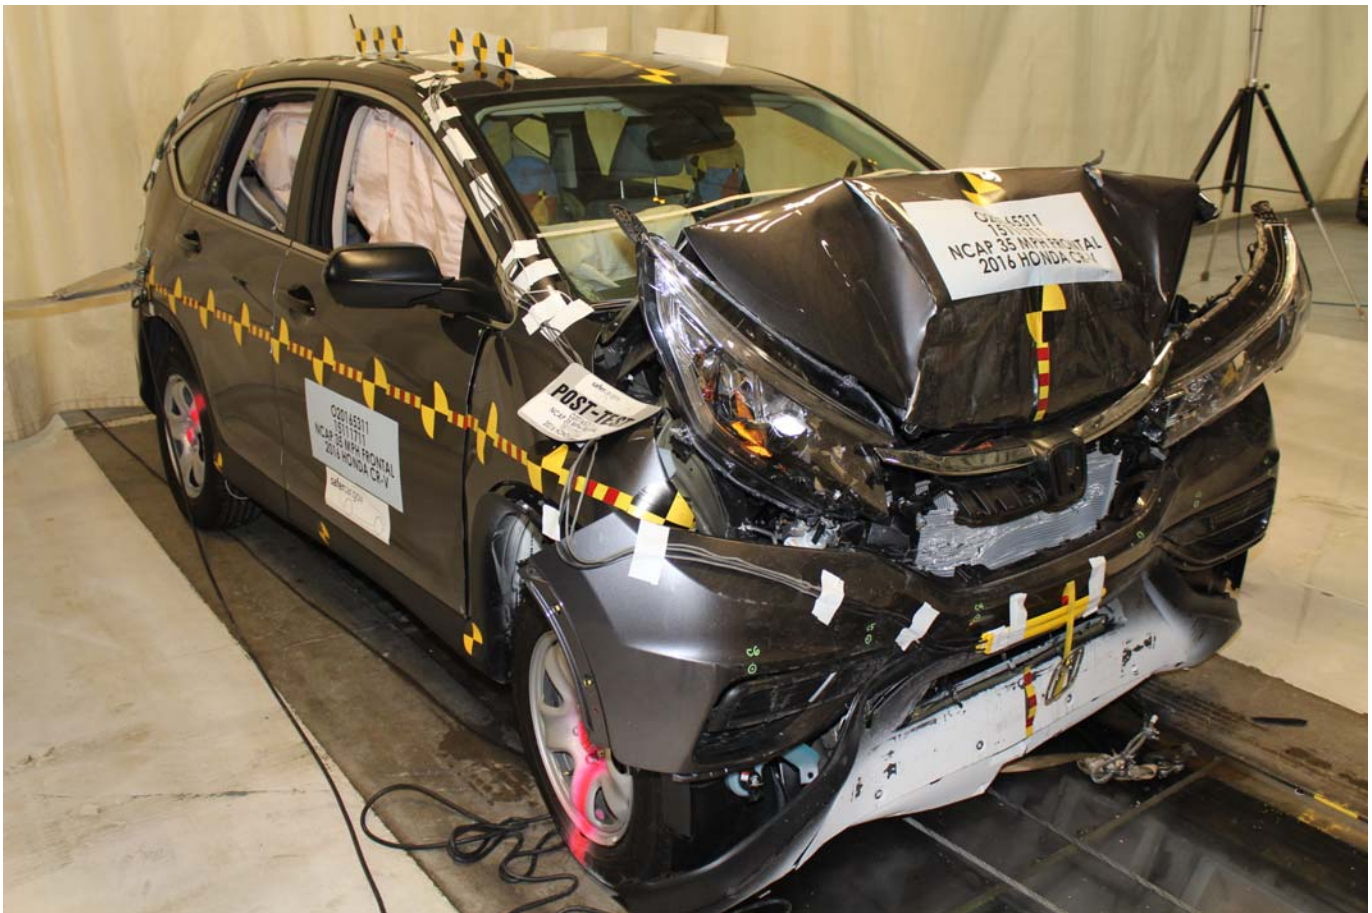
Photo No. 015 - Post-Test Right Front 3-4 View

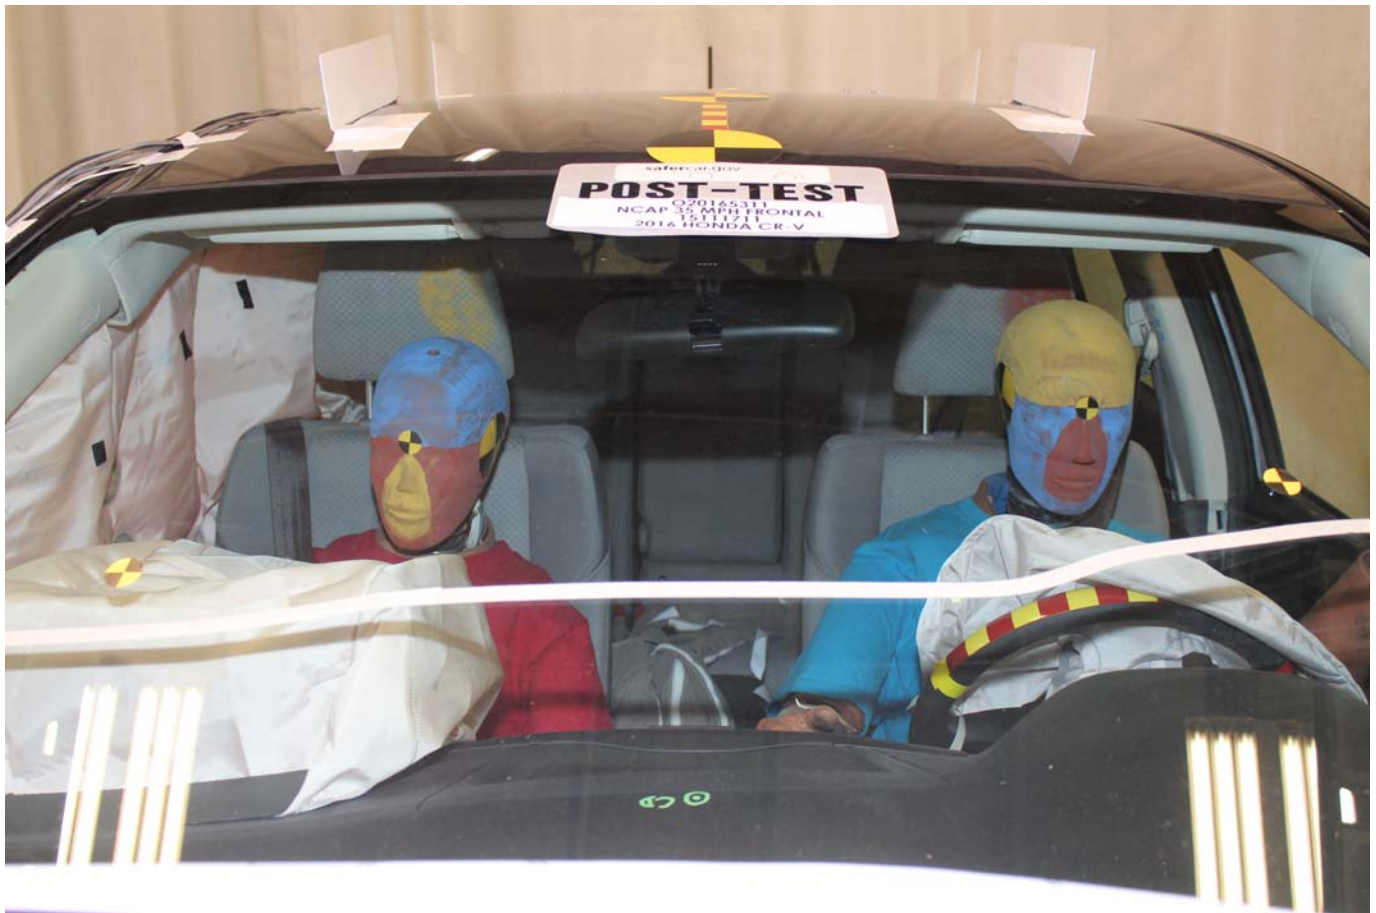
Photo No. 019 - Post-Test Windshield View

There was 100 percent windshield retention and no intrusion into the protected zone of the windshield during the event. There was no Stoddard Solvent leakage after the event or during any phase of the static rollover.

| Critical Areas of Performance | Observations and Conclusions |
|---|---|
| Windshield Damage | Cracked |

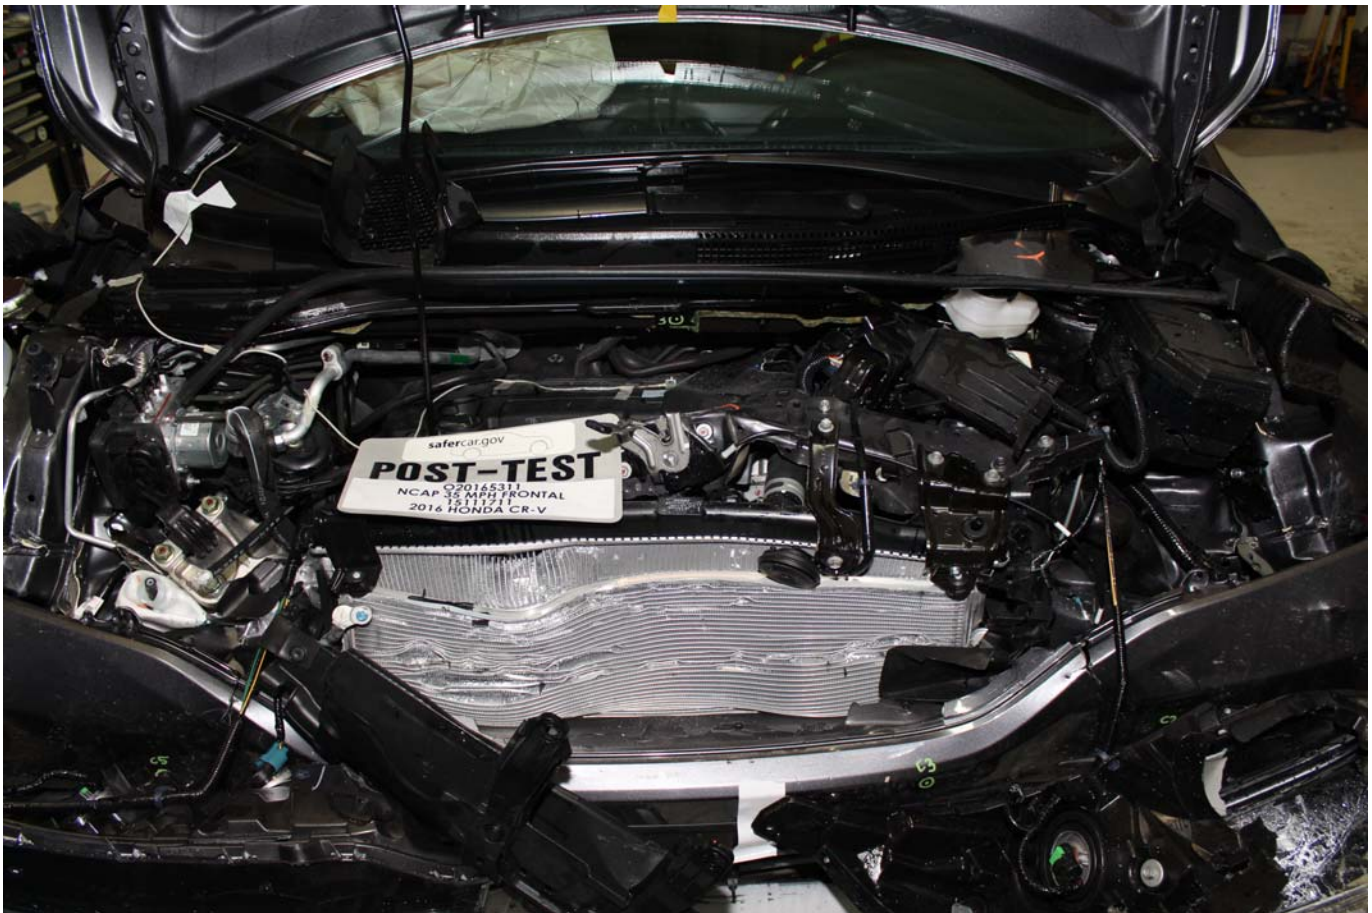
Photo No. 021 - Post-Test Engine Compartment View

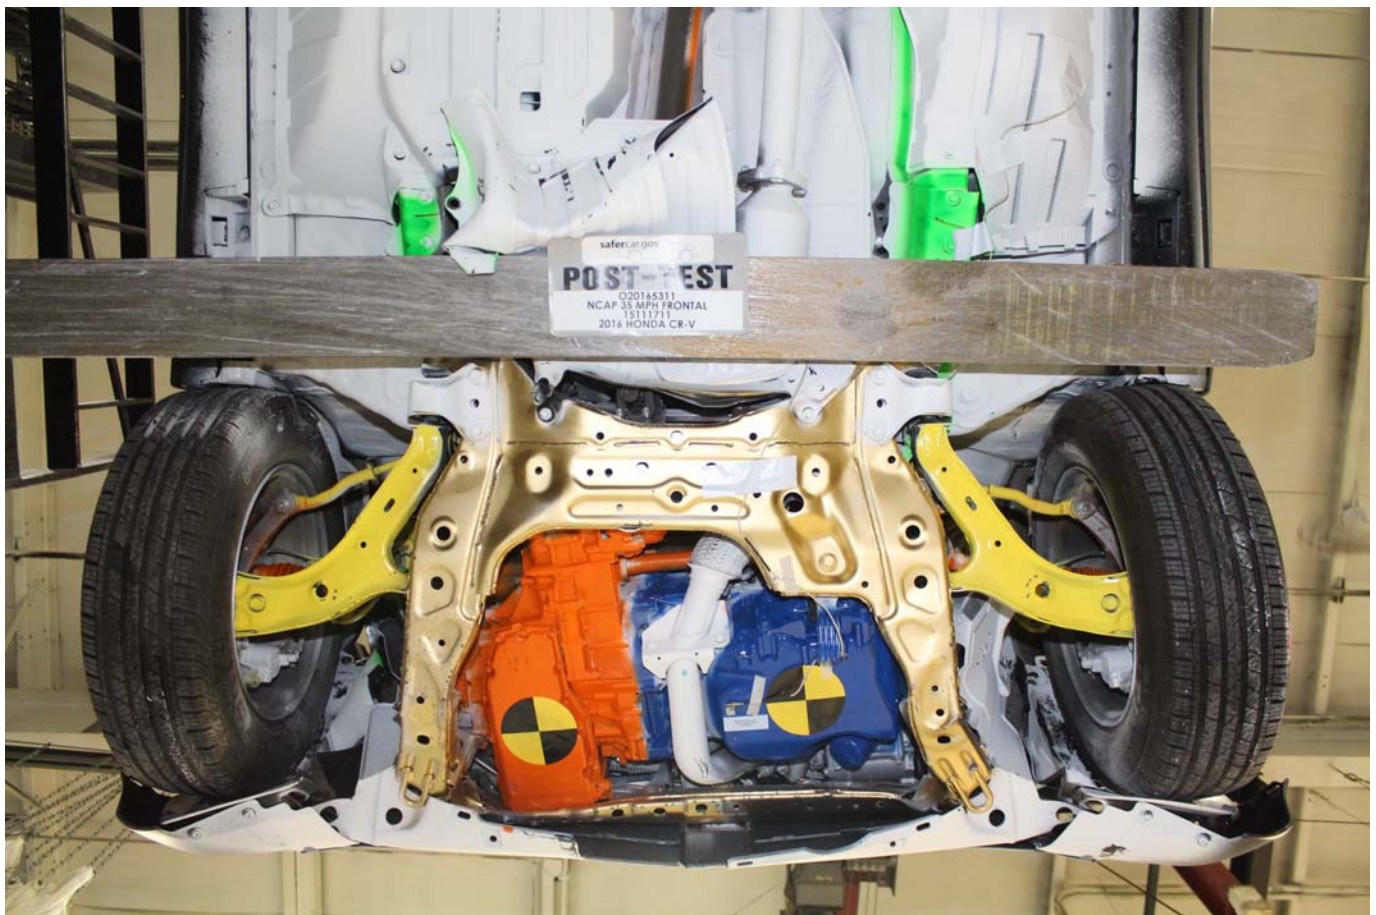
Photo No. 025 - Post-Test Front Underbody View

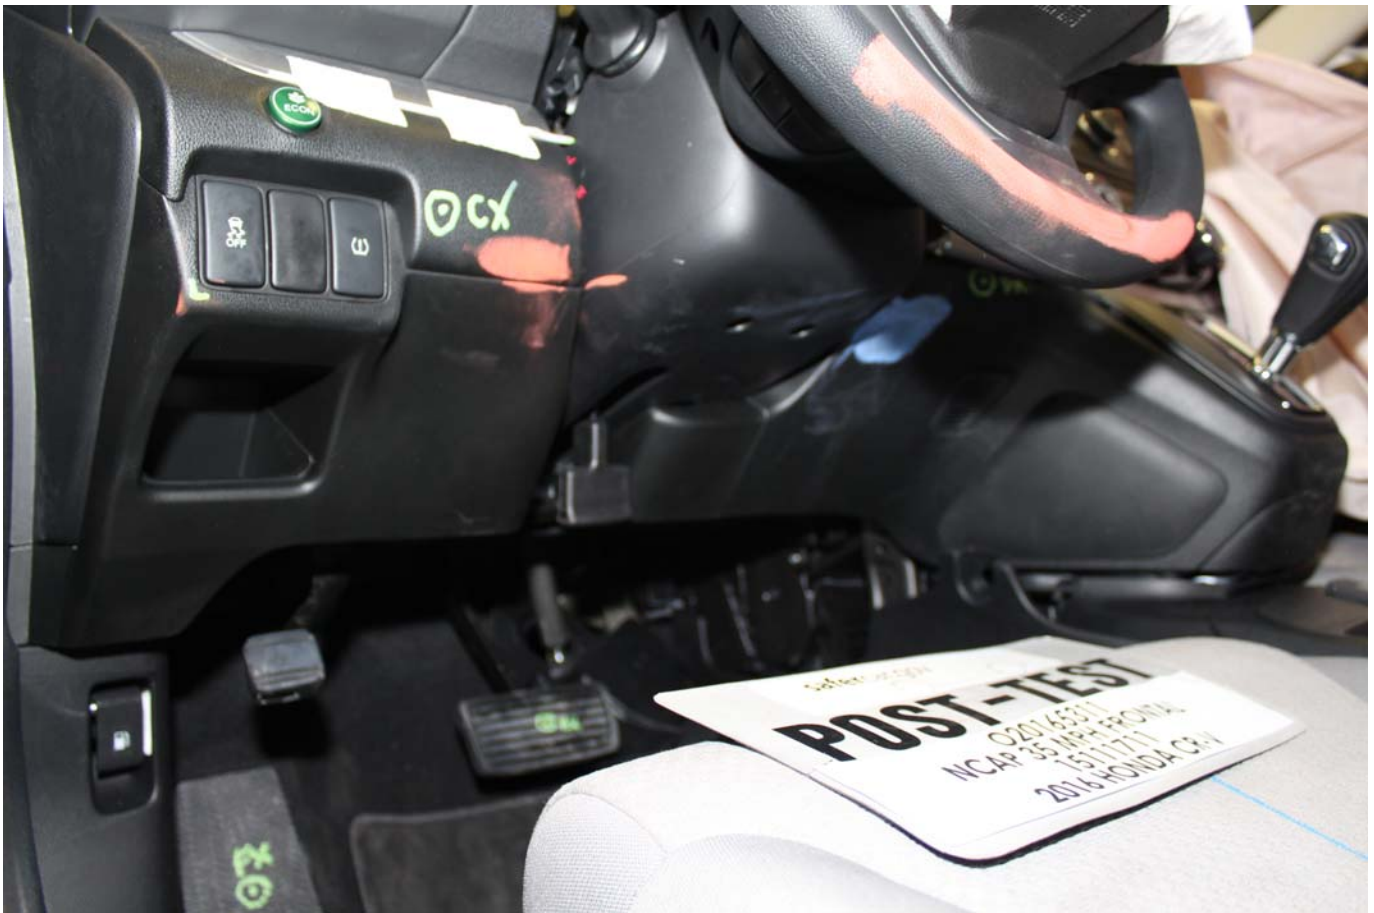
Photo No. 043 - Post-Test Driver's Side Knee Bolster (without dummy)

The driver's visible contact points were as follows: The driver's head contacted the airbag. The driver's head also contacted the headrest. The driver's knees contacted the knee bolster. The passenger's visible contact points were as follows: The passenger's head contacted the airbag. The passenger's head also contacted the headrest. The passenger's knees contacted the glove box.

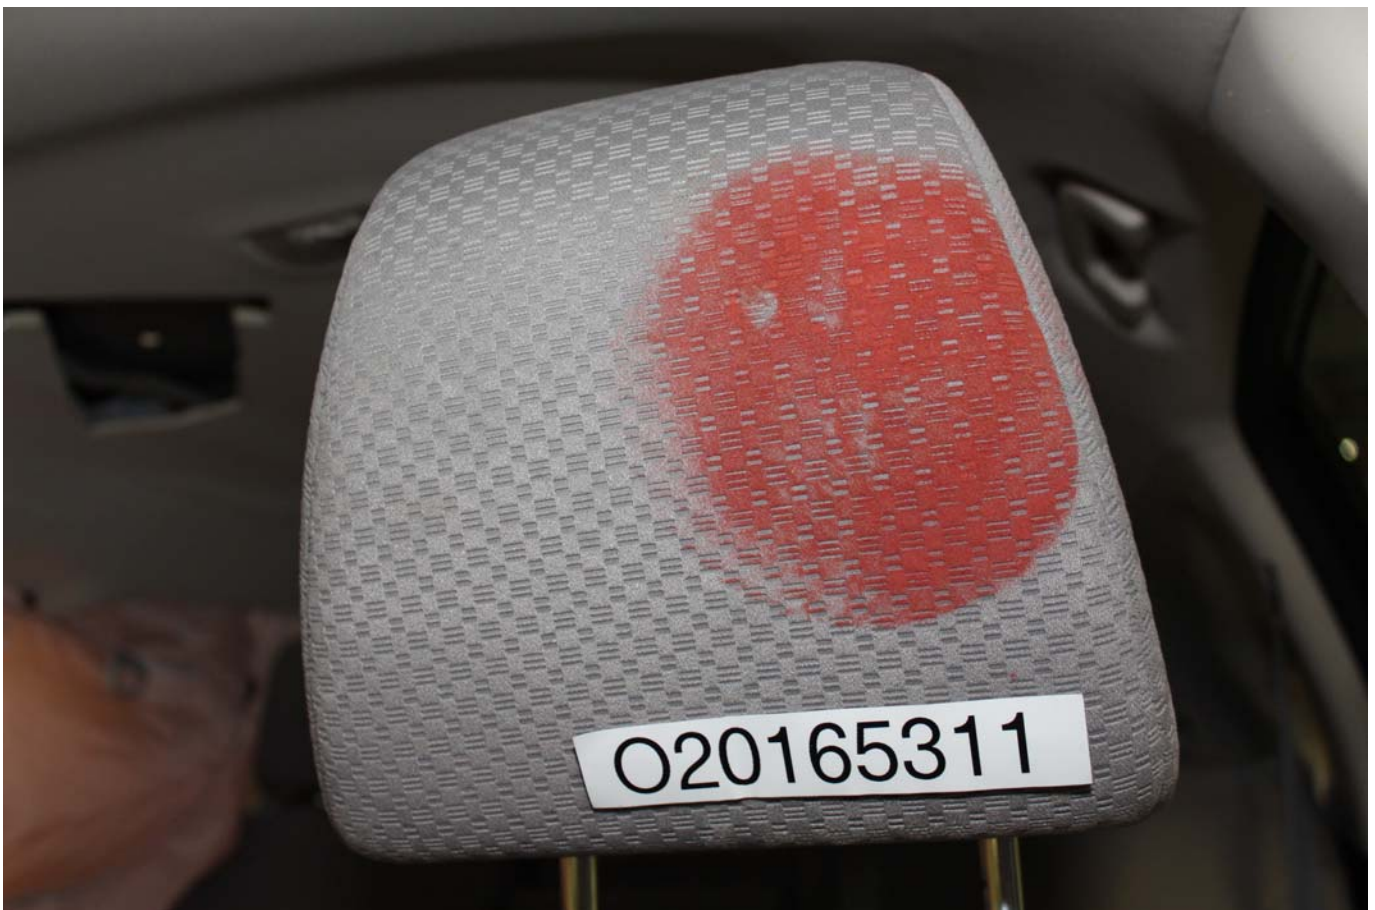
Photo No. 048 - Post-Test Driver Dummy Contact with Headrest

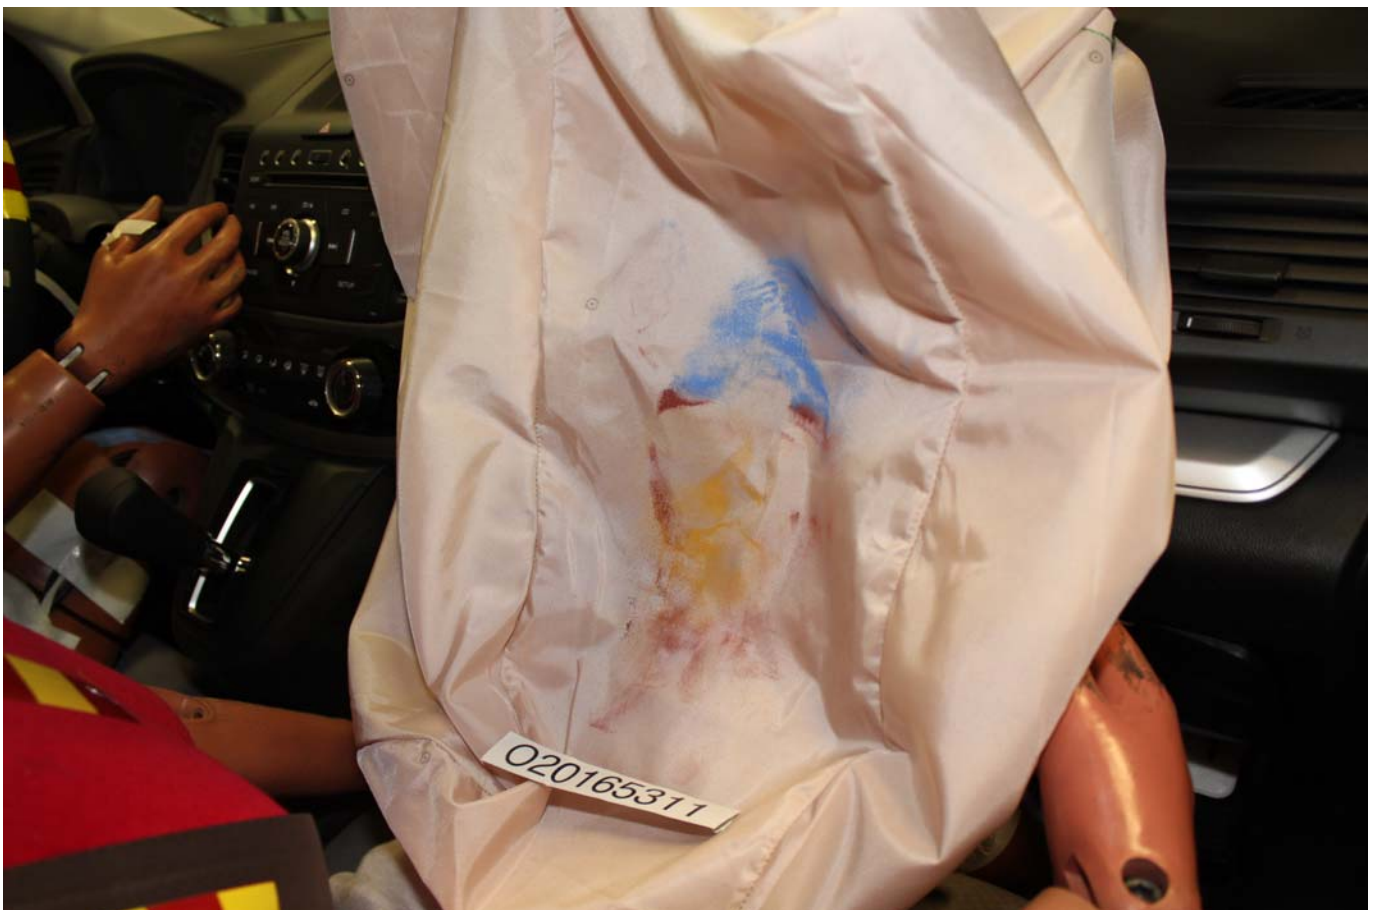
Photo No. 068 - Post-Test Passenger Dummy Contact with Airbag

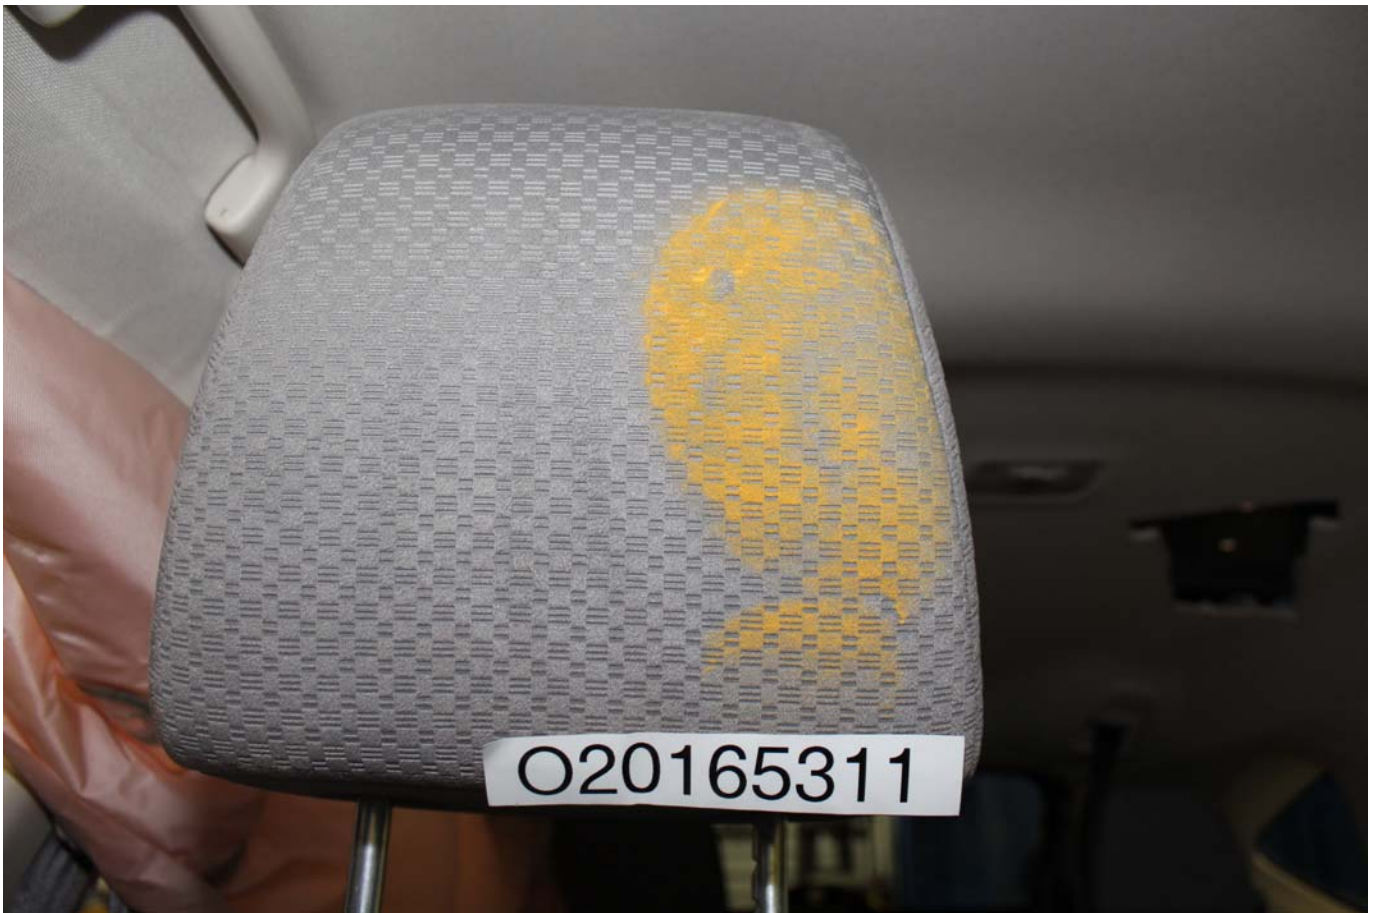
Photo No. 069 - Post-Test Passenger Dummy Contact with Headrest

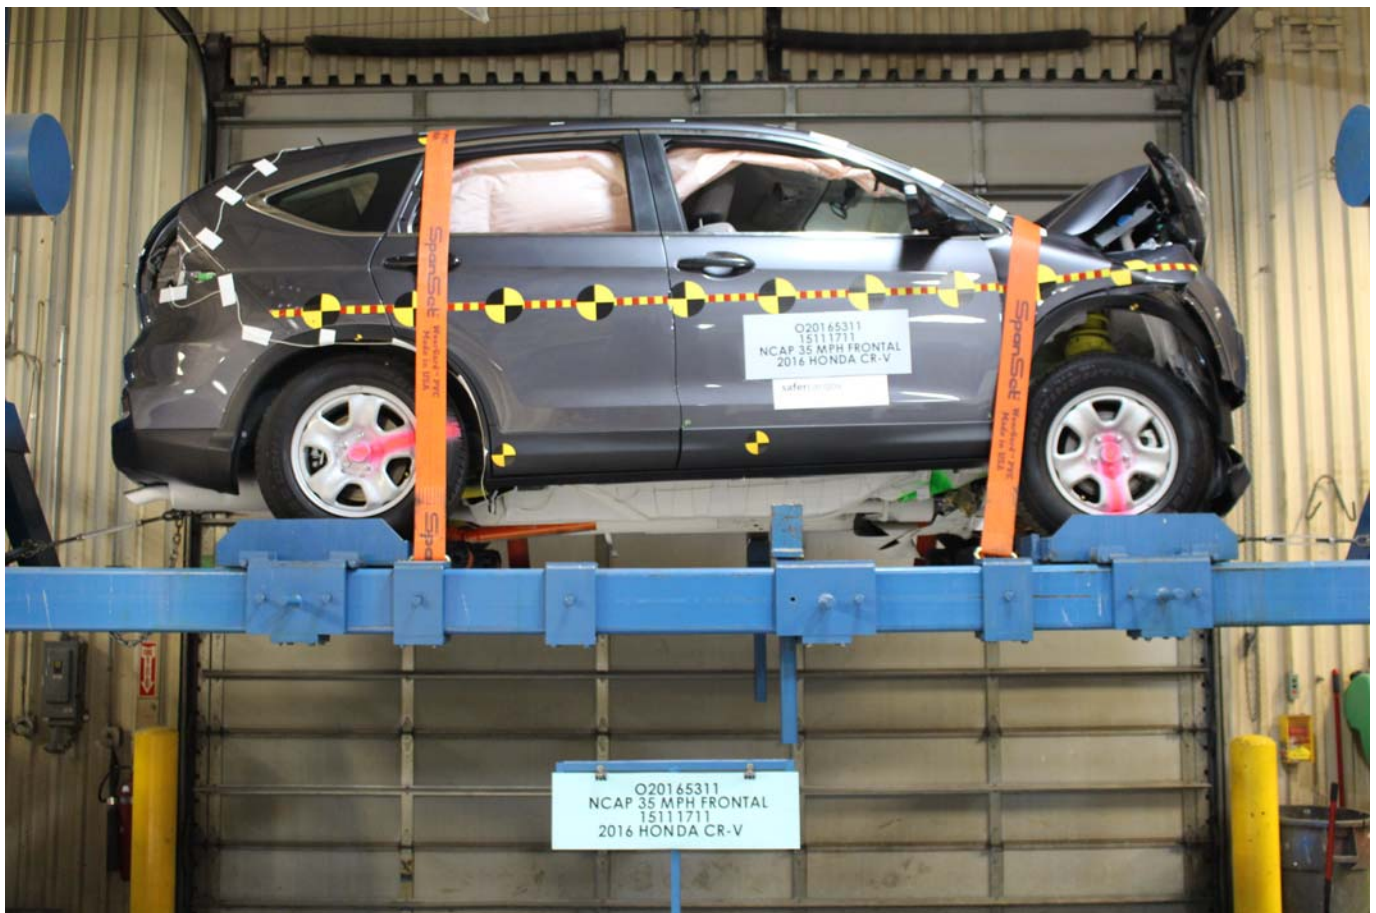
Photo No. 073 - Vehicle at 0 Degree on Static Rollover Device

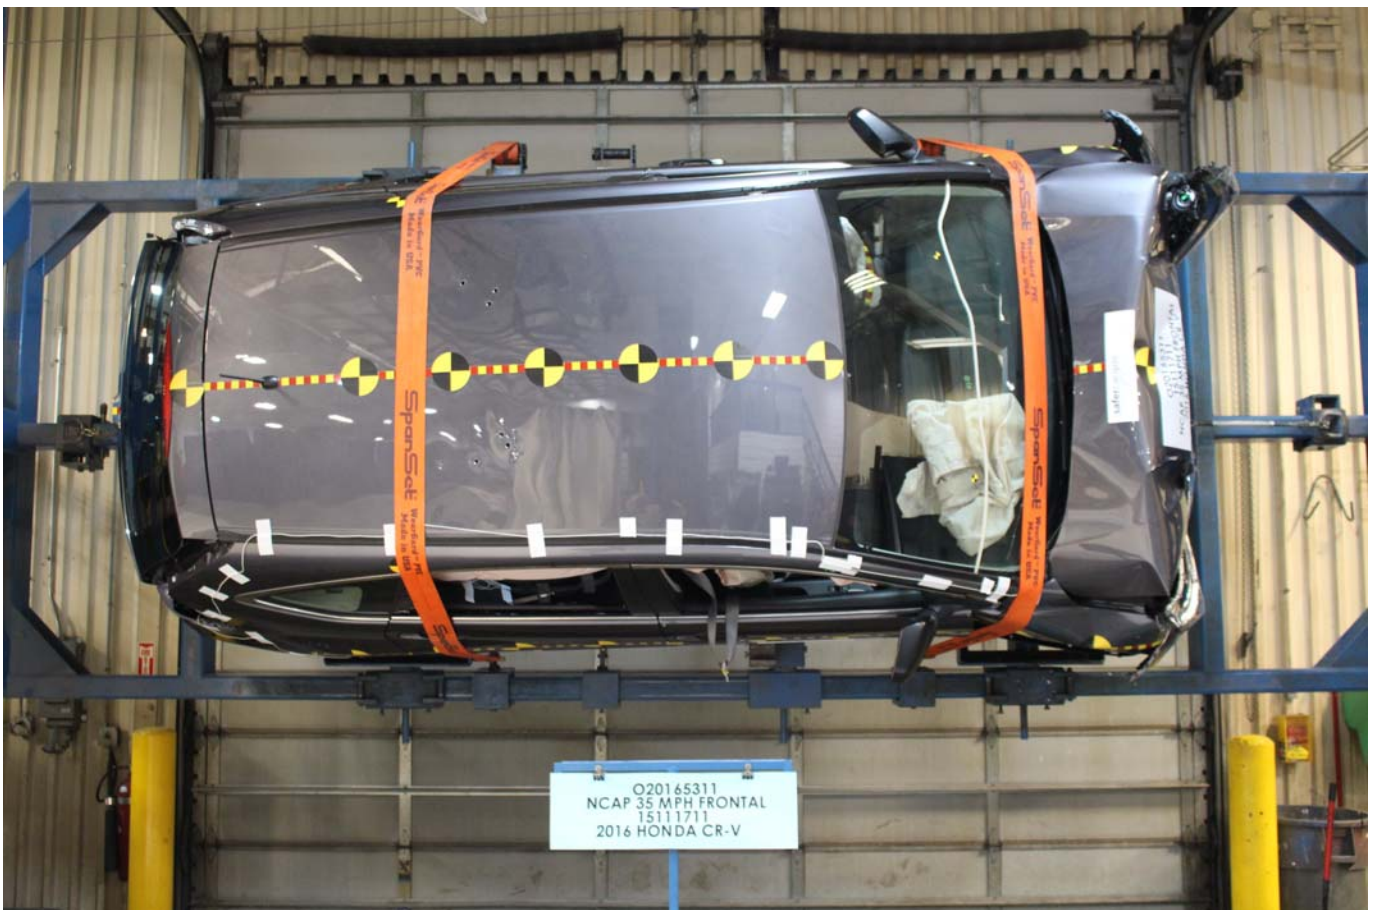
Photo No. 076 - Vehicle at 270 Degrees on Static Rollover Device

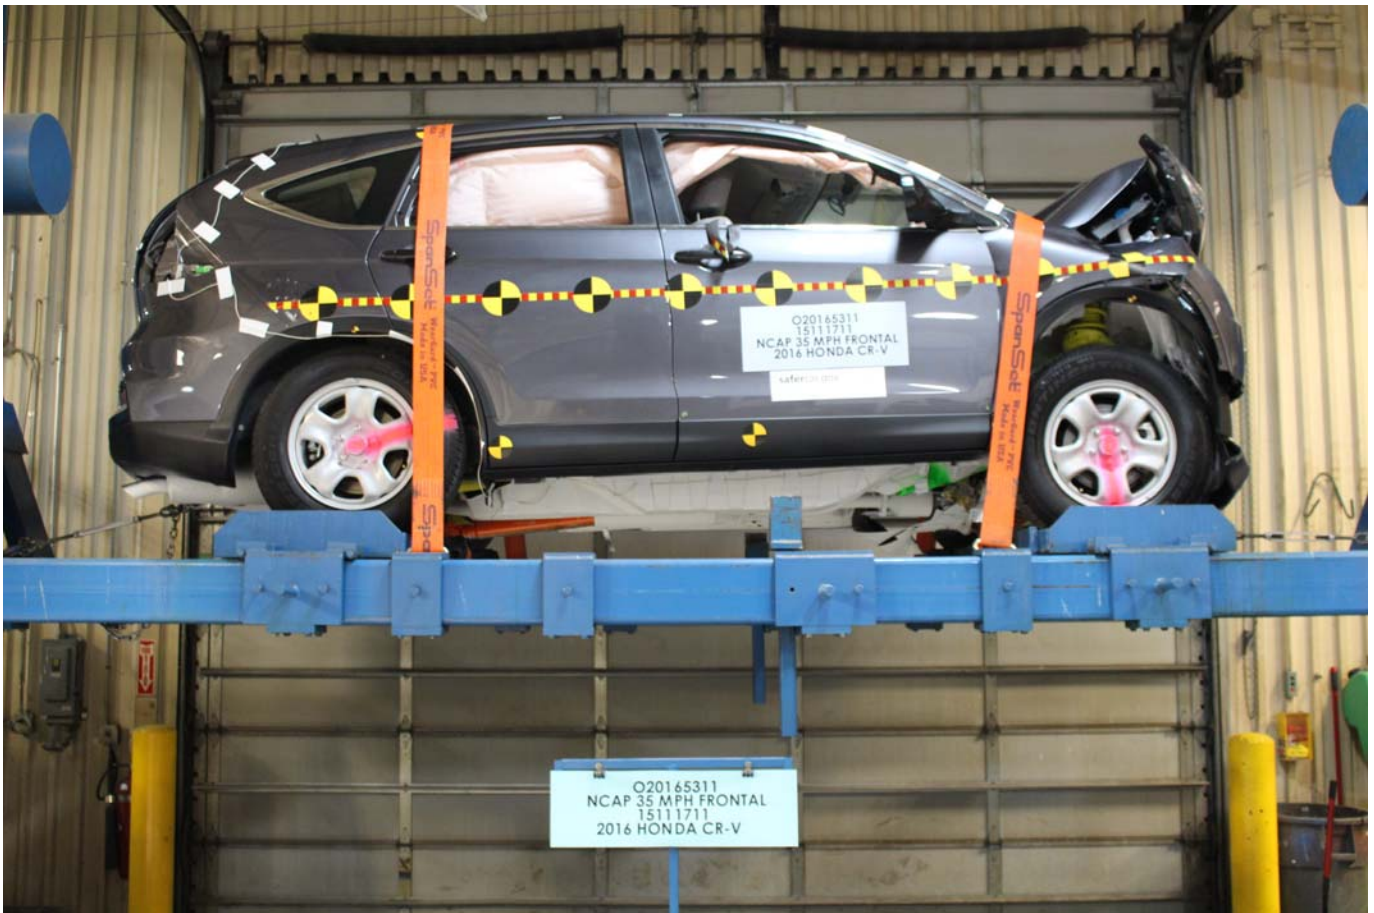
Photo No. 077 - Vehicle at 360 Degrees on Static Rollover Device
