**REPORT NUMBER: NCAP-KAR-16-008**

**NEW CAR ASSESSMENT PROGRAM (NCAP)  
FRONTAL BARRIER IMPACT TEST**

**MAZDA MOTOR CORPORATION  
2016 MAZDA CX-3 TOURING AWD SUV**

**PREPARED BY:  
KARCO ENGINEERING, LLC.  
9270 HOLLY ROAD  
ADELANTO, CA 92301**

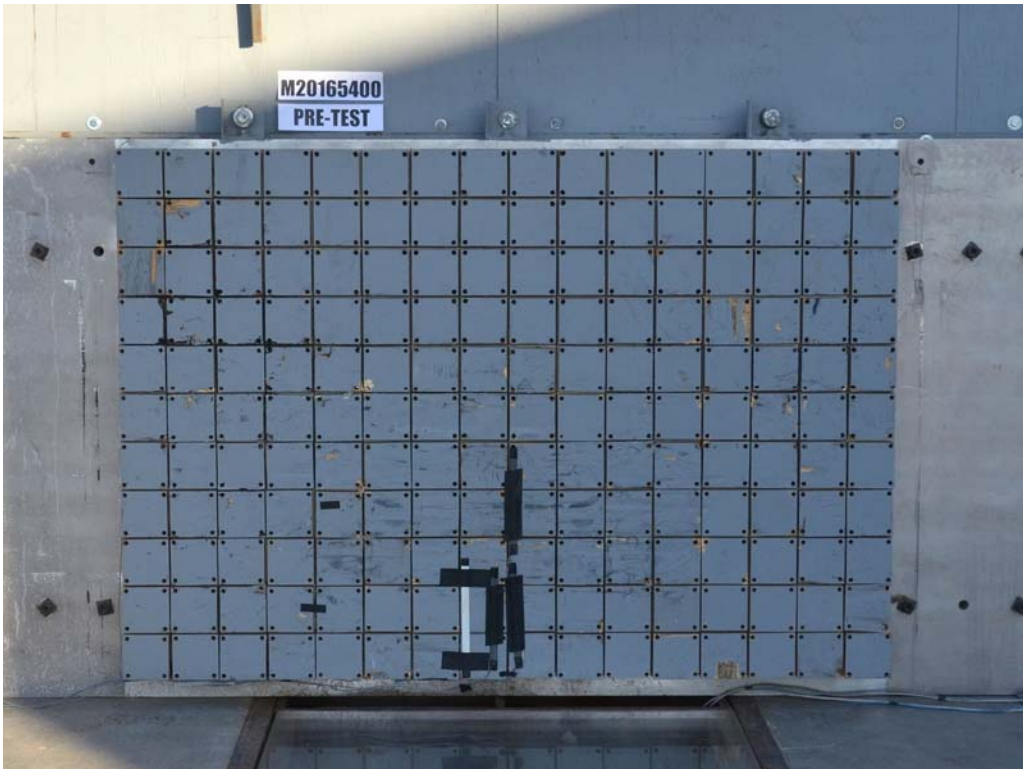
FIGURE 2. Load Cell Wall

A load cell barrier consisting of 176 load cells was impacted by a 2016 Mazda CX-3 Touring AWD SUV at a velocity of 56.19 km/h. The test was performed at KARCO Engineering, LLC. on November 18, 2015. Pre- and post-test photographs of the vehicle and dummies can be found in Appendix A of this report. The Appendix A photographs label the test vehicle as a 5-door hatchback; however, the test vehicle is classified as a SUV throughout this report.

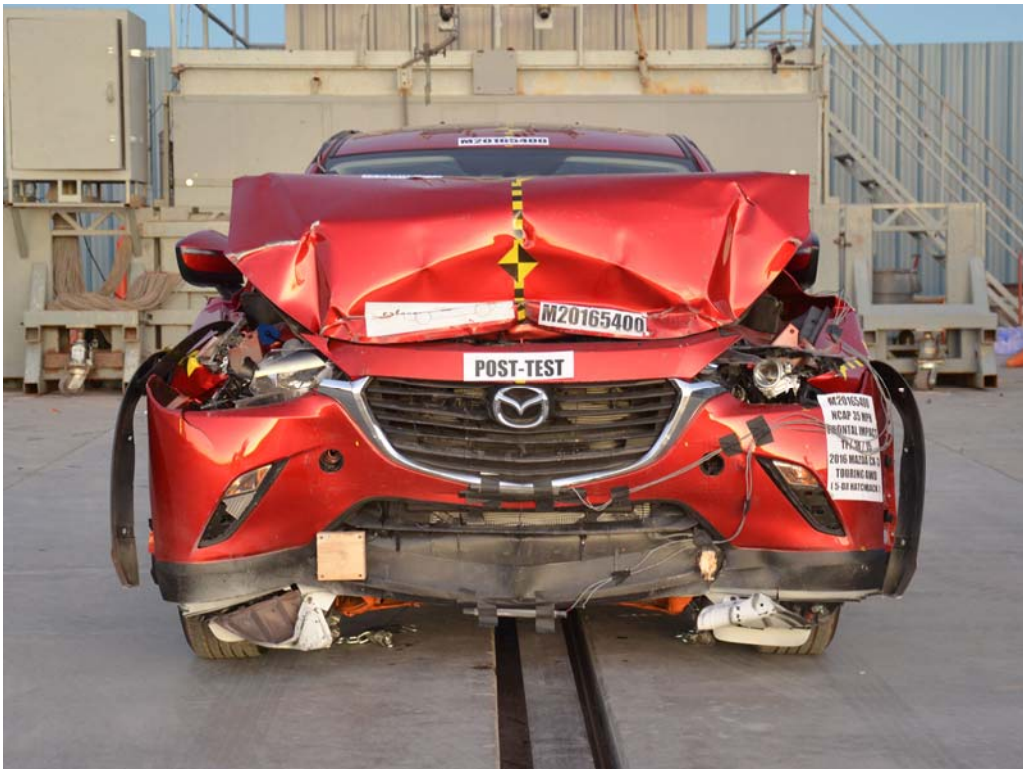
FIGURE 8. Post-Test Front View of Test Vehicle

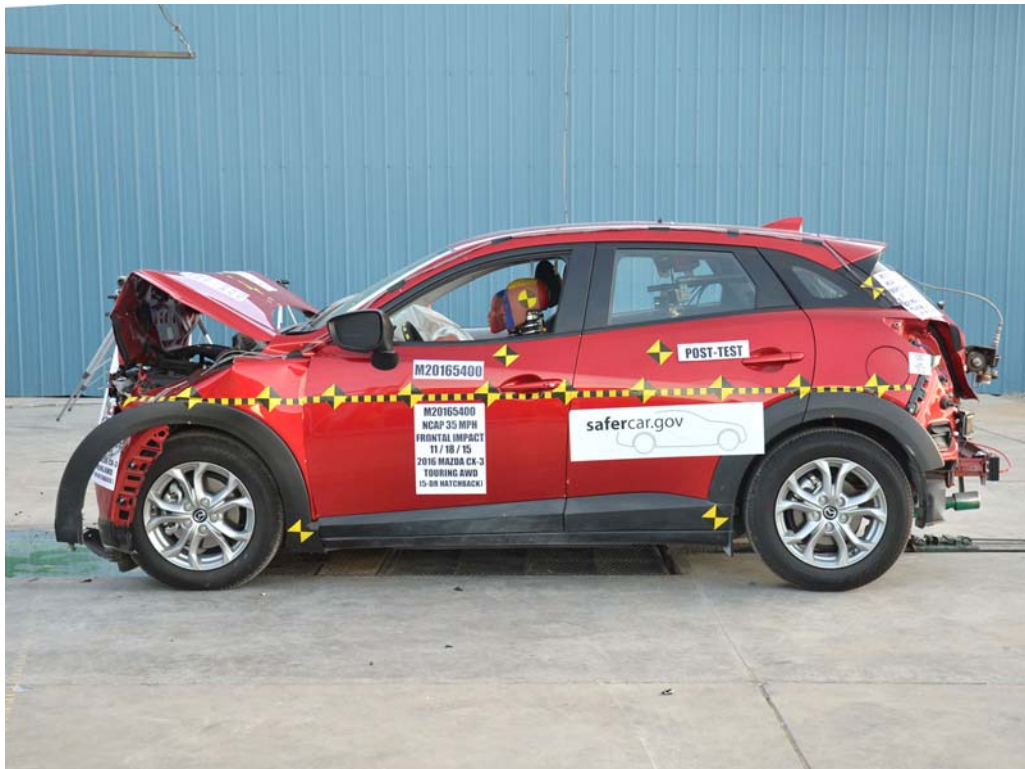
FIGURE 10. Post-Test Left View of Test Vehicle

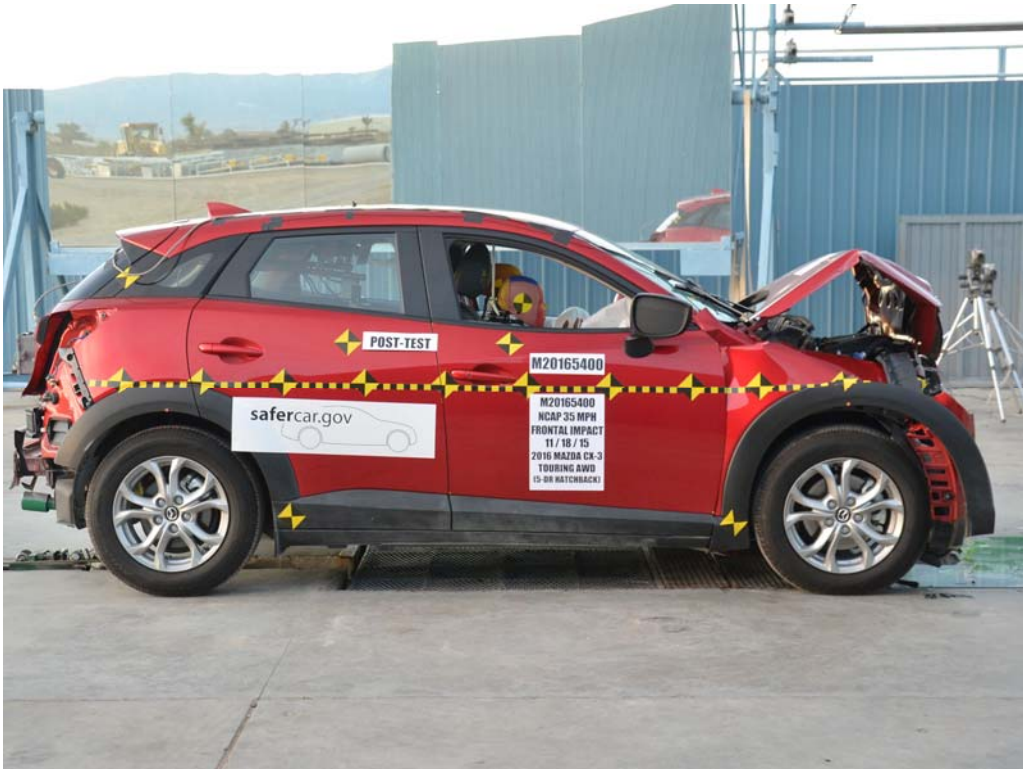
FIGURE 12. Post-Test Right View of Test Vehicle

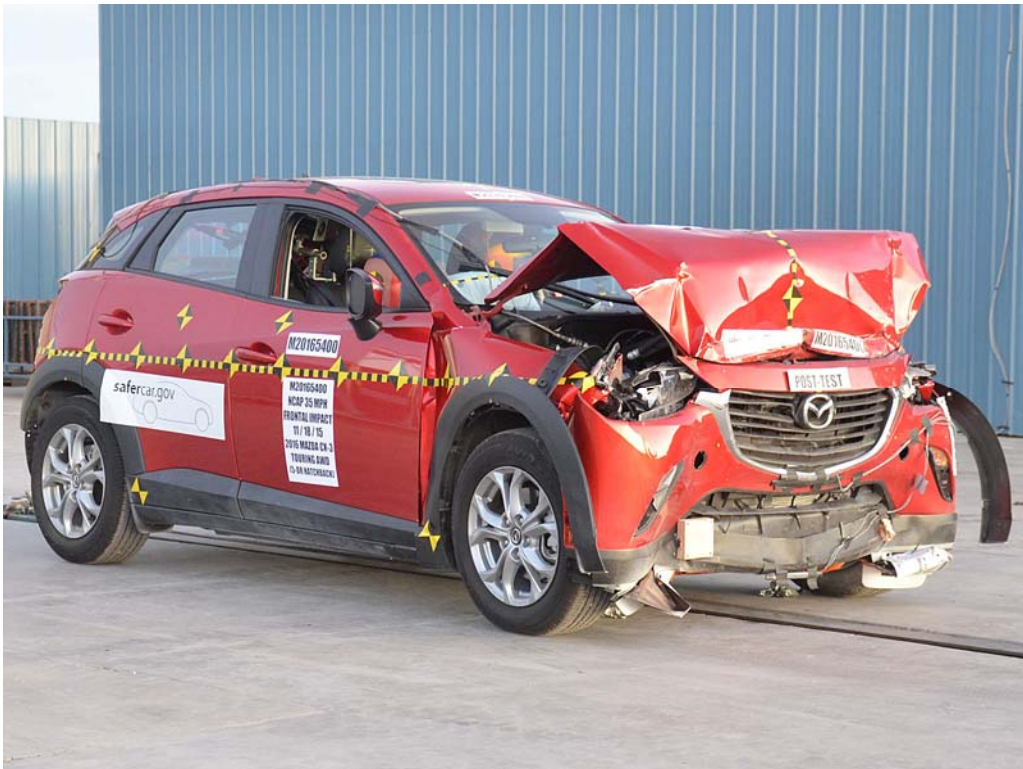
FIGURE 14. Post-Test Right Front 3/4 View

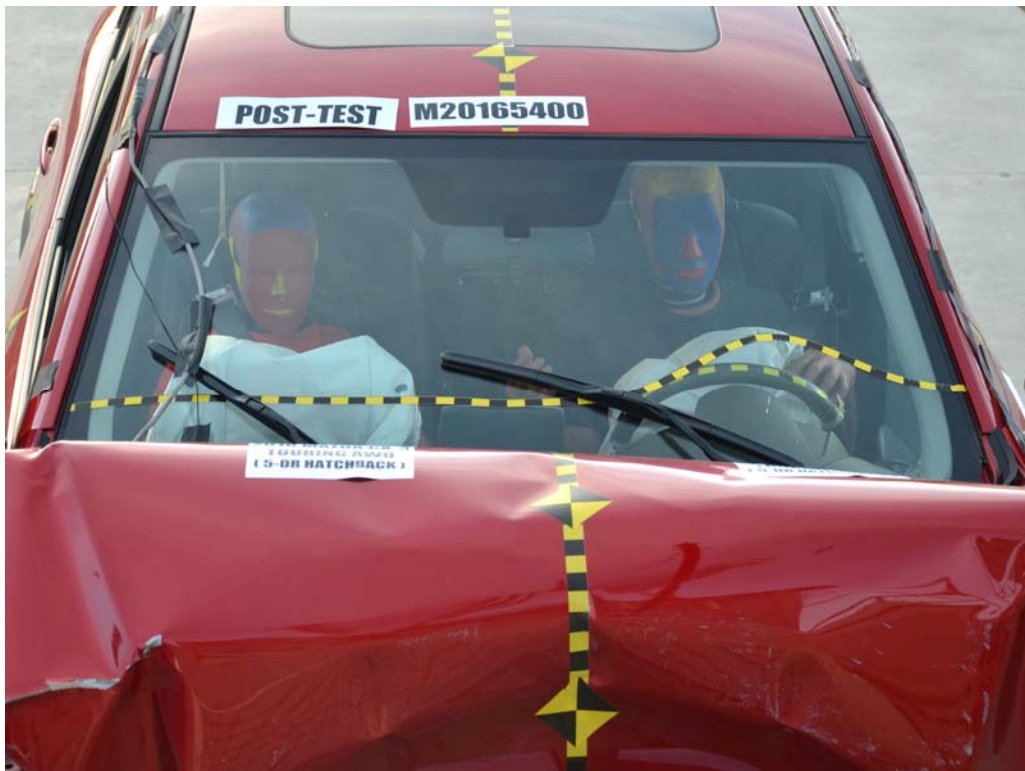
FIGURE 18. Post-Test Windshield View

| Critical Areas of Performance | Observations and Conclusions |
|---|---|
| Windshield Damage | Broken |

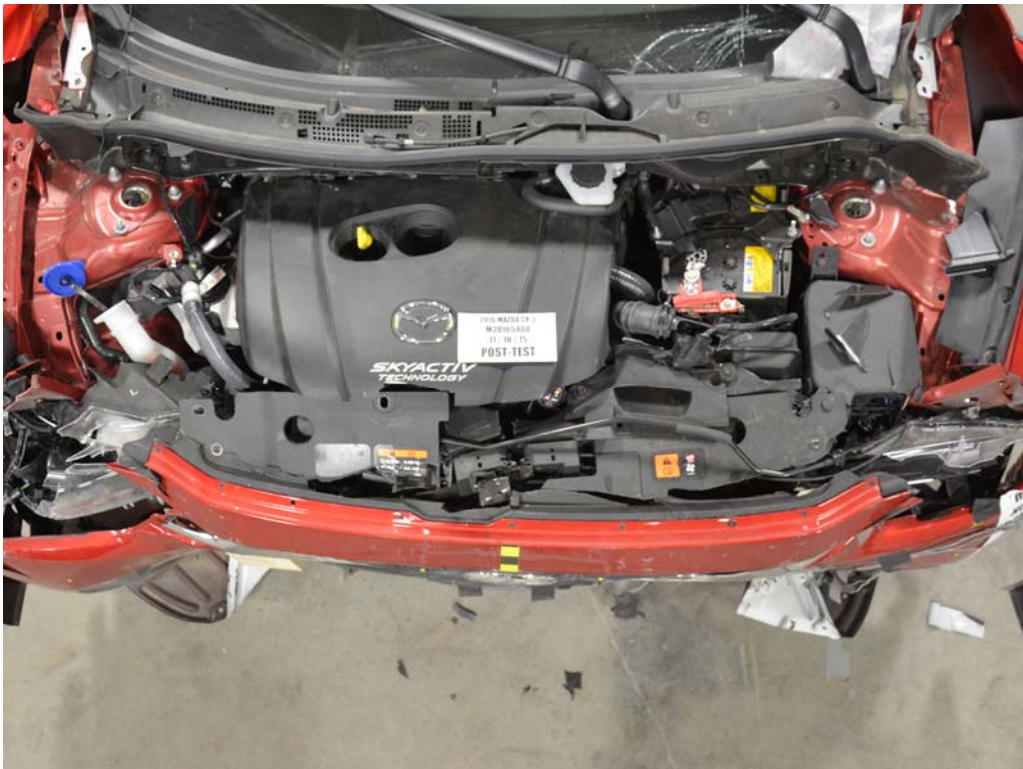
FIGURE 20. Post-Test Engine Compartment View

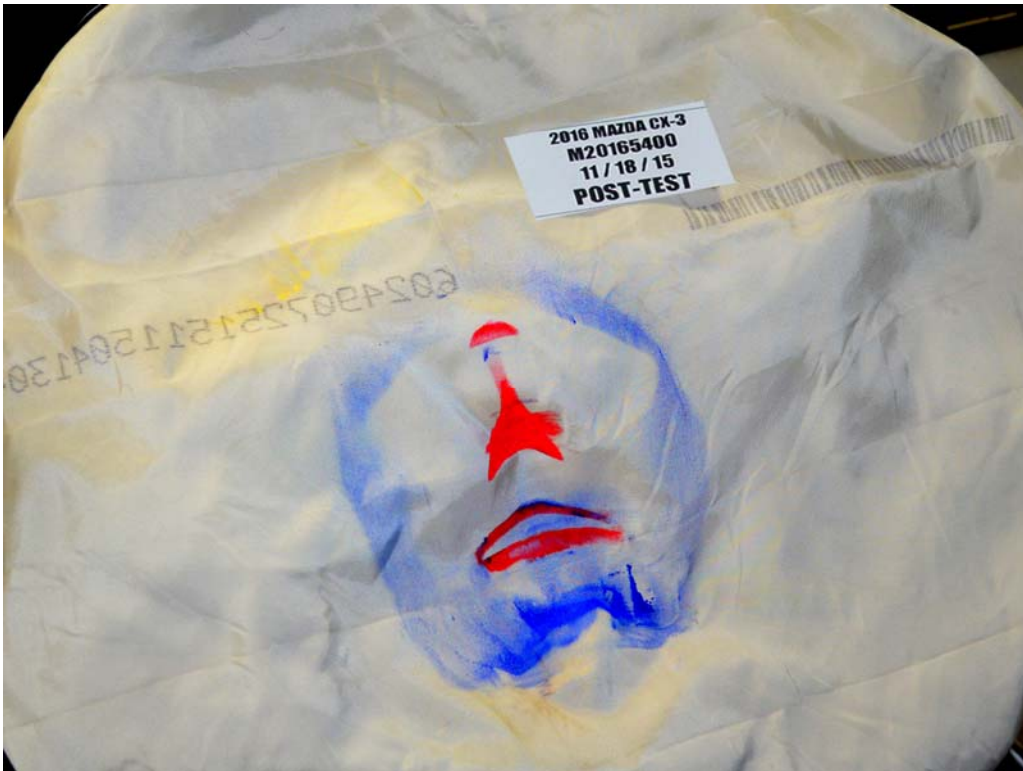
FIGURE 46. Post-Test Driver Dummy Contact with Airbag

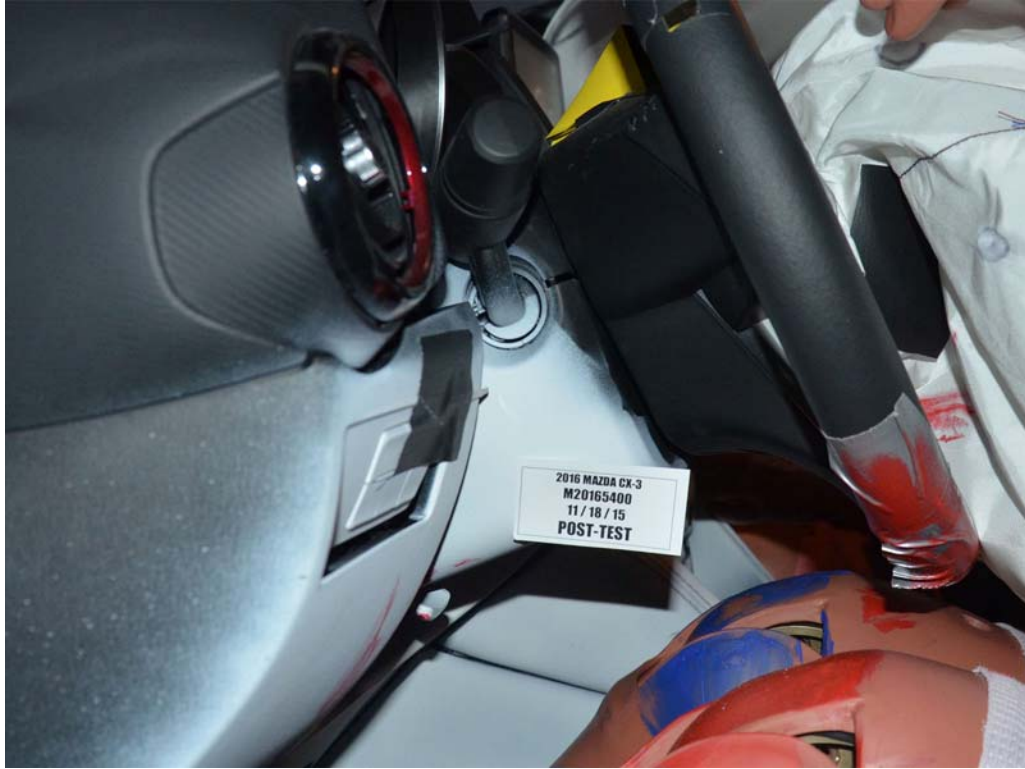
FIGURE 49. Post-Test View of the Steering Wheel

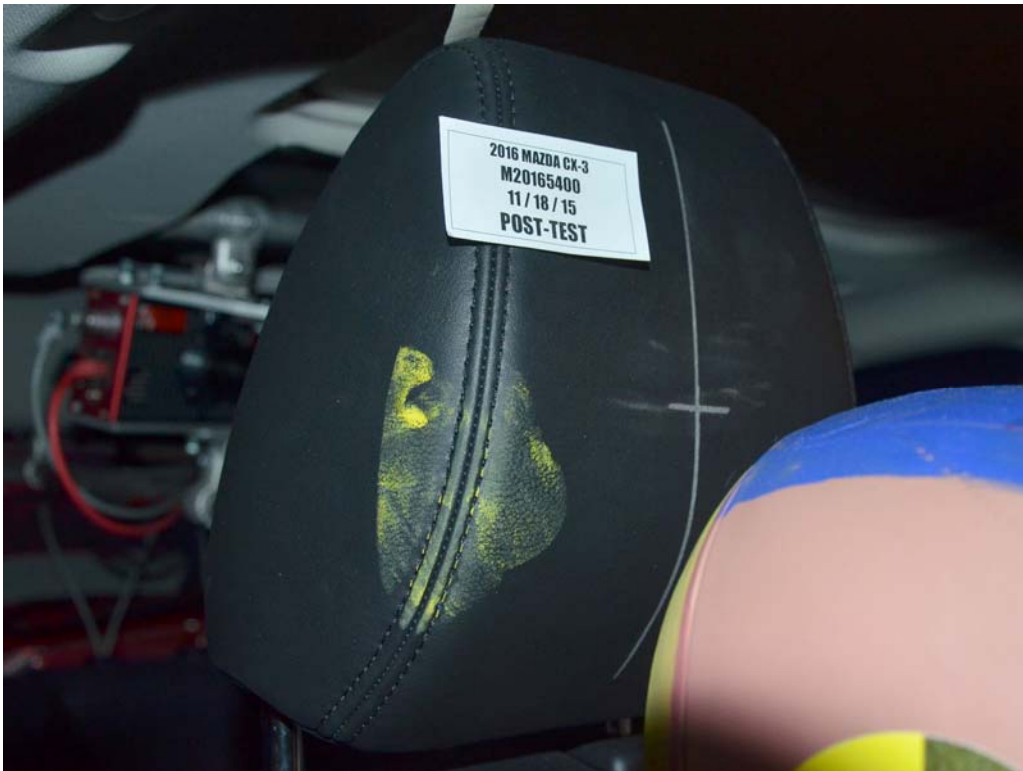
FIGURE 68. Post-Test Passenger Dummy Contact with Headrest

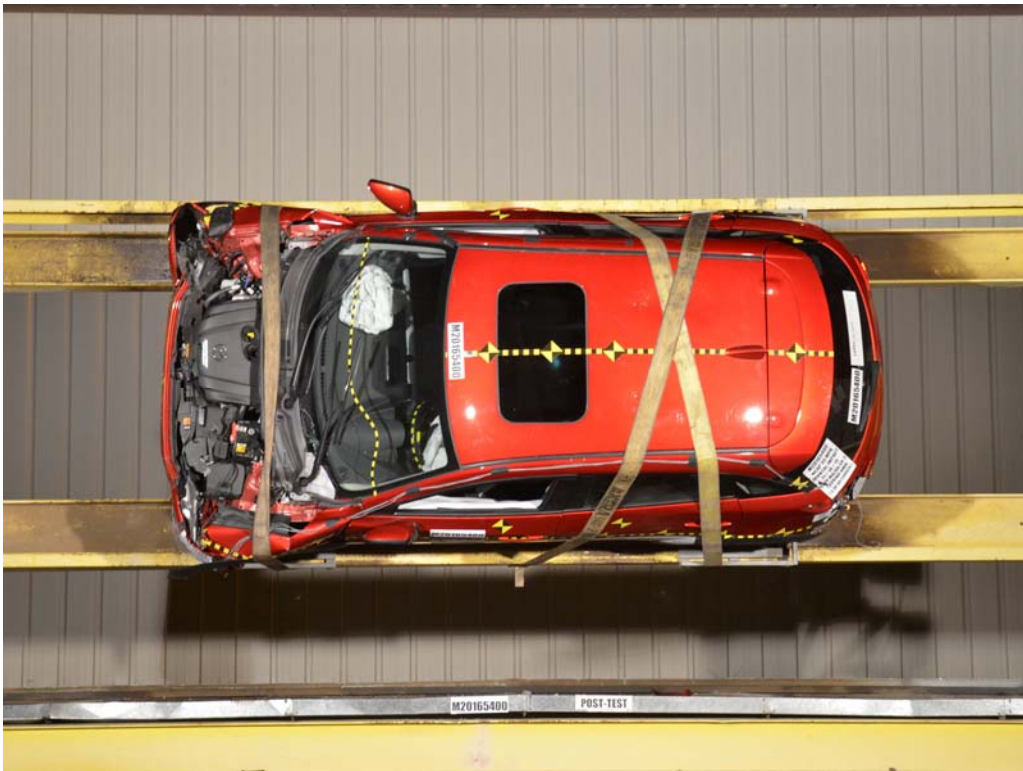
FIGURE 73. Vehicle at 90° on Static Rollover Device

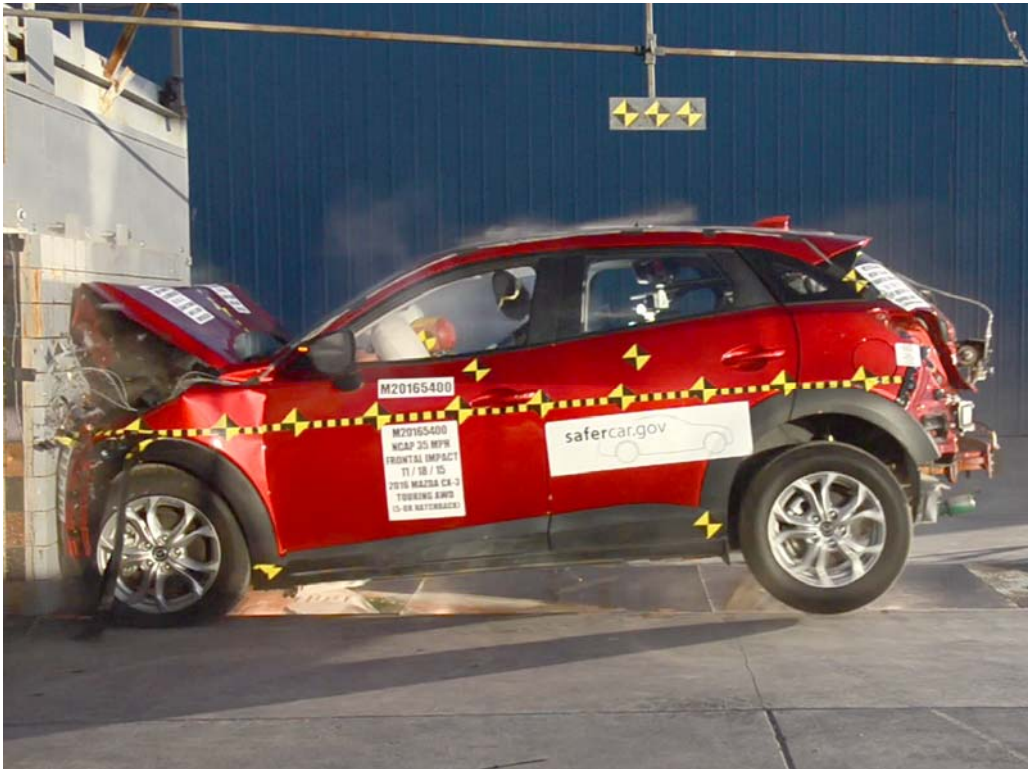
FIGURE 77. 2016 Mazda CX-3 Frontal Impact Event
