**DRAFT REPORT NUMBER: SPNCAP-TRC-16-003**

**NEW CAR ASSESSMENT PROGRAM (NCAP)  
SIDE IMPACT POLE TEST**

**FCA US LLC  
2016 Chrysler 300 4-Door Sedan  
NHTSA NUMBER: M20160301**

**FINAL REPORT**

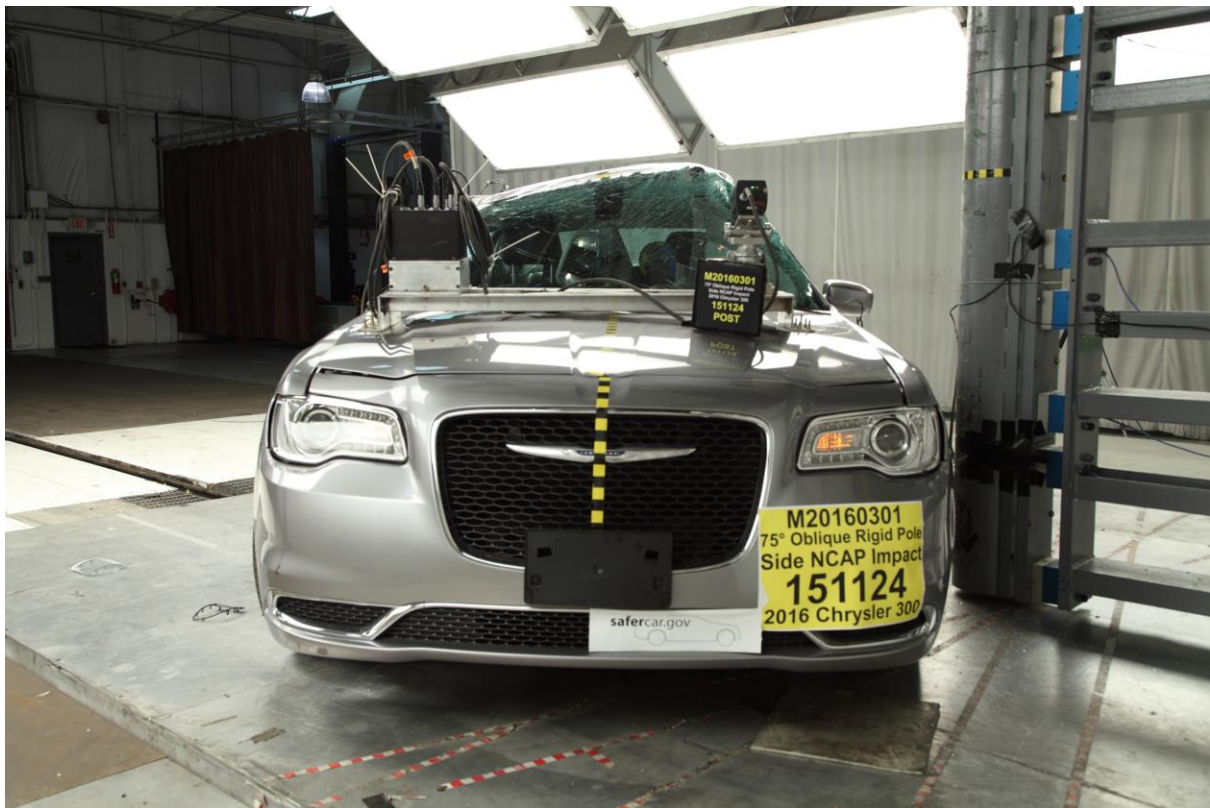
**004** Post-Test Frontal View of Test Vehicle

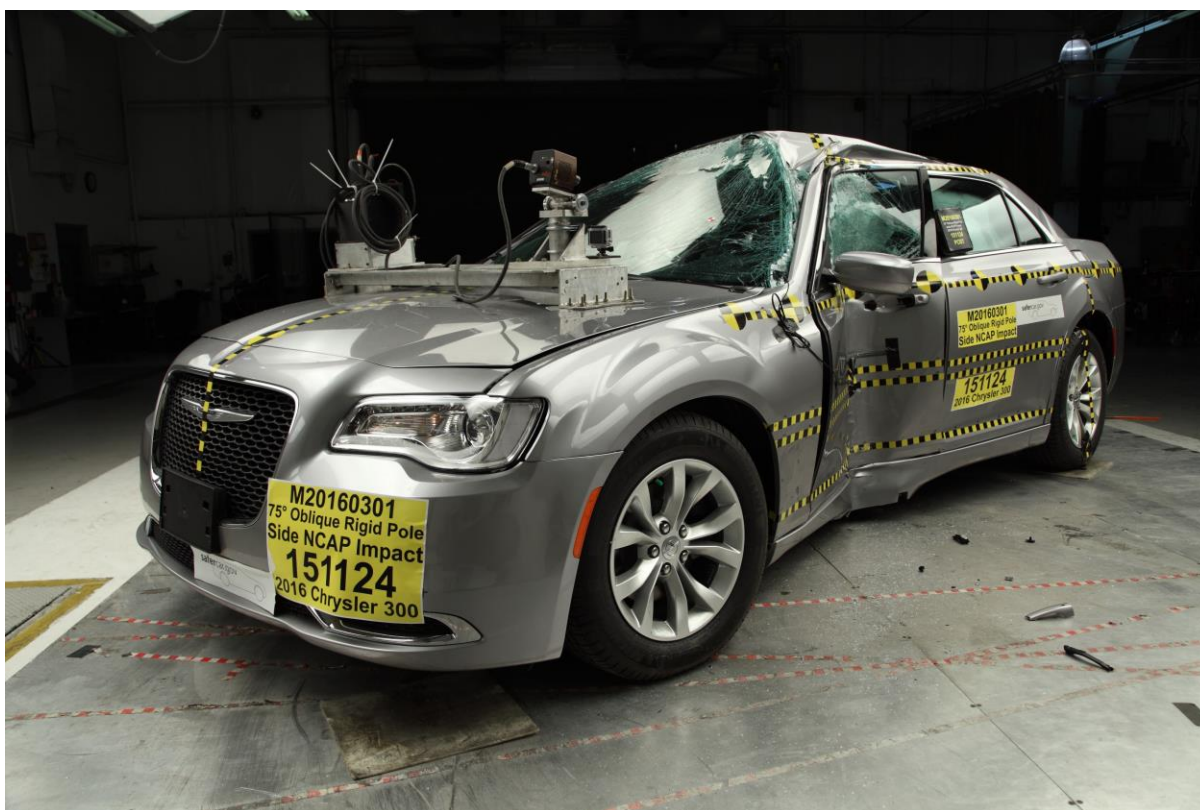
**006** Post-Test Left Front 3-4 View of Test Vehicle

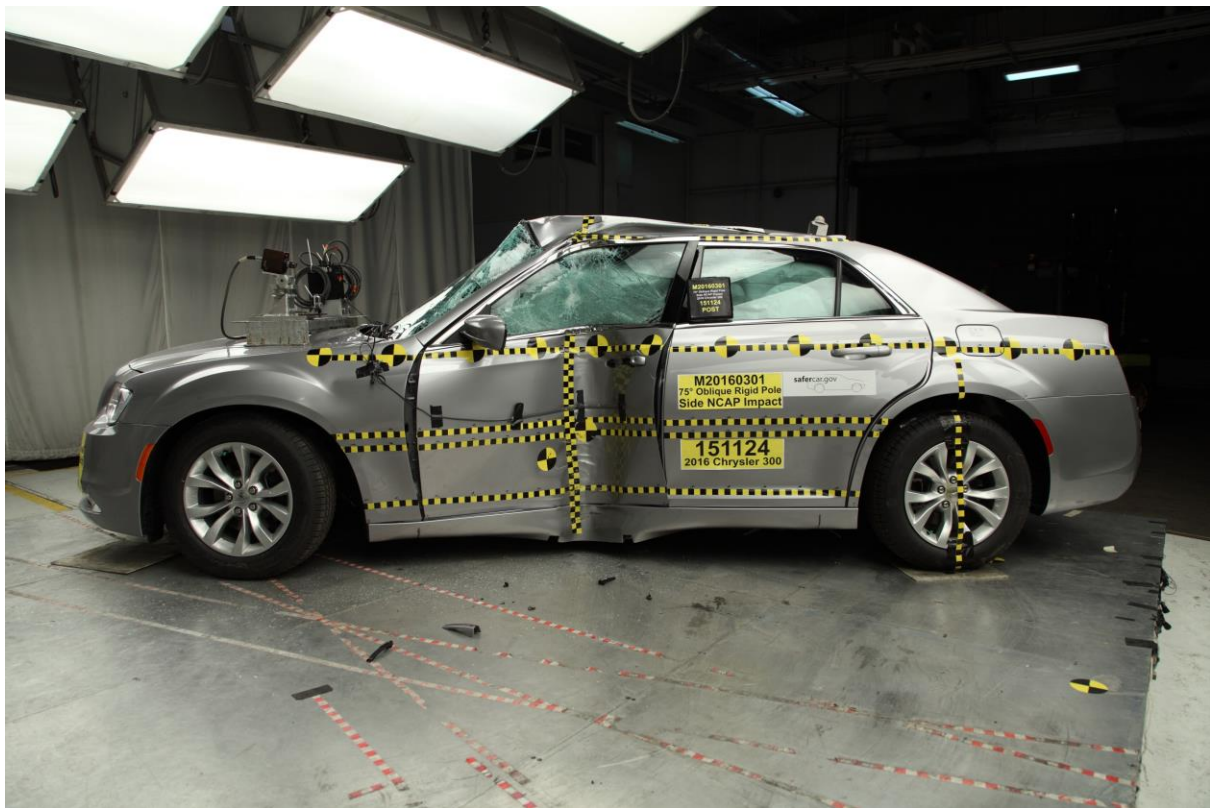
**008** Post-Test Left Side View of Test Vehicle

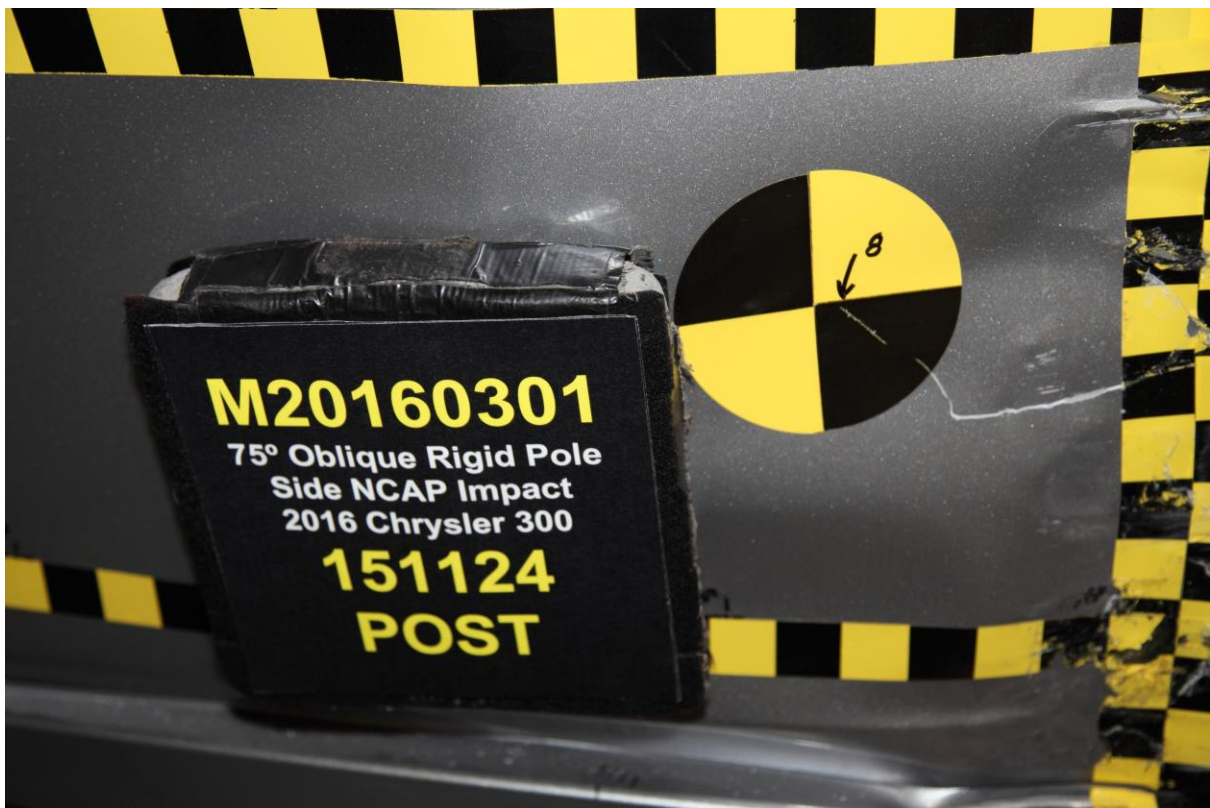
020 Post-Test Close-Up View of Impact Point Target Showing Impact Location

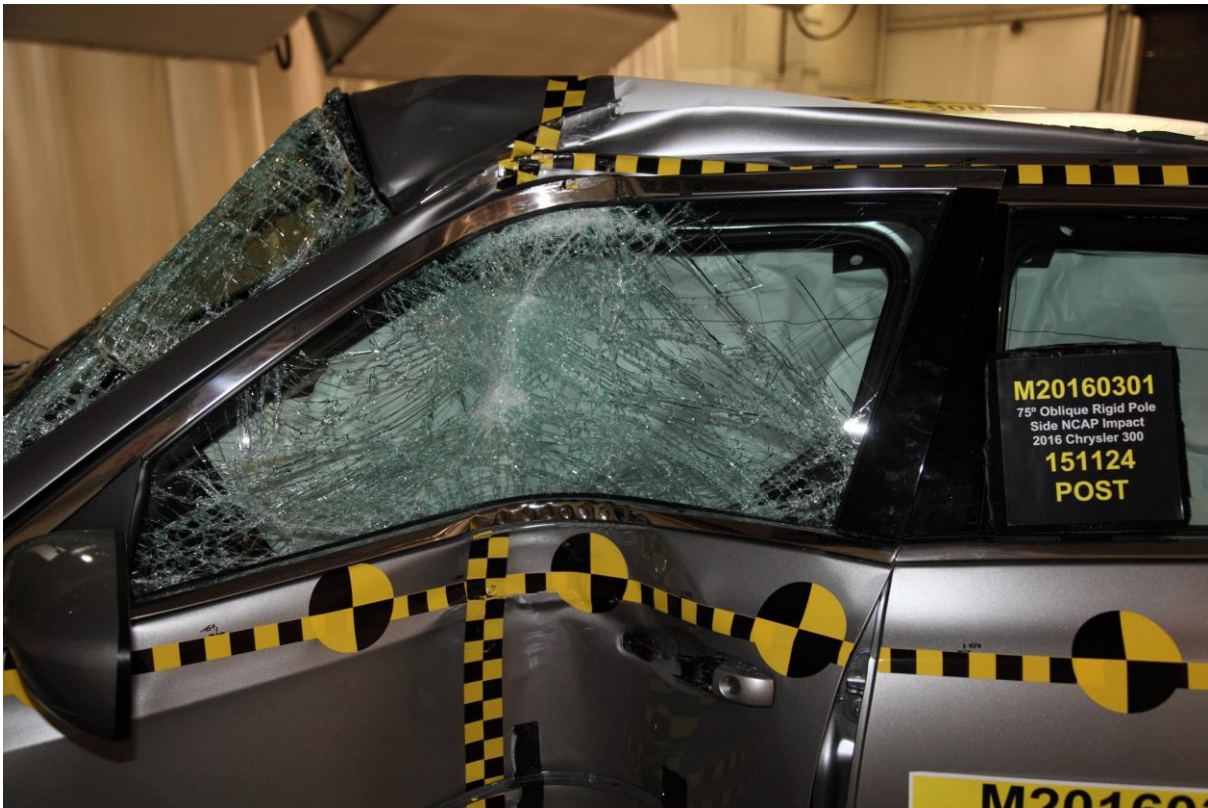
**025** Post-Test Left Side View of Dummy Shoulder and Door Top View

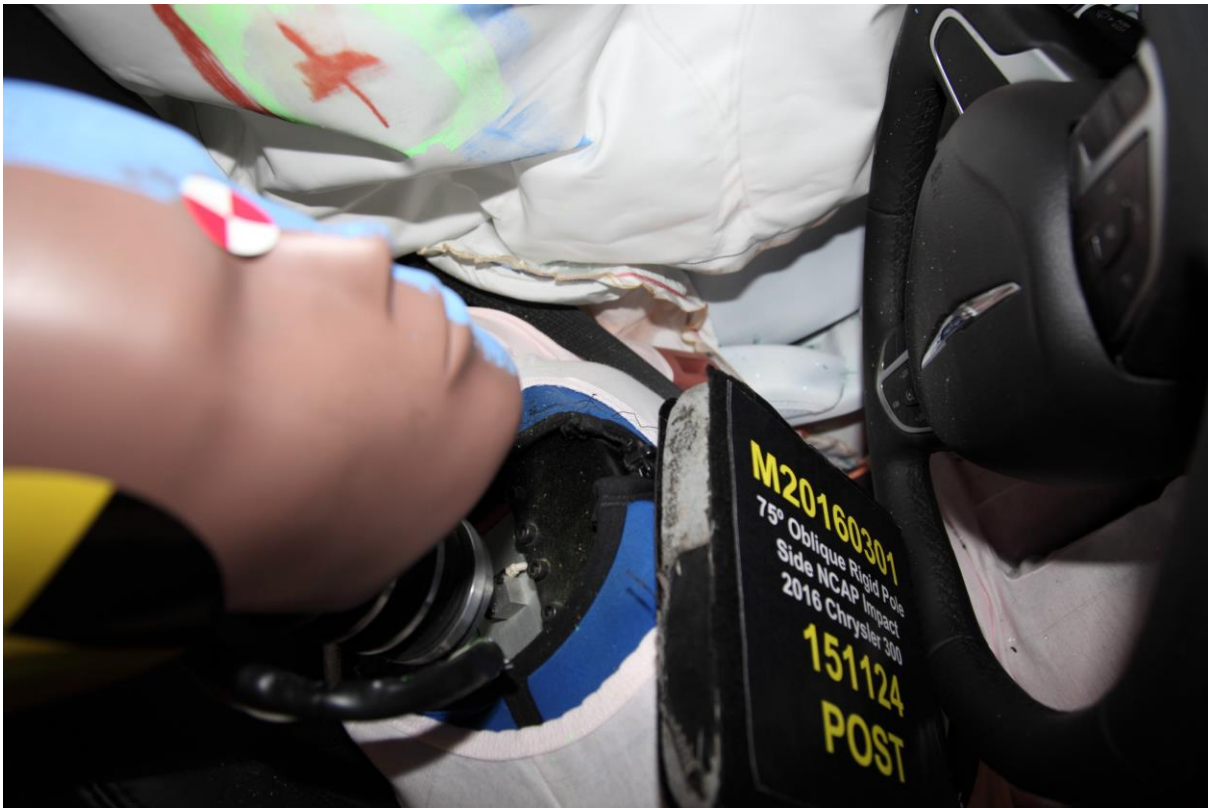
**041** Post-Test Dummy and Door Clearance View

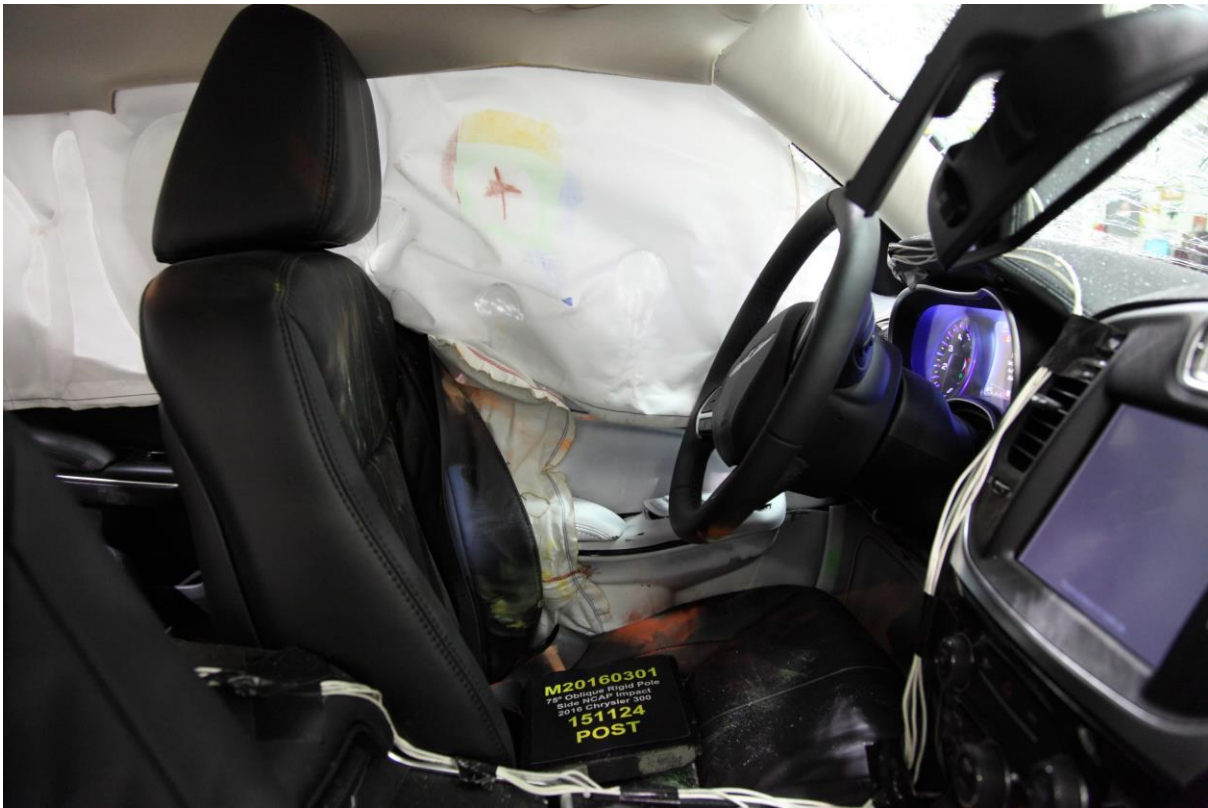
**045** Post-Test Inner Driver Door Panel View Showing Dummy Contact Location

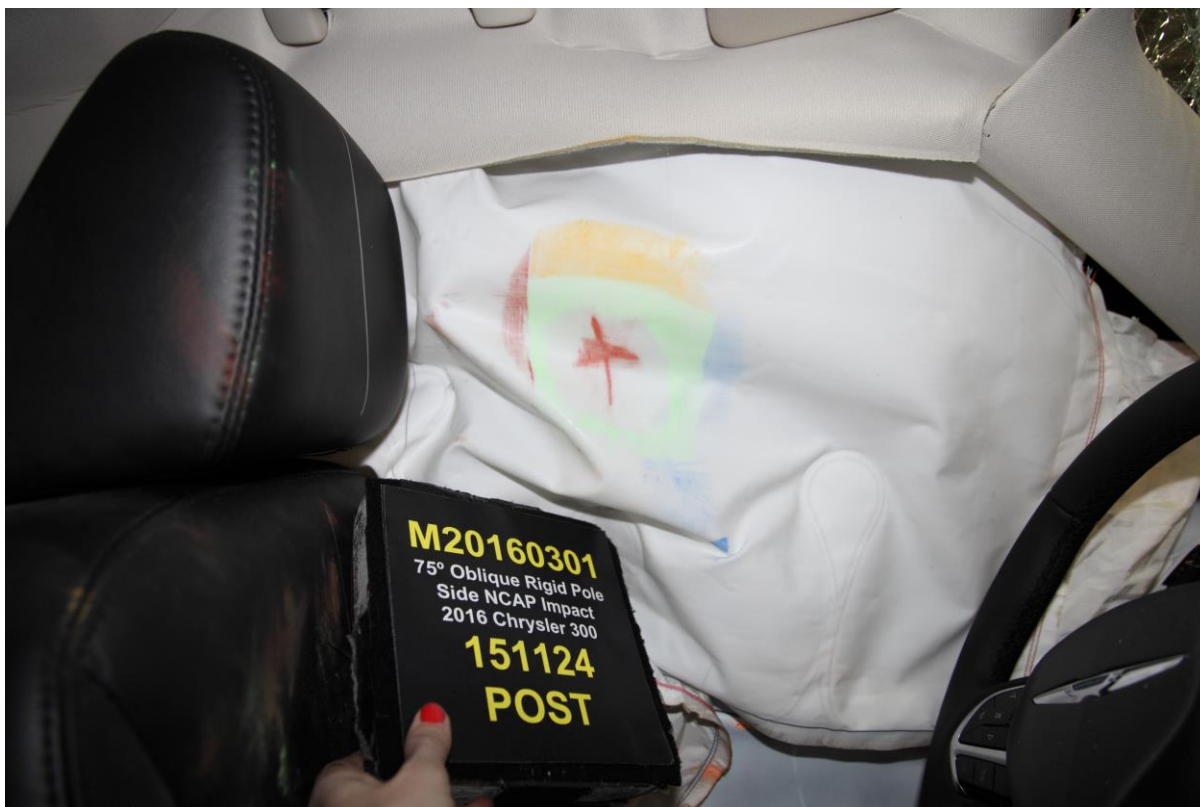
**047** Post-Test Dummy Close-Up Head Contact with Side Airbag View

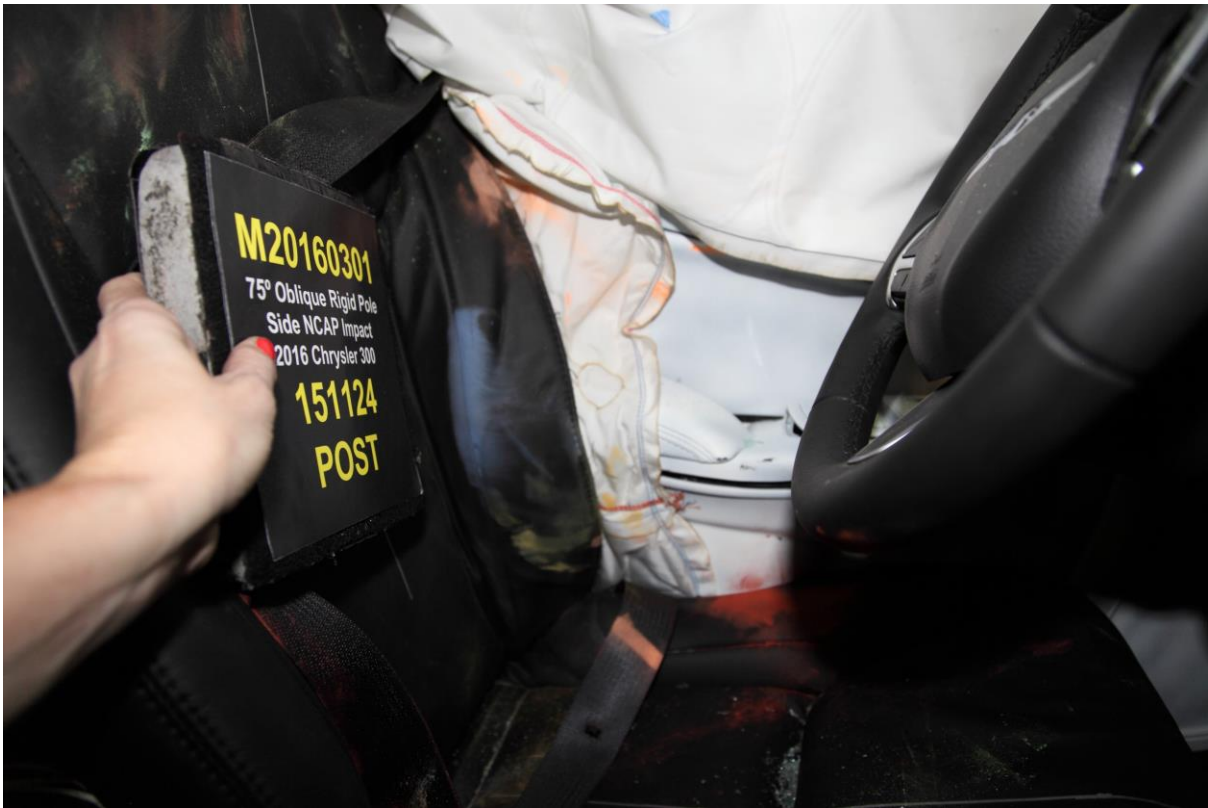
**049** Post-Test Dummy Close-Up Torso Contact with Side Airbag View

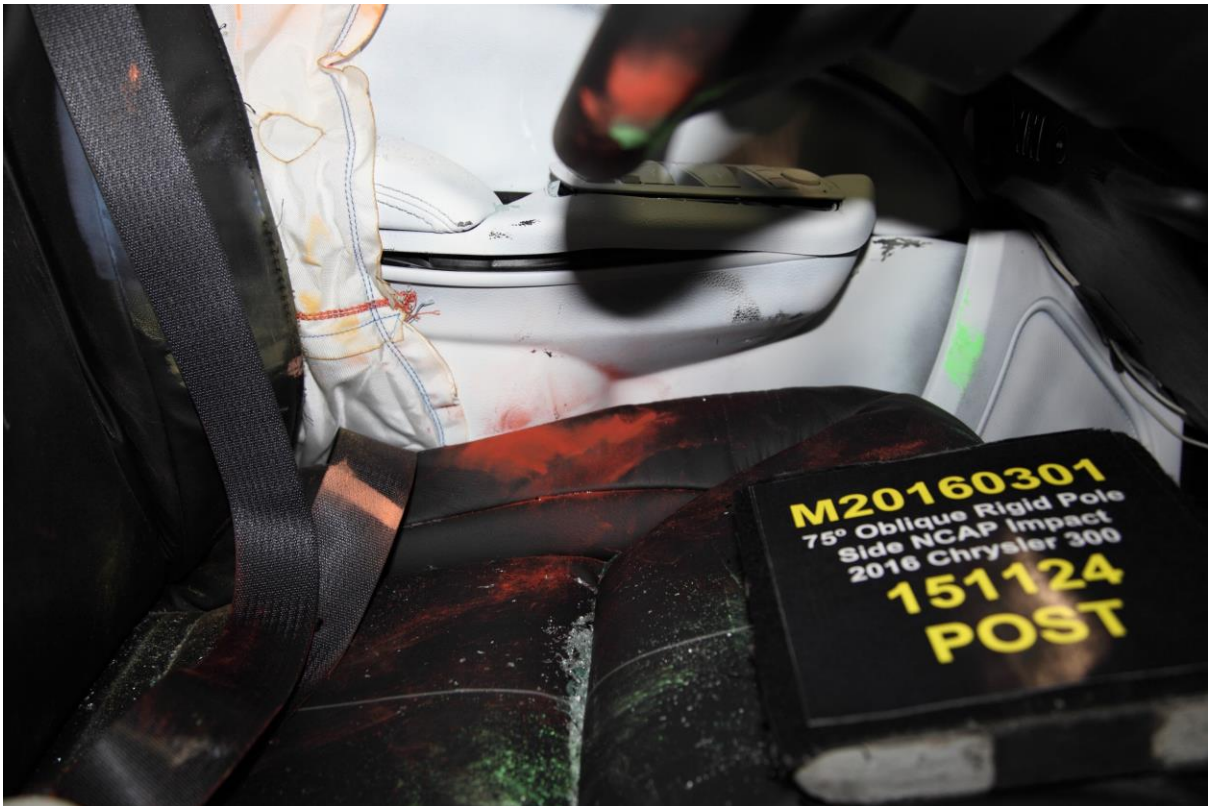
**050** Post-Test Dummy Close-Up Pelvis Contact with Vehicle Interior View

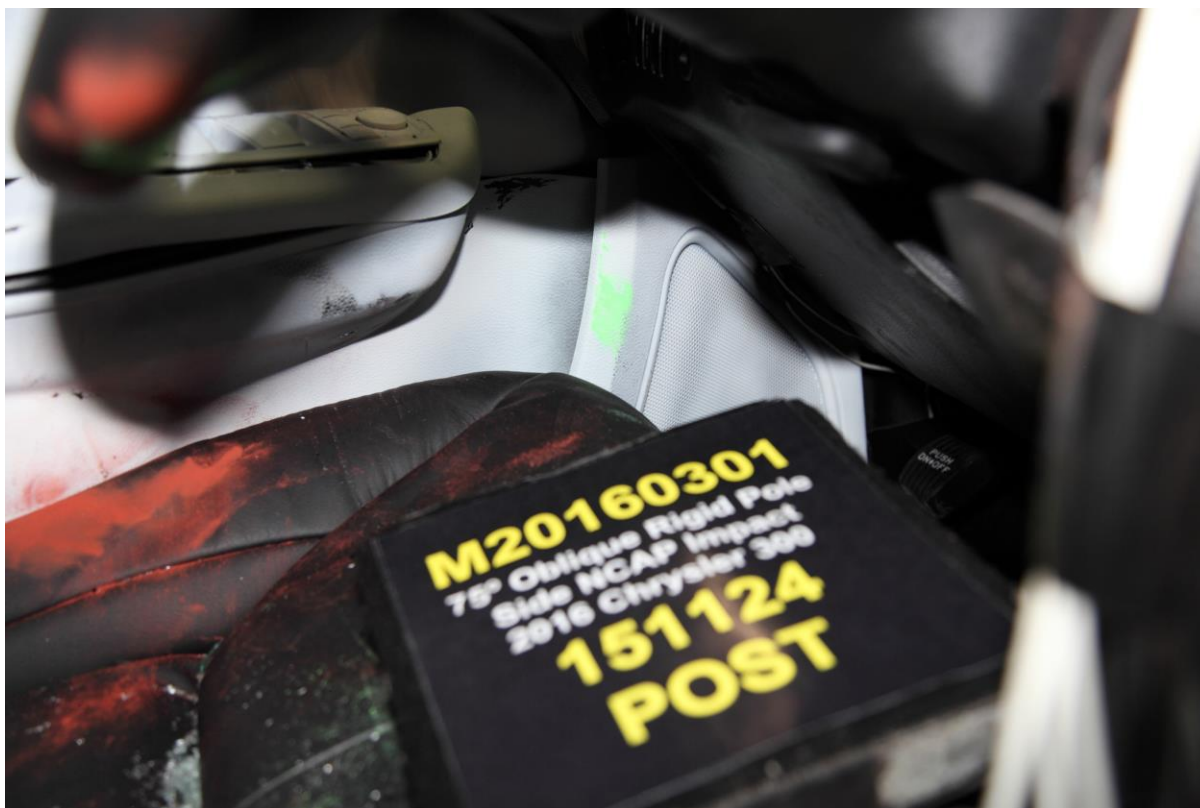
**052** Post-Test Dummy Close-Up Knee Contact with Vehicle Interior View

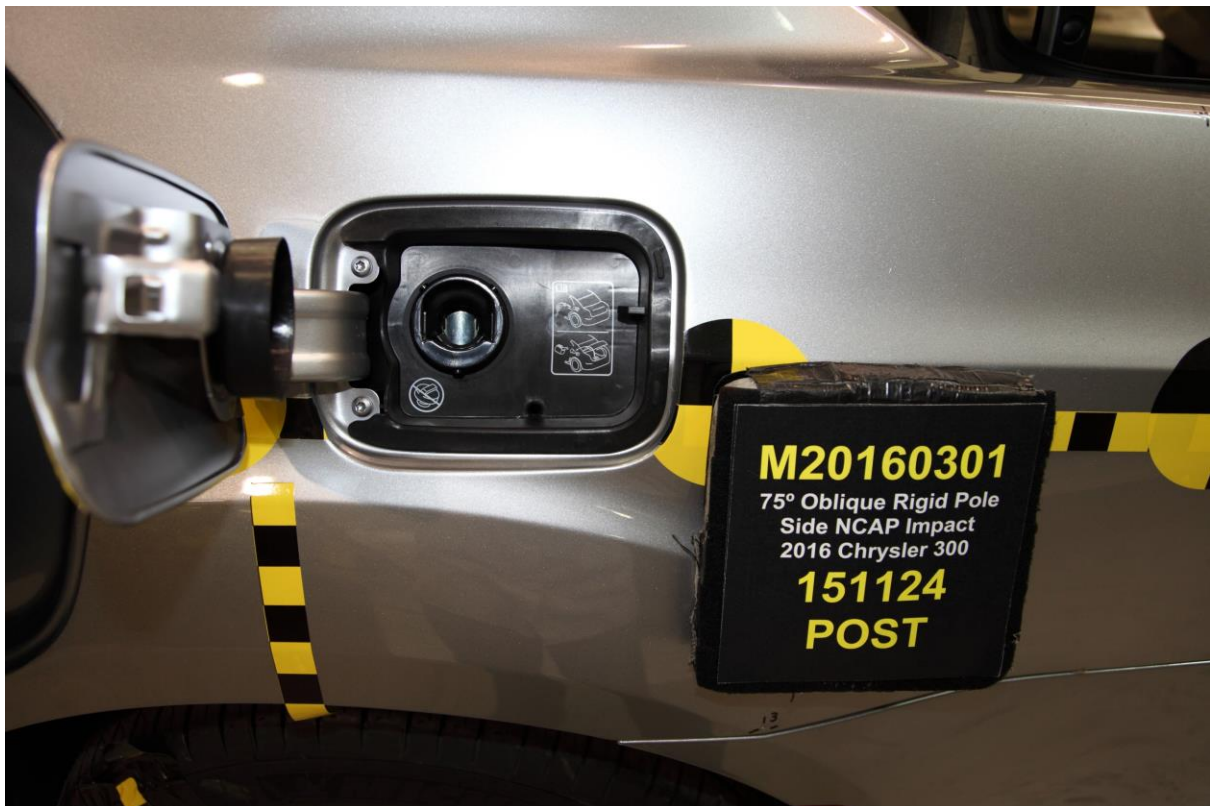
**054** Post-Test View of Fuel Filler Cap or Fuel Filler Neck

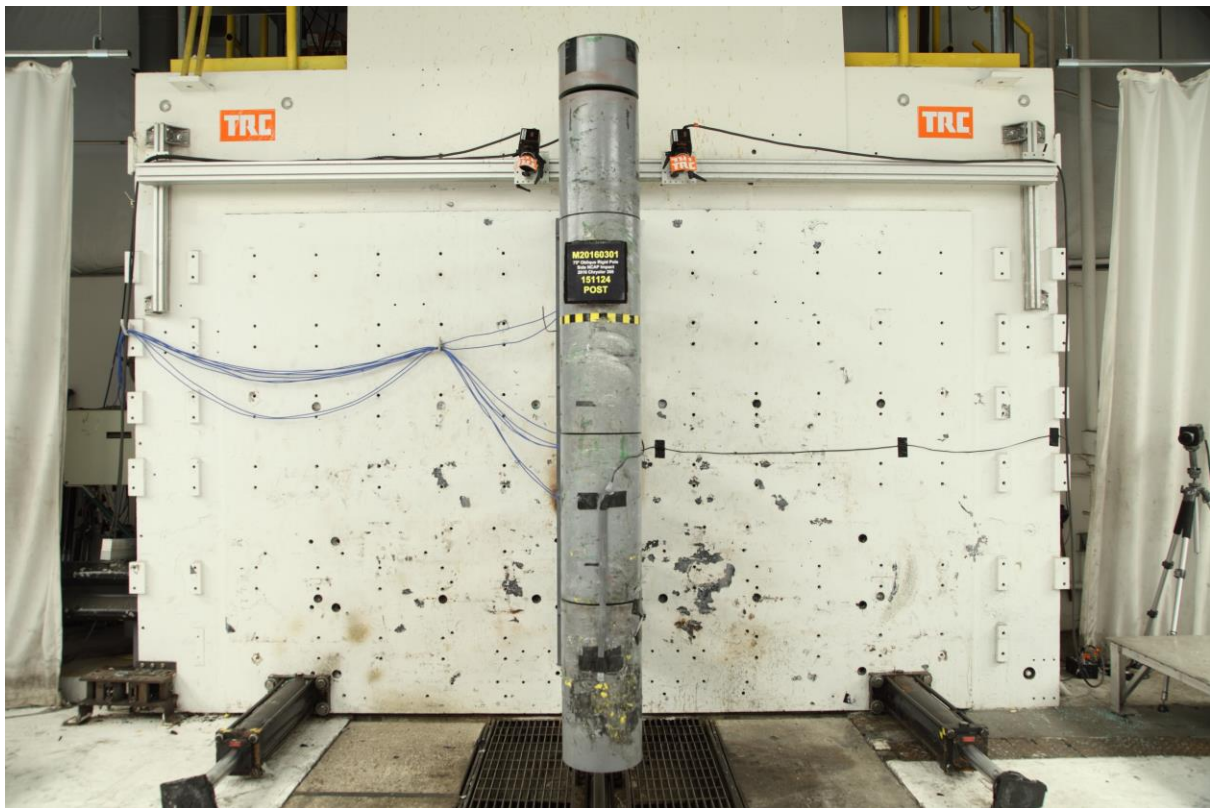
**058 Post-Test Pole Barrier Front View**

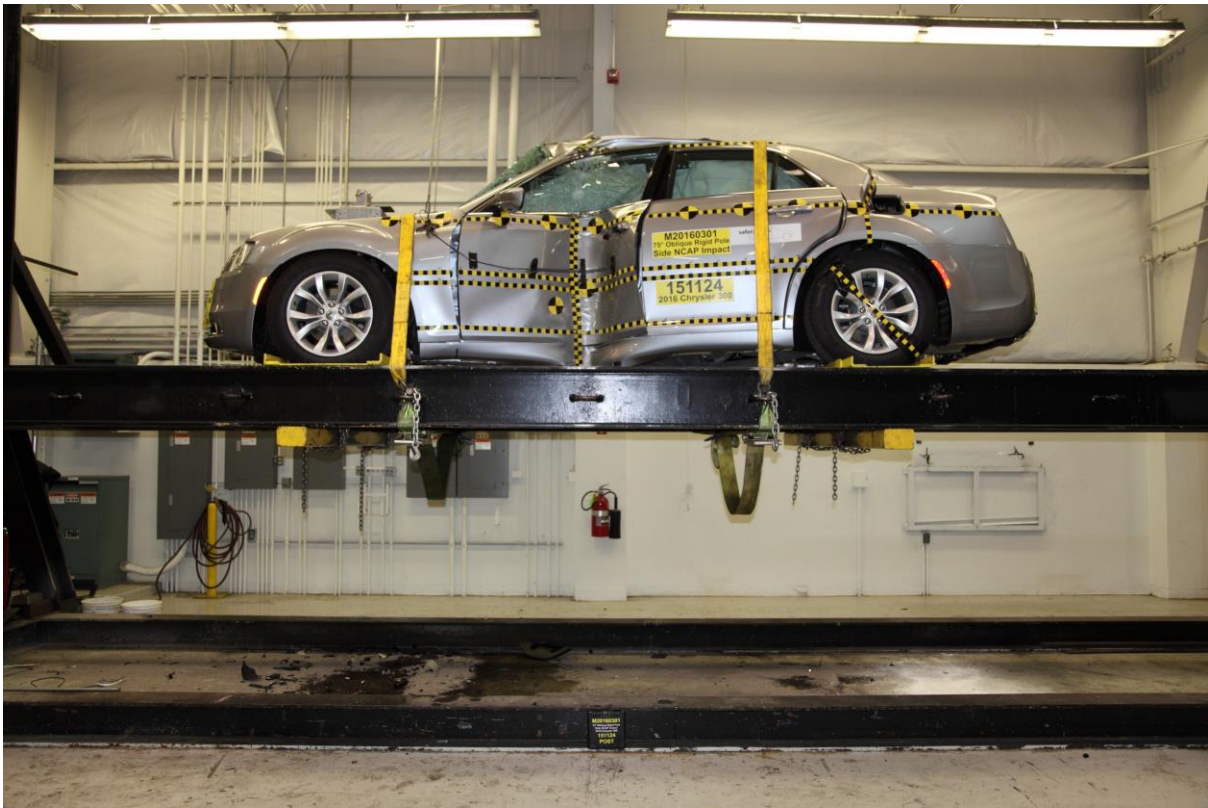
**063** FMVSS No. 301 Static Rollover 0 Degrees

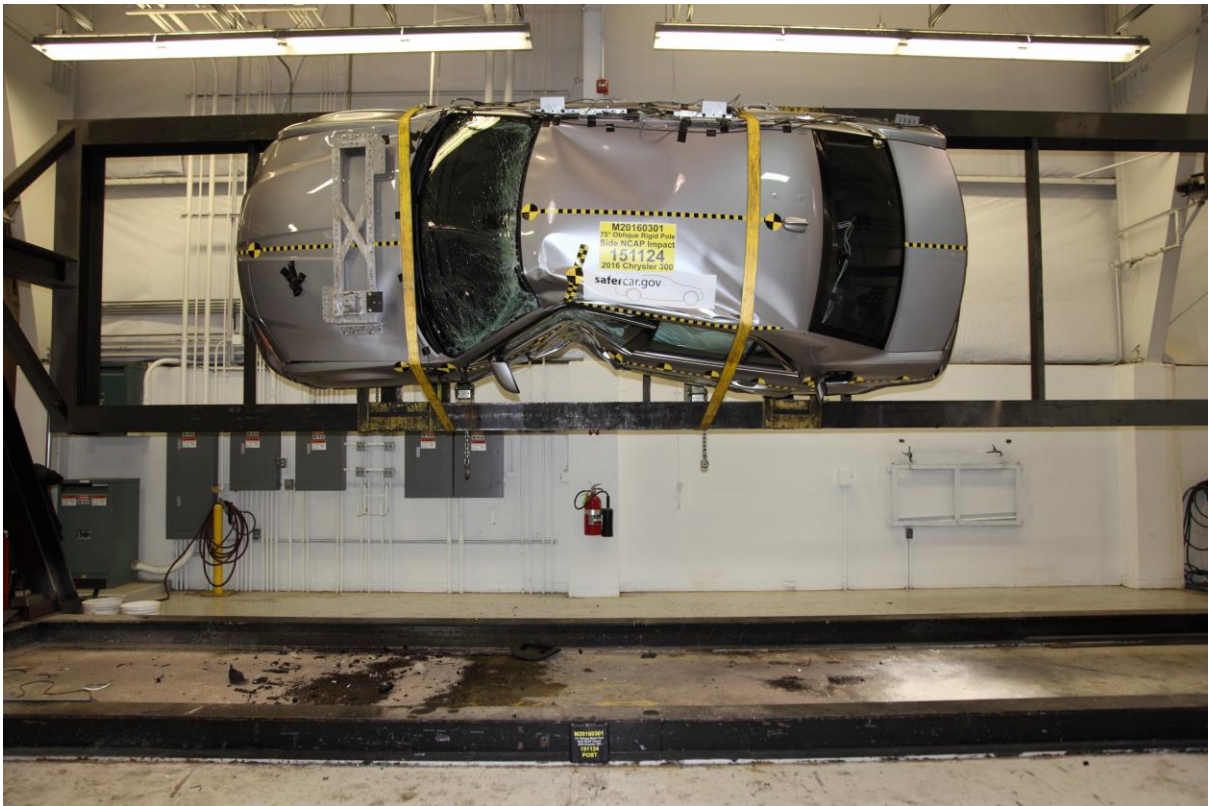
**064** FMVSS No. 301 Static Rollover 90 Degrees

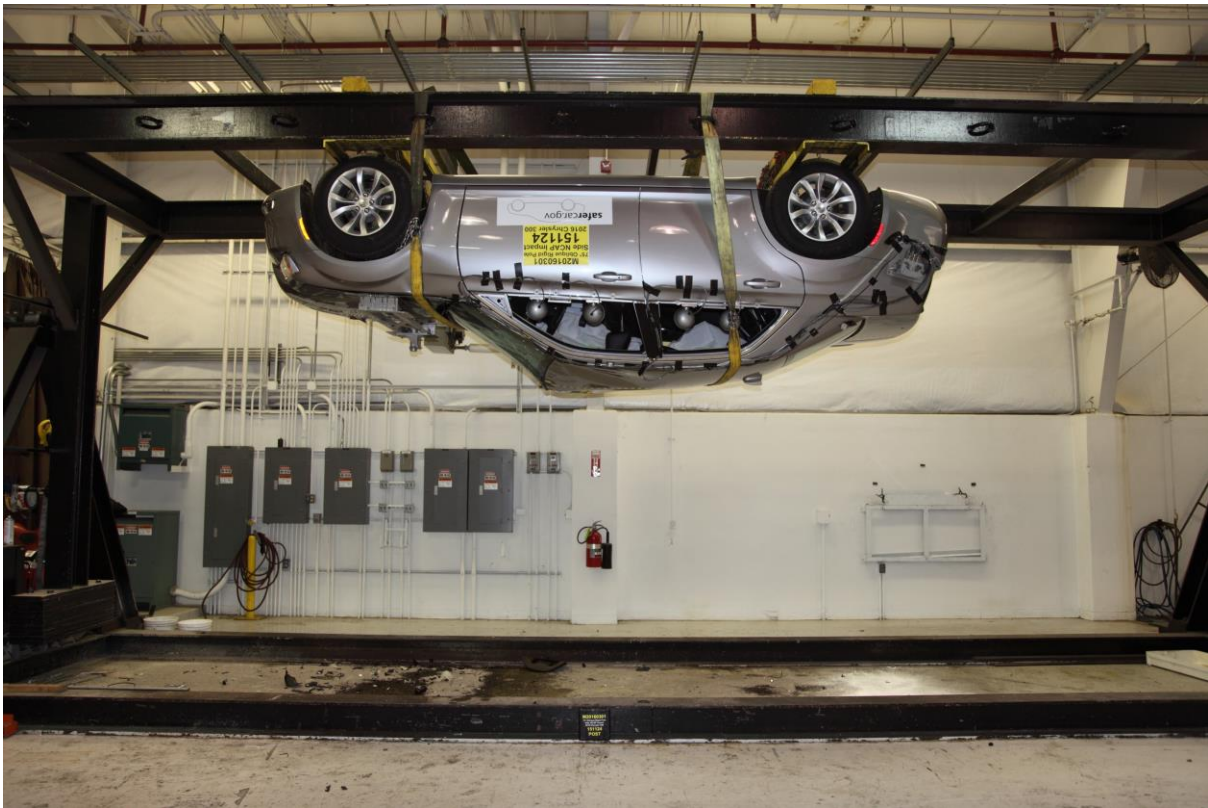
**065** FMVSS No. 301 Static Rollover 180 Degrees

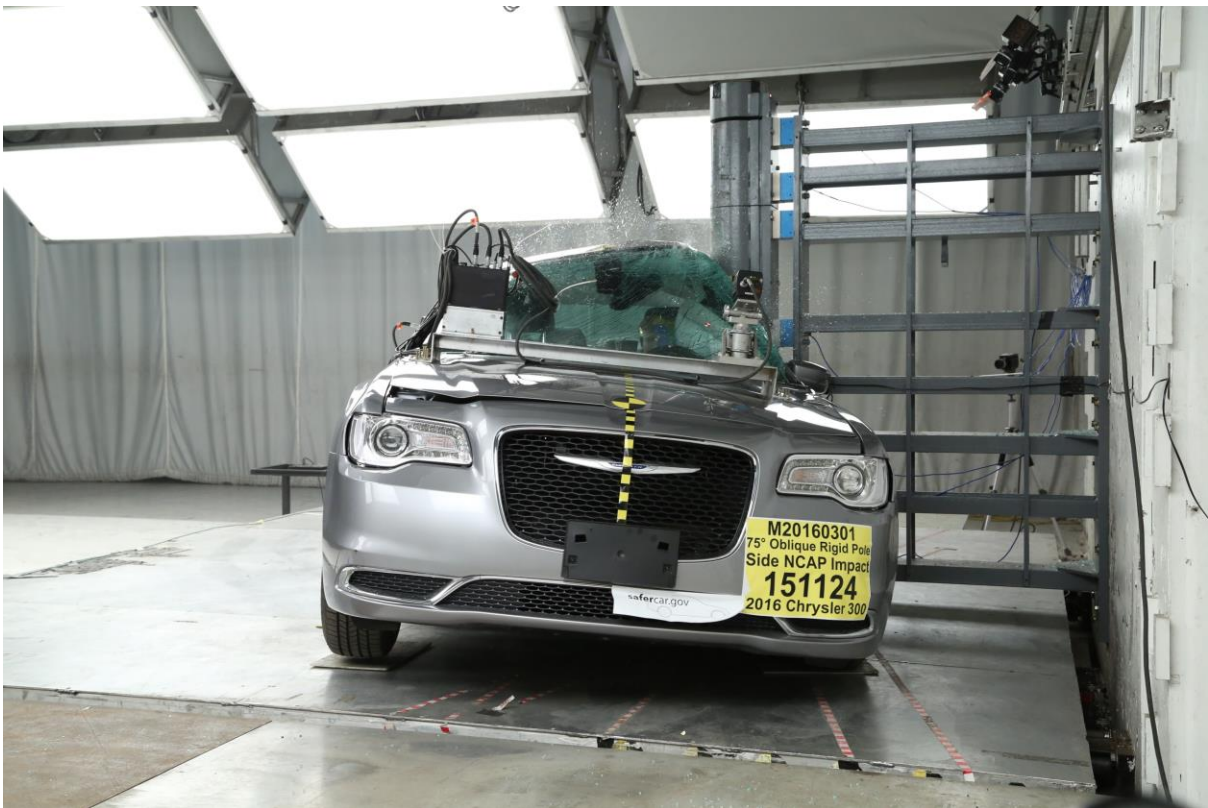
**068** Impact Event
