REPORT NUMBER: SINCAP-CAL-16-003

**NEW CAR ASSESSMENT PROGRAM (NCAP)
MOVING DEFORMABLE BARRIER SIDE IMPACT TEST**

**Volvo Car Corporation
2016 Volvo S60i
Four Door Sedan**

NHTSA No: O20165901

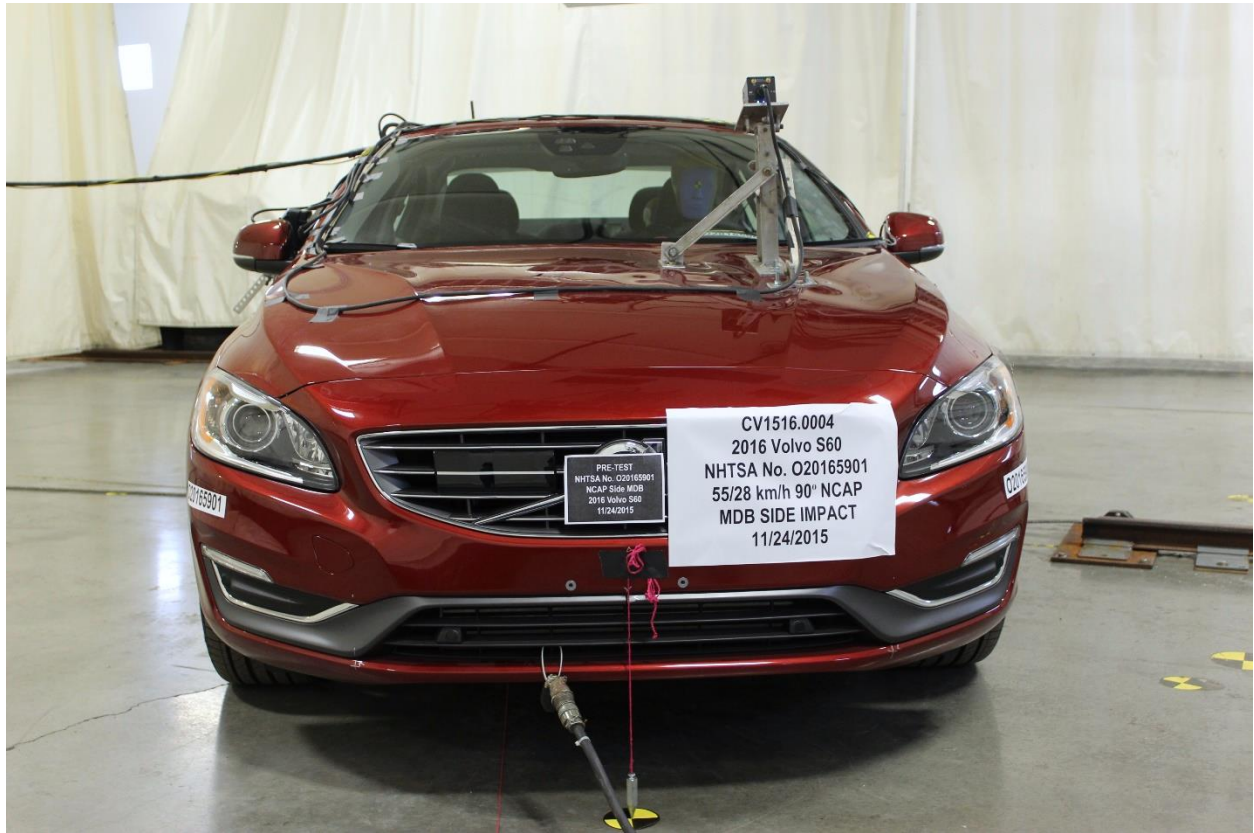
Figure A-3: Pre-Test Frontal View of Test Vehicle

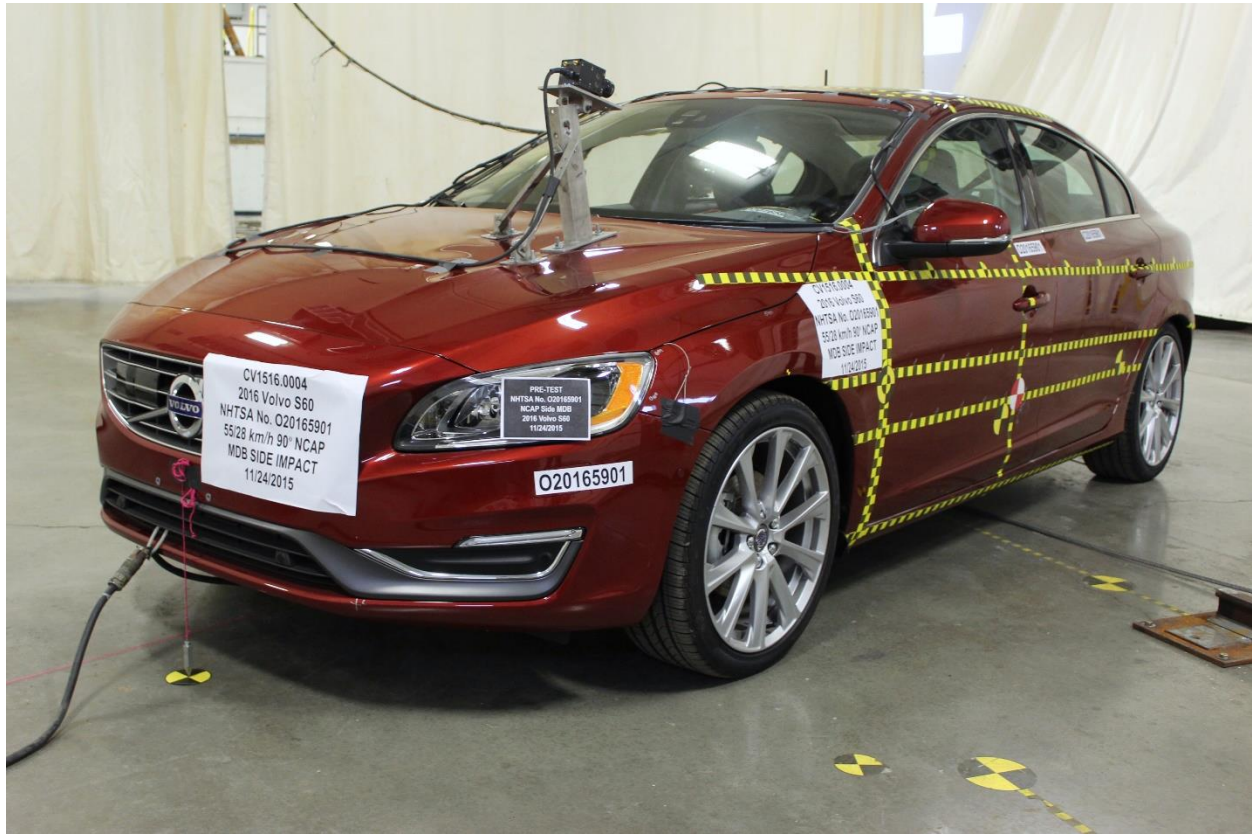
Figure A-5: Pre-Test Left Front ¾ View of Test Vehicle

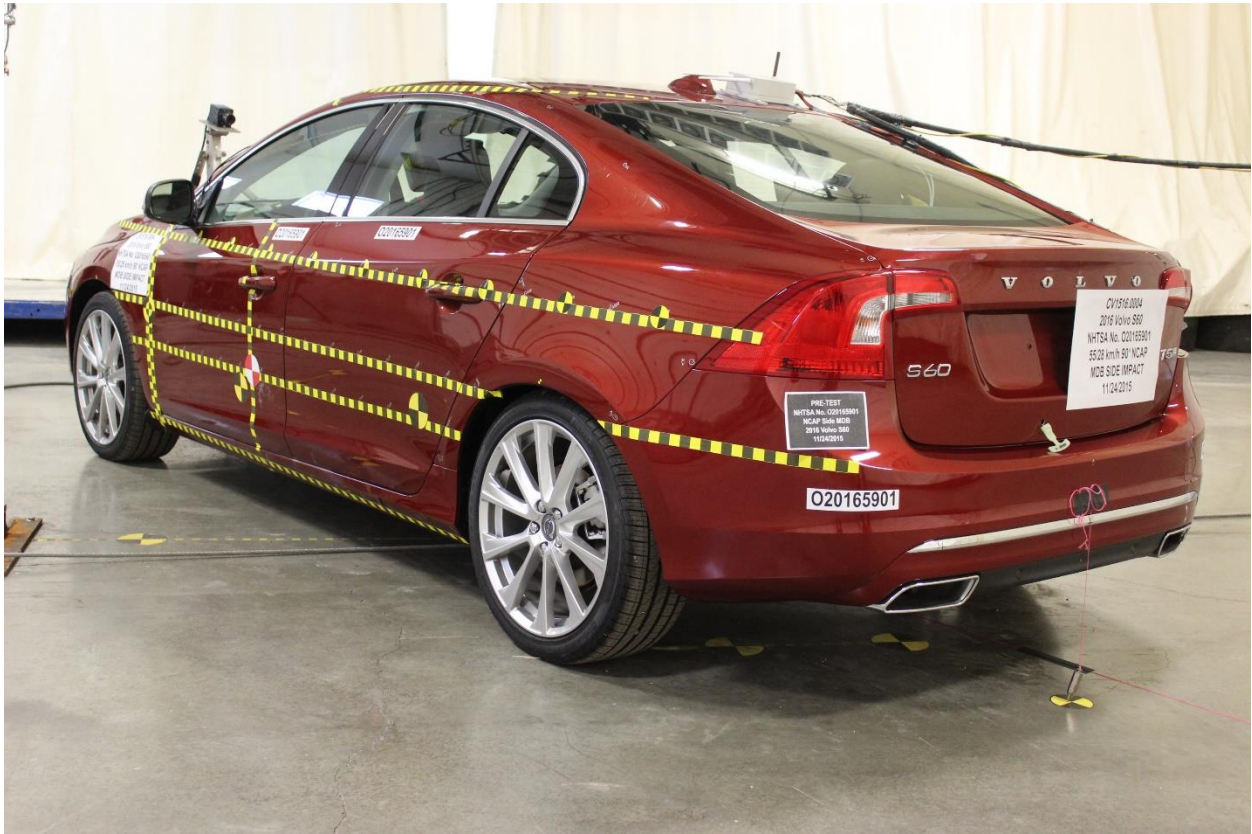
Figure A-9: Pre-Test Left Rear $\frac{3}{4}$ View of Test Vehicle

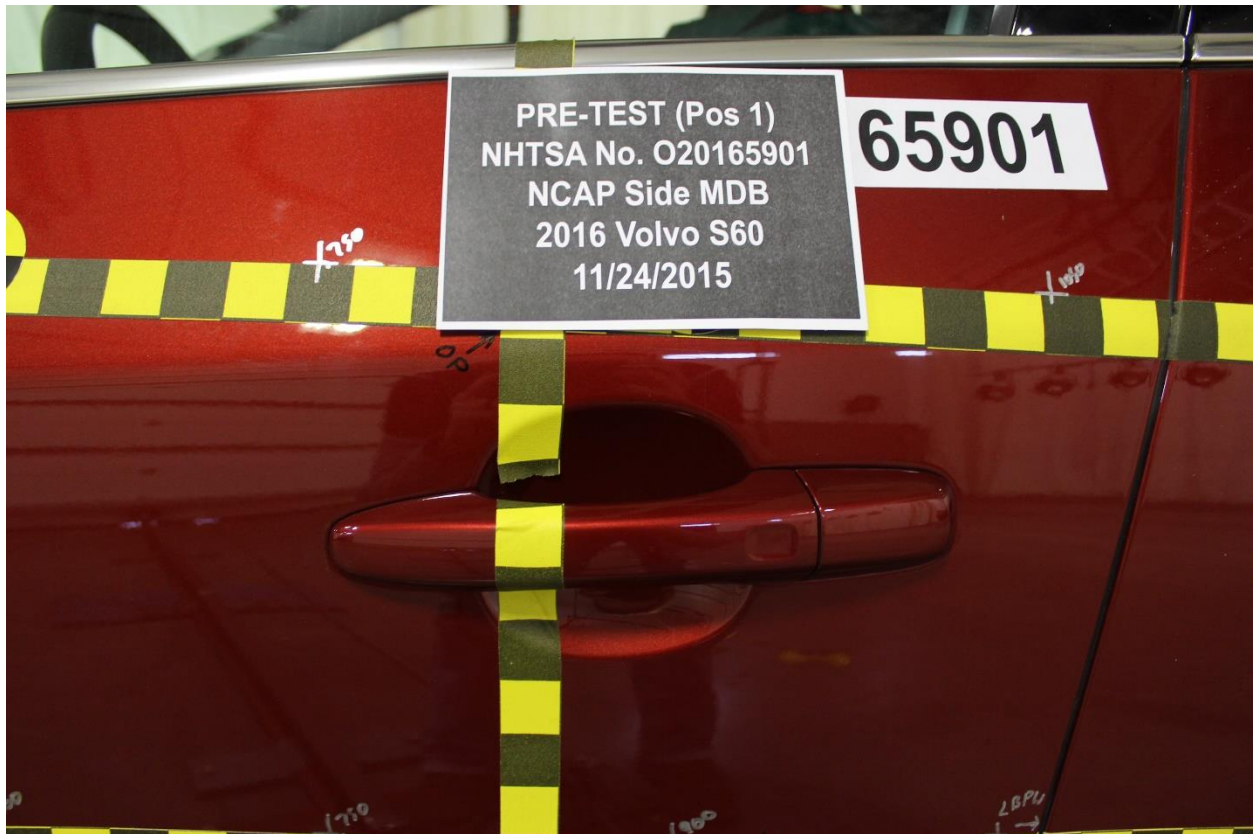
Figure A-21: Pre-Test Left Front Door Latch Close-Up

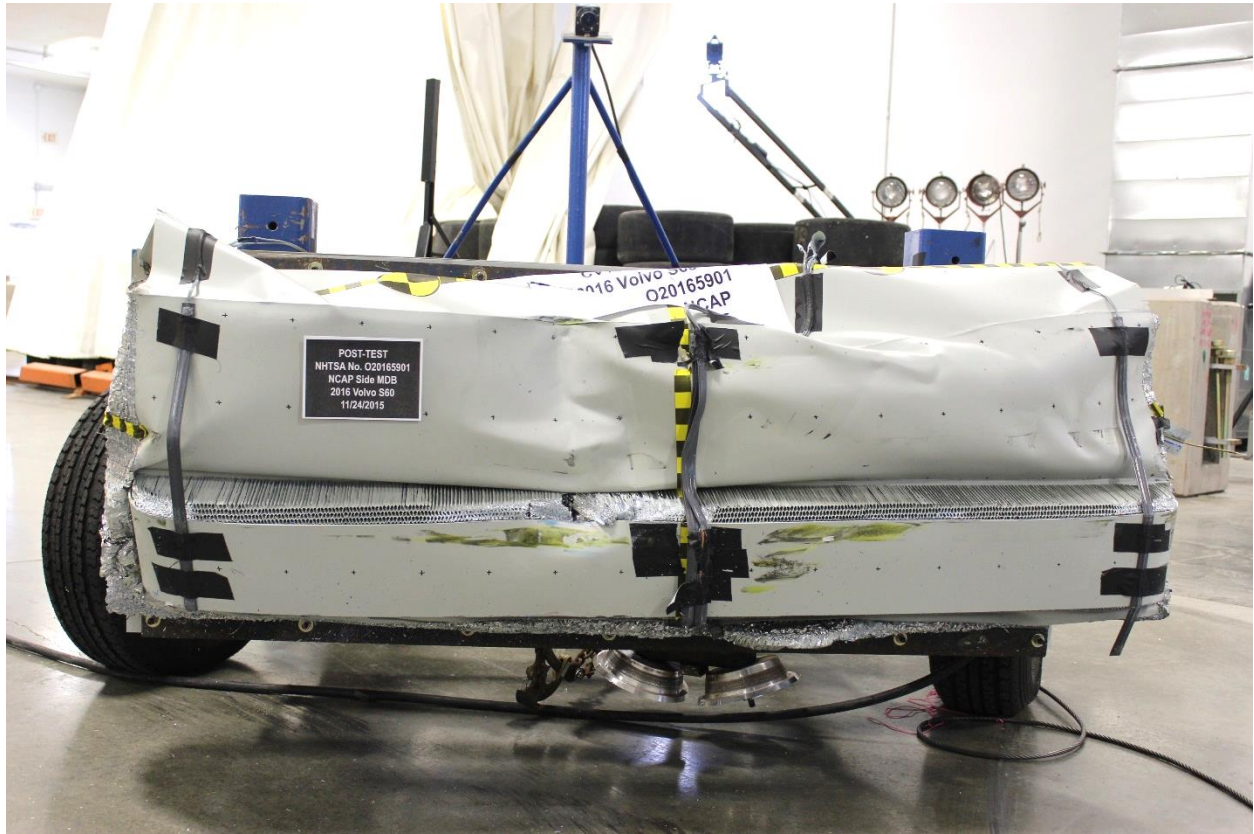
Figure A-85: Post-Test Front View of MDB Impactor Face

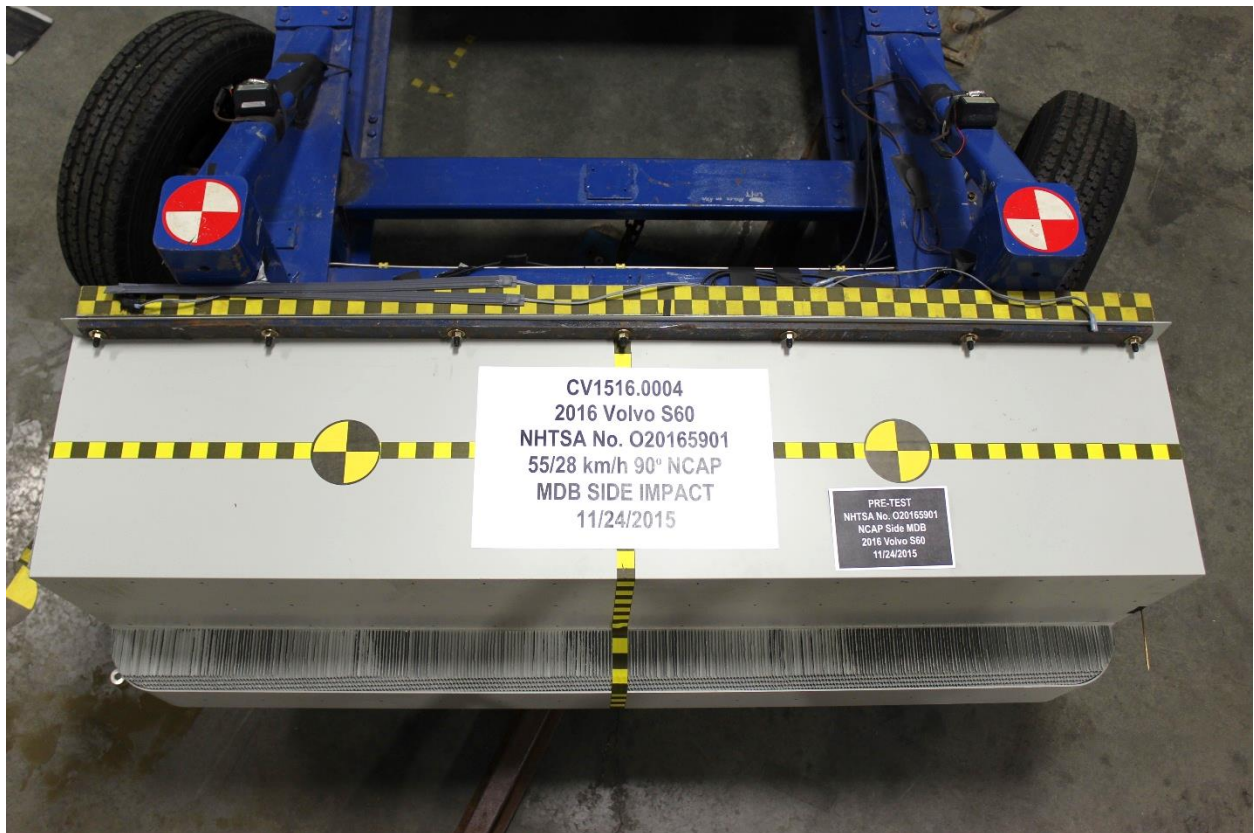
Figure A-86: Pre-Test Top View of MDB Impactor Face
