**REPORT NUMBER: R&D-CAL-15-010**

**MOVING BARRIER TO VEHICLE CRASH TEST IN SUPPORT OF NHTSA'S  
FRONTAL OBLIQUE OFFSET PROGRAM  
OBLIQUE MOVING DEFORMABLE BARRIER INTO LEFT FRONT OF A**

**2016 Mazda CX-5**

**90.1KPH, 15 DEGREE ANGLE, 35% OVERLAP**

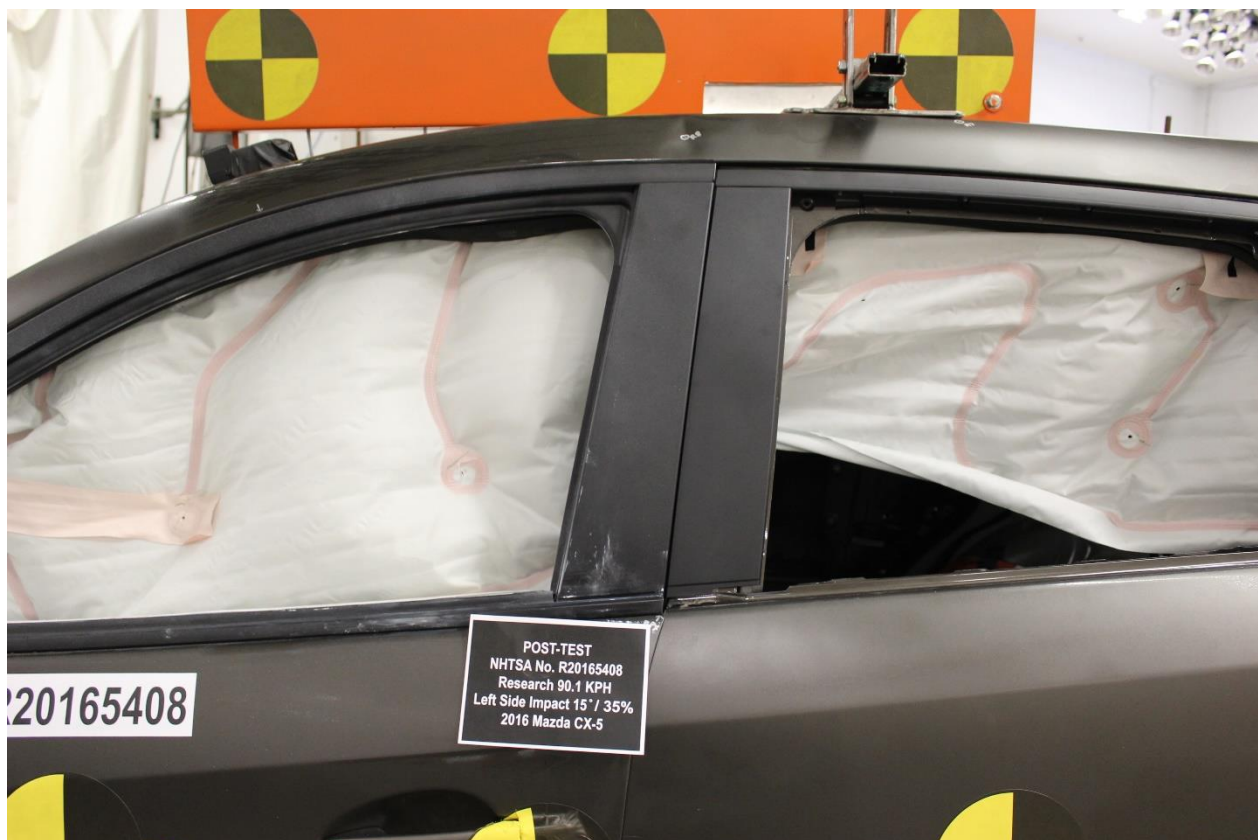
**No. 162: Post-Test View of Deformation of B pillar-Struck Side**

- Windshield had cracks throughout with minor separation along the driver side.
- The A-Pillar, B-Pillar & C-Pillar Buckled during impact
- Hood bent inwards and exposed part of the engine compartment

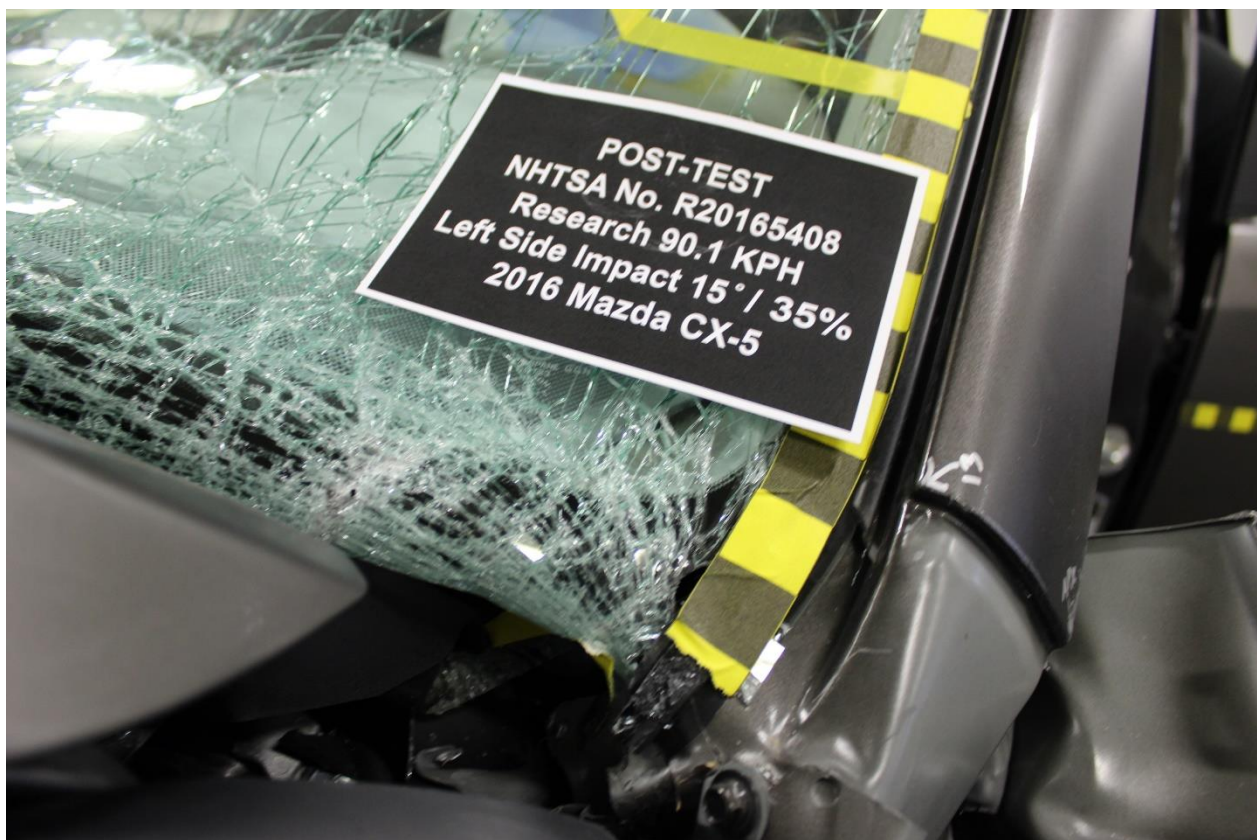
**No. 166: Post-Test View of Windshield Separation**

| Critical Areas of Performance | Observations and Conclusions | Photo Taken (Y/N) |
|---|---|---|
| Windshield Damage | Cracks throughout with minor separation | Y |

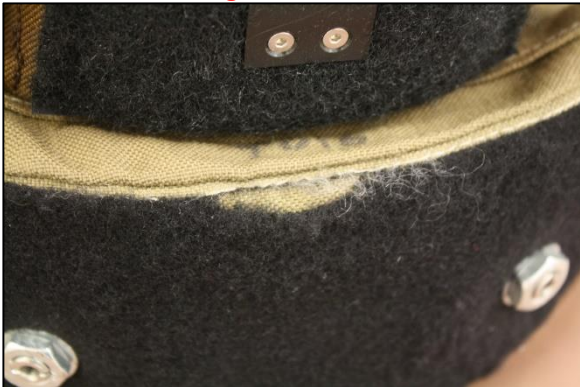
| HEAD | |
|---|---|
| Y / N | No evidence of tearing, cuts, or broken stitches in lower abdomen bag and zipper<br><b>Tear in center of bag.</b> |

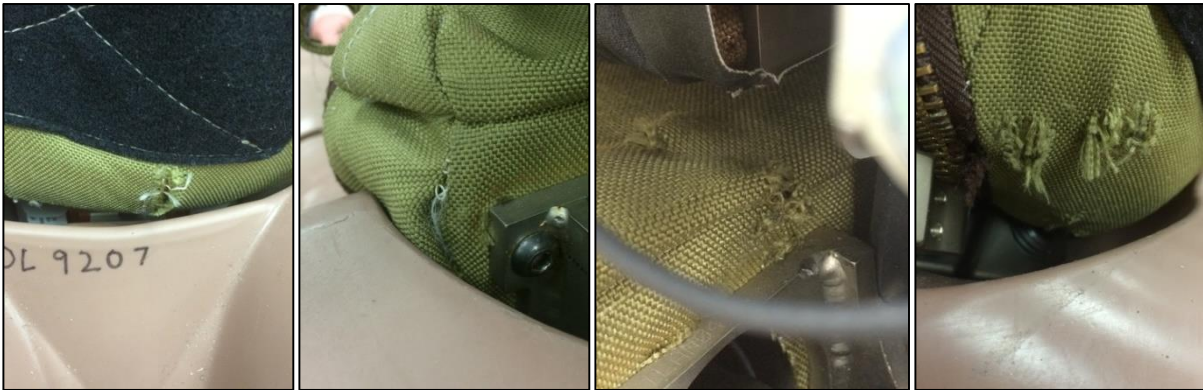
| HEAD | |
|---|---|
| | <b>Multiple tears and broken stitches in lower abdomen bag. The upper and lower abdomen bags appear to be from THOR SN007</b> |

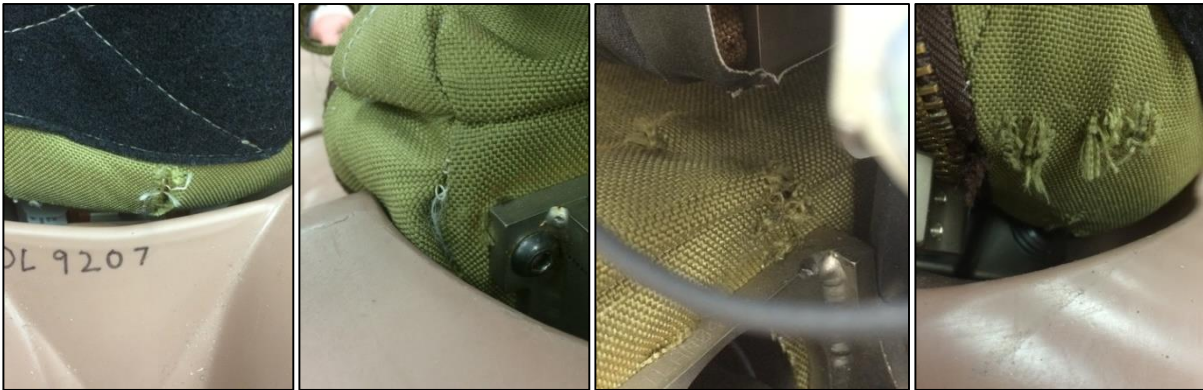
| HEAD | |
|---|---|
| | <b>Multiple tears and broken stitches in lower abdomen bag. The upper and lower abdomen bags appear to be from THOR SN007</b> |
