**REPORT NUMBER: R&D-CAL-15-011**

**MOVING BARRIER TO VEHICLE CRASH TEST IN SUPPORT OF NHTSA'S  
FRONTAL OBLIQUE OFFSET PROGRAM  
OBLIQUE MOVING DEFORMABLE BARRIER INTO LEFT FRONT OF A**

**2016 Mazda CX-5**

**90.1KPH, 15 DEGREE ANGLE, 35% OVERLAP**

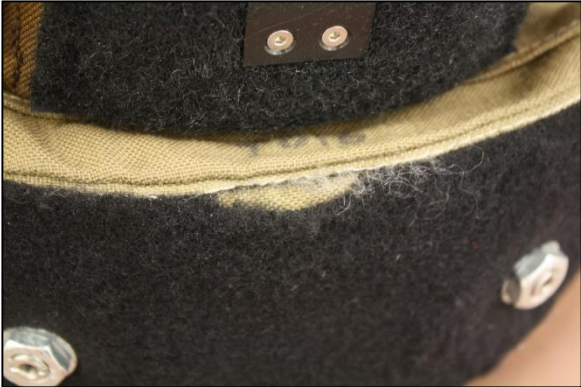
| HEAD | |
|---|---|
| Y / N | No evidence of tearing, cuts, or broken stitches in lower abdomen bag and zipper<br><b>Tear in center of bag.</b> |

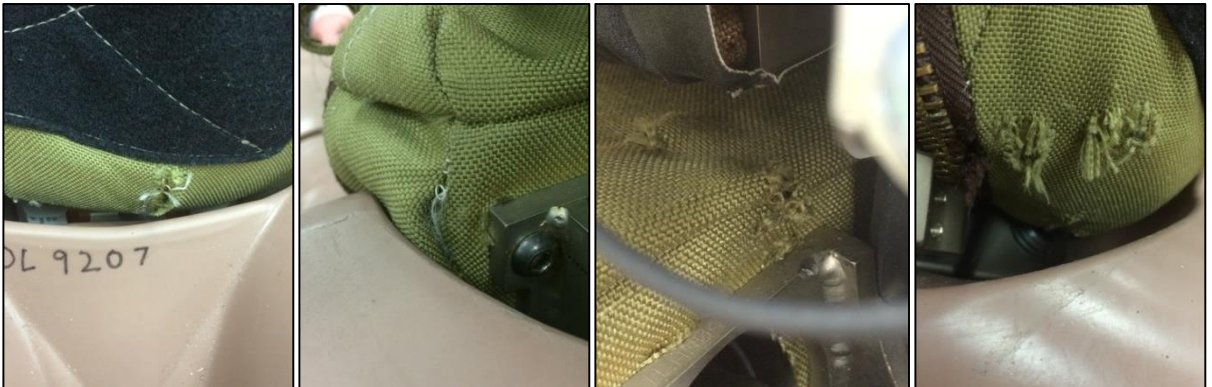
| HEAD | |
|---|---|
| | <b>Multiple tears and broken stitches in lower abdomen bag. The upper and lower abdomen bags appear to be from THOR SN007</b> |

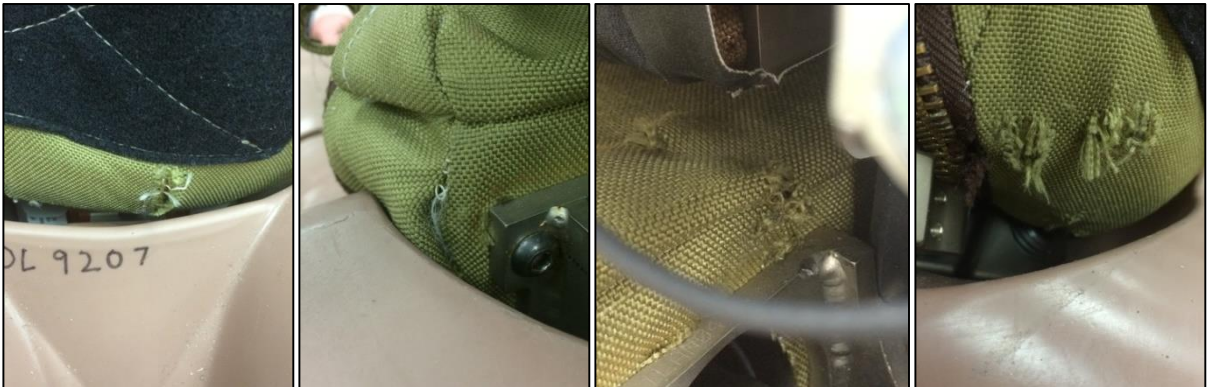
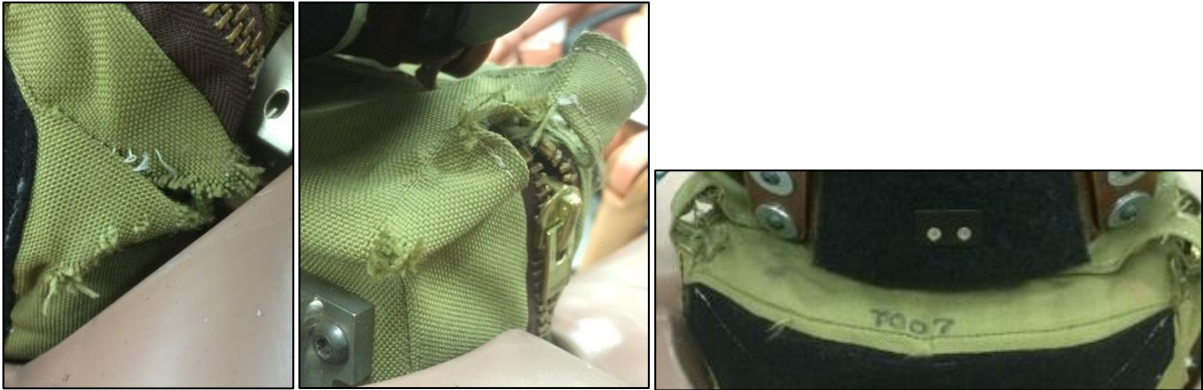
| HEAD | |
|---|---|
| | <b>Multiple tears and broken stitches in lower abdomen bag. The upper and lower abdomen bags appear to be from THOR SN007</b> |
