**REPORT NUMBER: R&D-CAL-15-012**

**MOVING BARRIER TO VEHICLE CRASH TEST IN SUPPORT OF NHTSA'S  
FRONTAL OBLIQUE OFFSET PROGRAM  
OBLIQUE MOVING DEFORMABLE BARRIER INTO LEFT FRONT OF A**

**2016 Mazda CX-5**

**90.1KPH, 15 DEGREE ANGLE, 35% OVERLAP**

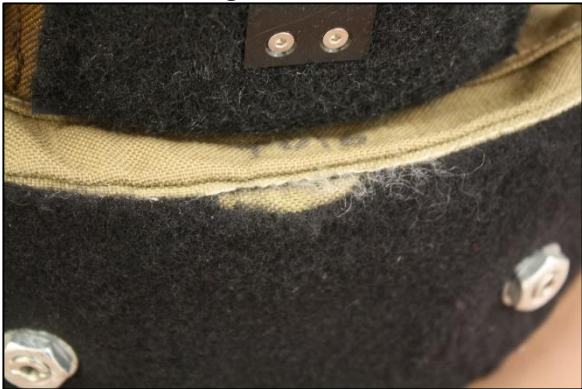
| HEAD | |
|---|---|
| Y / N | No evidence of tearing, cuts, or broken stitches in lower abdomen bag and zipper<br><b>Tear in center of bag.</b> |

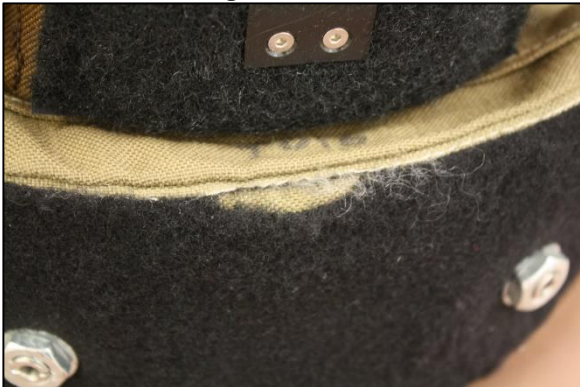
| HEAD | |
|---|---|
| Y / N | No evidence of tearing, cuts, or broken stitches in lower abdomen bag and zipper<br><b>Tear in center of bag.</b> |

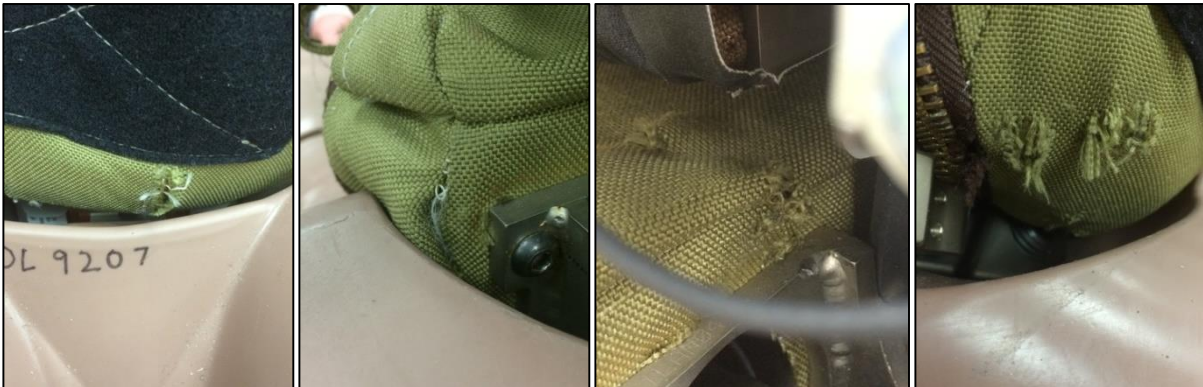
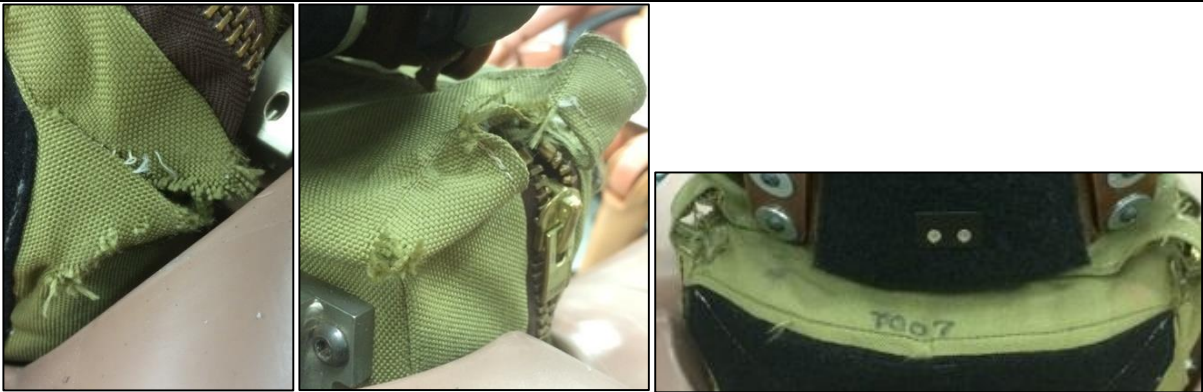
| HEAD | |
|---|---|
| | <b>Multiple tears and broken stitches in lower abdomen bag. The upper and lower abdomen bags appear to be from THOR SN007</b> |

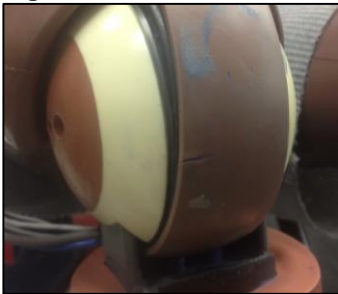
| Y / N | No cuts, tears, or scuffing of knee flesh<br><b>Right knee flesh torn</b> |

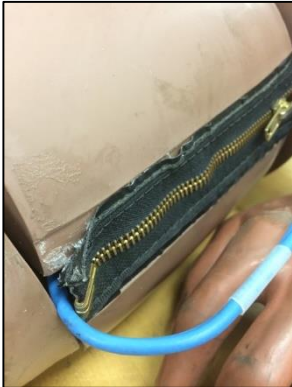
| OTHER | <b>Left femur flesh is separating from zipper. We placed gaffer's tape across zipper to prevent further damage.</b> |

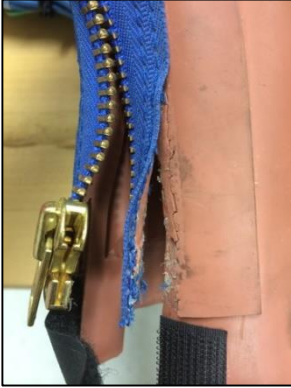
| LOWER EXTREMITY (LX) | |
|---|---|
| Y / N | No cuts, tears, or scuffing of leg flesh<br><b>Left lower leg flesh is torn near zipper. We placed gaffer's tape around the flesh to prevent further damage.</b> |

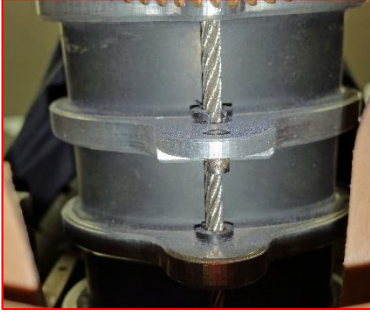
| HEAD | |
|---|---|
| Y / N | No evidence of de-bonding or permanent compression in neck soft stop assemblies<br>Front of the neck is missing the soft stop |

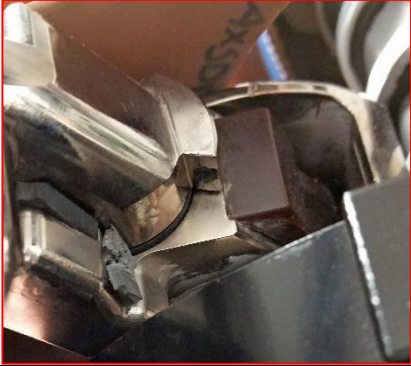
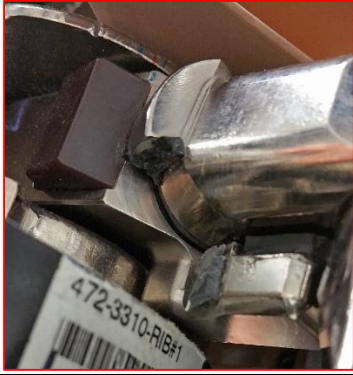
| HEAD | |
|---|---|
| Y / N | No evidence of de-bonding, tearing, or permanent compression of posterior soft stops<br>Damage to both the left and right shoulder soft stops. The left shoulder is missing one entirely.<br>Left: Right: |

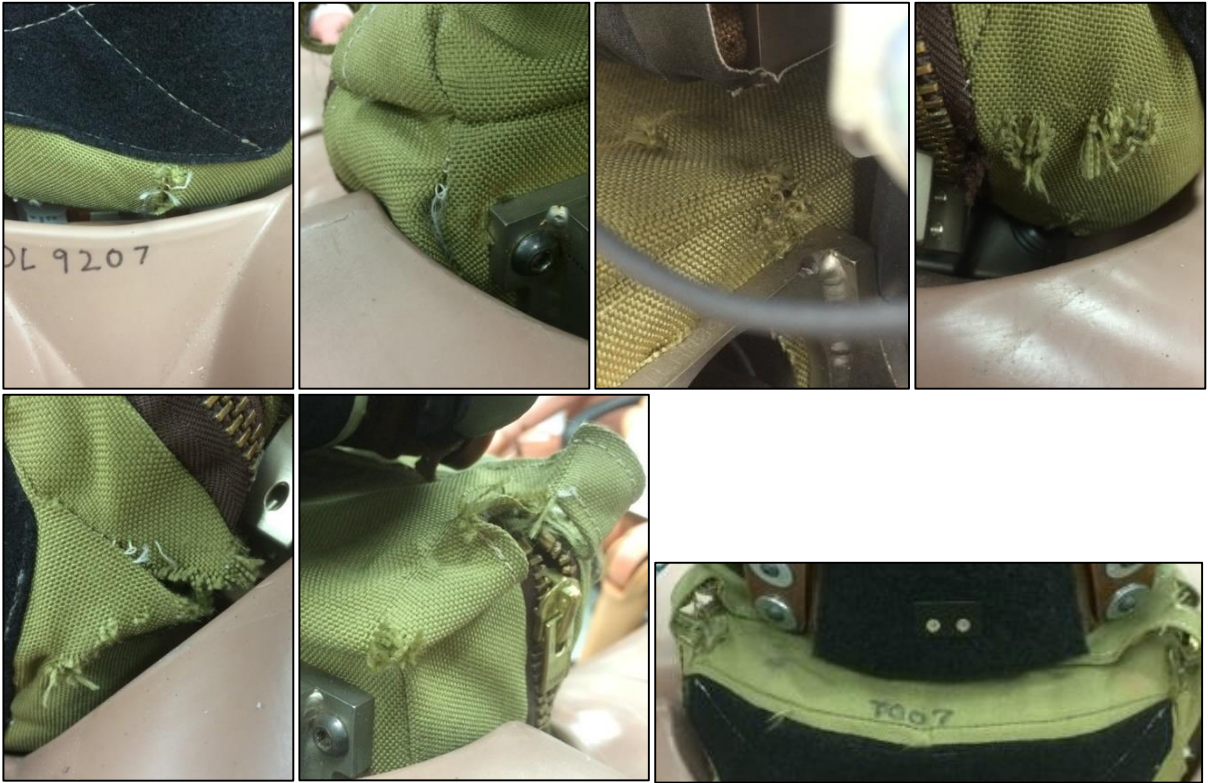
| THORAX | |
|---|---|
| Y / N | No evidence of tearing, cuts, or broken stitches in lower abdomen bag and zipper<br><b>Multiple tears and broken stitches in lower abdomen bag. The upper and lower abdomen bags appear to be from THOR SN007</b> |

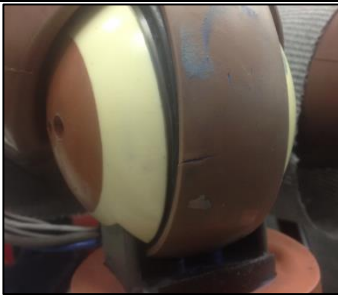
| THORAX | |
|---|---|
| Y / N | No cuts, tears, or scuffing of knee flesh<br><b>Right knee flesh torn</b> |

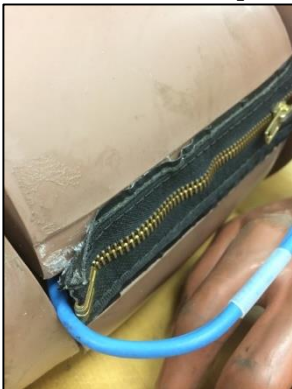
| OTHER | <p><b>Left femur flesh is separating from zipper. We placed gaffer's tape across zipper to prevent further damage.</b></p> | |

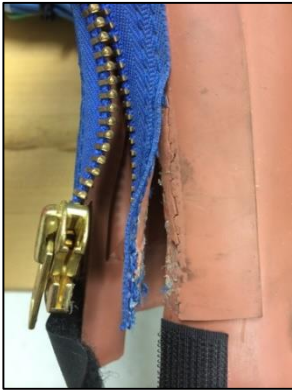
| Y / N | <p>No cuts, tears, or scuffing of leg flesh</p> <p><b>Left lower leg flesh is torn near zipper. We placed gaffer's tape around the flesh to prevent further damage.</b></p> | |
