REPORT NUMBER: SPNCAP-MGA-2016-027

**NEW CAR ASSESSMENT PROGRAM (NCAP)
Side Impact Pole Test**

**FCA US LLC.
2016 Dodge Charger SE RWD 4-Door Sedan
NHTSA No.: M20160304**

**MGA RESEARCH CORPORATION
5000 Warren Road
Burlington, WI 53105**

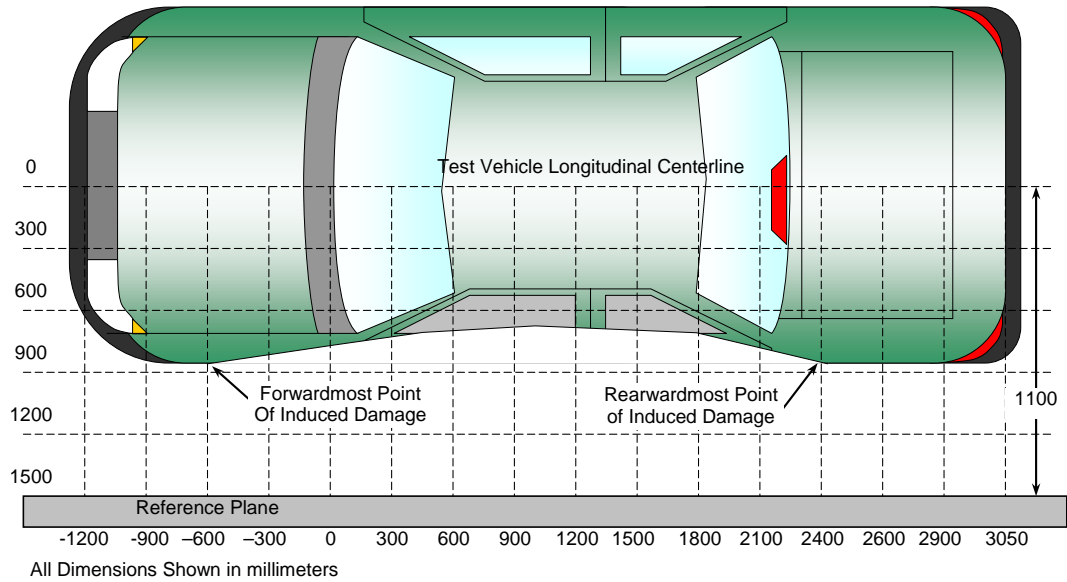
DATA SHEET NO. 11
VEHICLE DAMAGE PROFILE DISTANCES

TOP VIEW

DAMAGE PROFILE DISTANCES

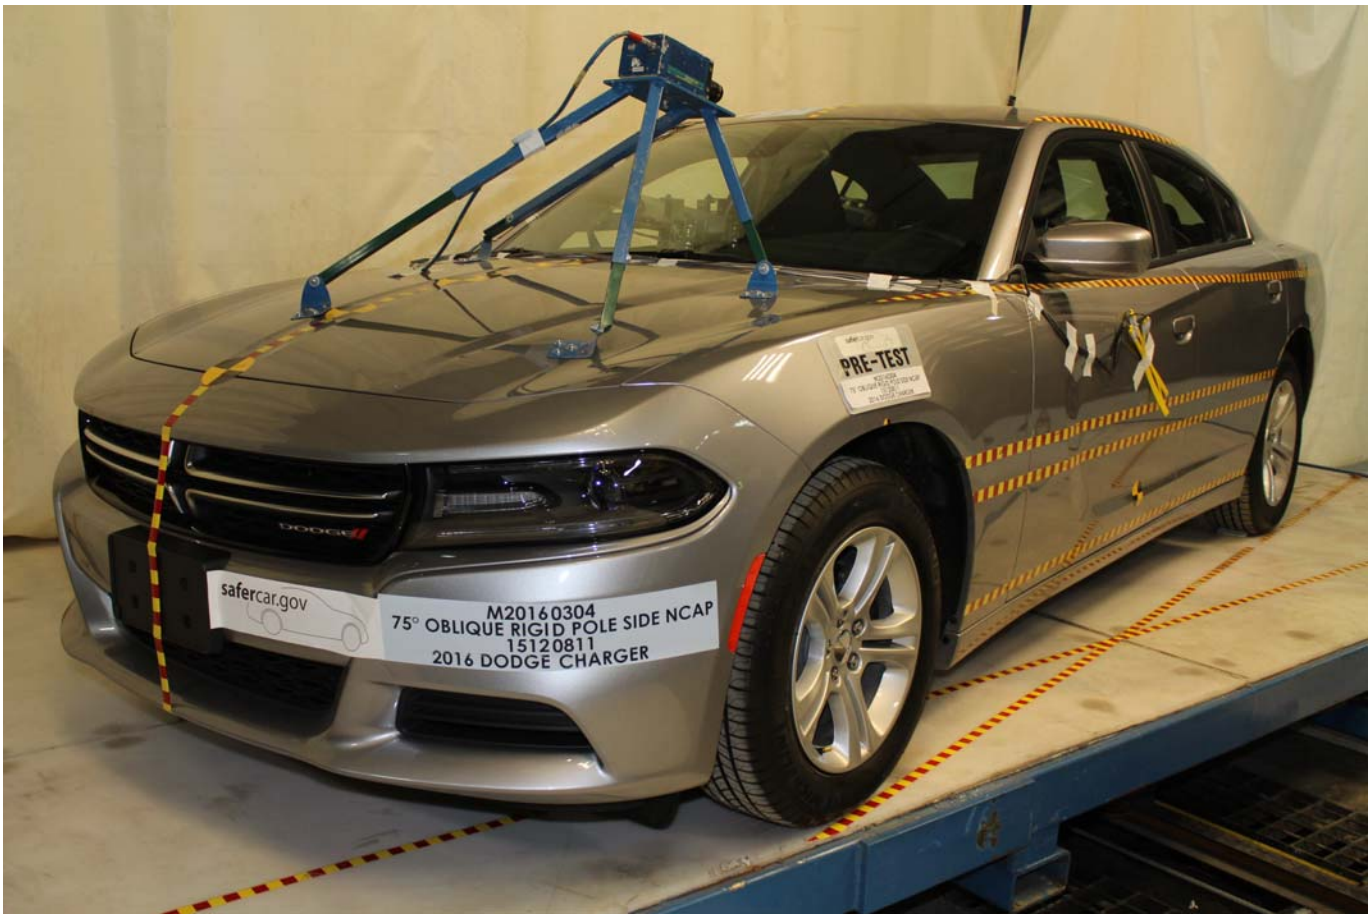
Photo No. 004 - Post-Test Frontal View of Test Vehicle

Critical Areas of Performance	Observations and Conclusions
Pillar Performance	No Separation
Sill Separation	None
Windshield Damage	Cracked
Side Window Damage	Left Front Window Cracked
Other Notable Effects	None

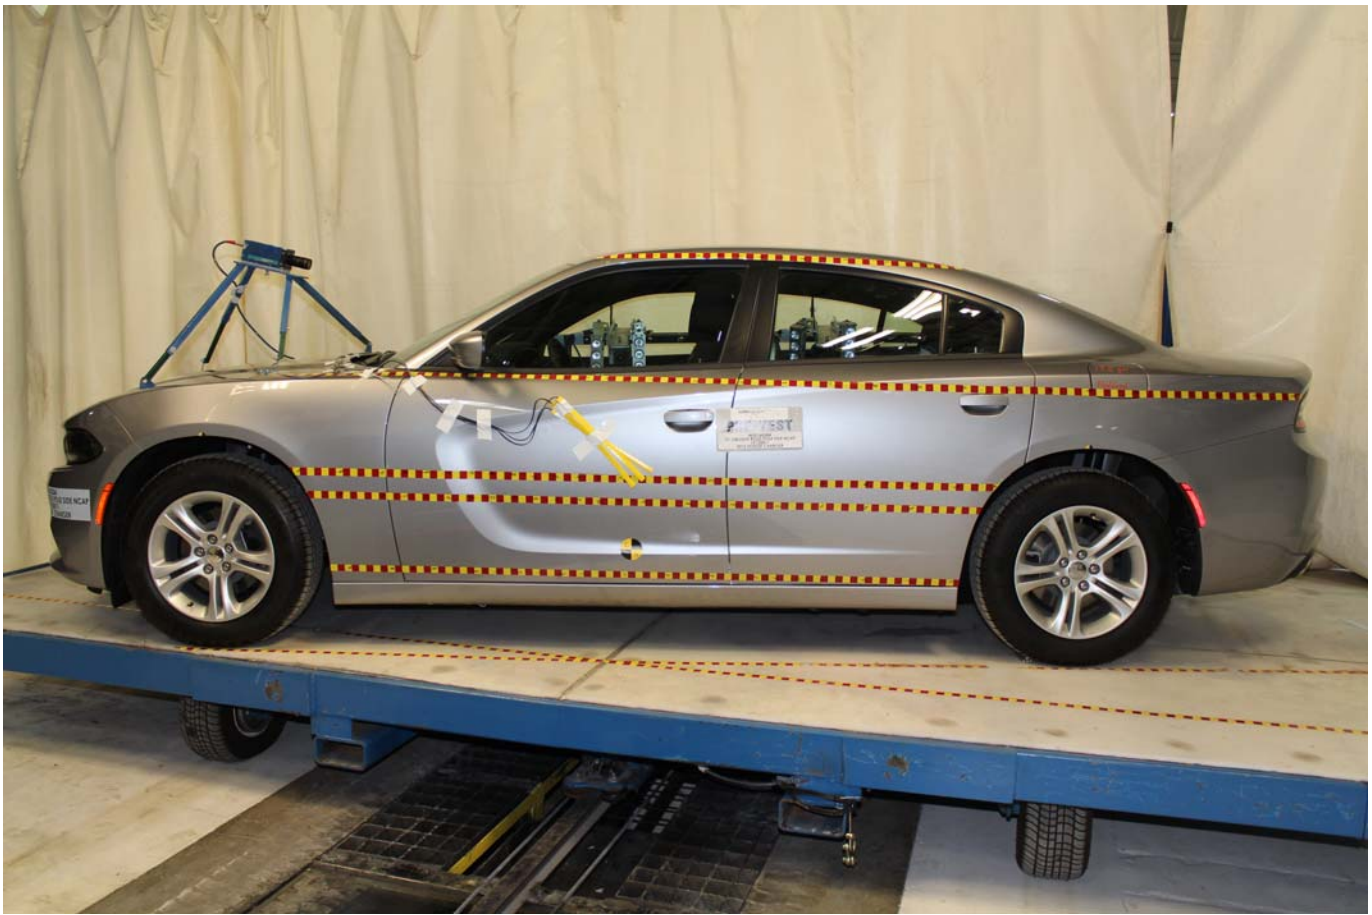
Photo No. 006 - Post-Test Left Front $\frac{3}{4}$ View of Test Vehicle

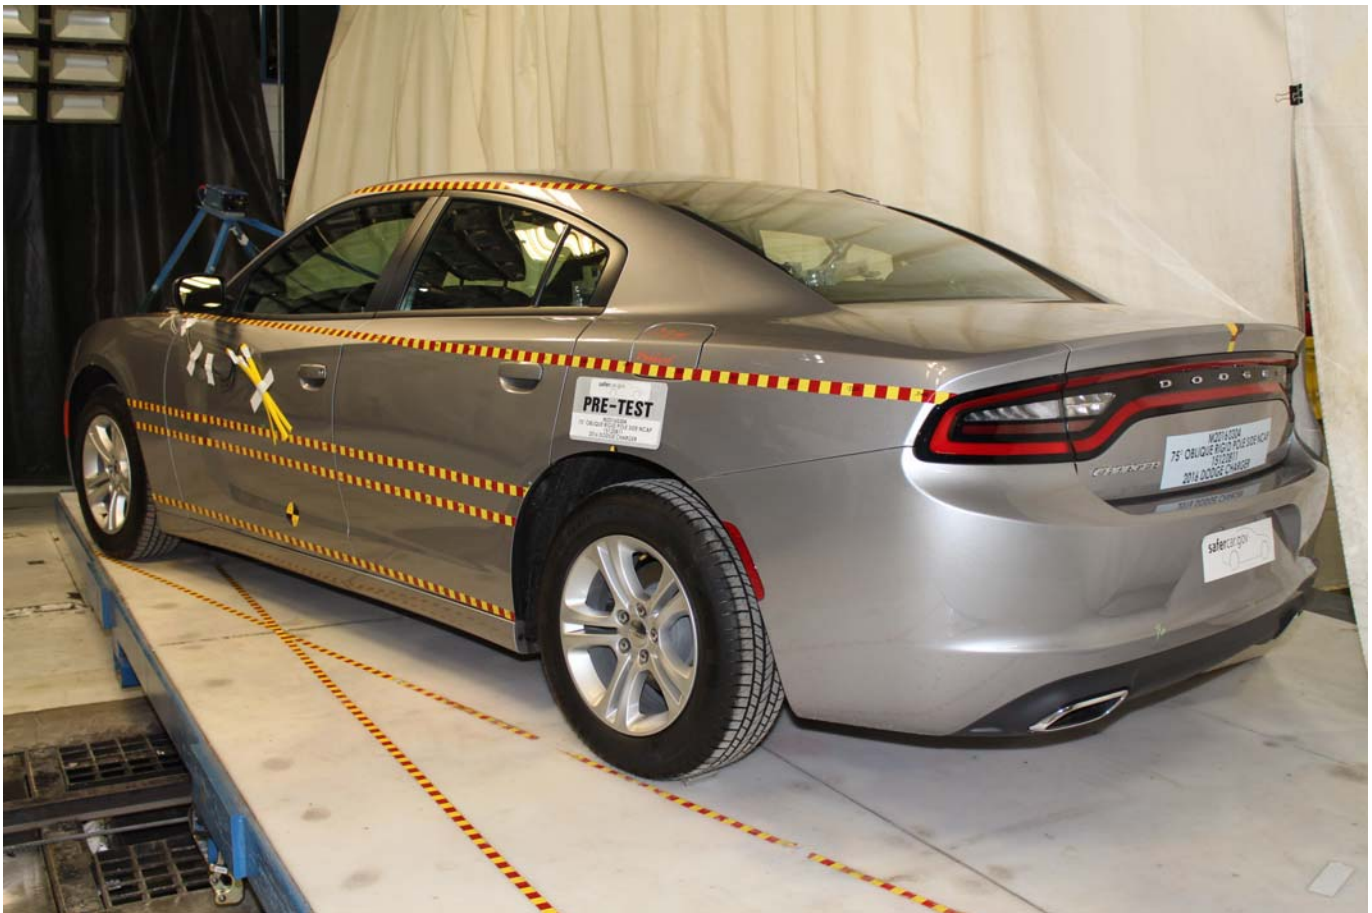
Photo No. 008 - Post-Test Left Side View of Test Vehicle

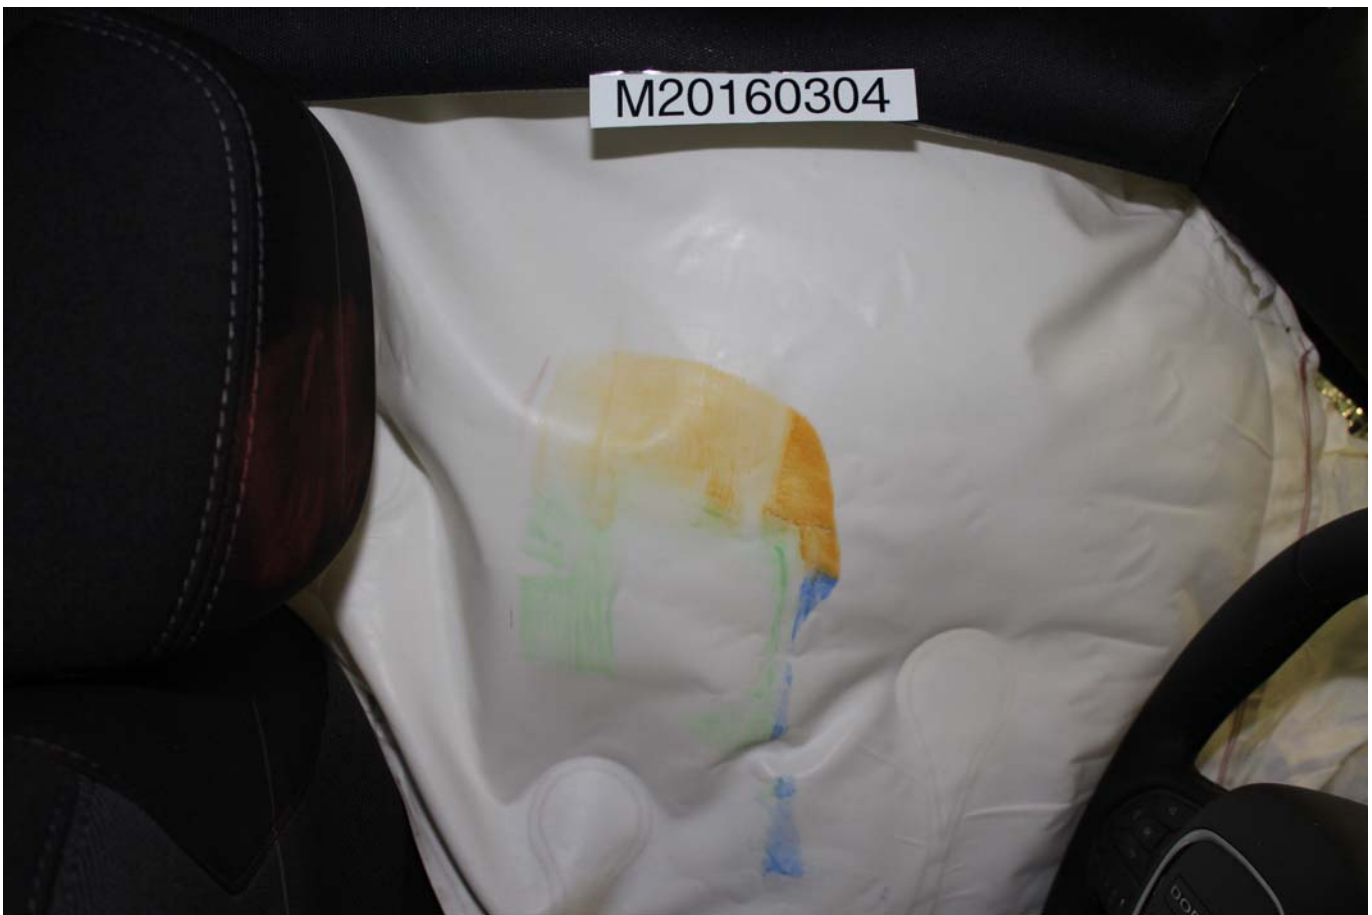
Photo No. 046 - Post-Test Dummy Close-Up Head Contact with Vehicle Interior View

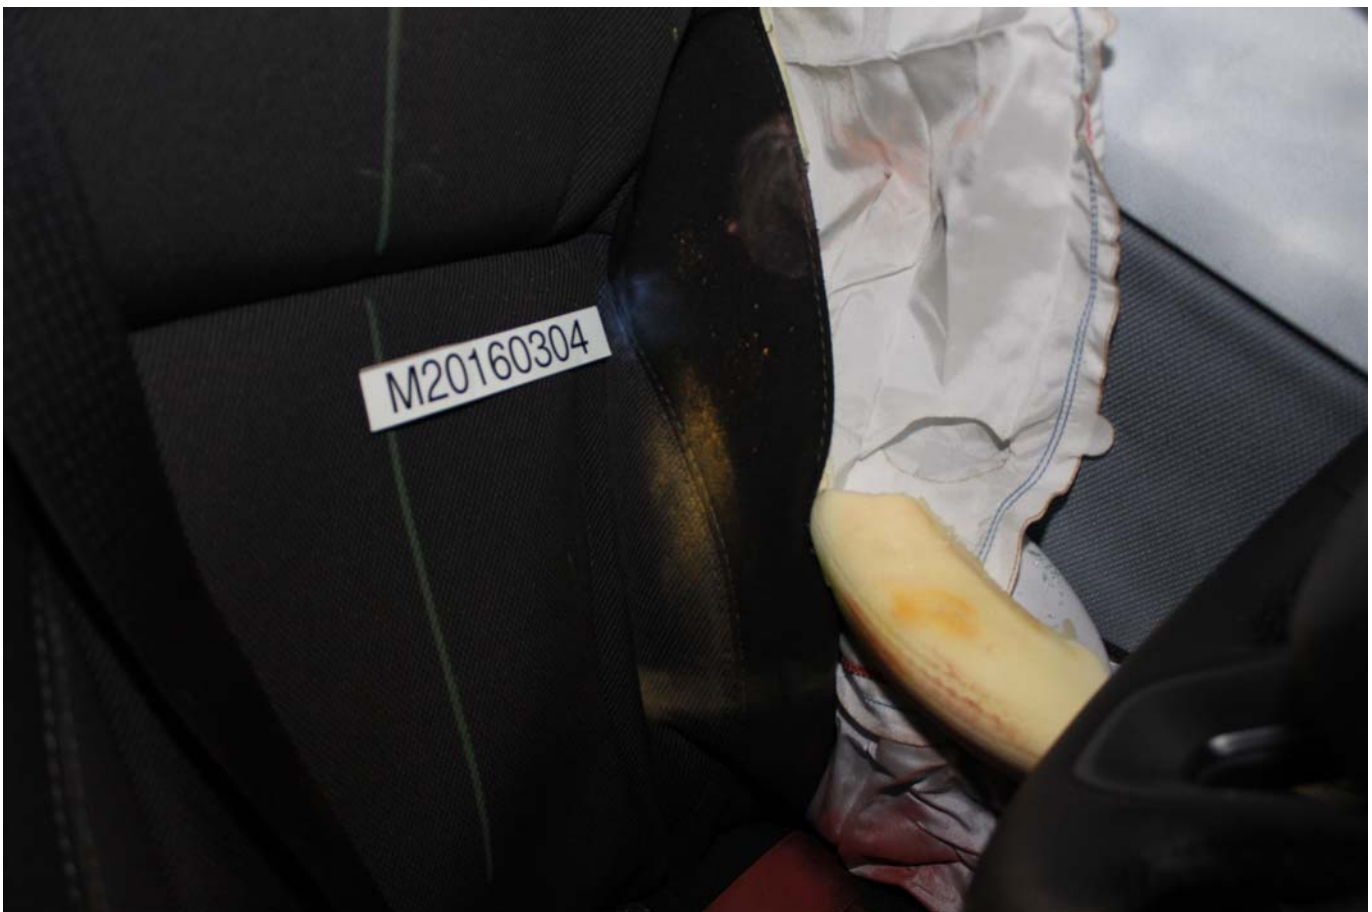
Photo No. 047 - Post-Test Dummy Close-Up Head Contact with Side Air Bag View

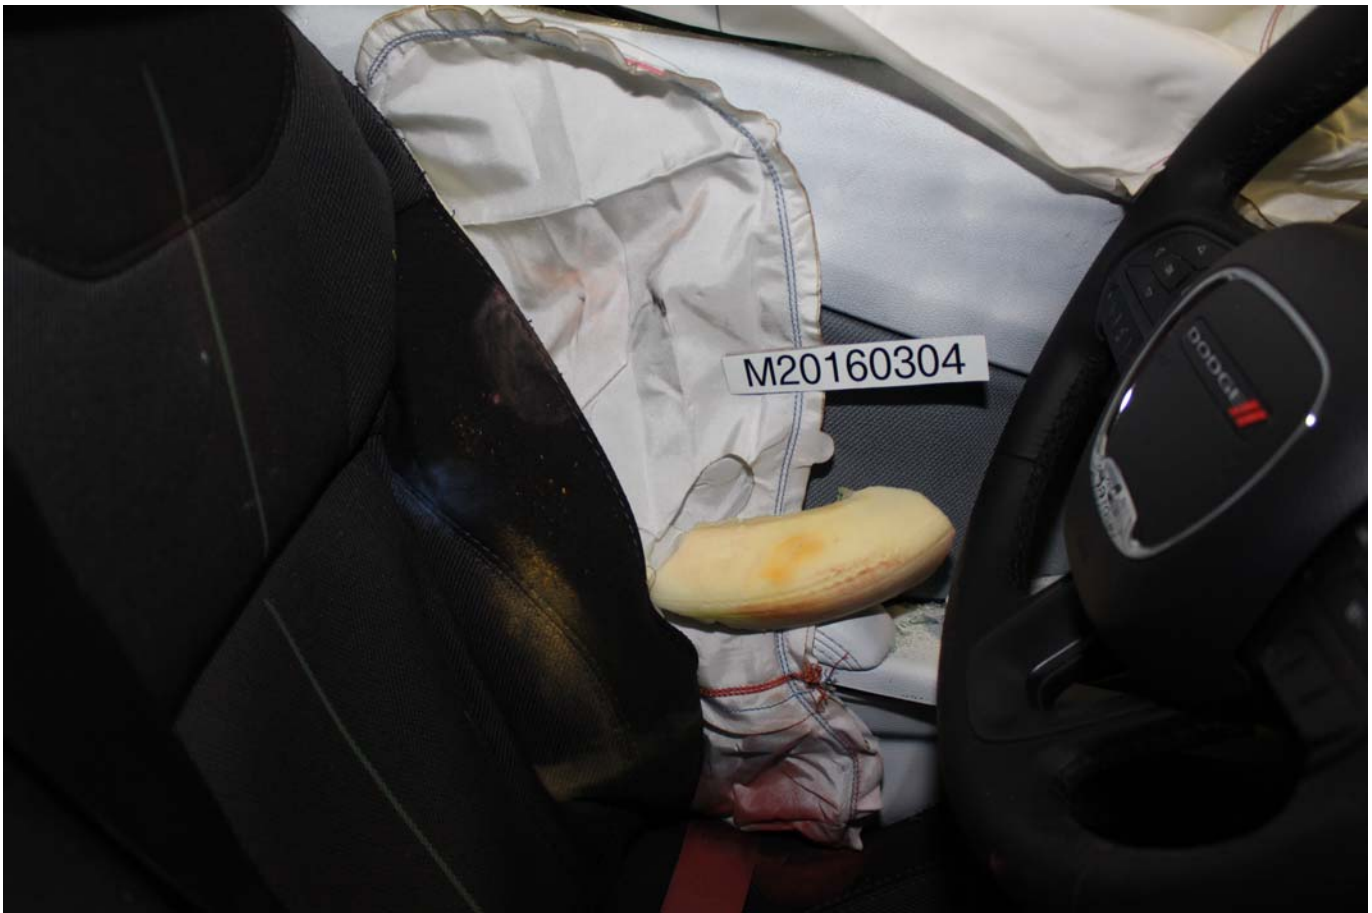
Photo No. 048 - Post-Test Dummy Close-Up Torso Contact with Vehicle Interior View

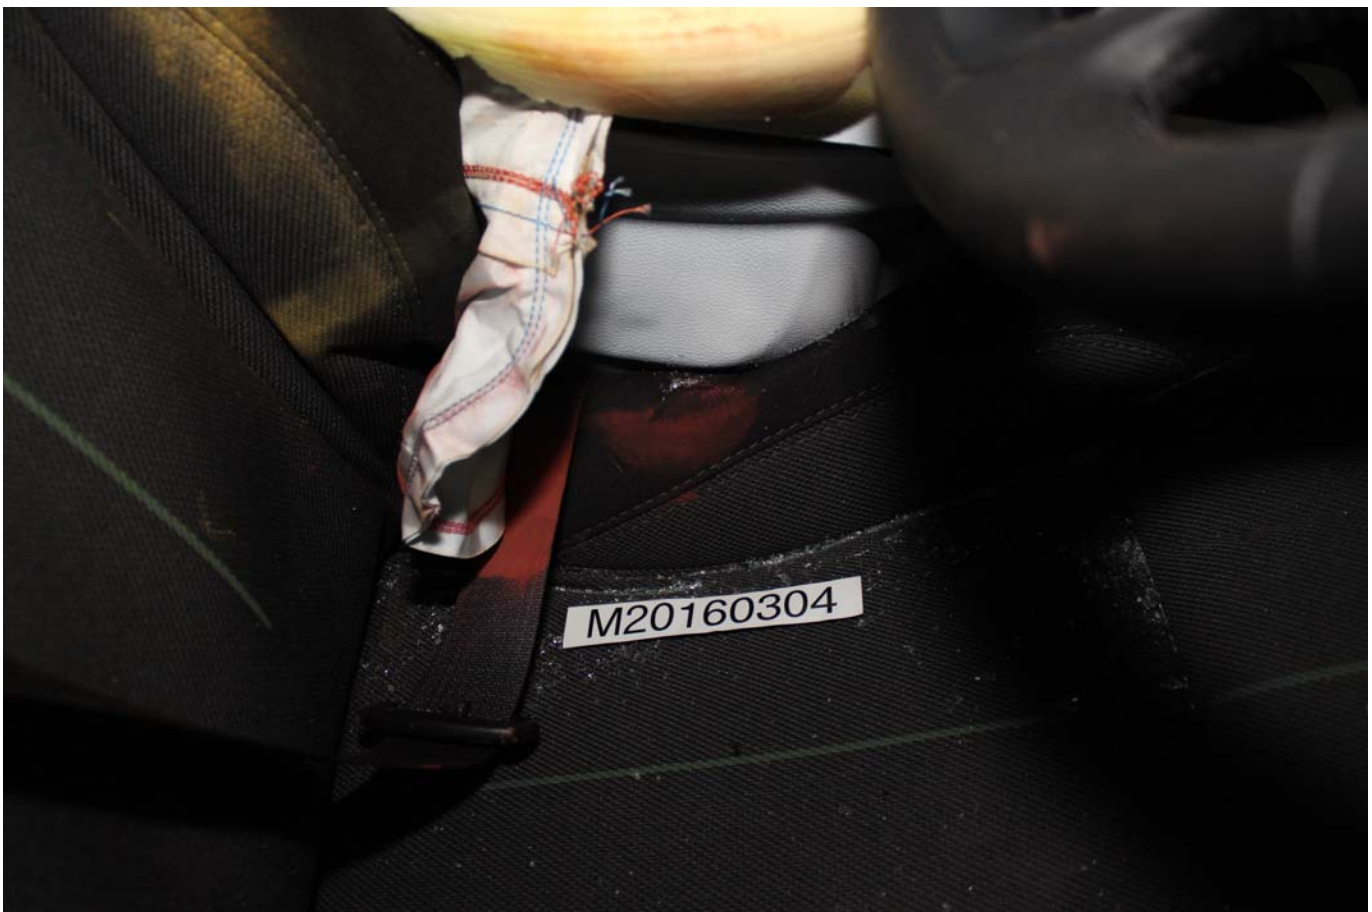
Photo No. 049 - Post-Test Dummy Close-Up Torso Contact with Side Air Bag View

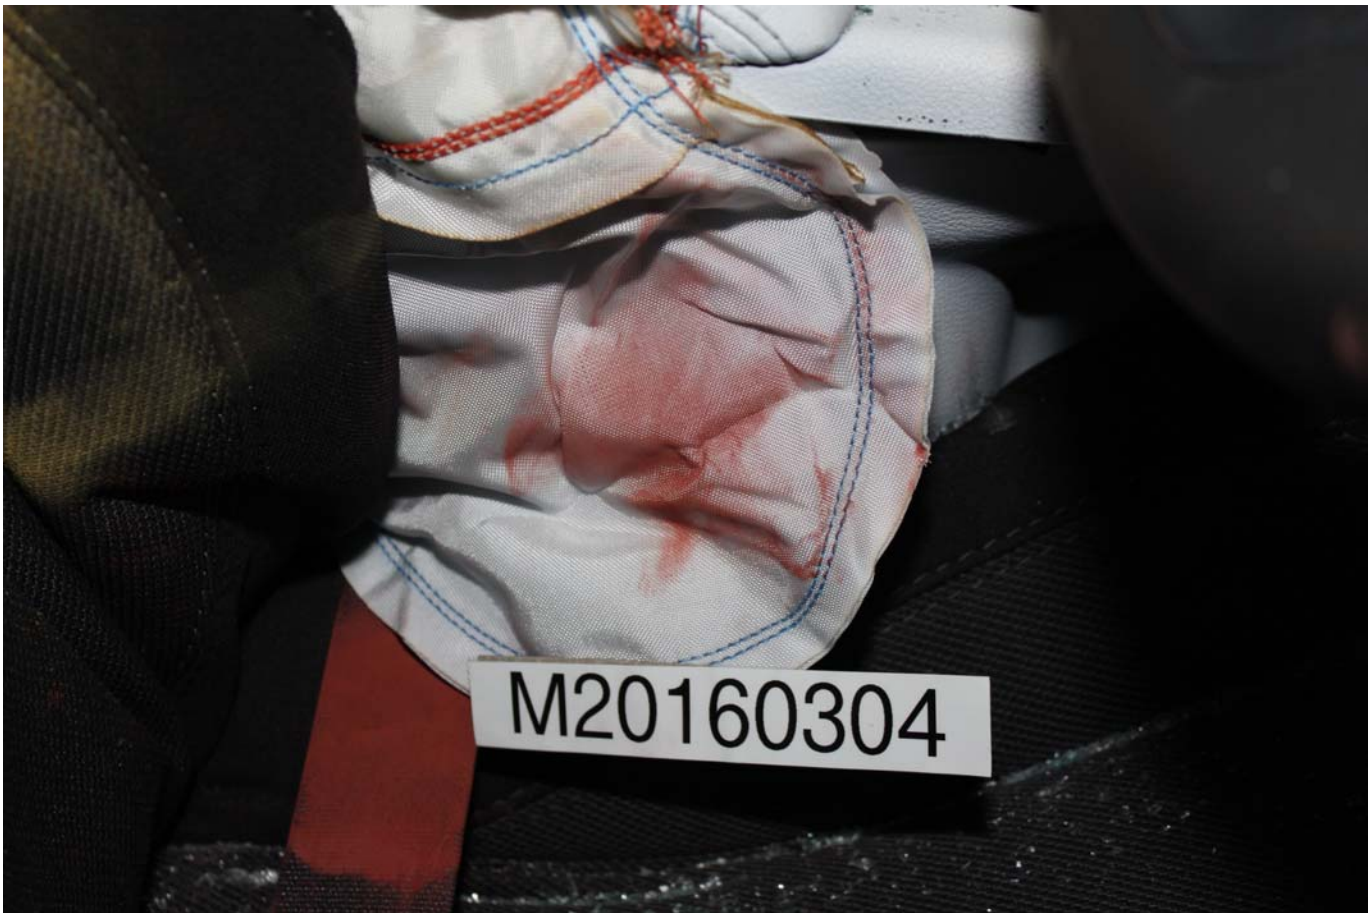
Photo No. 050 - Post-Test Dummy Close-Up Pelvis Contact with Vehicle Interior View

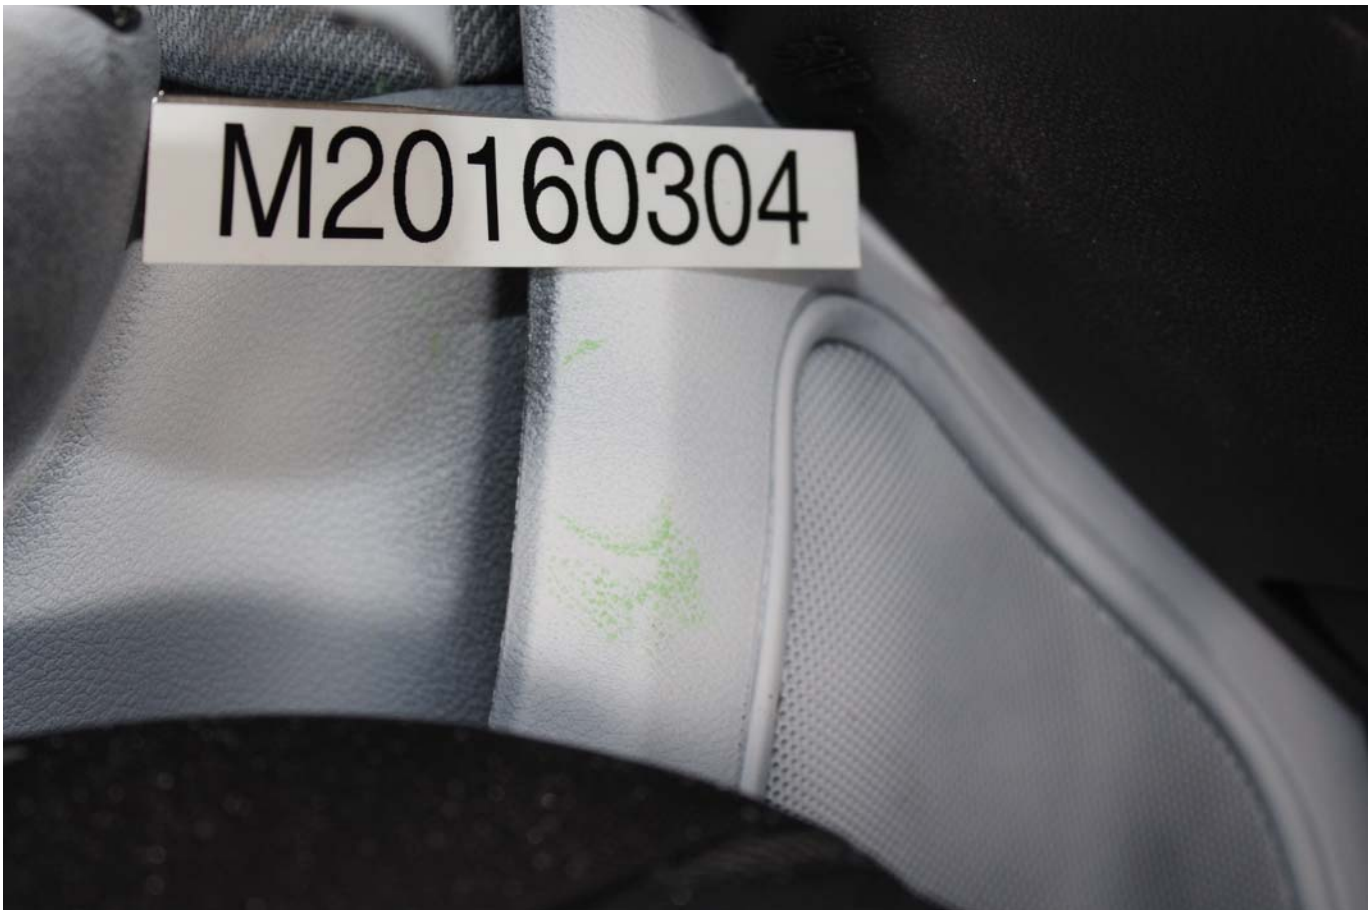
Photo No. 051 - Post-Test Dummy Close-Up Pelvis Contact with Side Air Bag View

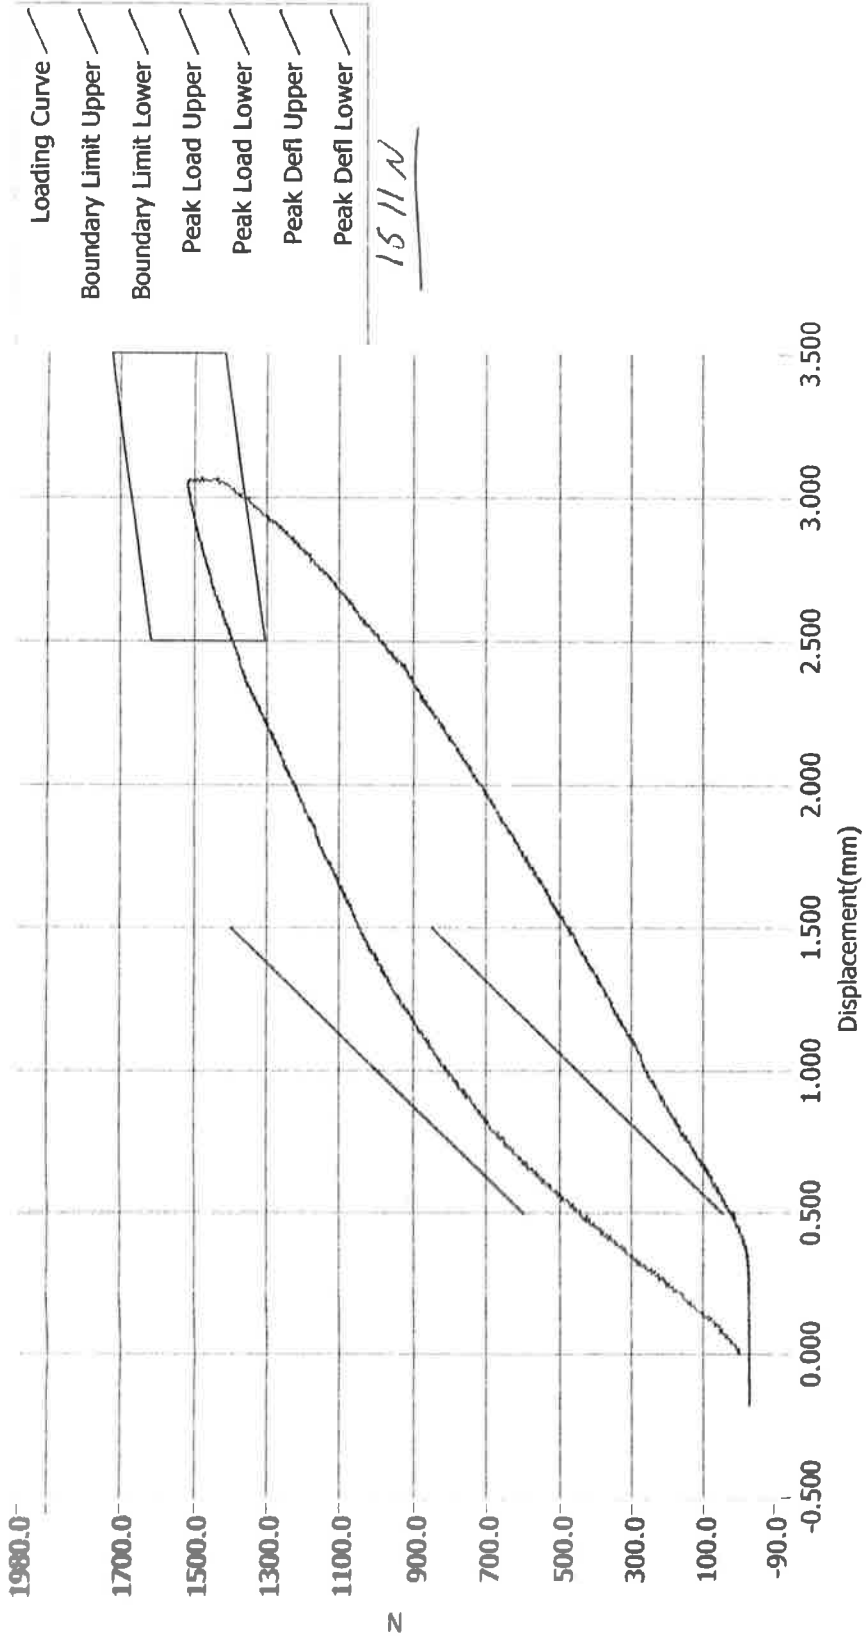
Resultant Data - SIDIIs Plug Compression

- Loading Curve
- Boundary Limit Upper
- Boundary Limit Lower
- Peak Load Upper
- Peak Load Lower
- Peak Defl Upper
- Peak Defl Lower
