REPORT NUMBER: NCAP-MGA-2016-026

**NEW CAR ASSESSMENT PROGRAM (NCAP)
Frontal Barrier Impact Test**

**FCA US LLC.
2016 Dodge Charger SE AWD 4-Dr. Sedan
NHTSA No.: M20160303**

**MGA RESEARCH CORPORATION
5000 Warren Road
Burlington, WI 53105**

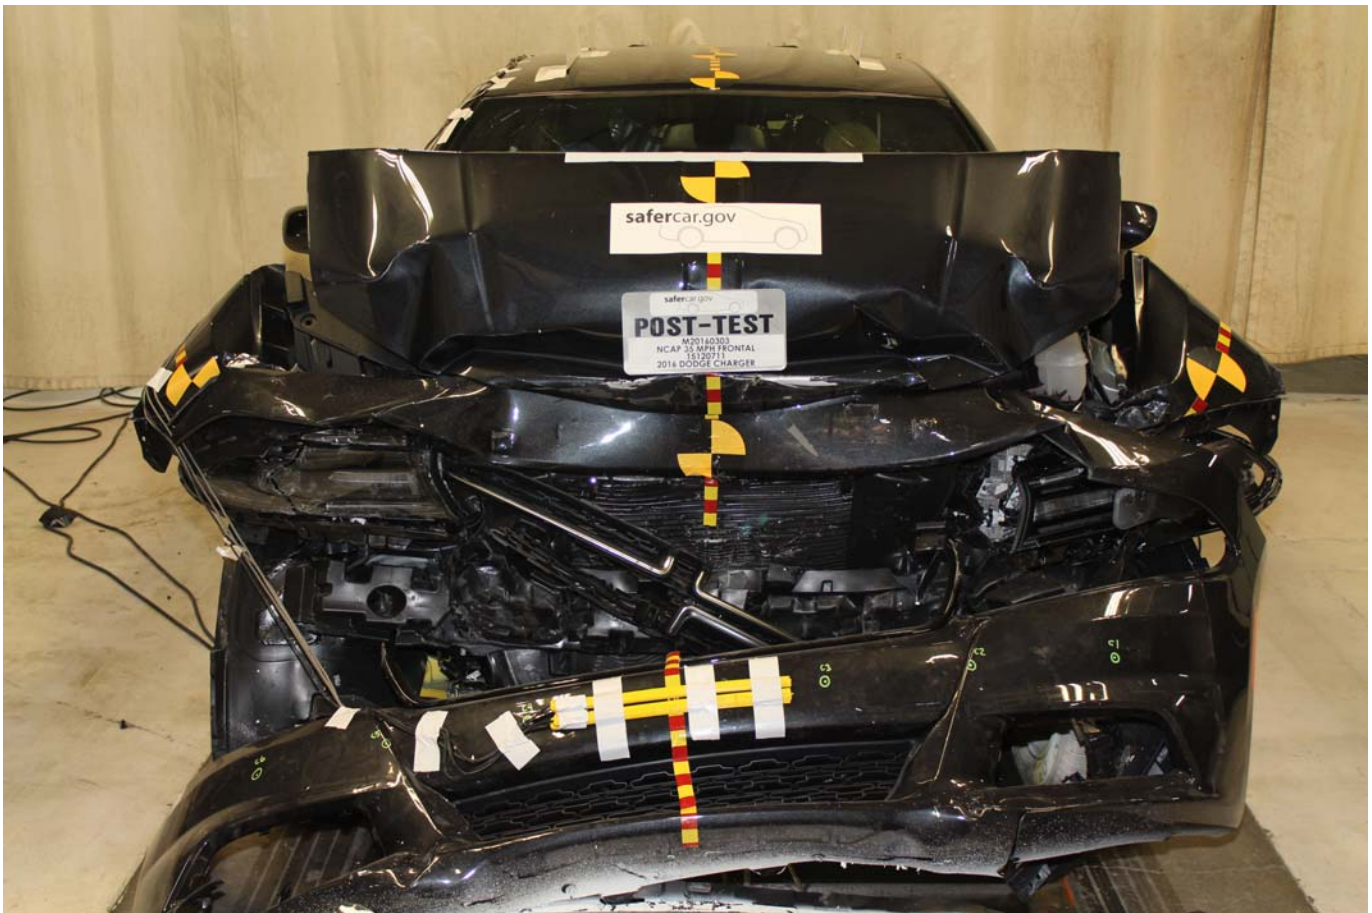
Photo No. 009 - Post-Test Front View of Test Vehicle

The maximum static crush of the vehicle was 489 mm to the right of centerline and both the driver and passenger side doors remained closed during the impact event and were operable after the impact.

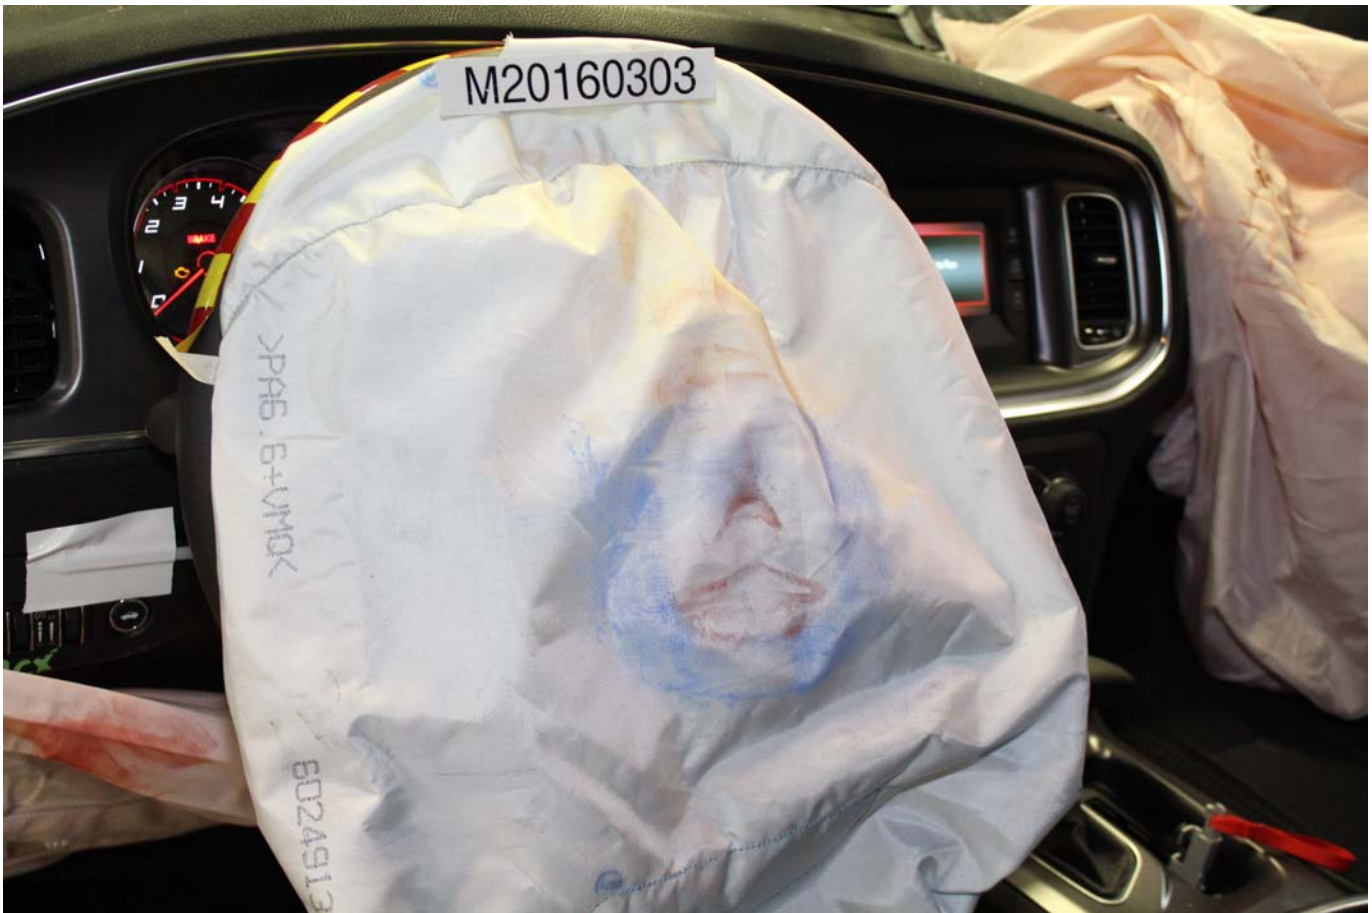
Photo No. 047 - Post-Test Driver Dummy Contact with Airbag

The driver's visible contact points were as follows: The driver's head contacted the airbag. The driver's head also contacted the headrest. The driver's knees contacted the airbag. The passenger's visible contact points were as follows: The passenger's head contacted the airbag. The passenger's head also contacted the headrest. The passenger's knees contacted the glove box.
