**REPORT NUMBER: SINCAP-CAL-16-004**

**NEW CAR ASSESSMENT PROGRAM (NCAP)  
MOVING DEFORMABLE BARRIER SIDE IMPACT TEST**

**General Motors LLC  
2016 Chevrolet Colorado  
Crew Cab Pickup Truck**

**NHTSA No: M20160102**

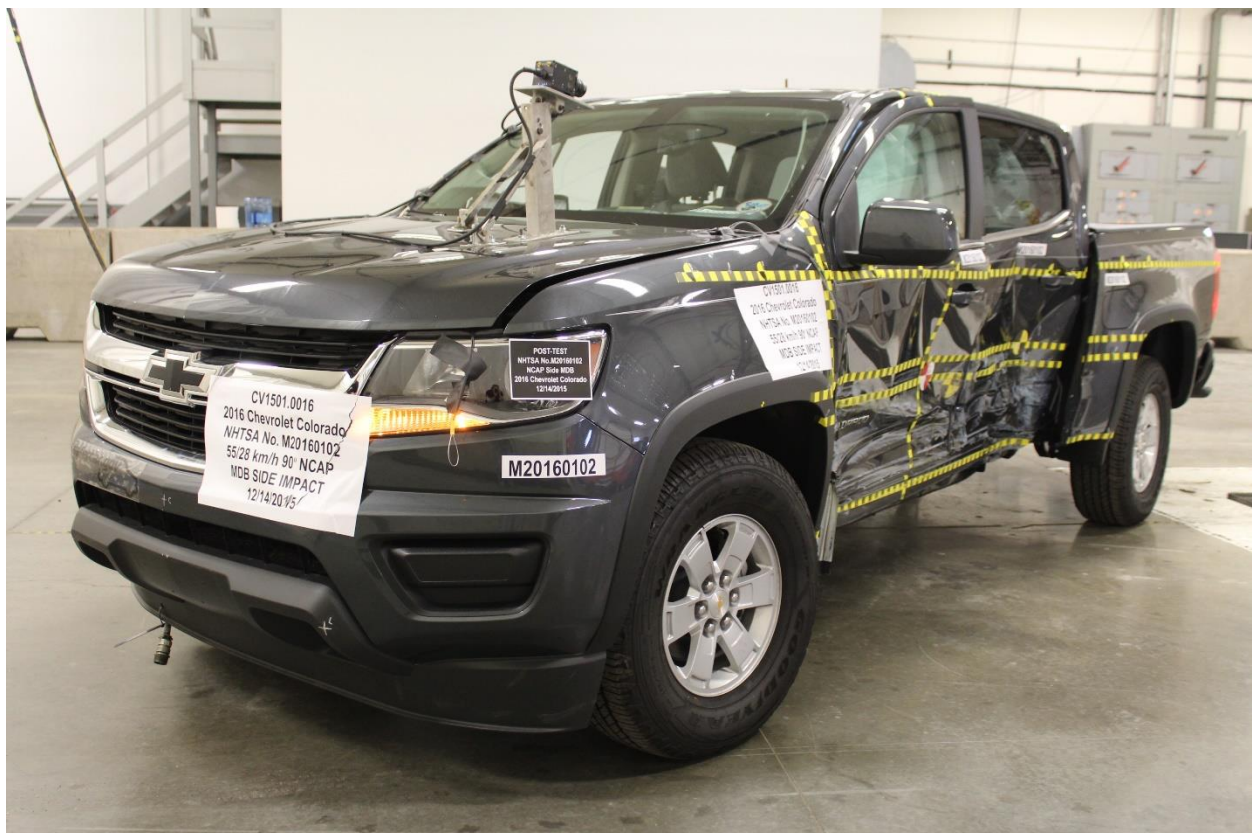
**Figure A-6: Post-Test Left Front  $\frac{3}{4}$  View of Test Vehicle**

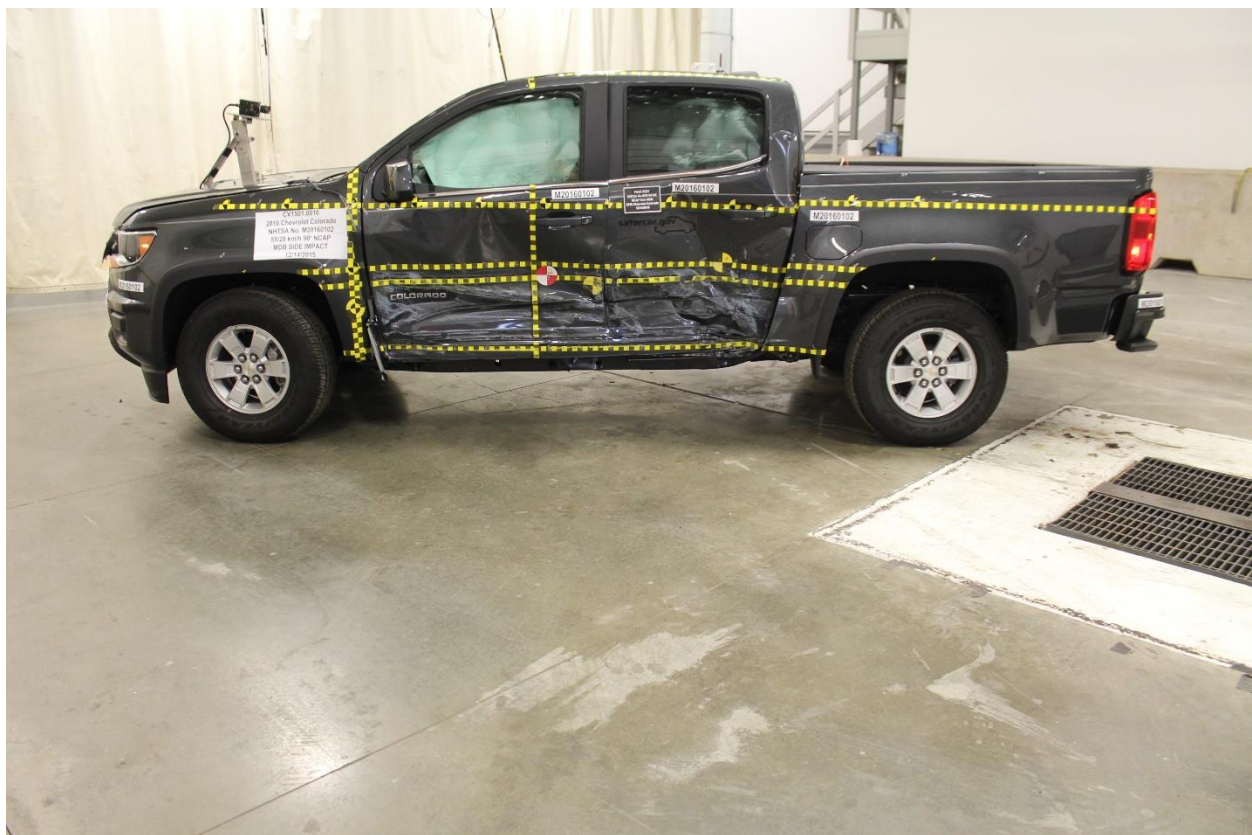
**Figure A-8: Post-Test Left Side View of Test Vehicle**

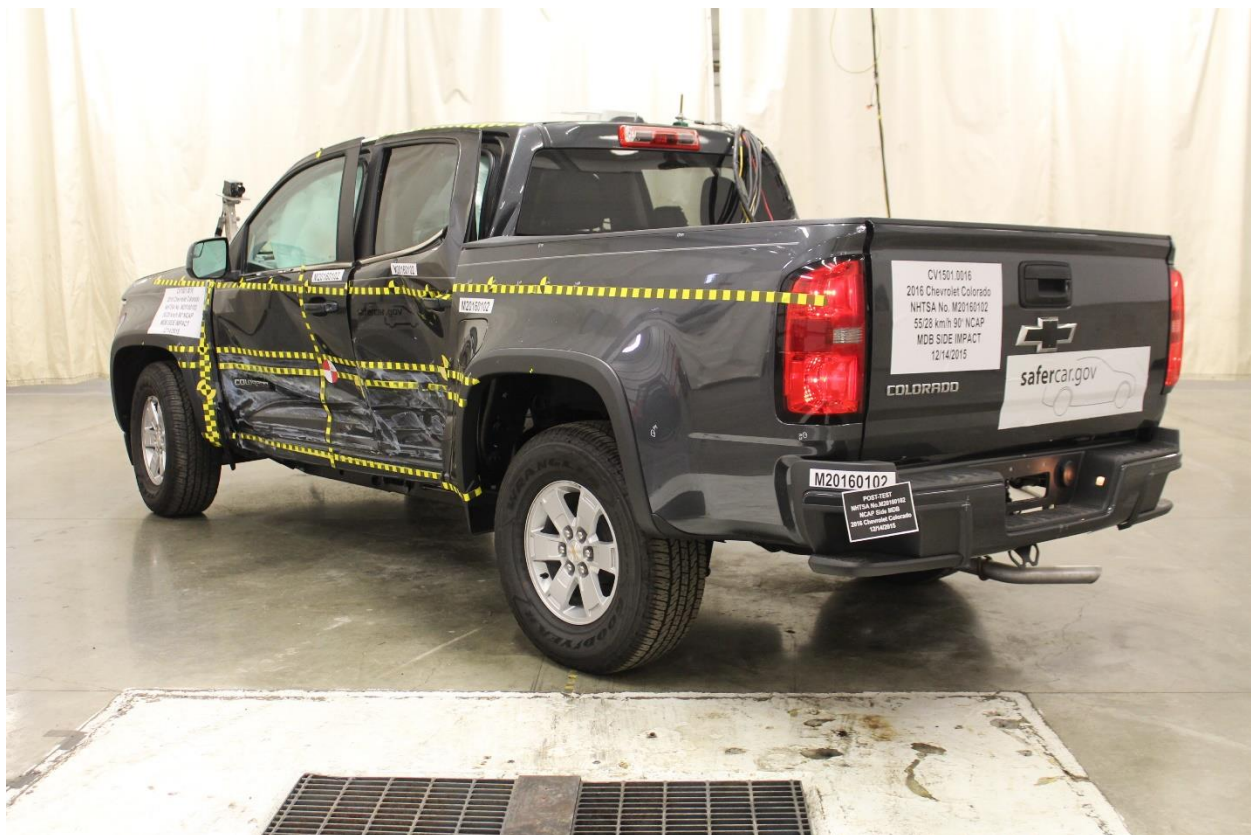
**Figure A-10: Post-Test Left Rear  $\frac{3}{4}$  View of Test Vehicle**

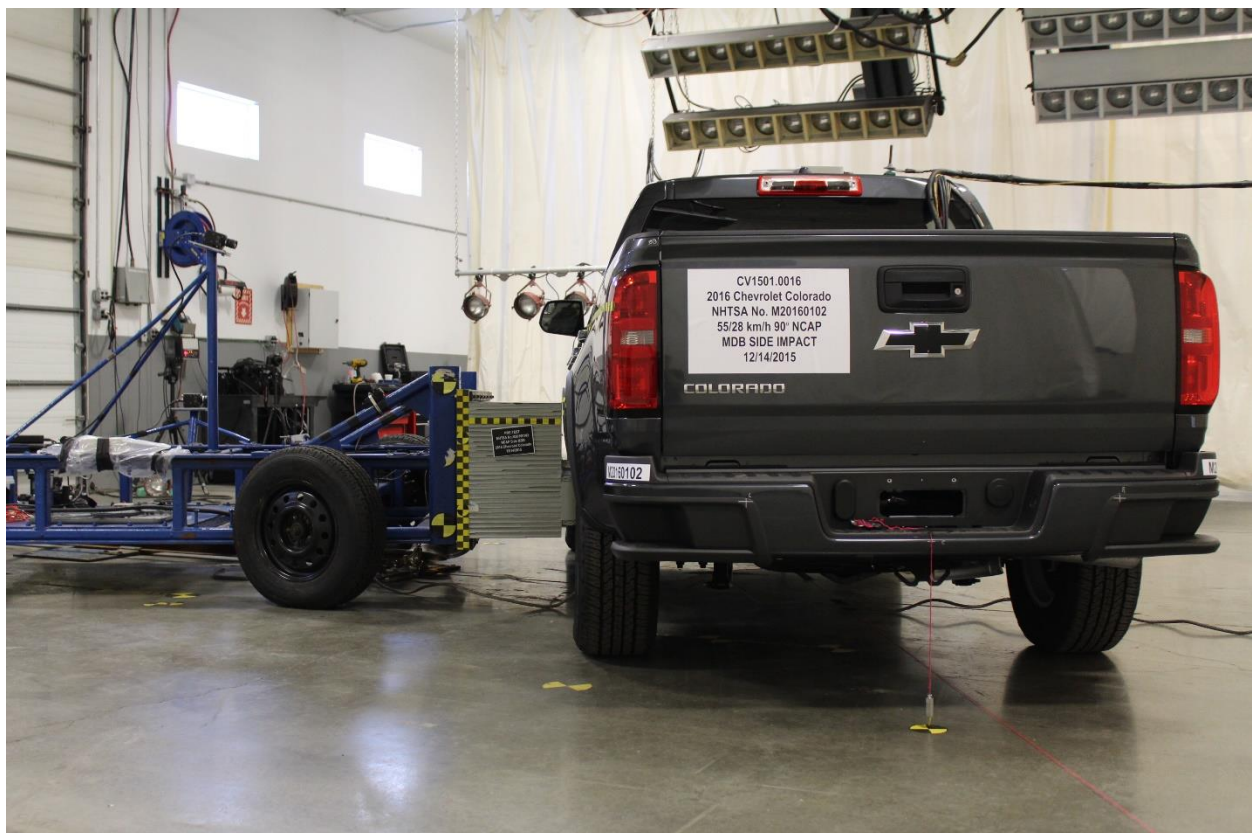
**Figure A-18: Pre-Test Right Side View of MDB Positioned Against Side of Test Vehicle**

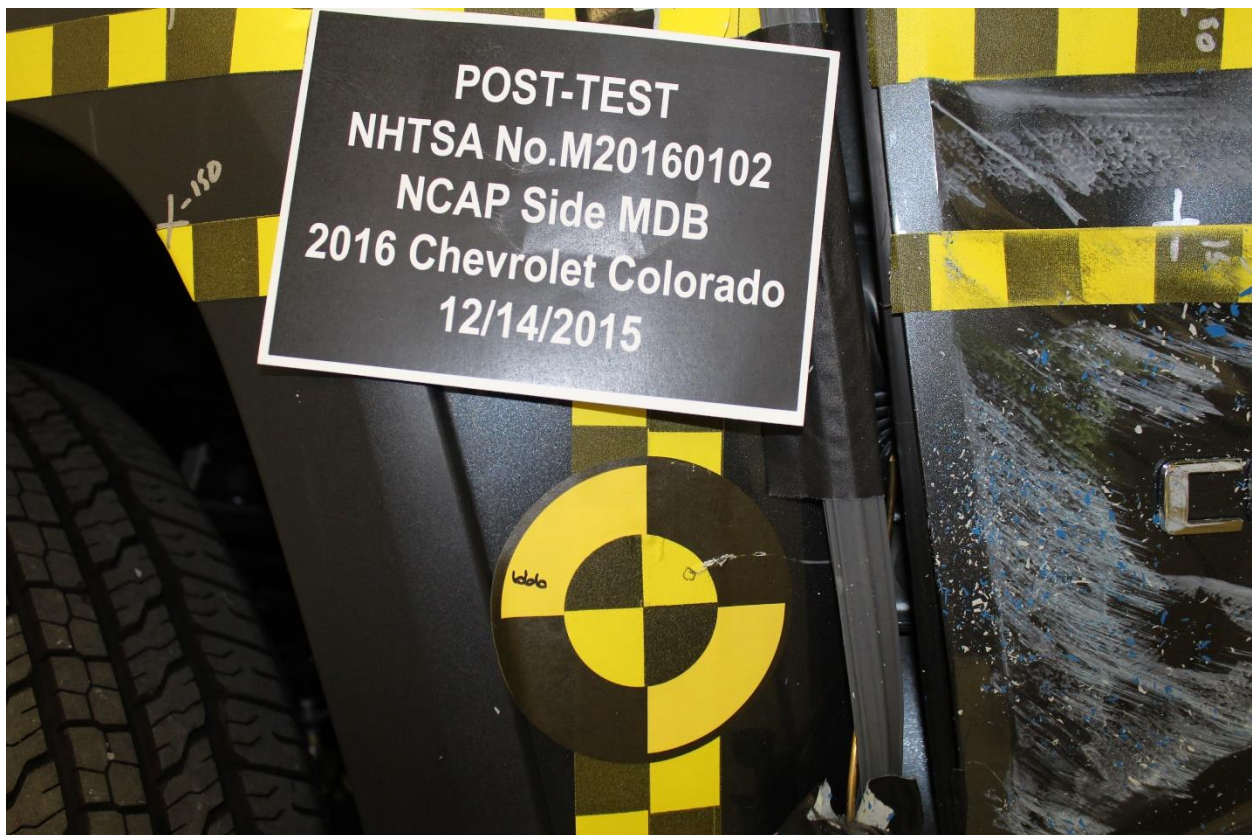
**Figure A-20: Post-Test Close-up View of Impact Point Target**

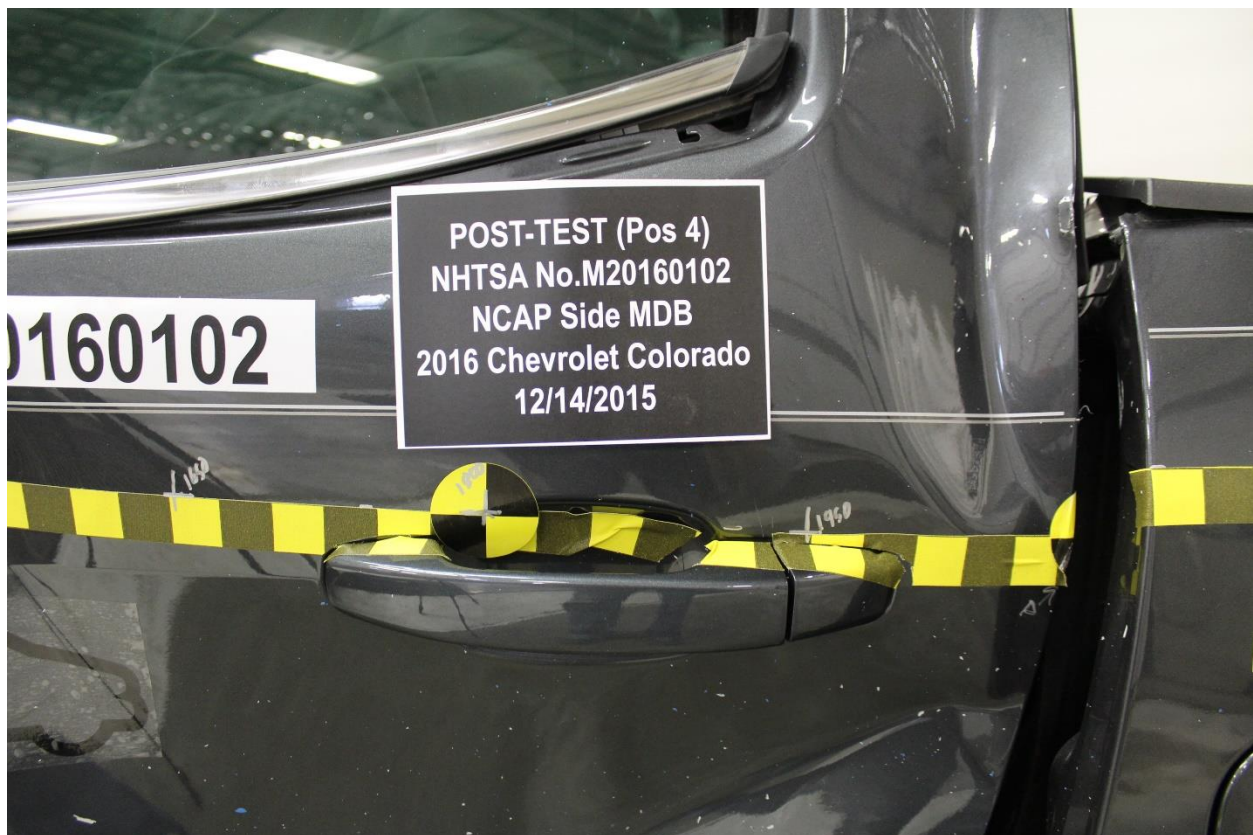
Figure A-24: Post-Test Left Rear Door Latch Close-Up

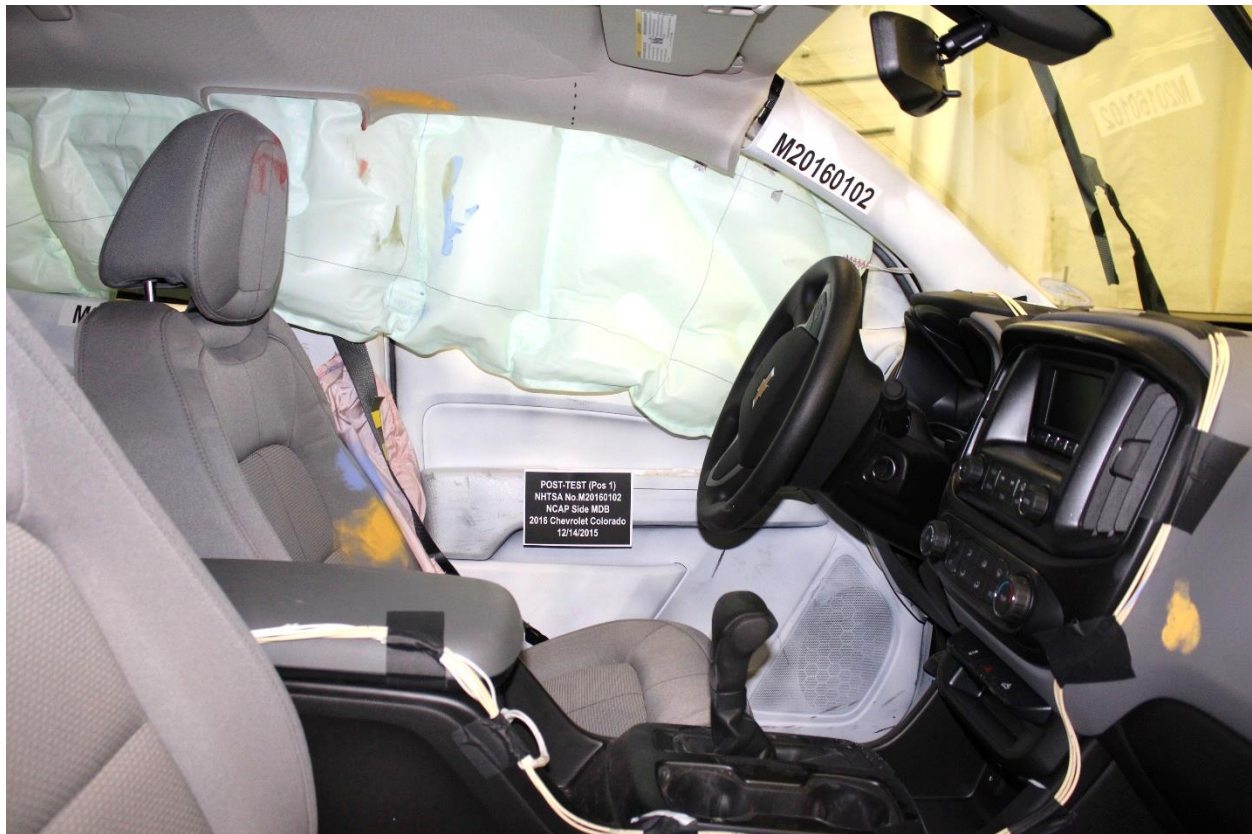
**Figure A-47: Post-Test Driver Inner Door Panel View**

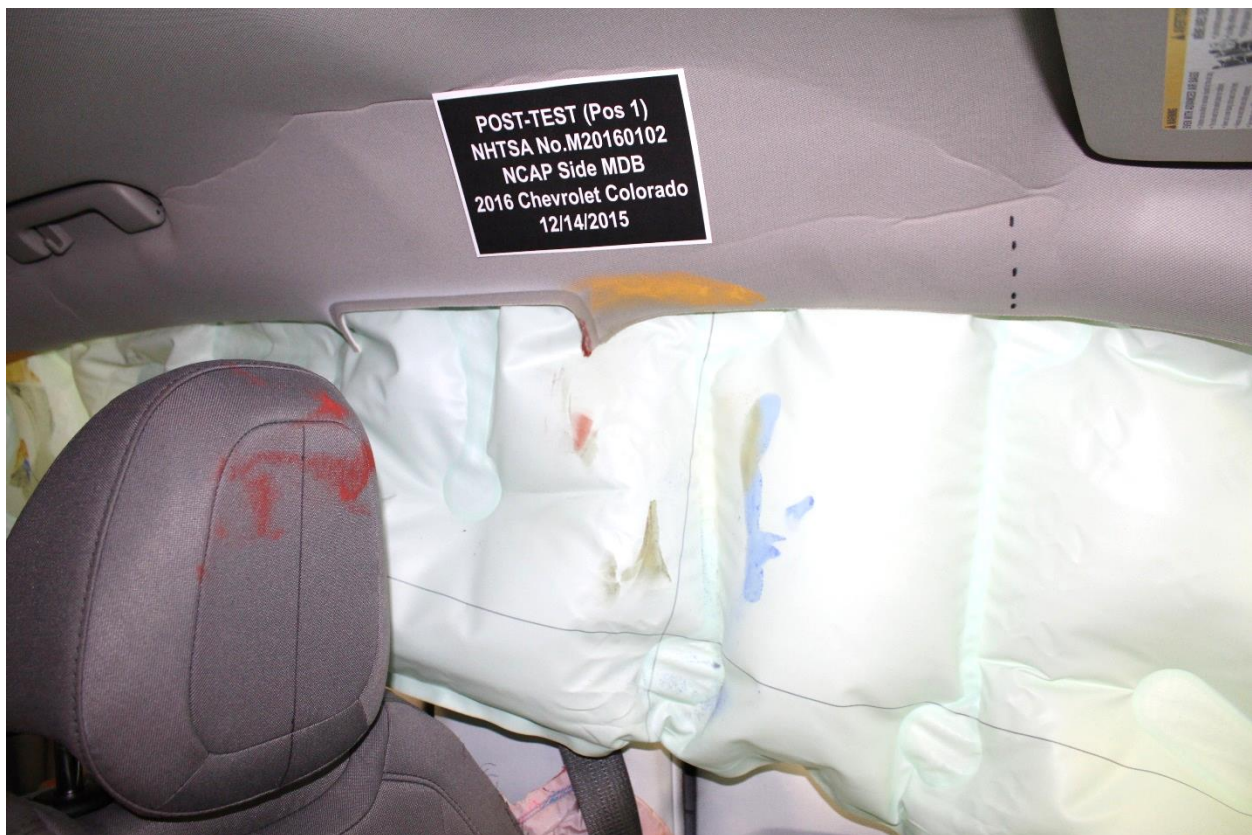
**Figure A-48: Post-Test Driver Dummy Close-Up Head Contact with Vehicle View**

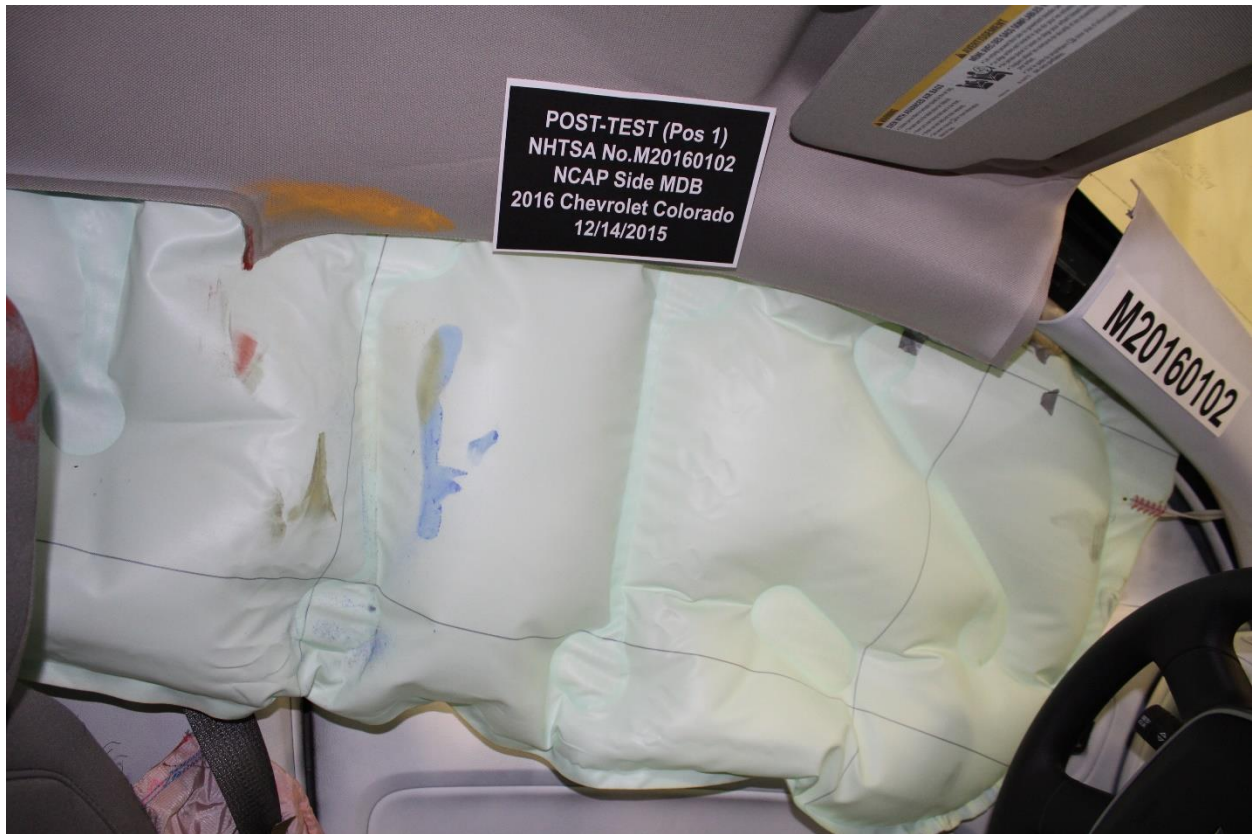
**Figure A-49: Post-Test Driver Dummy Close-Up Head Contact with Side Airbag View**

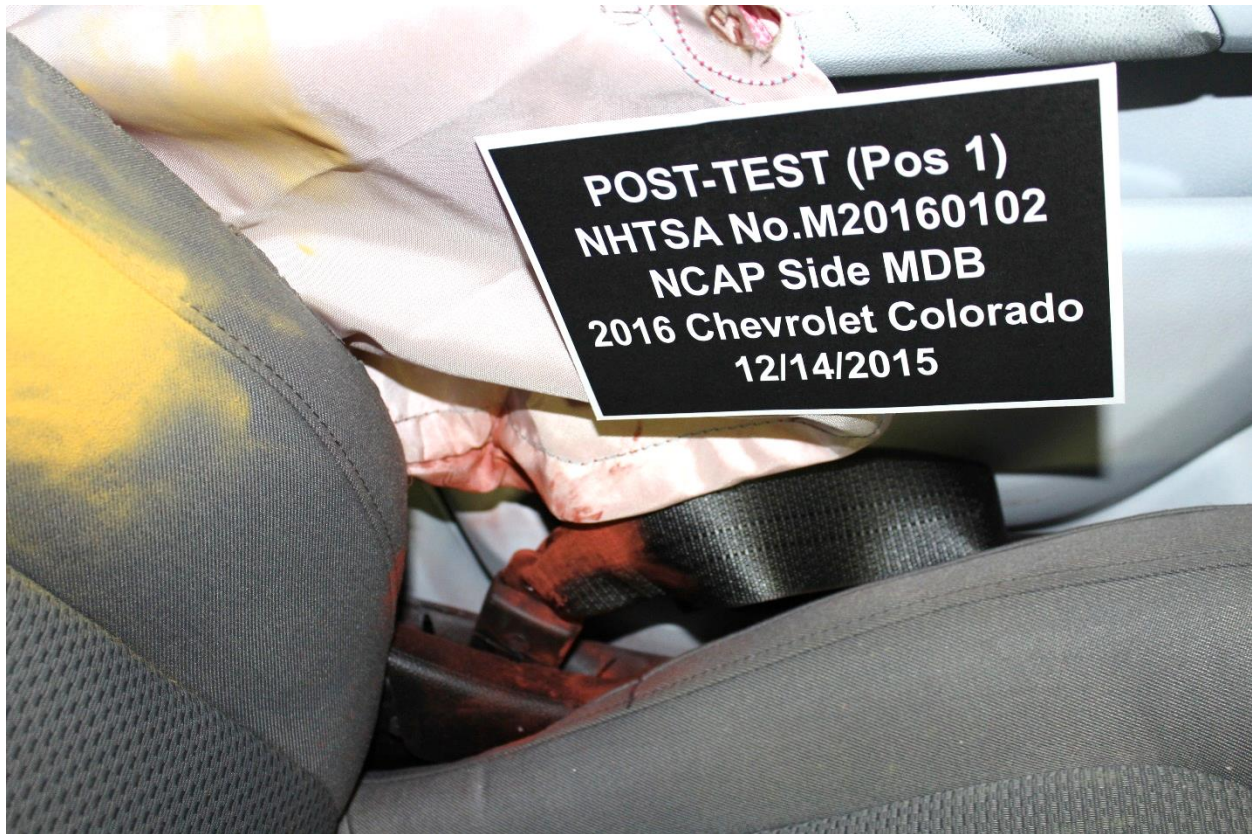
**Figure A-53: Post-Test Driver Dummy Close-Up Pelvis Contact with Side Airbag View**

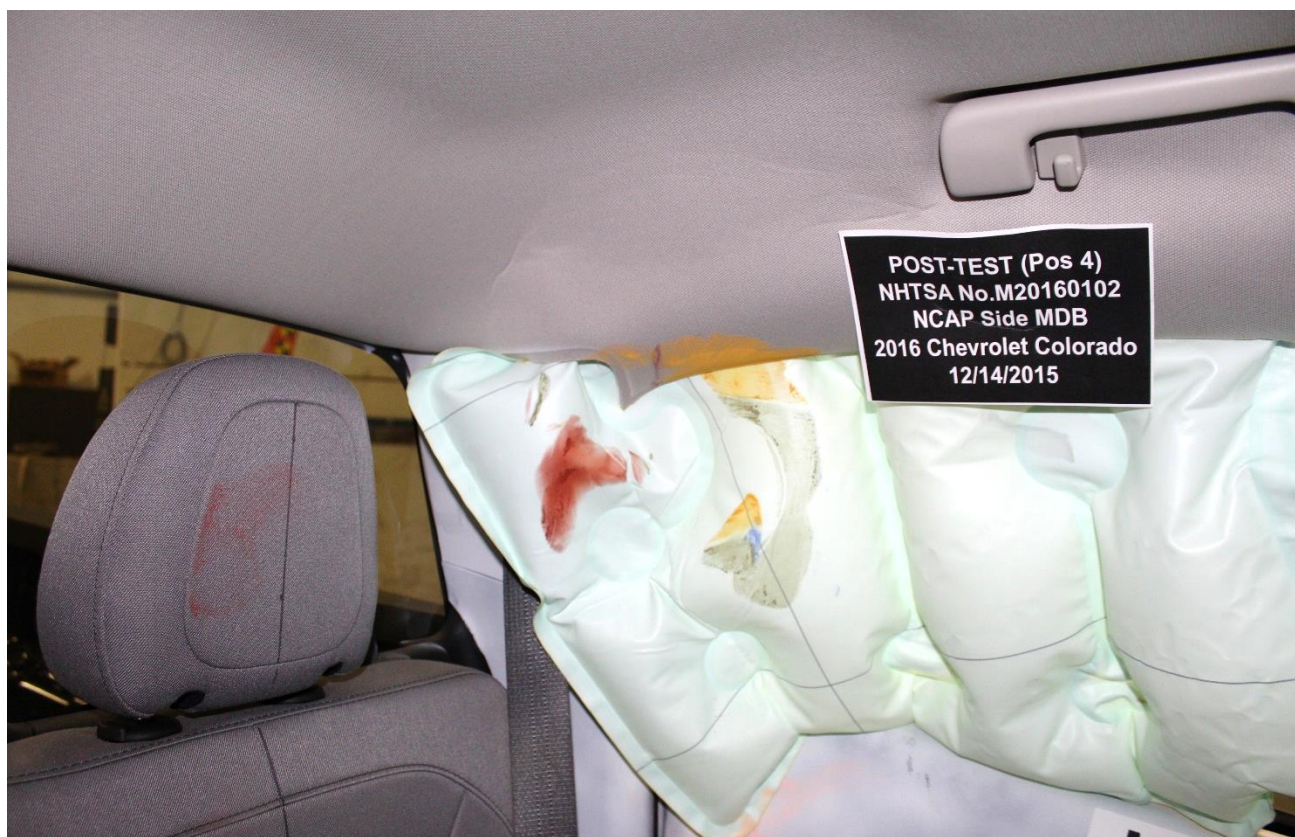
**Figure A-75: Post-Test Rear Passenger Dummy Close-Up Head Contact with Vehicle View**

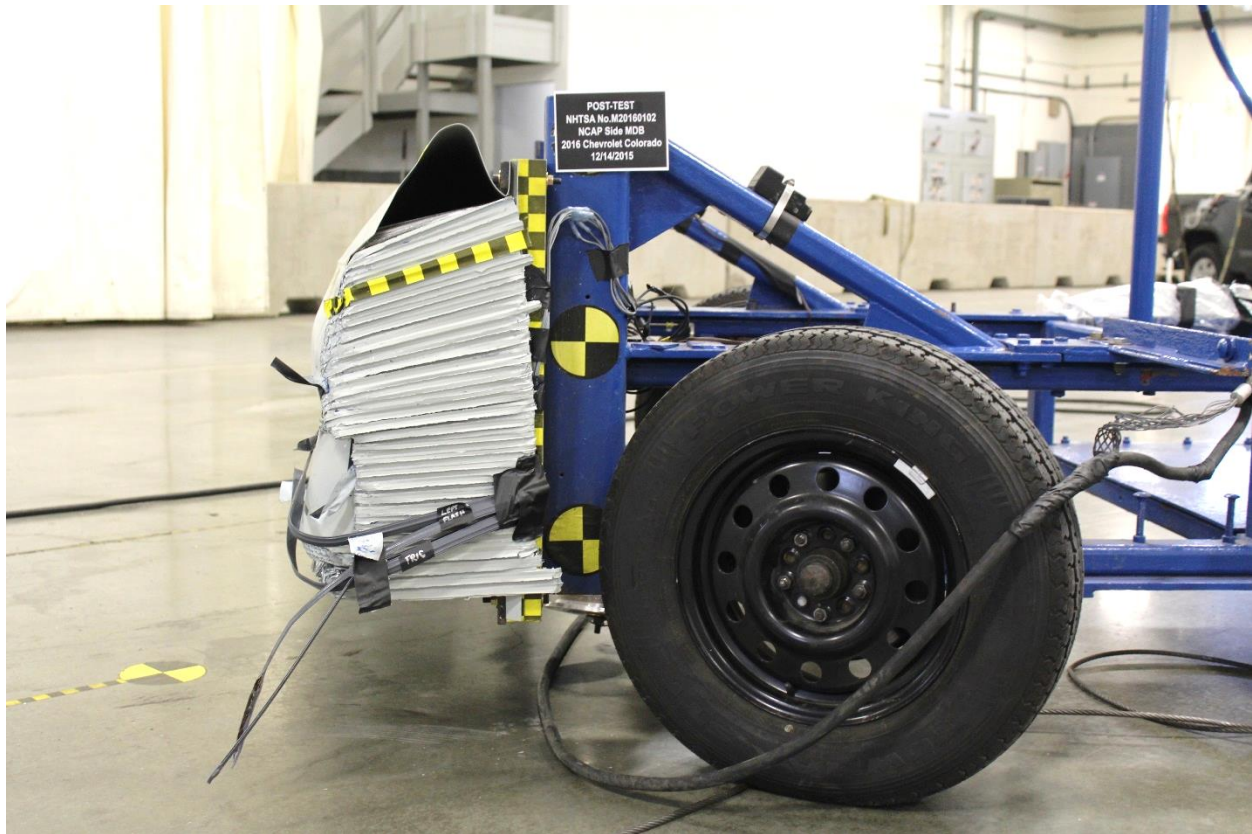
**Figure A-89: Post-Test Left Side View of MDB Impactor Face**

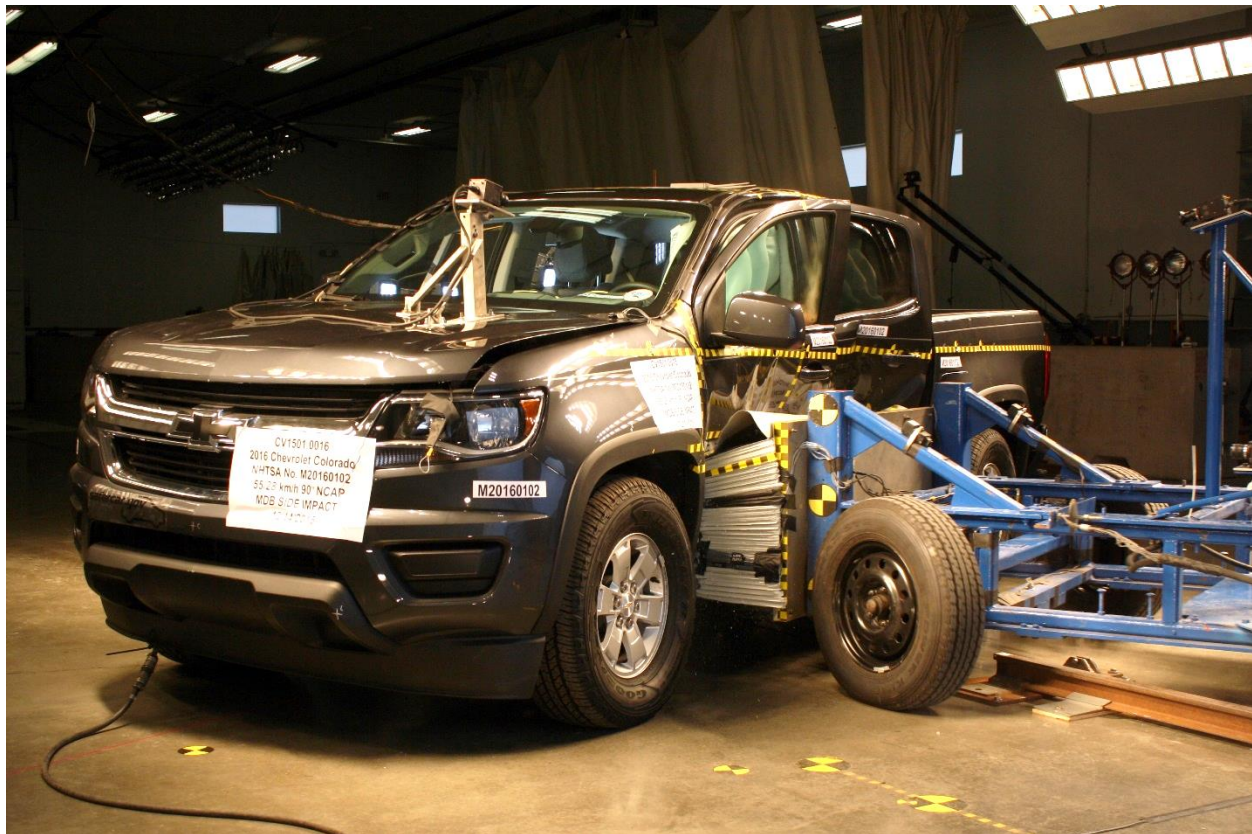
### Figure A-101: Impact Event
