**REPORT NUMBER: NCAP-CAL-16-001**

**NEW CAR ASSESSMENT PROGRAM (NCAP)  
FRONTAL BARRIER IMPACT TEST**

**General Motors LLC  
2016 Chevrolet Colorado  
Crew Cab Pickup Truck**

**FINAL REPORT**

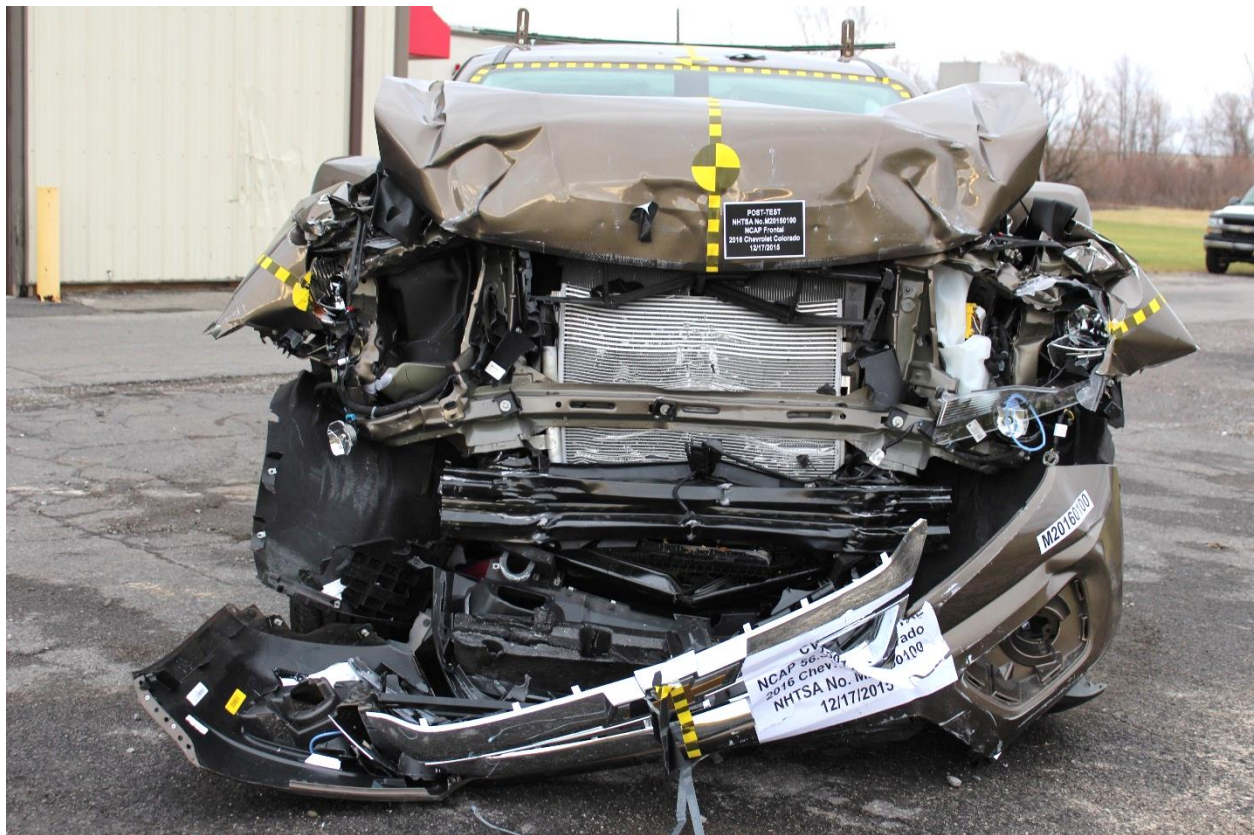
**Figure A-8: Post-Test Front View of Test Vehicle**

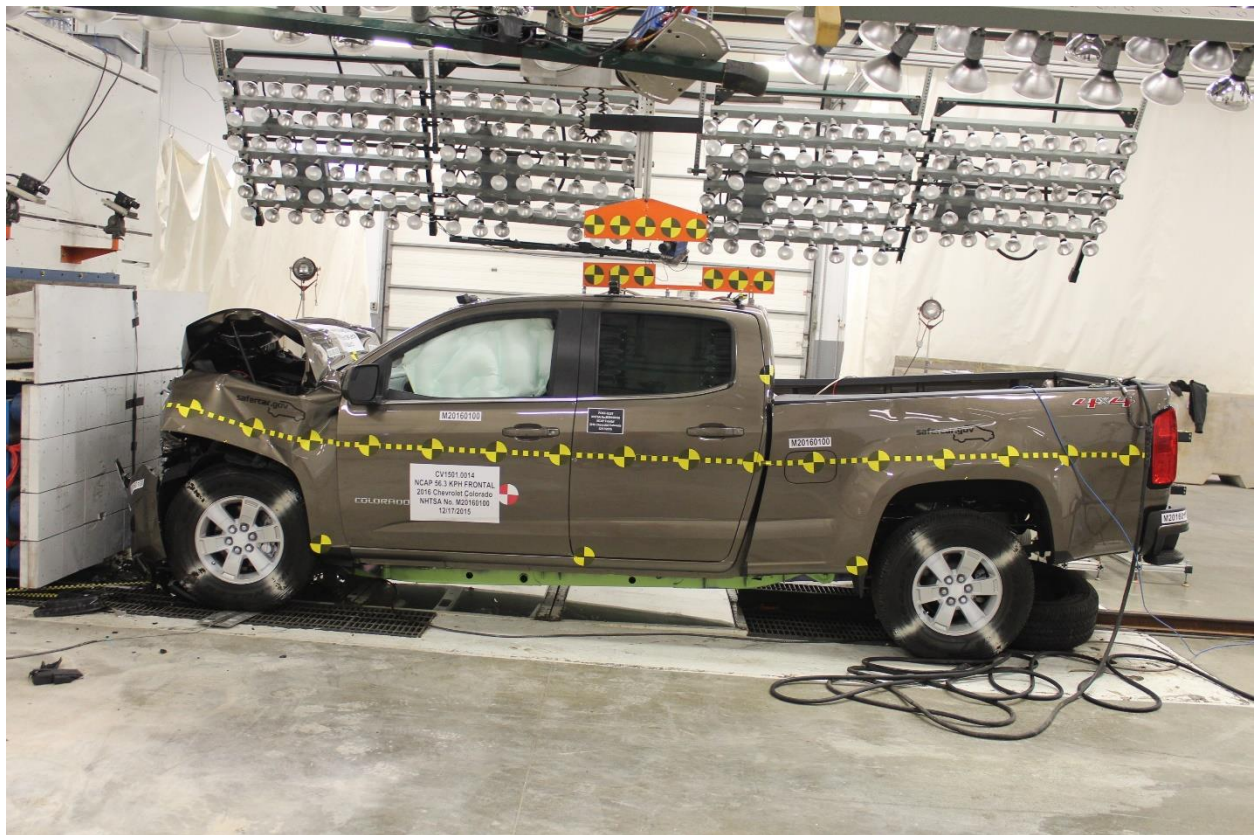
**Figure A-10: Post-Test Left View of Test Vehicle**

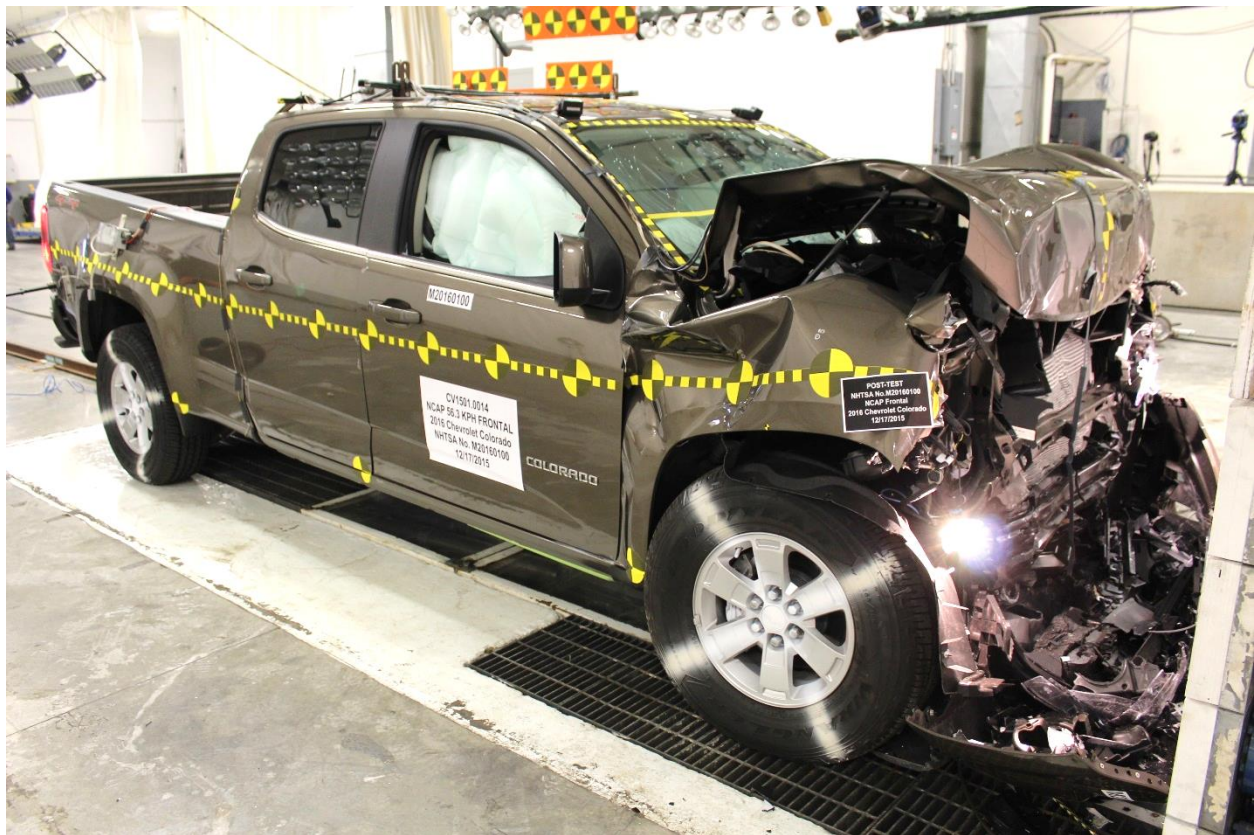
**Figure A-14: Post-Test Right Front 3-4 View**

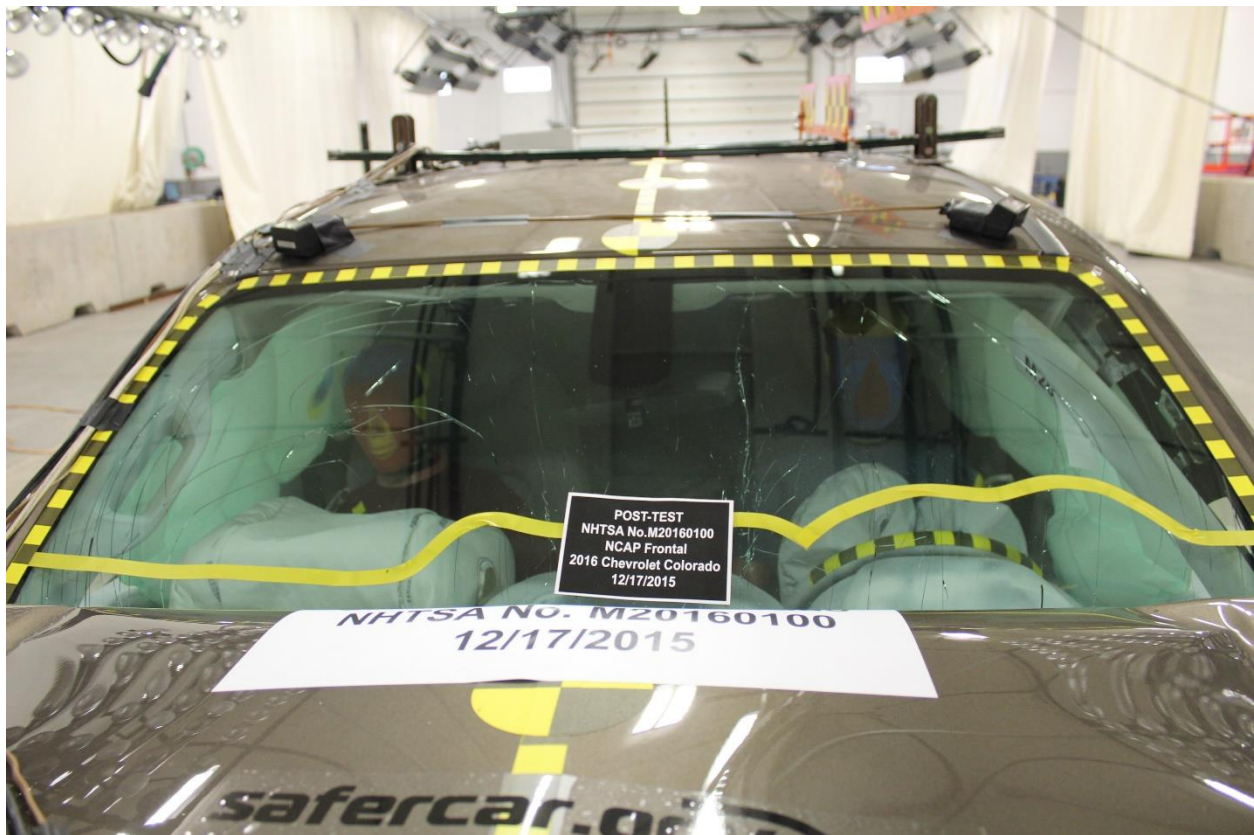
**Figure A-18: Post-Test Windshield View**

| Critical Areas of Performance | Observations and Conclusions |
|---|---|
| Windshield Damage | Minor Cracks |

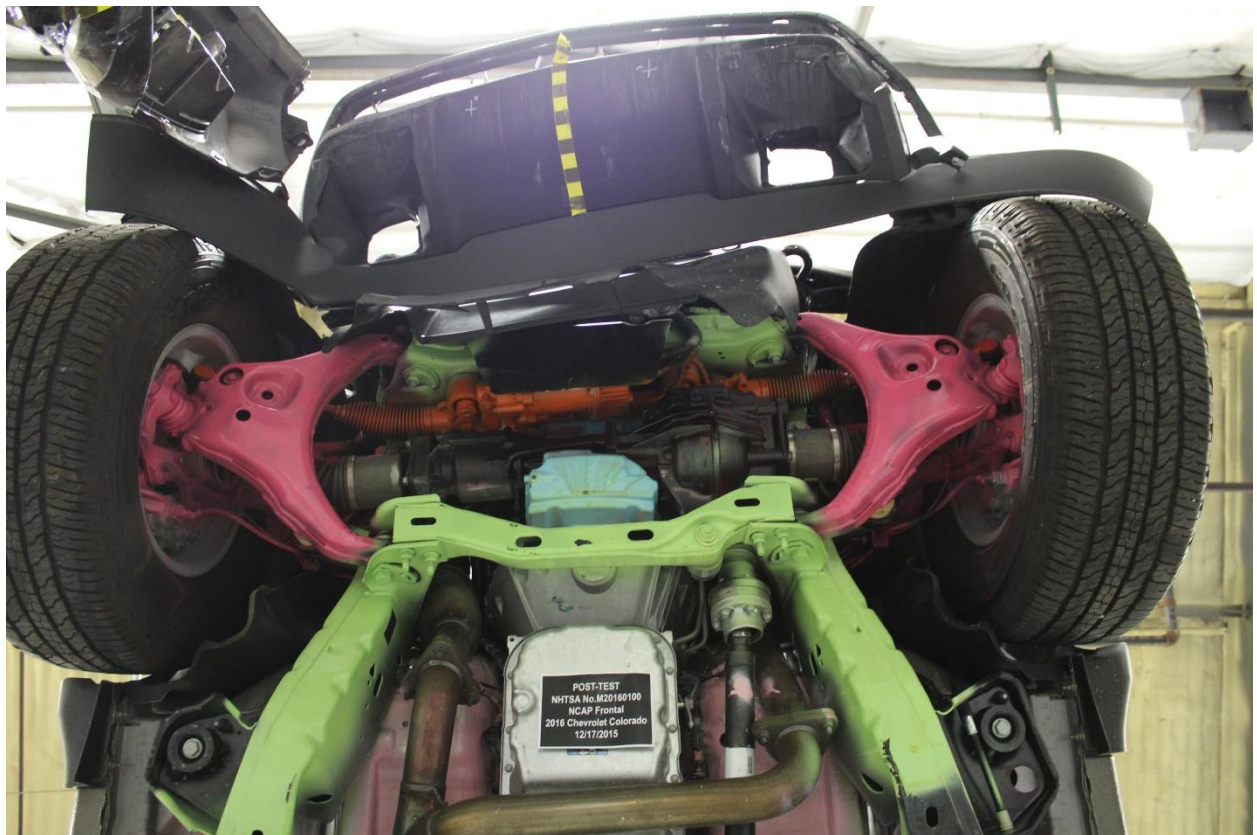
**Figure A-24: Post-Test Front Underbody View**

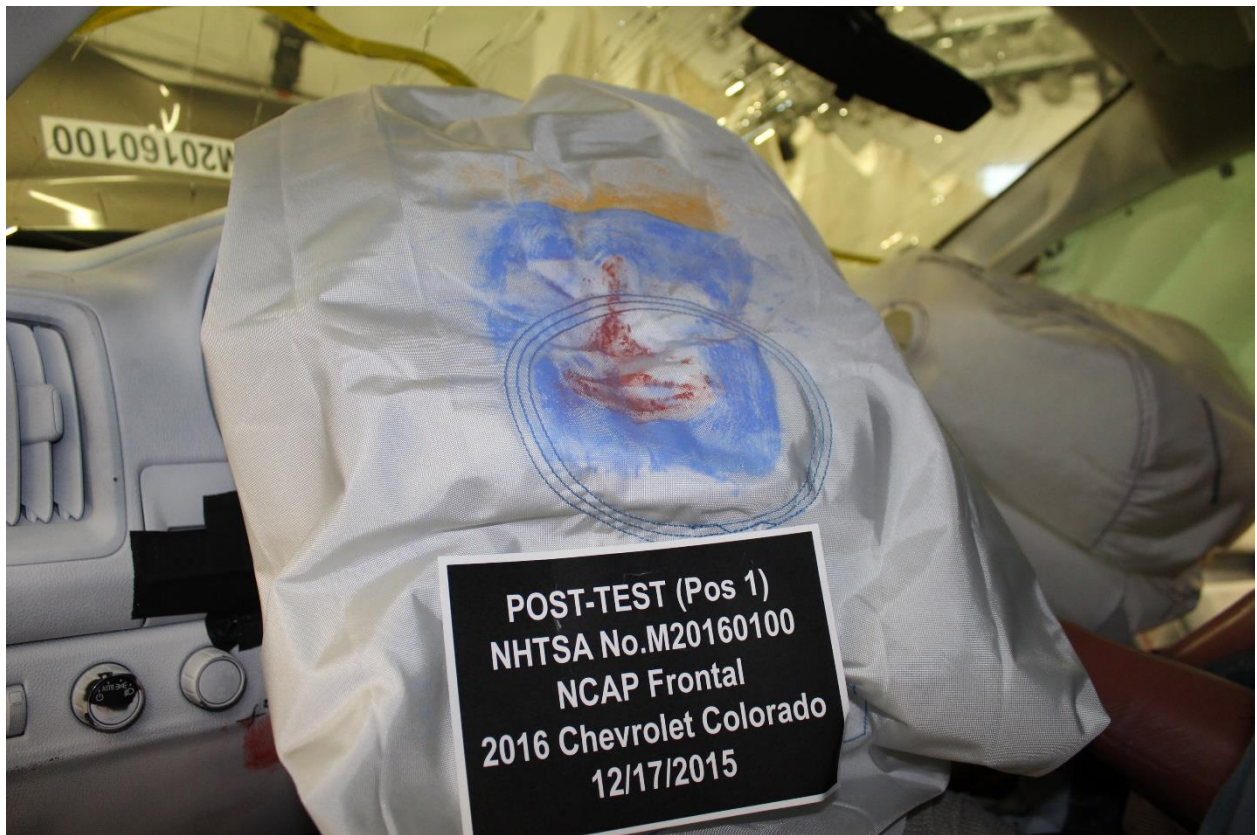
**Figure A-46: Post-Test Driver Dummy Contact With Airbag**

The driver's visible contact points were as follows: The driver's head contacted the frontal airbag and then the head restraint. The upper torso contacted the frontal airbag. Both knees contacted the knee bolster.

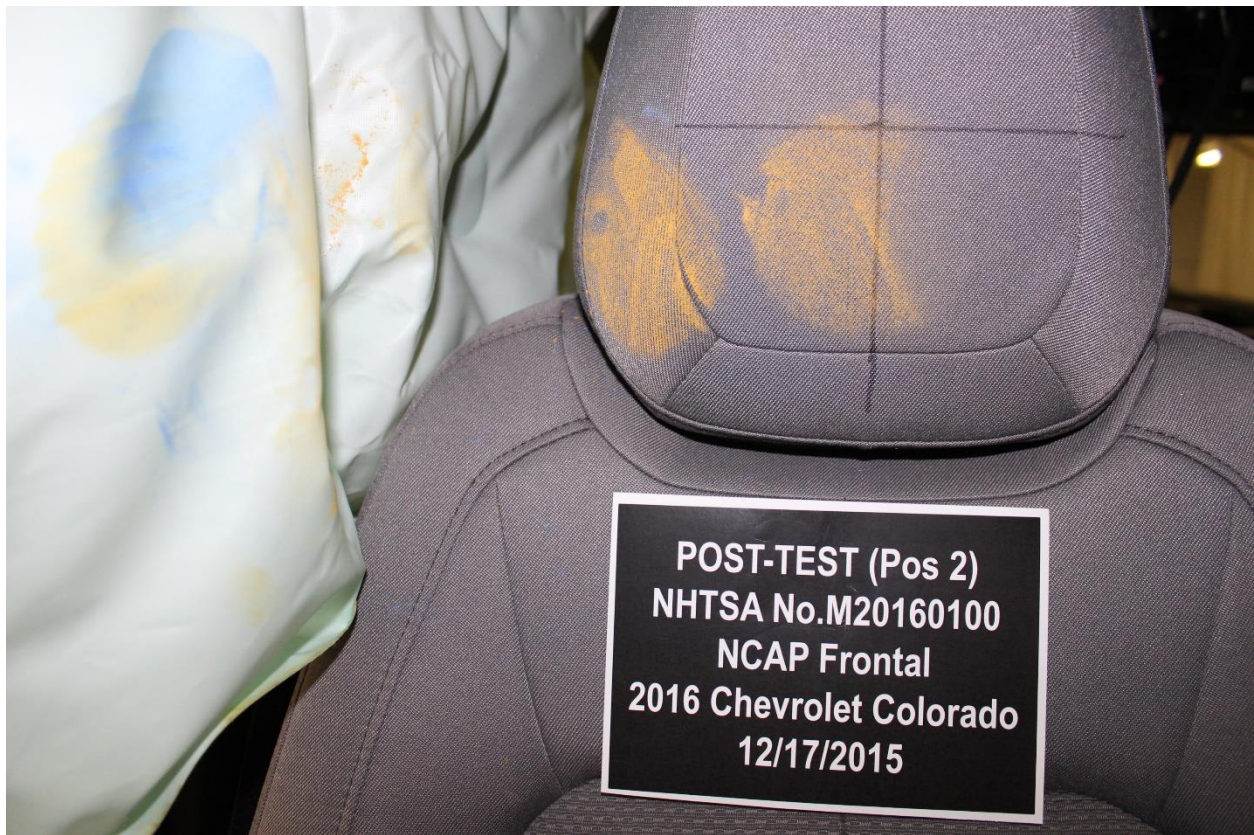
**Figure A-68: Post-Test Passenger Dummy Contact With Headrest**

The passenger's visible contact points were as follows: The passenger's head contacted the frontal airbag and then the head restraint and curtain airbag. The upper torso contacted the frontal airbag. Both knees contacted the glove box.

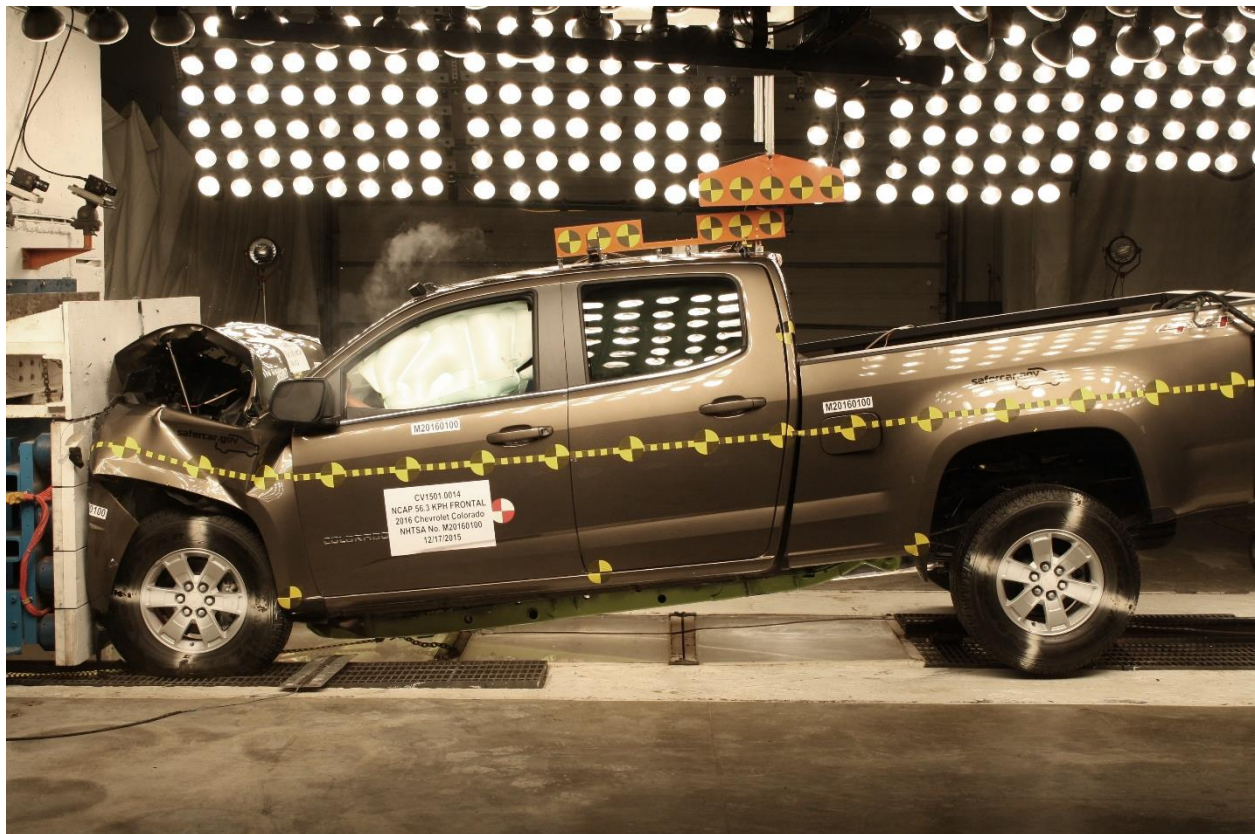
Figure A-77: 2016 Chevrolet Colorado Crew Cab Frontal Impact Event

A ridged fixed barrier was impacted by a 2016 Chevrolet Colorado Crew Cab Pickup Truck at a velocity of 56.26 km/h. The test was performed at Calspan Corporation's Transportation Test Operations facility in Buffalo, New York on December 17, 2015. Pre- and post-test photographs of the vehicle and dummies to document the test can be found in Appendix A. One real-time camera and 14 high-speed cameras were used to document the frontal barrier impact event. Camera locations and other pertinent camera information can be found in Data Sheet 6 of this report.
