**REPORT NUMBER: SPNCAP-KAR-16-009  
NEW CAR ASSESSMENT PROGRAM (NCAP)  
SIDE IMPACT POLE TEST**

**NISSAN MOTOR CO.  
2016 NISSAN VERSA S 4-DOOR SEDAN**

**NHTSA No: M20165204**

**FINAL REPORT**

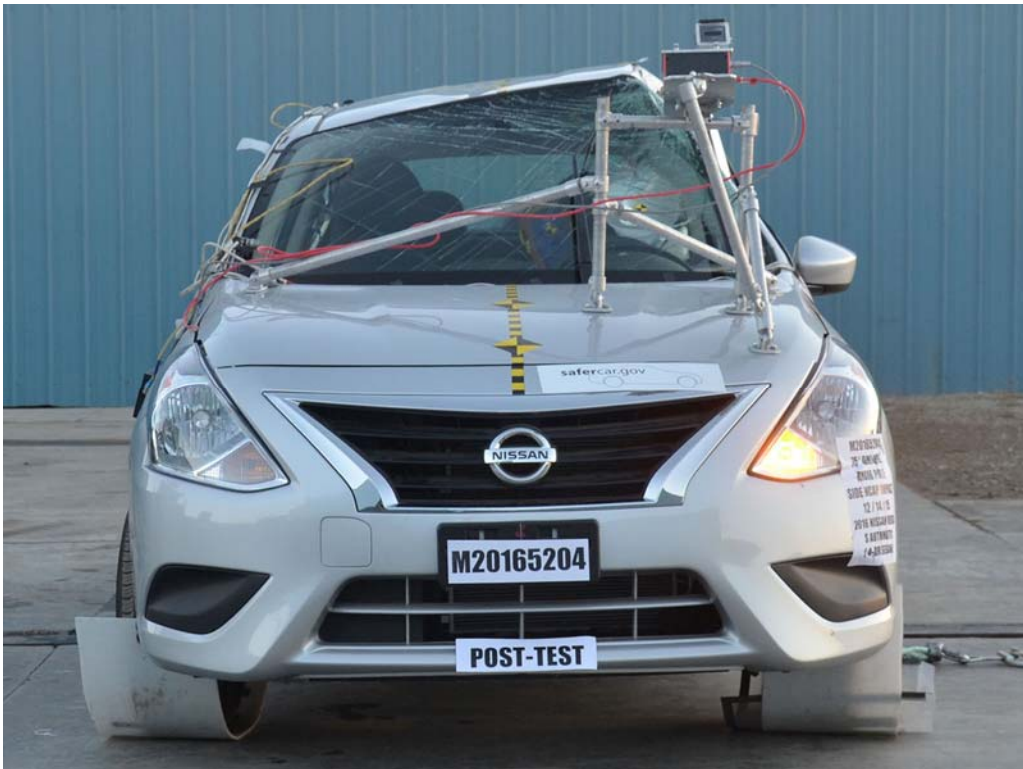
FIGURE 4. Post-Test Frontal View of Test Vehicle

Both the front and rear doors on the struck side of the vehicle were jammed shut while remaining closed and latched. The roof of the car lifted from the body and separated at the seam with the front driver window and windshield broken. The windshield separated from the vehicle. There was no separation at the hinges or latches. Both doors on the non-struck side remained closed and latched. The trunk opened during impact. There were no ATD values that exceeded limits.

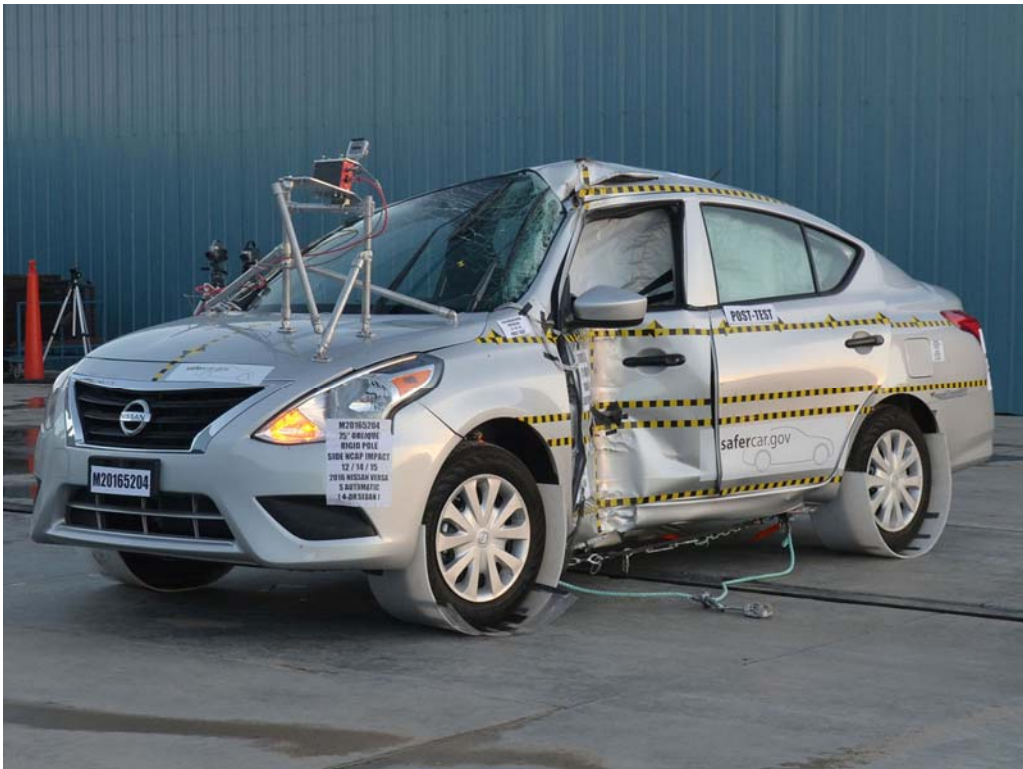
FIGURE 6. Post-Test Left Front  $\frac{3}{4}$  View of Test Vehicle

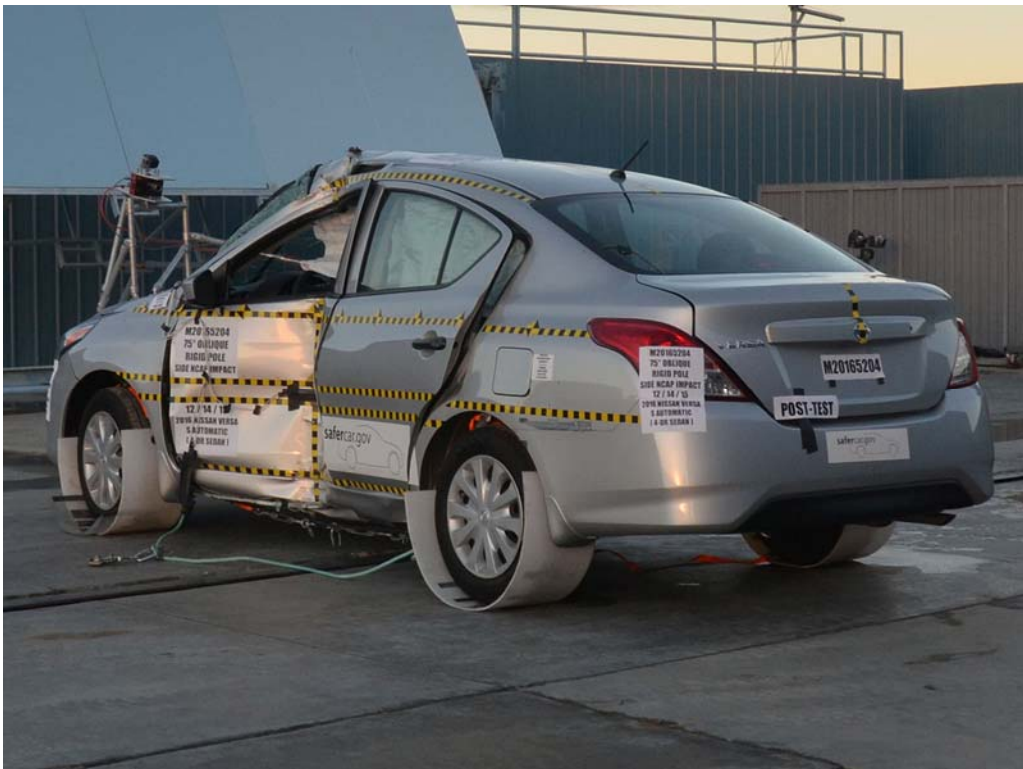
FIGURE 10. Post-Test Left Rear  $\frac{3}{4}$  View of Test Vehicle

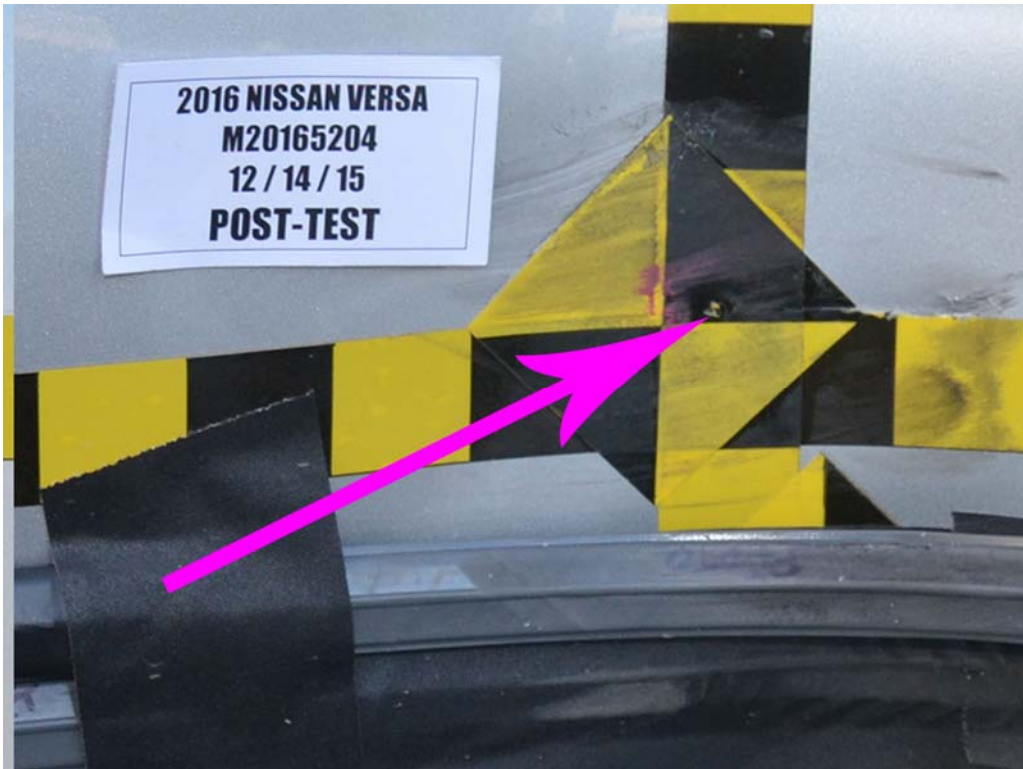
FIGURE 20. Post-Test Close-Up View of Impact Point Target  
Showing Impact Location

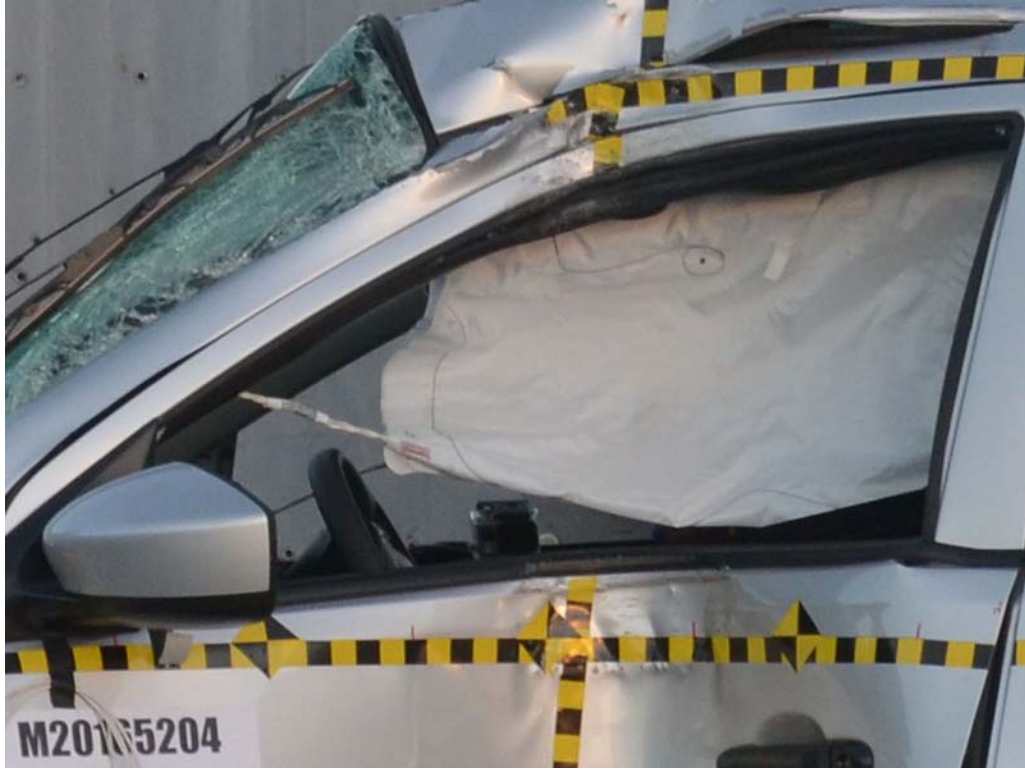
FIGURE 25. Post-Test Left Side View of Dummy Shoulder and Door Top View

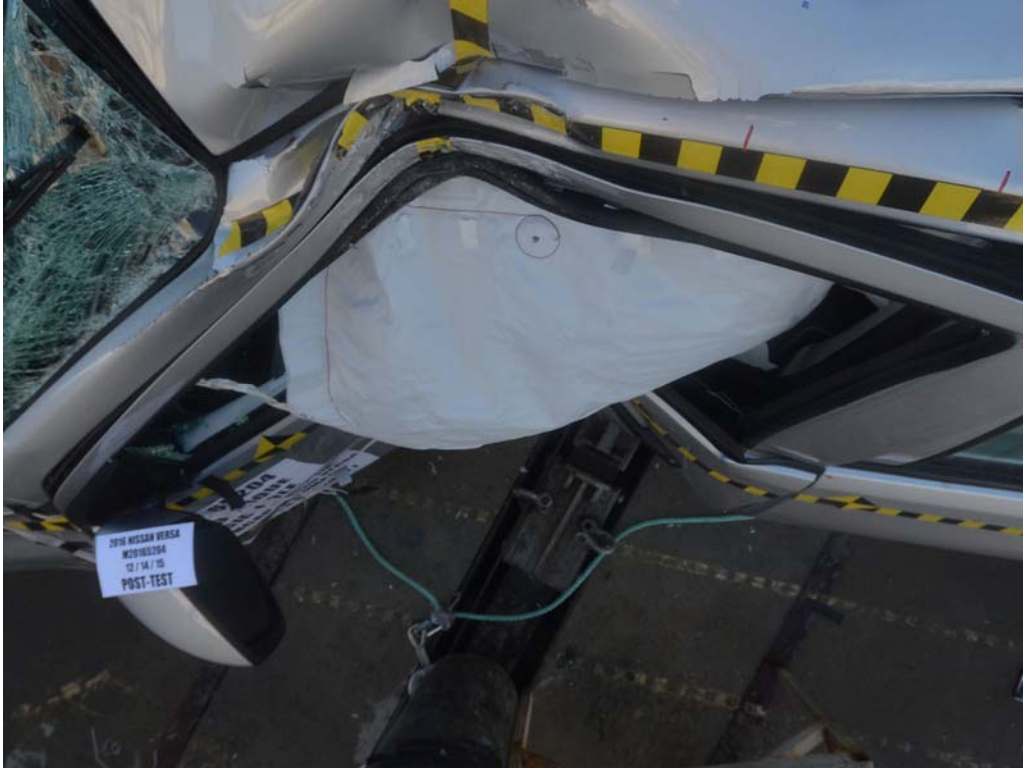
FIGURE 41. Post-Test Dummy and Door Clearance View

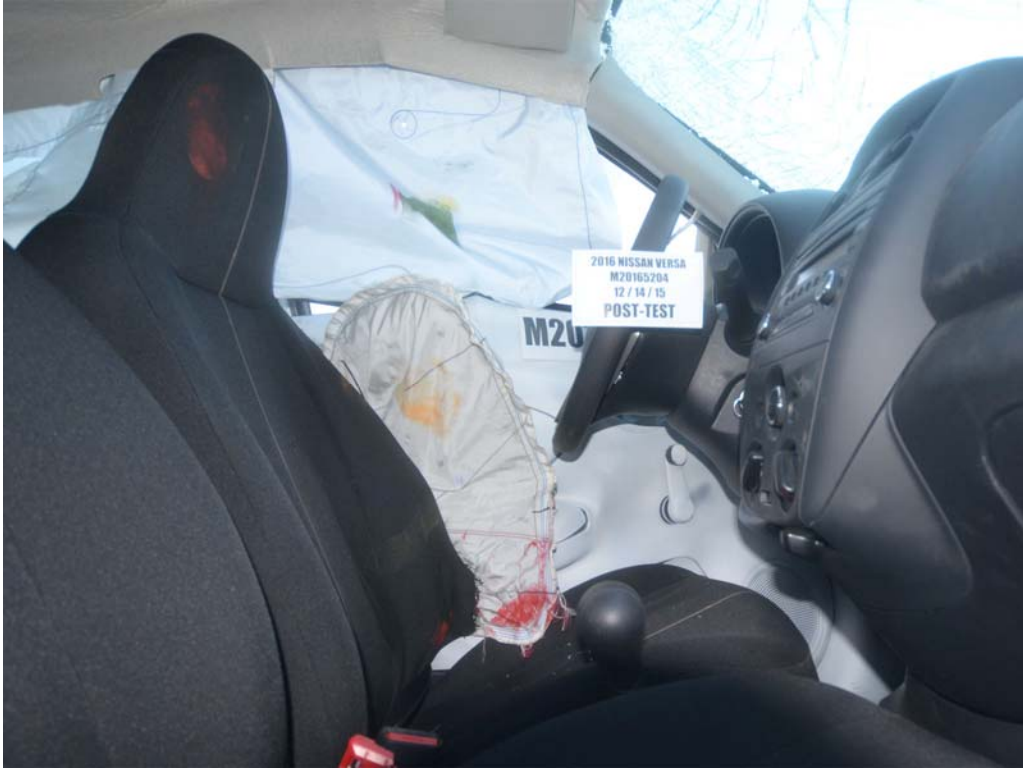
FIGURE 45. Post-Test Inner Door Panel View  
Showing Dummy Contact Locations

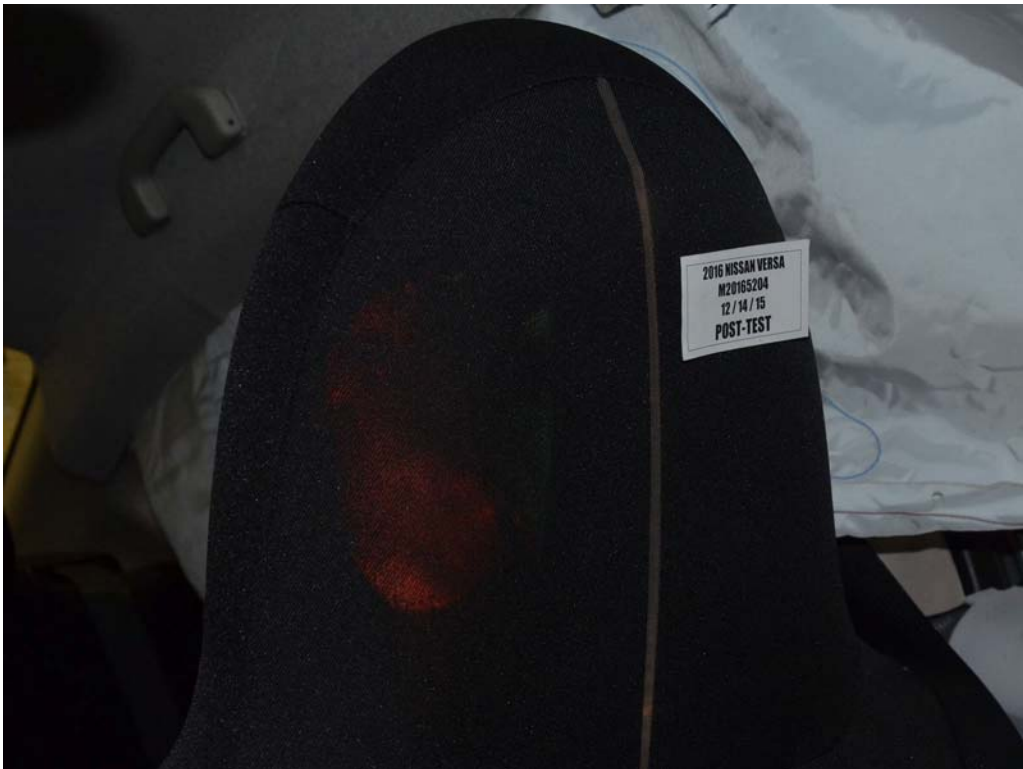
FIGURE 46. Post-Test Dummy Close-Up Head Contact with Vehicle Interior View

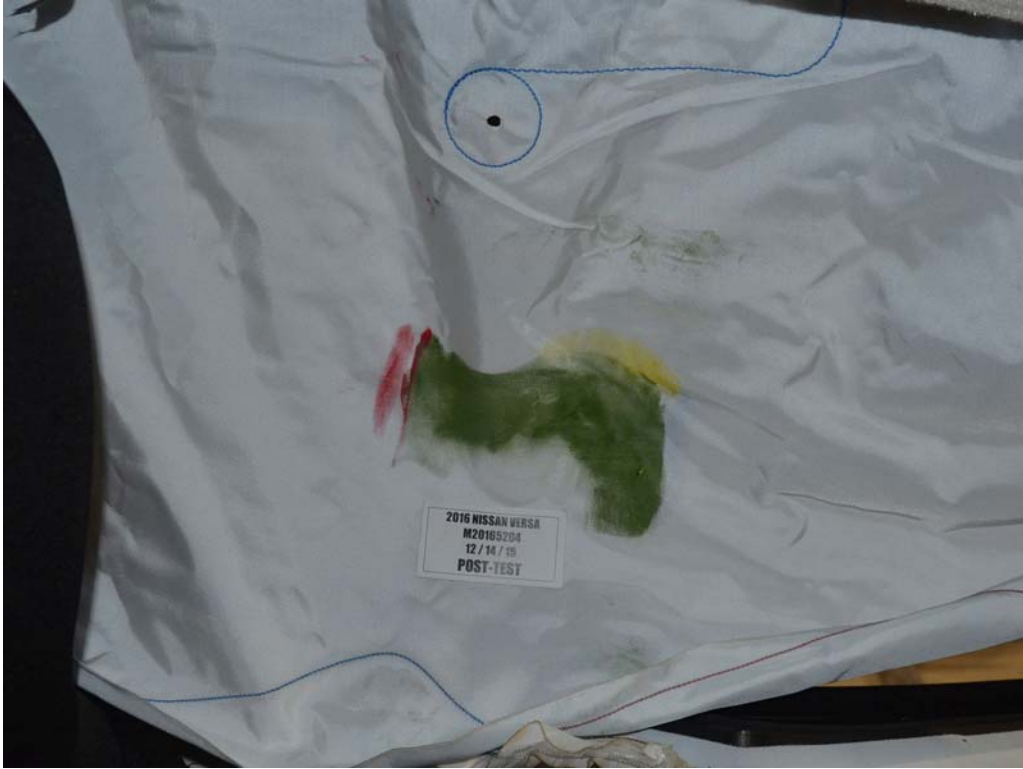
FIGURE 47. Post-Test Dummy Close-Up Head Contact With Side Airbag View

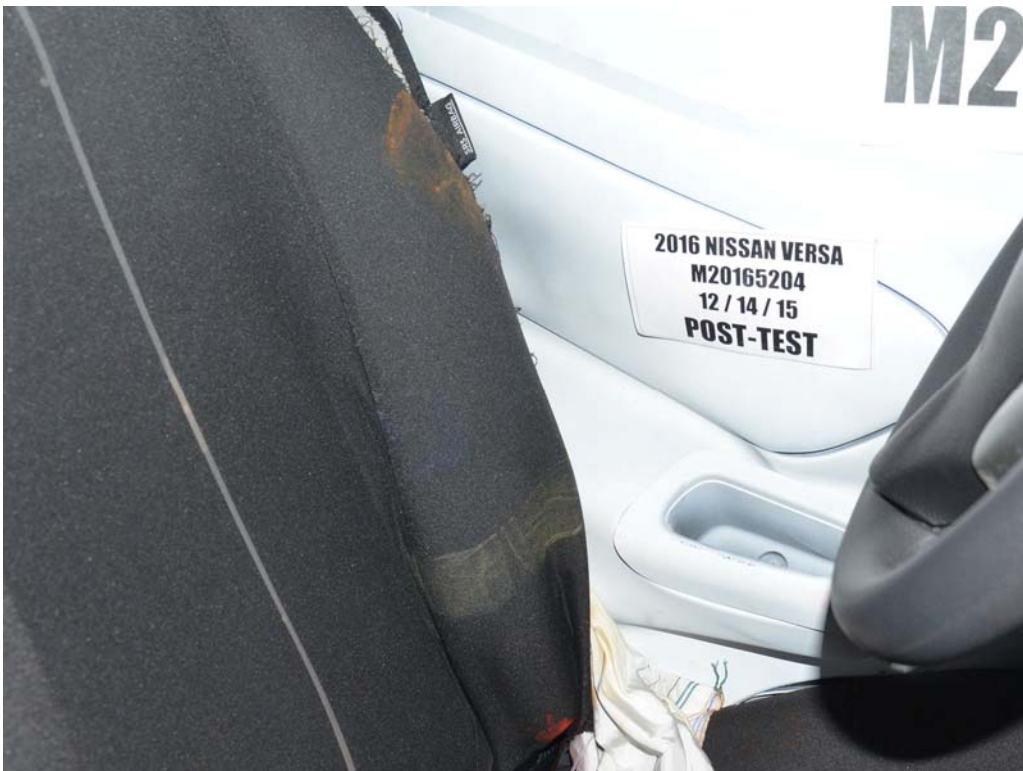
FIGURE 48. Post-Test Dummy Close-Up Torso Contact With Vehicle Interior View

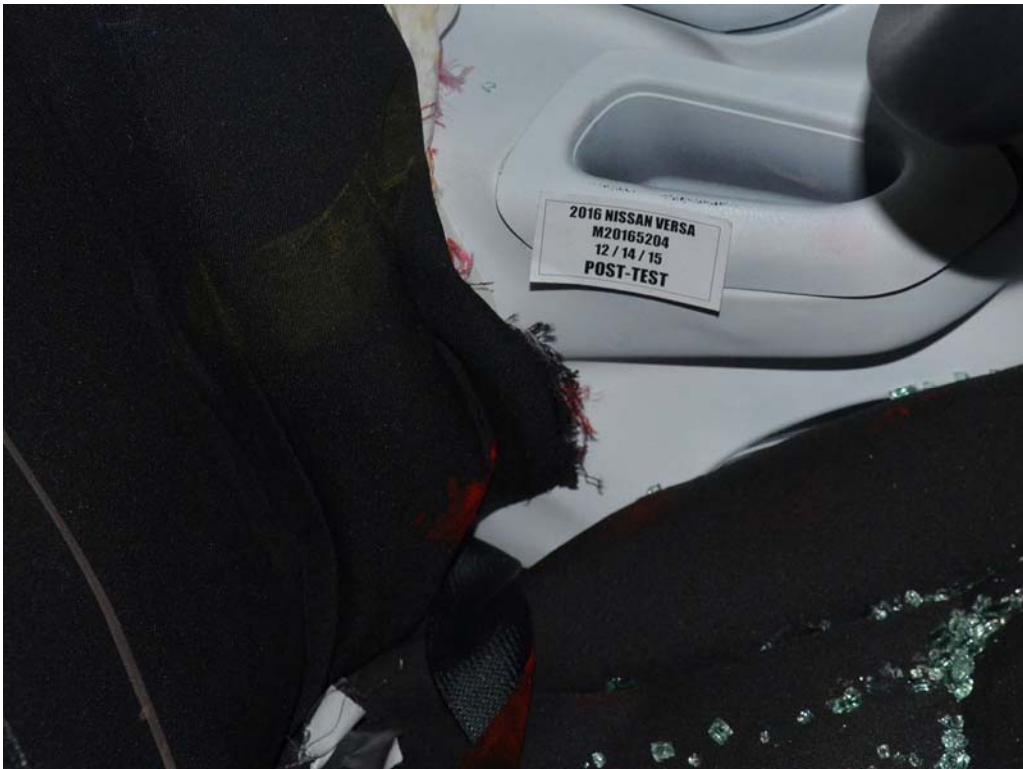
FIGURE 50. Post-Test Dummy Close-Up Pelvis Contact With Vehicle Interior View

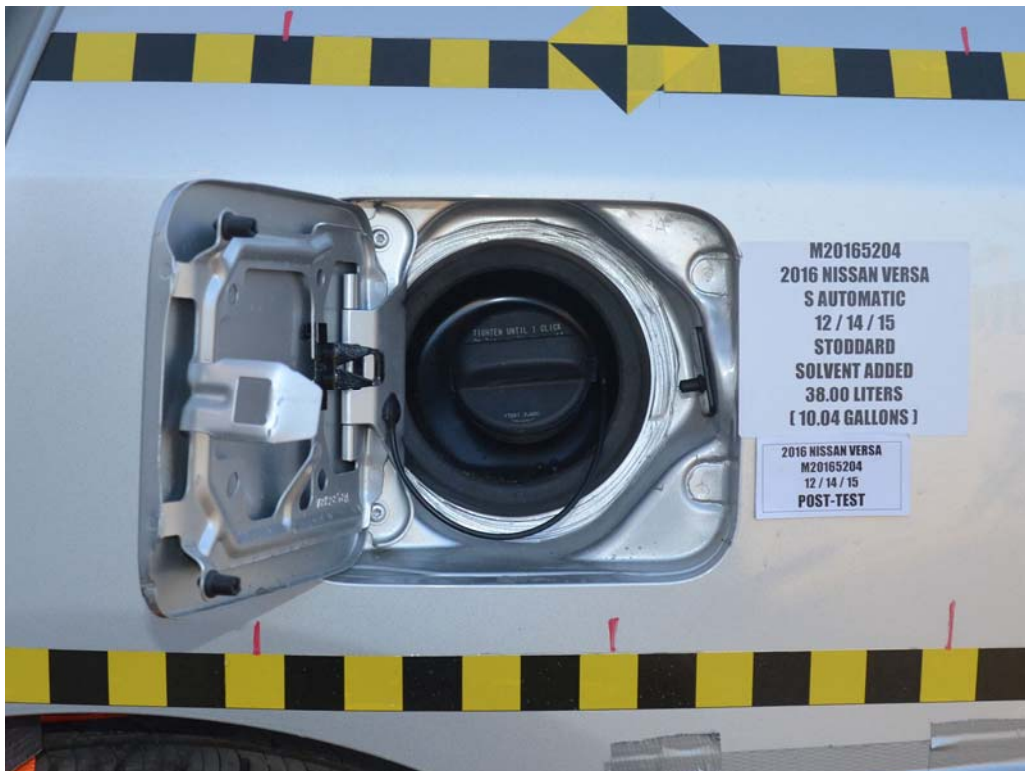
FIGURE 54. Post-Test View of Fuel Filler Cap or Fuel Filler Neck

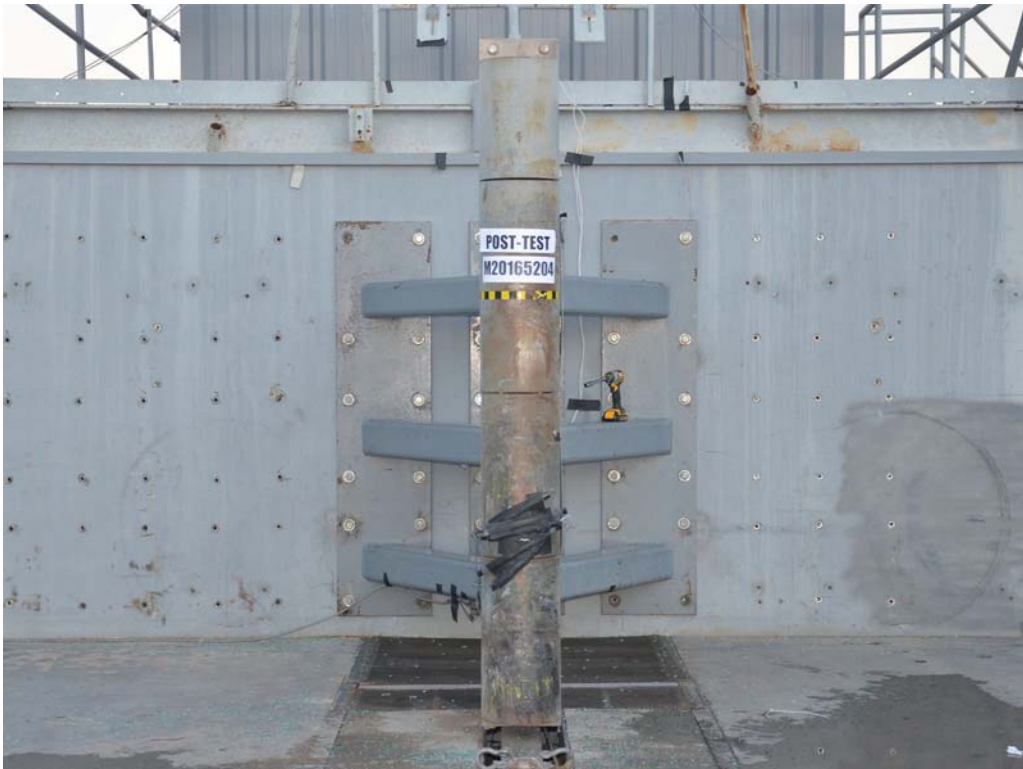
FIGURE 58. Post-Test Pole Barrier Front View

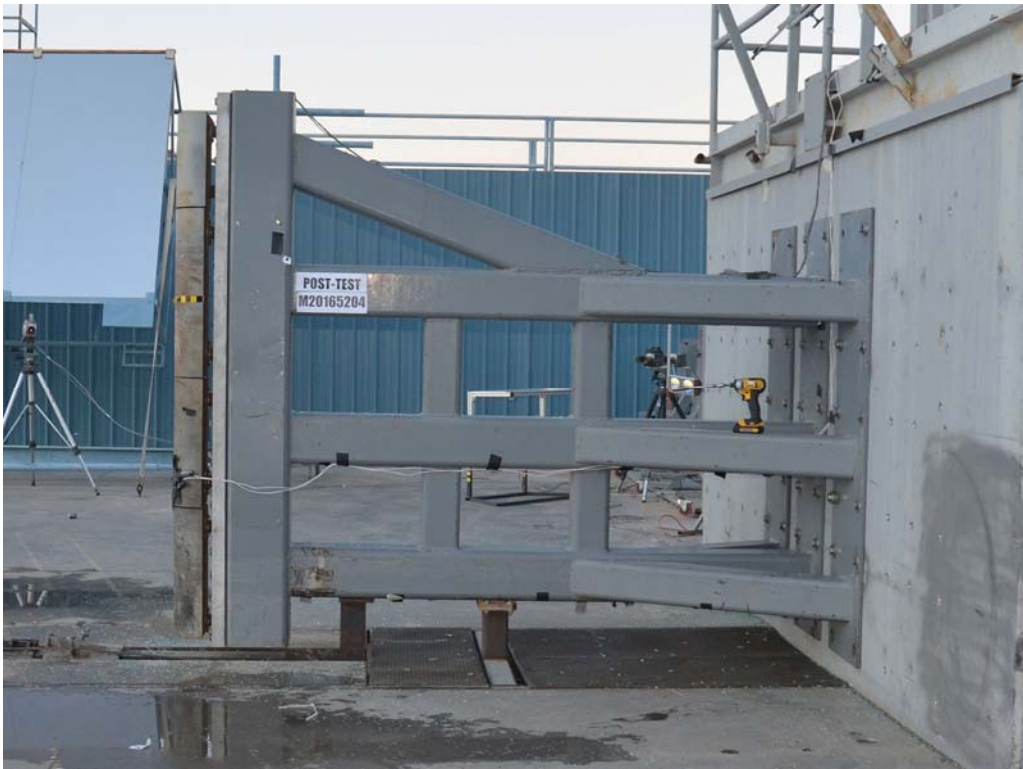
FIGURE 60. Post-Test Pole Barrier Side View
