REPORT NUMBER: NCAP-MGA-2016-029

**NEW CAR ASSESSMENT PROGRAM (NCAP)
Frontal Barrier Impact Test**

**FCA ITALY S.p.A.
2016 Jeep Renegade Sport 4x4 5-Dr. SUV
NHTSA No.: M20160310**

**MGA RESEARCH CORPORATION
5000 Warren Road
Burlington, WI 53105**

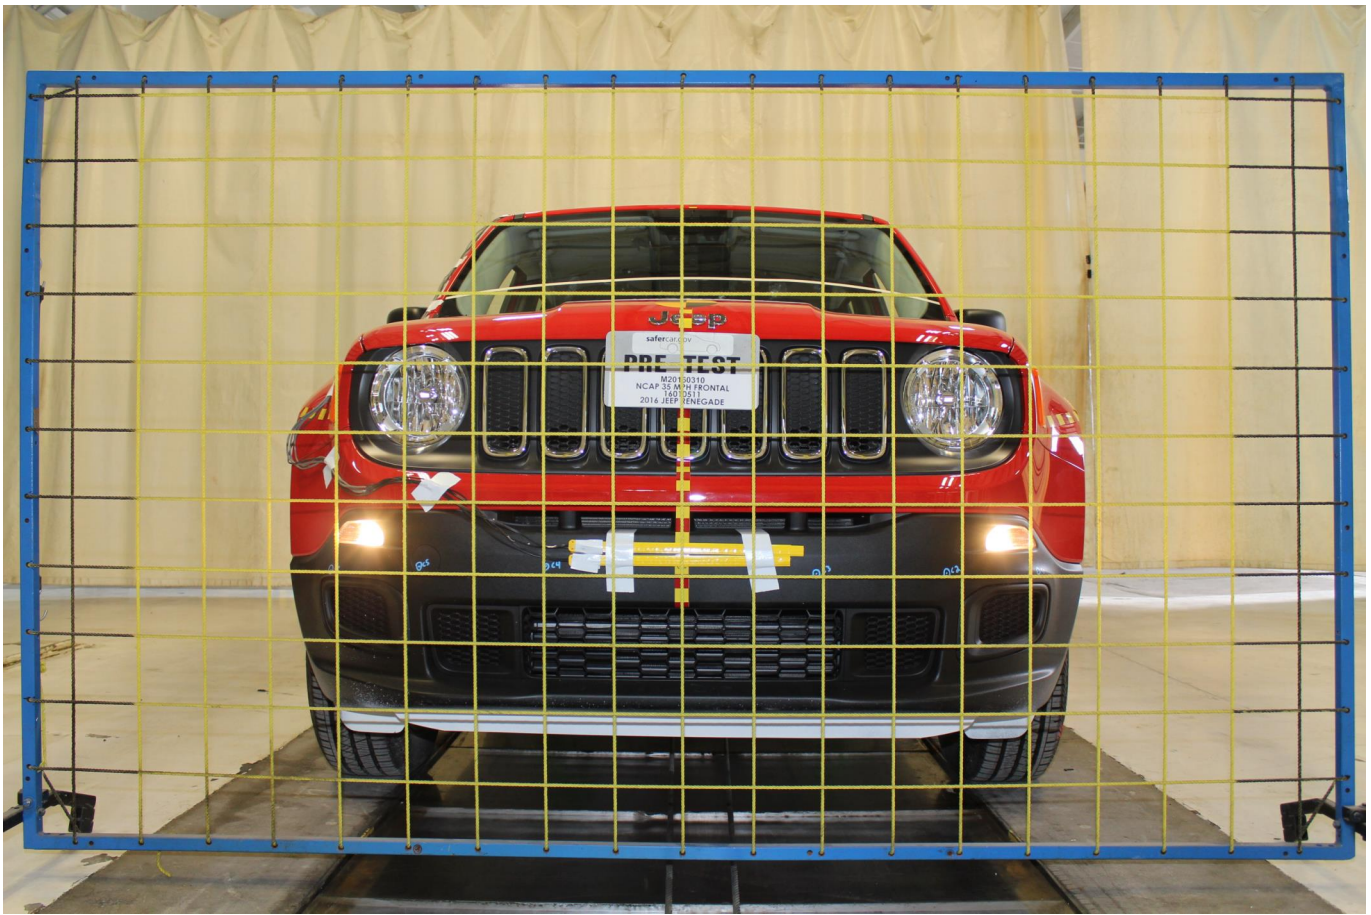
Photo No. 001 - Load Cell Location

A load cell barrier consisting of 176 load cells was impacted by a 2016 Jeep Renegade Sport 4x4 5-Dr. SUV at a velocity of 56.30 km/h. The test was performed at MGA Research Corporation on January 5, 2016. Pre-test and post-test photographs of the vehicle and dummies can be found in Appendix A.

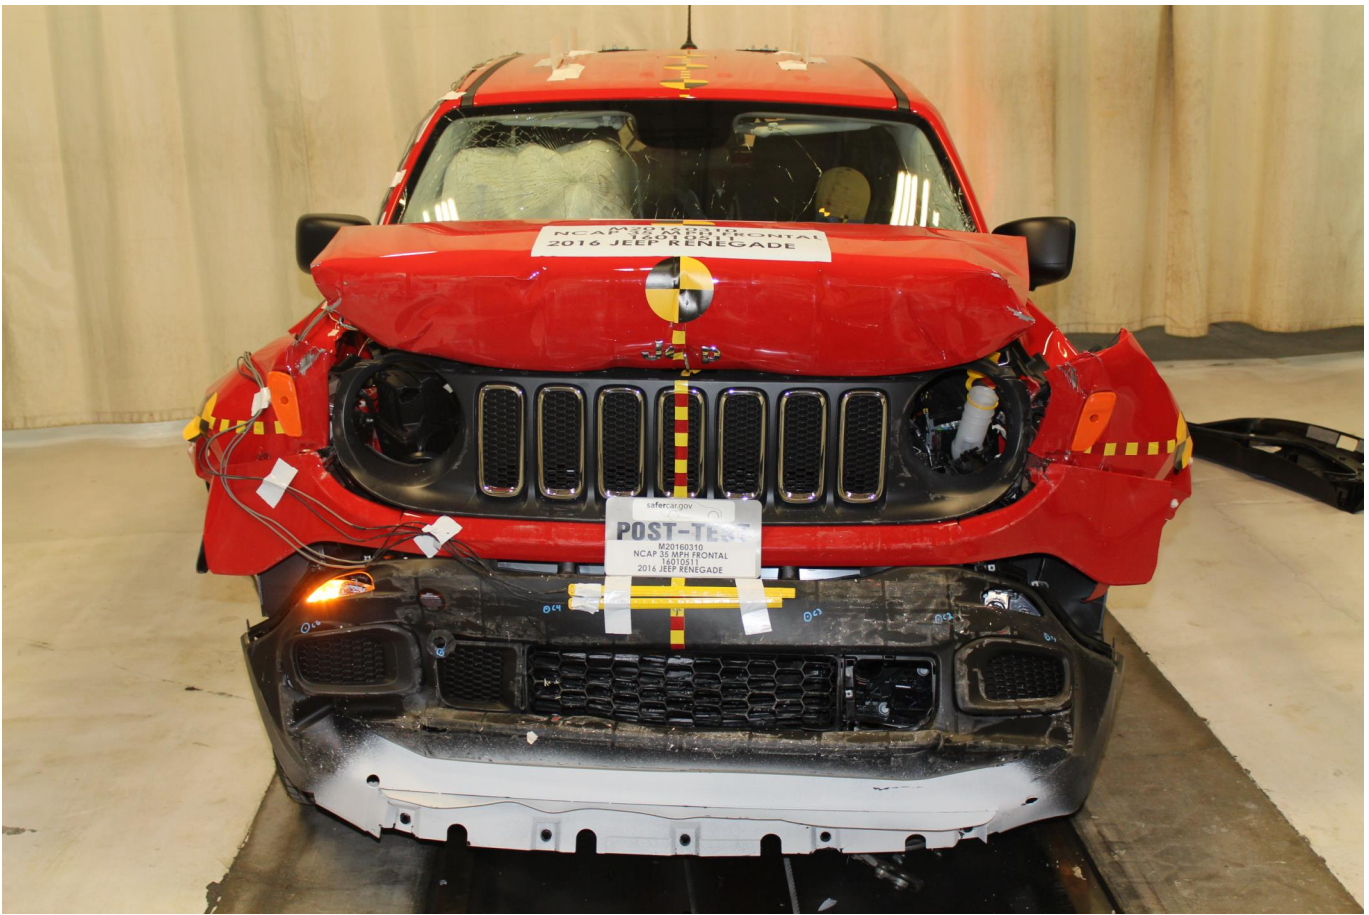
Photo No. 009 - Post-Test Front View of Test Vehicle

The maximum static crush of the vehicle was 287 mm to the right of the vehicle centerline and both the driver and passenger side doors remained closed during the impact event and were operable after the impact.

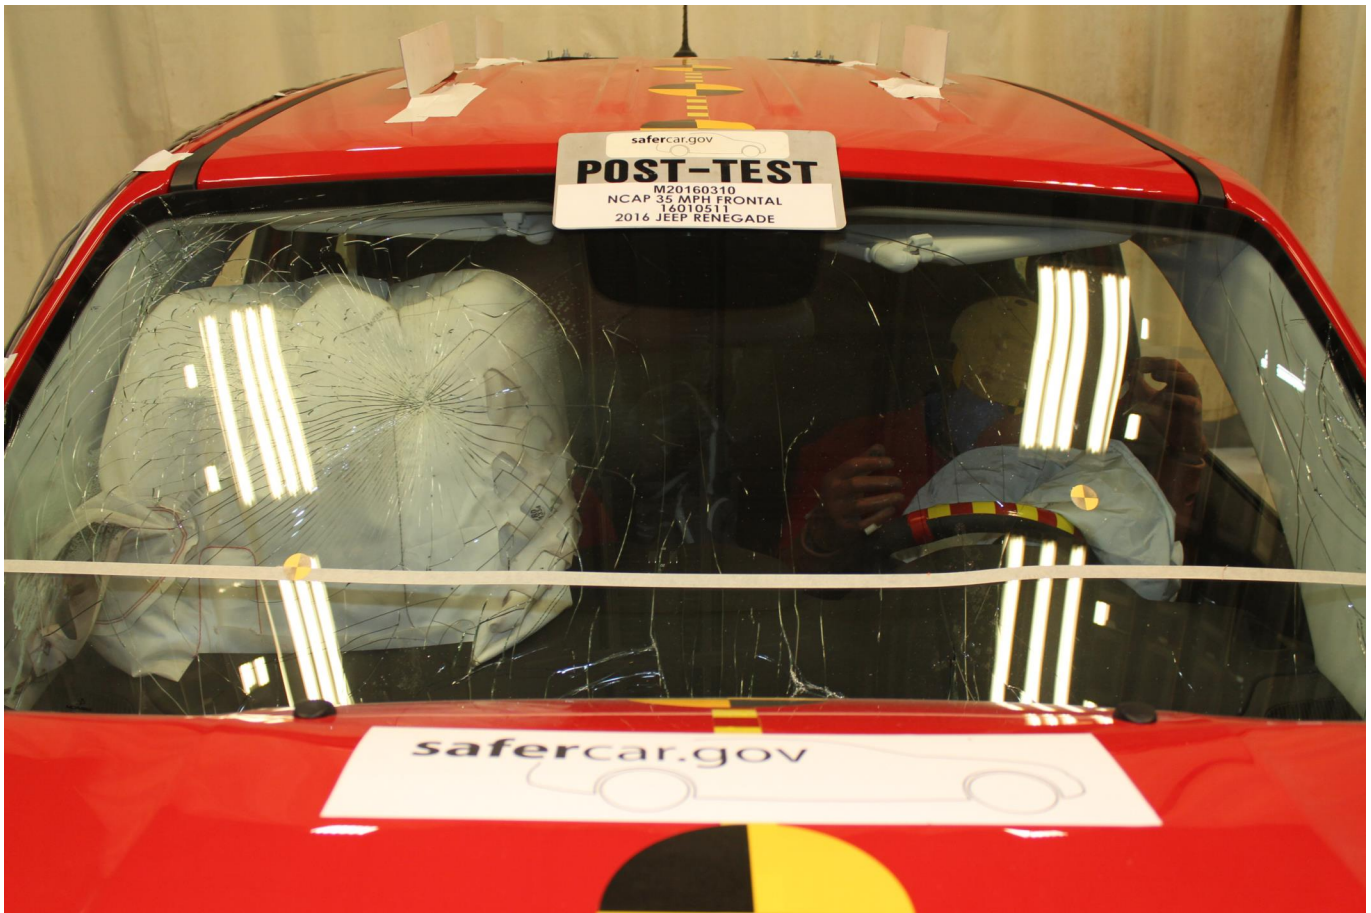
Photo No. 019 - Post-Test Windshield View

There was 100 percent windshield retention and no intrusion into the protected zone of the windshield during the event. There was no Stoddard Solvent leakage after the event or during any phase of the static rollover.

Critical Areas of Performance	Observations and Conclusions
Windshield Damage	Cracked
Window Damage	None
Other Notable Effects	None

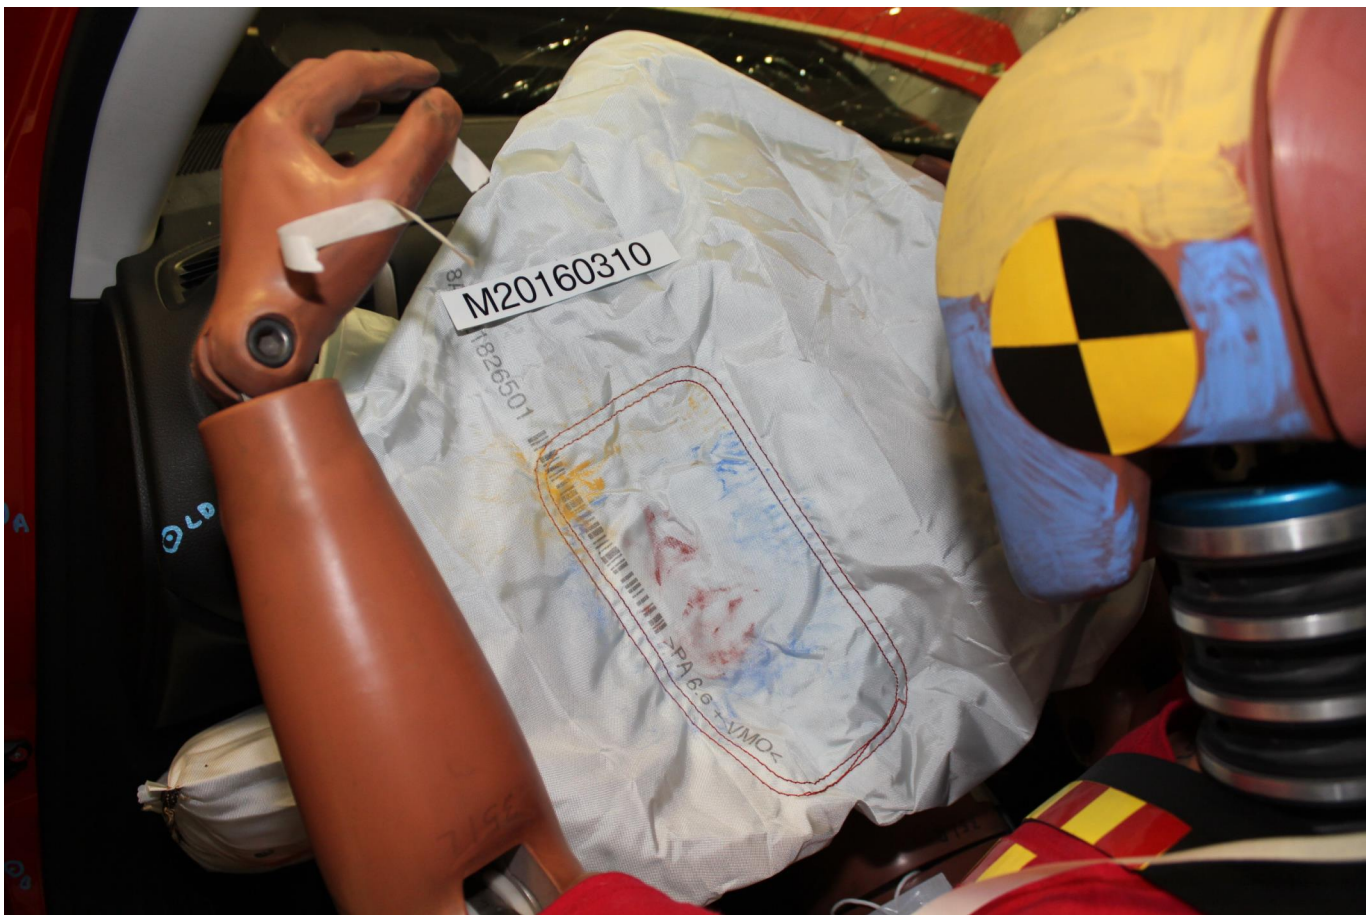
Photo No. 047 - Post-Test Driver Dummy Contact with Airbag

The driver's visible contact points were as follows: The driver's head contacted the airbag. The driver's head also contacted the headrest. The driver's knees contacted the knee airbag. The passenger's visible contact points were as follows: The passenger's head contacted the airbag. The passenger's head also contacted the headrest. The passenger's knees contacted the glove box.

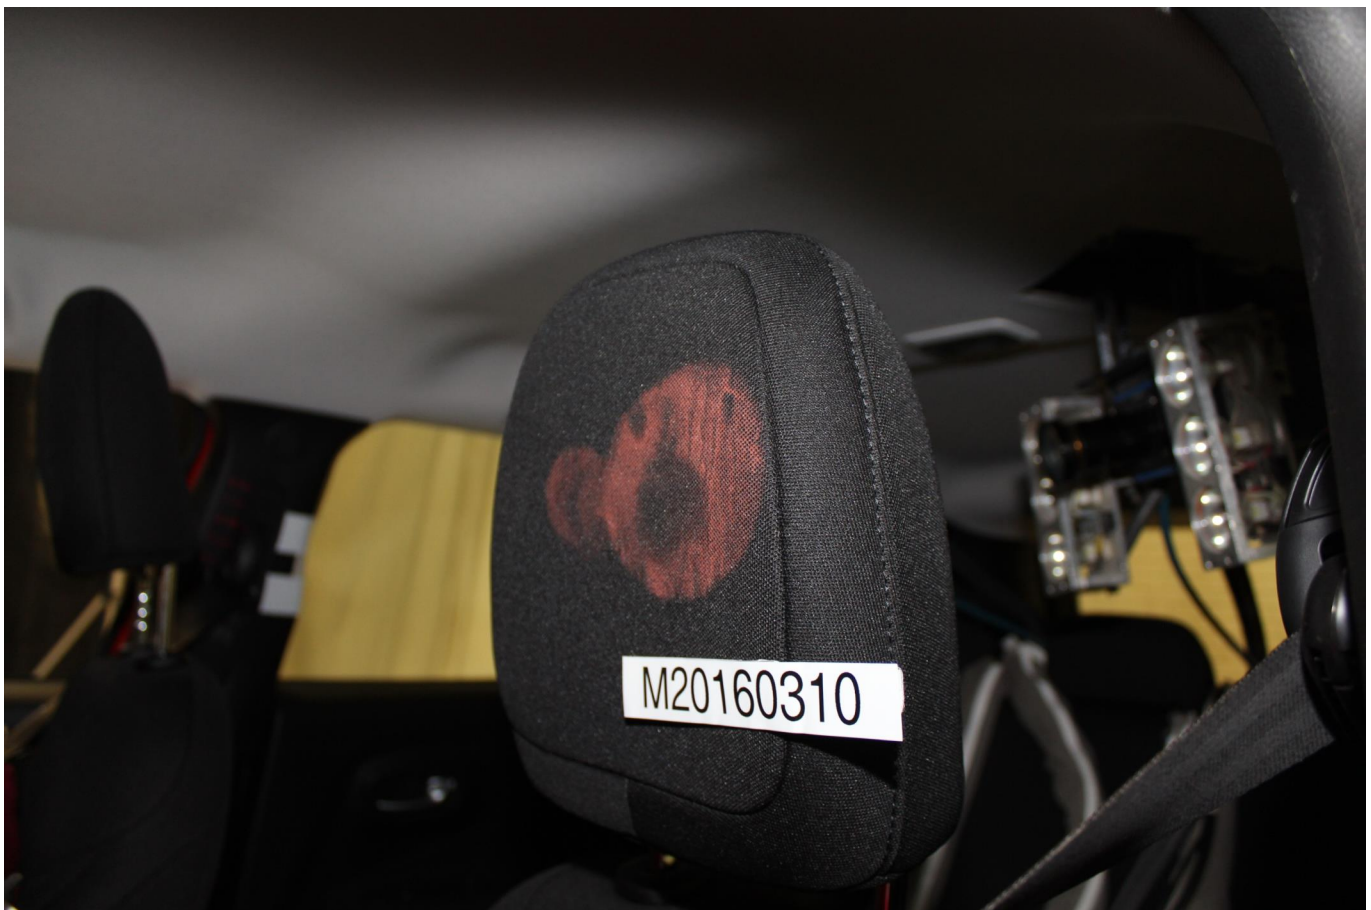
Photo No. 048 - Post-Test Driver Dummy Contact with Headrest

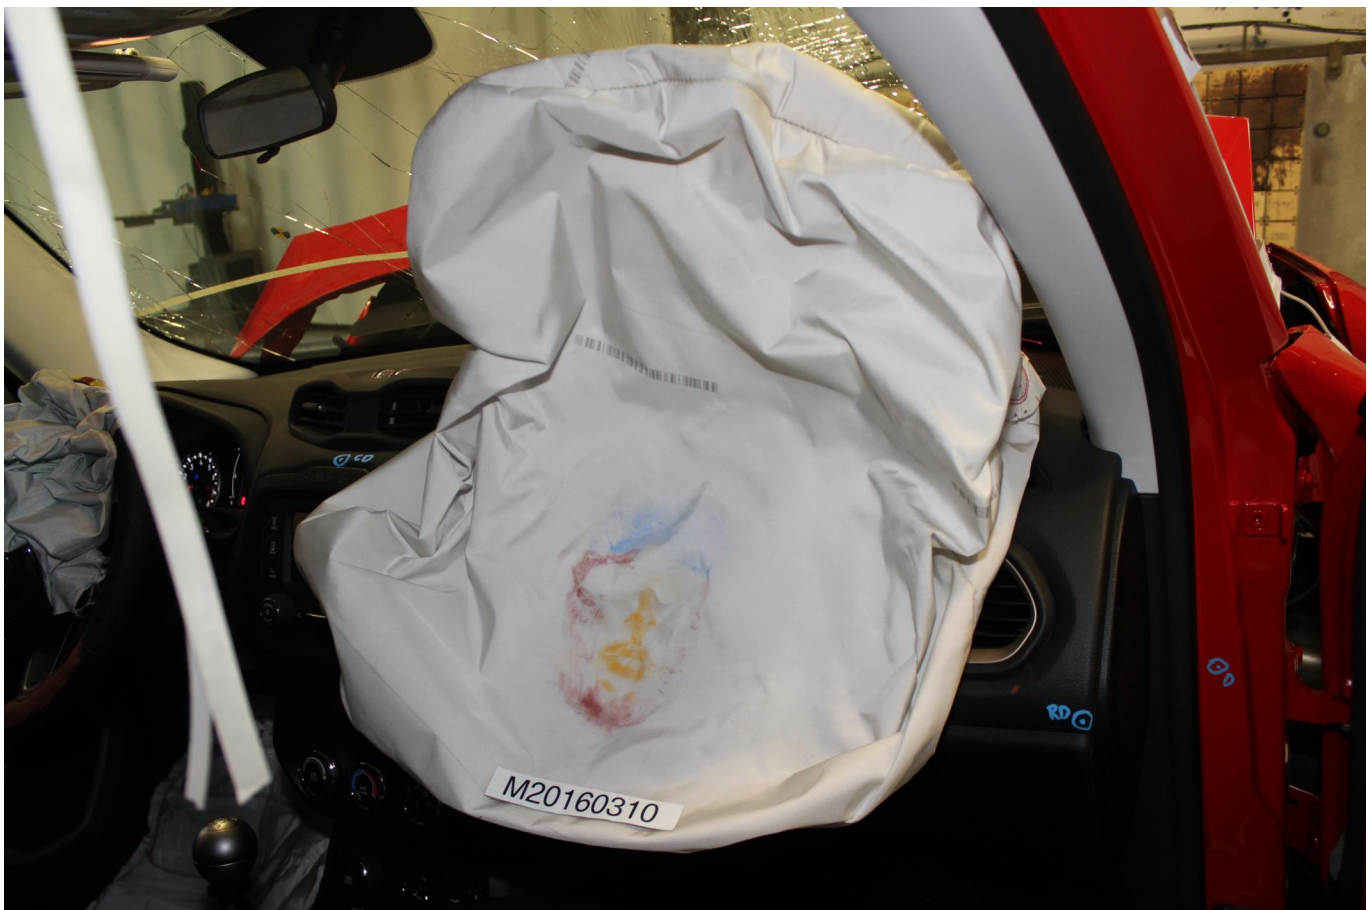
Photo No. 068 - Post-Test Passenger Dummy Contact with Airbag

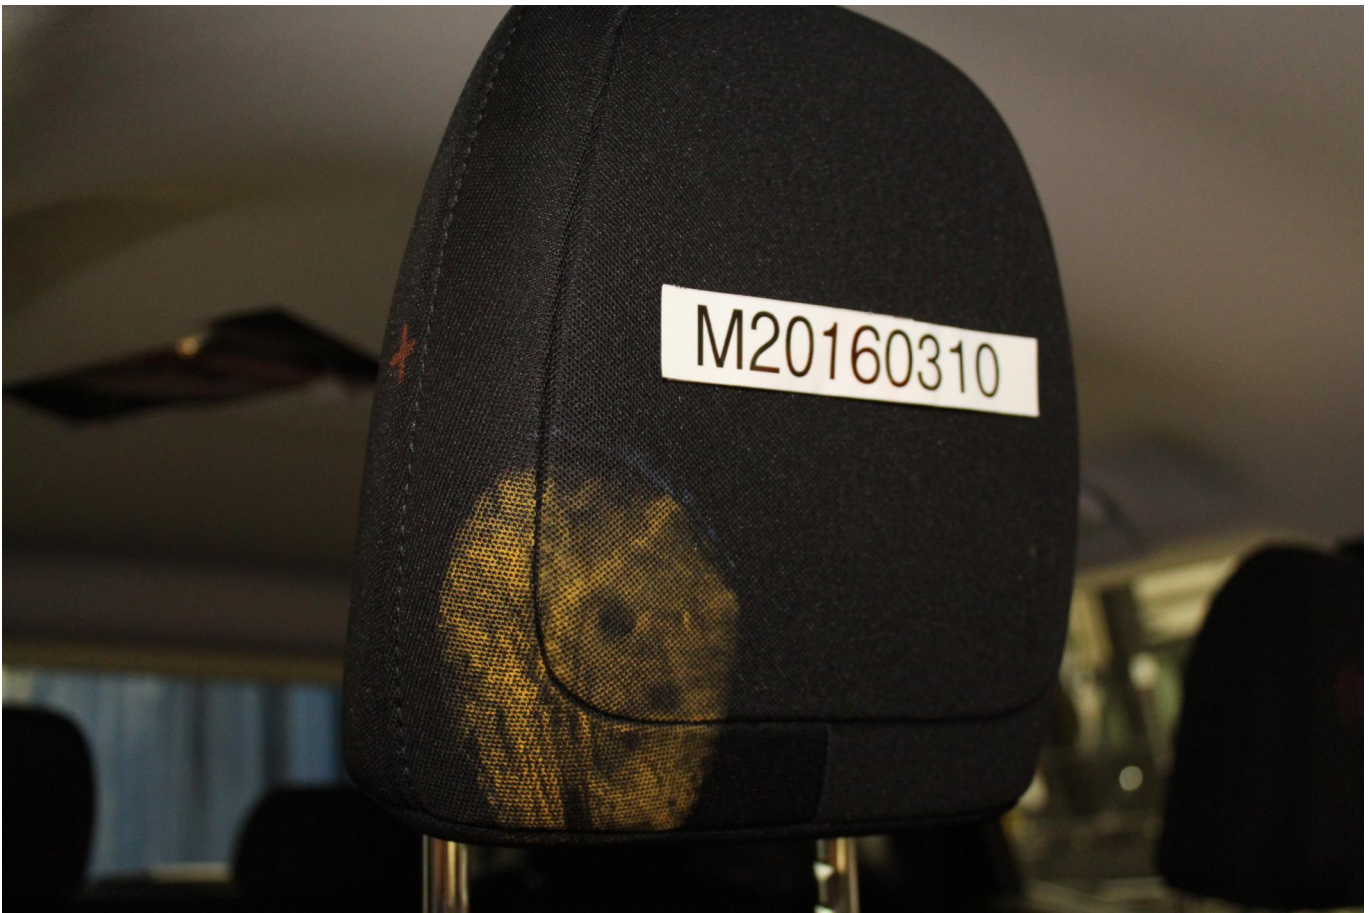
Photo No. 069 - Post-Test Passenger Dummy Contact with Headrest

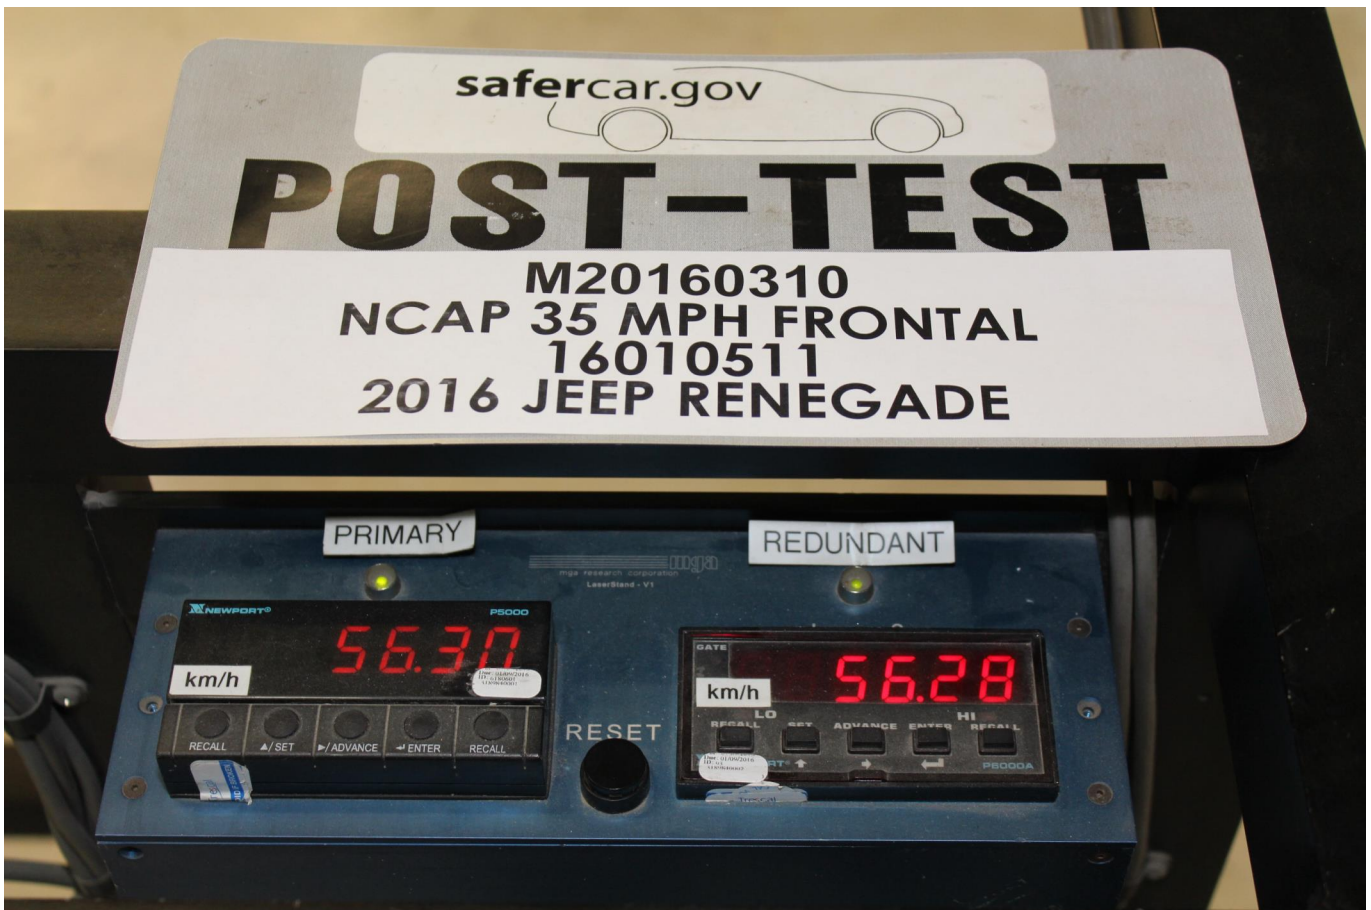
Photo No. 072 - Post-Test Speed Trap Read-Out

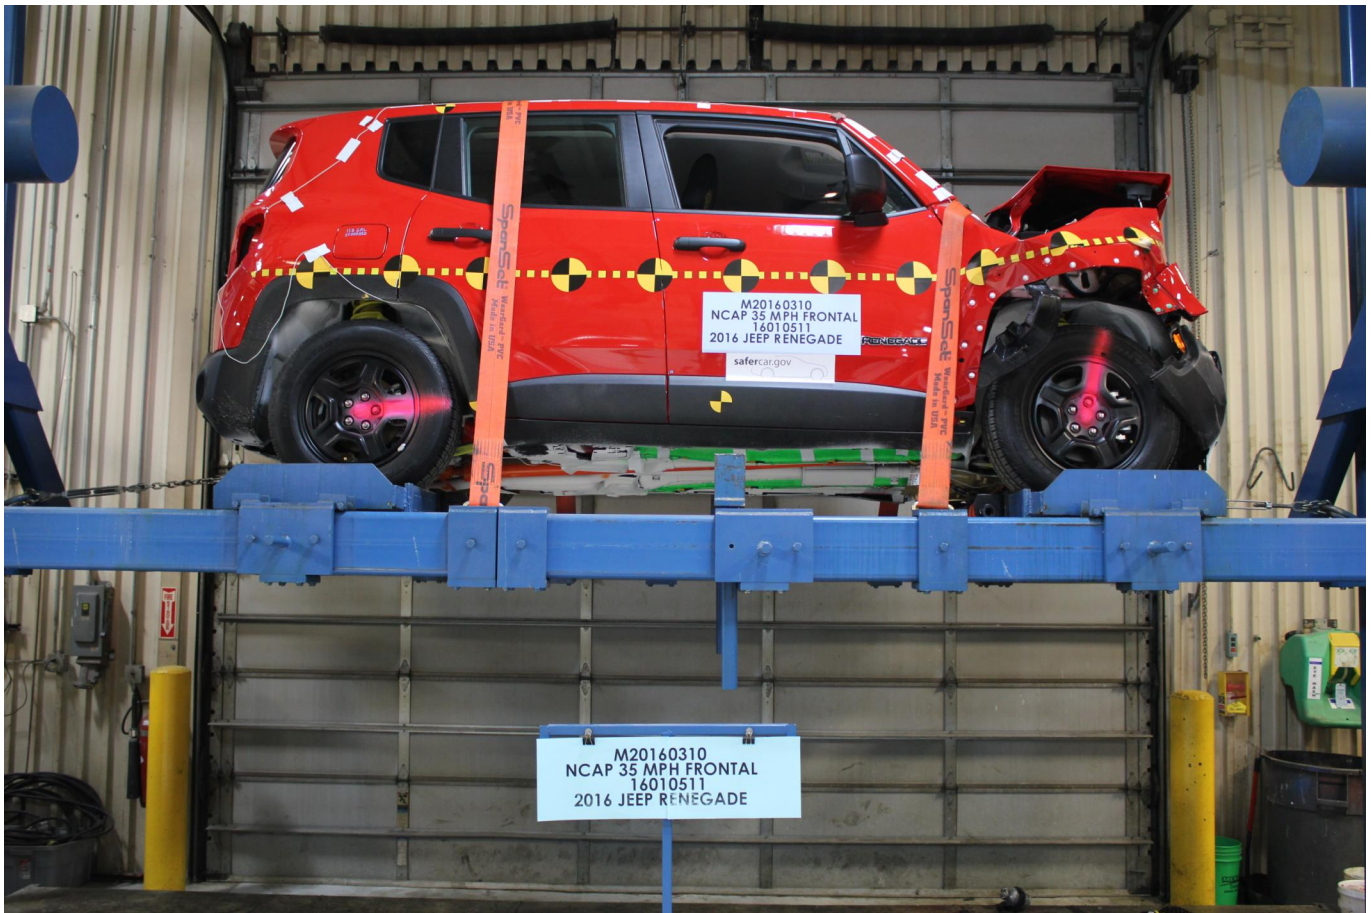
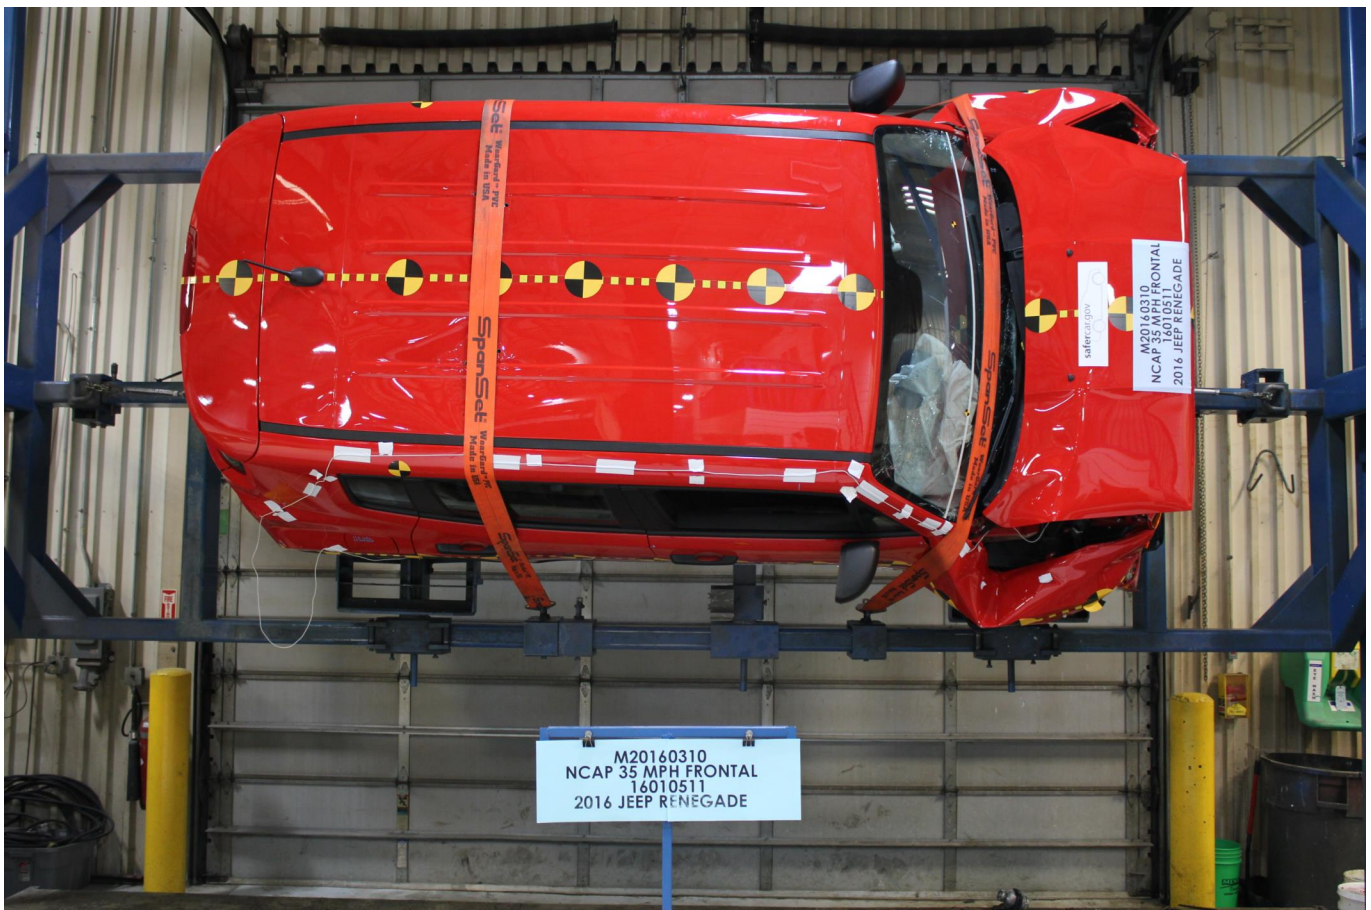
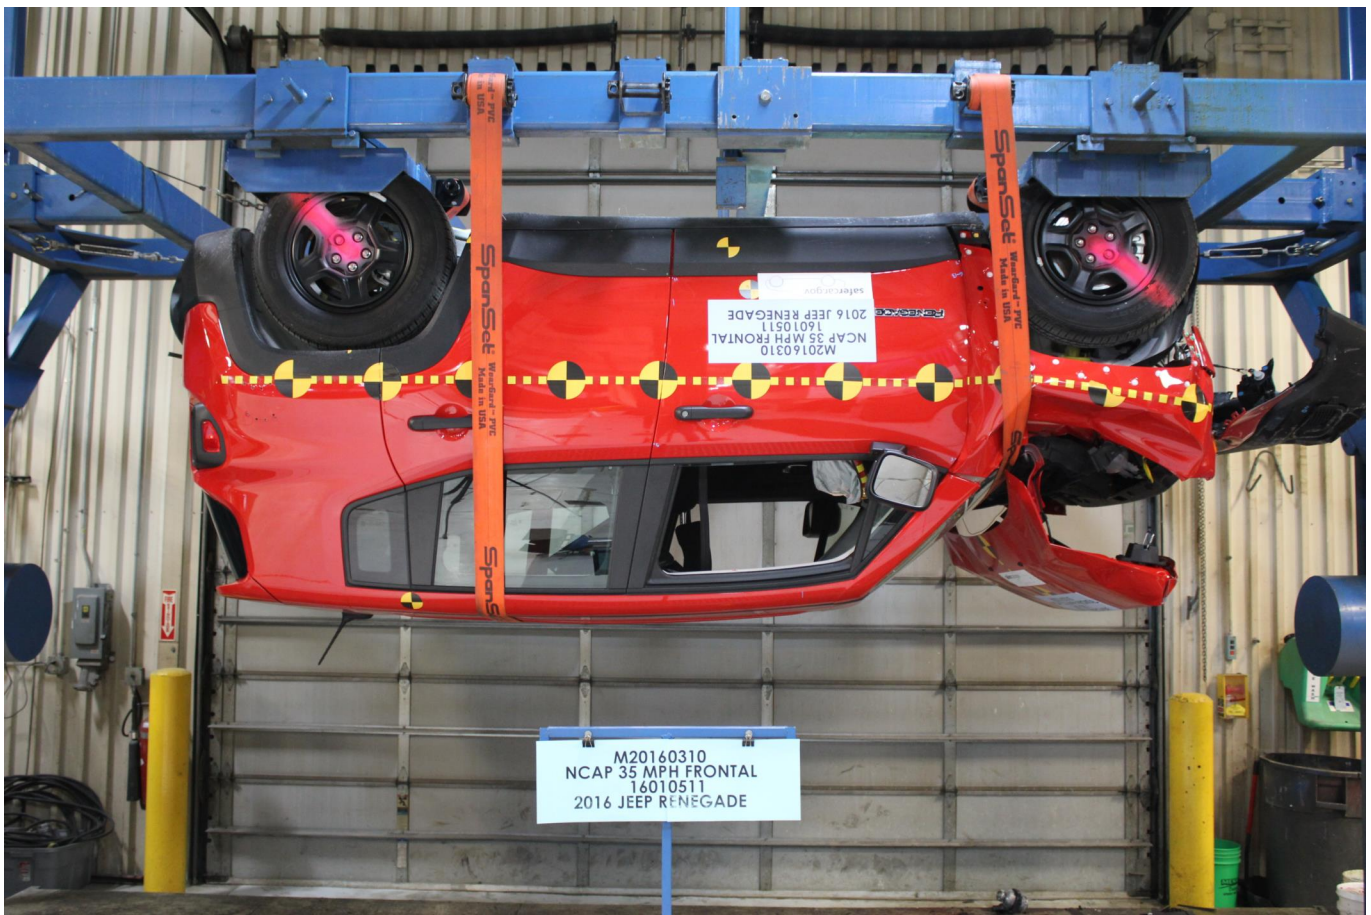
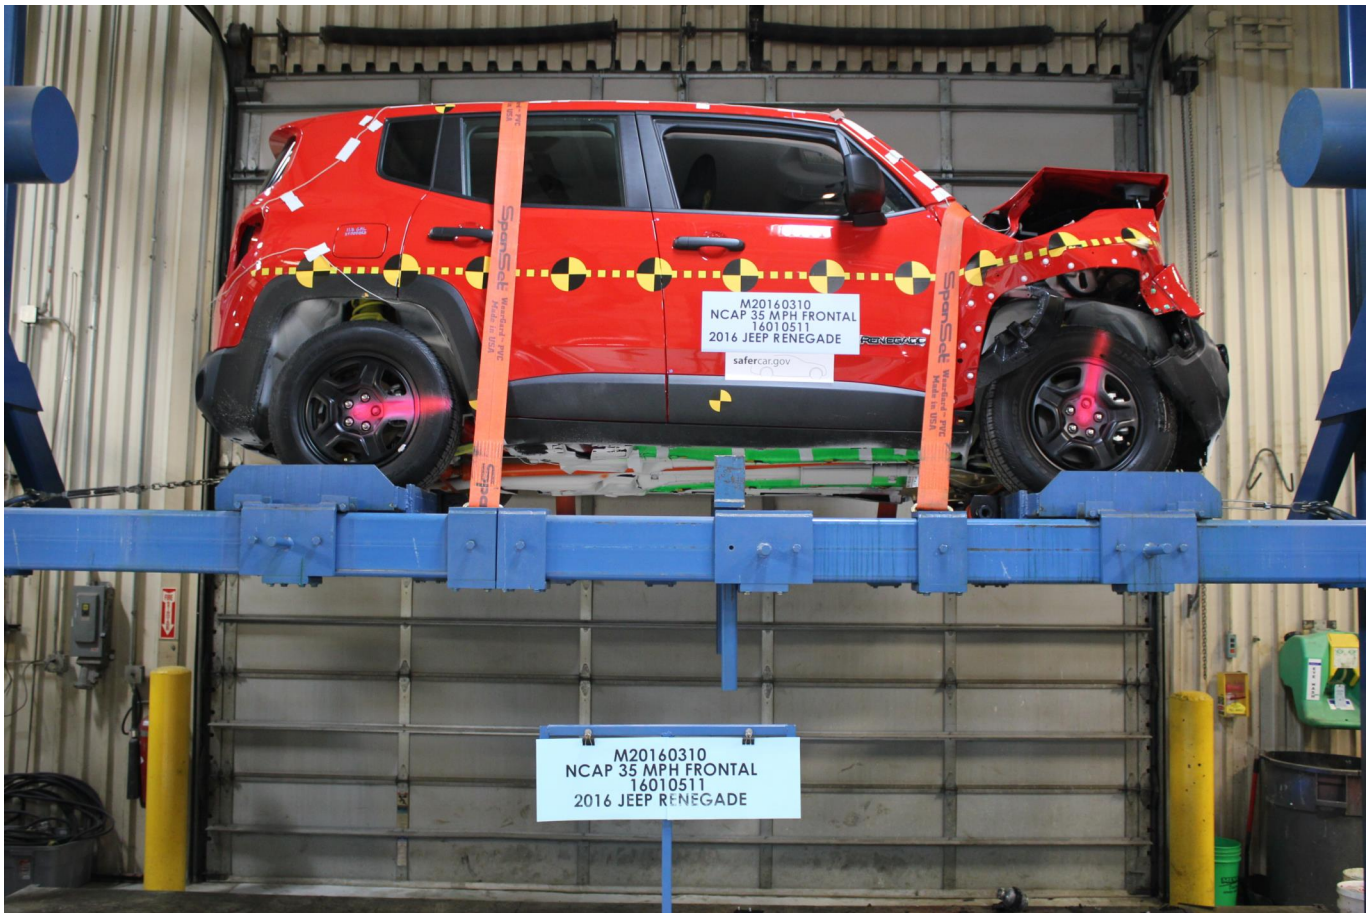
Photo No. 073 - Vehicle at 0 Degree on Static Rollover Device

Photo No. 074 - Vehicle at 90 Degrees on Static Rollover Device

Photo No. 075 - Vehicle at 180 Degrees on Static Rollover Device

Photo No. 076 - Vehicle at 270 Degrees on Static Rollover Device

Photo No. 077 - Vehicle at 360 Degrees on Static Rollover Device
