REPORT NUMBER: SINCAP-MGA-2016-031

**NEW CAR ASSESSMENT PROGRAM (NCAP)
Moving Deformable Barrier Side Impact Test**

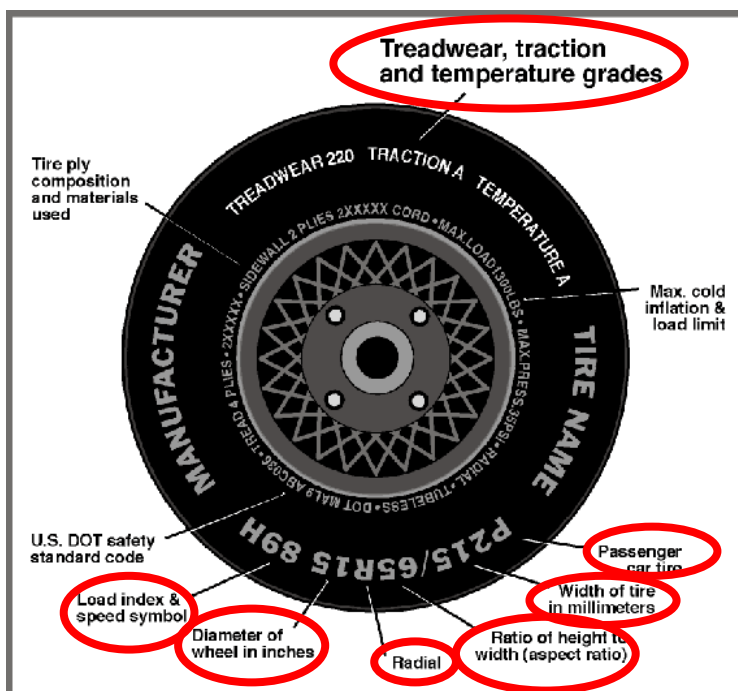
Measured Parameter	Front	Rear
Max. Tire Pressure (kPa)	350	350
Cold Pressure (kPa)	240	240
Recommended Tire Size	215/65R16	215/65R16
Tire Size on Vehicle	215/65R16	215/65R16
Tire Manufacturer	Continental	Continental
Tire Model	Cross Contact	Cross Contact
Treadwear	480	480
Traction	A	A
Temperature Grade	A	A
Tire Plies Sidewall	1 Rayon	1 Rayon
Tire Plies Body	1 Rayon, 2 Steel, 2 Polyamide	1 Rayon, 2 Steel, 2 Polyamide
Load Index/Speed Symbol	98H	98H
Tire Material	Rubber	Rubber
DOT Safety Code Left	HW6V D3PA 3615	HW6V D3PA 3615
DOT Safety Code Right	HW6V D3PA 3615	HW6V D3PA 3615

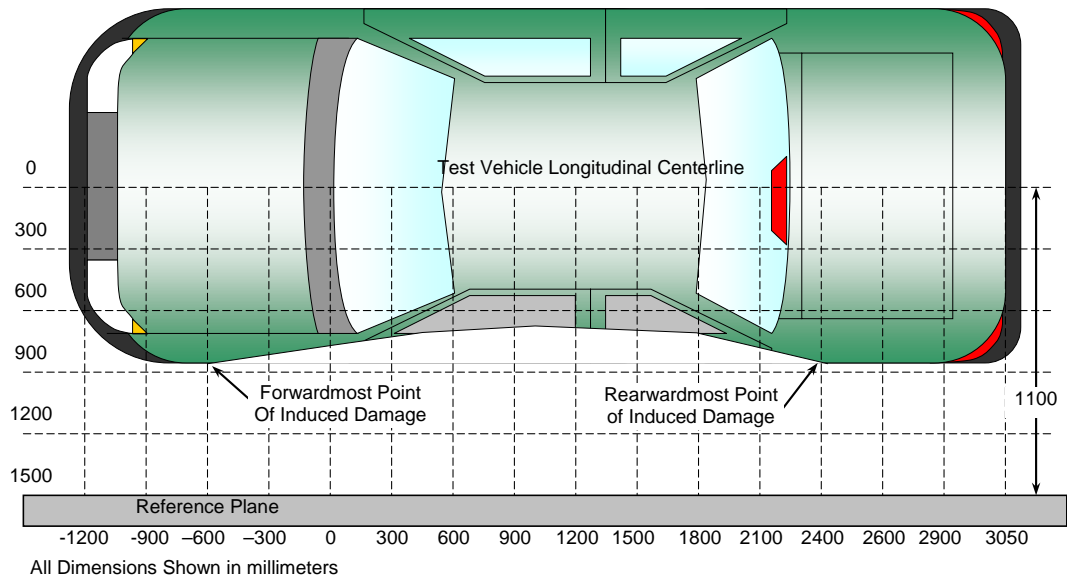
NHTSA No. M20160312
Test Date: 1/6/2016

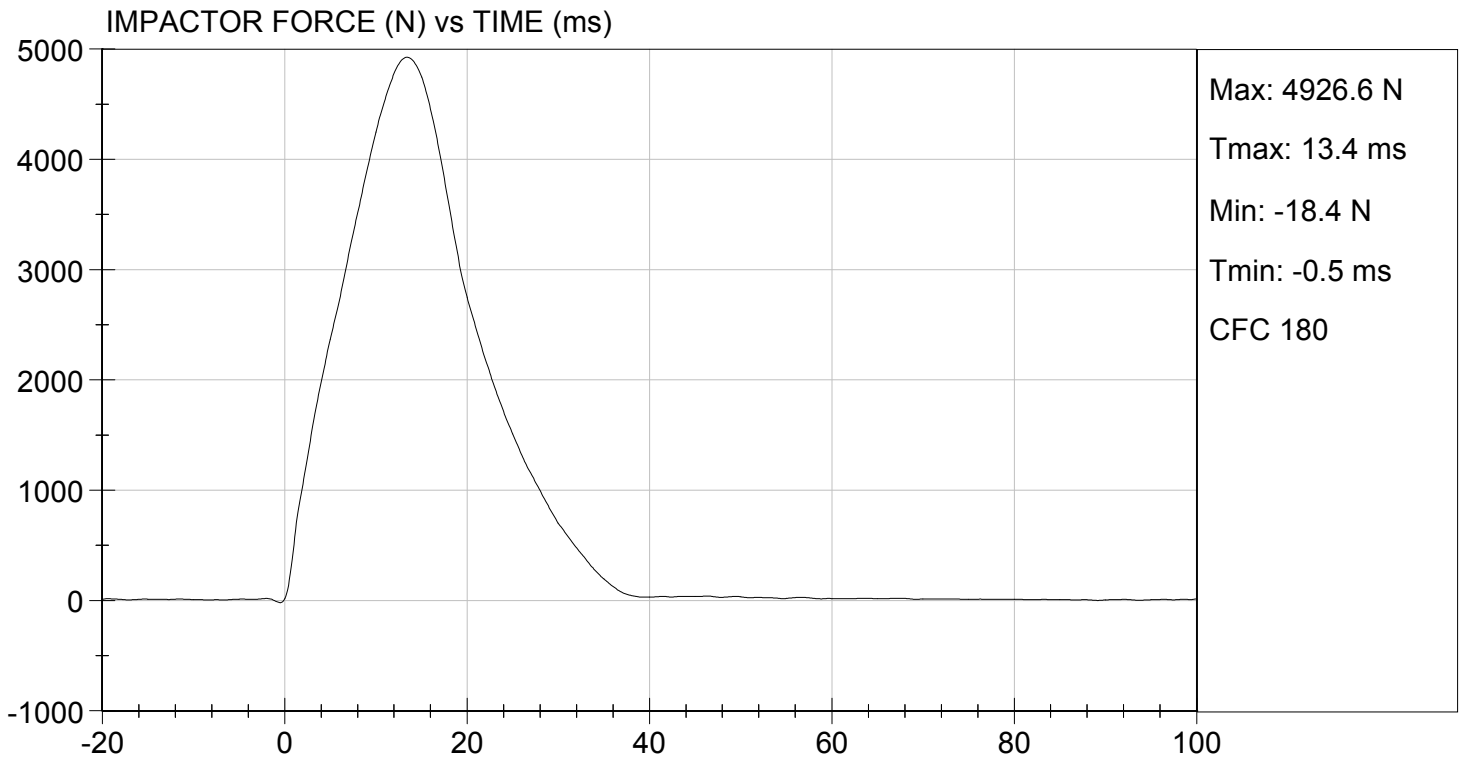
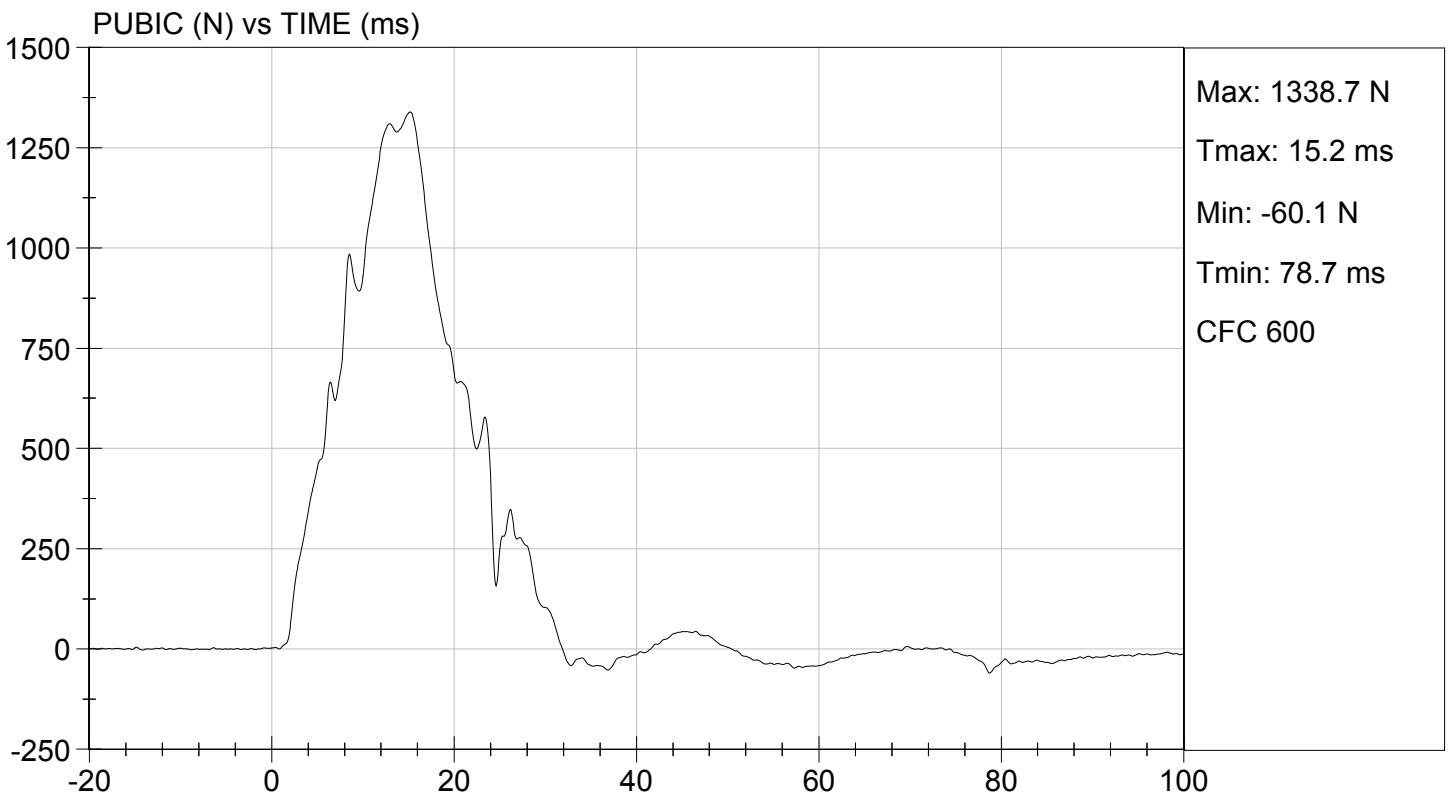
ES-2re External Measurements
SN: 032

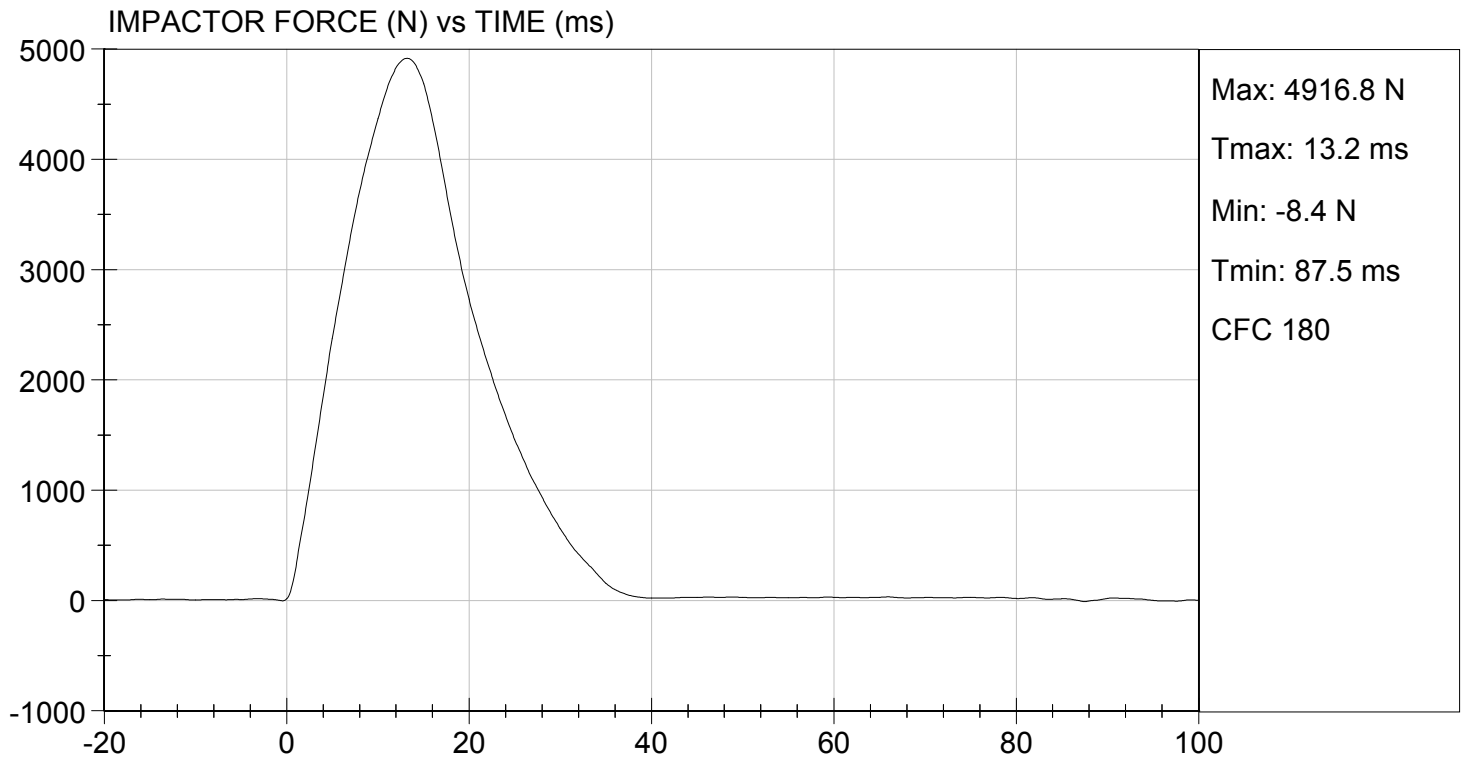
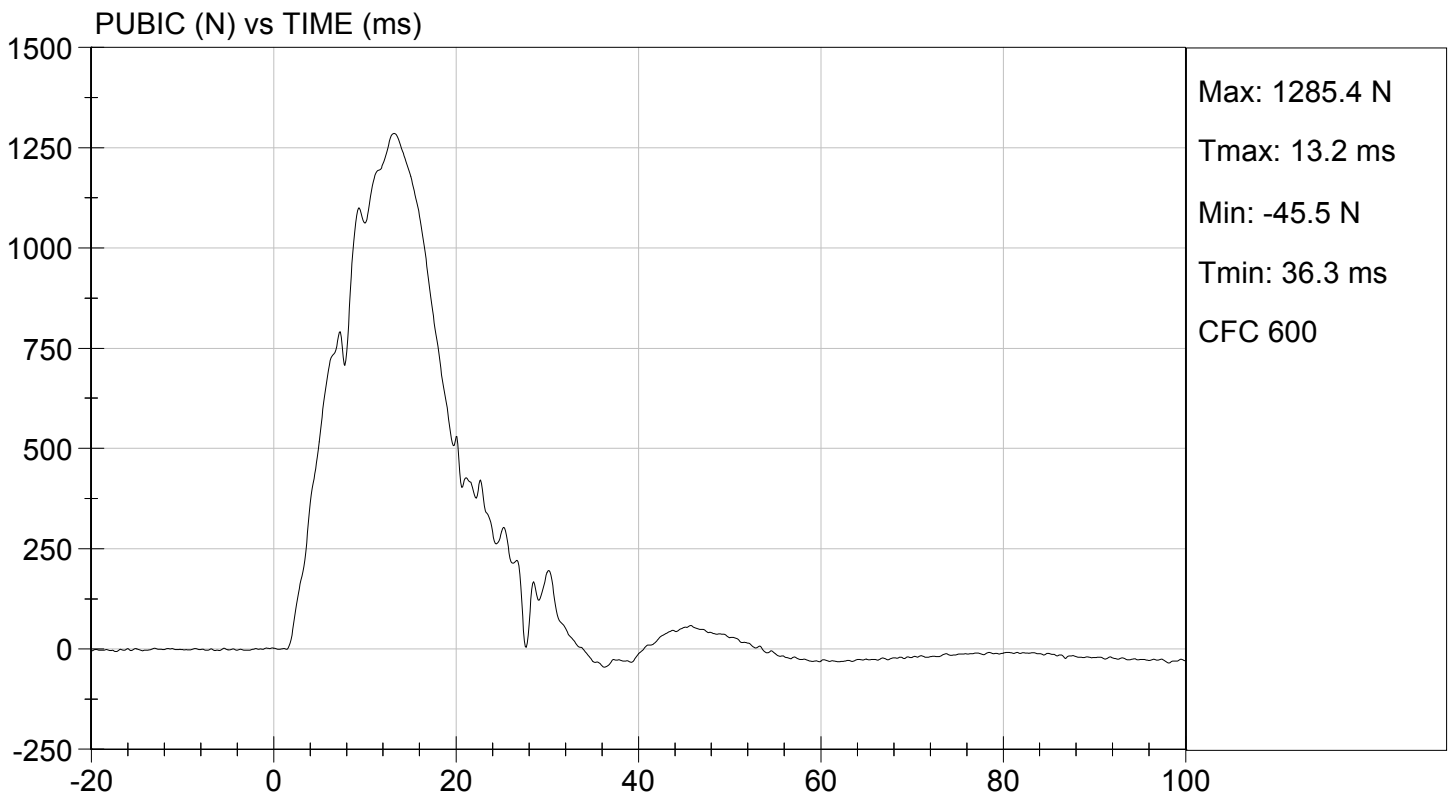
SID-IIsD External Measurements
SN: 296

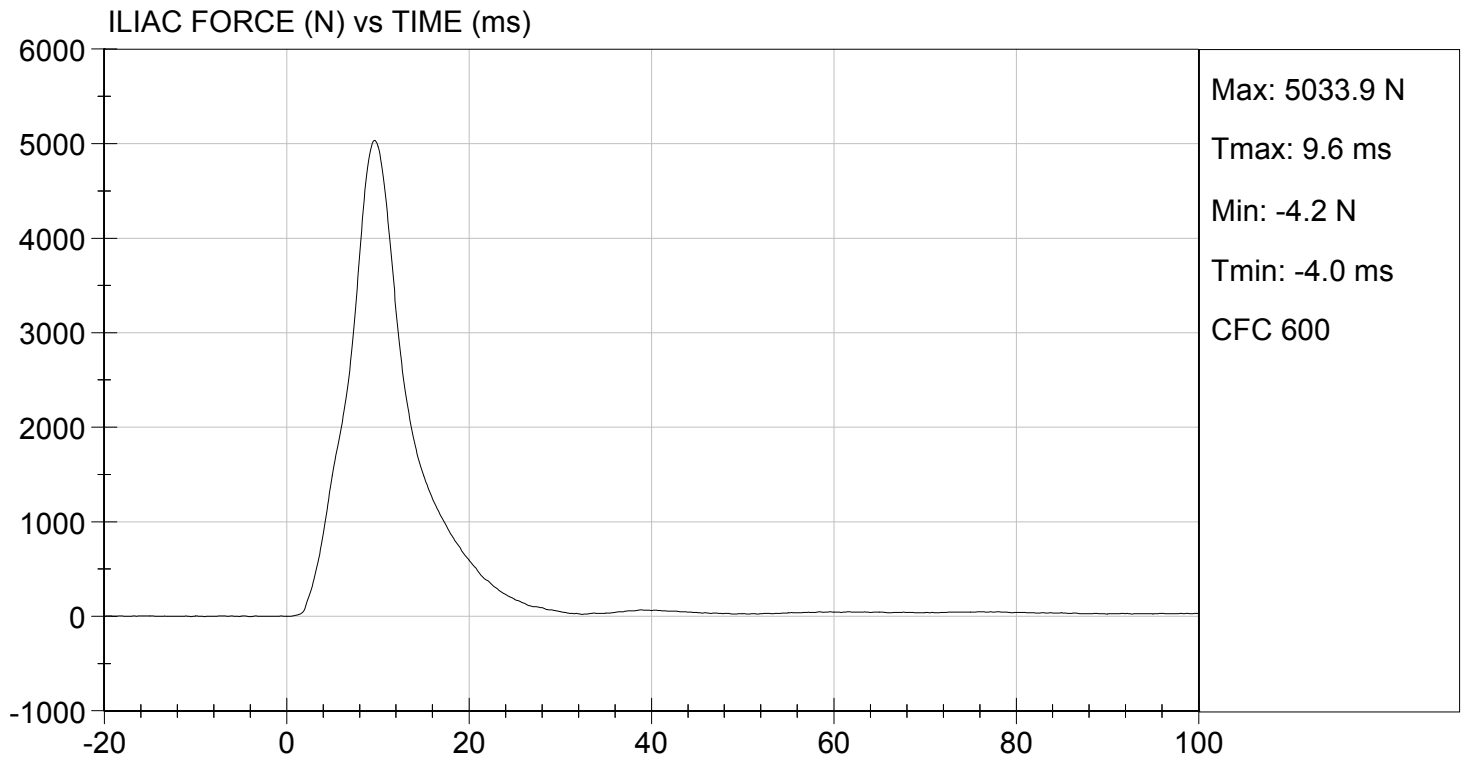
SID-IIsD External Measurements
SN: 296
