**REPORT NUMBER: SPNCAP-KAR-16-012  
NEW CAR ASSESSMENT PROGRAM (NCAP)  
SIDE IMPACT POLE TEST**

**NISSAN MOTOR CO.  
2016 NISSAN VERSA NOTE 5-DOOR HATCHBACK**

**NHTSA No: M20165207**

**FINAL REPORT**

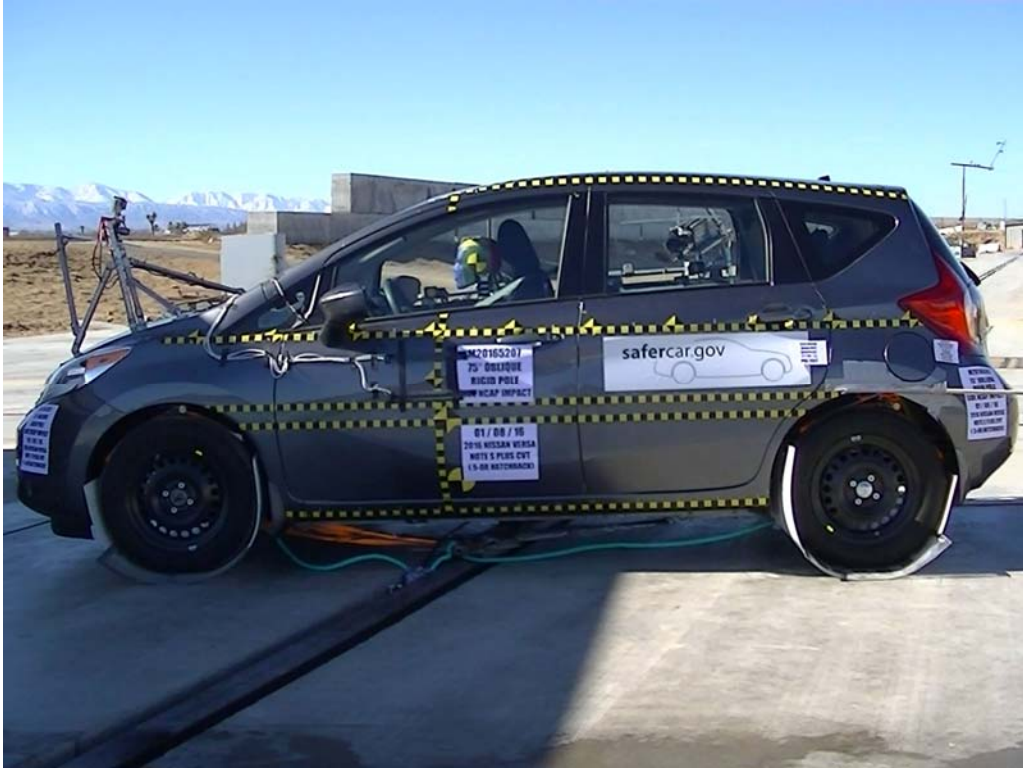
FIGURE 6. Post-Test Left Front  $\frac{3}{4}$  View of Test Vehicle

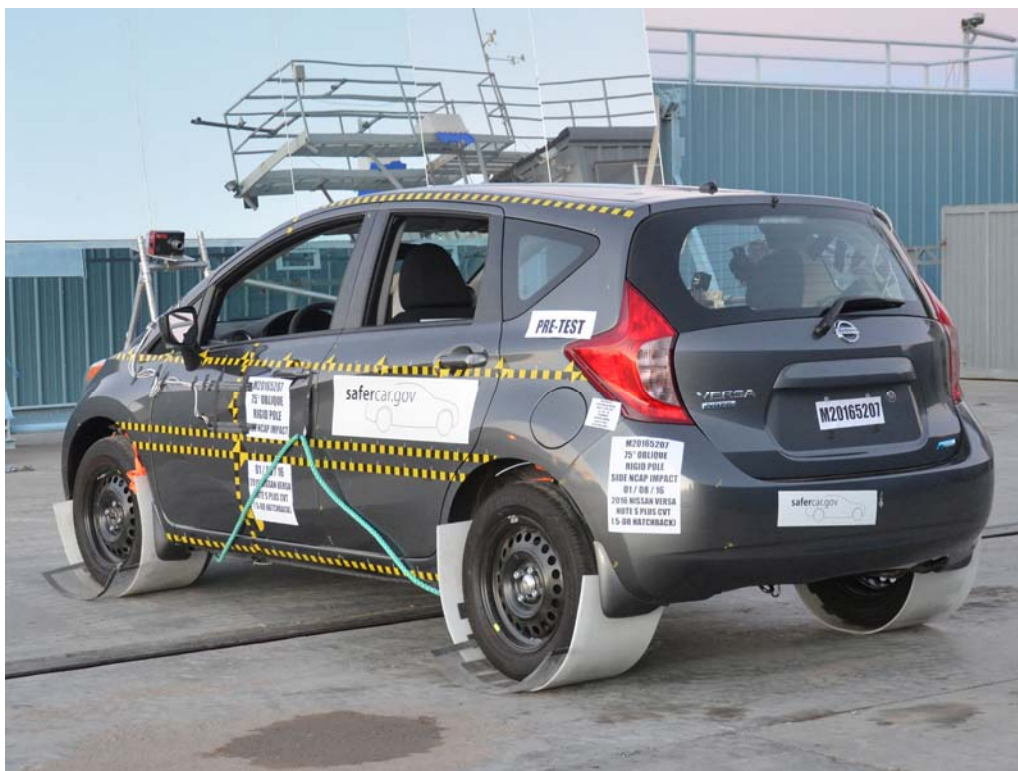
FIGURE 8. Post-Test Left Side View of Test Vehicle

Both the front and rear doors on the struck side of the vehicle were jammed shut while remaining closed and latched. The windshield and front driver window broke as a result of the impact. There was no separation at the hinges or latches. Both doors on the non-struck side remained closed and latched. There were no ATD values that exceeded limits.

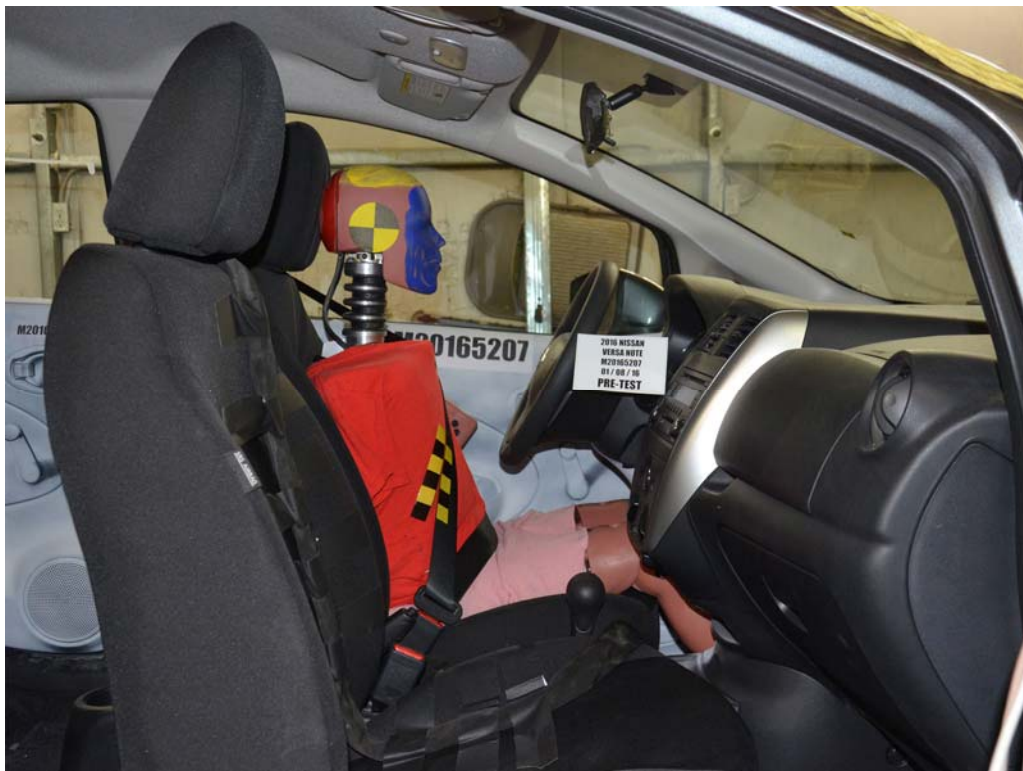
FIGURE 41. Post-Test Dummy and Door Clearance View

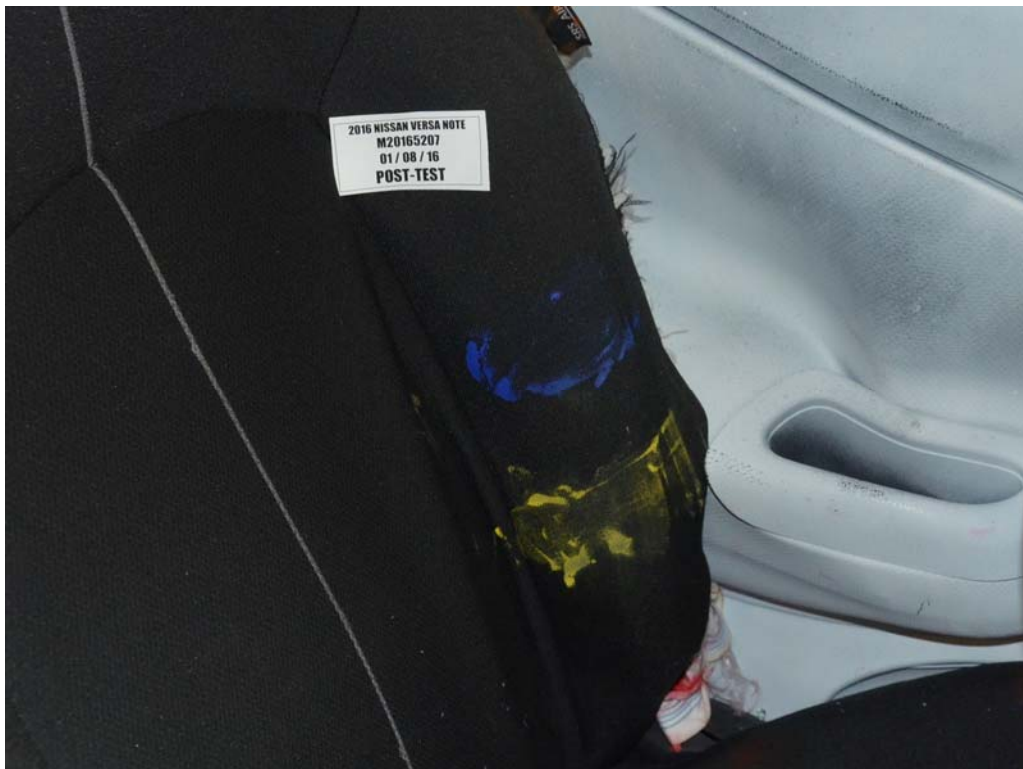
FIGURE 47. Post-Test Dummy Close-Up Head Contact With Side Airbag View

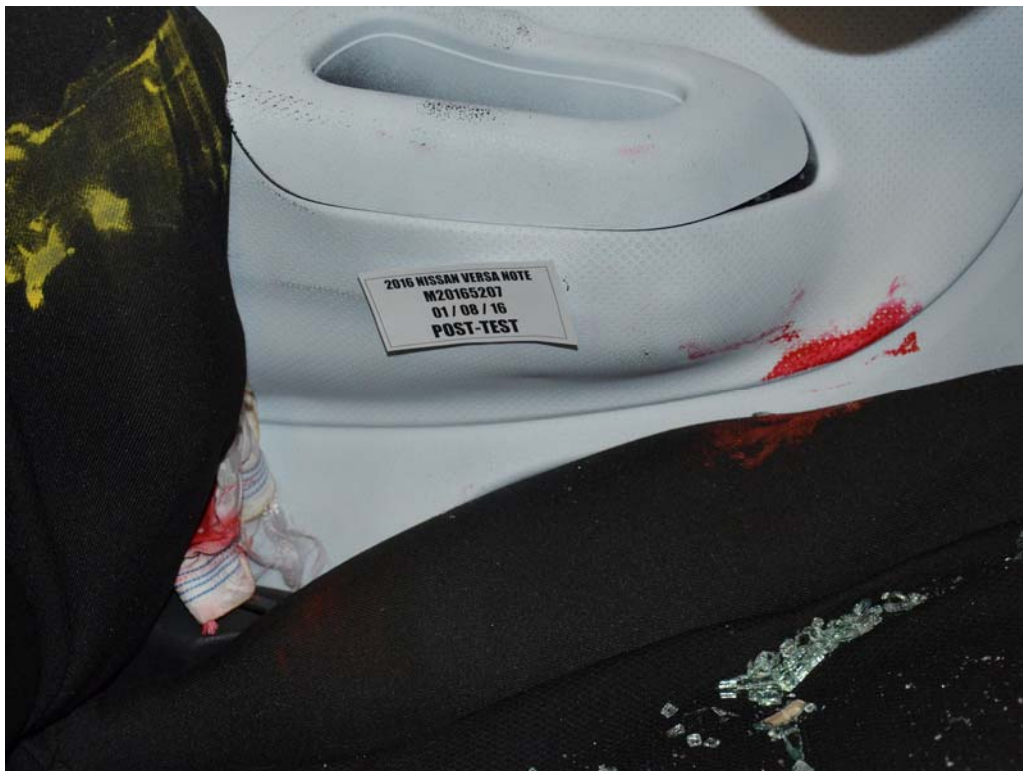
FIGURE 49. Post-Test Dummy Close-Up Torso Contact With Side Airbag View

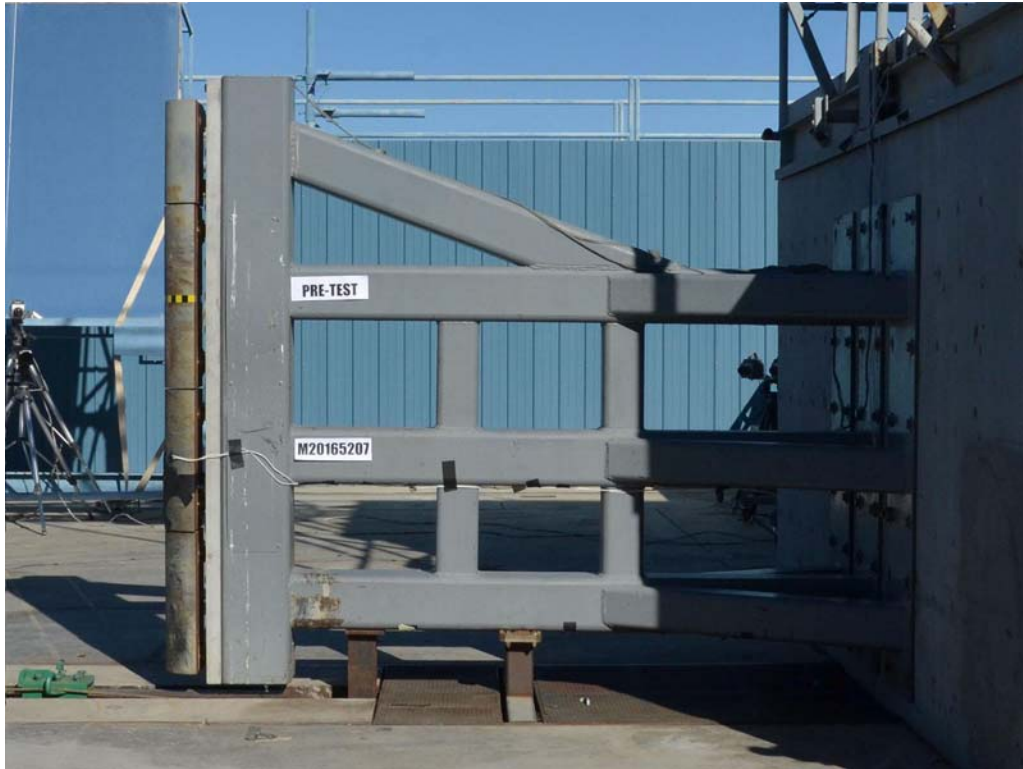
FIGURE 58. Post-Test Pole Barrier Front View
