**REPORT NUMBER: SPNCAP-MGA-2016-033**

**NEW CAR ASSESSMENT PROGRAM (NCAP)  
Side Impact Pole Test**

**VOLKSWAGEN GROUP OF AMERICA  
2016 Volkswagen Passat 1.8T S 4-Door Sedan  
NHTSA No.: O20165801**

**MGA RESEARCH CORPORATION  
5000 Warren Road  
Burlington, WI 53105**

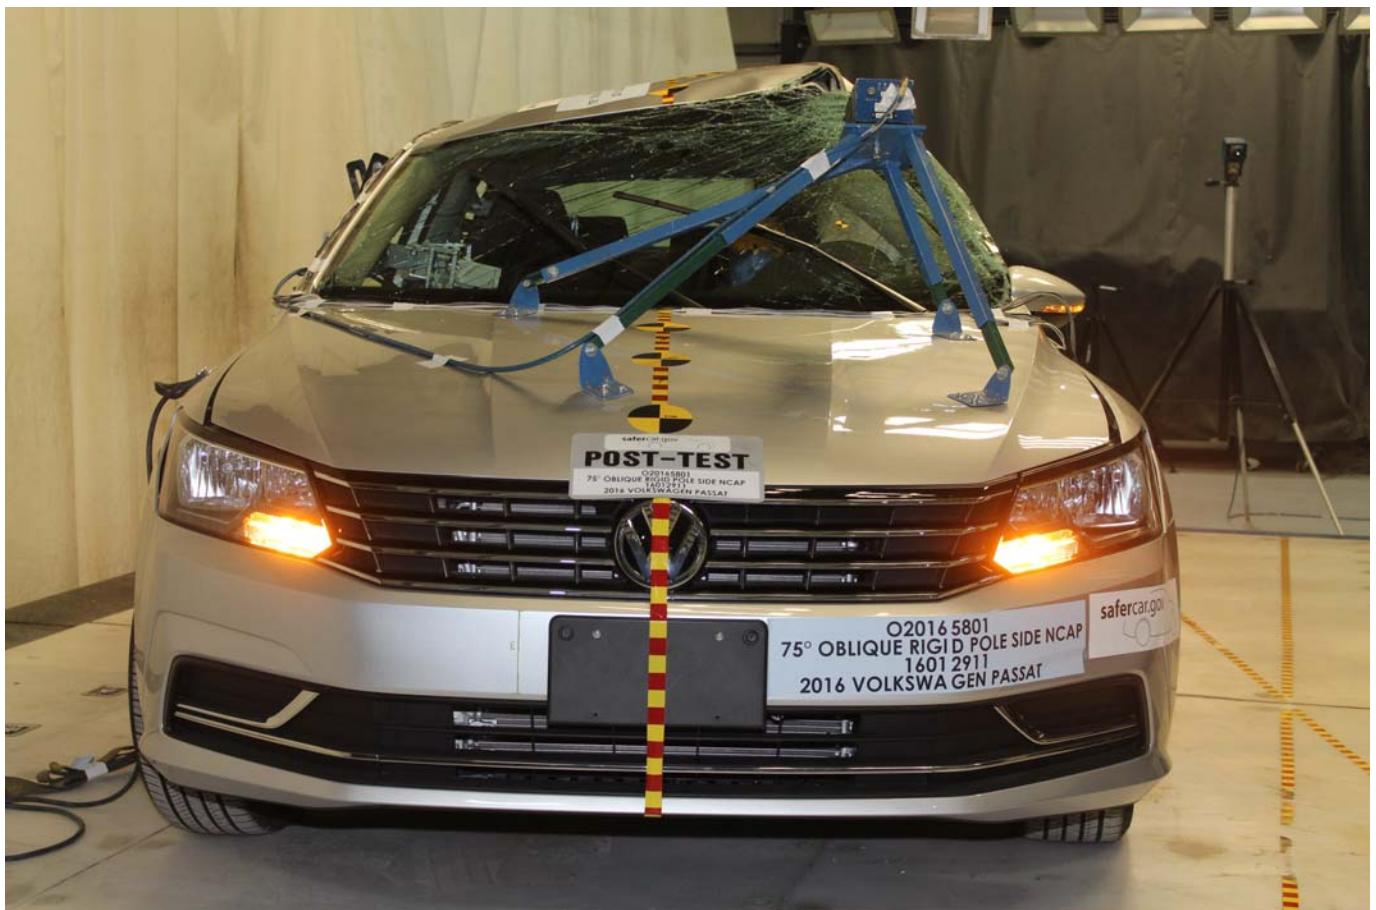
Photo No. 004 - Post-Test Frontal View of Test Vehicle

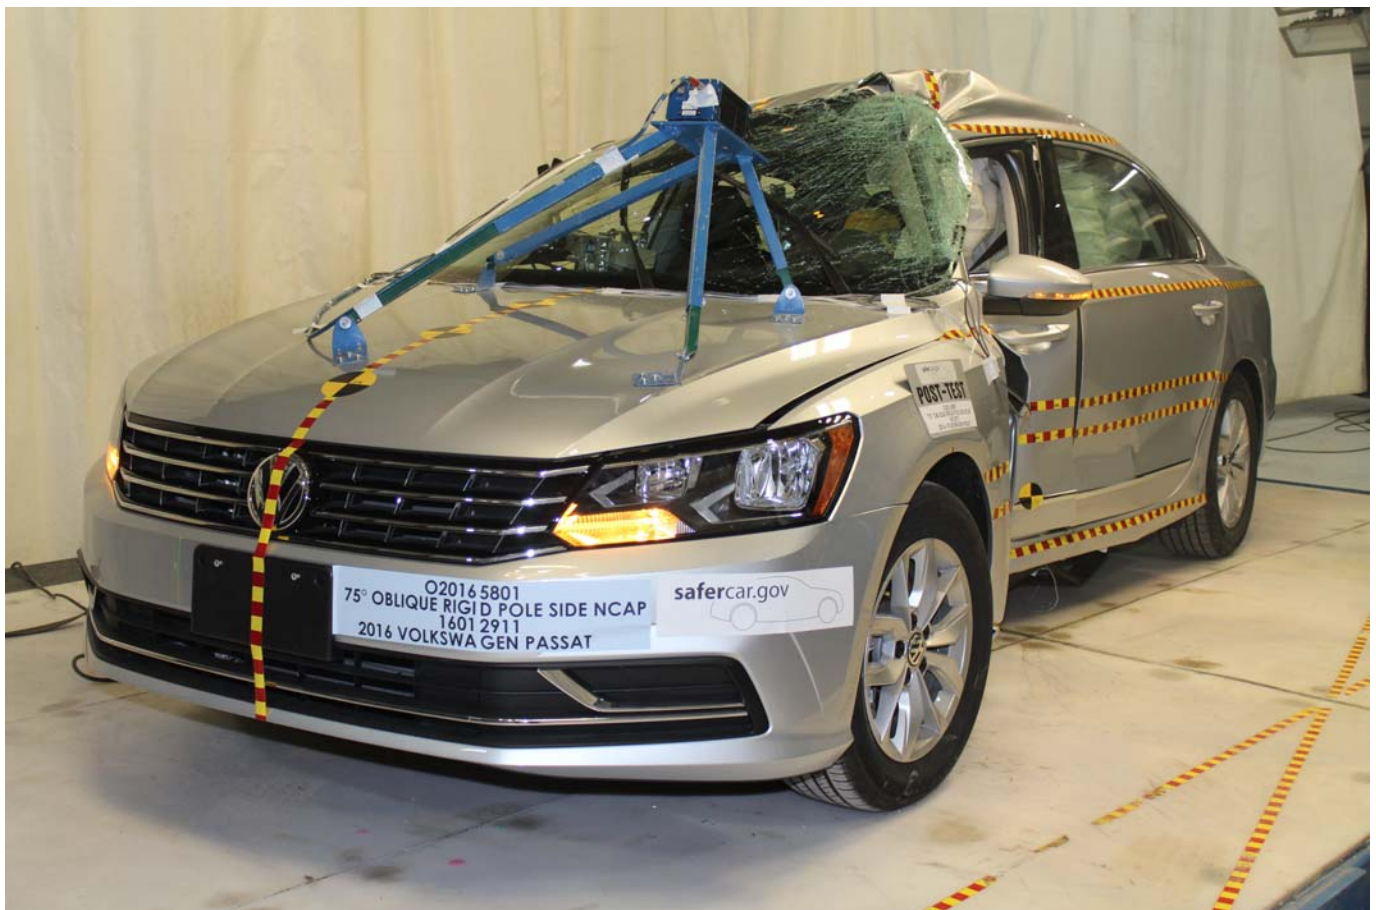
Photo No. 006 - Post-Test Left Front  $\frac{3}{4}$  View of Test Vehicle

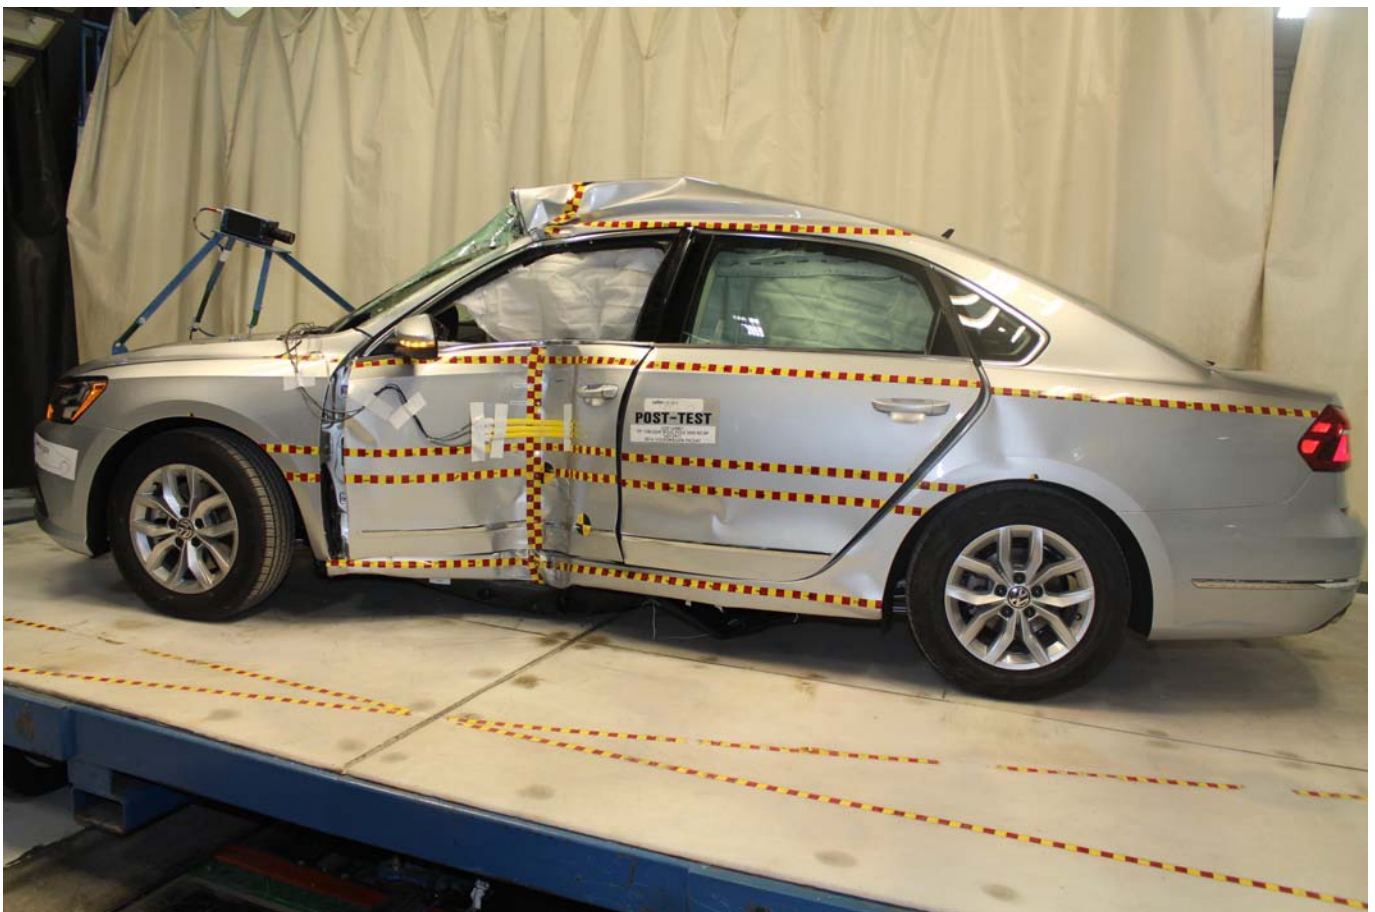
Photo No. 008 - Post-Test Left Side View of Test Vehicle

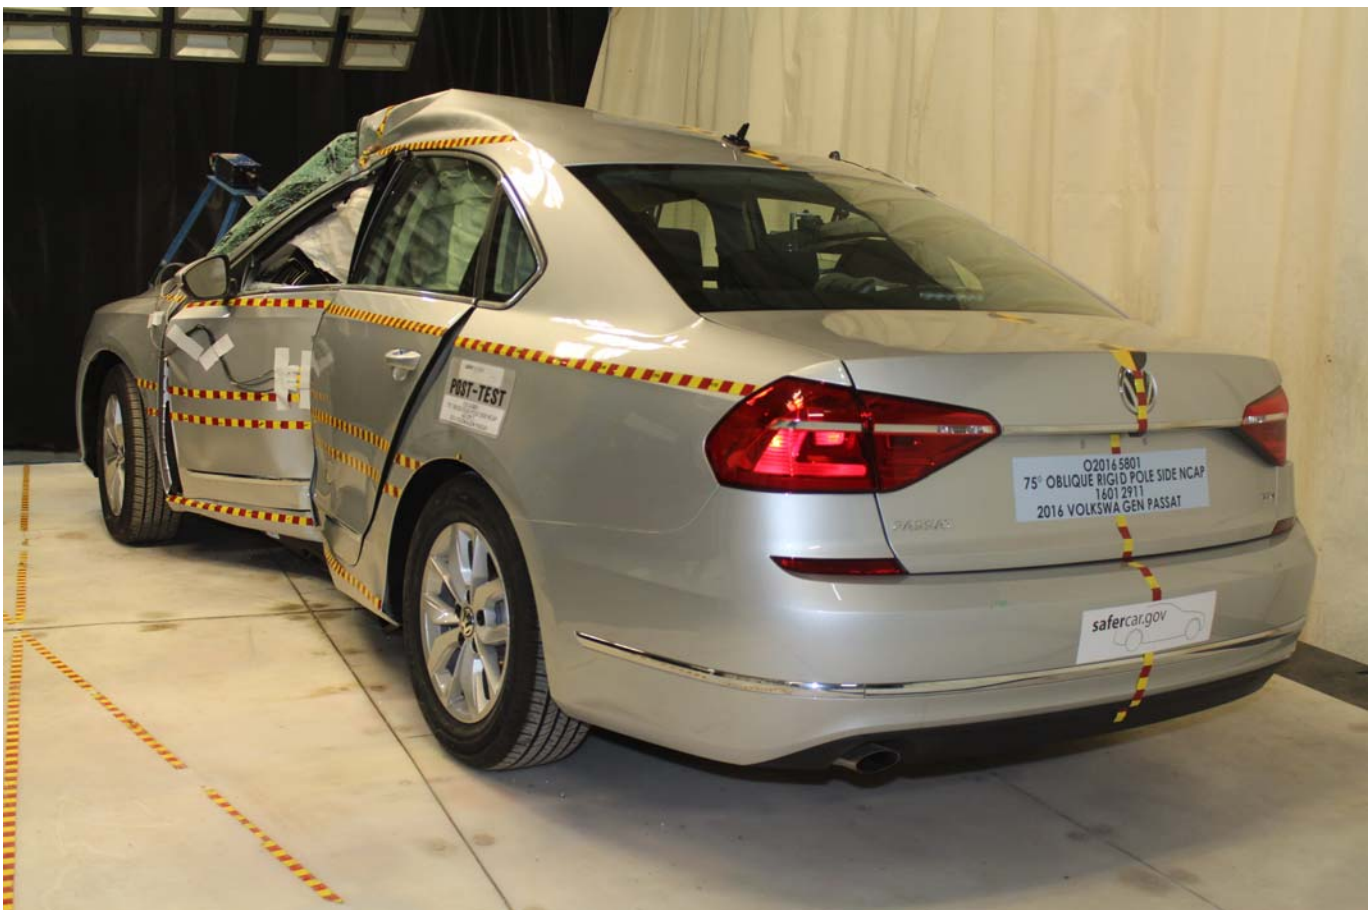
Photo No. 010 - Post-Test Left Rear  $\frac{3}{4}$  View of Test Vehicle

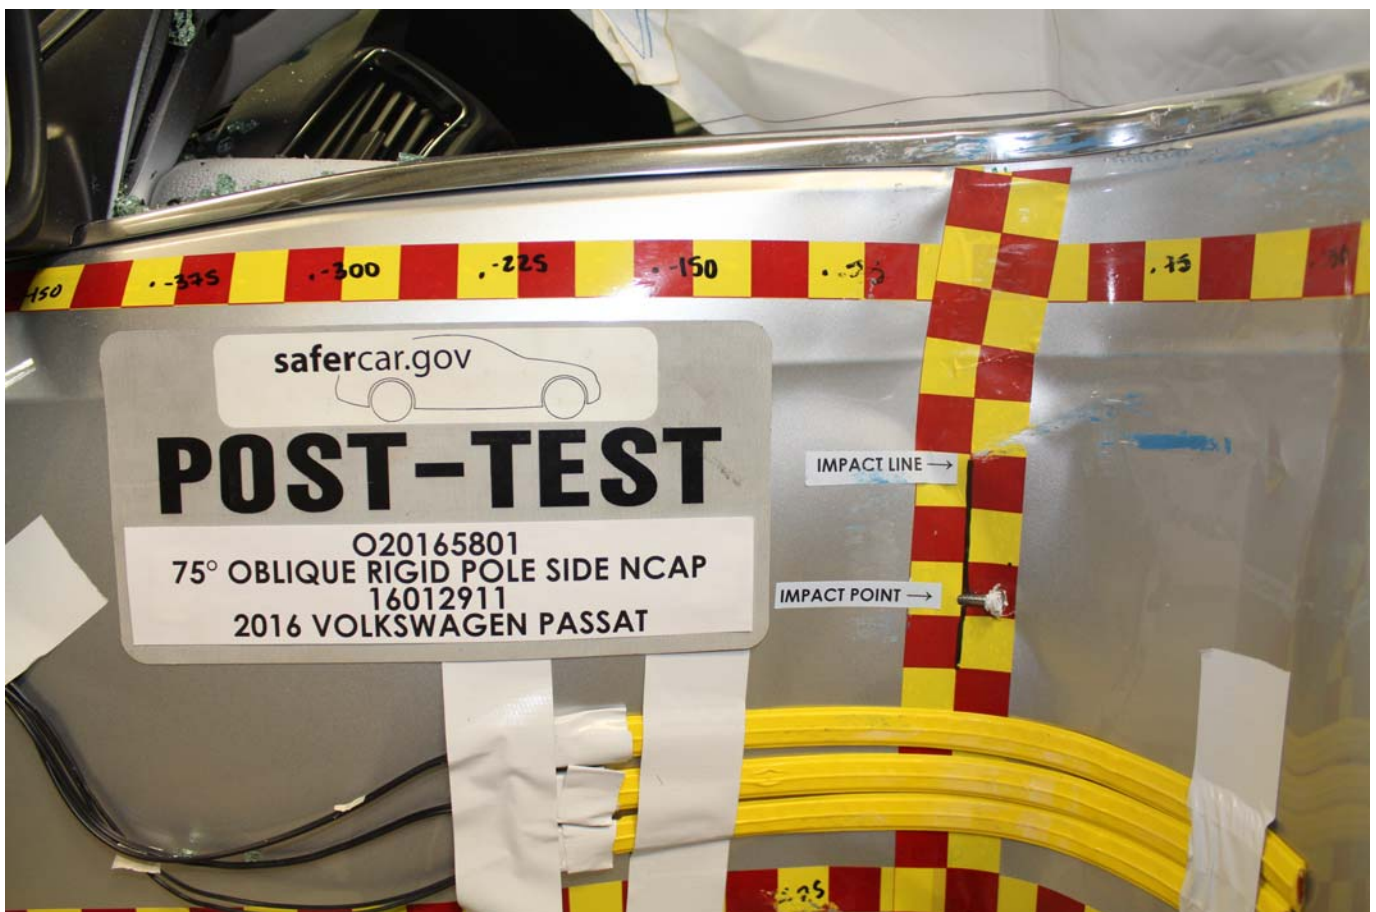
Photo No. 020 - Post-Test Close-Up View of Impact Point Target Showing Impact Location

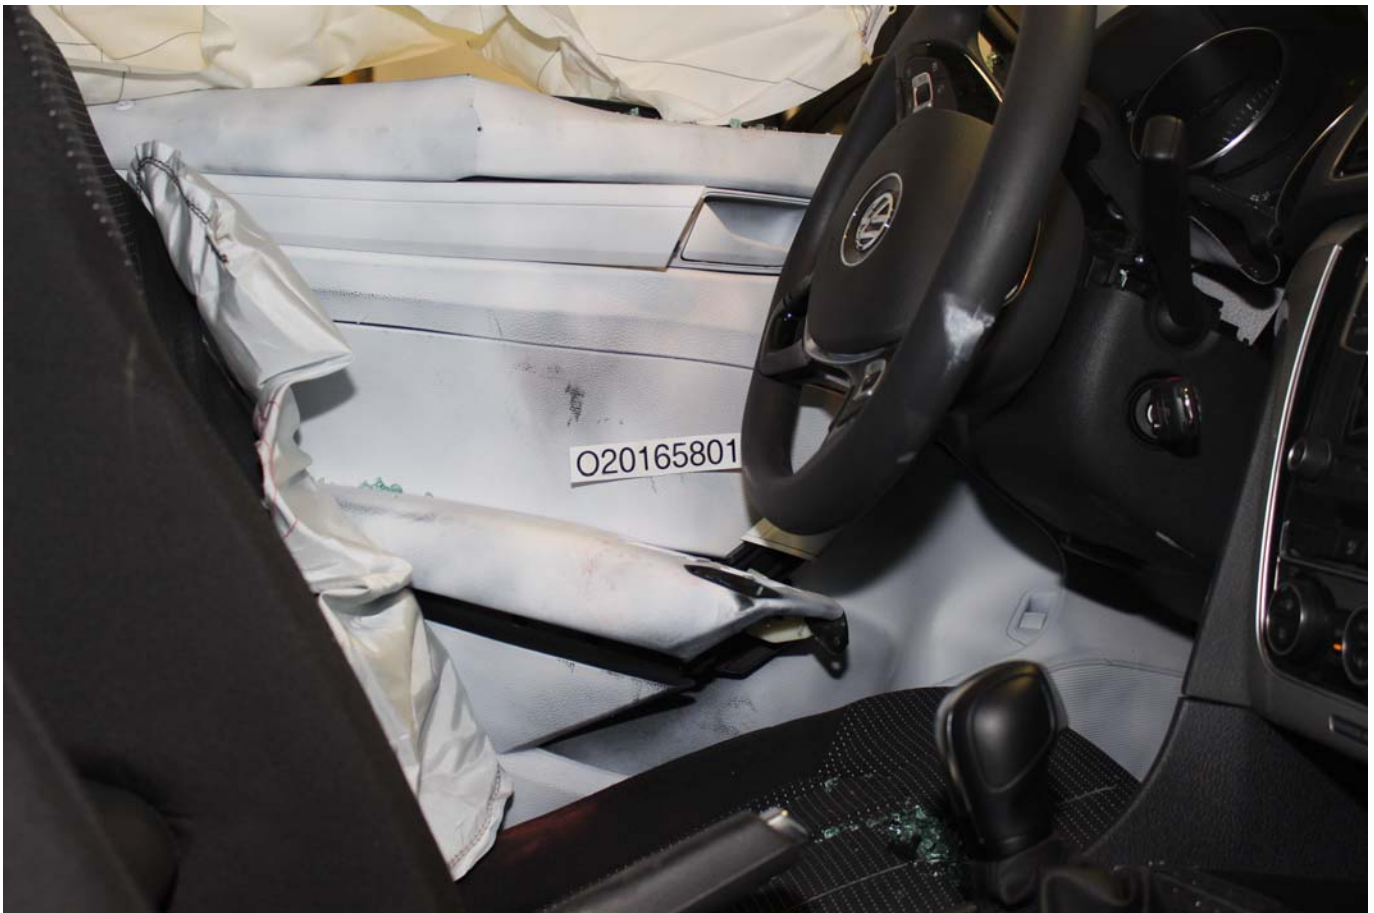
Photo No. 045 - Post-Test Inner Door Panel View Showing Dummy Contact Location

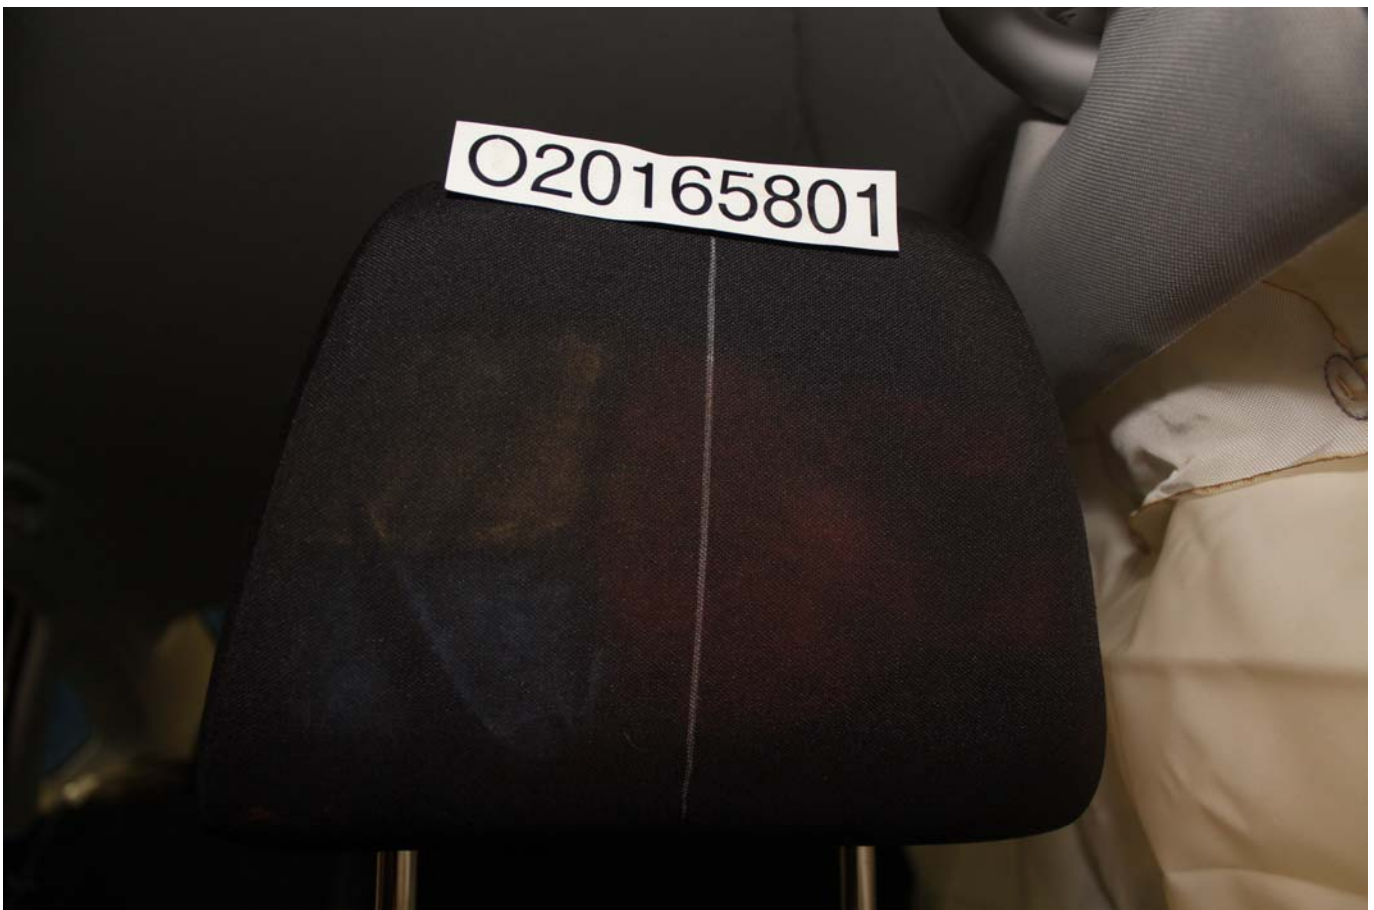
Photo No. 046 - Post-Test Dummy Close-Up Head Contact with Vehicle Interior View

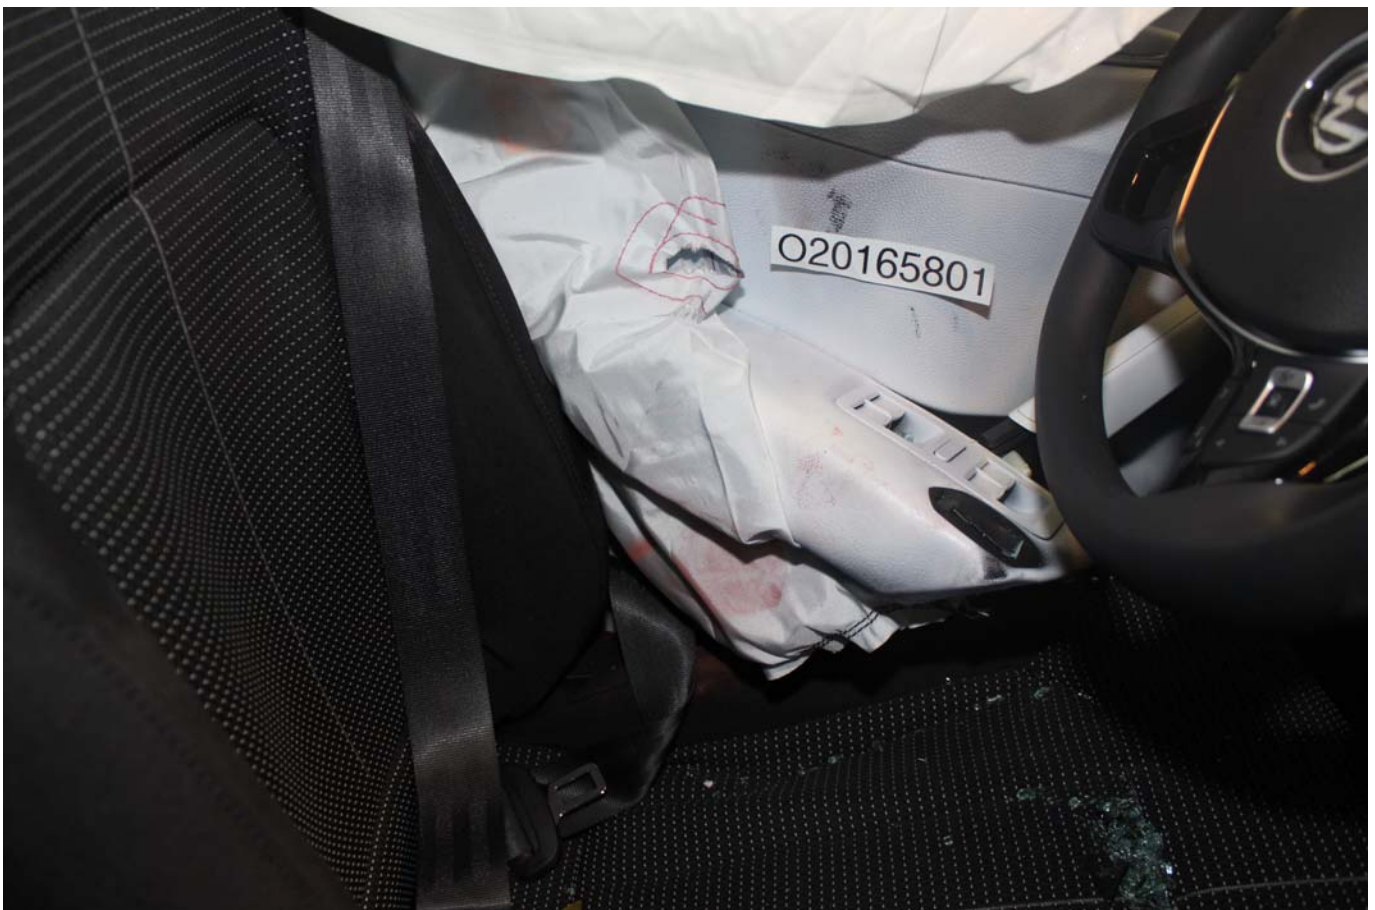
Photo No. 048 - Post-Test Dummy Close-Up Torso Contact with Vehicle Interior View

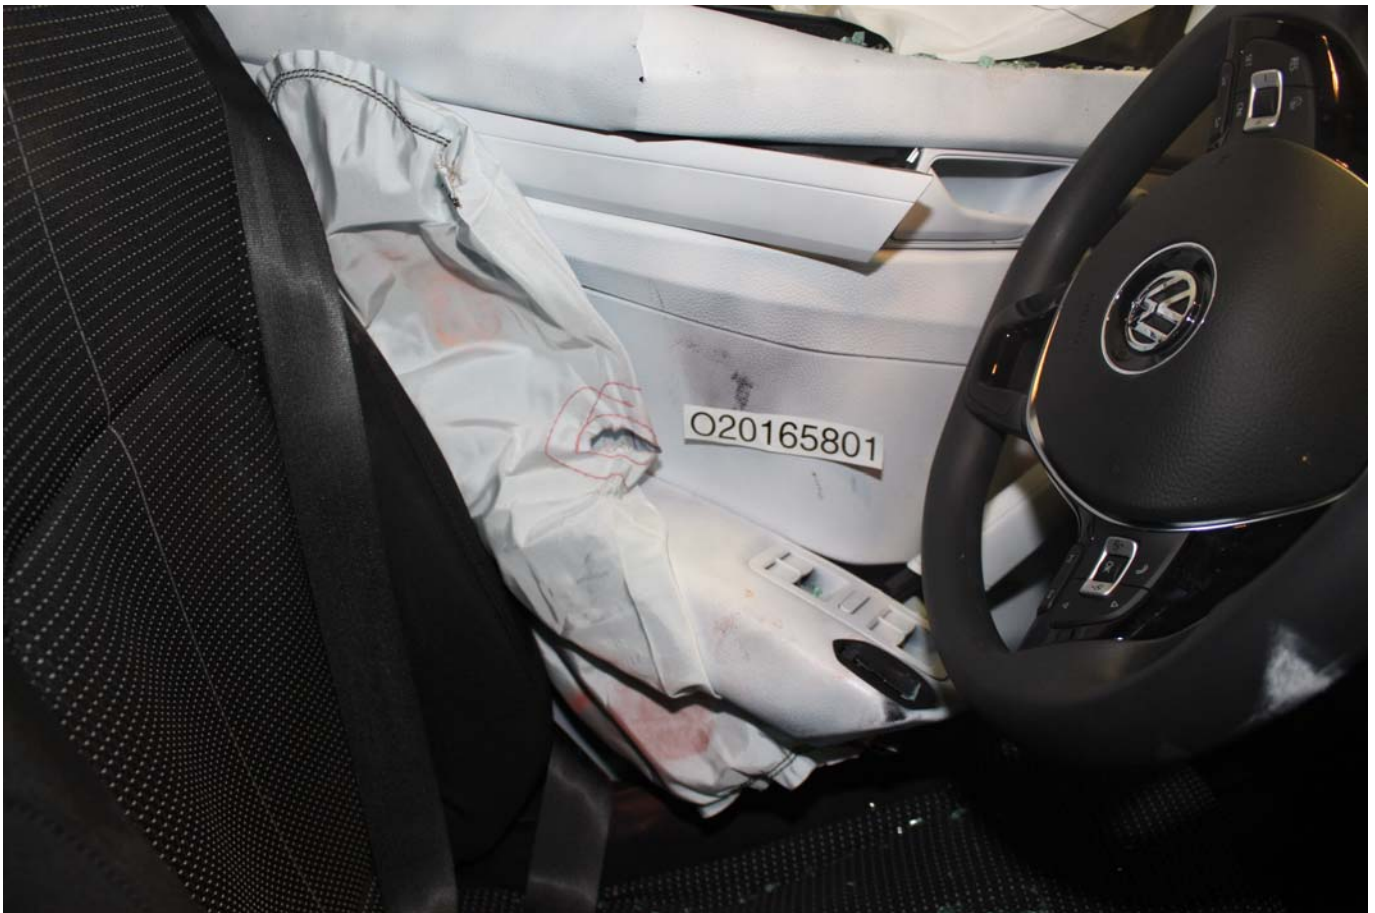
| Critical Areas of Performance | Observations and Conclusions |
|---|---|
| Side Window Damage | Left Front Window Broken |

Photo No. 071 - Post-Test View of Shattered Vehicle Inner Door Panel
