**Final Report Number: NCAP-TRC-16-004**

**New Car Assessment Program (NCAP)  
Frontal Barrier Impact Test**

**General Motors LLC  
2016 Chevrolet Malibu  
NHTSA Number: M20160106**

**Report Date: March 23, 2016**

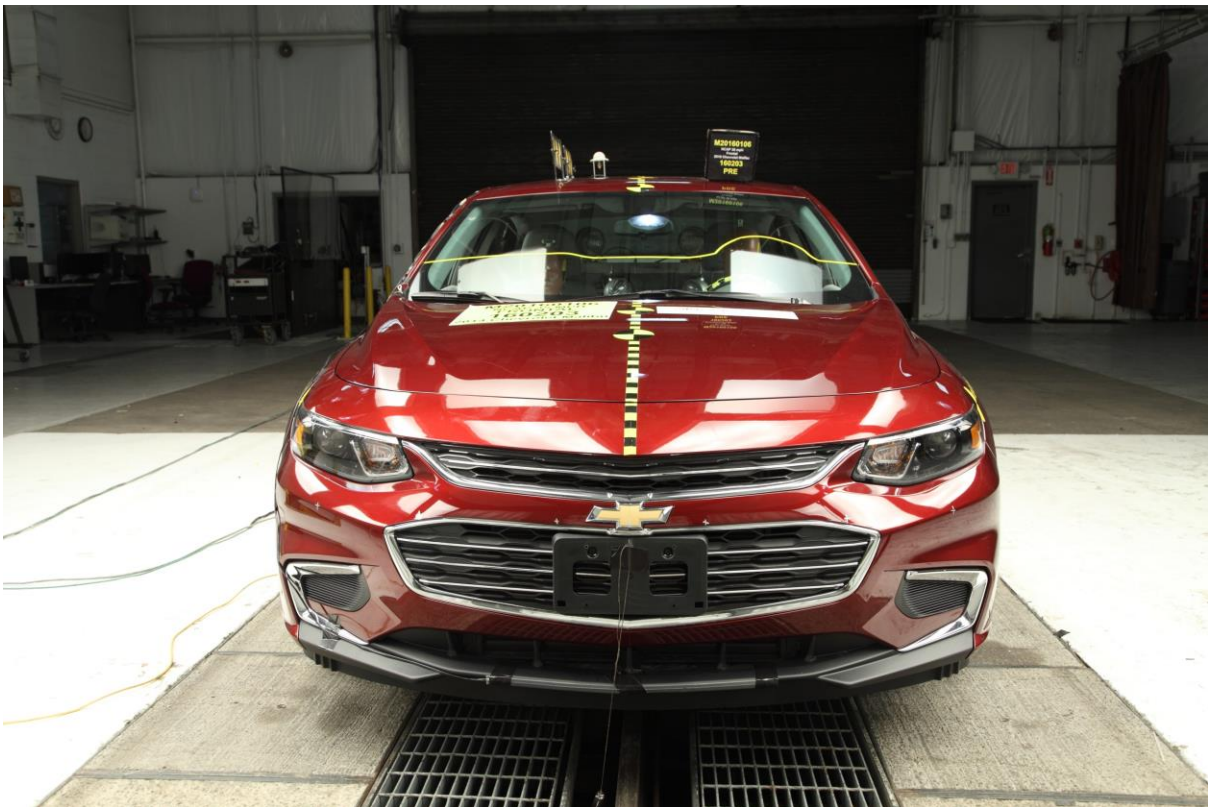
**008 Pre-Test Front View of Test Vehicle<sup>1</sup>**

<sup>1</sup> Pre-test placards say “2014 Chevrolet Malibu” rather than “2016 Chevrolet Malibu.” Photos were not retaken per COTR.

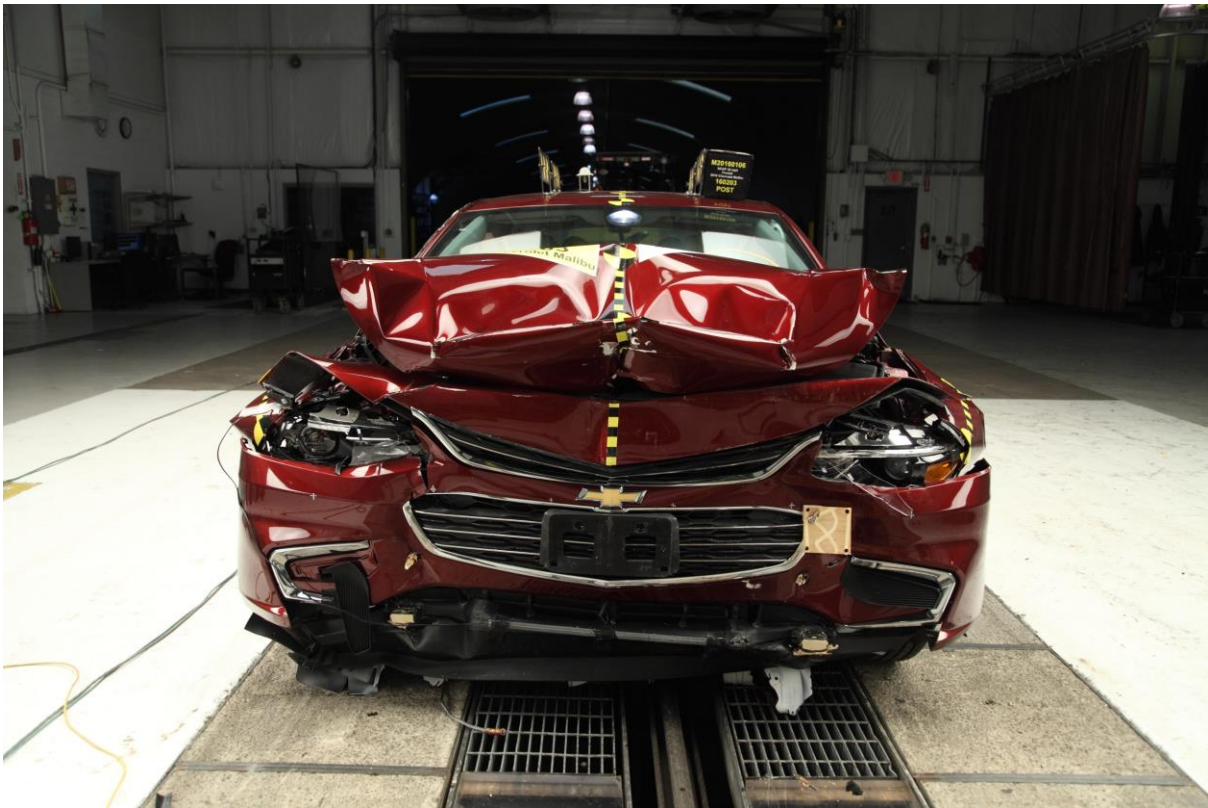
**009 Post-Test Front View of Test Vehicle**

The maximum static crush of the vehicle was 503 mm and both the driver and passenger side doors remained closed during the impact event and were operable after the impact.

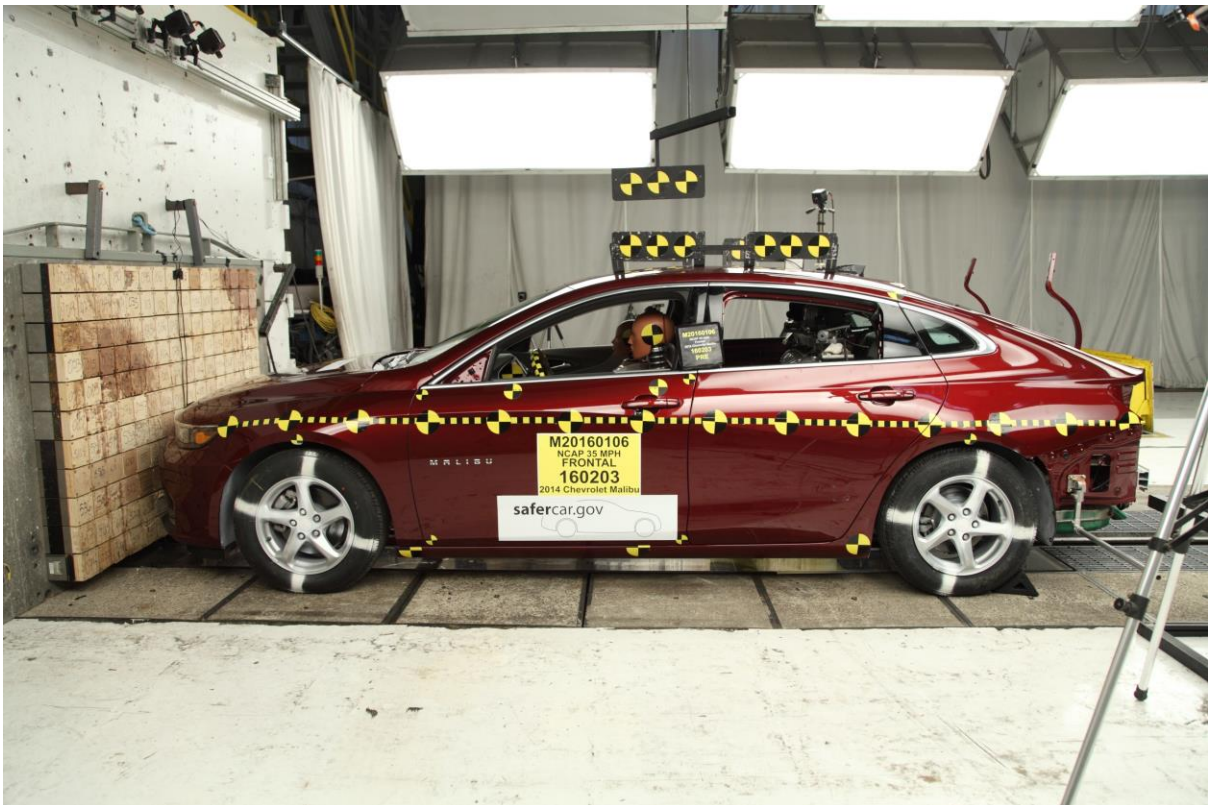
**010 Pre-Test Left View of Test Vehicle<sup>1</sup>**

<sup>1</sup> Pre-test placards say “2014 Chevrolet Malibu” rather than “2016 Chevrolet Malibu.” Photos were not retaken per COTR.

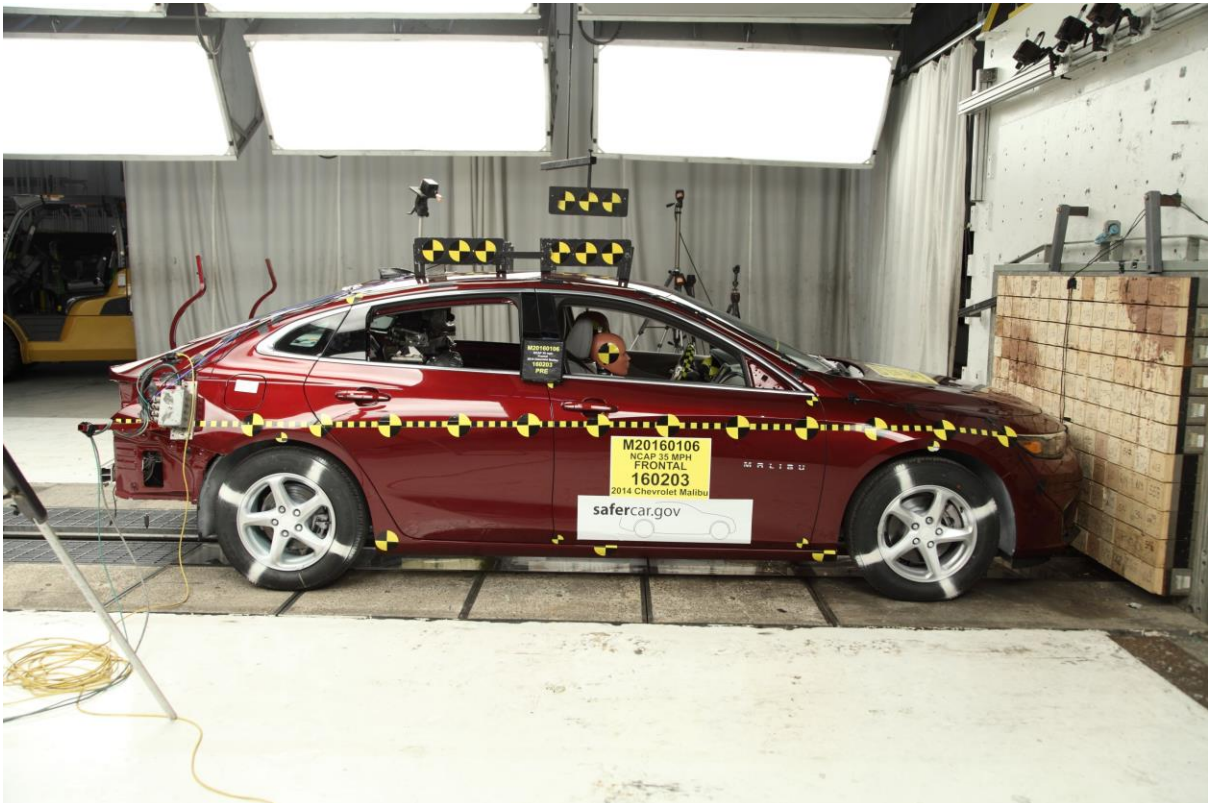
**012 Pre-Test Right View of Test Vehicle<sup>1</sup>**

<sup>1</sup> Pre-test placards say “2014 Chevrolet Malibu” rather than “2016 Chevrolet Malibu.” Photos were not retaken per COTR.

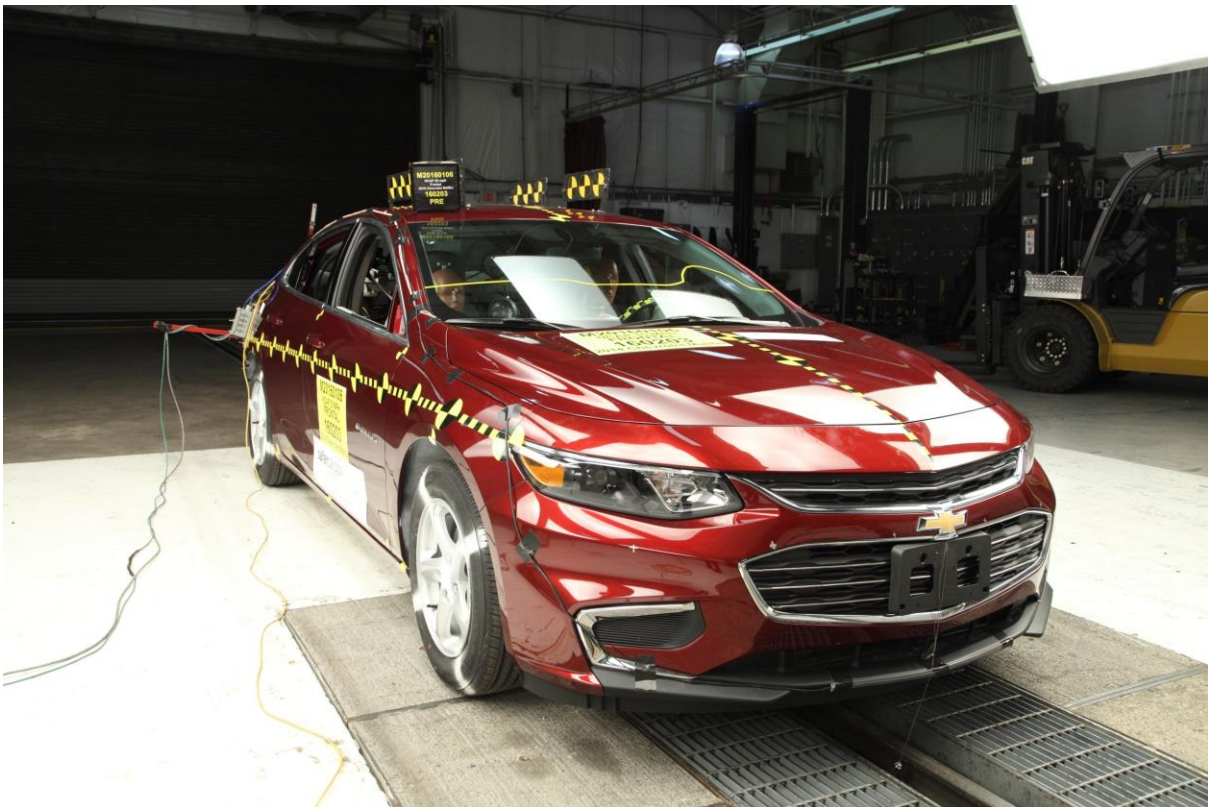
**014 Pre-Test Right Front 3-4 View<sup>1</sup>**

<sup>1</sup> Pre-test placards say “2014 Chevrolet Malibu” rather than “2016 Chevrolet Malibu.” Photos were not retaken per COTR.

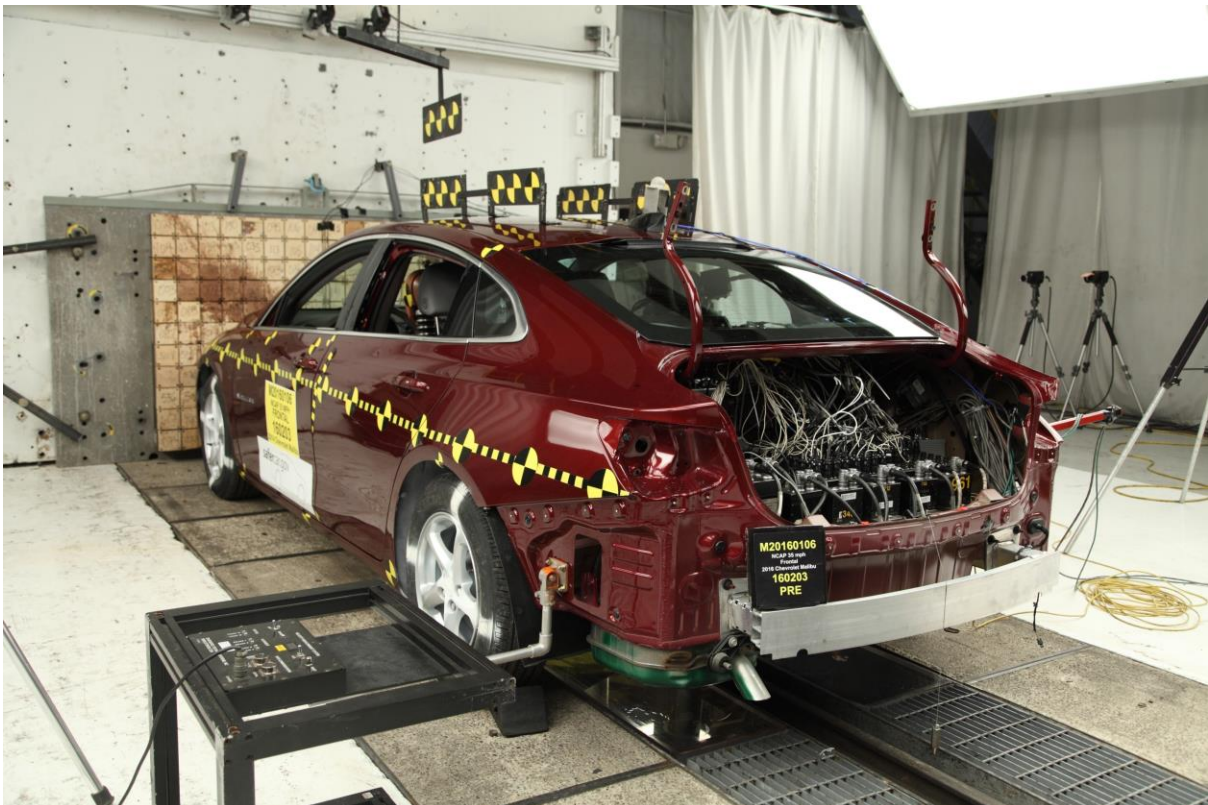
**016 Pre-Test Left Rear 3-4 View<sup>1</sup>**

<sup>1</sup> Pre-test placards say “2014 Chevrolet Malibu” rather than “2016 Chevrolet Malibu.” Photos were not retaken per COFR.

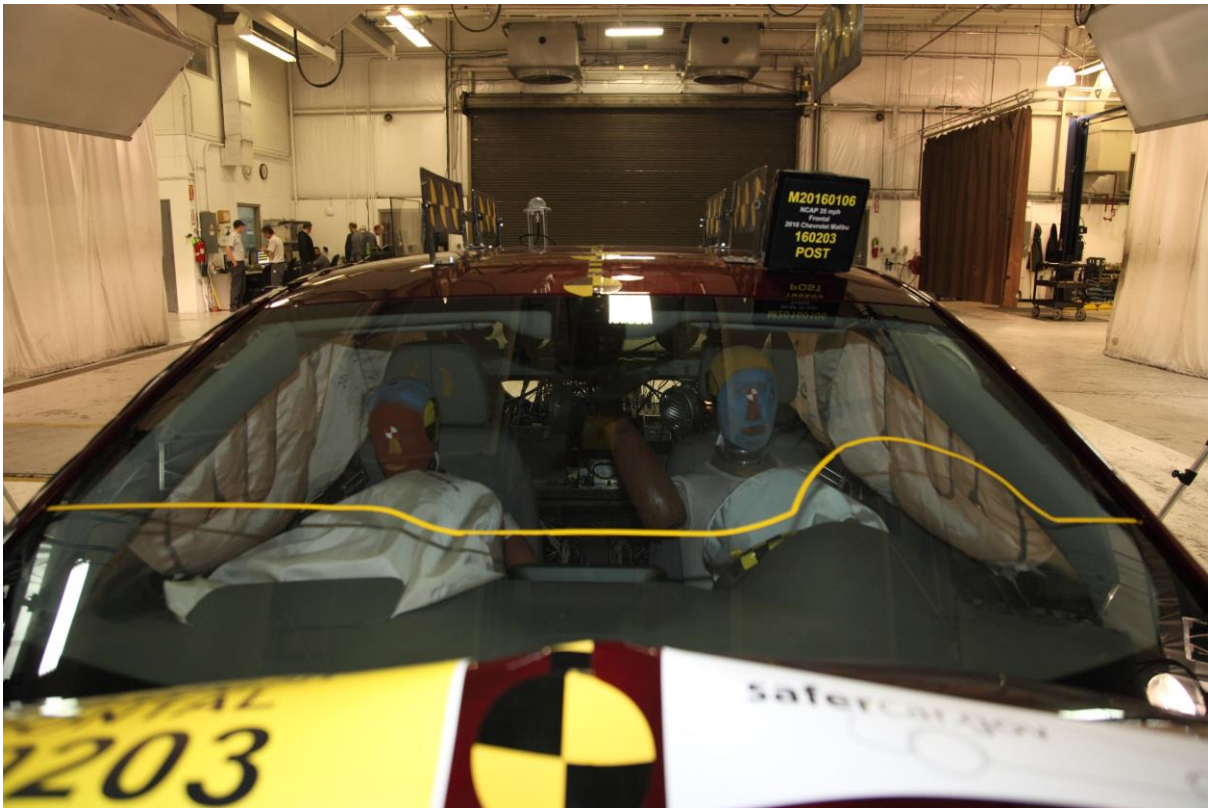
019 Post-Test Windshield View

There was 100.0 percent windshield retention and no intrusion into the protected zone of the windshield during the event. There was no Stoddard solvent leakage after the event or during any phase of the static rollover.

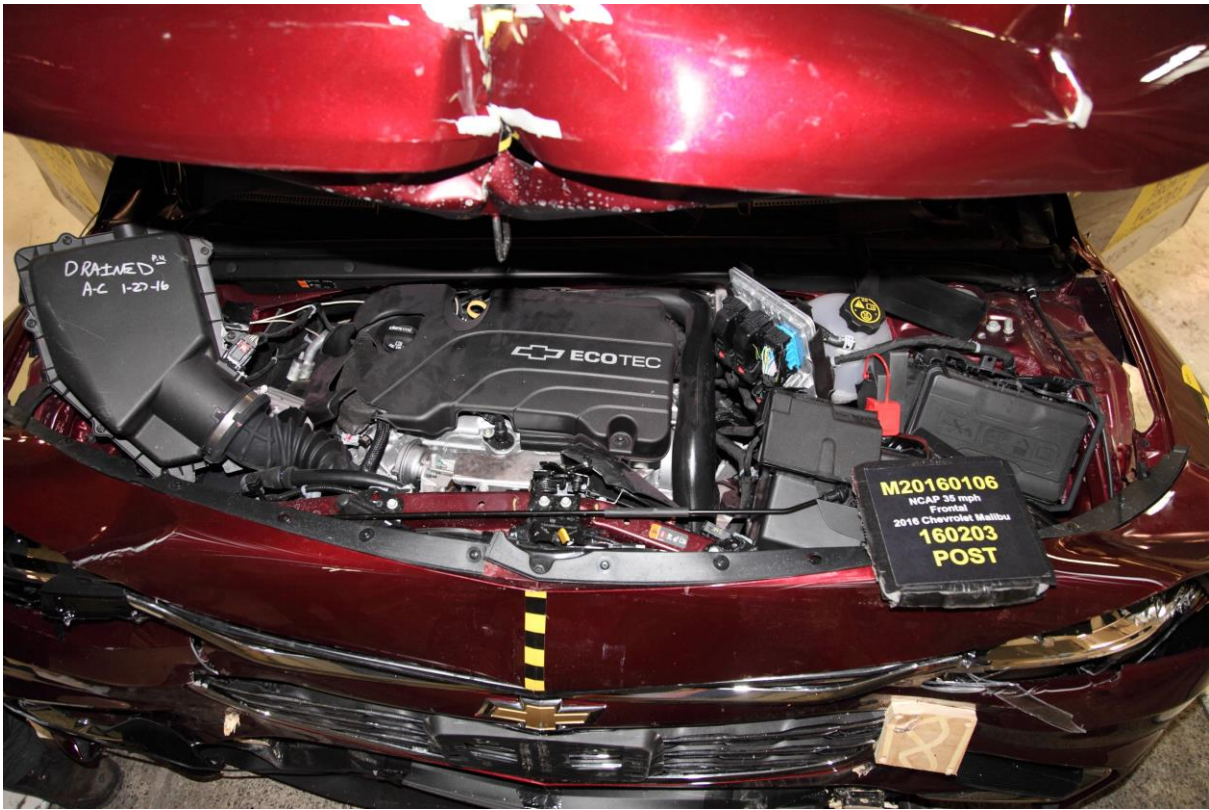
**021 Post-Test Engine Compartment View**

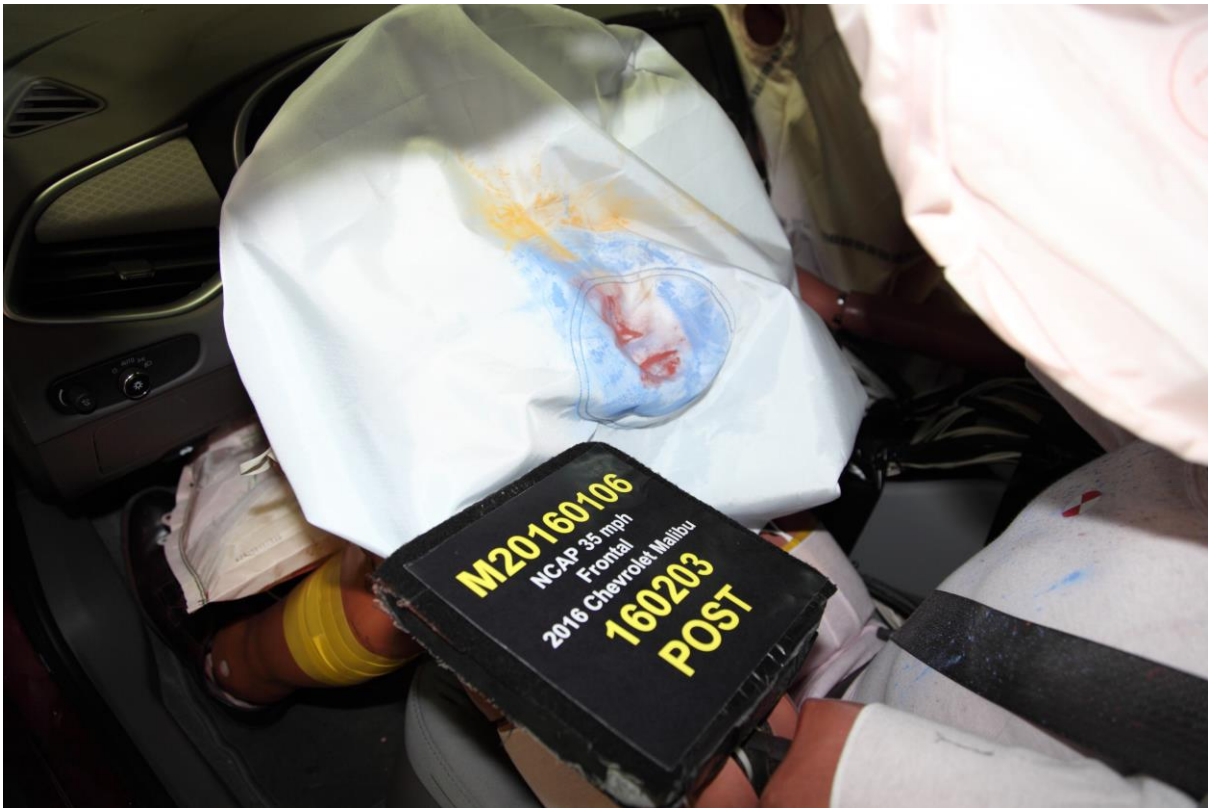
**047 Post-Test Driver Dummy Contact With Airbag**

The driver’s visible contact points were as follows: front airbag, headrest, and knee airbag. The passenger’s visible contact points were as follows: front airbag, headrest, and knee airbag.

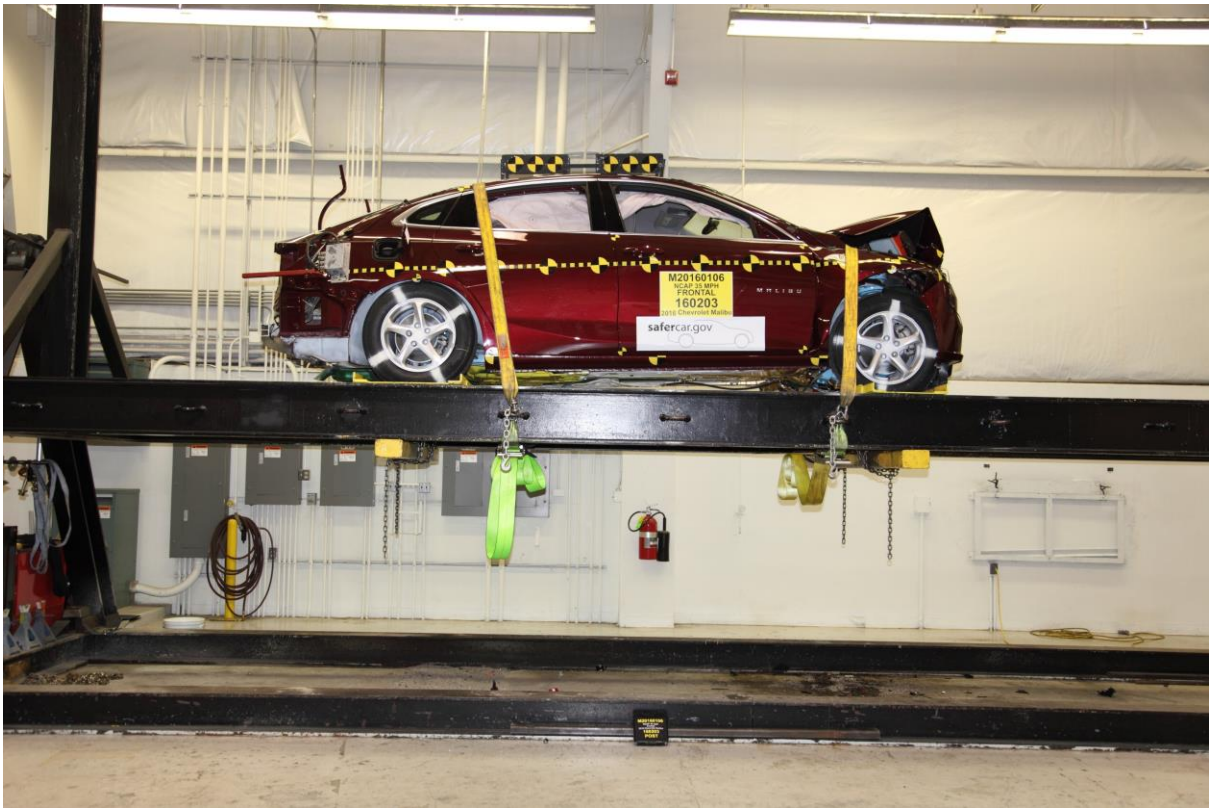
**073 Vehicle at 0° on Static Rollover Device**

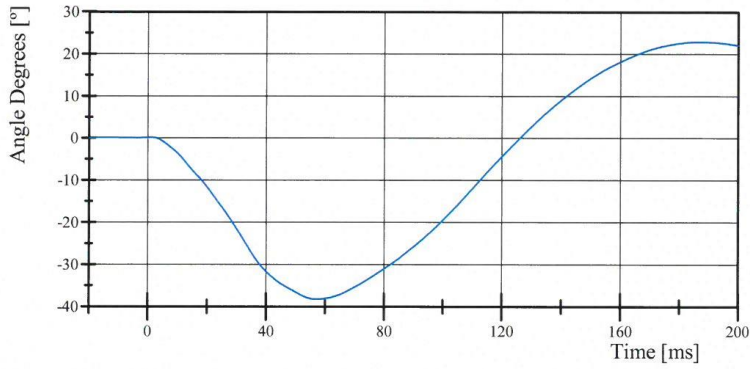
Pot Rotation at the Base of Neck

Filter Class: CFC\_60  
Max: 22.8 ° at 186.6 ms  
Min: -38.3 ° at 57.2 ms
