REPORT NUMBER: NCAP-KAR-16-017

**NEW CAR ASSESSMENT PROGRAM (NCAP)
FRONTAL BARRIER IMPACT TEST**

**KIA MOTORS MANUFACTURING GEORGIA, INC.
2016 KIA OPTIMA LX 4-DOOR SEDAN**

FINAL REPORT

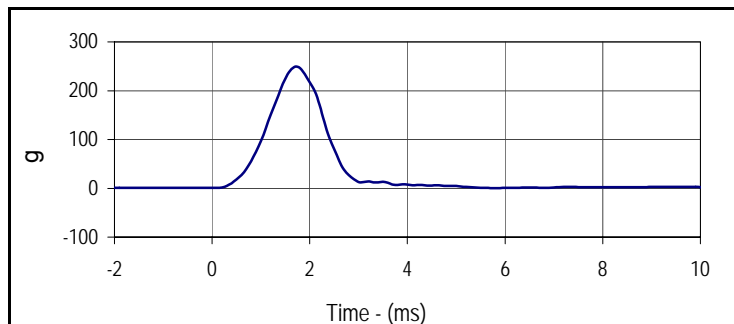
Curve Description			
Head Resultant			
Plot No.	Type	SAE Class	Units
001	RES	1000	g
Max	Time	Min	Time
249.3	1.7	0.3	88.2

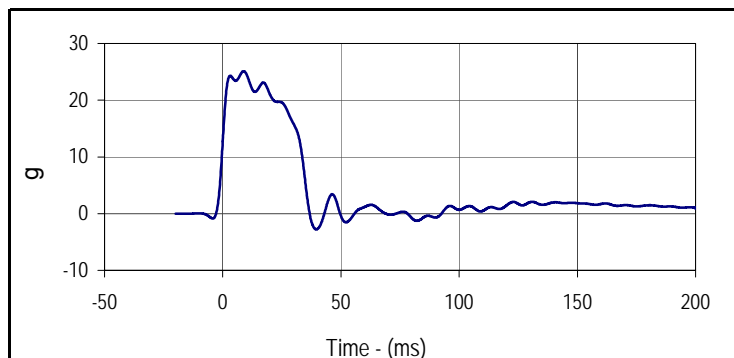
Curve Description			
Pendulum Deceleration			
Plot No.	Type	SAE Class	Units
001	FIL	60	g
Max	Time	Min	Time
25.1	8.8	-2.8	39.6

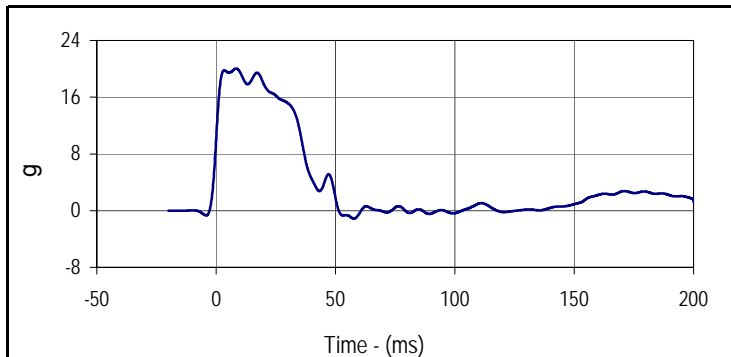
Curve Description			
Pendulum Deceleration			
Plot No.	Type	SAE Class	Units
001	FIL	60	g
Max	Time	Min	Time
20.0	8.4	-1.1	57.7

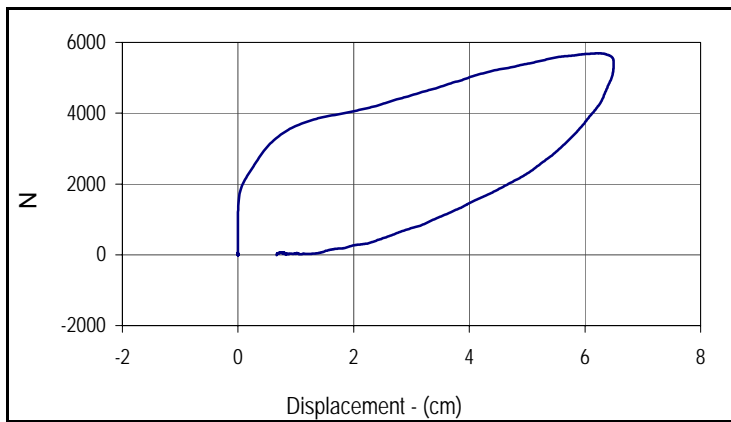
Curve Description			
Probe Force vs. Chest Deflection			
Plot No.	Type	SAE Class	Hysteresis
001	FIL	180	70.6
Peak Probe Force		Peak Chest Deflection	
5693		6.49

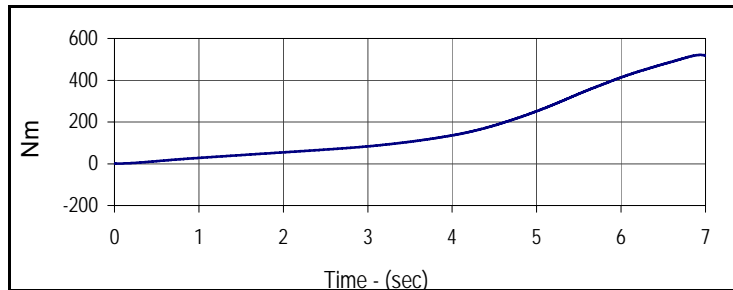
Curve Description			
Right Femur Torque			
Plot No.	Type	SAE Class	Units
004	FIL	600	Nm
Max	Time	Min	Time
521.2	6.9	0.4	0.0

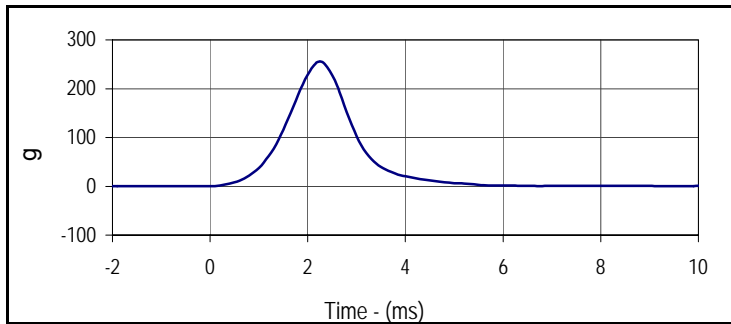
Curve Description			
Head Resultant			
Plot No.	Type	SAE Class	Units
001	RES	1000	g
Max	Time	Min	Time
255.0	2.2	0.0	0.0

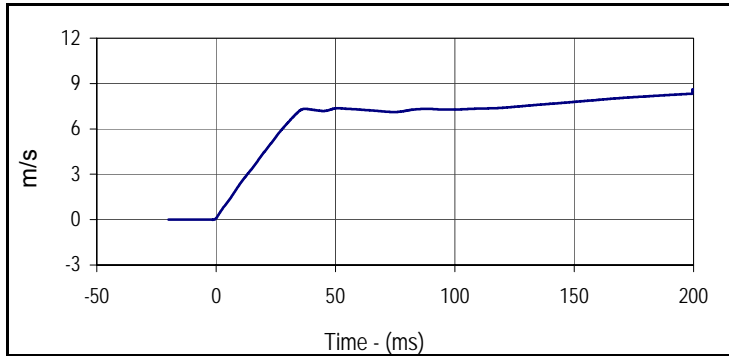
Curve Description			
Pendulum Velocity			
Plot No.	Type	SAE Class	Units
001	FIL	180	m/s
Max	Time	Min	Time
8.6	199.5	0.0	-1.4

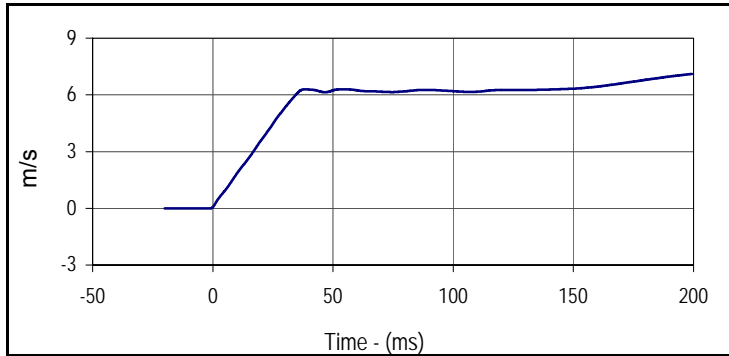
Curve Description			
Pendulum Velocity			
Plot No.	Type	SAE Class	Units
001	FIL	180	m/s
Max	Time	Min	Time
7.1	199.4	0.0	-1.3

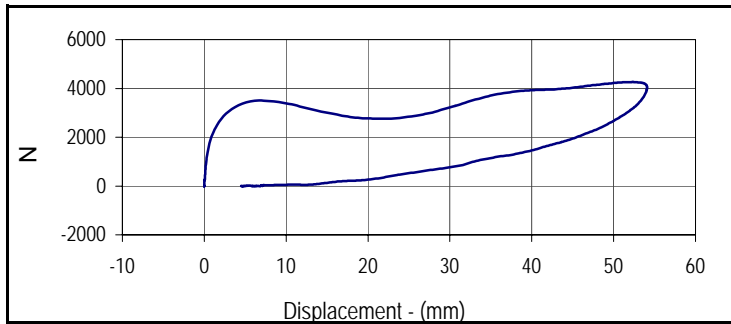
Curve Description			
Probe Force vs. Chest Deflection			
Plot No.	Type	SAE Class	Hysteresis
001	FIL	180	72.5
Peak Probe Force		Peak Chest Deflection	
4262.4		54.1

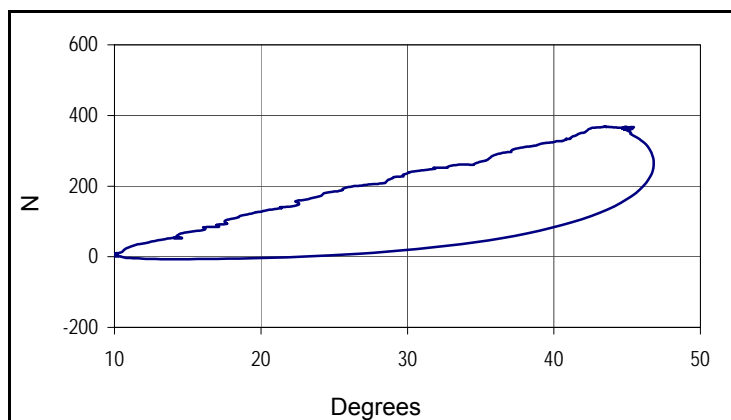
Curve Description		
Force vs Torso Rotation		
Plot No.	Type	Filter Freq
001	FIL	1 Hz
Peak Force		Peak Rotation
369.0		46.8

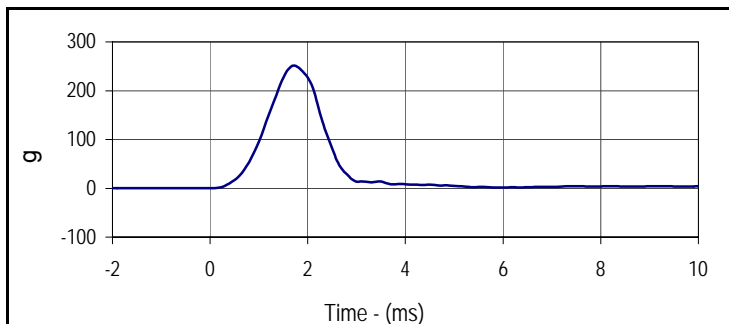
Curve Description			
Head Resultant			
Plot No.	Type	SAE Class	Units
001	RES	1000	g
Max	Time	Min	Time
251.4	1.7	0.2	-3.4

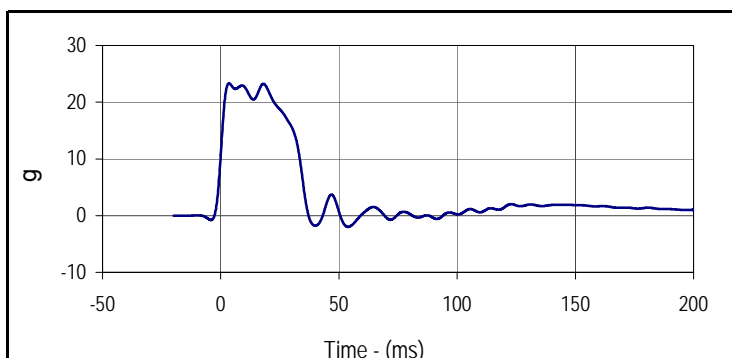
Curve Description			
Pendulum Deceleration			
Plot No.	Type	SAE Class	Units
001	FIL	60	g
Max	Time	Min	Time
23.3	3.5	-2.0	53.9

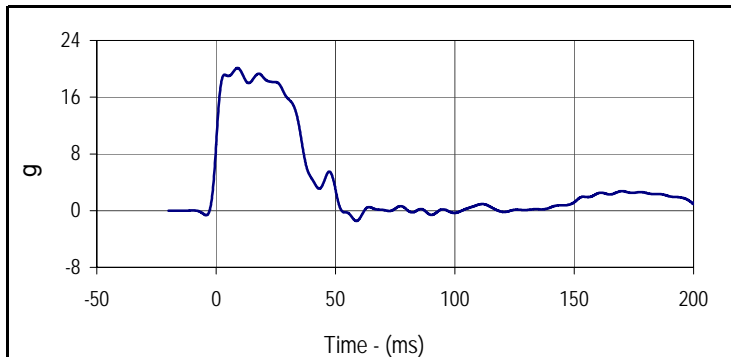
Curve Description			
Pendulum Deceleration			
Plot No.	Type	SAE Class	Units
001	FIL	60	g
Max	Time	Min	Time
20.1	8.9	-1.5	58.8

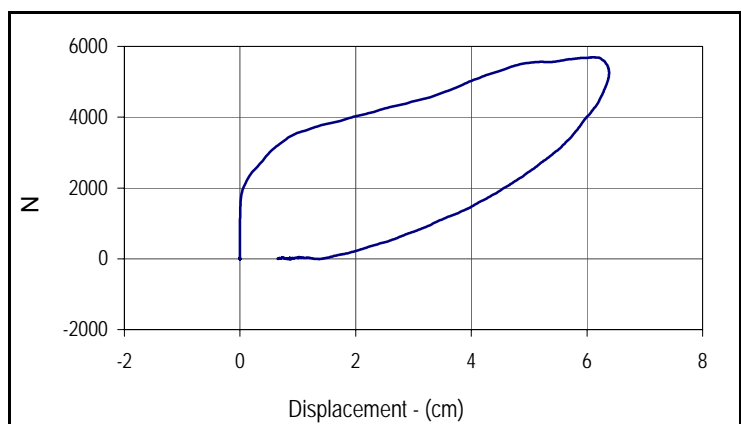
Curve Description			
Probe Force vs. Chest Deflection			
Plot No.	Type	SAE Class	Hysteresis
001	FIL	180	70.6
Peak Probe Force		Peak Chest Deflection	
5691		6.38

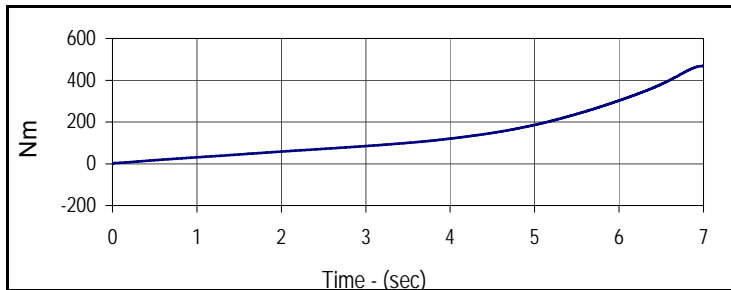
Curve Description			
Right Femur Torque			
Plot No.	Type	SAE Class	Units
004	FIL	600	Nm
Max	Time	Min	Time
467.7	7.0	0.2	0.0

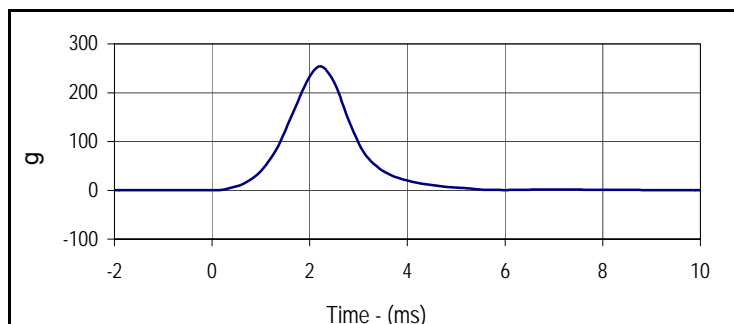
Curve Description			
Head Resultant			
Plot No.	Type	SAE Class	Units
001	RES	1000	g
Max	Time	Min	Time
254.0	2.2	0.0	172.8

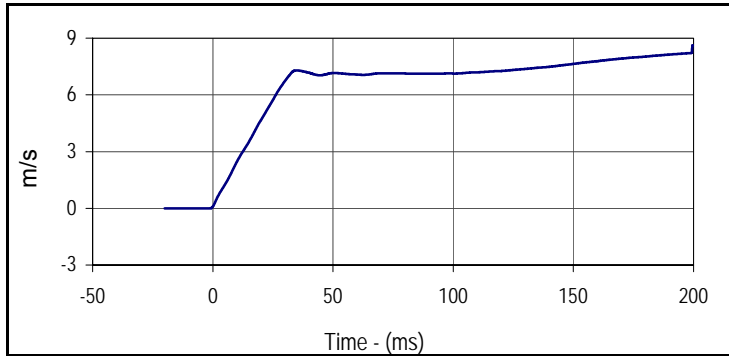
Curve Description			
Pendulum Velocity			
Plot No.	Type	SAE Class	Units
001	FIL	180	m/s
Max	Time	Min	Time
8.6	199.5	0.0	-1.4

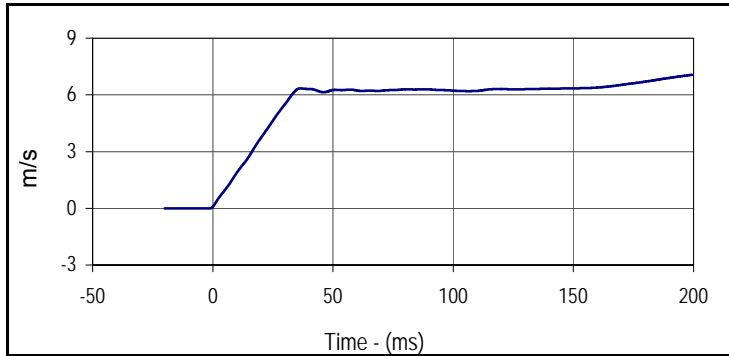
Curve Description			
Pendulum Velocity			
Plot No.	Type	SAE Class	Units
001	FIL	180	m/s
Max	Time	Min	Time
7.1	199.4	0.0	-1.4

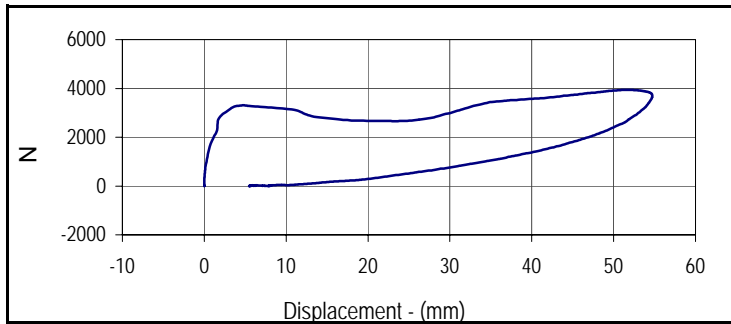
Curve Description			
Probe Force vs. Chest Deflection			
Plot No.	Type	SAE Class	Hysteresis
001	FIL	180	71.7
Peak Probe Force		Peak Chest Deflection	
3942.4		54.7

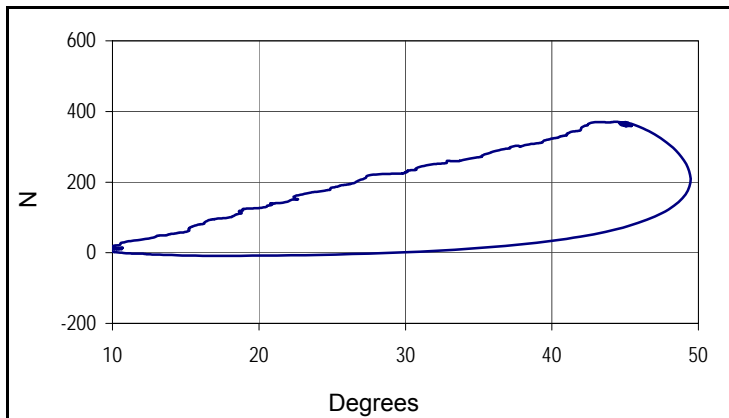
Curve Description		
Force vs Torso Rotation		
Plot No.	Type	Filter Freq
001	FIL	1 Hz
Peak Force		Peak Rotation
371.0		49.4
