**FINAL REPORT NUMBER: SPNCAP-TRC-16-005**

**NEW CAR ASSESSMENT PROGRAM (NCAP)  
SIDE IMPACT POLE TEST**

**General Motors LLC  
2016 Chevrolet Malibu  
NHTSA NUMBER: M20160107**

**PREPARED BY:  
Transportation Research Center Inc.  
10820 State Route 347  
P. O. Box B-67  
East Liberty, OH 43319**

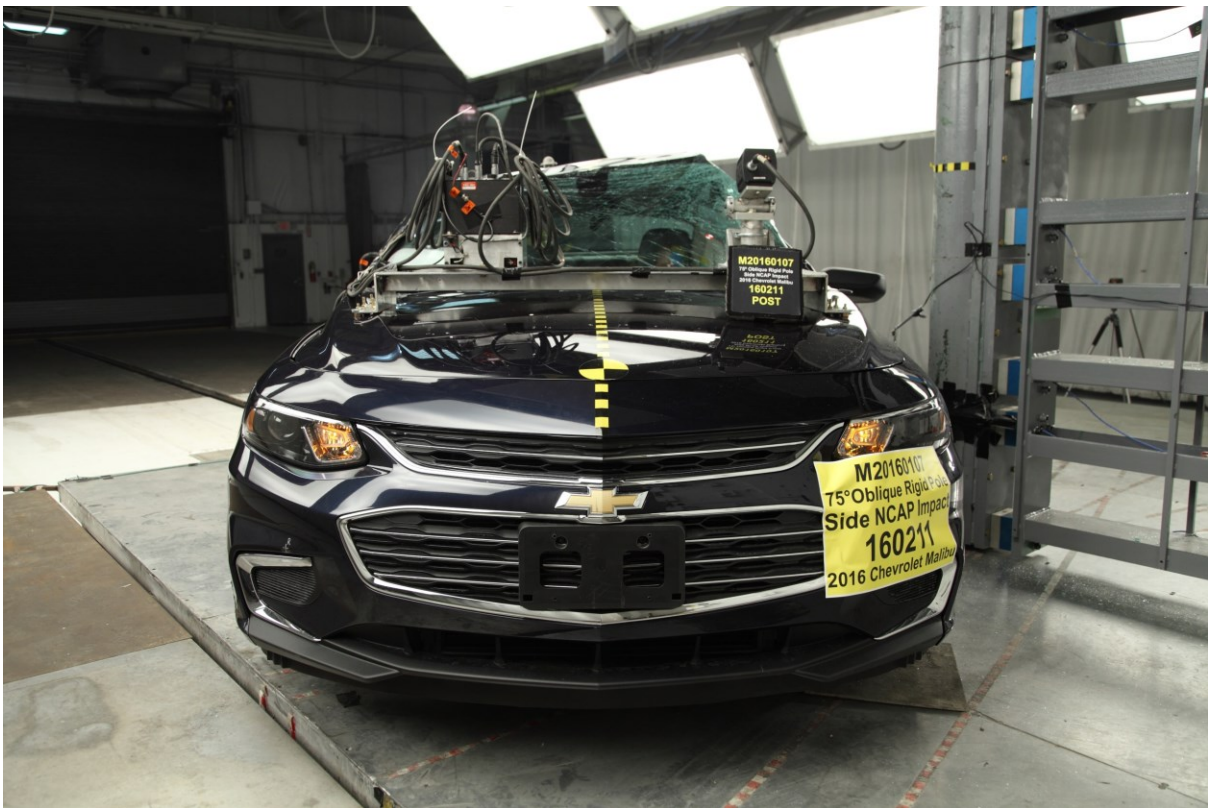
**004** Post-Test Frontal View of Test Vehicle

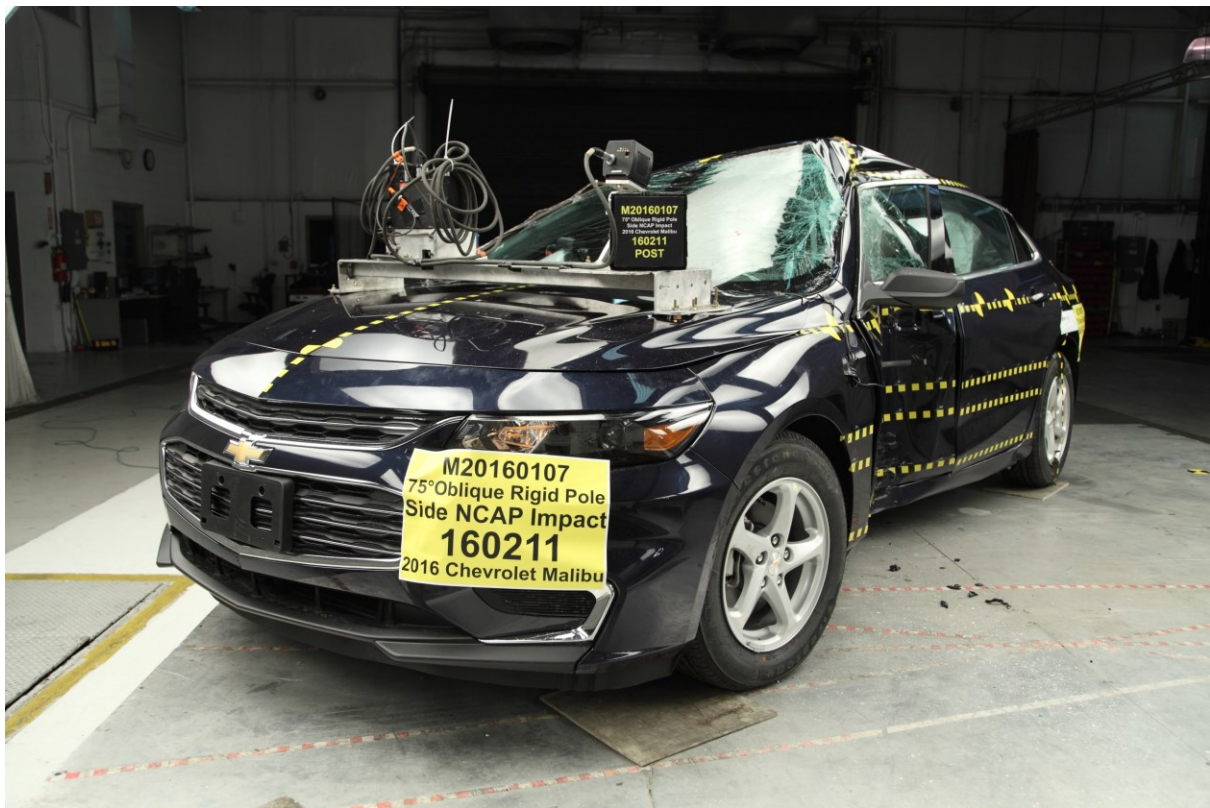
**006** Post-Test Left Front  $\frac{3}{4}$  View of Test Vehicle

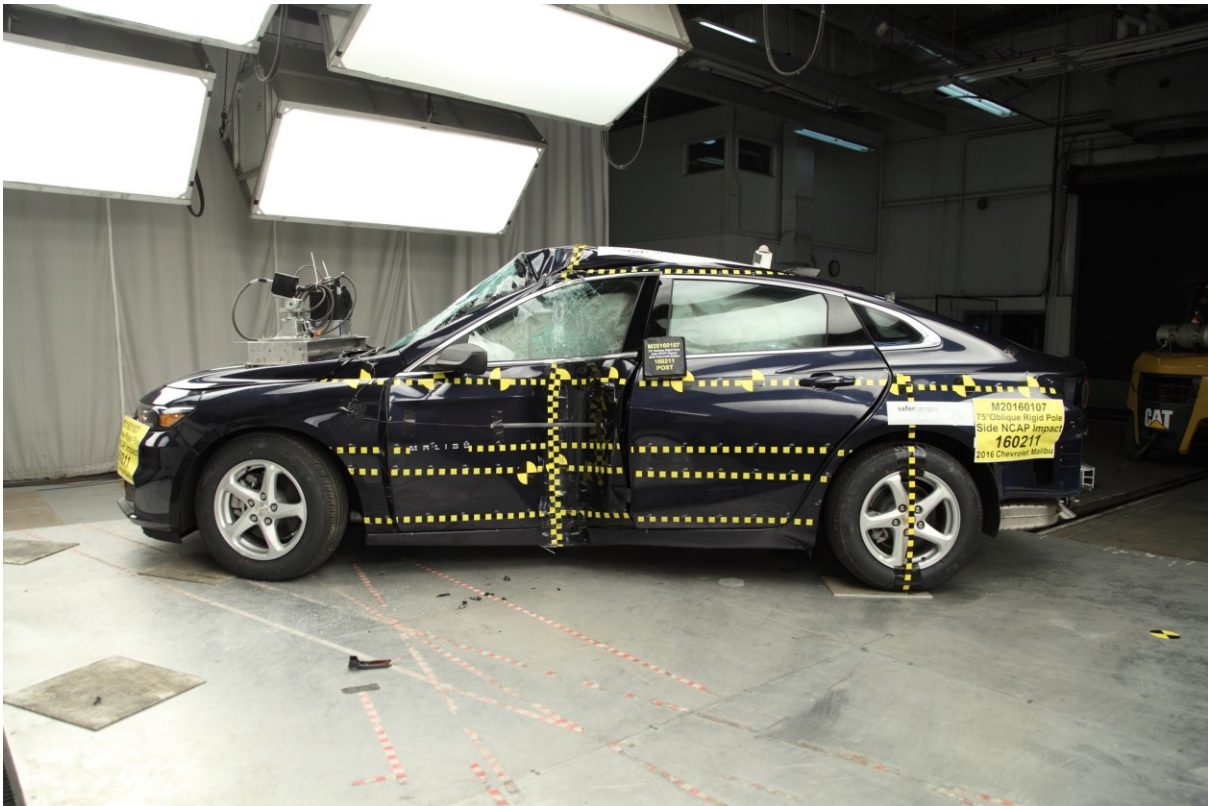
**008** Post-Test Left Side View of Test Vehicle

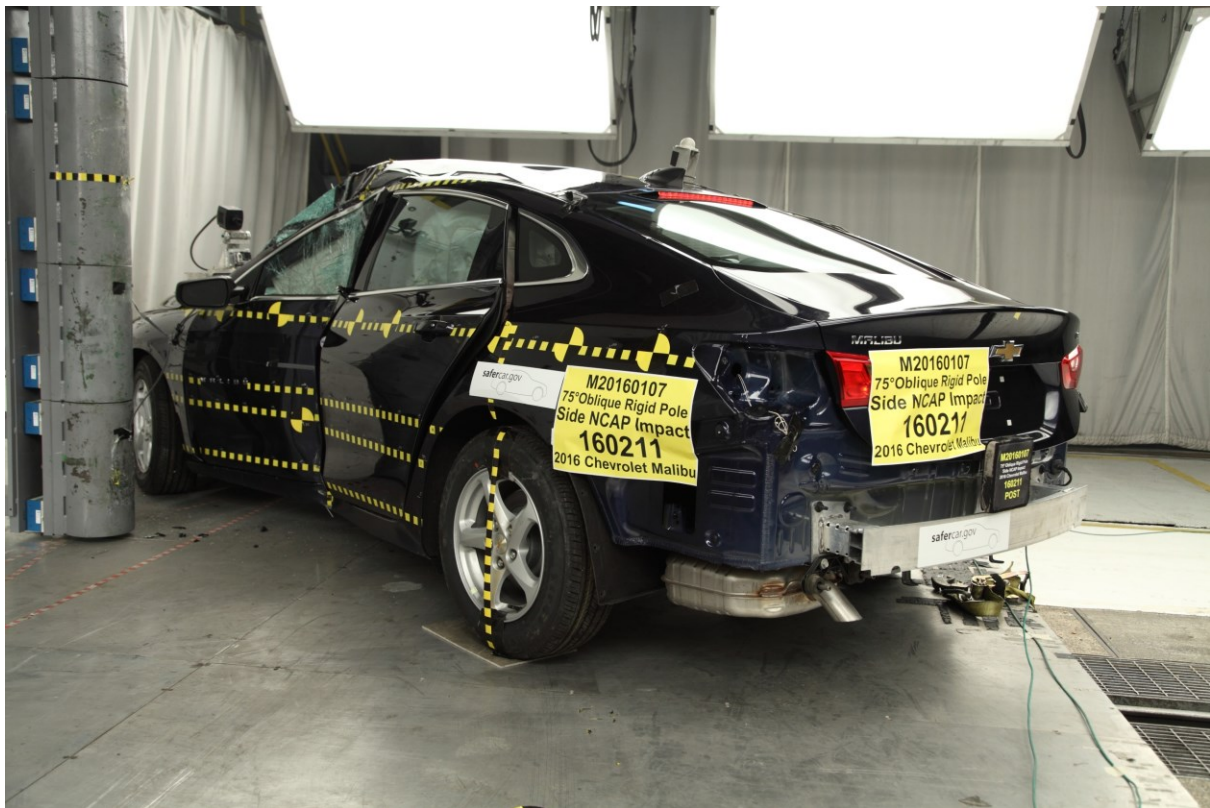
**010** Post-Test Left Rear  $\frac{3}{4}$  View of Test Vehicle

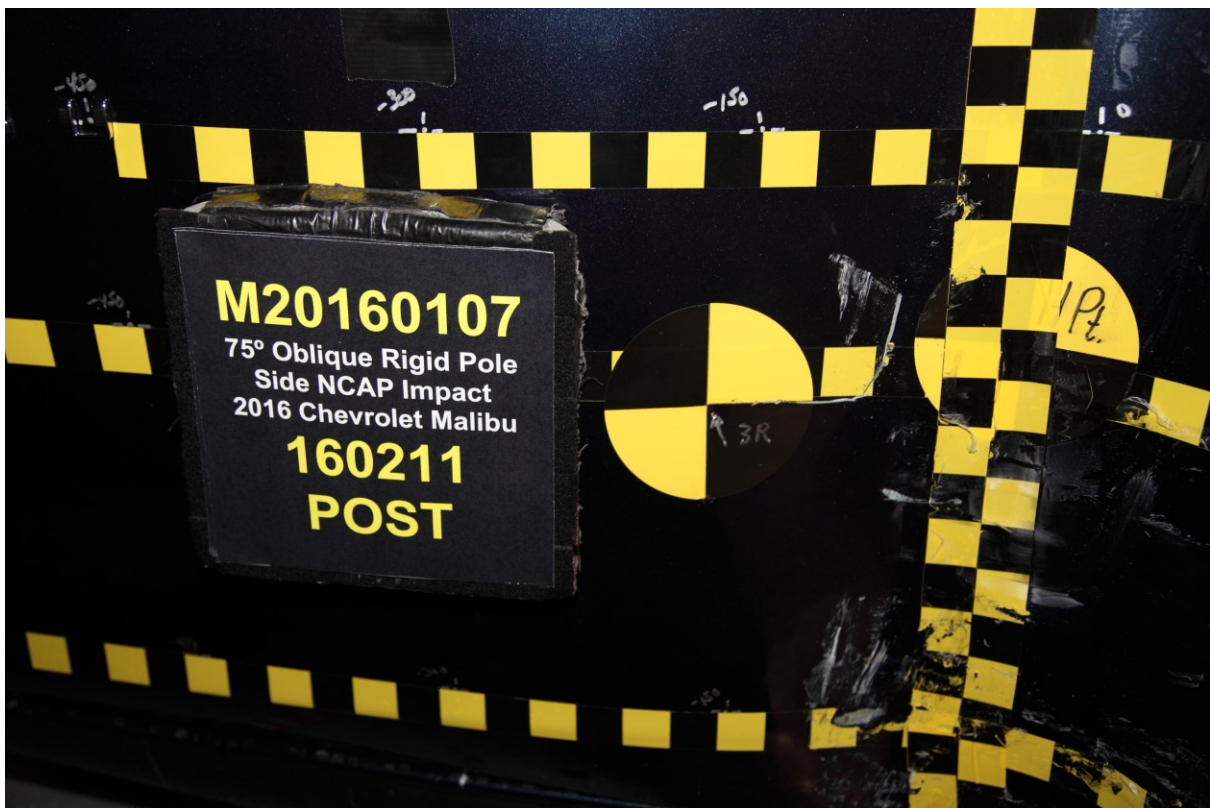
**020** Post-Test Close-Up View of Impact Point Target Showing Impact Location

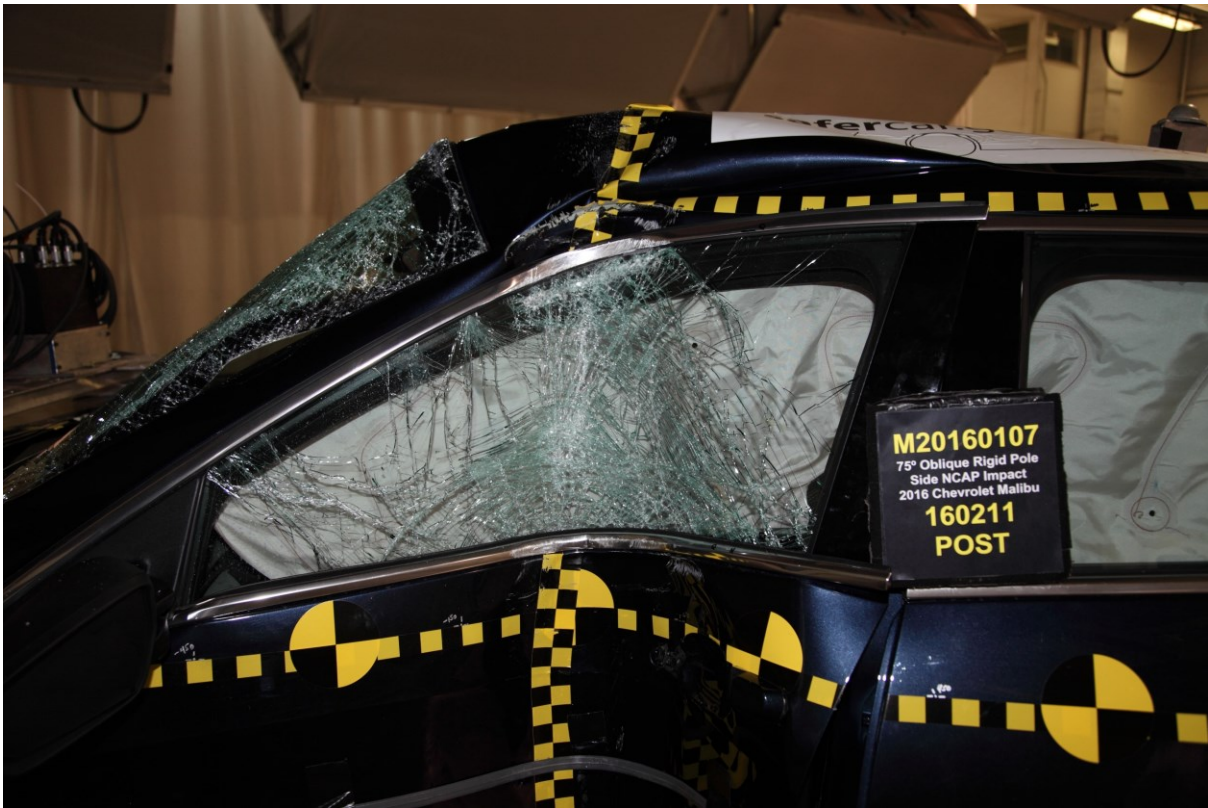
**025** Post-Test Left Side View of Dummy Shoulder and Door Top View

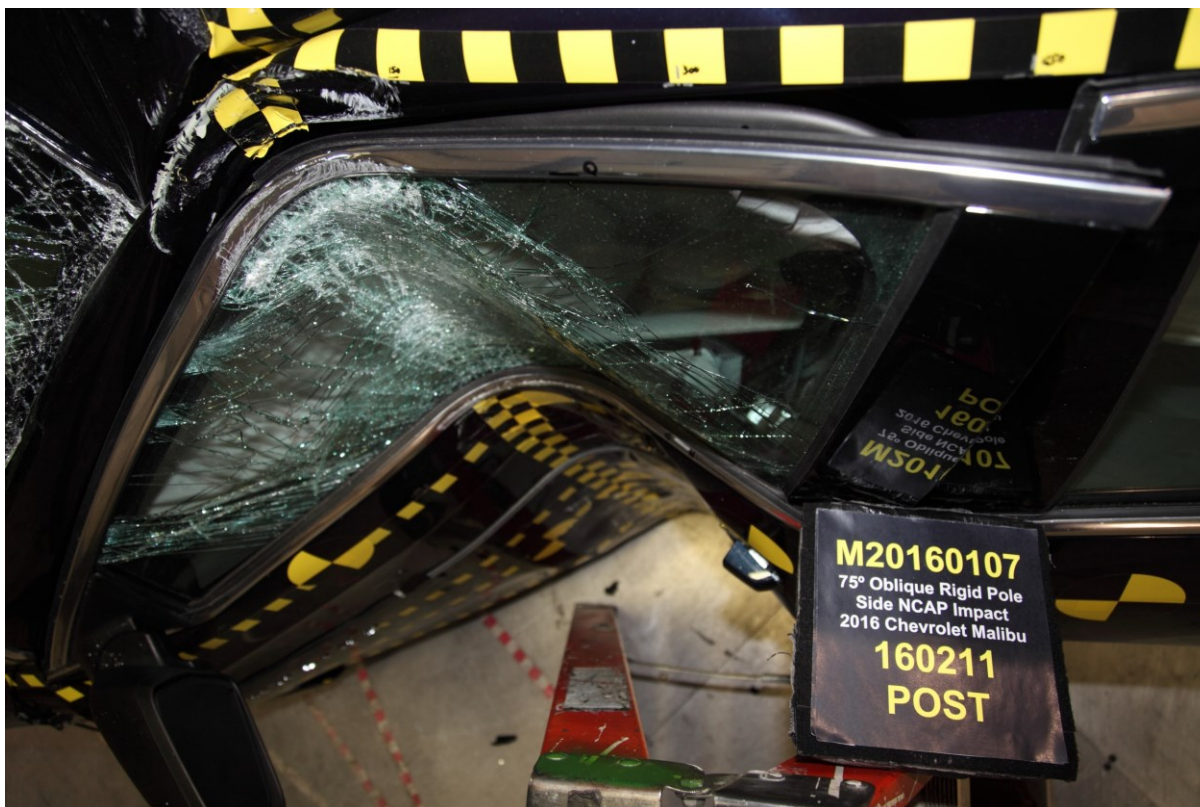
**041** Post-Test Dummy and Door Clearance View

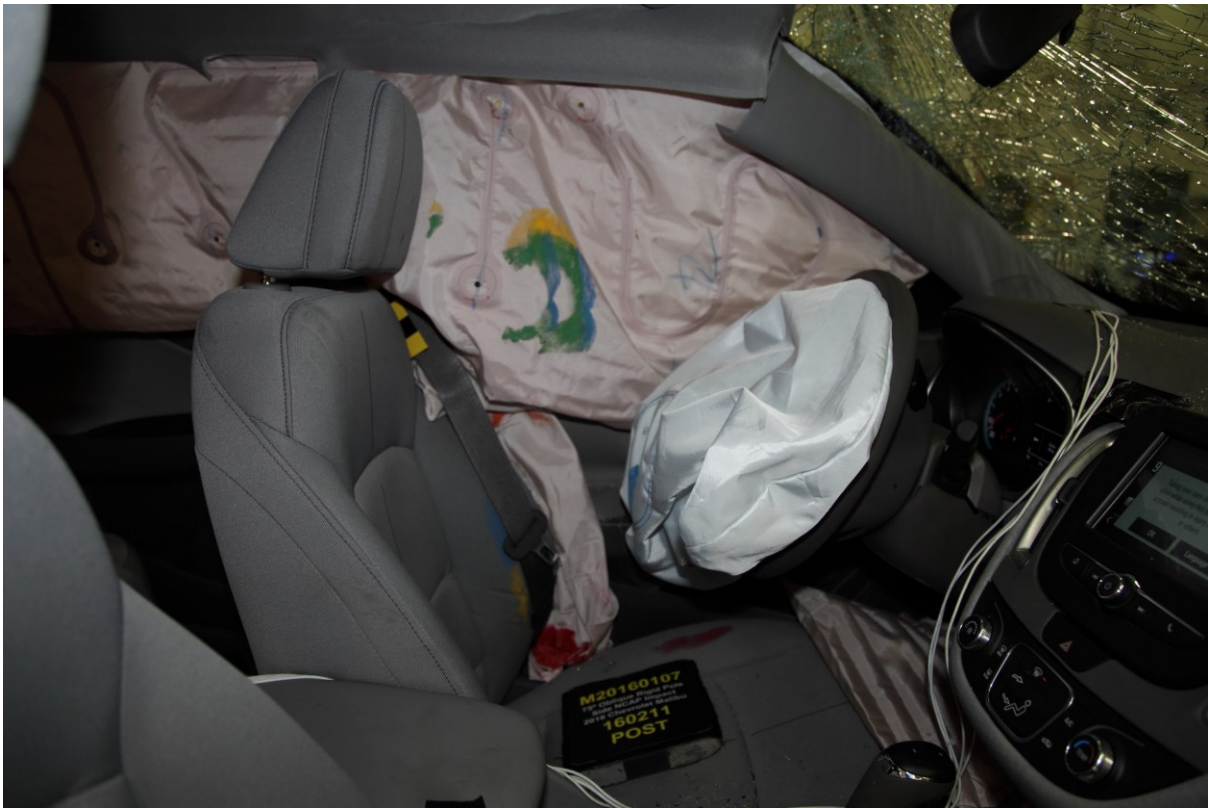
**045** Post-Test Inner Driver Door Panel View Showing Dummy Contact Location

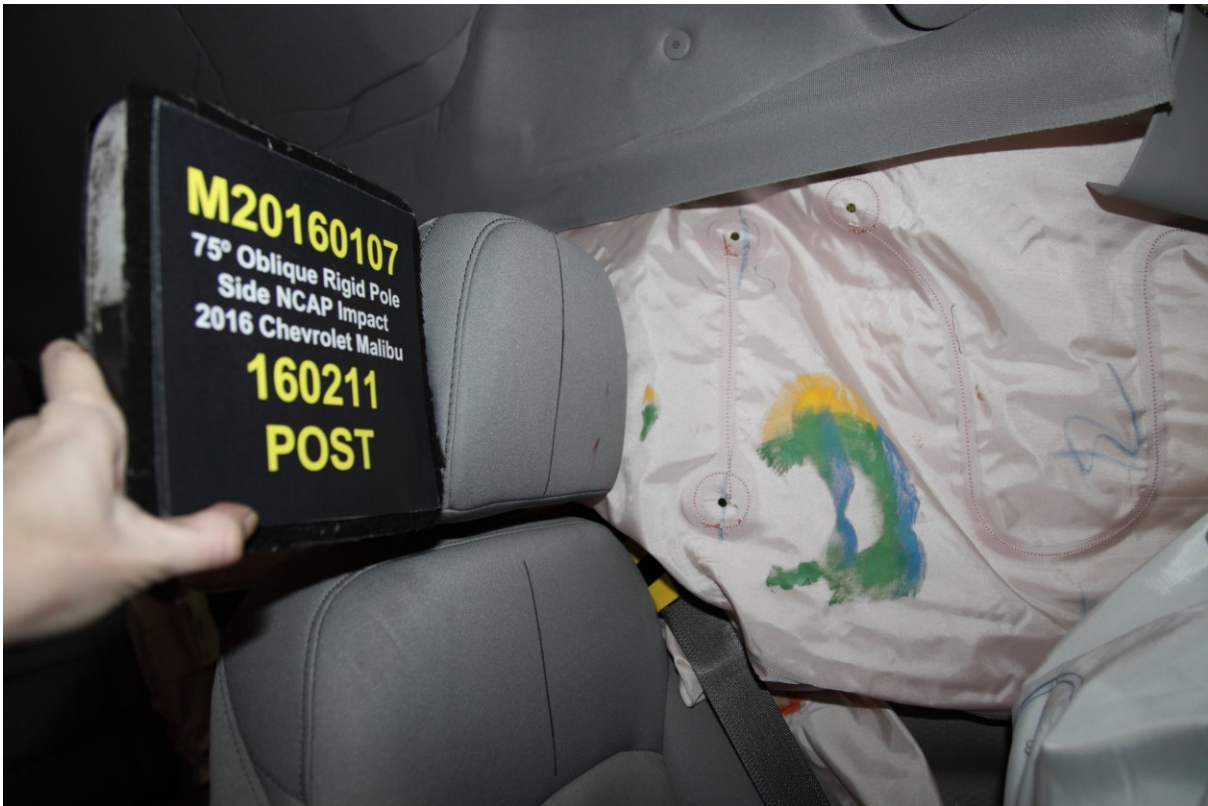
**046** Post-Test Dummy Close-Up Head Contact with Vehicle View

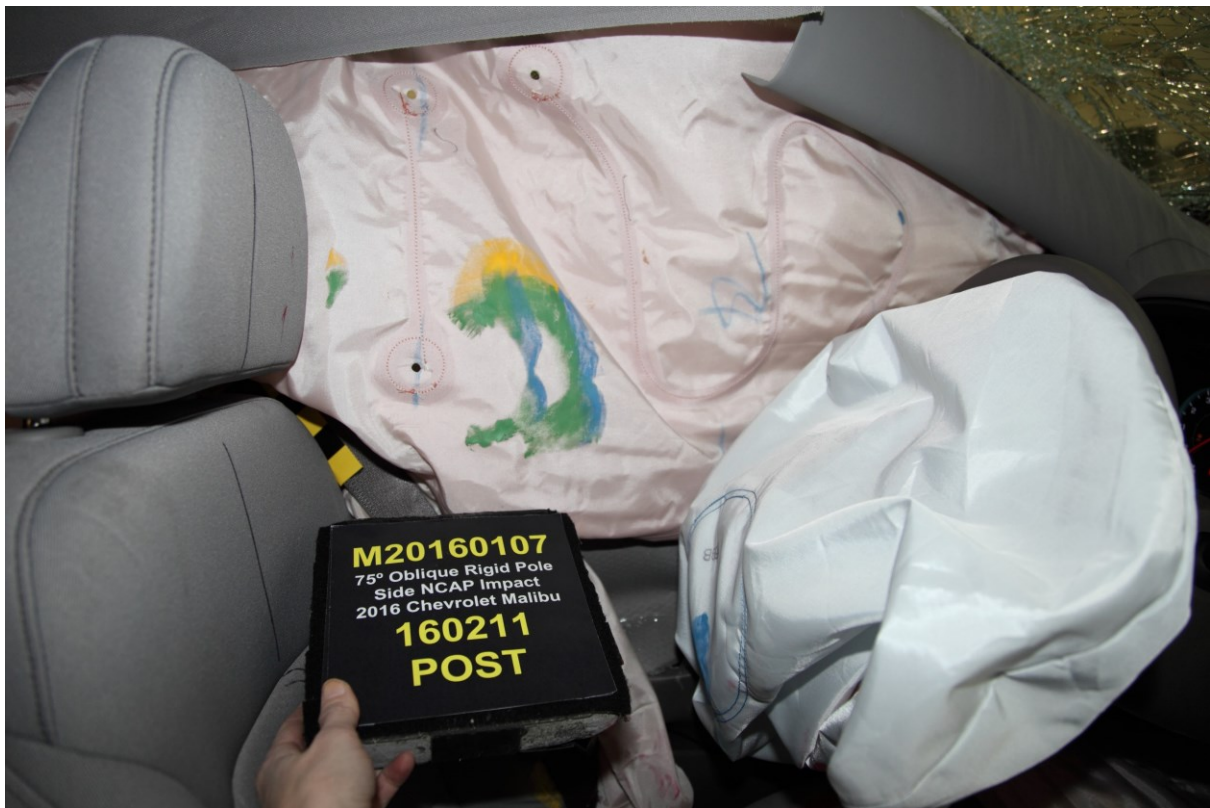
**047** Post-Test Dummy Close-Up Head Contact with Side Airbag View

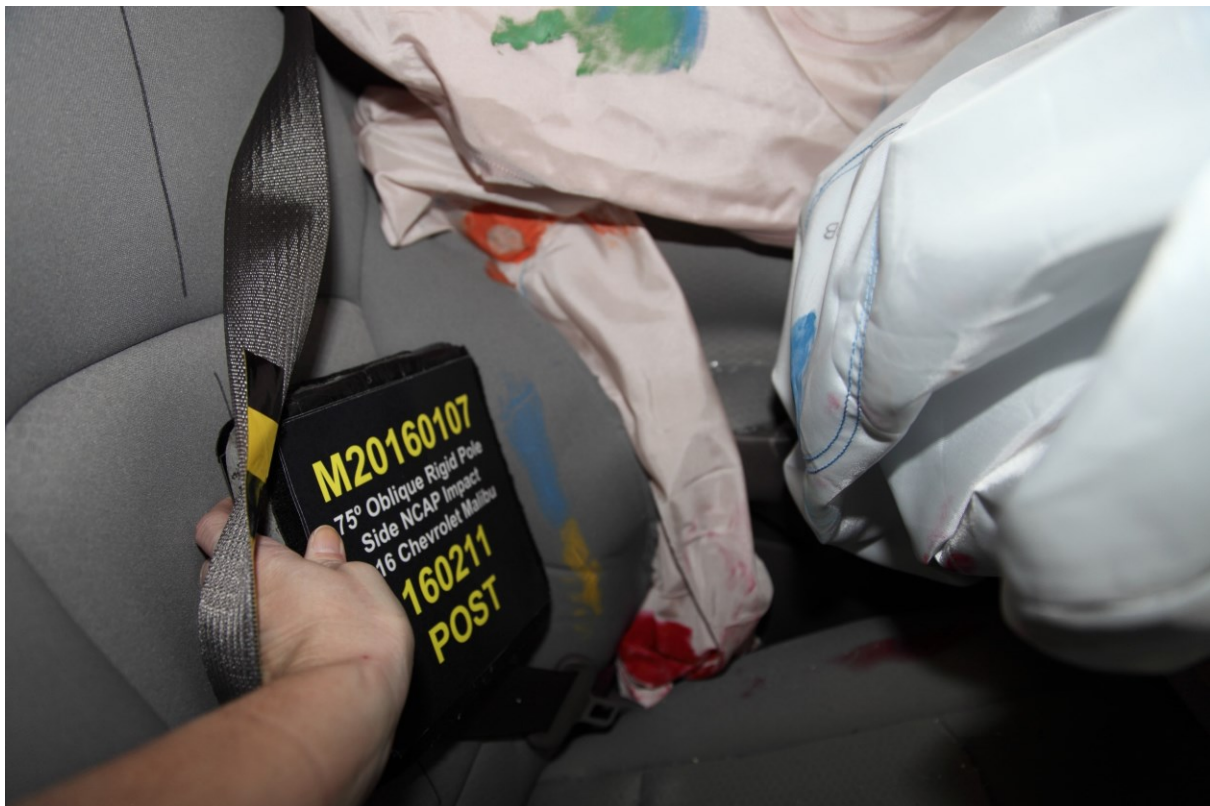
**048** Post-Test Dummy Close-Up Torso Contact with Vehicle Interior View

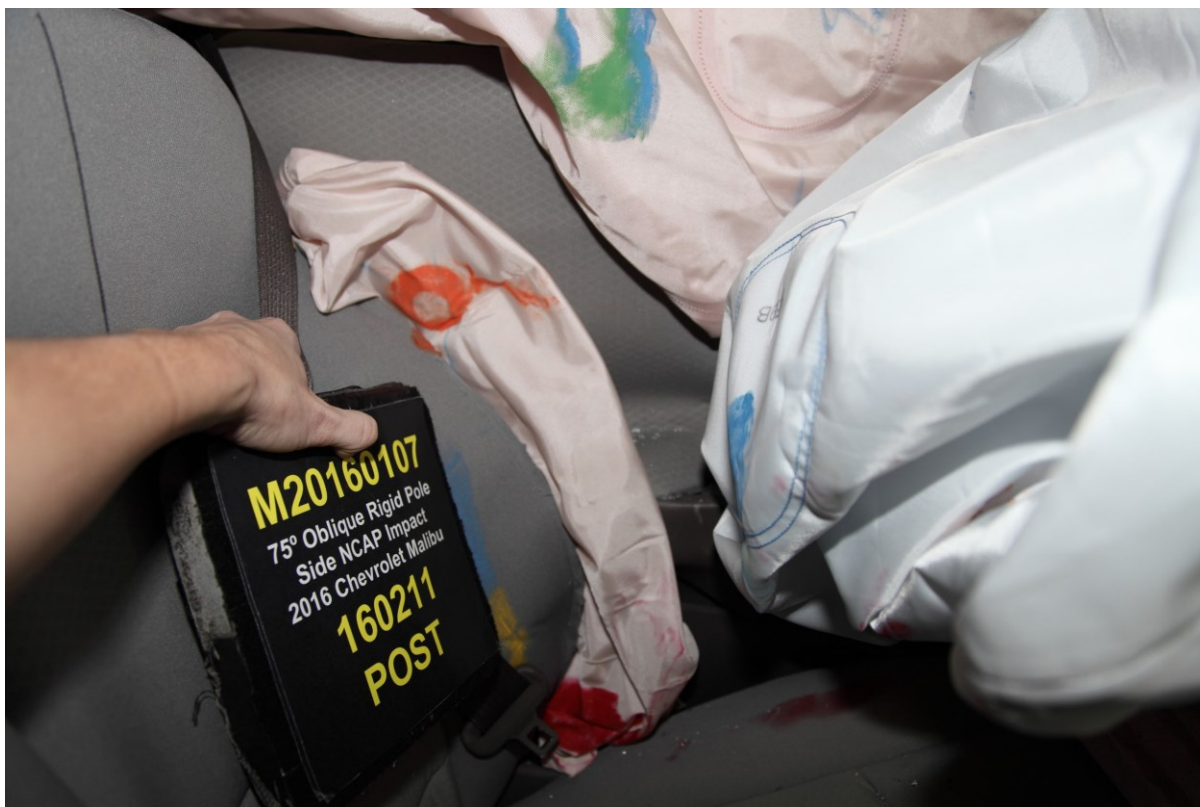
**049** Post-Test Dummy Close-Up Torso Contact with Side Airbag View

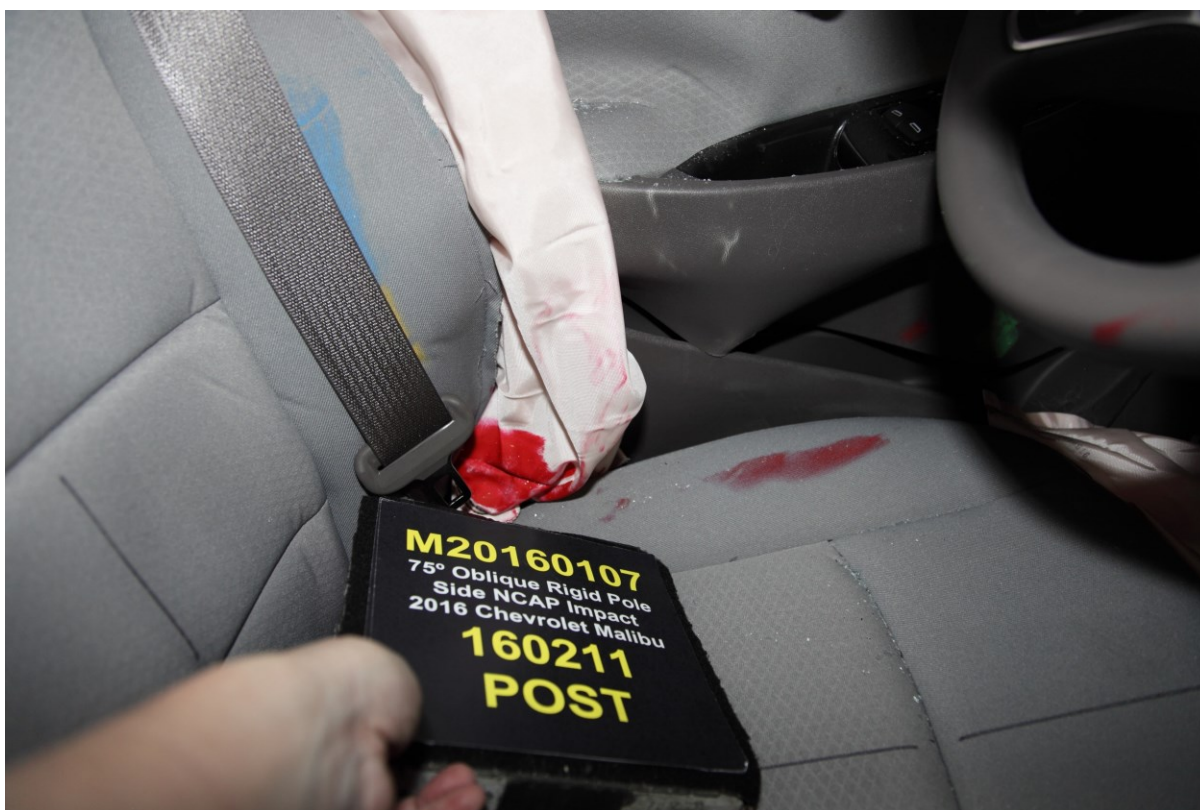
**050** Post-Test Dummy Close-Up Pelvis Contact with Vehicle Interior View

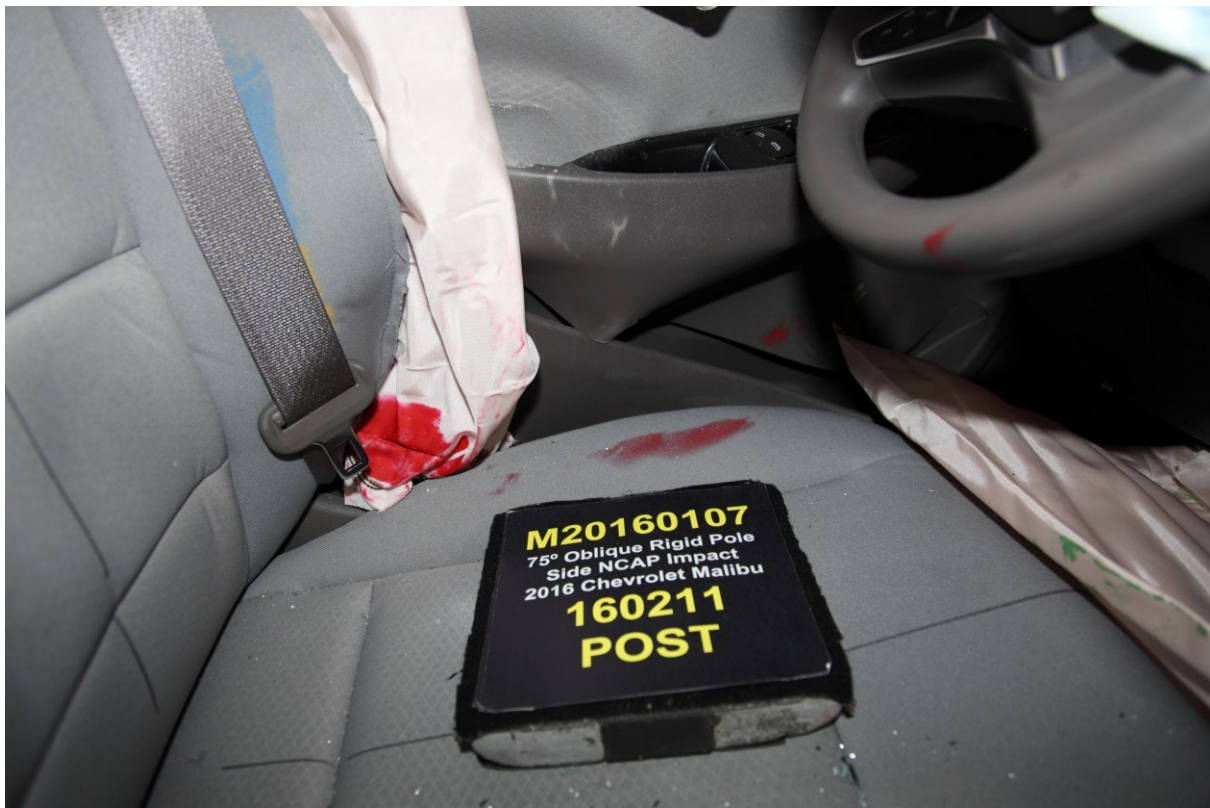
**051** Post-Test Dummy Close-Up Pelvis Contact with Side Airbag View

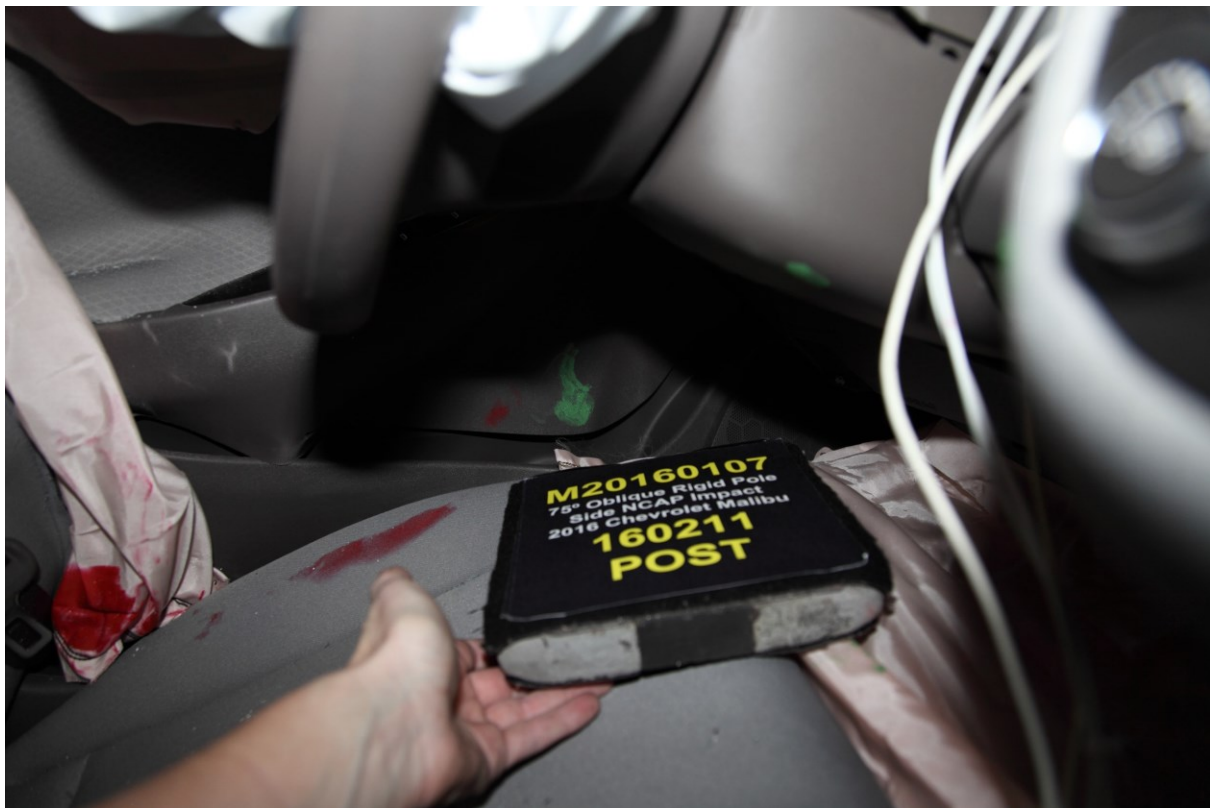
**052** Post-Test Dummy Close-Up Knee Contact with Vehicle Interior View
