**REPORT NUMBER: R&D-CAL-15-010**

**VEHICLE TO FRONTAL BARRIER CRASH TEST IN SUPPORT OF NHTSA'S  
FRONTAL RESEARCH PROGRAM**

**2016 Nissan Rogue**

**56.3 KPH RIGID BARRIER FRONTAL**

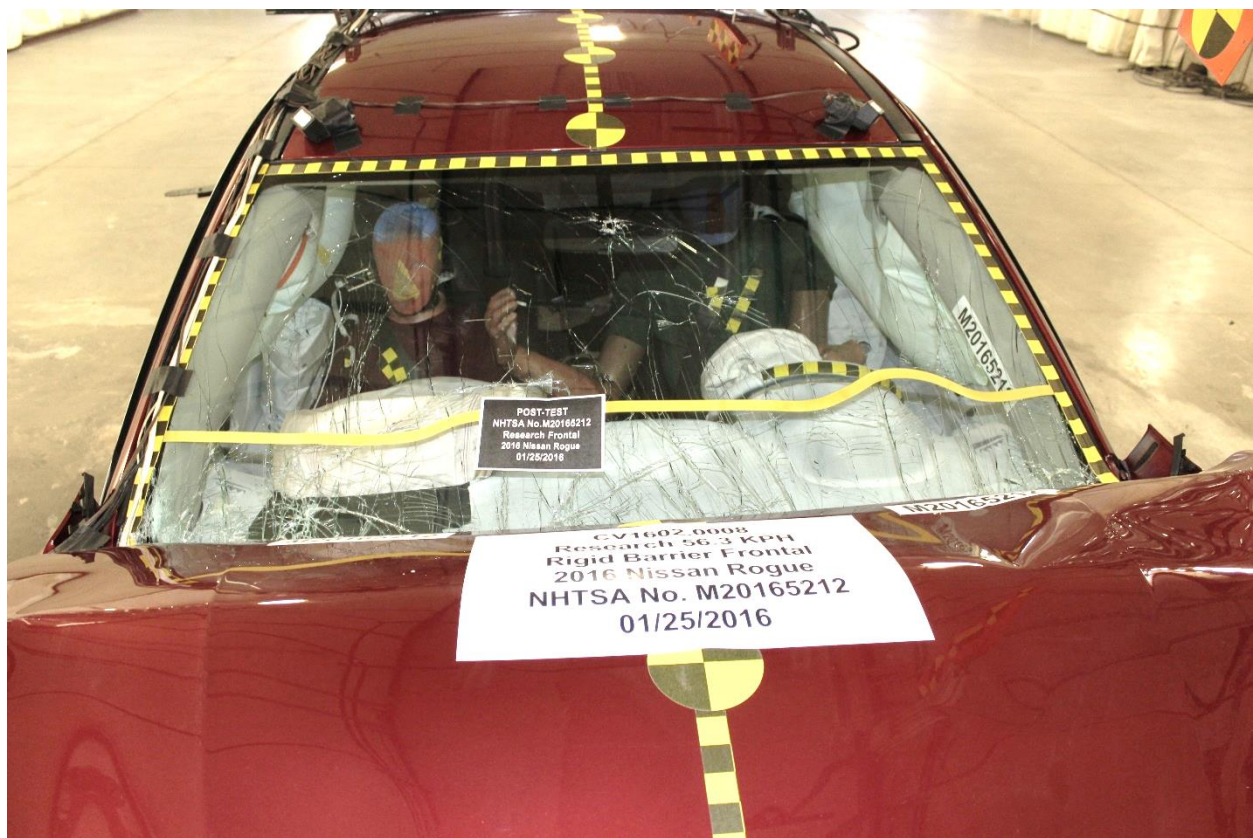
**Figure A-18: Post-Test Windshield View**

| Critical Areas of Performance | Observations and Conclusions |
|---|---|
| Windshield Damage | Cracks throughout with separation along drivers side |

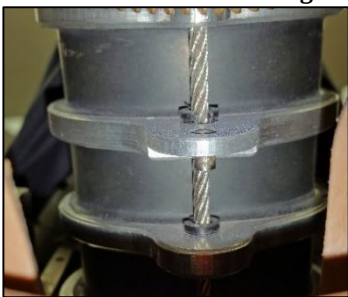
| HEAD | |
|---|---|
| Y / N | No evidence of de-bonding or permanent compression in neck soft stop assemblies<br><b>Front of the neck is missing the soft stop</b> |

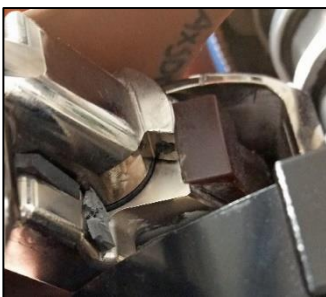
| HEAD | |
|---|---|
| Y / N | No evidence of de-bonding, tearing, or permanent compression of posterior soft stops<br><b>Damage to both the left and right shoulder soft stops. The left shoulder is missing one.</b> |

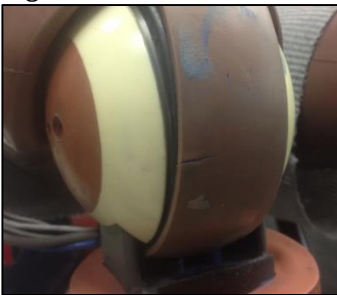
| ABDOMEN | |
|---|---|
| Y / N | No cuts, tears, or scuffing of knee flesh<br><b>Right knee flesh torn</b> |

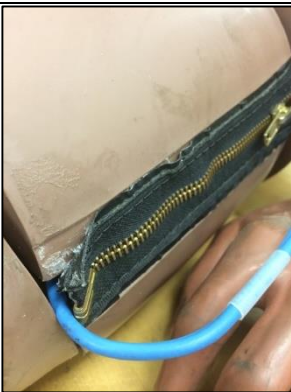
| ABDOMEN | |
|---|---|
| OTHER | Left femur flesh is separating from zipper. We placed gaffer's tape across zipper to prevent further damage. |

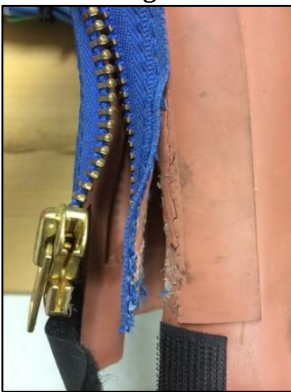
| Y / N | No cuts, tears, or scuffing of leg flesh<br><b>Left lower leg flesh is torn near zipper. We placed gaffer's tape around the flesh to prevent further damage.</b> | |

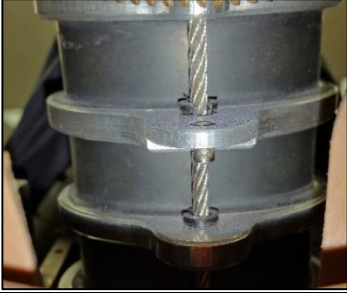
| HEAD | |
|---|---|
| Y / N | No evidence of de-bonding or permanent compression in neck soft stop assemblies<br><b>Front of the neck is missing the soft stop</b> |

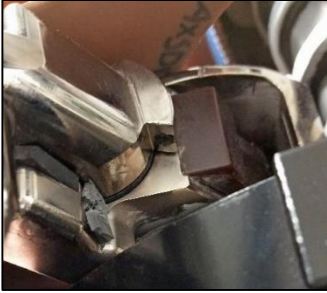
| HEAD | |
|---|---|
| Y / N | No evidence of de-bonding, tearing, or permanent compression of posterior soft stops<br><b>Damage to both the left and right shoulder soft stops. The left shoulder is missing one.</b> |

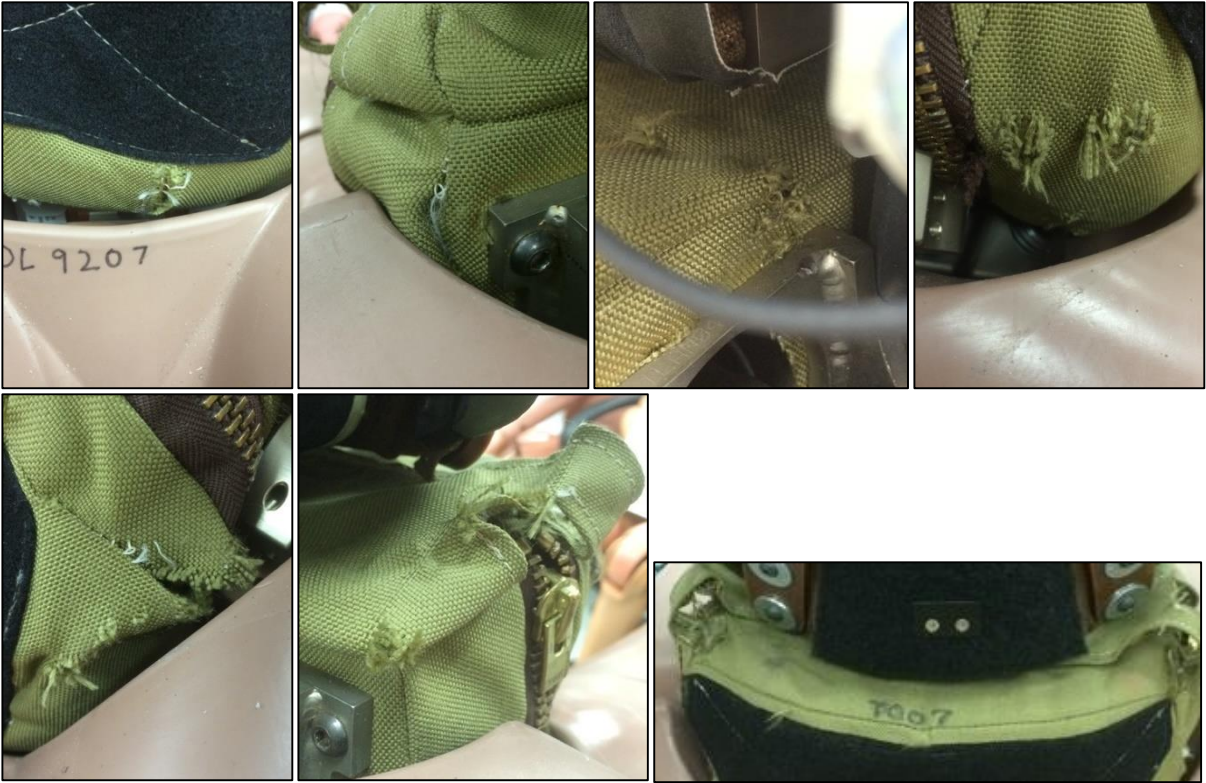
| ABDOMEN | |
|---|---|
| Y / N | No evidence of tearing, cuts, or broken stitches in lower abdomen bag and zipper<br><b>Multiple tears and broken stitches in lower abdomen bag. The upper and lower abdomen bags appear to be from THOR SN007</b> |

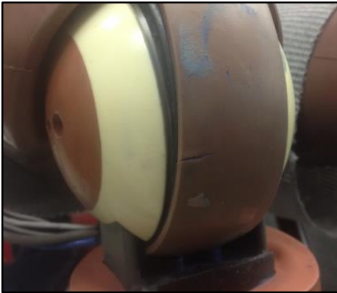
| ABDOMEN | |
|---|---|
| Y / N | No cuts, tears, or scuffing of knee flesh<br><b>Right knee flesh torn</b> |

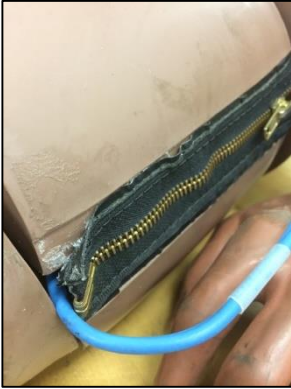
| OTHER | <p><b>Left femur flesh is separating from zipper. We placed gaffer's tape across zipper to prevent further damage.</b></p> |

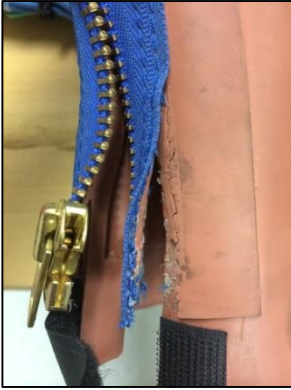
| Y / N | <p>No cuts, tears, or scuffing of leg flesh<br/> <b>Left lower leg flesh is torn near zipper. We placed gaffer's tape around the flesh to prevent further damage.</b></p> |

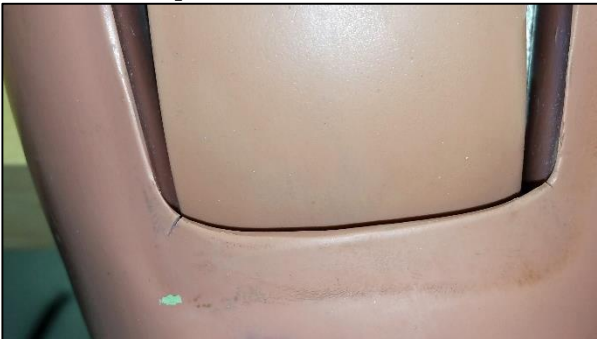
| HEAD | |
|---|---|
| Y / N | Leg flesh is in good condition<br><b>Small cuts at top of tibia flesh:</b><br> |

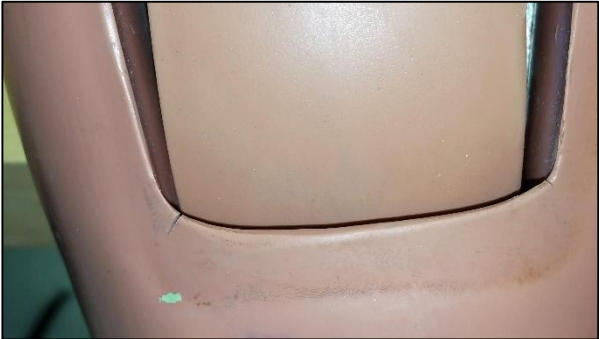
| HEAD | |
|---|---|
| Y / N | Leg flesh is in good condition<br><b>Small cuts at top of tibia flesh:</b> |

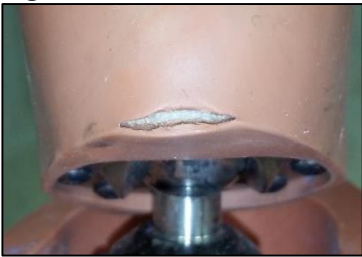
| Y / N | Leg flesh is in good condition<br><b>Right tibia flesh has minor cut at bottom front</b> |

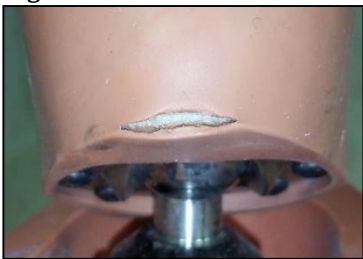
| HEAD | |
|---|---|
| Y / N | Leg flesh is in good condition<br><b>Right tibia flesh has minor cut at bottom front</b> |
