REPORT NUMBER: R&D-CAL-15-018

**MOVING BARRIER TO VEHICLE CRASH TEST IN SUPPORT OF NHTSA'S
FRONTAL OBLIQUE OFFSET PROGRAM
OBLIQUE MOVING DEFORMABLE BARRIER INTO LEFT FRONT OF A**

2016 Honda Fit

90.1KPH, 15 DEGREE ANGLE, 35% OVERLAP

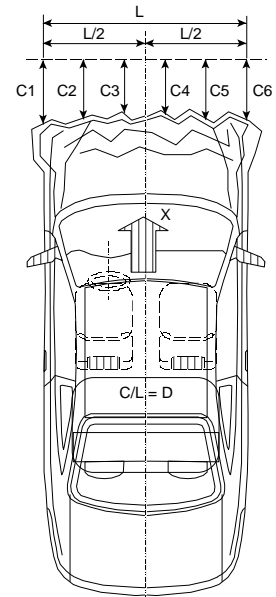
CRUSH PROFILE

Collision Deformation Classification: 12FLEE6
Midpoint of Damage: C2
Damage Region Length (mm): 1341
Impact Mode: Frontal 15° Angle, 35% Left Offset

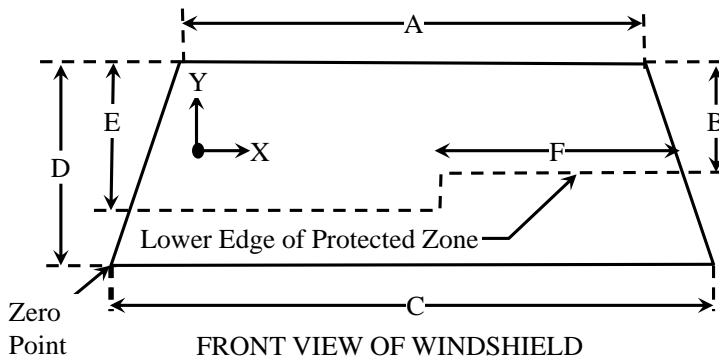
WINDSHIELD PERIPHERY MEASUREMENTS

Measurement	Pre-Test (mm)	Post-Test (mm)	% Retention
Left Side	2157	1952	90.5
Right Side	2168	2168	100
Total	4325	4120	95.3

Item	Units	Value
A	mm	1076
B	mm	503
C	mm	1348
D	mm	956
E	mm	601
F	mm	432

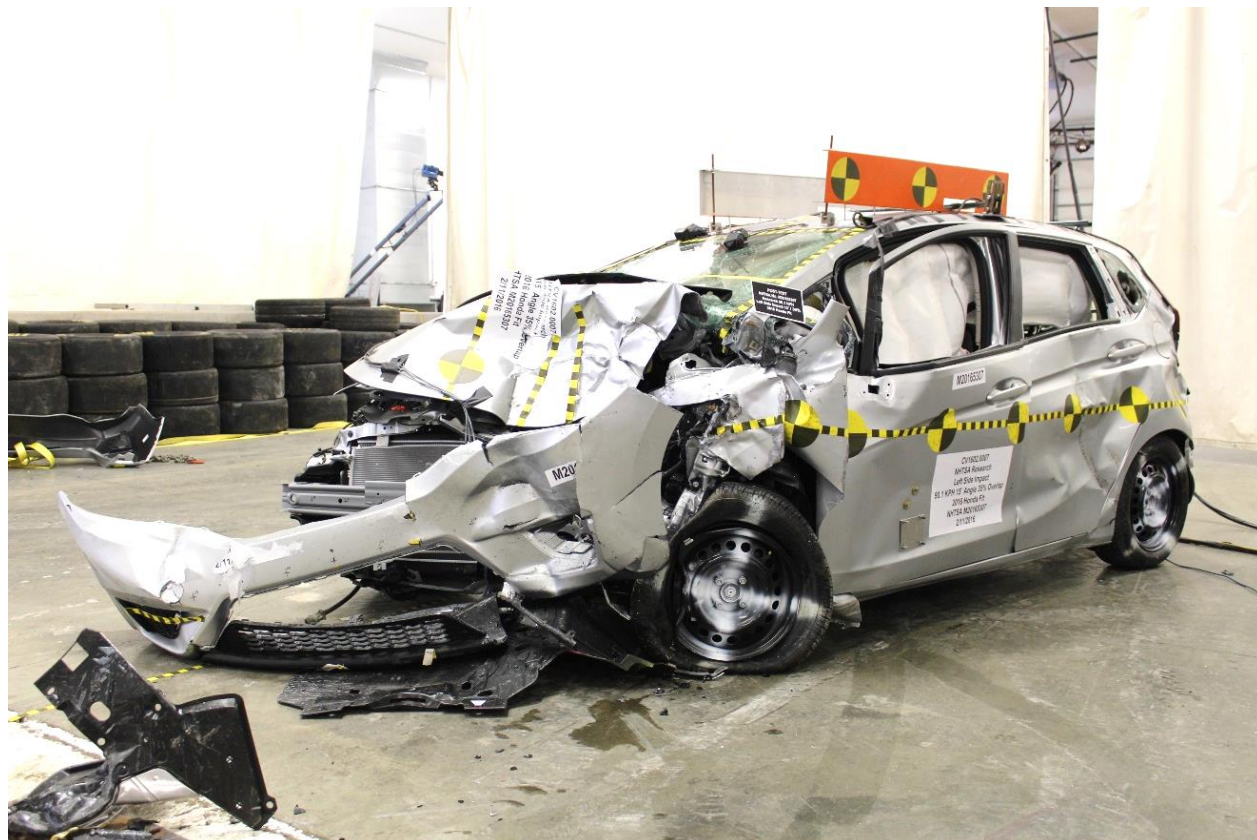
No. 008 Post-Test Left Front 3-4 View of Test Vehicle

- Windshield had cracks throughout with minor separation along the driver side. And an 800mm tear along the passenger side
- The A-Pillar, B-Pillar and C-Pillars Buckled during impact
- Driver's Side Sill Buckled
- Hood bent inwards and exposed part of the engine compartment

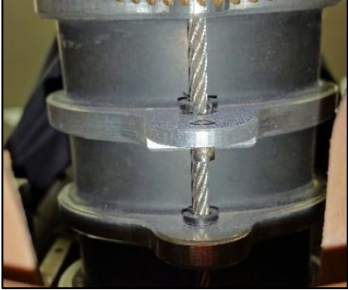
HEAD	
Y / N	Rear head cap mounts securely to head
Y / N	Head skin fits securely over skull
Y / N	Head skin shows no sign of tears or damage
Y / N	Interior components of skull cavity (ballast, accelerometer mount, accelerometers) securely attached
Y / N	Head securely mounted to OC joint
OTHER	
NECK	
Y / N	Neck cables slide freely through holes in neck plates
Y / N	Neck cables show no sign of fraying, broken strands, or kinking
Y / N	No evidence of de-bonding between neck pucks and plates
Y / N	No evidence of de-bonding or permanent compression in neck soft stop assemblies Front of the neck is missing the soft stop

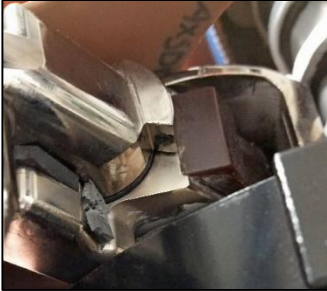
Y / N	No evidence of de-bonding, tearing, or permanent compression of posterior soft stops Damage to both the left and right shoulder soft stops. The left shoulder is missing one.
	Left:

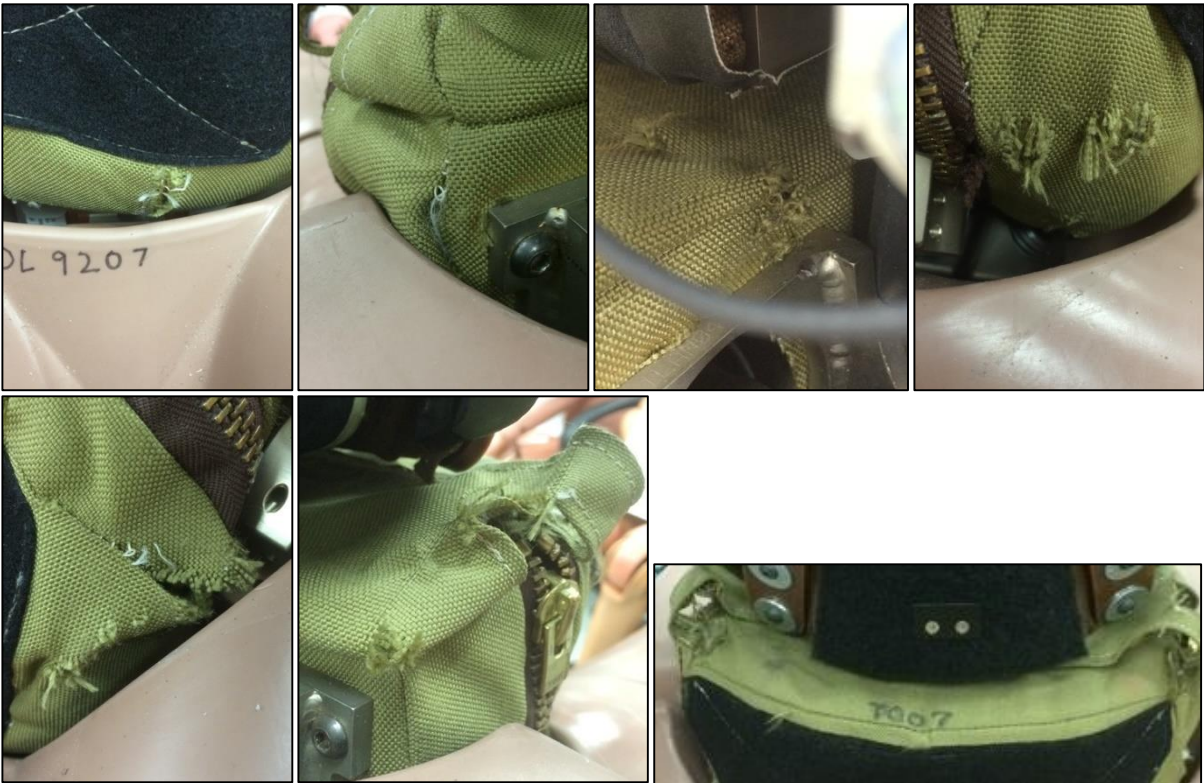
ABDOMEN	
Y / N	No evidence of tearing, cuts, or broken stitches in upper abdomen bag and zipper
Y / N	Upper abdomen insert securely attached to spine
Y / N	Upper abdomen insert shows no evidence of permanent set
Y / N	No evidence of tearing, cuts, or broken stitches in lower abdomen bag and zipper Multiple tears and broken stitches in lower abdomen bag. The upper and lower abdomen bags appear to be from THOR SN007

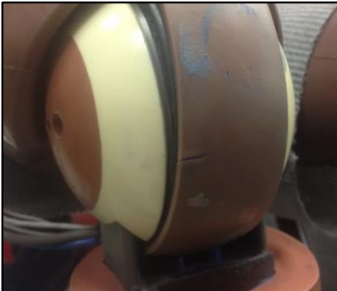
Y / N	Lower abdomen insert securely attached to spine
Y / N	Lower abdomen insert shows no evidence of permanent set
OTHER	
PELVIS	
Y / N	Pelvis flesh fits securely over pelvis bones
Y / N	H-point tool fits securely into hole on both sides of pelvis
OTHER	
FEMUR	
Y / N	Acetabular load cells firmly attached
Y / N	Femur load cells firmly attached
Y / N	No evidence of deformation of knee slider bump stop
Y / N	No cuts, tears, or scuffing of knee flesh Right knee flesh torn

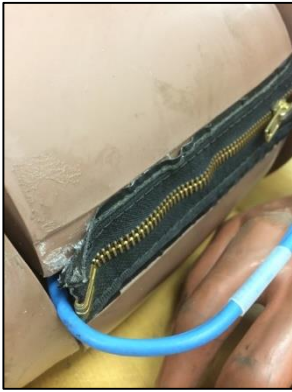
OTHER	<p>Left femur flesh is separating from zipper. We placed gaffer's tape across zipper to prevent further damage.</p>

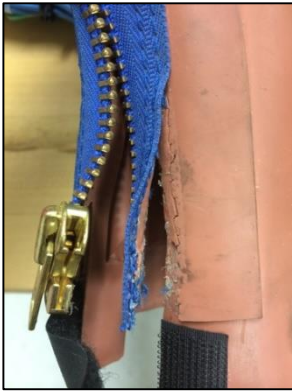
LOWER EXTREMITY (LX)	
Y / N	Rotational potentiometers in ankle securely attached
Y / N	Achilles tendon provides resistance to dorsiflexion
Y / N	No evidence of de-bonding, tearing, or permanent compression of ankle soft stops
Y / N	<p>No cuts, tears, or scuffing of leg flesh Left lower leg flesh is torn near zipper. We placed gaffer's tape around the flesh to prevent further damage.</p>

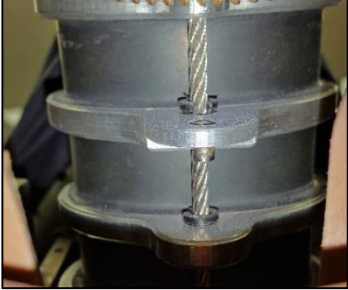
HEAD	
Y / N	Rear head cap mounts securely to head
Y / N	Head skin fits securely over skull
Y / N	Head skin shows no sign of tears or damage
Y / N	Interior components of skull cavity (ballast, accelerometer mount, accelerometers) securely attached
Y / N	Head securely mounted to OC joint
OTHER	
NECK	
Y / N	Neck cables slide freely through holes in neck plates
Y / N	Neck cables show no sign of fraying, broken strands, or kinking
Y / N	No evidence of de-bonding between neck pucks and plates
Y / N	No evidence of de-bonding or permanent compression in neck soft stop assemblies Front of the neck is missing the soft stop

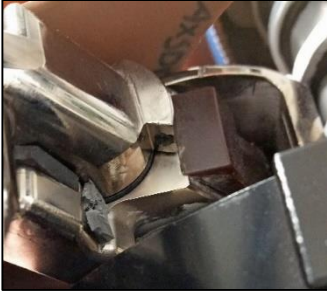
Y / N	No evidence of de-bonding, tearing, or permanent compression of posterior soft stops Damage to both the left and right shoulder soft stops. The left shoulder is missing one.
	Left:

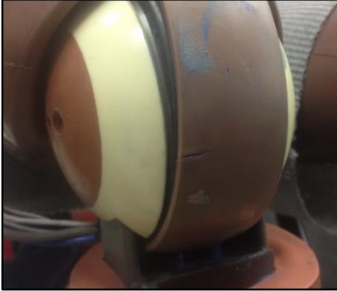
FEMUR	
Y / N	Acetabular load cells firmly attached
Y / N	Femur load cells firmly attached
Y / N	No evidence of deformation of knee slider bump stop
Y / N	No cuts, tears, or scuffing of knee flesh Right knee flesh torn

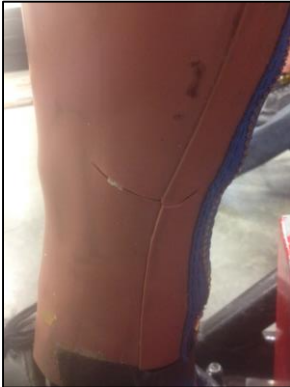
LOWER EXTREMITY (LX)	
Y / N	Rotational potentiometers in ankle securely attached
Y / N	Achilles tendon provides resistance to dorsiflexion
Y / N	No evidence of de-bonding, tearing, or permanent compression of ankle soft stops
Y / N	No cuts, tears, or scuffing of leg flesh Right lower leg flesh has large cut.

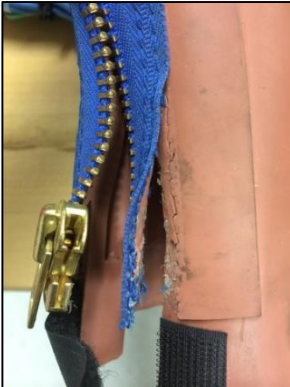
Left lower leg flesh is torn near zipper. We placed gaffer's tape around the flesh to prevent further damage.

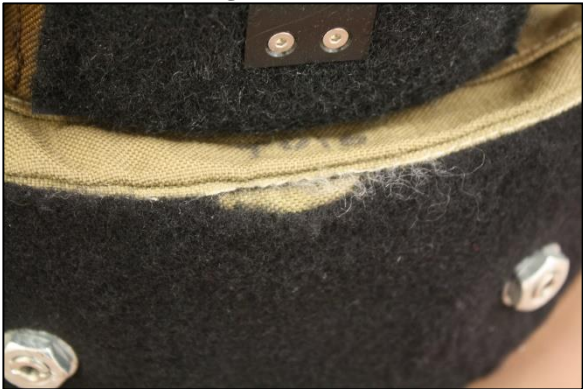
Y / N	No evidence of tearing, cuts, or broken stitches in lower abdomen bag and zipper Tear in center of bag.

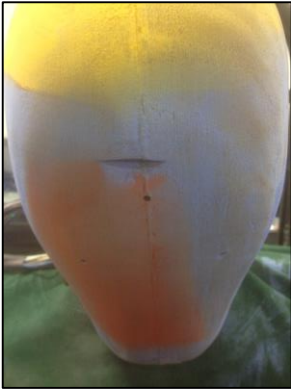
HEAD	
Y / N	Rear head cap mounts securely to head
Y / N	Head skin fits securely over skull
Y / N	Head skin shows no sign of tears or damage Small cut in center of face above Nasion

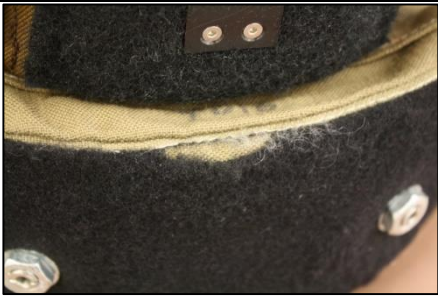
Y / N	Upper abdomen insert securely attached to spine
Y / N	Upper abdomen insert shows no evidence of permanent set
Y / N	No evidence of tearing, cuts, or broken stitches in lower abdomen bag and zipper Tear in center of bag.
