**REPORT NUMBER: SPNCAP-MGA-2016-038**

**NEW CAR ASSESSMENT PROGRAM (NCAP)  
Side Impact Pole Test**

**TOYOTA MOTOR MANUFACTURING CANADA, INC.  
2016 Lexus RX 350 5-Door SUV  
NHTSA No.: M20165104**

**FINAL REPORT**

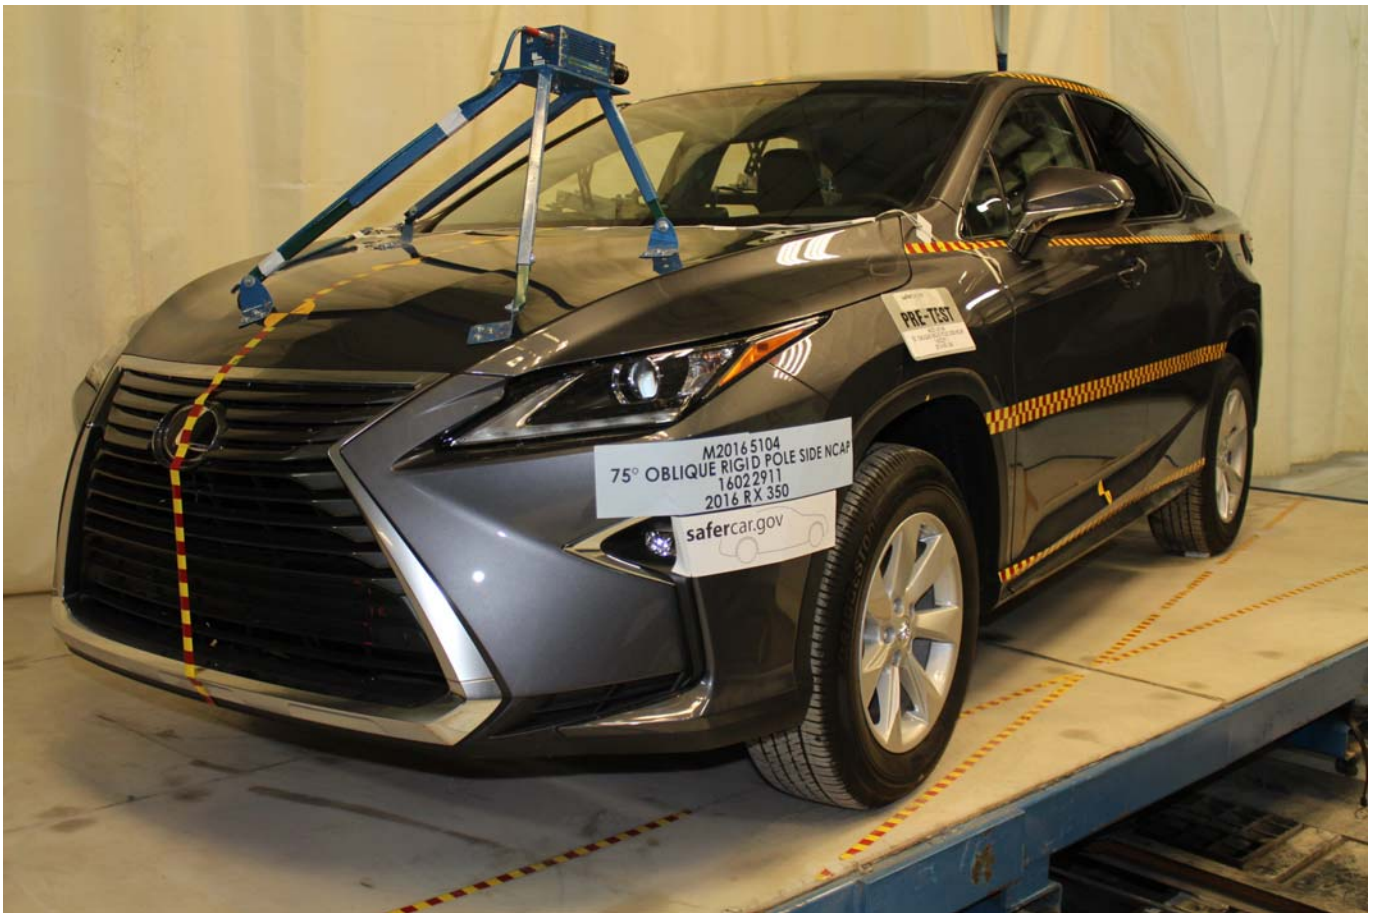
Photo No. 004 - Post-Test Frontal View of Test Vehicle

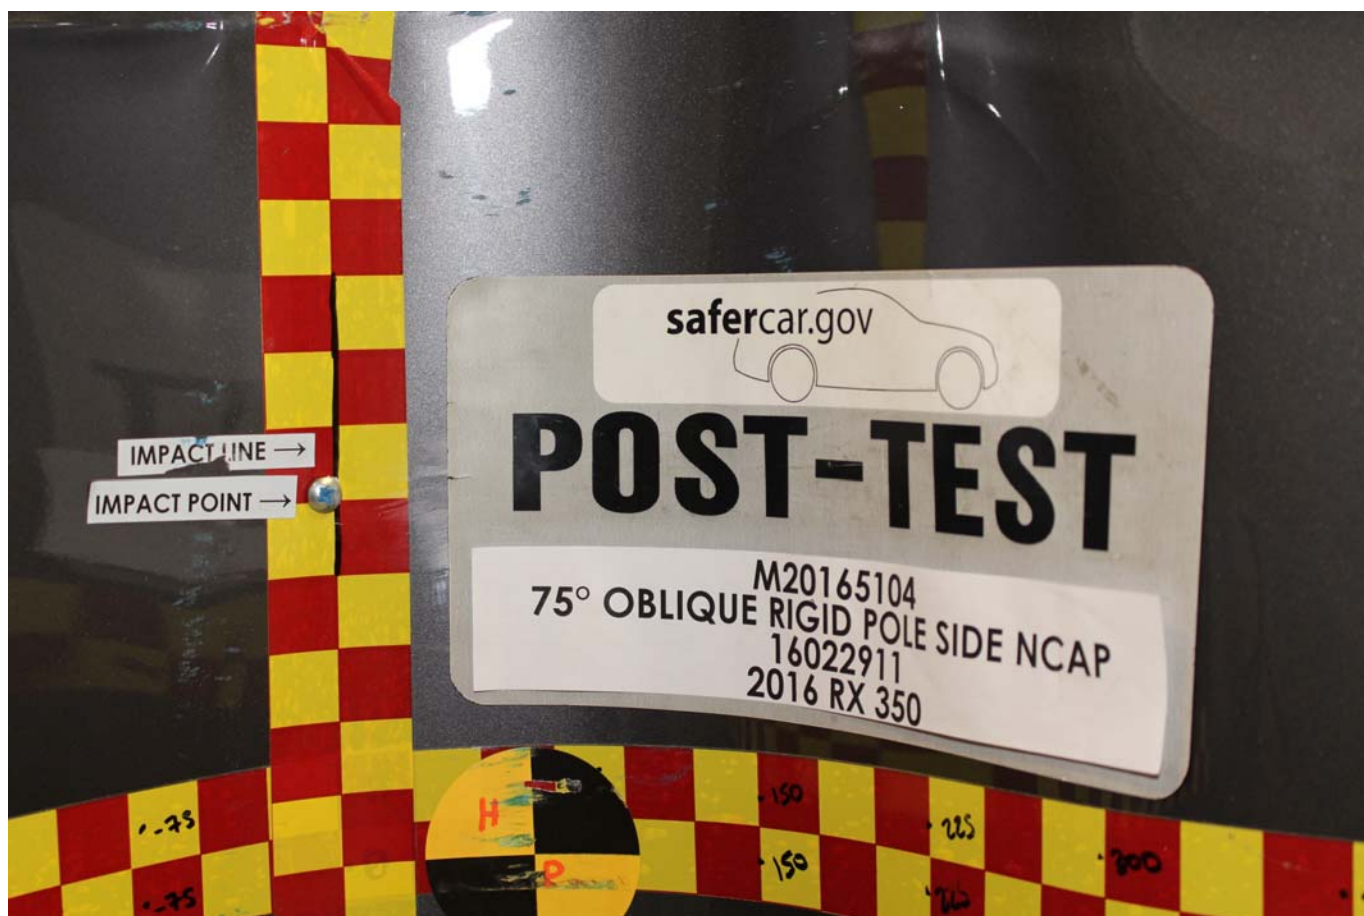
Photo No. 020 - Post-Test Close-Up View of Impact Point Target Showing Impact Location

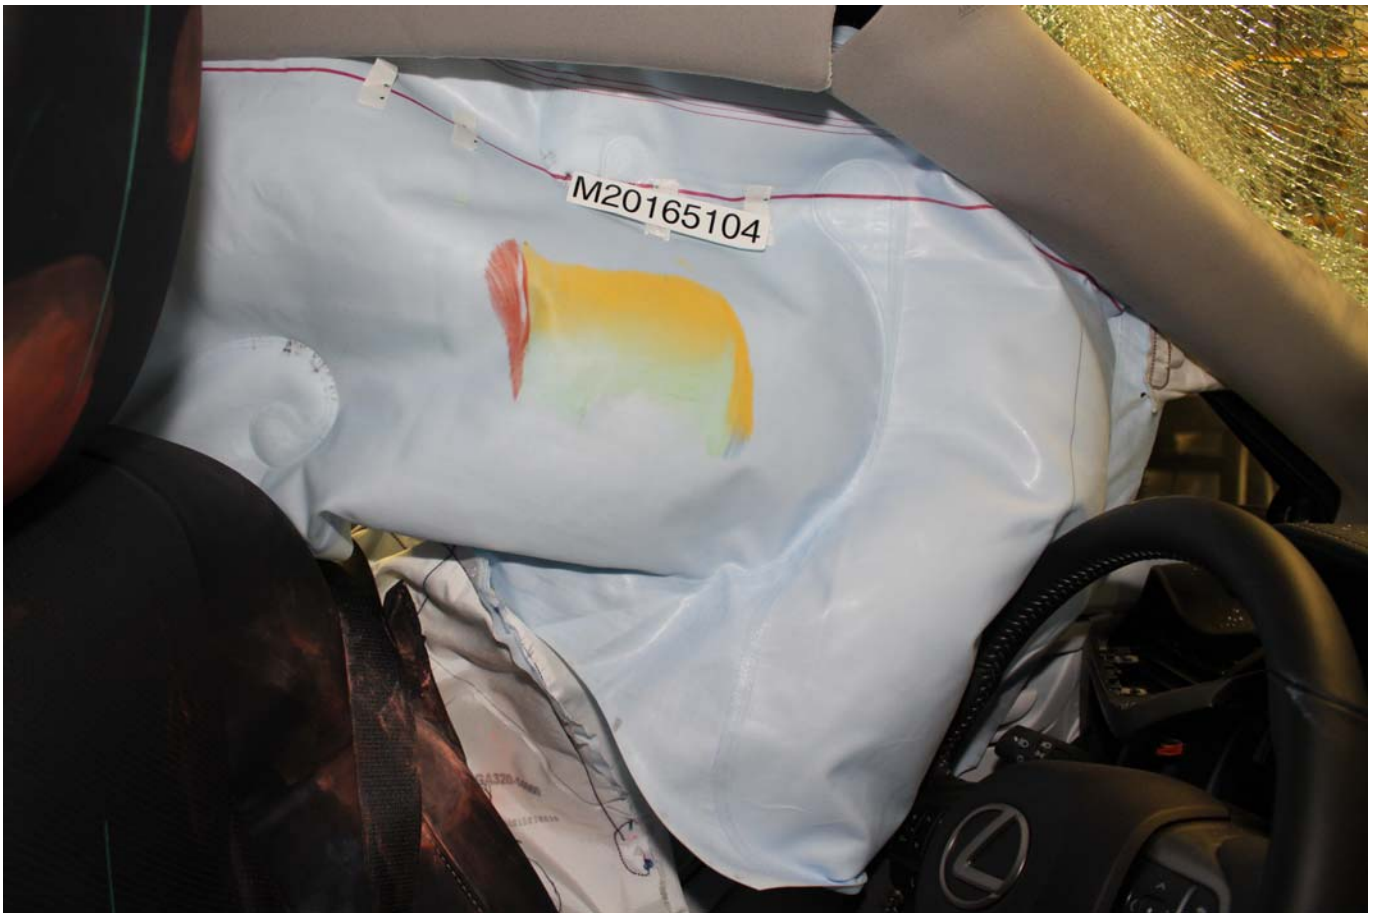
Photo No. 046 - Post-Test Dummy Close-Up Head Contact with Vehicle Interior View

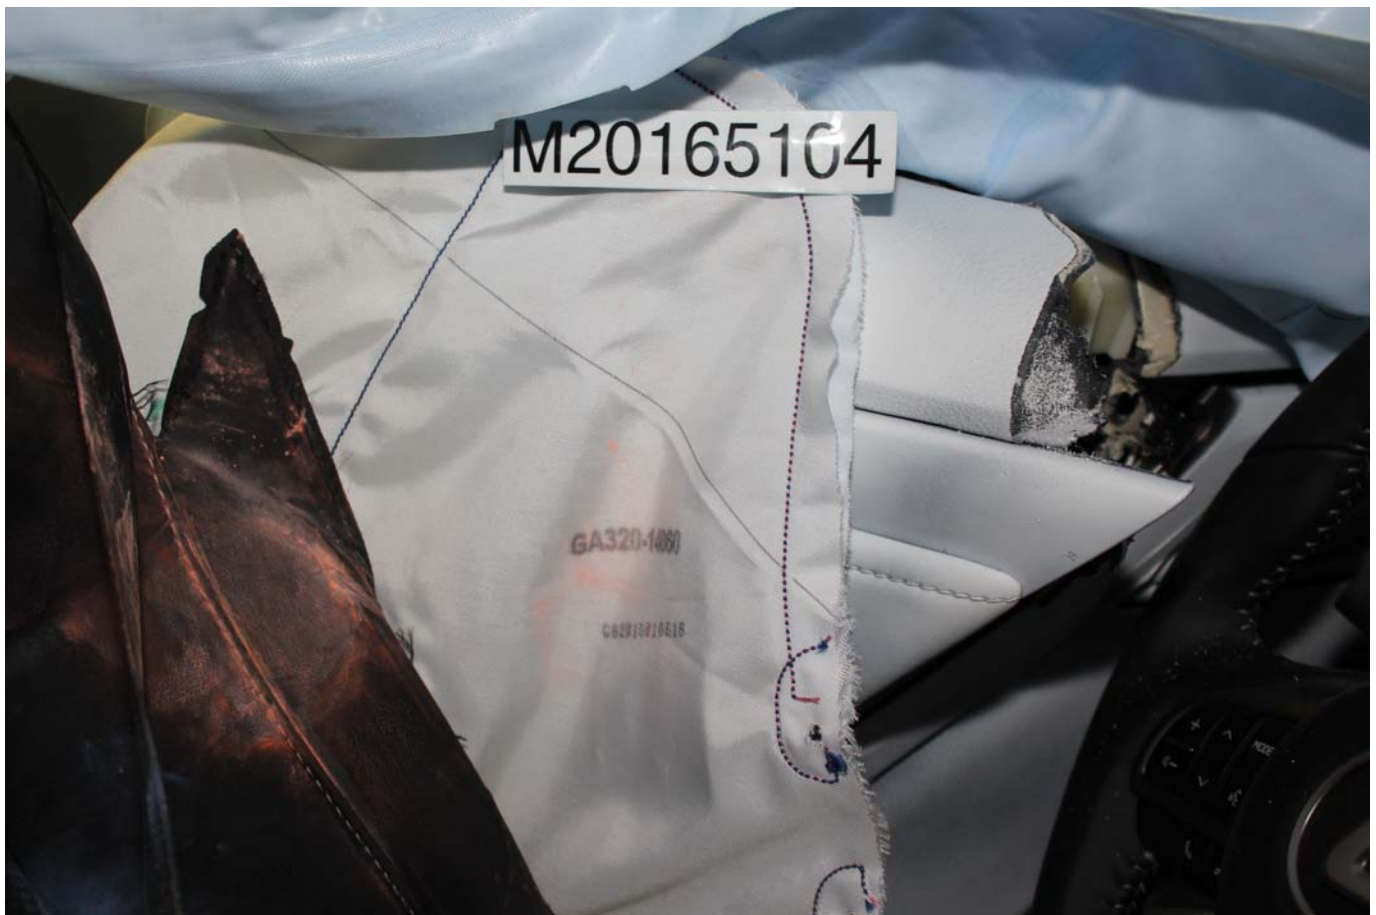
Photo No. 048 - Post-Test Dummy Close-Up Torso Contact with Vehicle Interior View

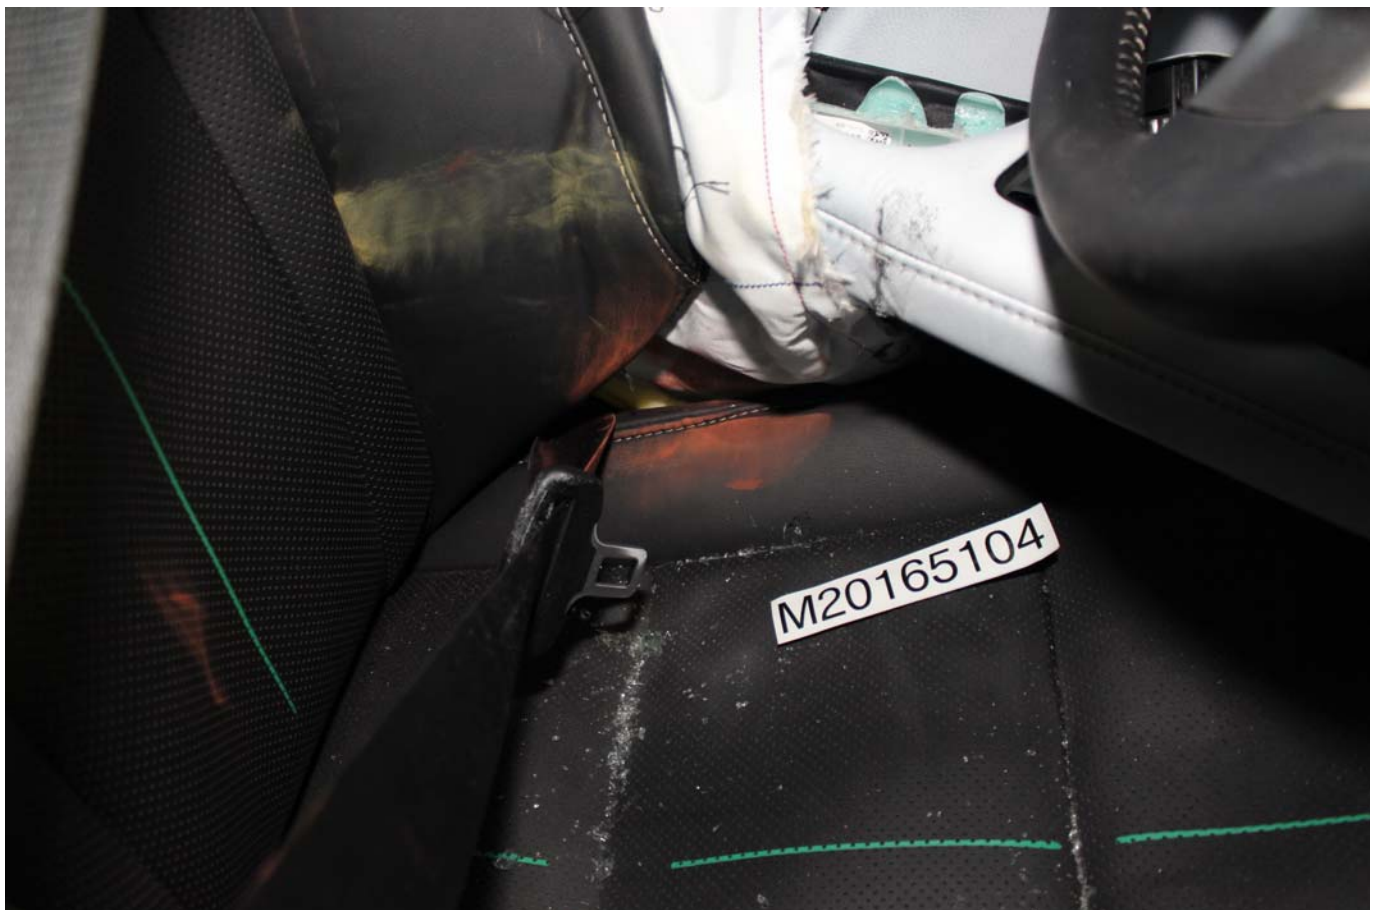
Photo No. 049 - Post-Test Dummy Close-Up Torso Contact with Side Air Bag View

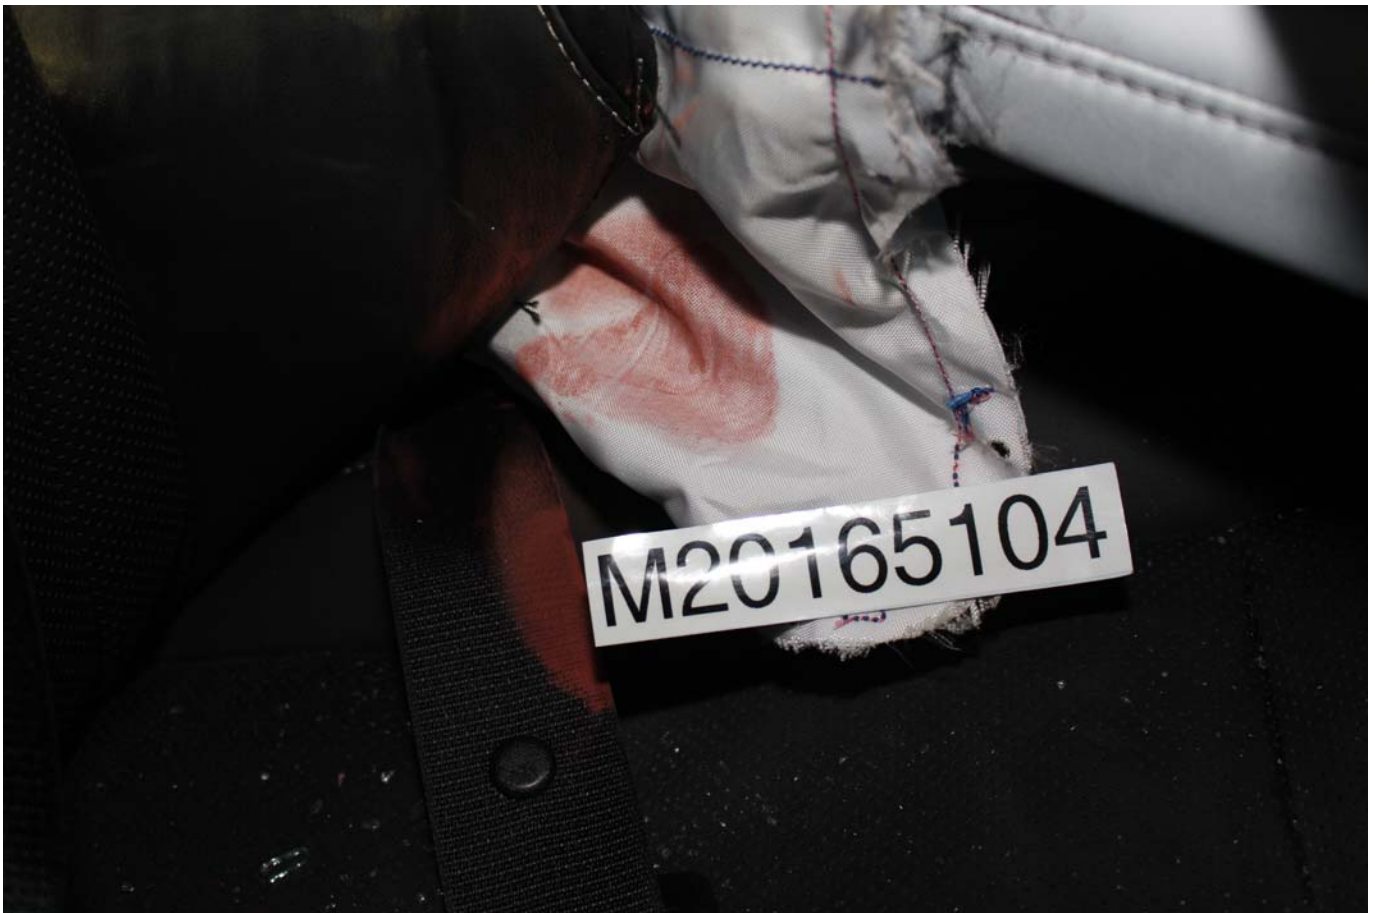
Photo No. 050 - Post-Test Dummy Close-Up Pelvis Contact with Vehicle Interior View

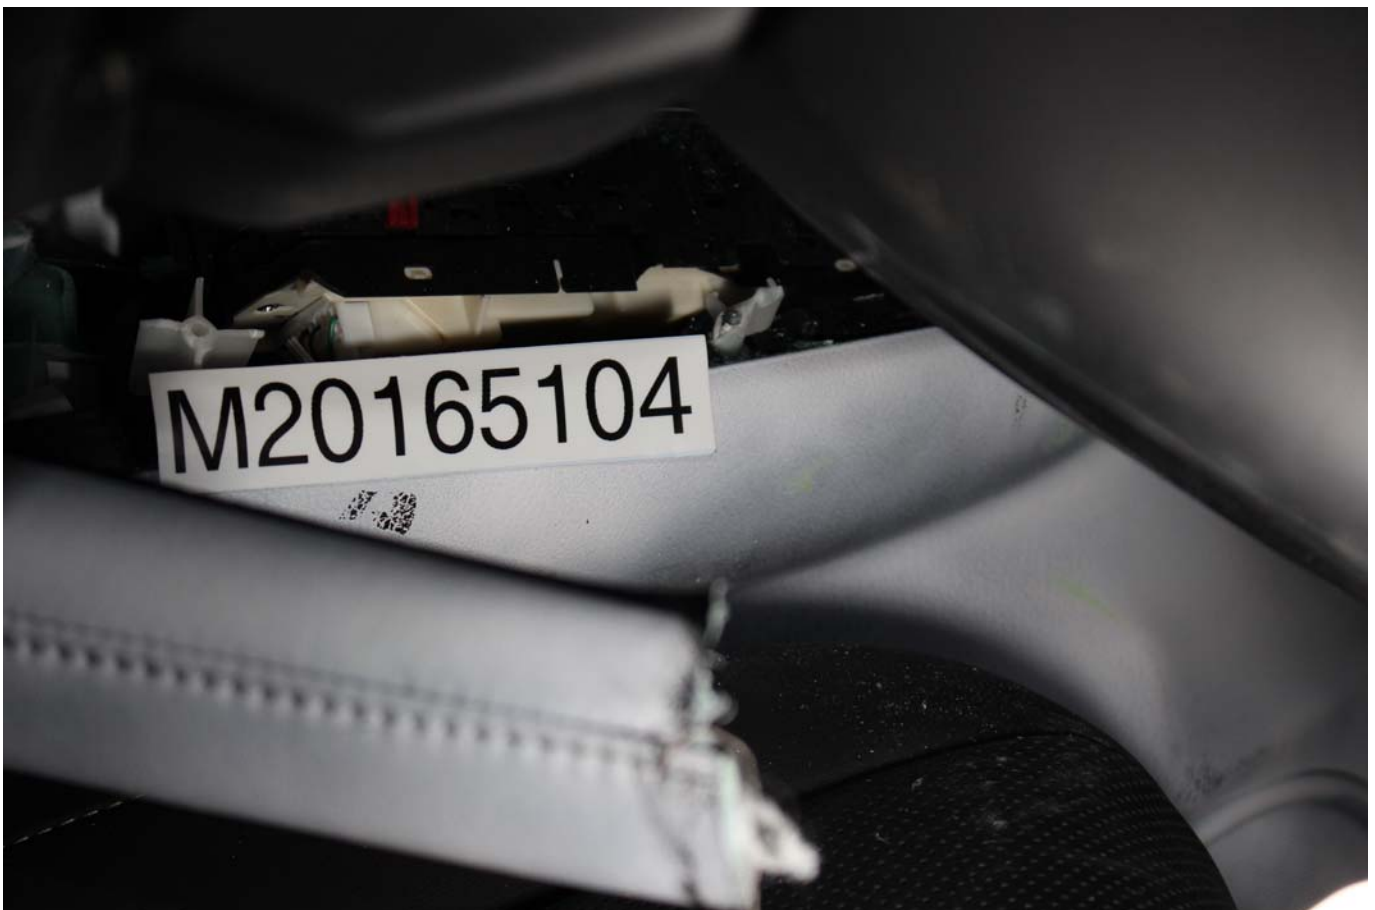
Photo No. 051 - Post-Test Dummy Close-Up Pelvis Contact with Side Air Bag View

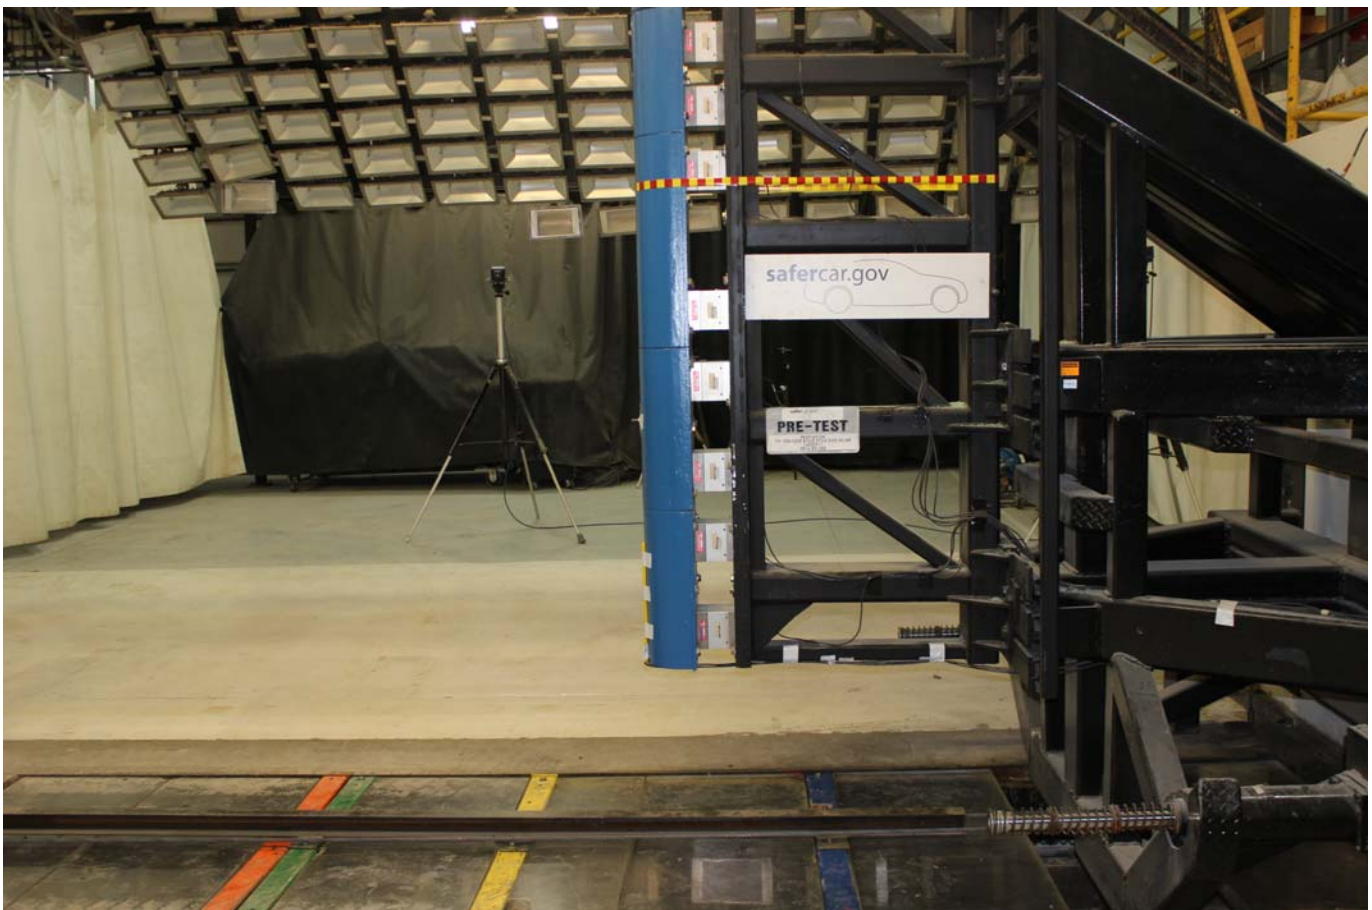
Photo No. 058 - Post-Test Pole Barrier Front View
