**REPORT NUMBER: SPNCAP-CAL-16-005**

**NEW CAR ASSESSMENT PROGRAM (NCAP)  
SIDE IMPACT POLE TEST**

**Toyota Motor Manufacturing, Kentucky, INC.  
2016 Toyota Avalon  
Four Door Sedan**

**FINAL REPORT**

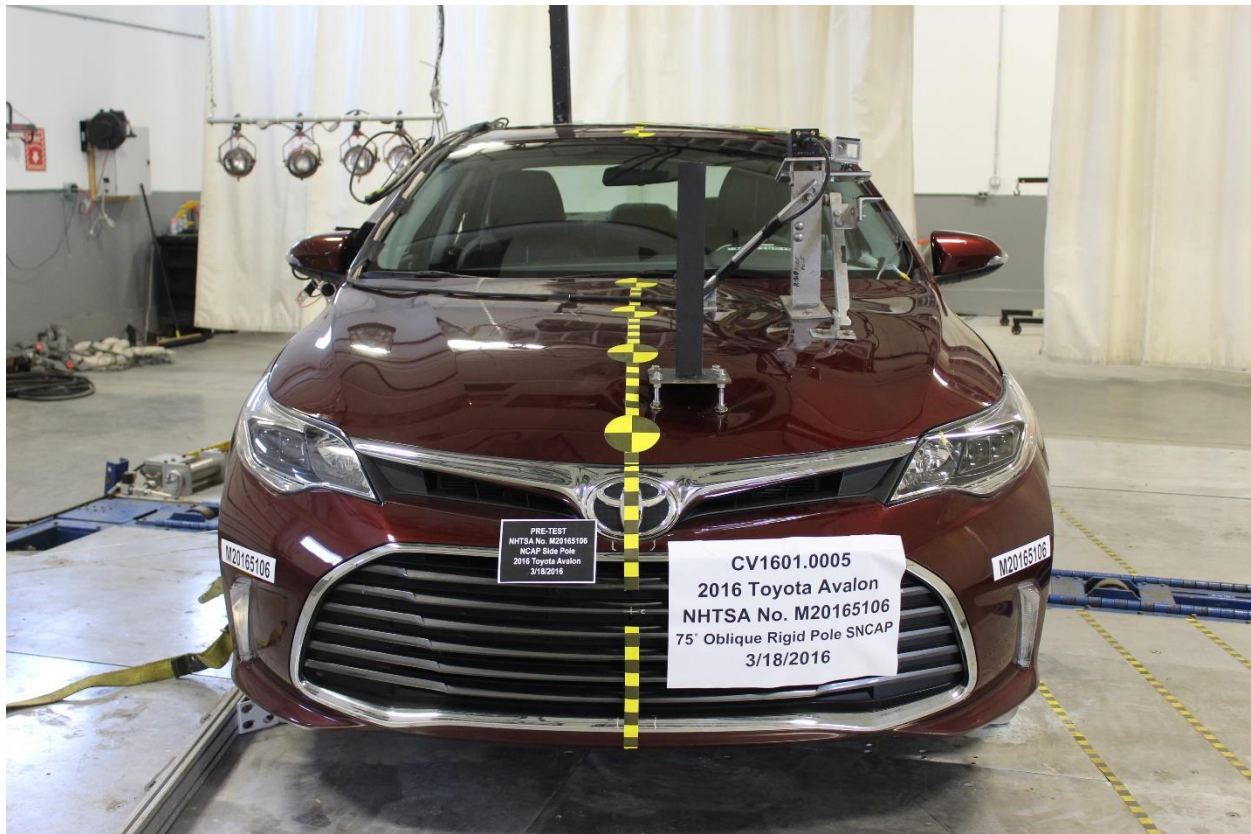
**Figure A-3: Pre-Test Frontal View of Test Vehicle**

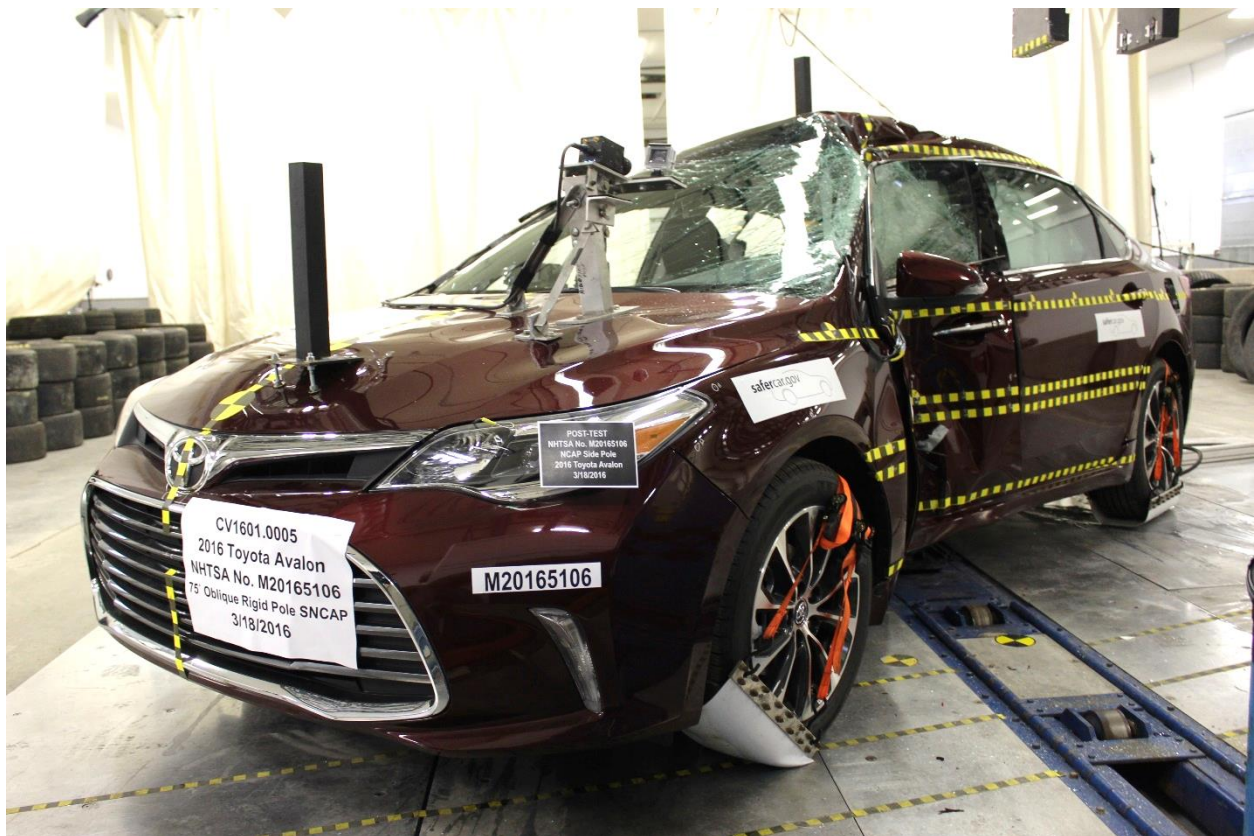
**Figure A-6: Post-Test Left Front  $\frac{3}{4}$  View of Test Vehicle**

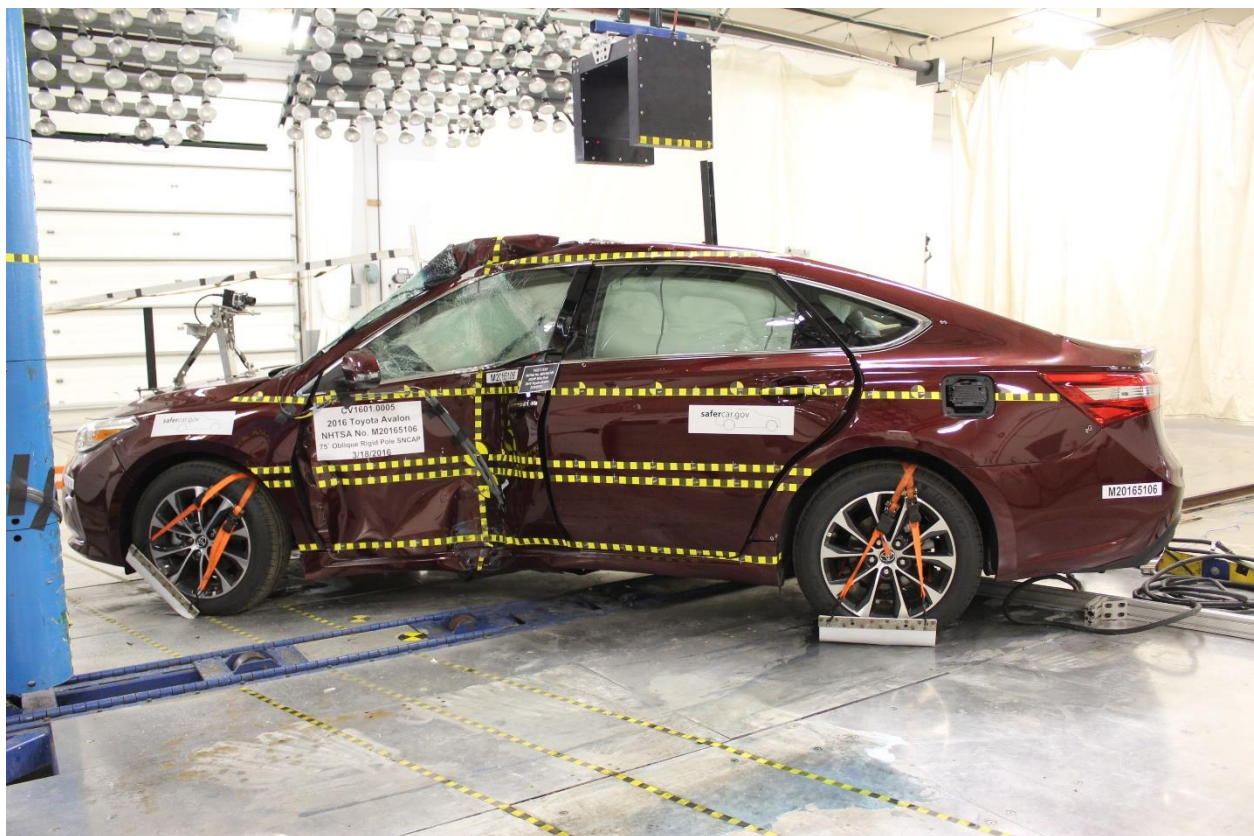
**Figure A-8: Post-Test Left Side View of Test Vehicle**

| Critical Areas of Performance | Observations and Conclusions |
|---|---|
| Windshield Damage | Front Windshield separated along A-Pillar |
| Side Window Damage | Driver window cracked throughout |

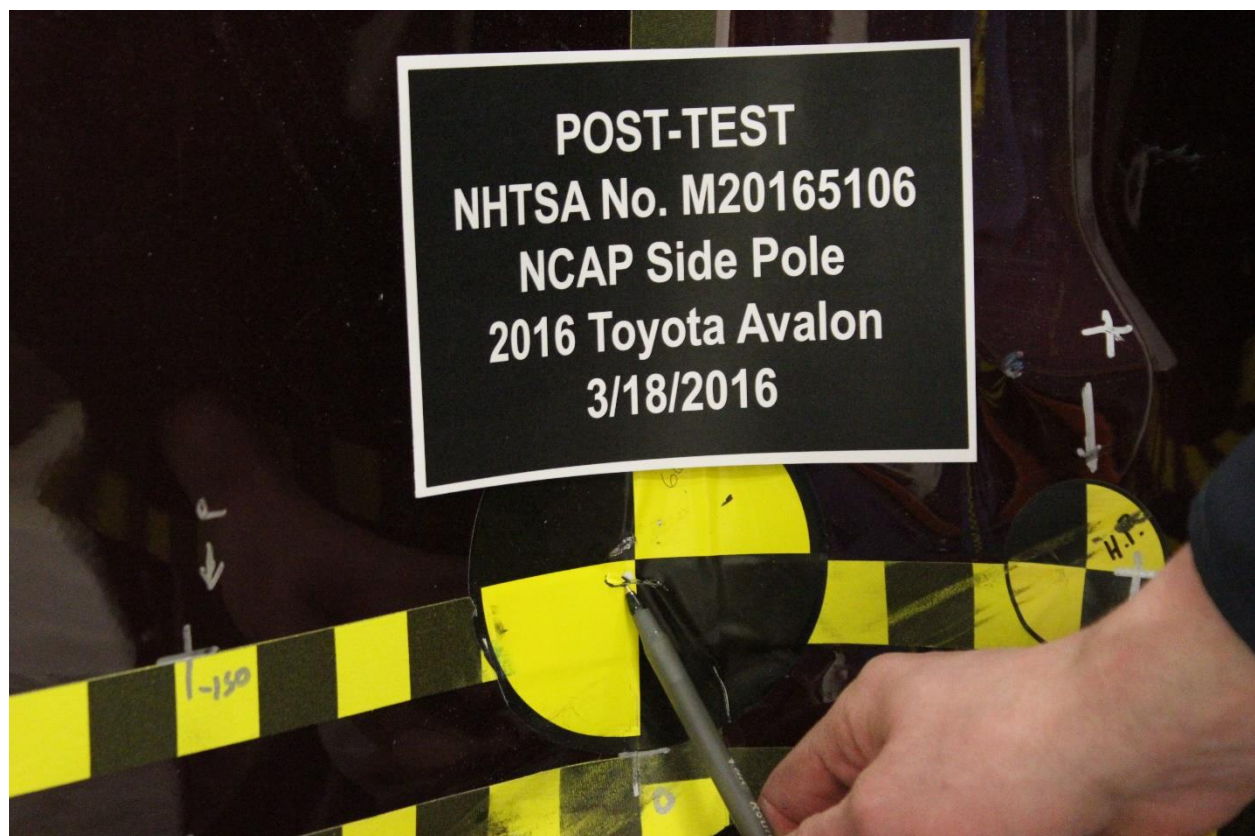
Figure A-20: Post-Test Close-Up View of Impact Point Target Showing Impact Location

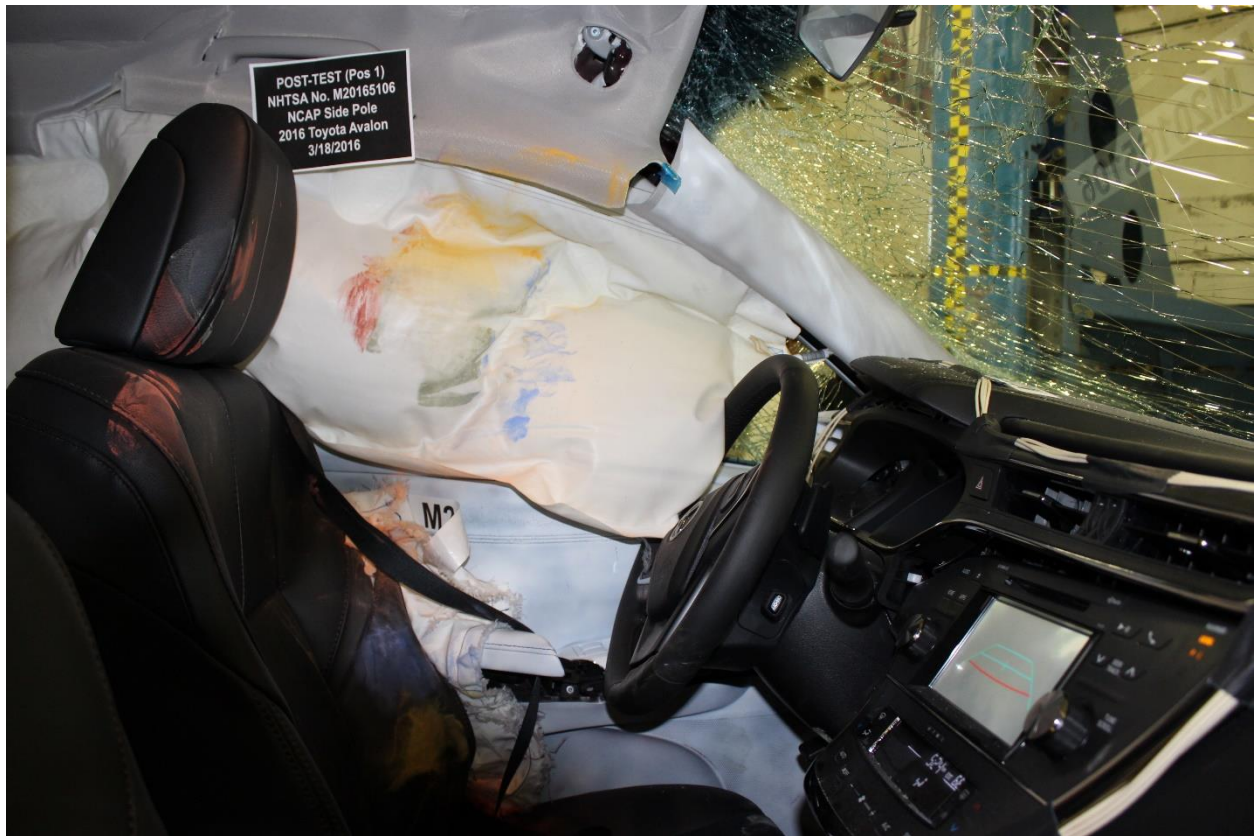
**Figure A-45: Post-Test Inner Door Panel View Showing Dummy Contact Location**

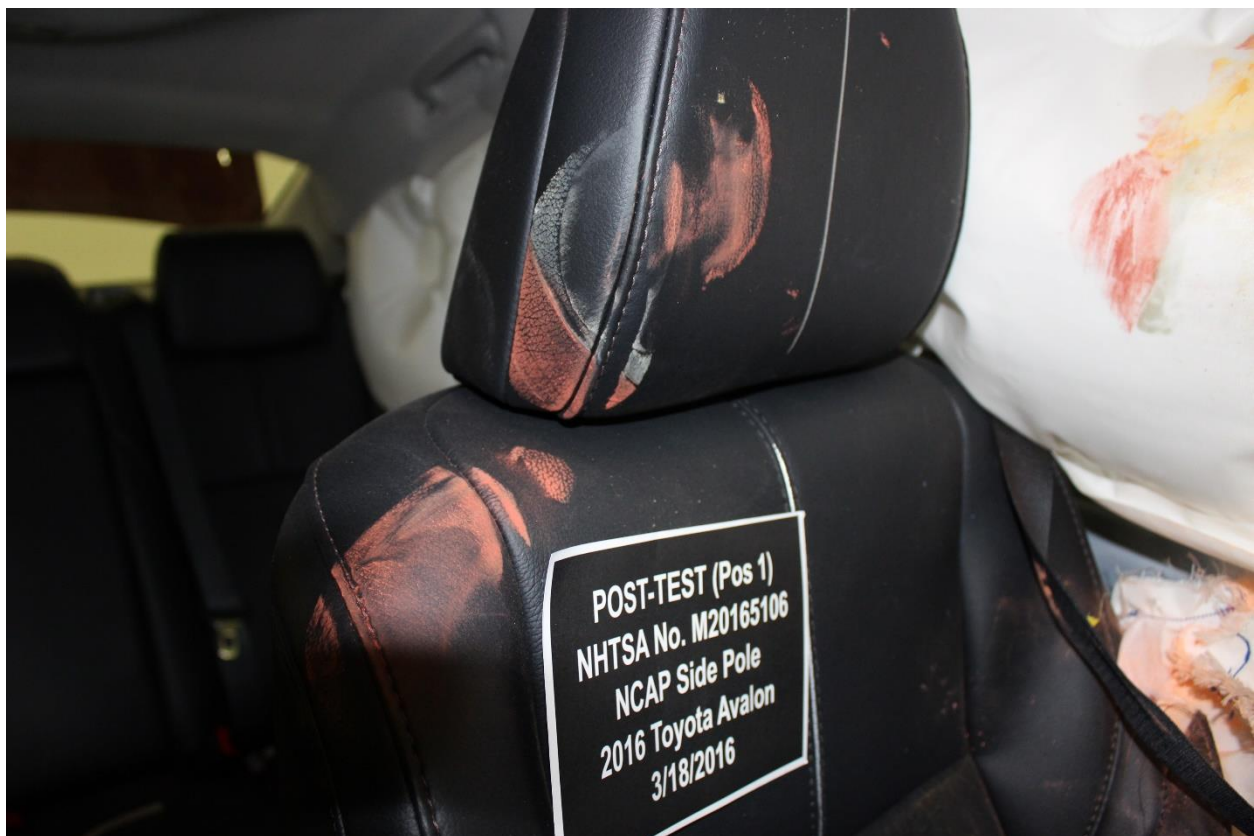
**Figure A-46: Post-Test Dummy Close-Up Head Contact with Vehicle Interior View**

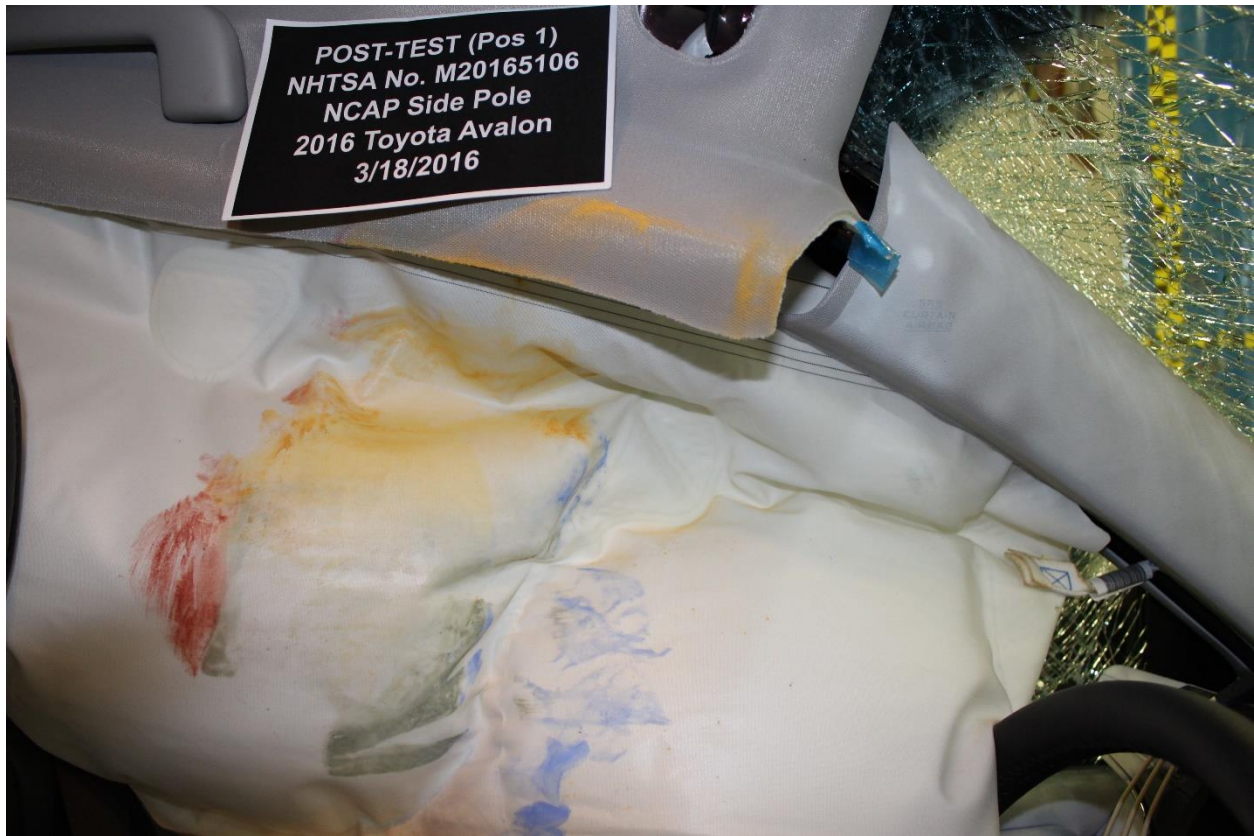
**Figure A-47: Post-Test Dummy Close-Up Head Contact with Side Airbag View**

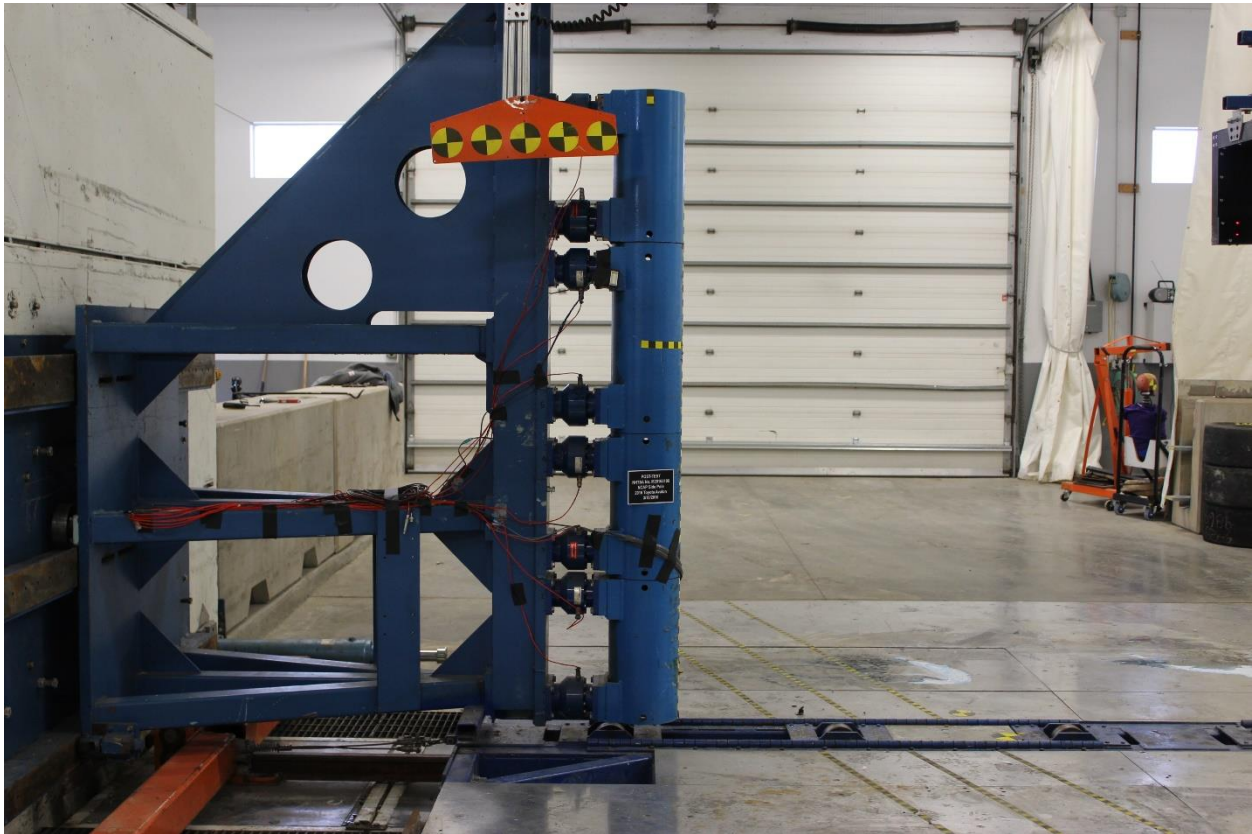
**Figure A-60: Post-Test Pole Barrier Side View**
