**REPORT NUMBER: NCAP-MGA-2016-044**

**NEW CAR ASSESSMENT PROGRAM (NCAP)  
Frontal Barrier Impact Test**

**TOYOTA MOTOR CORPORATION  
2016 Toyota Prius c One 5-Door Hatchback  
NHTSA No.: M20165111**

**FINAL REPORT**

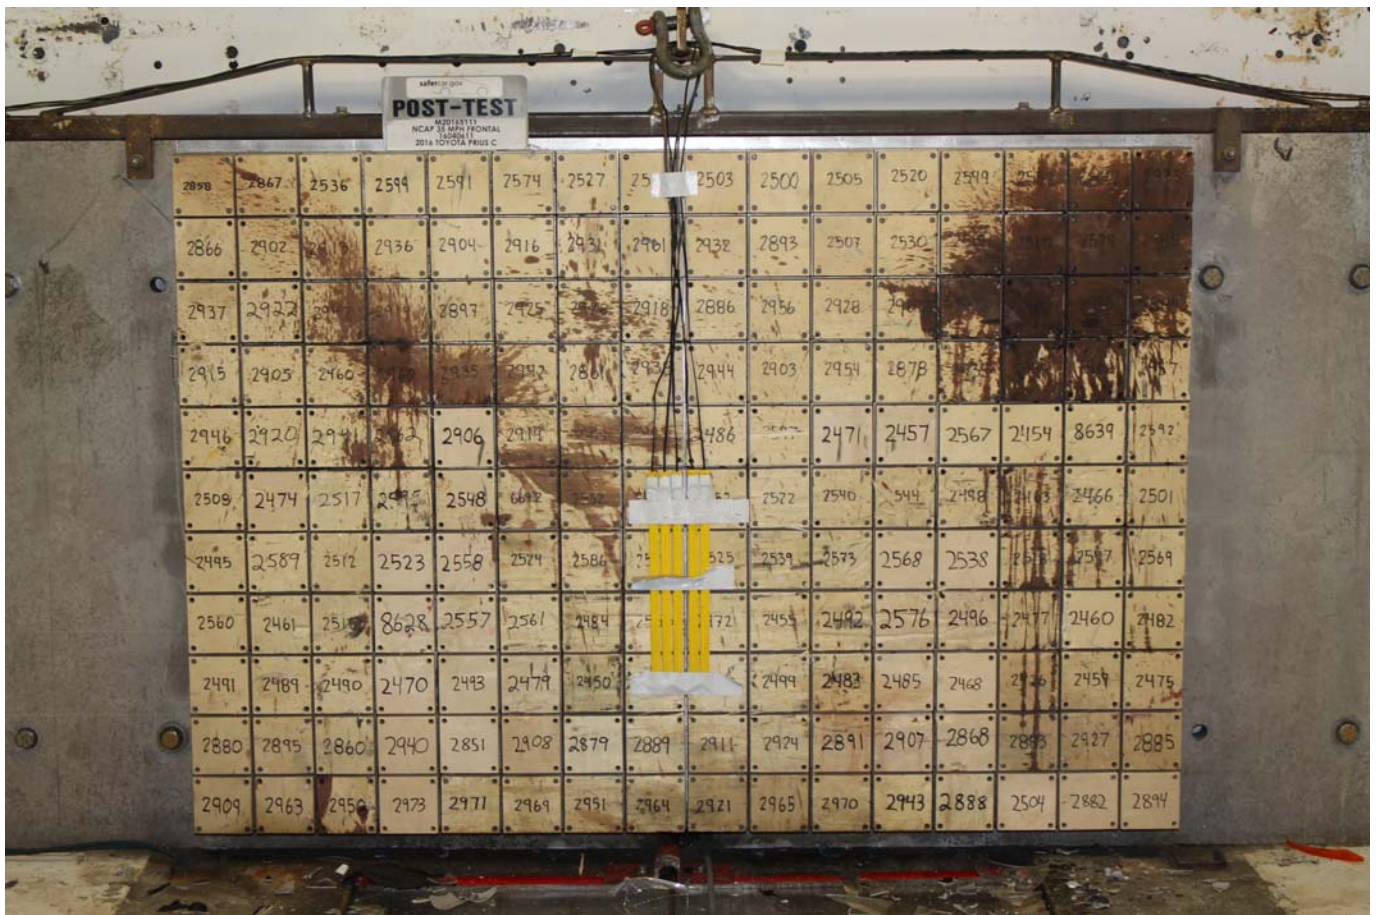
Photo No. 003 - Post-Test Load Cell Wall

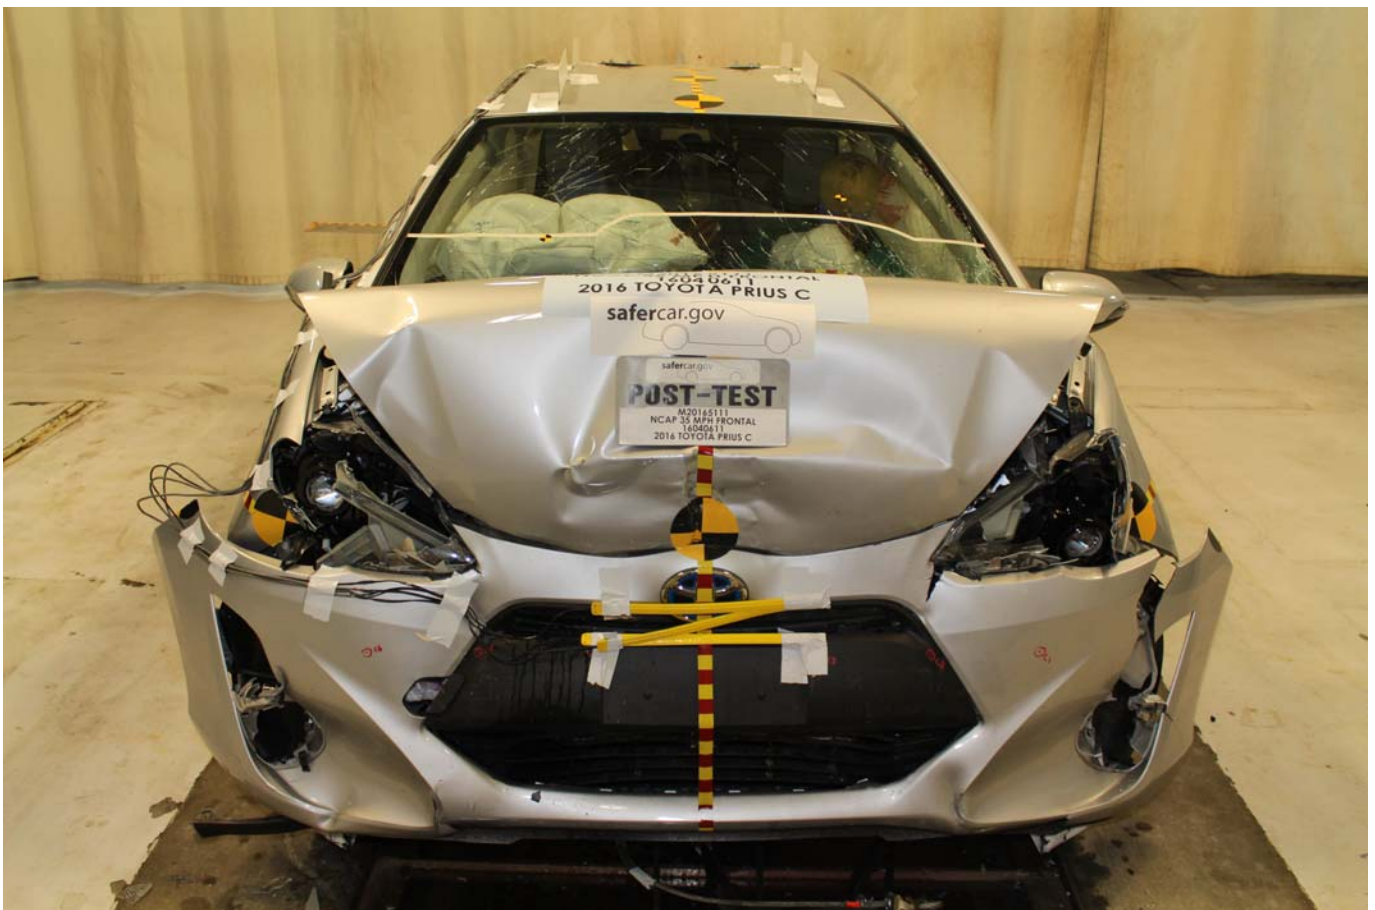
Photo No. 009 - Post-Test Front View of Test Vehicle

The maximum static crush of the vehicle was 491mm to the right of the vehicle centerline and both the driver and passenger side doors remained closed during the impact event and were operable after the impact.

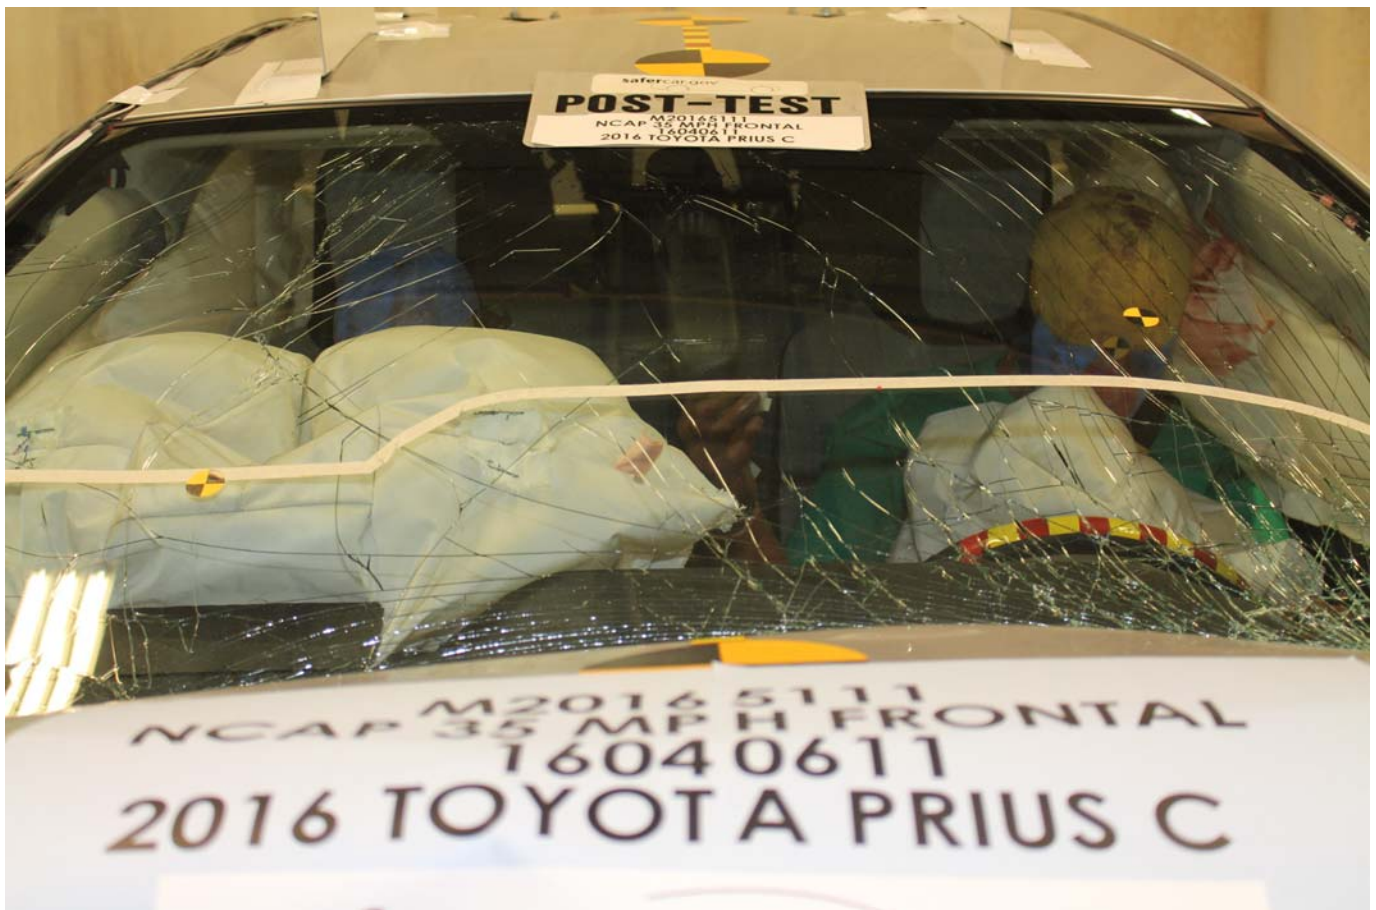
Photo No. 019 - Post-Test Windshield View

There was 95.8 percent windshield retention and no intrusion into the protected zone of the windshield during the event. There was no Stoddard Solvent leakage after the event or during any phase of the static rollover.

| Critical Areas of Performance | Observations and Conclusions |
|---|---|
| Windshield Damage | Cracked |

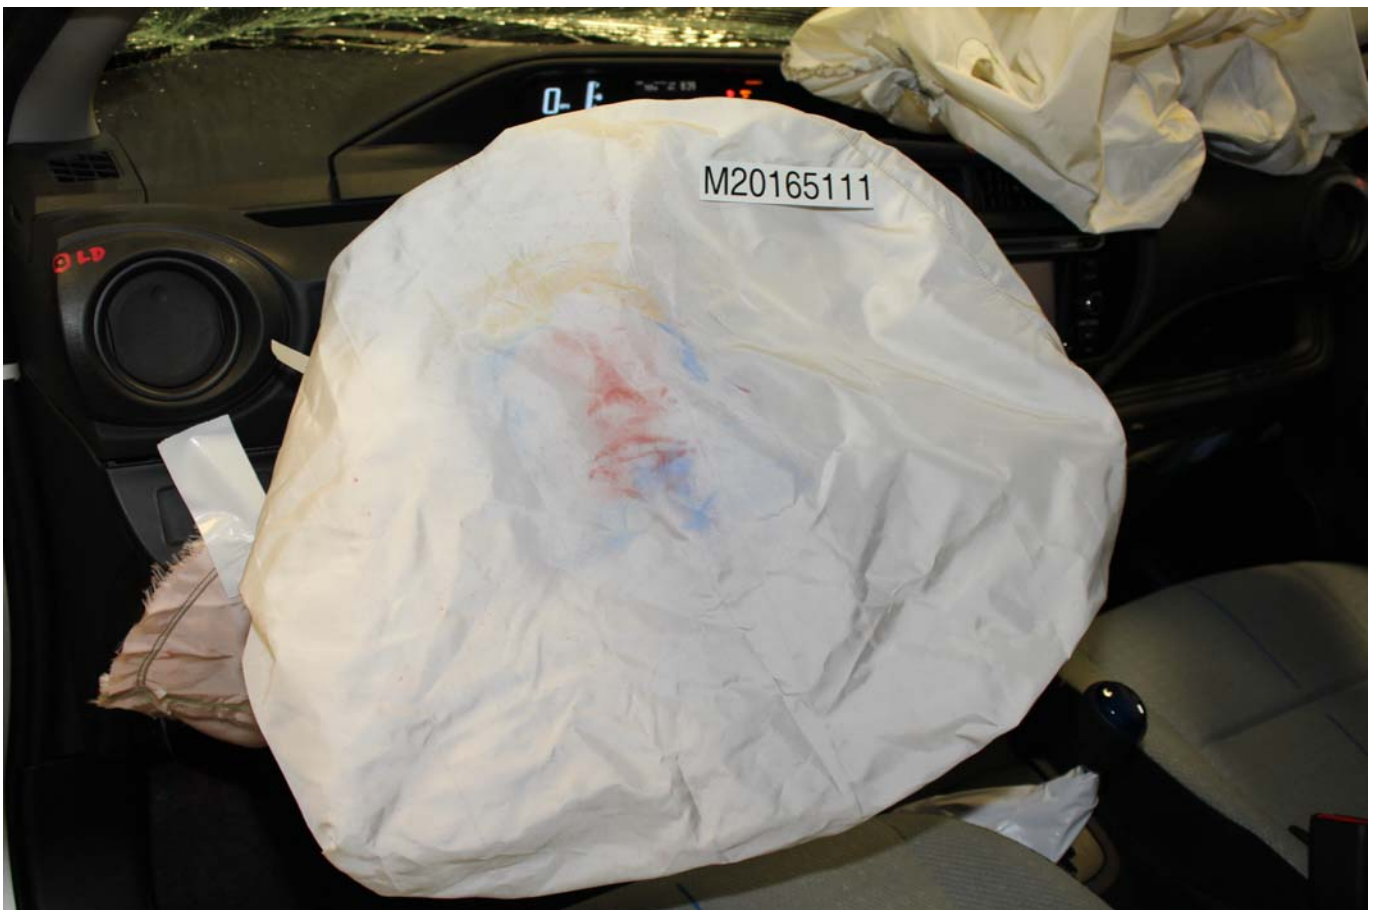
Photo No. 047 - Post-Test Driver Dummy Contact with Airbag

The driver's visible contact points were as follows: The driver's head contacted the airbag. The driver's head also contacted the headrest and the curtain airbag. The driver's knees contacted the knee airbag. The passenger's visible contact points were as follows: The passenger's head contacted the airbag. The passenger's head also contacted the headrest. The passenger's knees contacted the glove box.

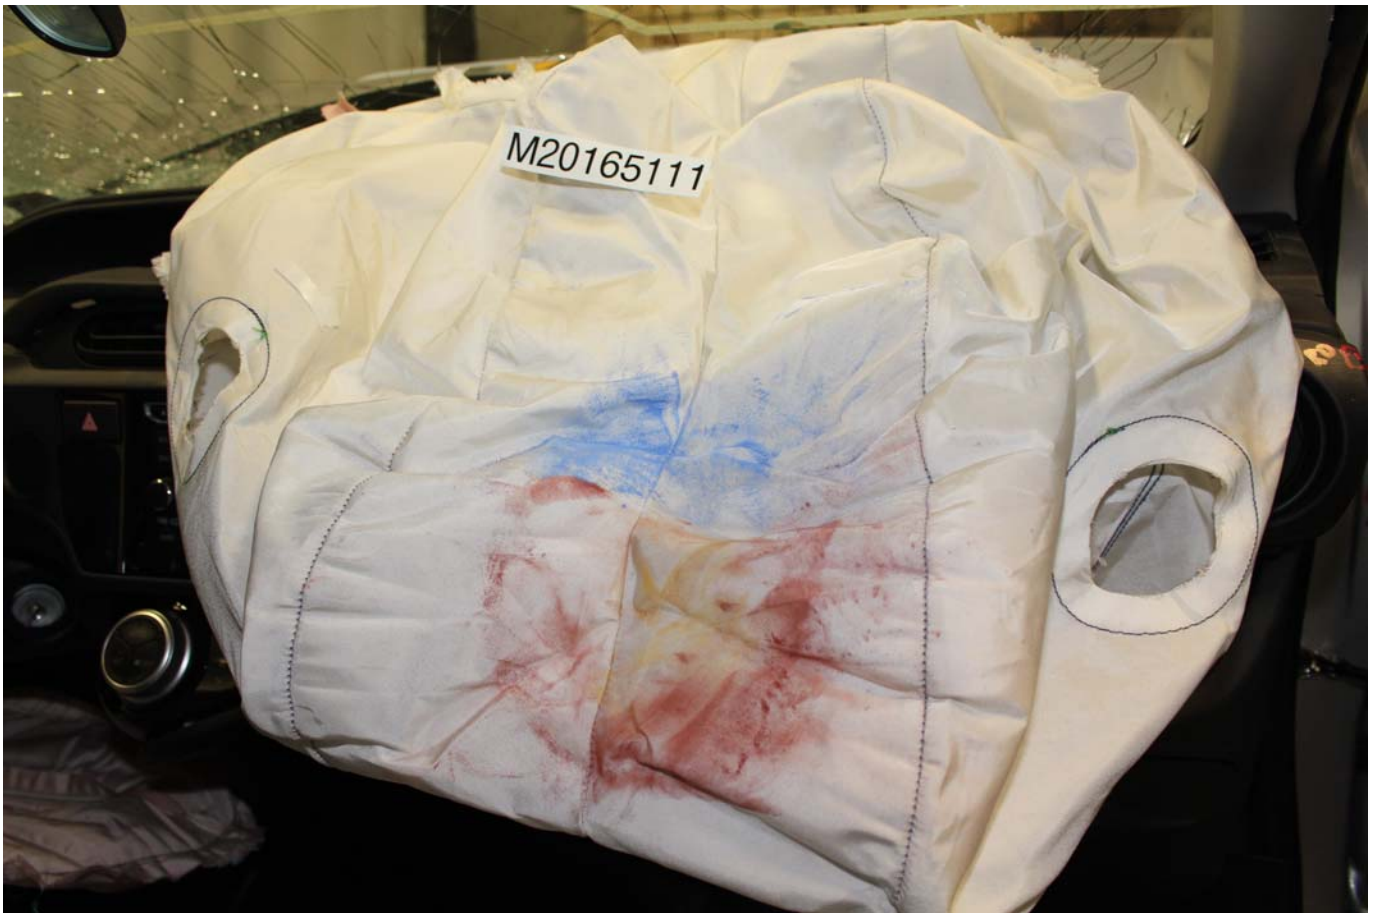
Photo No. 068 - Post-Test Passenger Dummy Contact with Airbag

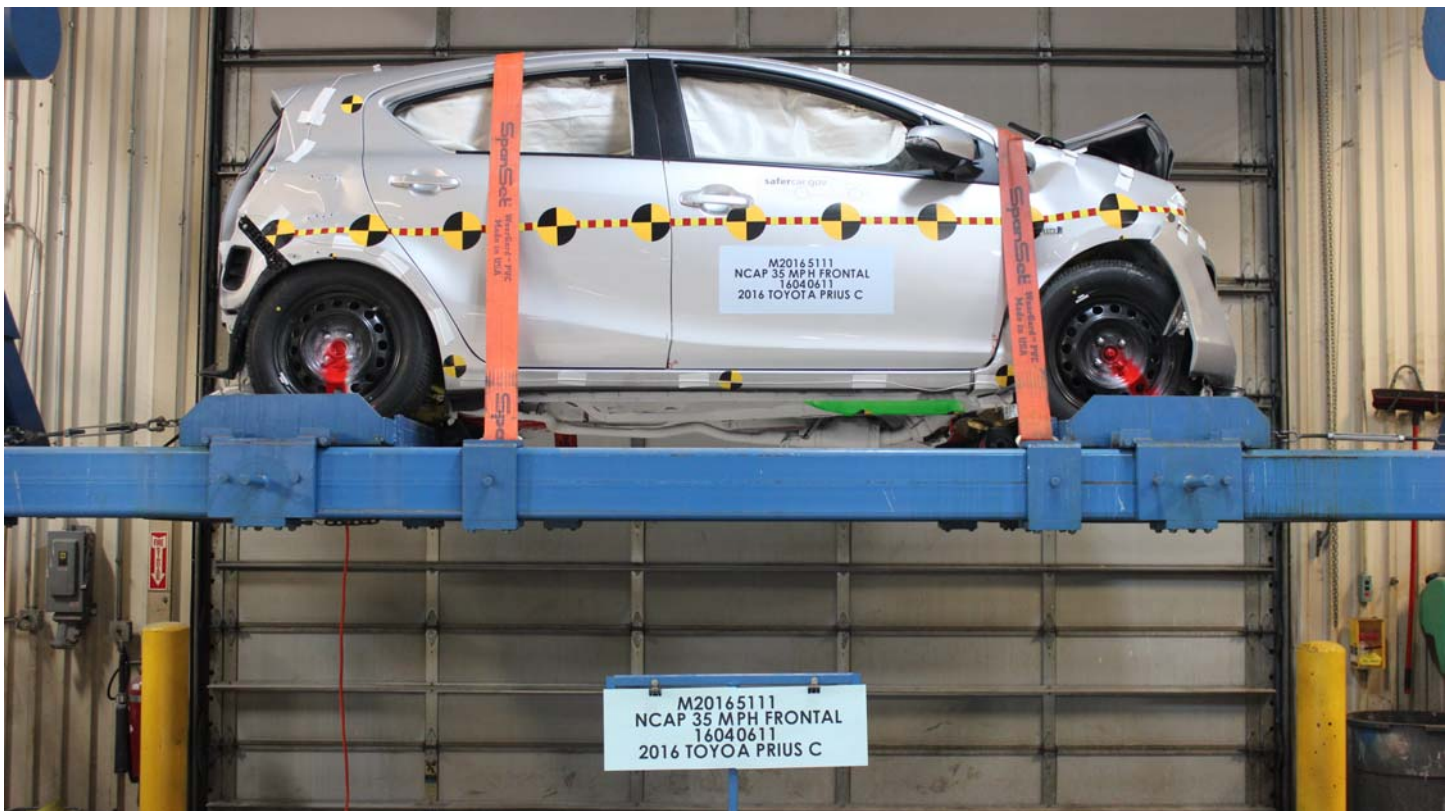
Photo No. 073 - Vehicle at 0 Degree on Static Rollover Device

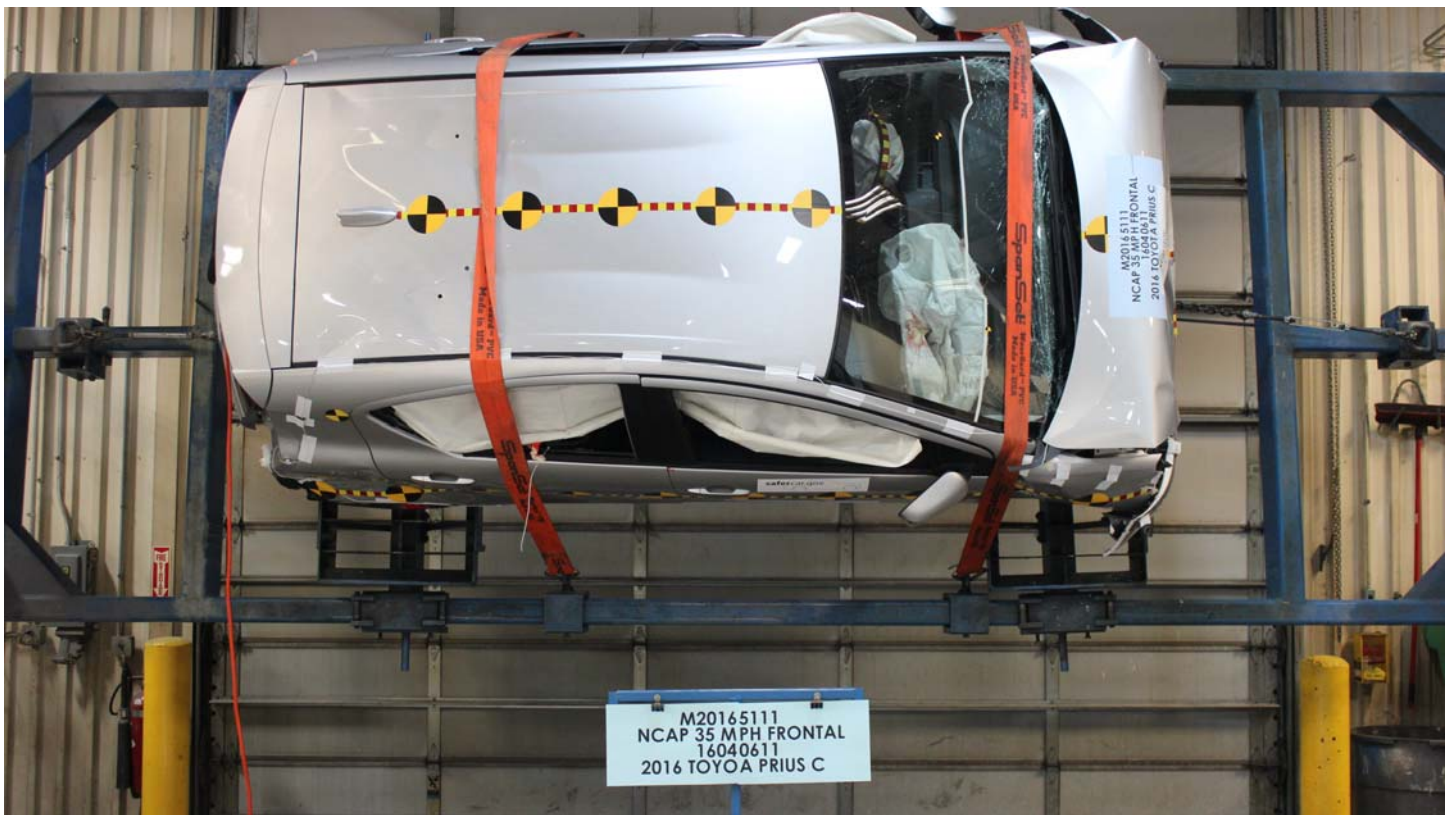
Photo No. 076 - Vehicle at 270 Degrees on Static Rollover Device
