**REPORT NUMBER: SINCAP-CAL-16-006**

**NEW CAR ASSESSMENT PROGRAM (NCAP)  
MOVING DEFORMABLE BARRIER SIDE IMPACT TEST**

**Toyota Motor Manufacturing, Kentucky, Inc  
2016 Toyota Avalon  
Four Door Sedan**

**NHTSA No: M20165107**

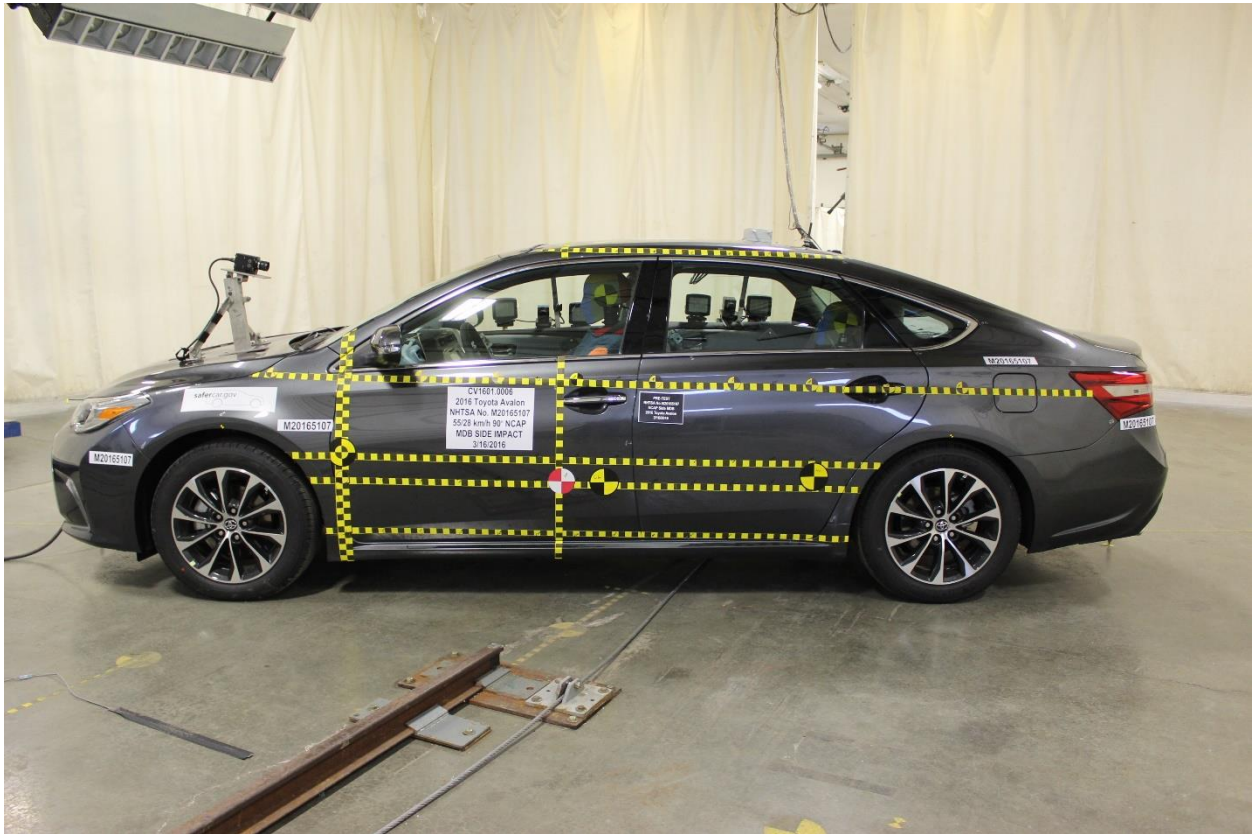
**Figure A-7: Pre-Test Left Side View of Test Vehicle**

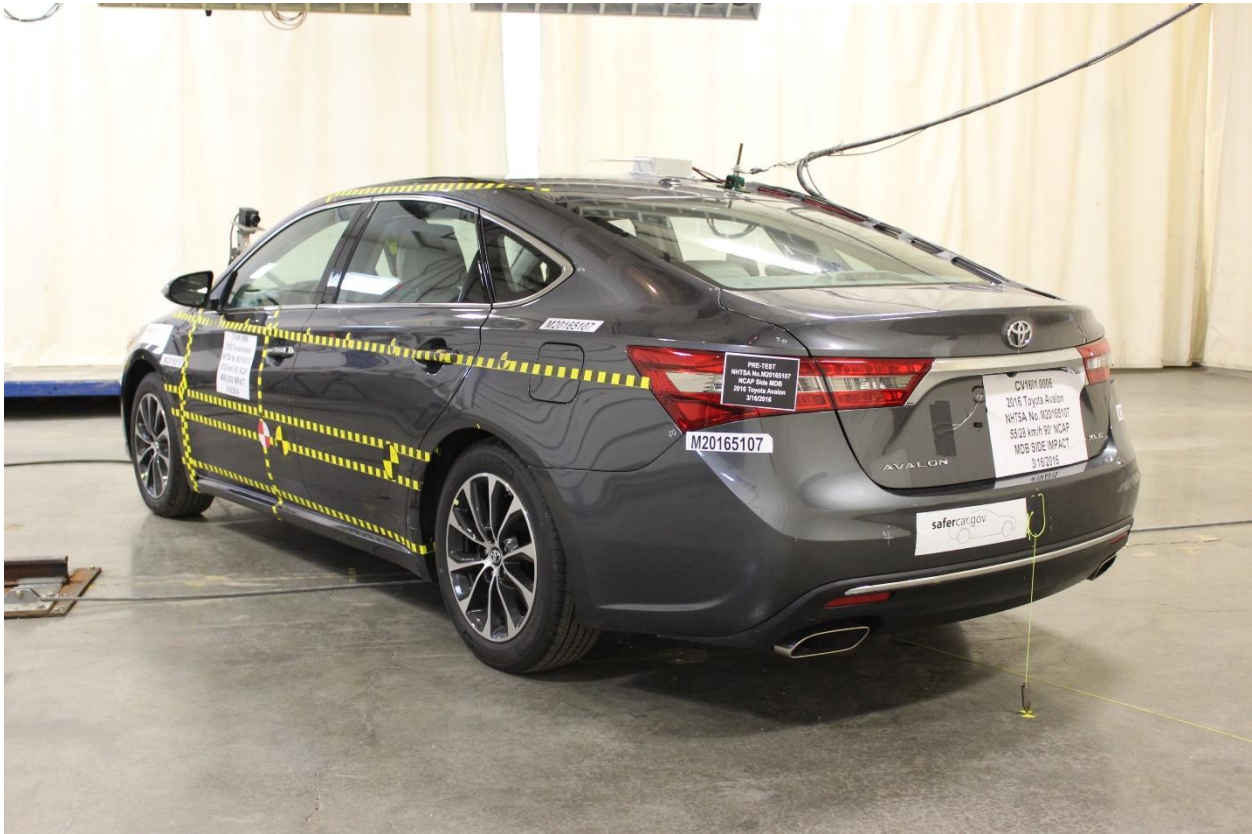
**Figure A-9: Pre-Test Left Rear  $\frac{3}{4}$  View of Test Vehicle**

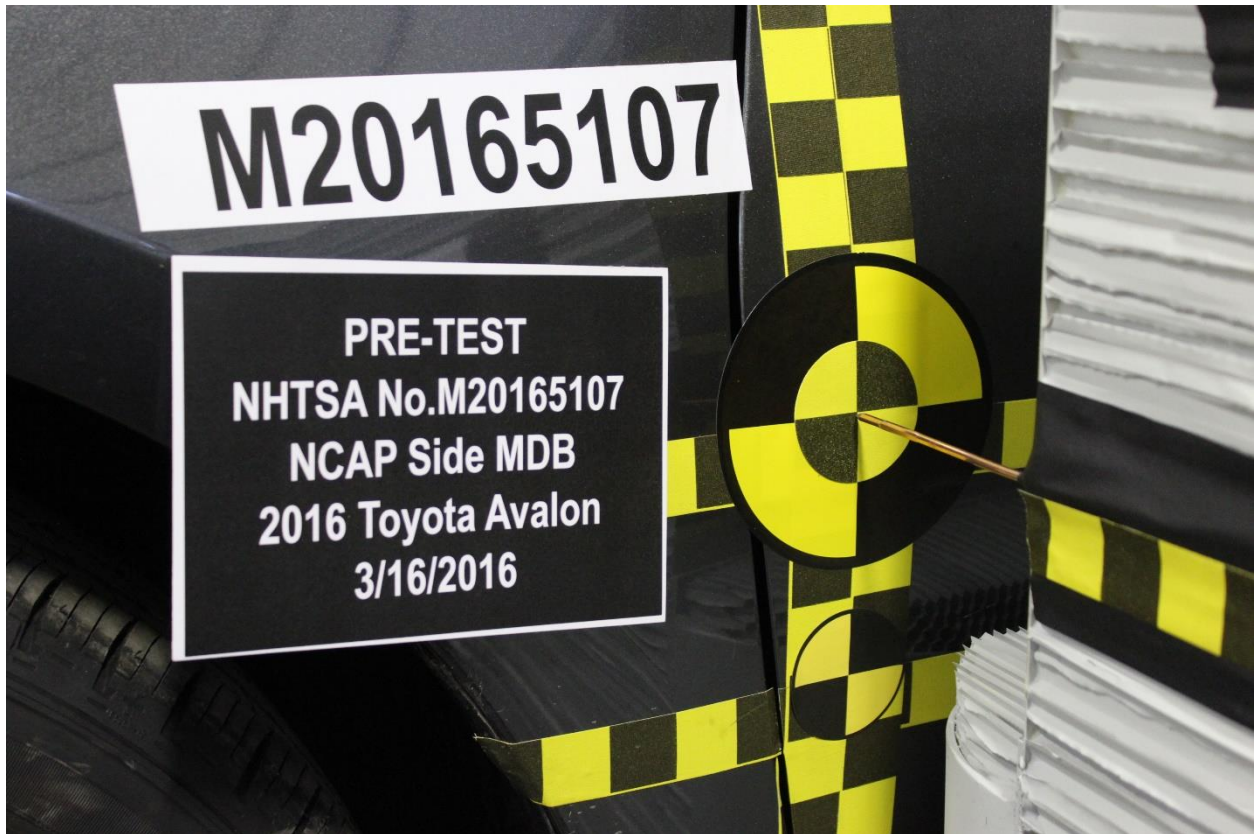
Figure A-19: Pre-Test Close-up View of Impact Point Target

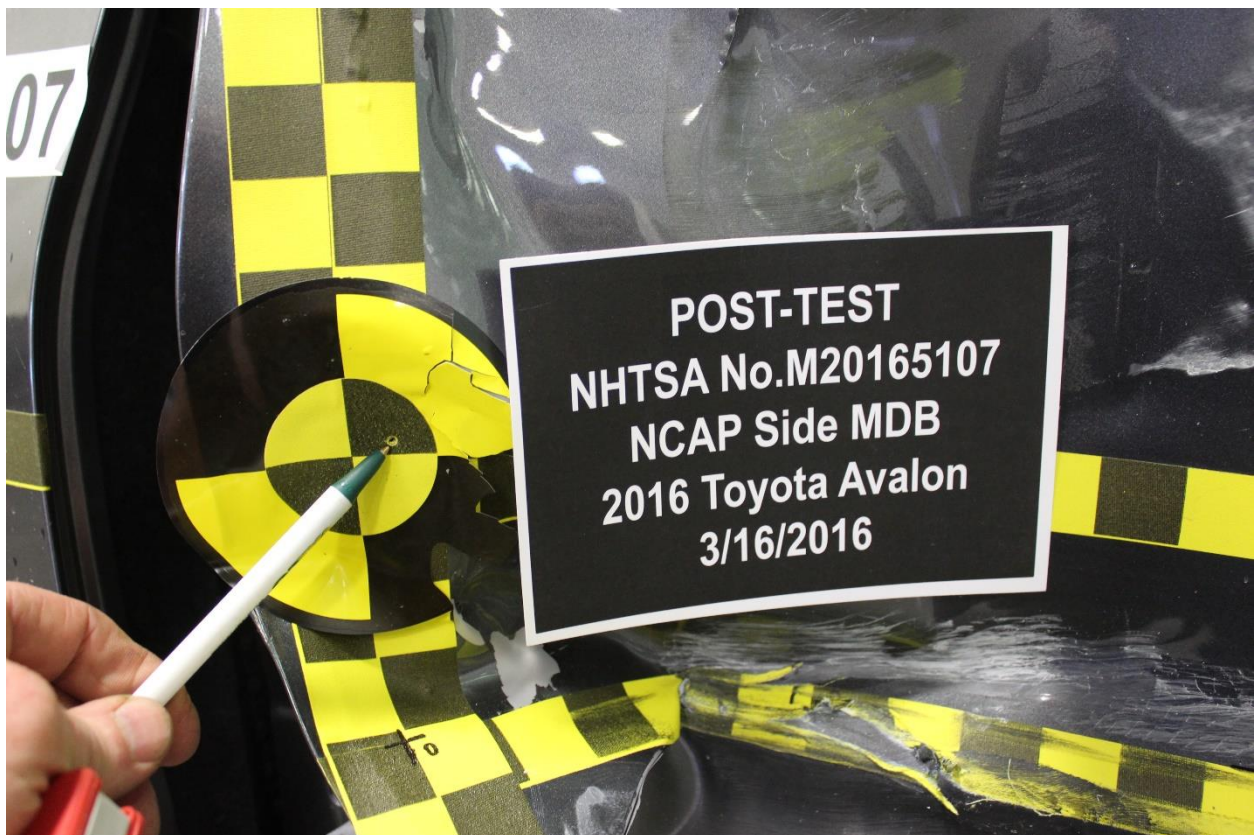
Figure A-20: Post-Test Close-up View of Impact Point Target

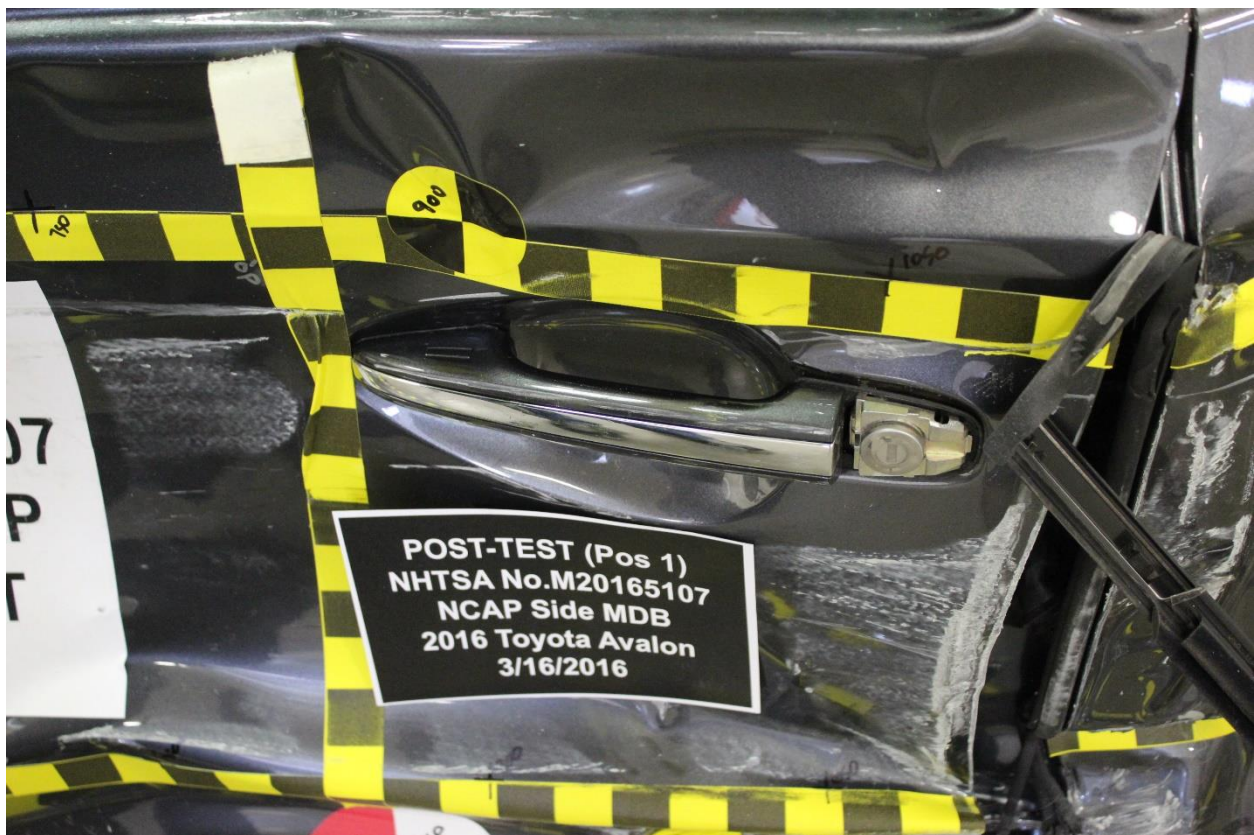
Figure A-22: Post-Test Left Front Door Latch Close-Up

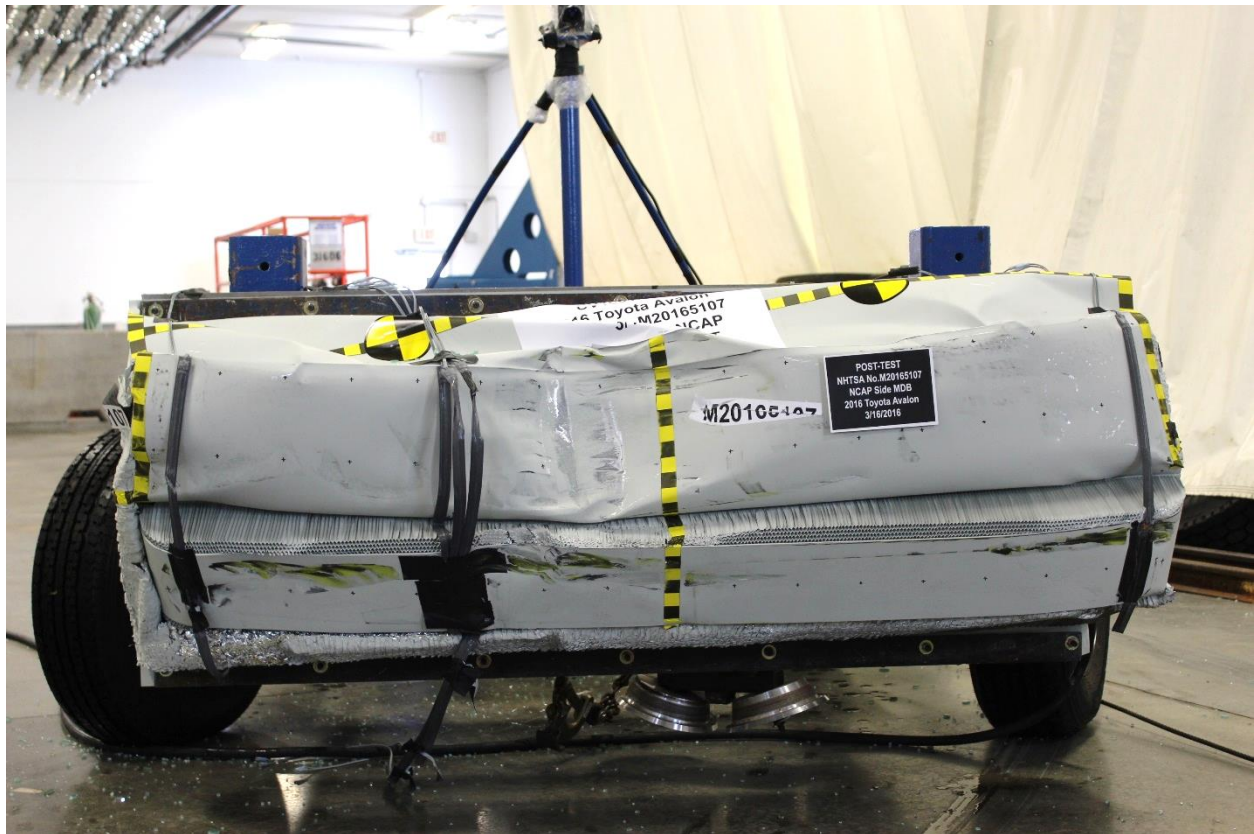
**Figure A-85: Post-Test Front View of MDB Impactor Face**

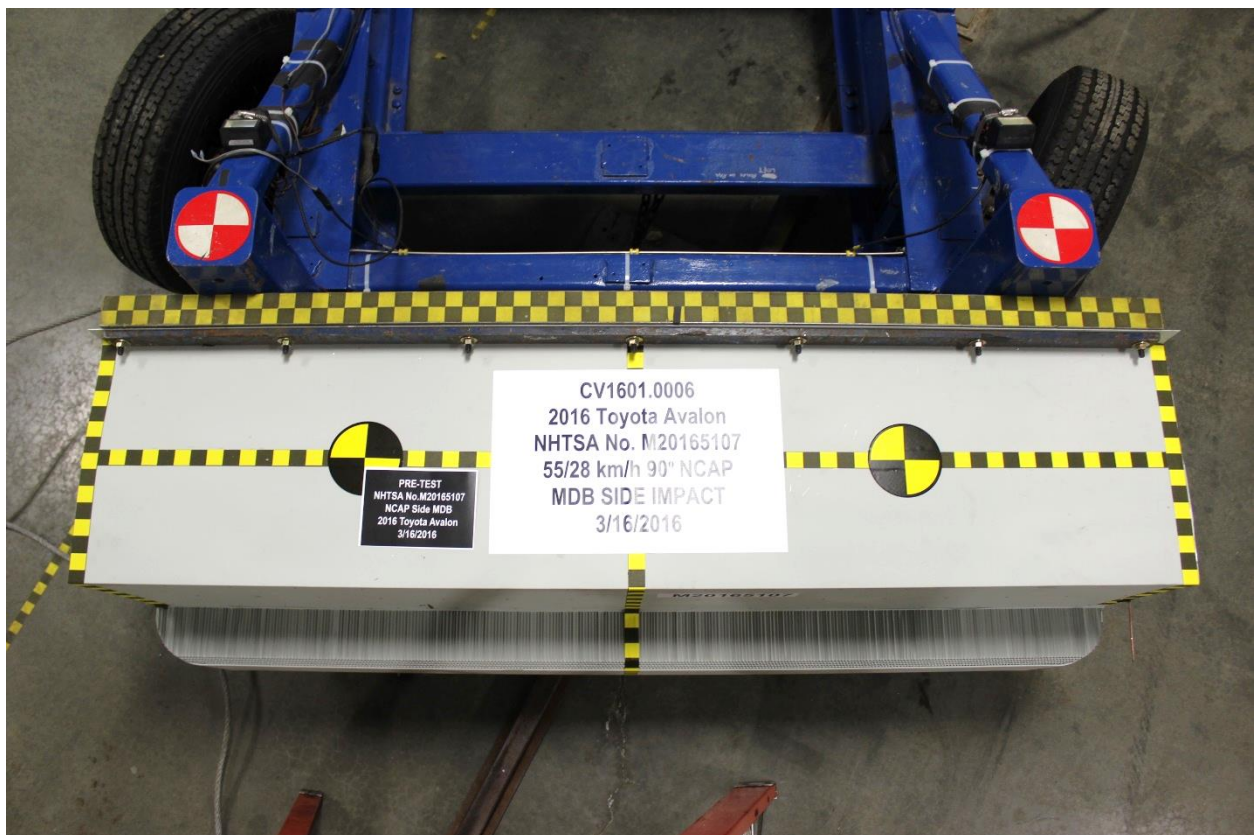
**Figure A-86: Pre-Test Top View of MDB Impactor Face**
