REPORT NUMBER: NCAP-MGA-2016-046

**NEW CAR ASSESSMENT PROGRAM (NCAP)
Frontal Barrier Impact Test**

**VOLVO CAR CORPORATION
2016 Volvo XC90 T8 Inscription 5-Door SUV
NHTSA No.: O20165903**

**MGA RESEARCH CORPORATION
5000 Warren Road
Burlington, WI 53105**

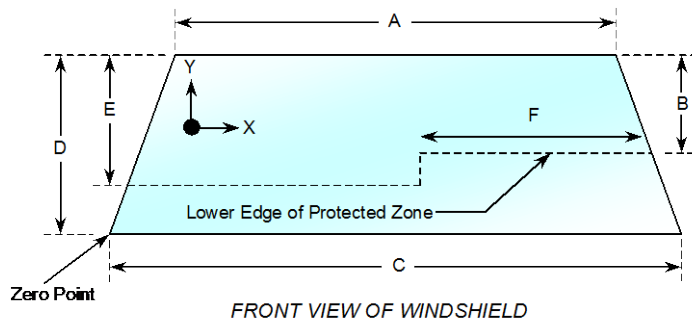
Item	Units	Value
A	mm	1276
B	mm	579
C	mm	1456
D	mm	862
E	mm	528
F	mm	576

AREA OF PROTECTED ZONE FAILURES - NONE

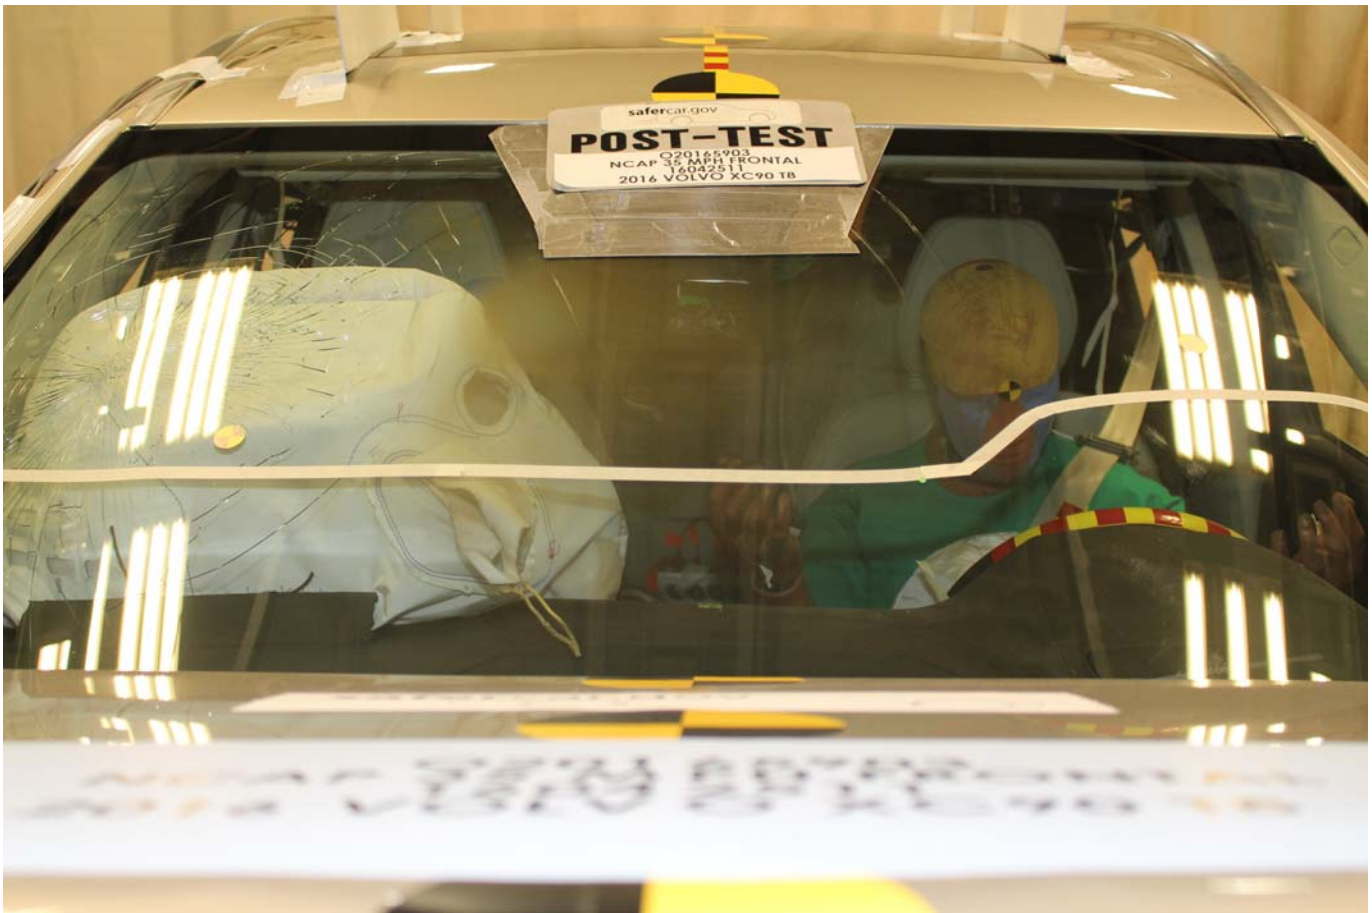
Photo No. 019 - Post-Test Windshield View

There was 100 percent windshield retention and no intrusion into the protected zone of the windshield during the event. There was no Stoddard Solvent leakage after the event or during any phase of the static rollover.

Critical Areas of Performance	Observations and Conclusions
Windshield Damage	Cracked
Window Damage	None
Other Notable Effects	None

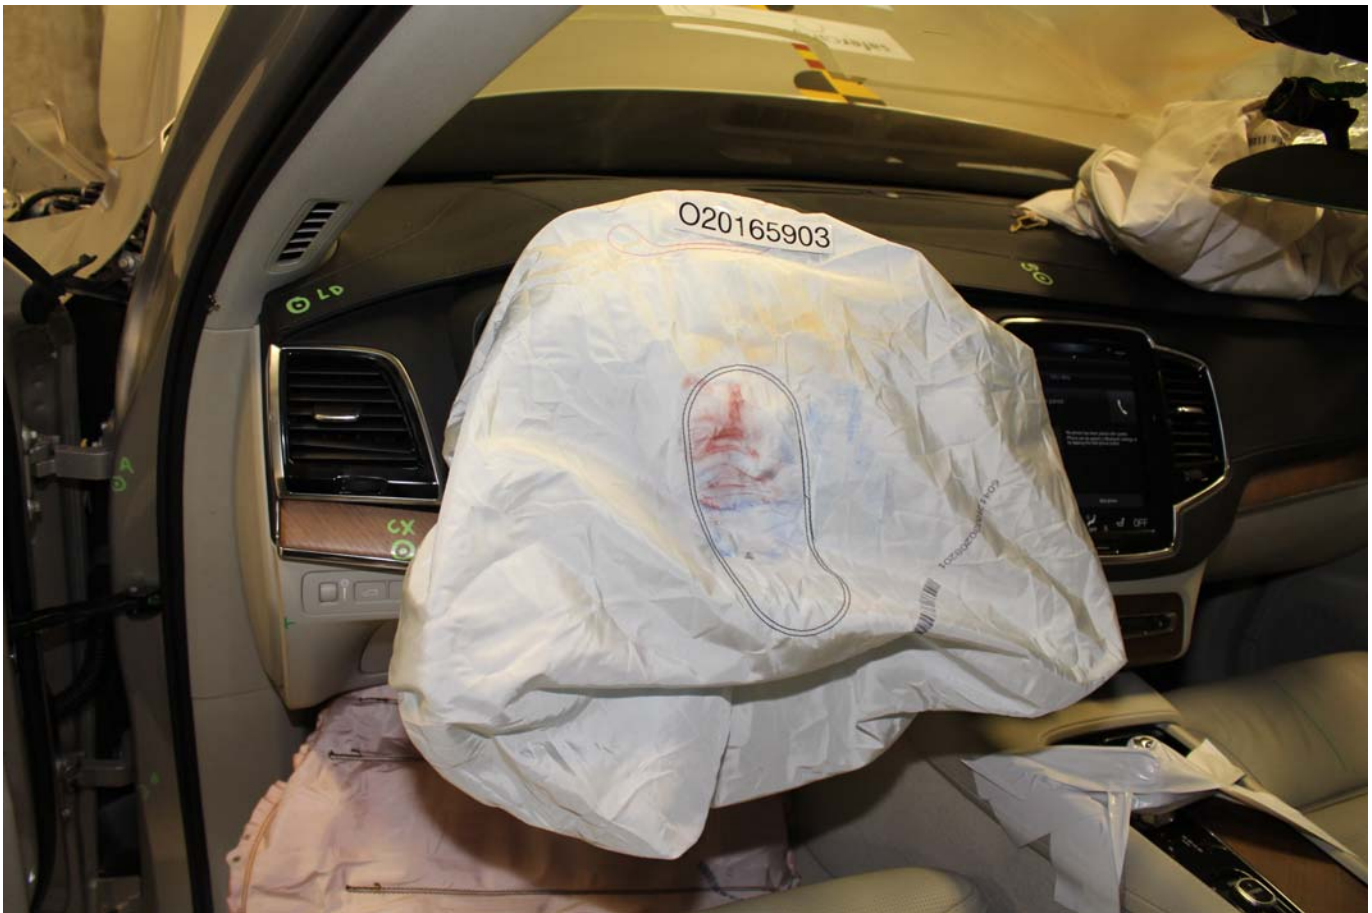
Photo No. 047 - Post-Test Driver Dummy Contact with Airbag

The driver's visible contact points were as follows: The driver's head contacted the airbag. The driver's knees contacted the knee airbag. The passenger's visible contact points were as follows: The passenger's head contacted the airbag. The passenger's head also contacted the headrest. The passenger's knees contacted the glove box.
