**REPORT NUMBER: SPNCAP-MGA-2016-047**

**NEW CAR ASSESSMENT PROGRAM (NCAP)  
Side Impact Pole Test**

**VOLVO CAR CORPORATION  
2016 Volvo XC90 T8 AWD Inscription 5-Door SUV  
NHTSA No.: O20165904**

**FINAL REPORT**

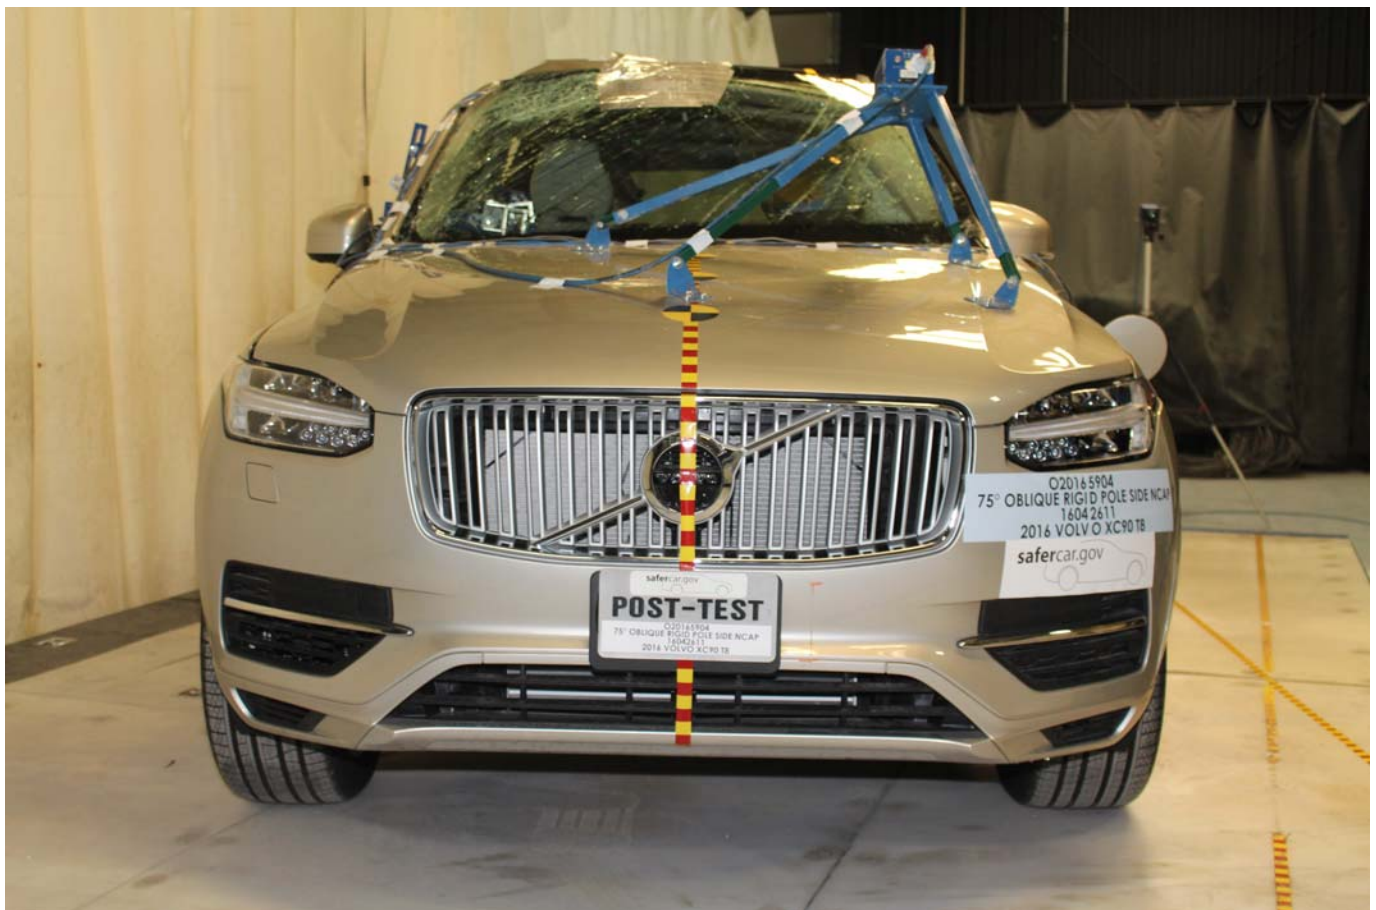
Photo No. 004 - Post-Test Frontal View of Test Vehicle

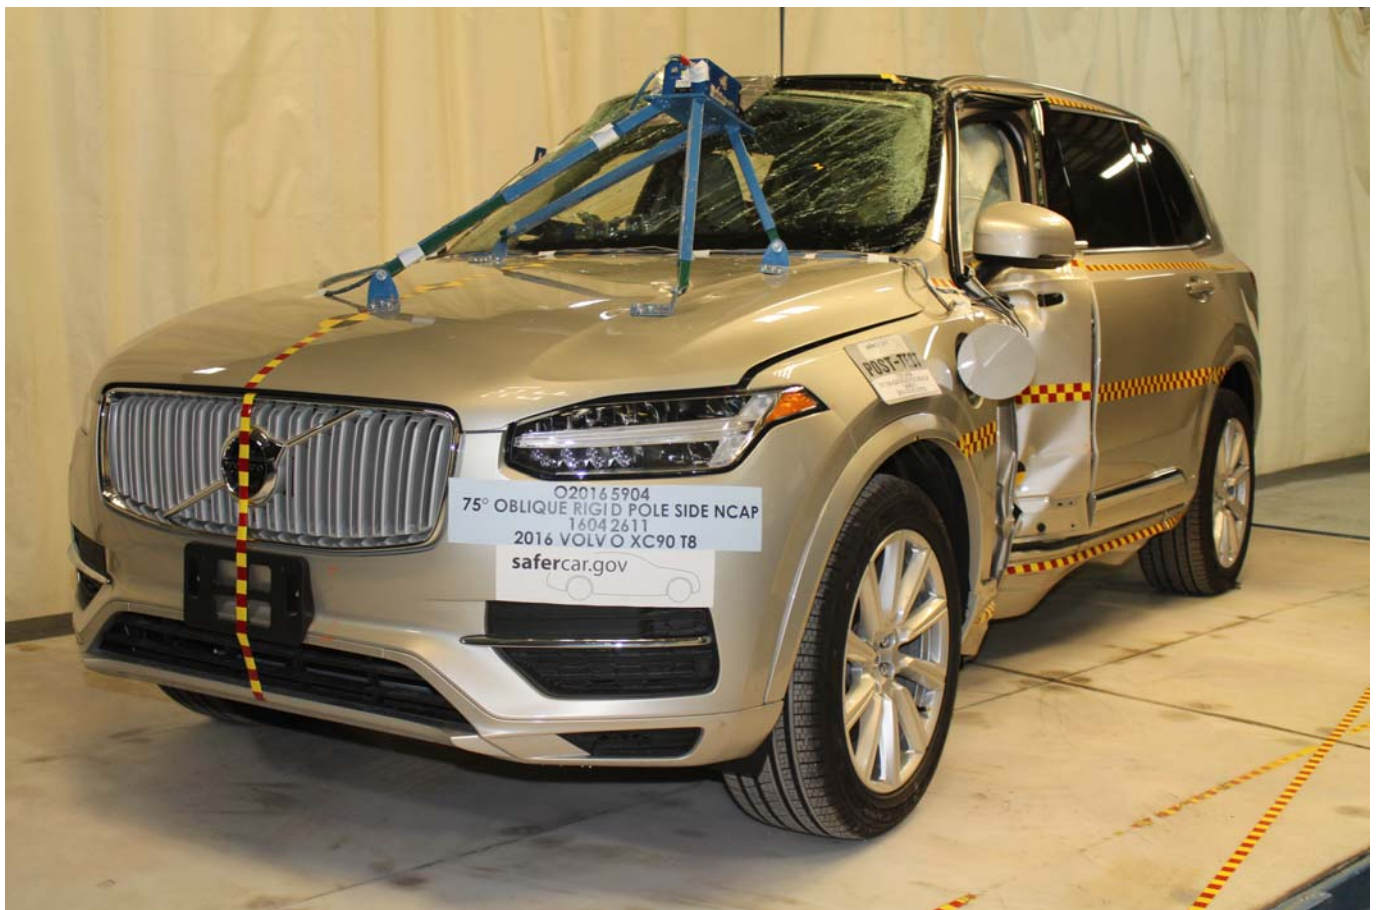
Photo No. 006 - Post-Test Left Front  $\frac{3}{4}$  View of Test Vehicle

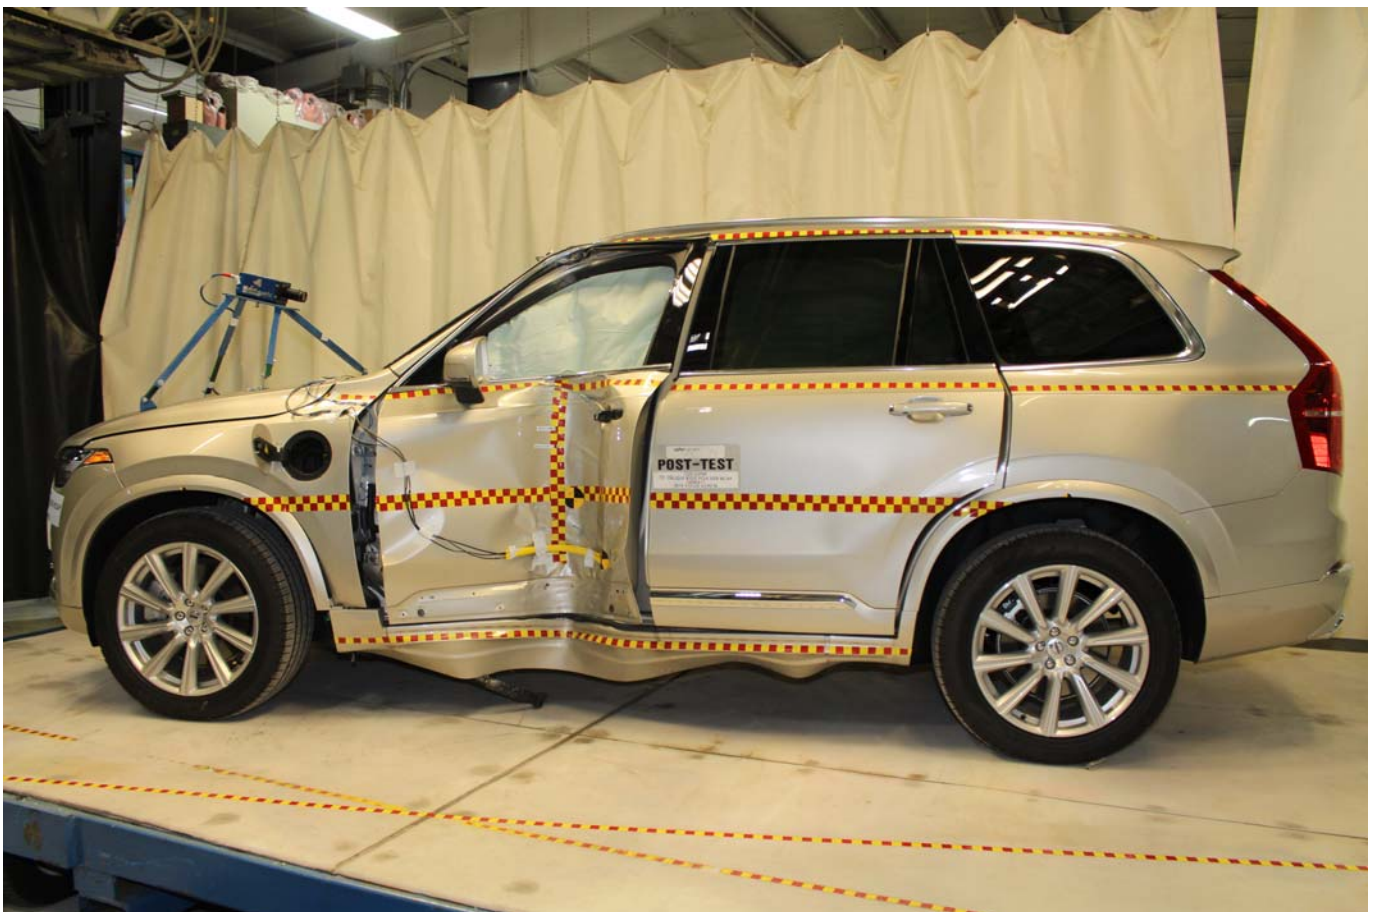
Photo No. 008 - Post-Test Left Side View of Test Vehicle

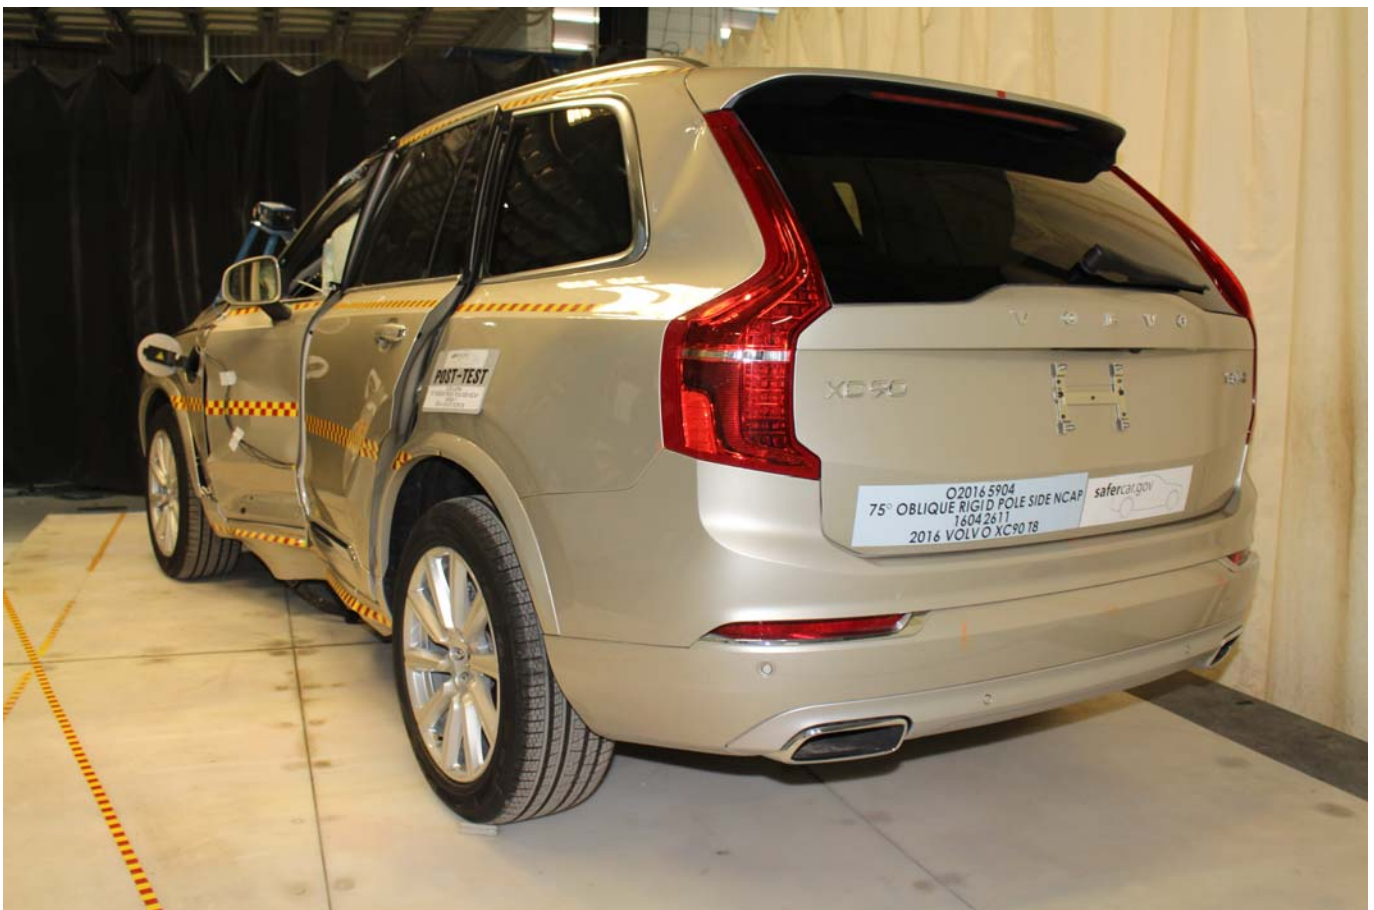
Photo No. 010 - Post-Test Left Rear  $\frac{3}{4}$  View of Test Vehicle

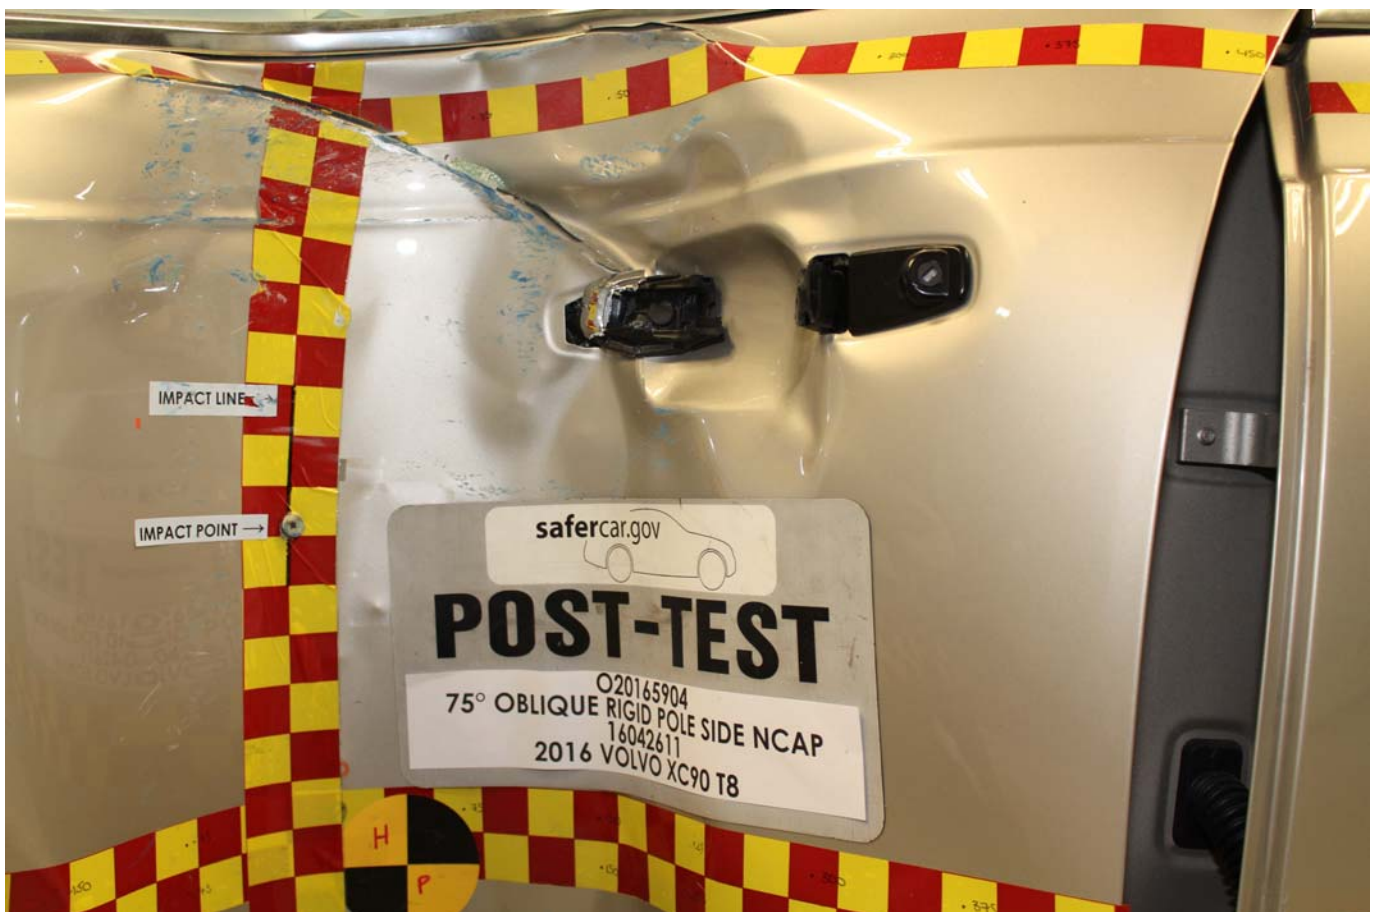
Photo No. 020 - Post-Test Close-Up View of Impact Point Target Showing Impact Location

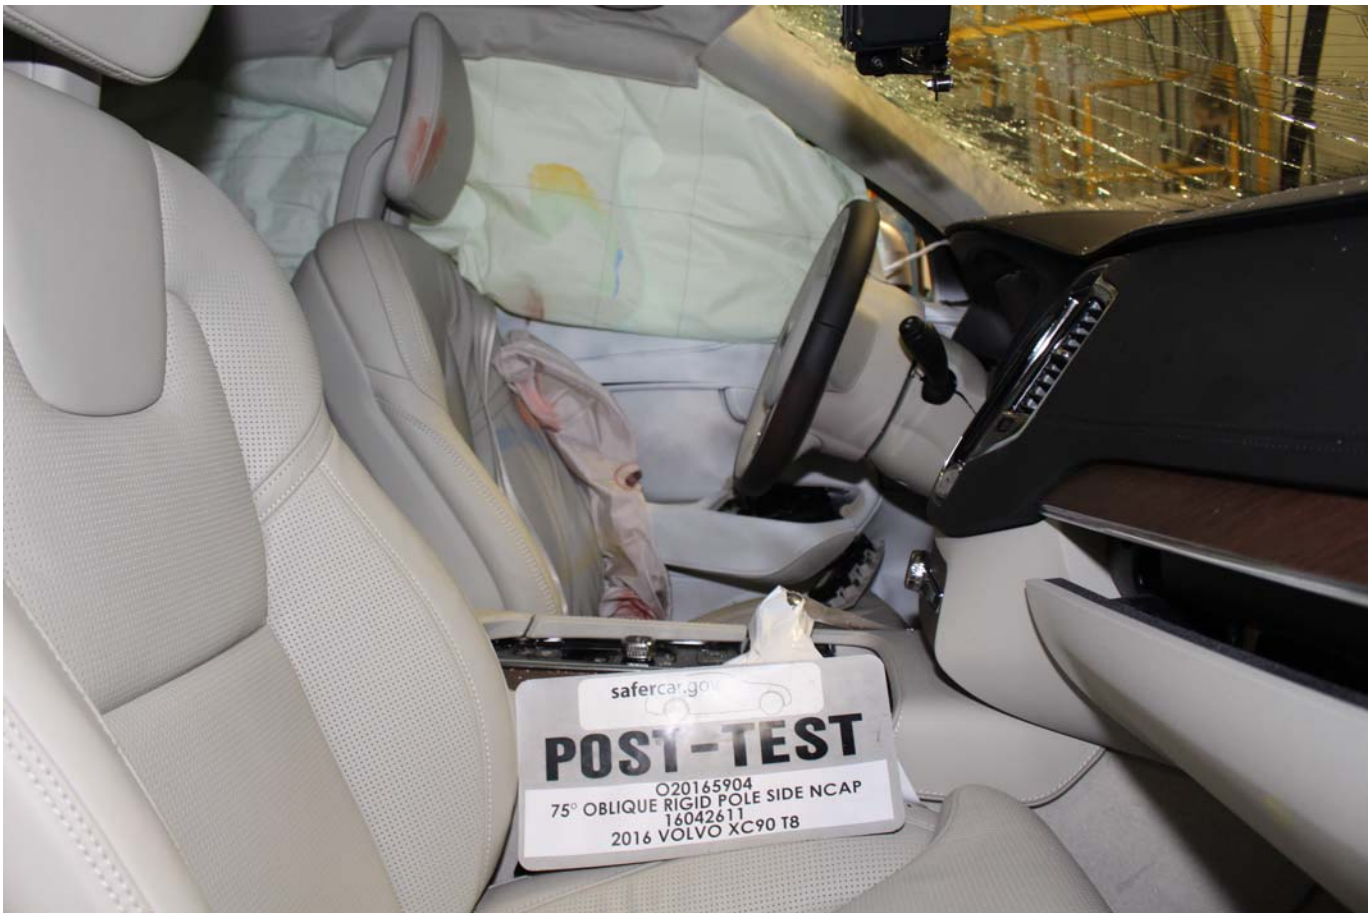
Photo No. 045 - Post-Test Inner Door Panel View Showing Dummy Contact Location

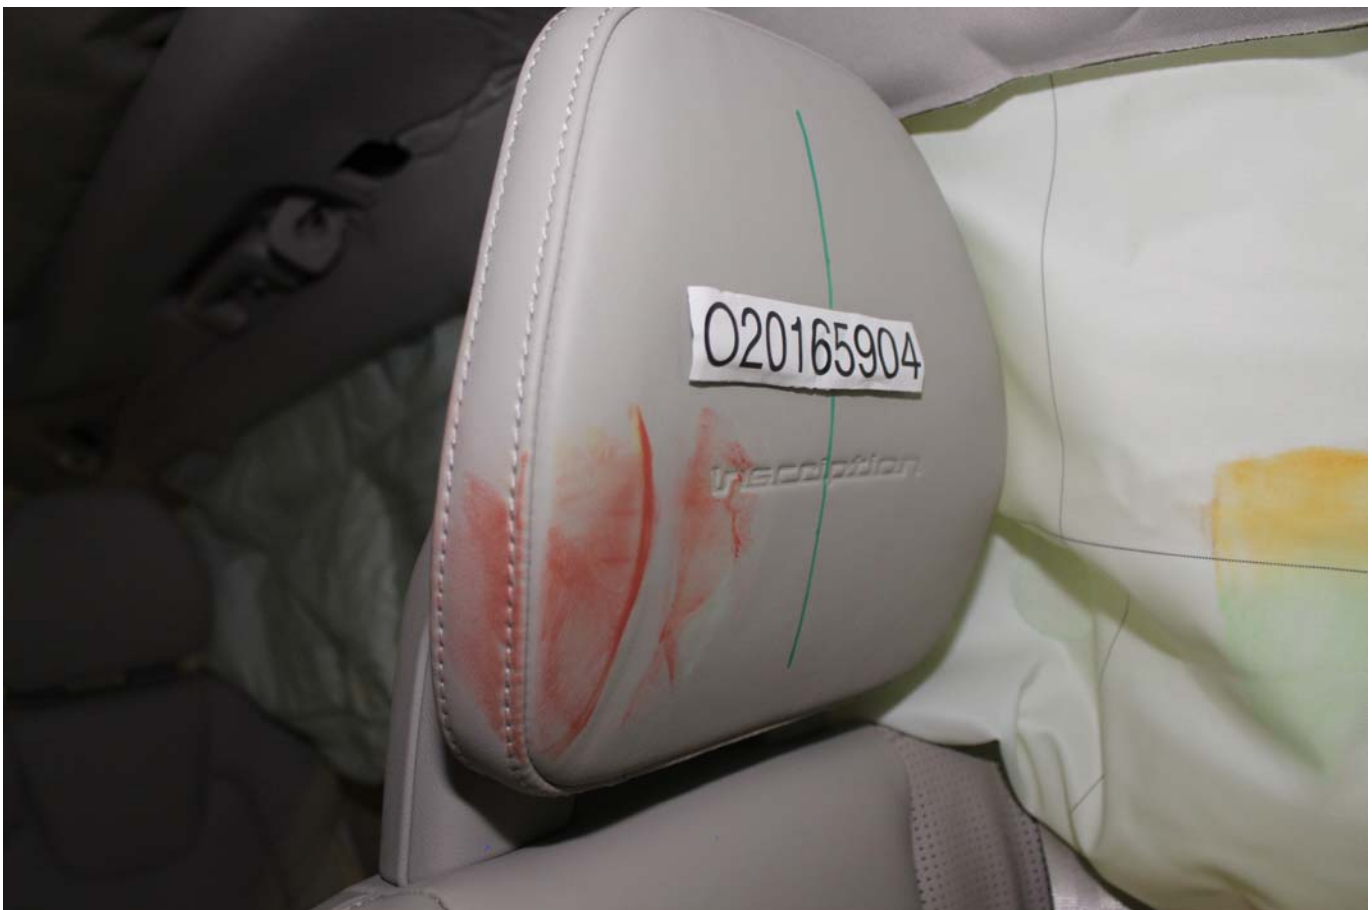
Photo No. 046 - Post-Test Dummy Close-Up Head Contact with Vehicle Interior View

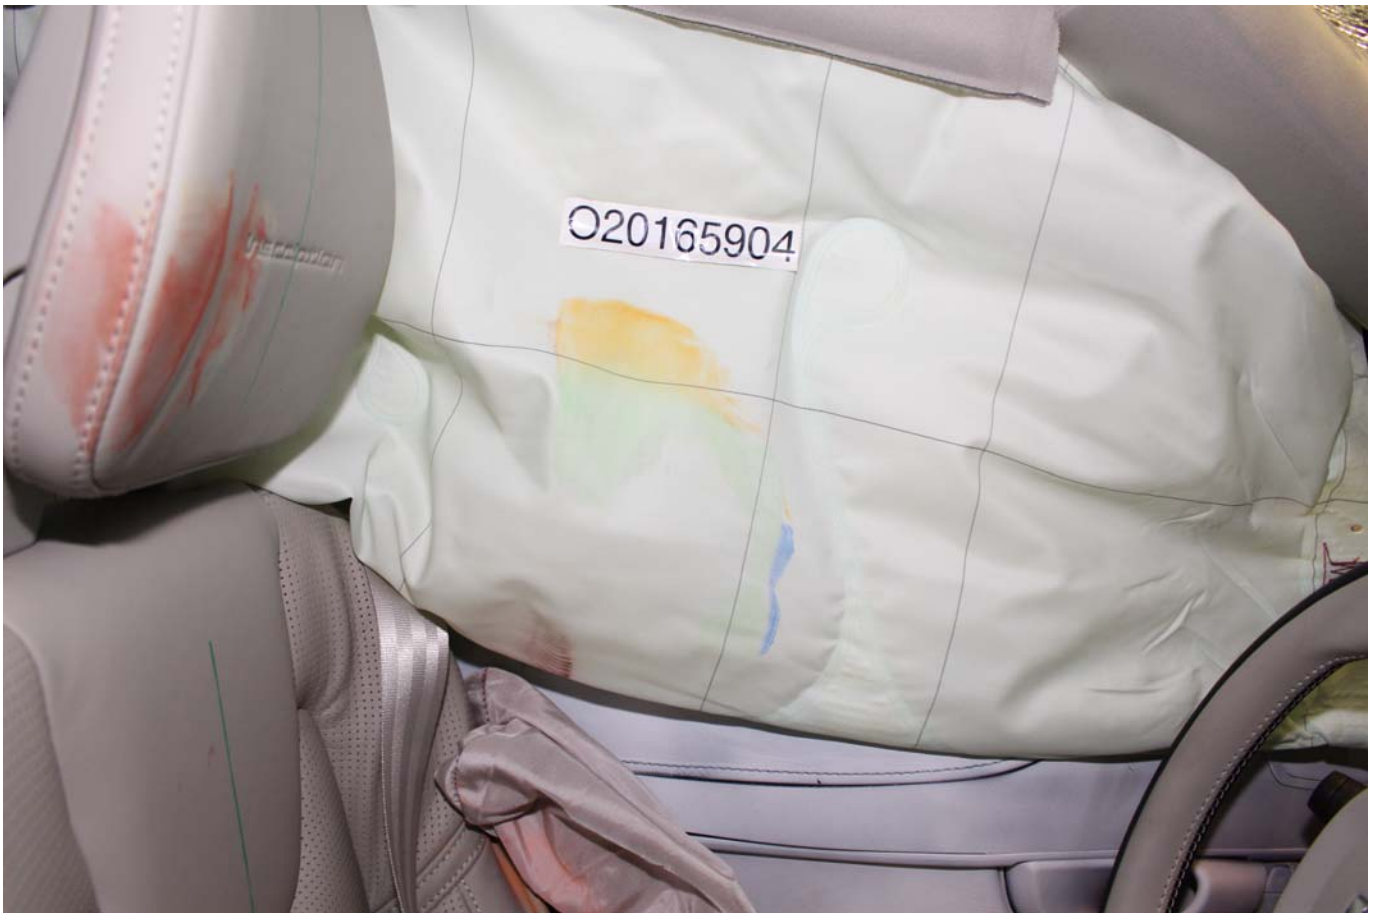
Photo No. 047 - Post-Test Dummy Close-Up Head Contact with Side Air Bag View

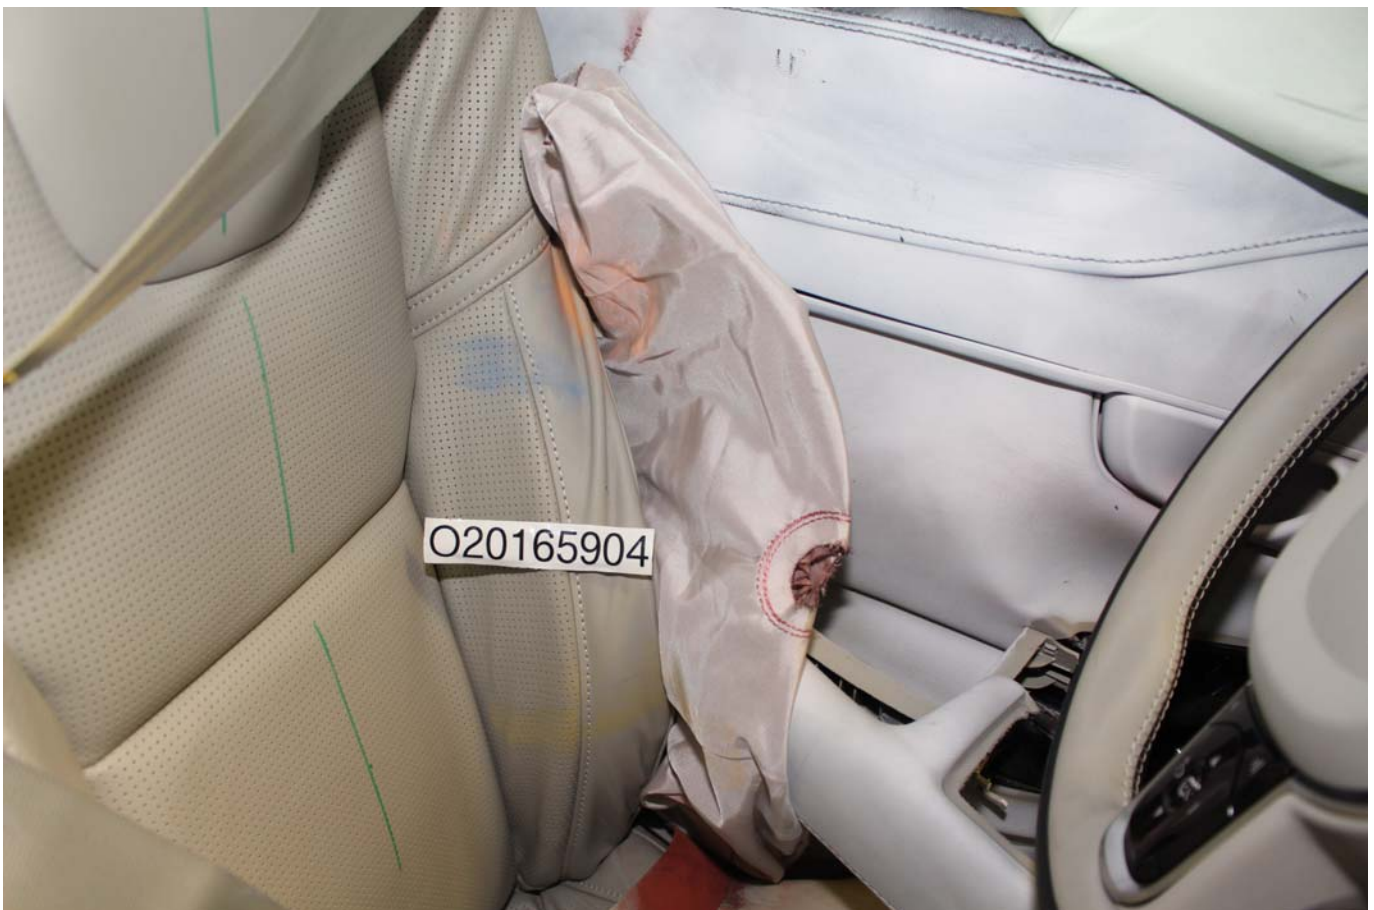
Photo No. 048 - Post-Test Dummy Close-Up Torso Contact with Vehicle Interior View

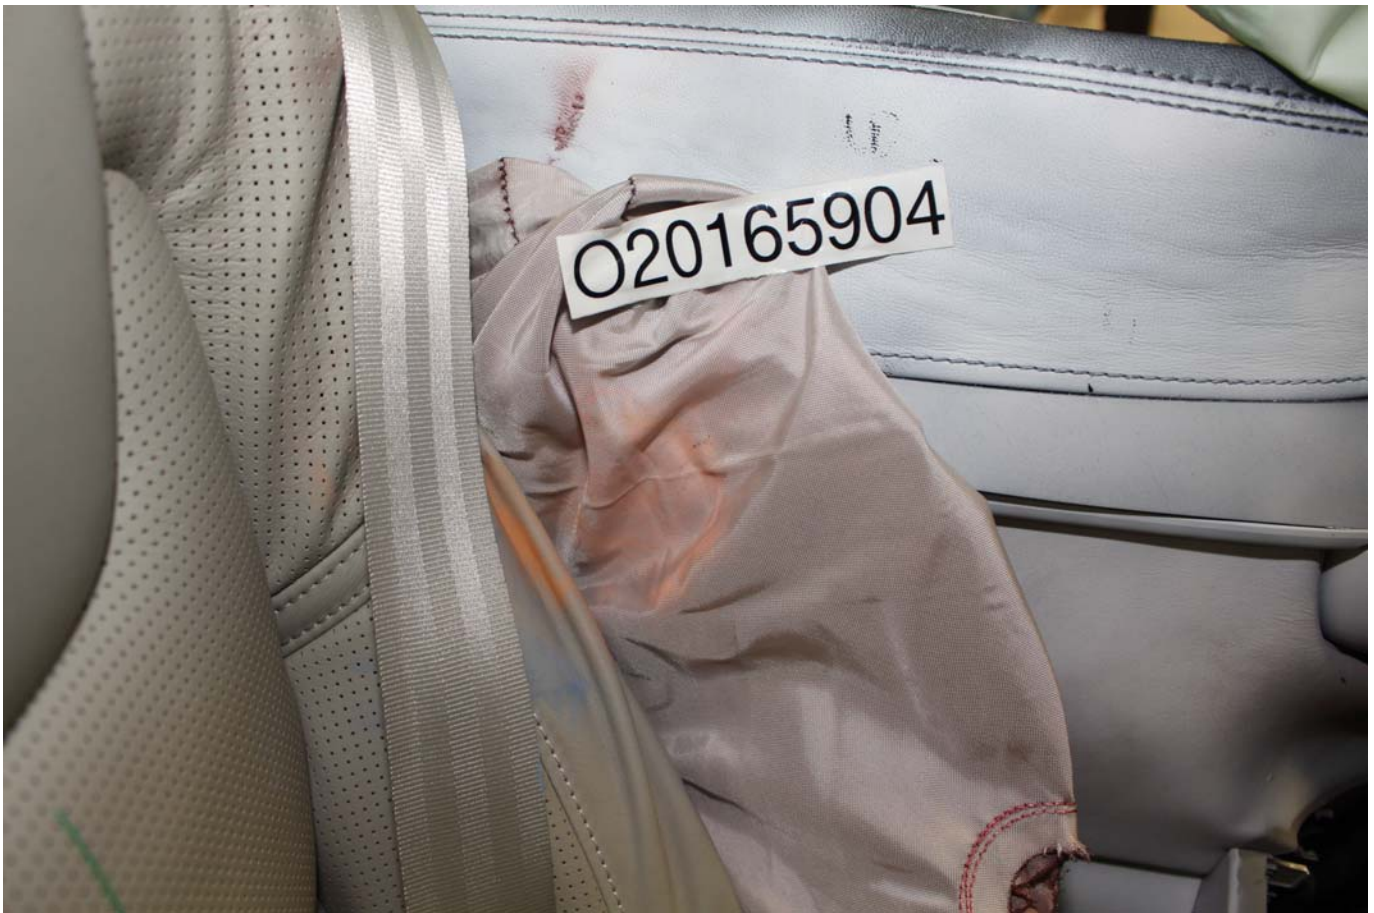
Photo No. 049 - Post-Test Dummy Close-Up Torso Contact with Side Air Bag View

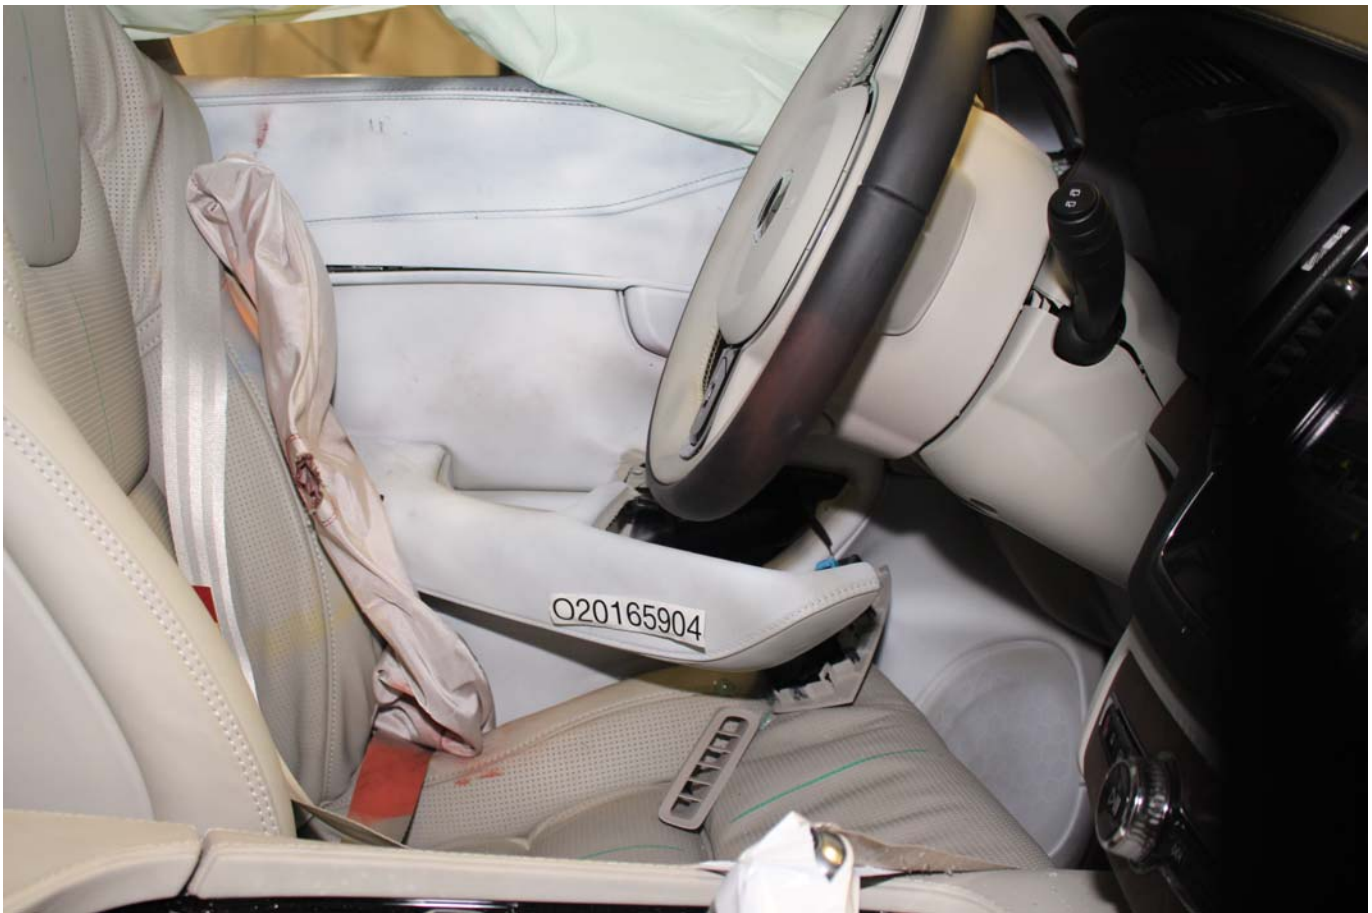
Photo No. 071 - Post-Test View of Shattered Vehicle Inner Door Panel
