**REPORT NUMBER: TWG-MGA-2016-001**

**SIDE AIRBAG OUT-OF-POSITION INJURY  
TECHNICAL WORKING GROUP**

**NISSAN MOTOR CO., LTD.  
2016 Nissan Maxima S 4-Dr Sedan  
NHTSA No.: M20165202TWG2**

**FINAL REPORT**

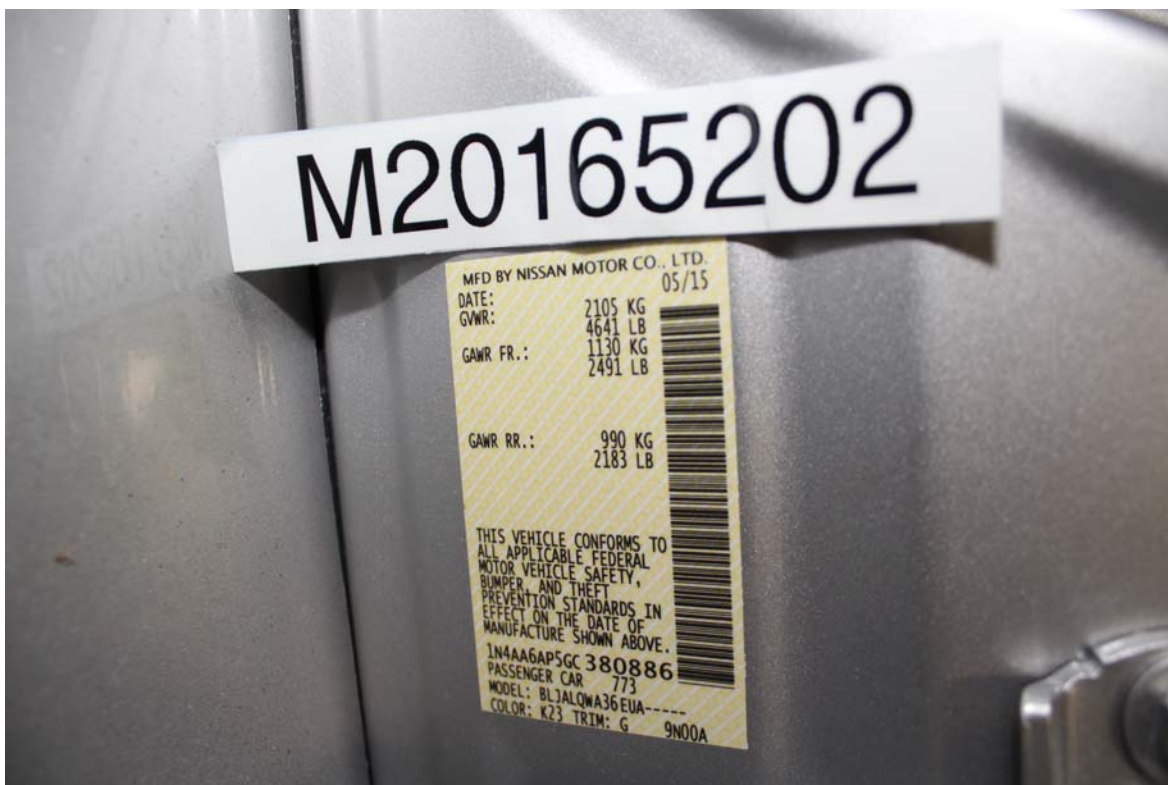
Photo No. 2. Vehicle Certification Label

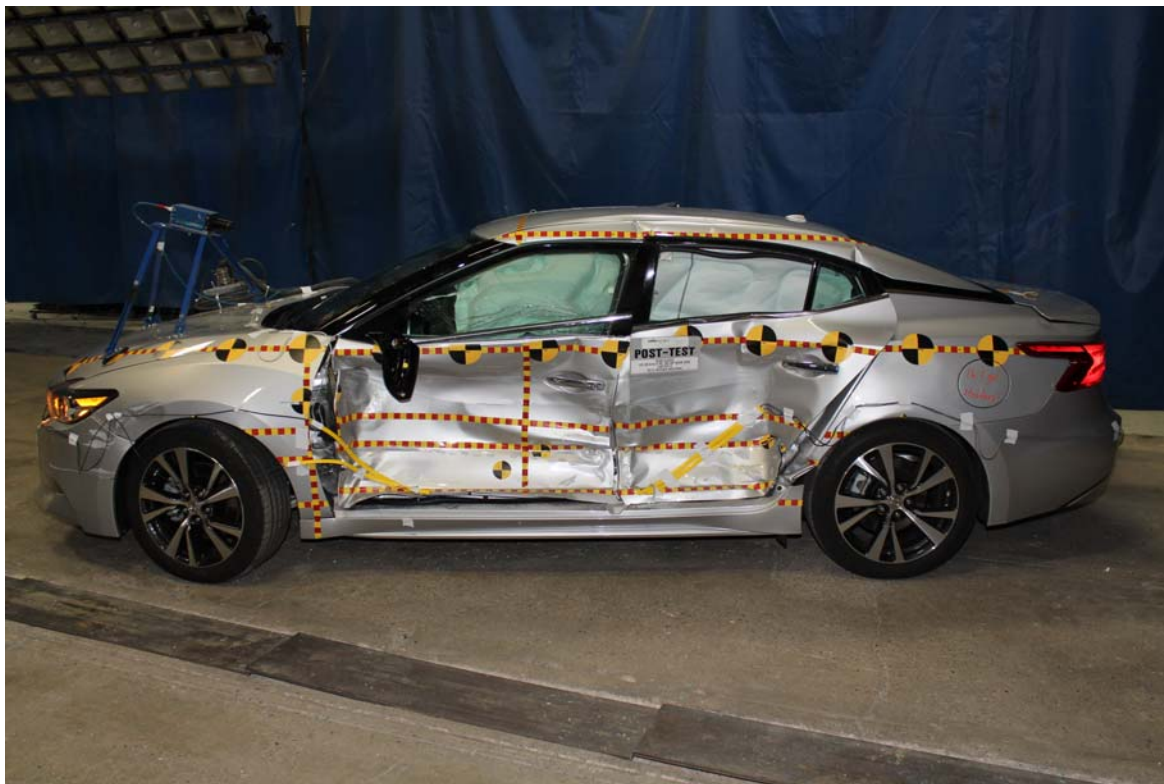
Photo No. 4. Post-Test Vehicle Left Side View

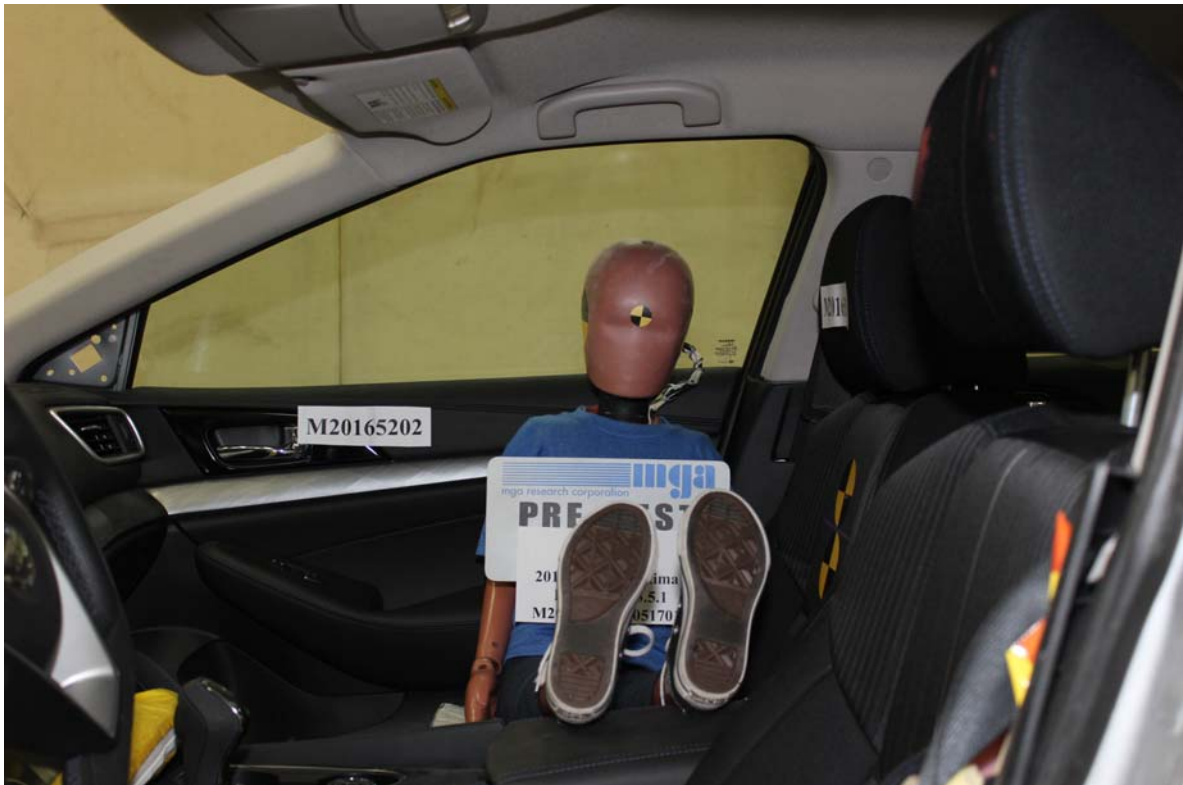
Photo No. 5. Pre-Test 6-Year-Old Child Dummy Left Side View

The Hybrid III 6-Year-Old child dummy was placed in the right front passenger seat along the outboard edge of the foam block, facing inboard with its legs extended and arms hanging at its sides. The seat track was positioned forward to maximize the cushion to head interaction. The dummy's pelvis was slid outboard until the dummy's back contacted the door trim panel or armrest and the center of gravity of the head was centered in the deployment trajectory of the airbag. The head remained in its neutral orientation. A vertical plane through the centerline of the dummy's shoulder bolts was parallel to the vehicle centerline. The dummy's arms were bent at the elbow until the fingertips contacted the foam block.

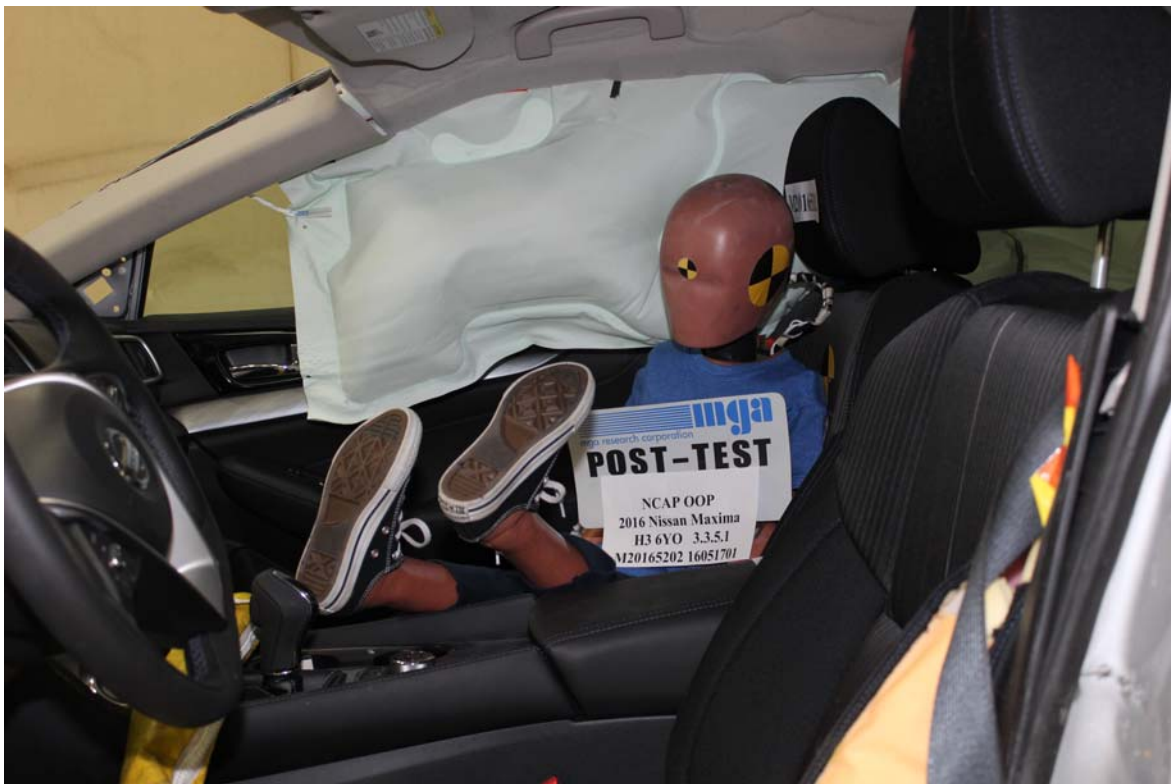
Photo No. 6. Post-Test 6-Year-Old Child Dummy Left Side View

- Curtain airbag to top and back of head
- Torso bag to left side of shoulder, torso, and pelvis

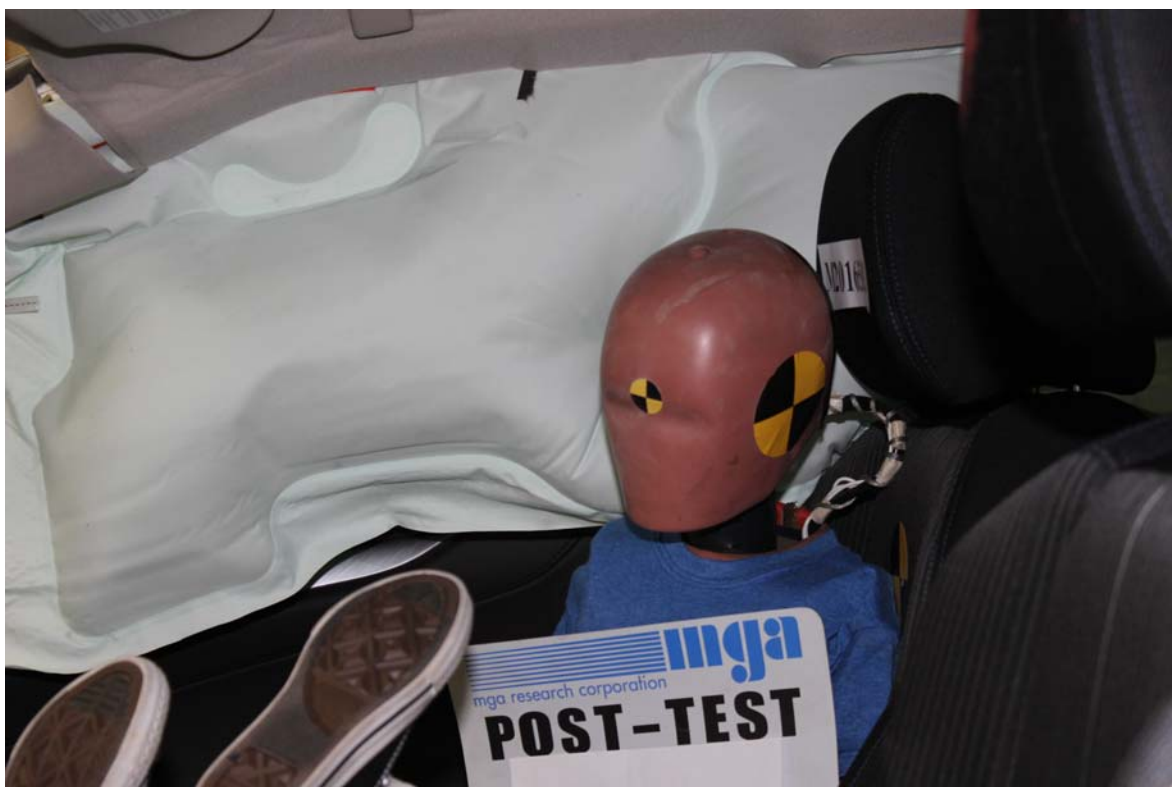
Photo No. 8. Post-Test 6-Year-Old Child Dummy Left Side Closeup View

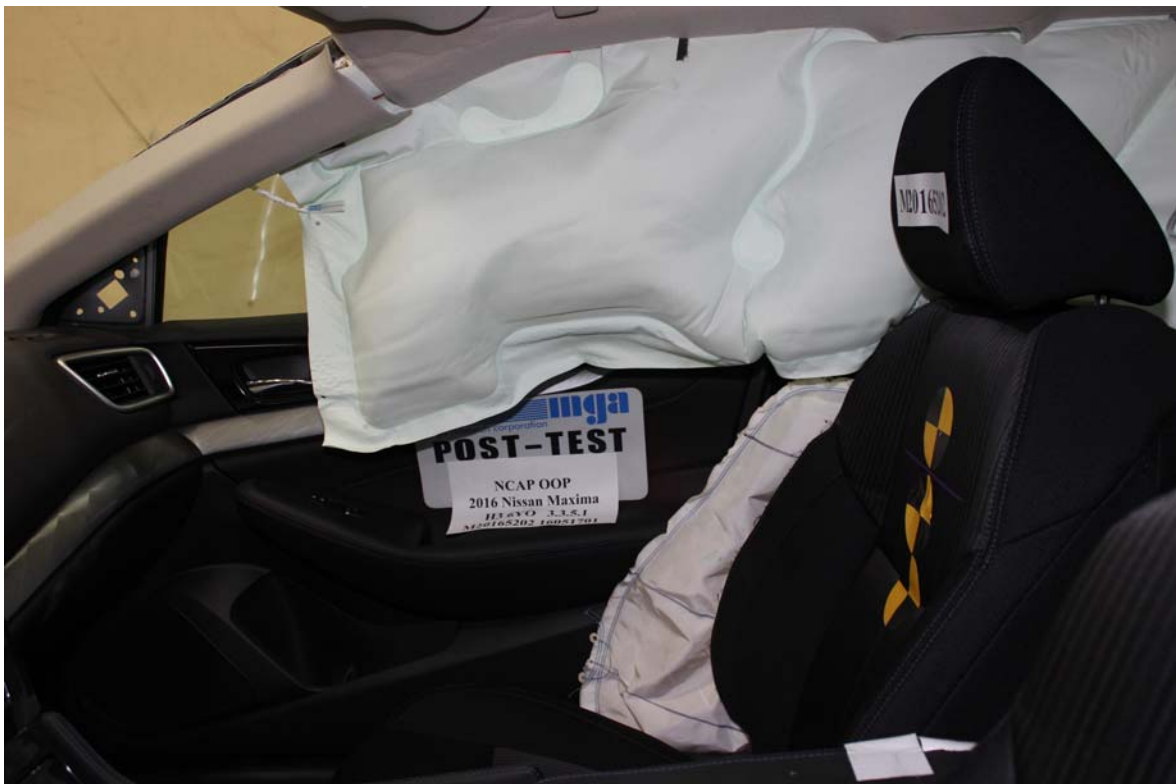
Photo No. 22. Post-Test Curtain Airbag Left Side View

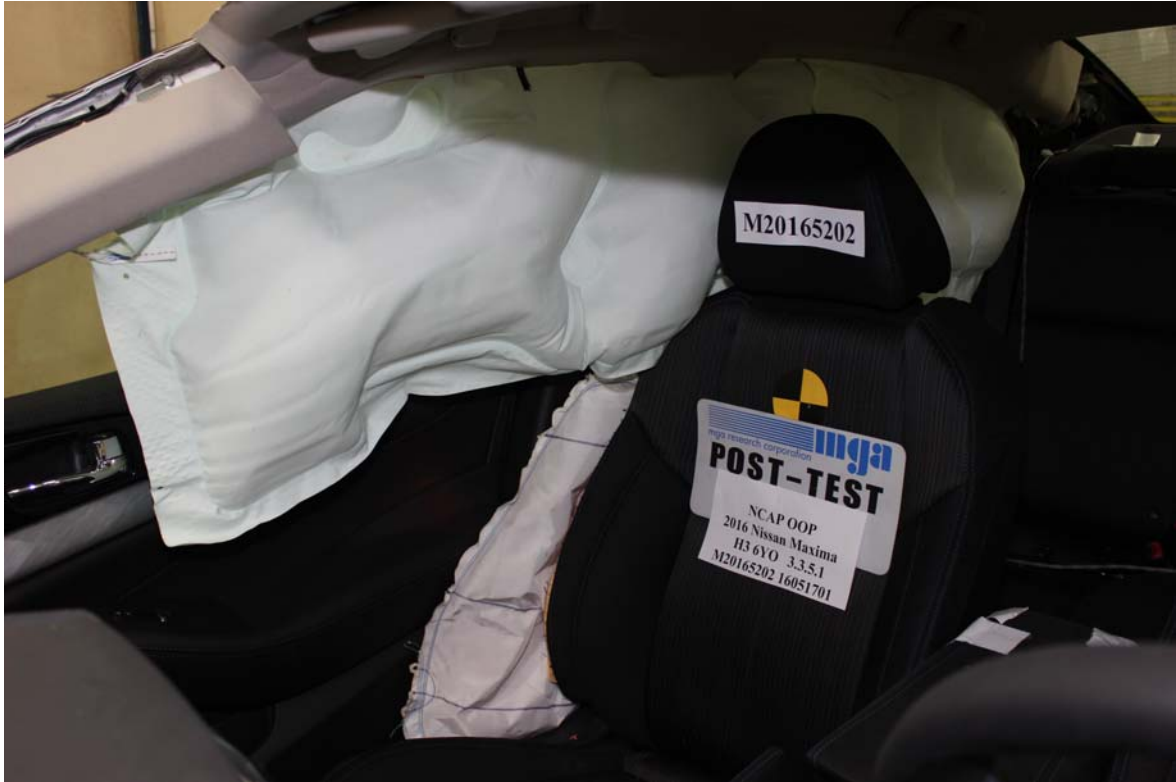
Photo No. 23. Post-Test Curtain Airbag Left ¾ Front View

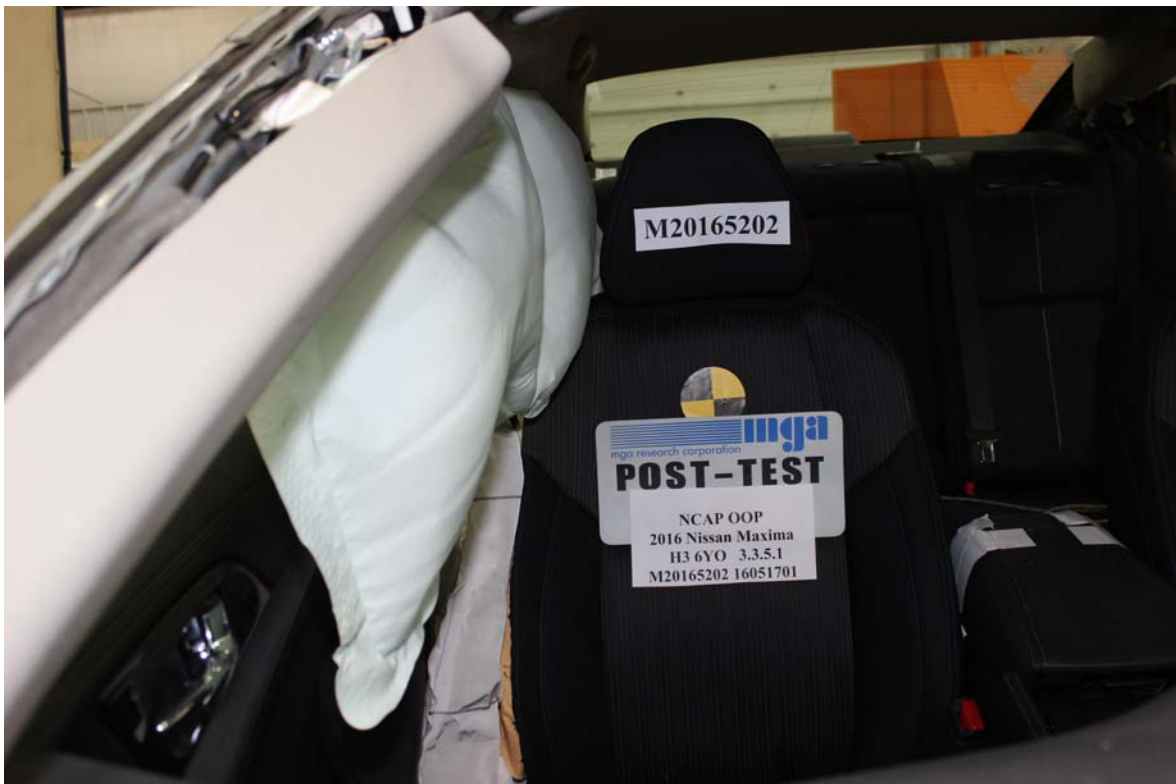
Photo No. 24. Post-Test Curtain Airbag Front View

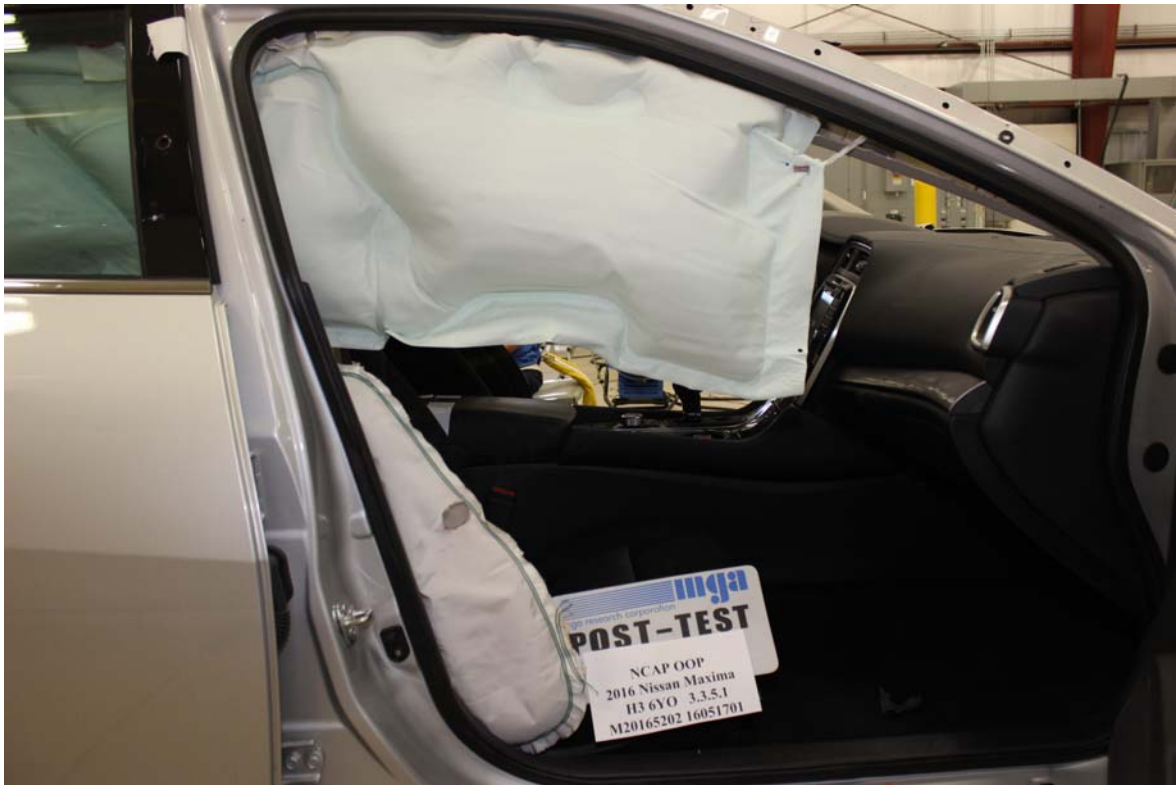
Photo No. 25. Post-Test Curtain Airbag Right Side View (Door Open)

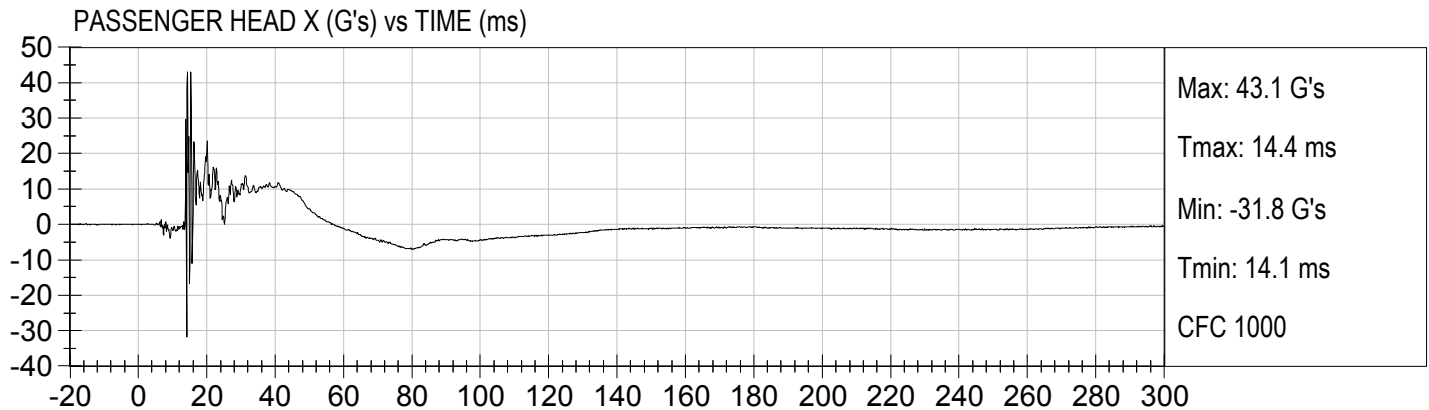
| | <u>Page No.</u> |
|---|---|
| Figure No. 1. Passenger Head X Acceleration vs. Time | 23 |

| | | MAXIMUM VALUE | | | |
|---|---|---|---|---|---|
| Head X | g | 43.1 | 14.4 | -31.8 | 14.1 |

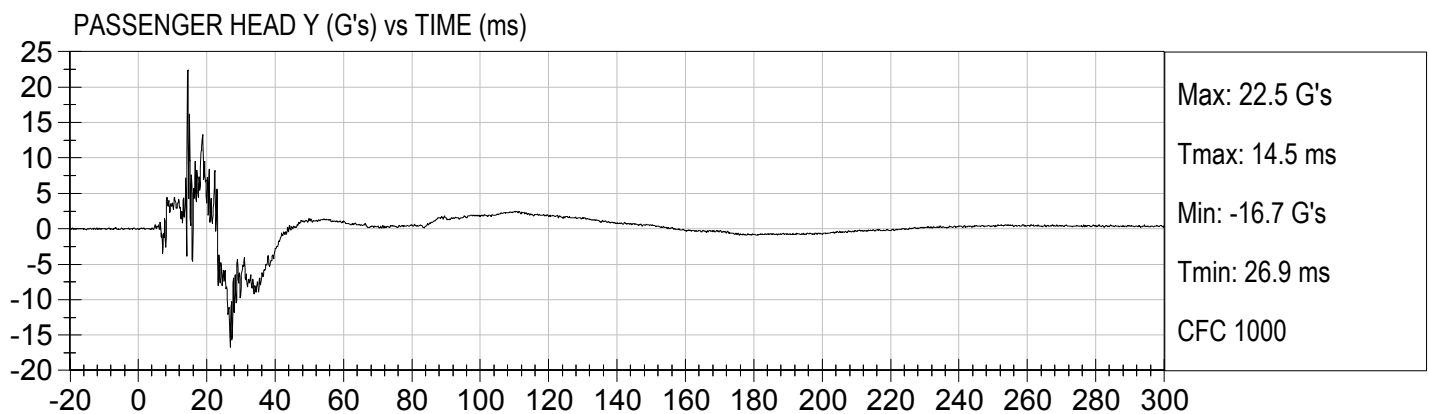
| | <u>Page No.</u> |
|---|---|
| Figure No. 2. Passenger Head Y Acceleration vs. Time | 23 |

| | | MAXIMUM VALUE | | | |
|---|---|---|---|---|---|
| Head Y | g | 22.5 | 14.5 | -16.7 | 26.9 |

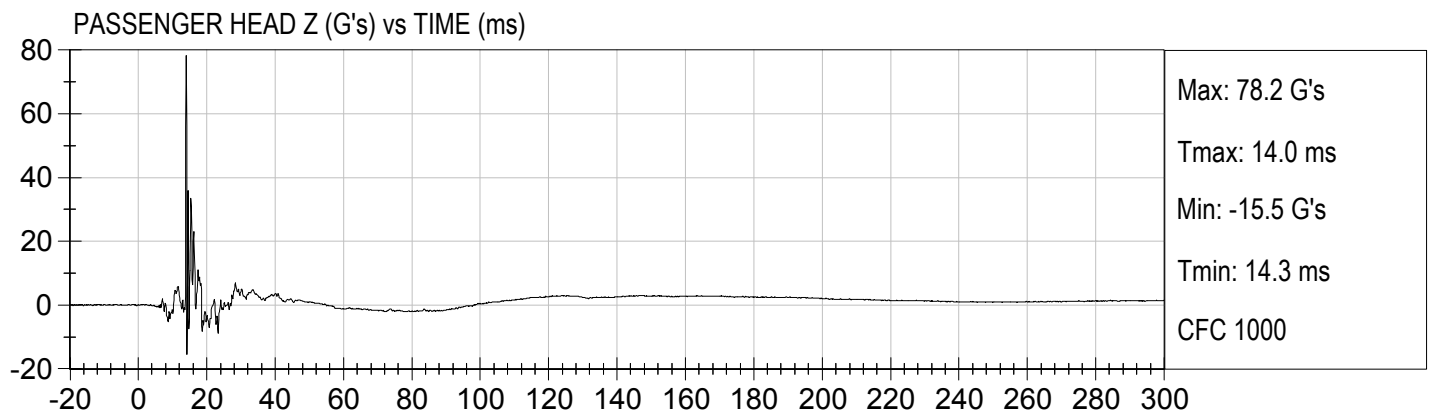
| | <u>Page No.</u> |
|---|---|
| Figure No. 3. Passenger Head Z Acceleration vs. Time | 23 |

| | | MAXIMUM VALUE | | | |
|---|---|---|---|---|---|
| Head Z | g | 78.2 | 14.0 | -15.5 | 14.3 |

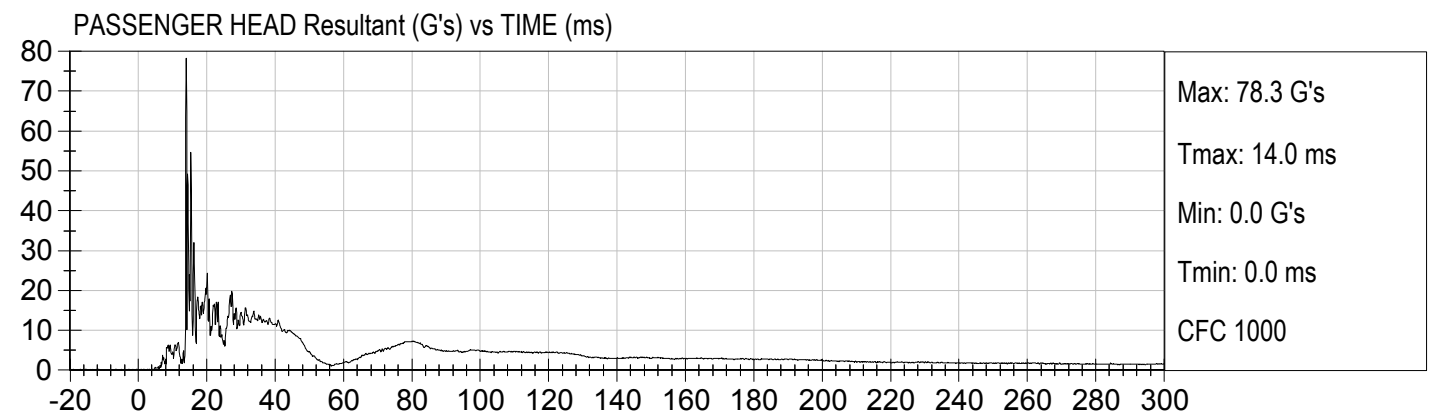
| | <u>Page No.</u> |
|---|---|
| Figure No. 4. Passenger Head Resultant Acceleration vs. Time | 23 |

| | | MAXIMUM VALUE | | | |
|---|---|---|---|---|---|
| Head Resultant | g | 78.3 | 14.0 | | |

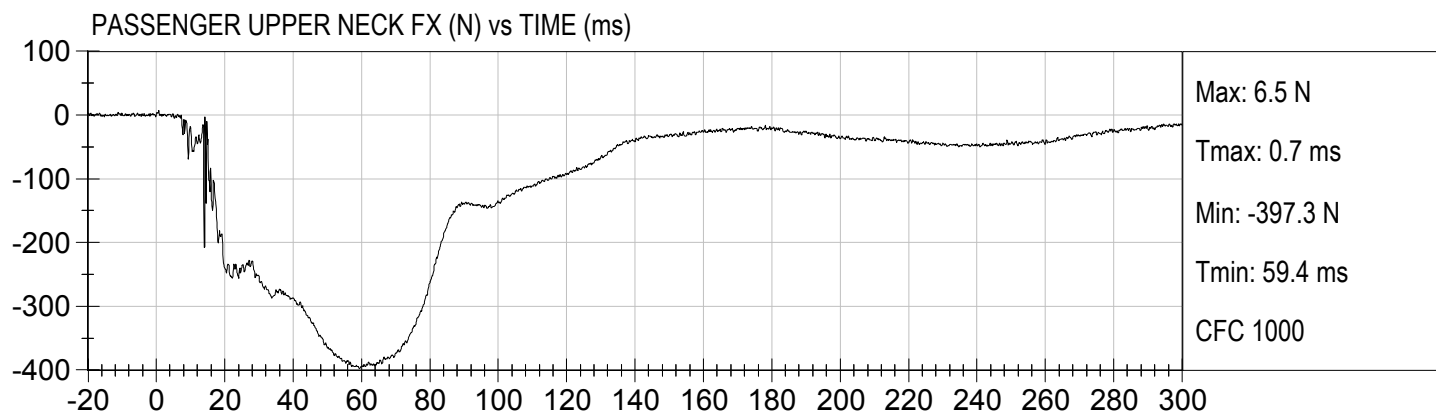
| | <u>Page No.</u> |
|---|---|
| Figure No. 5. Passenger Upper Neck X Force vs. Time | 24 |

| | | MAXIMUM VALUE | | | |
|---|---|---|---|---|---|
| Upper Neck Fx | N | 6.5 | 0.7 | -397.3 | 59.4 |

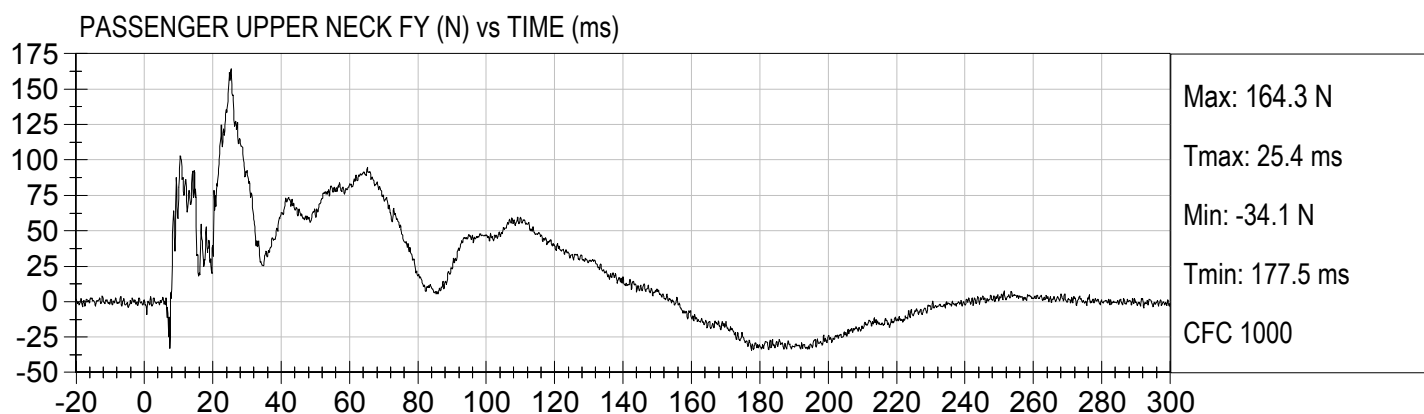
| | <u>Page No.</u> |
|---|---|
| Figure No. 6. Passenger Upper Neck Y Force vs. Time | 24 |

| | | MAXIMUM VALUE | | | |
|---|---|---|---|---|---|
| Upper Neck Fy | N | 164.3 | 25.4 | -34.1 | 177.5 |

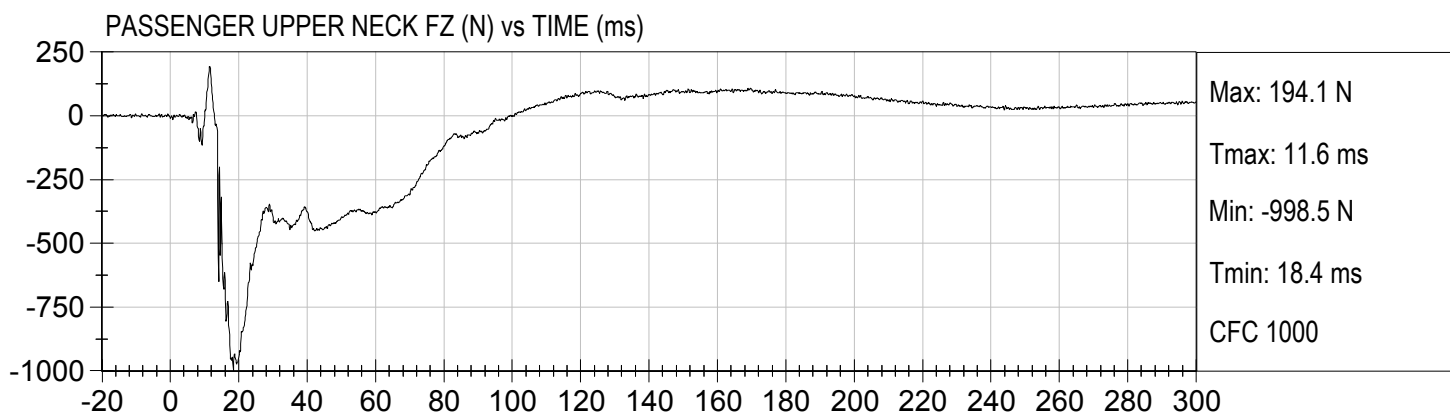
| | <u>Page No.</u> |
|---|---|
| Figure No. 7. Passenger Upper Neck Z Force vs. Time | 24 |

| | | MAXIMUM VALUE | | | |
|---|---|---|---|---|---|
| Upper Neck Fz | N | 194.1 | 11.6 | -998.5 | 18.4 |

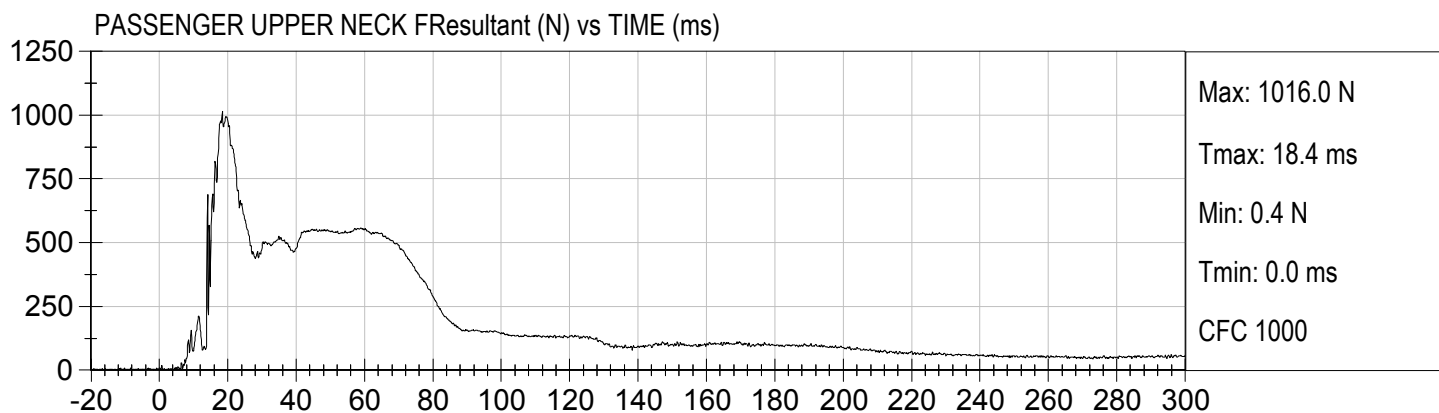
| | <u>Page No.</u> |
|---|---|
| Figure No. 8. Passenger Upper Neck Resultant Force vs. Time | 24 |

| | | MAXIMUM VALUE | | | |
|---|---|---|---|---|---|
| Upper Neck F Resultant | N | 1016.0 | 18.4 | | |

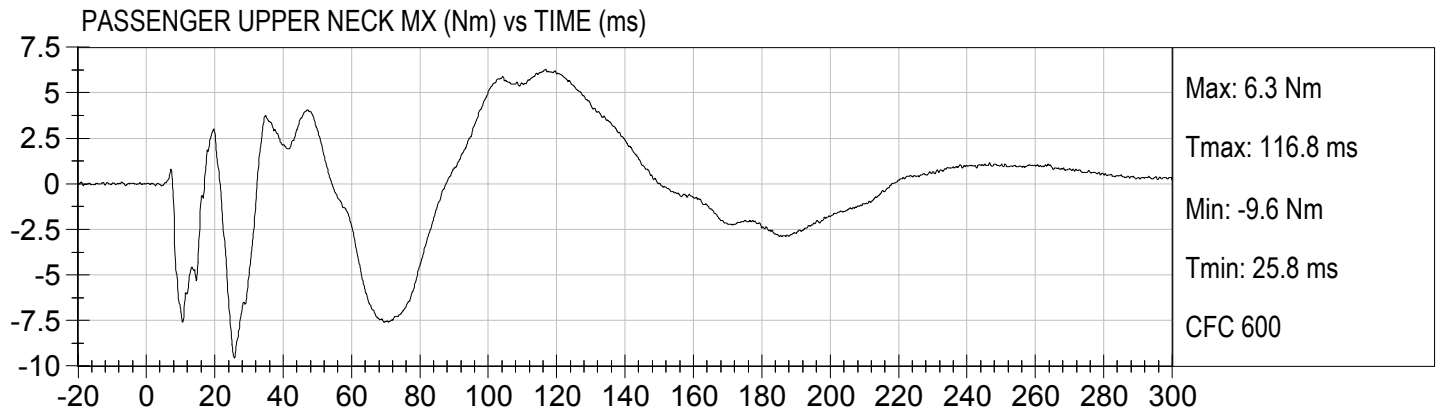
| | <u>Page No.</u> |
|---|---|
| Figure No. 9. Passenger Upper Neck X Moment vs. Time | 25 |

| | | MAXIMUM VALUE | | | |
|---|---|---|---|---|---|
| Upper Neck Mx | Nm | 6.3 | 116.8 | -9.6 | 25.8 |

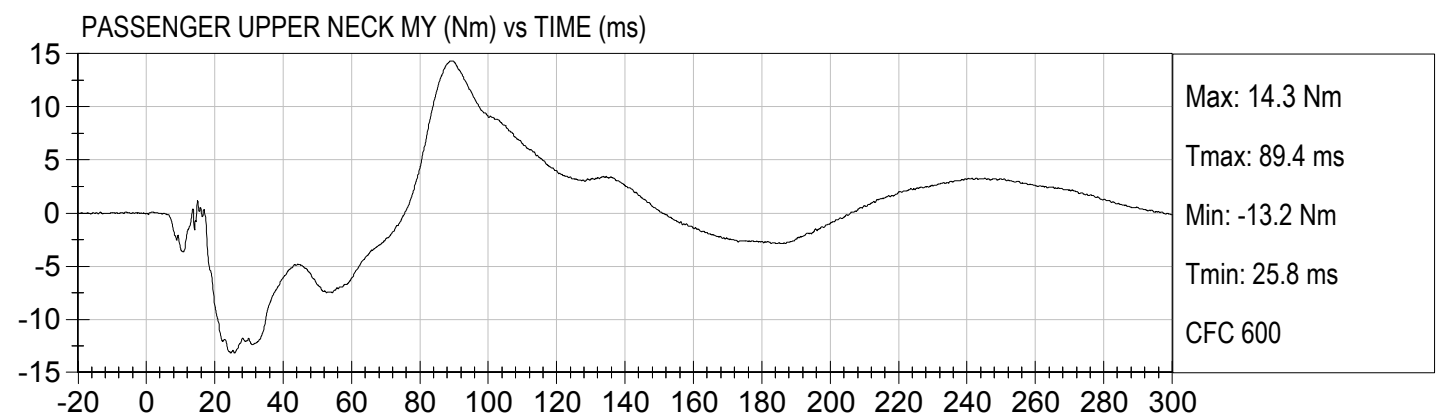
| | <u>Page No.</u> |
|---|---|
| Figure No. 10. Passenger Upper Neck Y Moment vs. Time | 25 |

| | | MAXIMUM VALUE | | | |
|---|---|---|---|---|---|
| Upper Neck My | Nm | 14.3 | 89.4 | -13.2 | 25.8 |

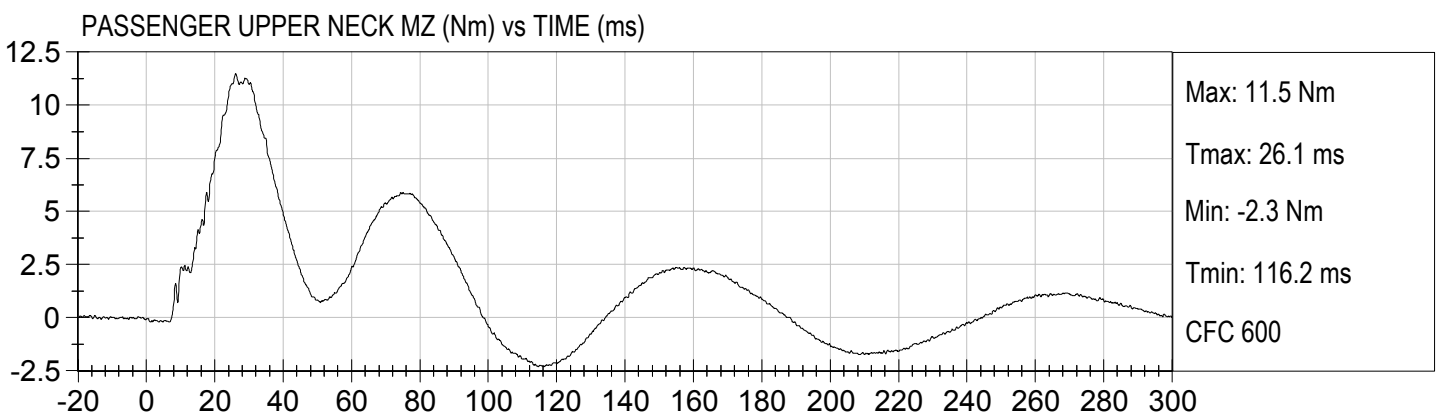
| | <u>Page No.</u> |
|---|---|
| Figure No. 11. Passenger Upper Neck Z Moment vs. Time | 25 |

| | | MAXIMUM VALUE | | | |
|---|---|---|---|---|---|
| Upper Neck Mz | Nm | 11.5 | 26.1 | -2.3 | 116.2 |

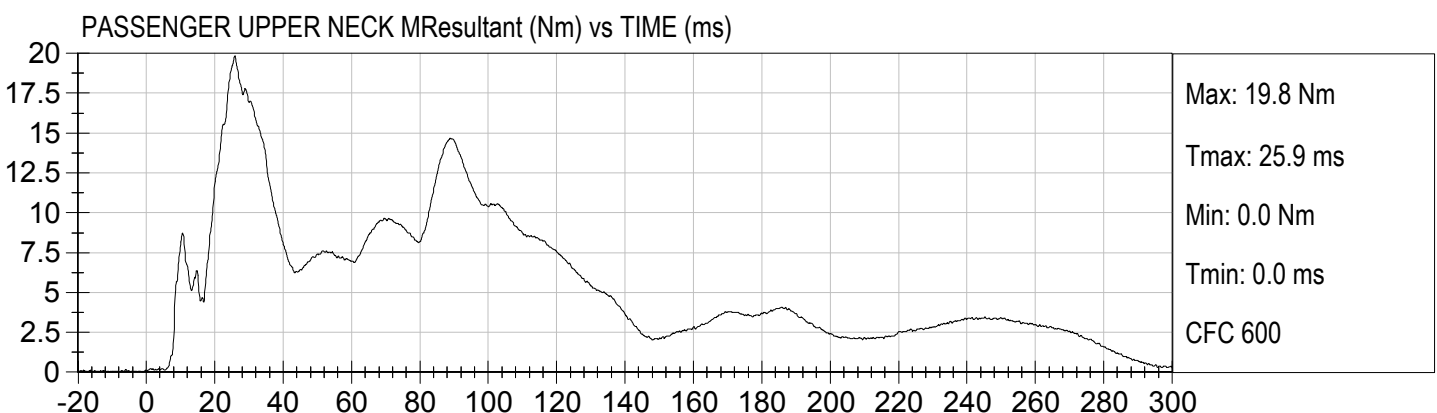
| | <u>Page No.</u> |
|---|---|
| Figure No. 12. Passenger Upper Neck Resultant Moment vs. Time | 25 |

| | | MAXIMUM VALUE | | | |
|---|---|---|---|---|---|
| Upper Neck M Resultant | Nm | 19.8 | 25.9 | | |

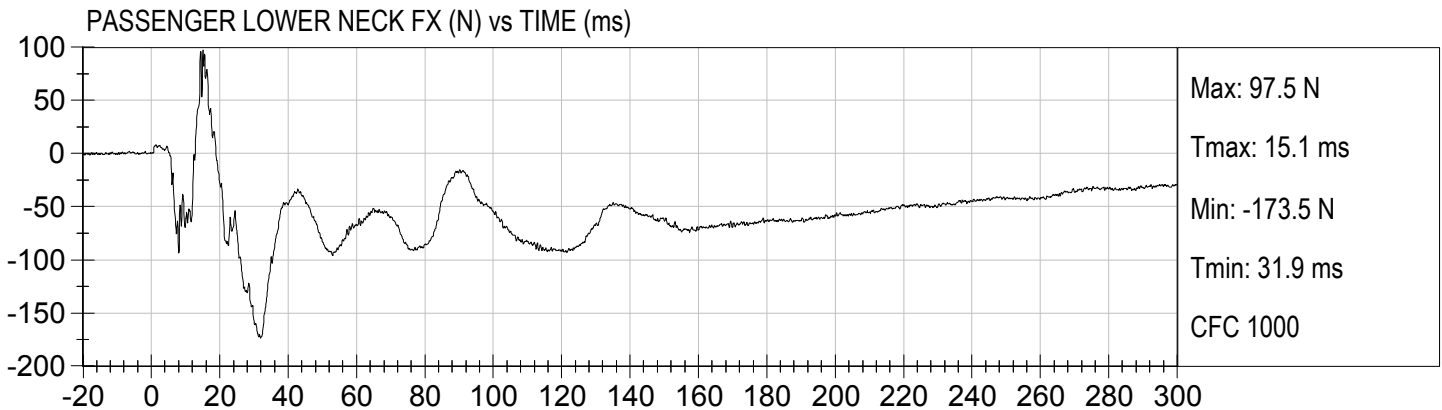
| | <u>Page No.</u> |
|---|---|
| Figure No. 13. Passenger Lower Neck X Force vs. Time | 26 |

| | | MAXIMUM VALUE | | | |
|---|---|---|---|---|---|
| Lower Neck Fx | N | 97.5 | 15.1 | -173.5 | 31.9 |

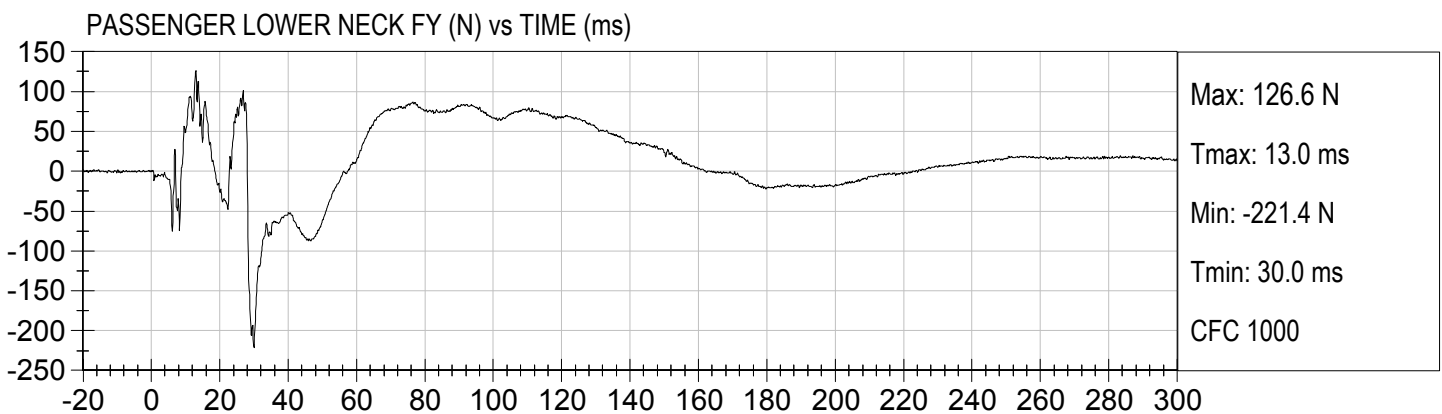
| | <u>Page No.</u> |
|---|---|
| Figure No. 14. Passenger Lower Neck Y Force vs. Time | 26 |

| | | MAXIMUM VALUE | | | |
|---|---|---|---|---|---|
| Lower Neck Fy | N | 126.6 | 13.0 | -221.4 | 30.0 |

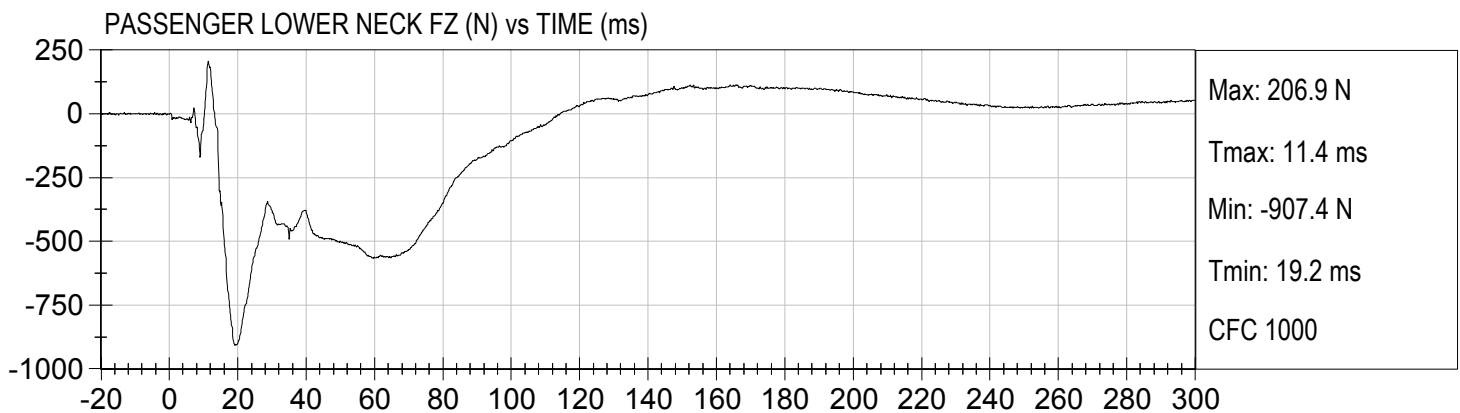
| | <u>Page No.</u> |
|---|---|
| Figure No. 15. Passenger Lower Neck Z Force vs. Time | 26 |

| | | MAXIMUM VALUE | | | |
|---|---|---|---|---|---|
| Lower Neck Fz | N | 206.9 | 11.4 | -907.4 | 19.2 |

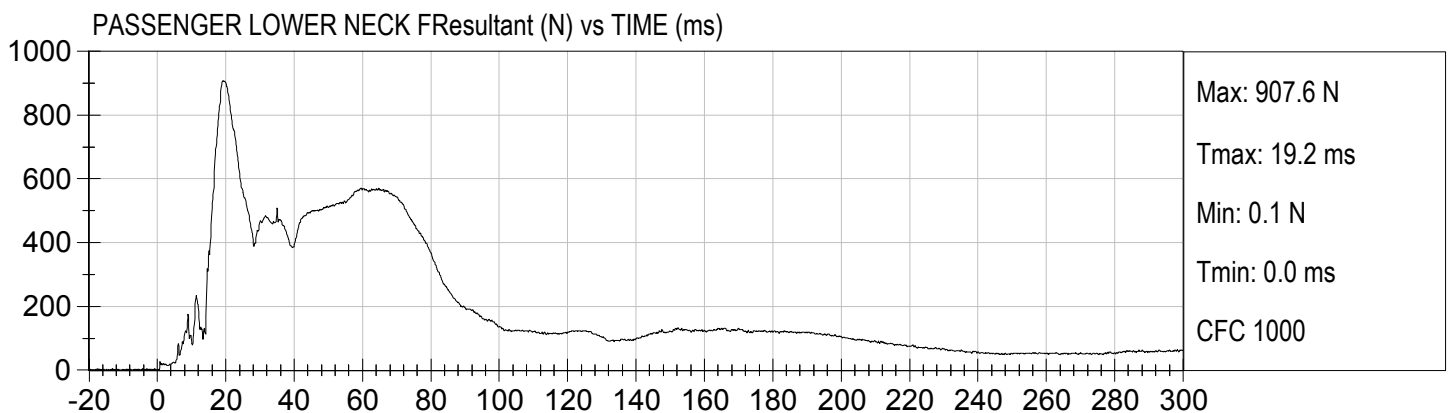
| | <u>Page No.</u> |
|---|---|
| Figure No. 16. Passenger Lower Neck Resultant Force vs. Time | 26 |

| | | MAXIMUM VALUE | | | |
|---|---|---|---|---|---|
| Lower Neck F Resultant | N | 907.6 | 19.2 | | |

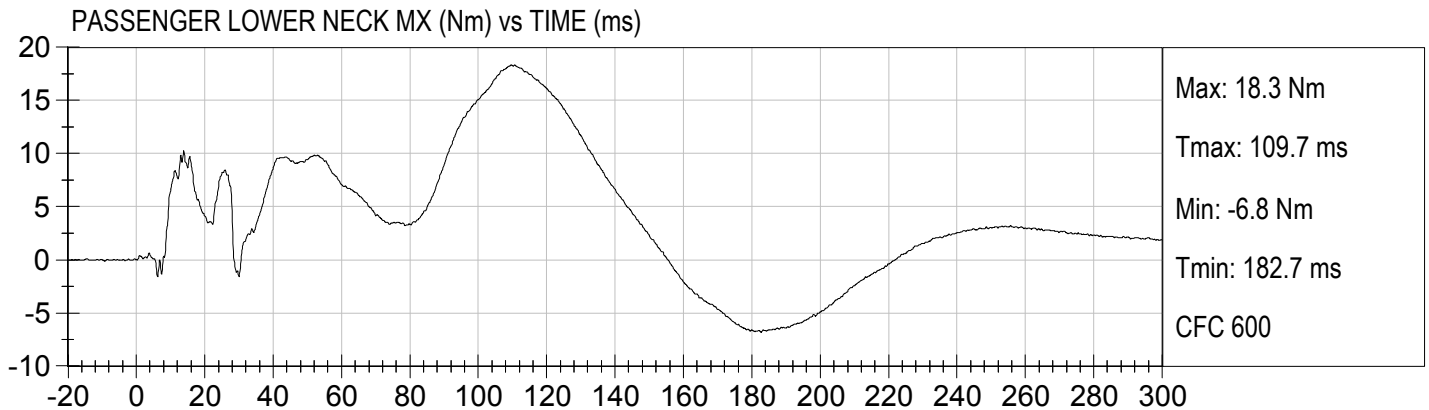
| | <u>Page No.</u> |
|---|---|
| Figure No. 17. Passenger Lower Neck X Moment vs. Time | 27 |

| | | MAXIMUM VALUE | | | |
|---|---|---|---|---|---|
| Lower Neck Mx | Nm | 18.3 | 109.7 | -6.8 | 182.7 |

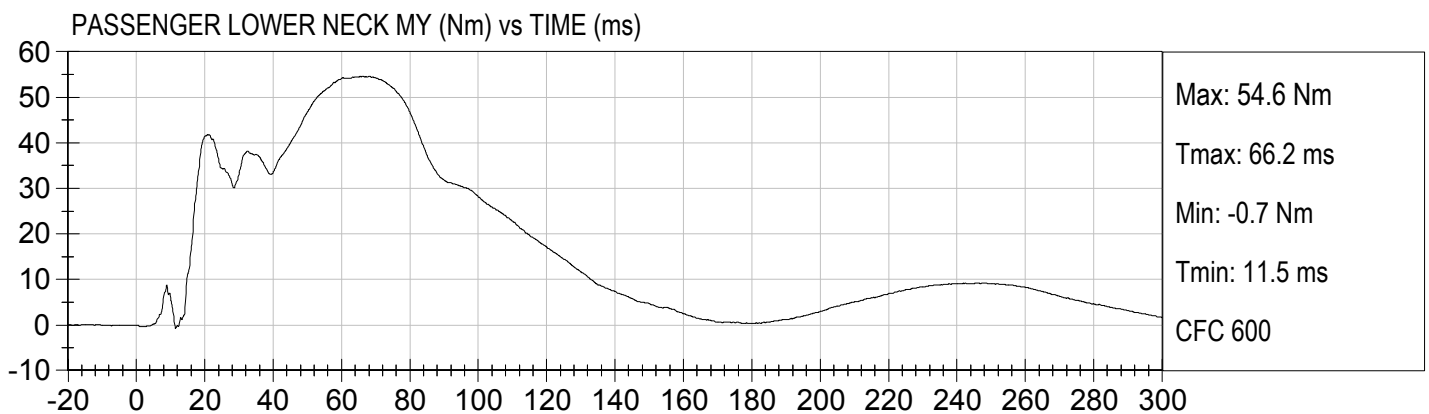
| | <u>Page No.</u> |
|---|---|
| Figure No. 18. Passenger Lower Neck Y Moment vs. Time | 27 |

| | | MAXIMUM VALUE | | | |
|---|---|---|---|---|---|
| Lower Neck My | Nm | 54.6 | 66.2 | -0.7 | 11.5 |

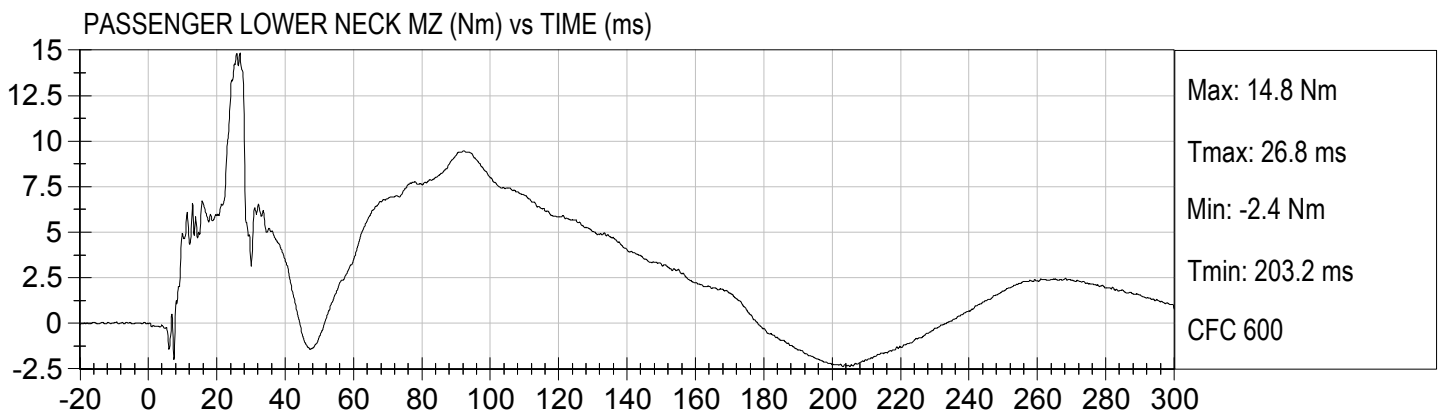
| | <u>Page No.</u> |
|---|---|
| Figure No. 19. Passenger Lower Neck Z Moment vs. Time | 27 |

| | | MAXIMUM VALUE | | | |
|---|---|---|---|---|---|
| Lower Neck Mz | Nm | 14.8 | 26.8 | -2.4 | 203.2 |

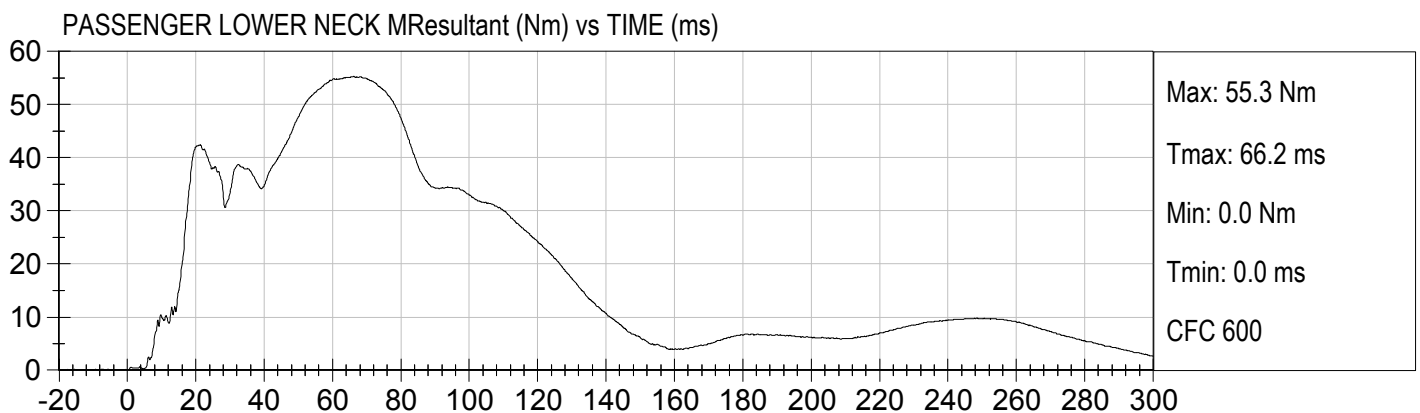
| | <u>Page No.</u> |
|---|---|
| Figure No. 20. Passenger Lower Neck Resultant Moment vs. Time | 27 |

| | | MAXIMUM VALUE | | | |
|---|---|---|---|---|---|
| Lower Neck M Resultant | Nm | 55.3 | 66.2 | | |

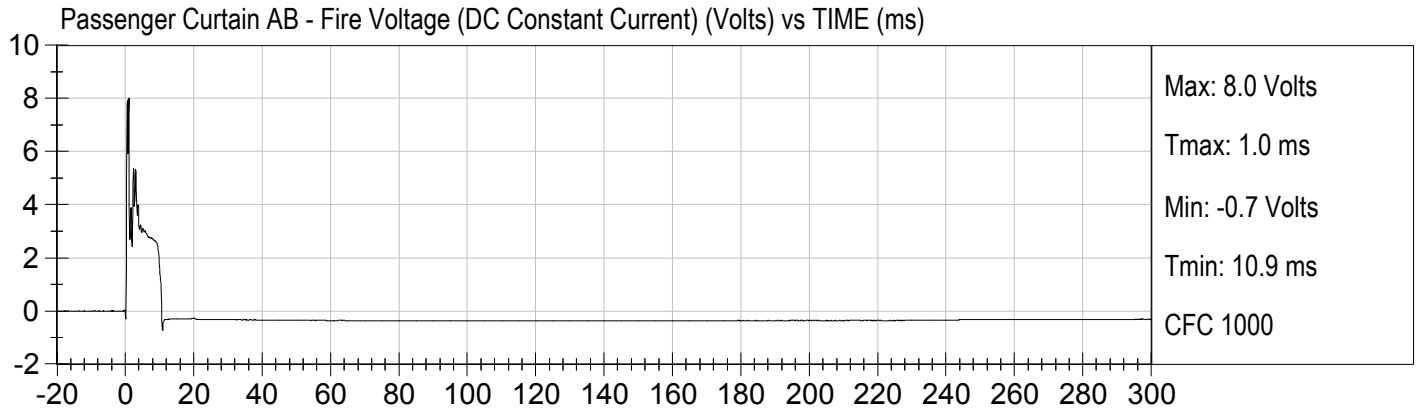
| | <u>Page No.</u> |
|---|---|
| Figure No. 21. Passenger Curtain Airbag – Fire Voltage vs. Time | 28 |

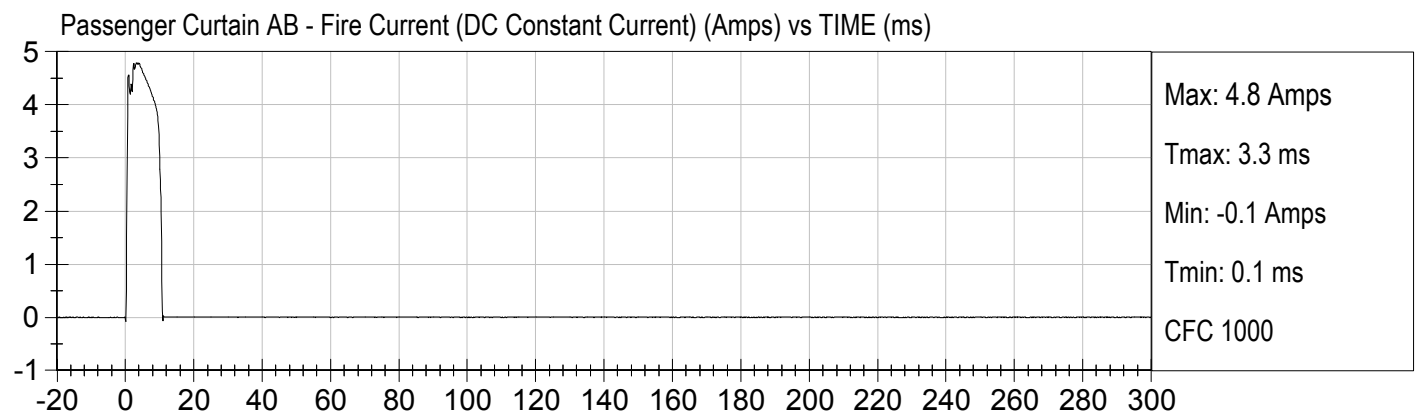
| | <u>Page No.</u> |
|---|---|
| Figure No. 22. Passenger Curtain Airbag – Fire Current vs. Time | 28 |
