**REPORT NUMBER: TWG-MGA-2016-001**

**SIDE AIRBAG OUT-OF-POSITION INJURY  
TECHNICAL WORKING GROUP**

**NISSAN MOTOR CO., LTD.  
2016 Nissan Maxima S 4-Dr Sedan  
NHTSA No.: M20165202TWG2**

**FINAL REPORT**

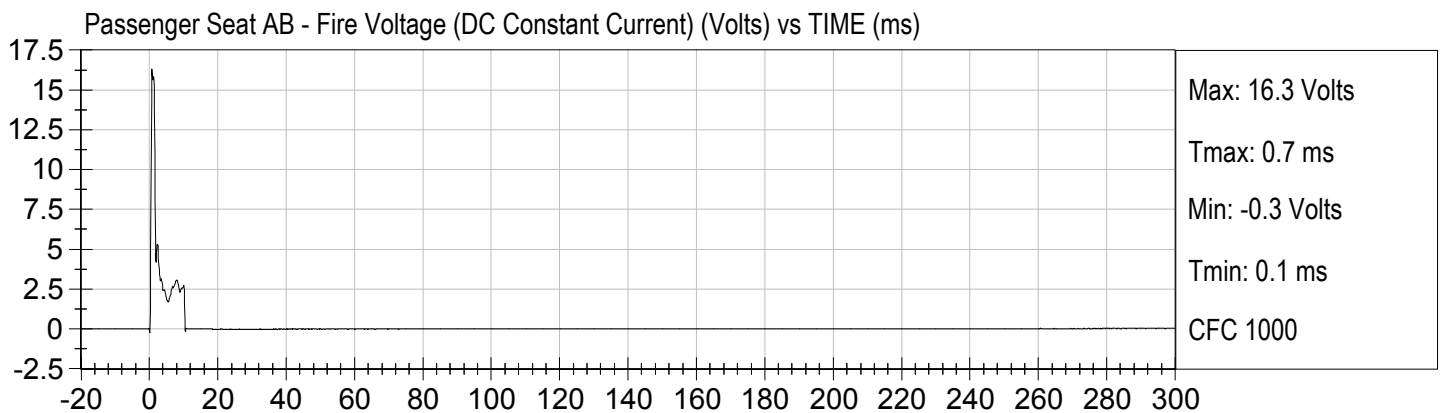
| | <u>Page No.</u> |
|---|---|
| Figure No. 23. Passenger Seat Airbag – Fire Voltage vs. Time | 28 |

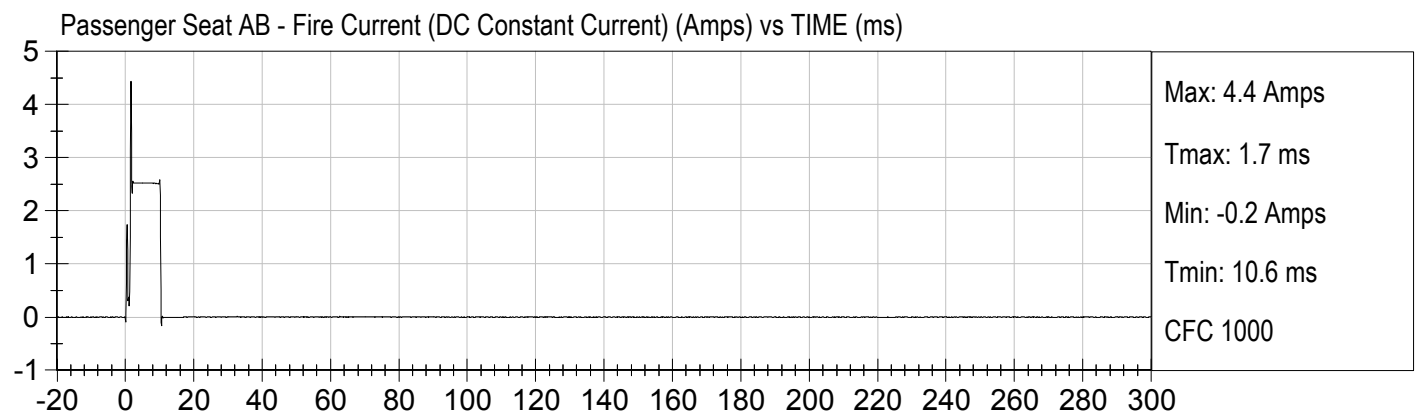
| | <u>Page No.</u> |
|---|---|
| Figure No. 24. Passenger Seat Airbag – Fire Current vs. Time | 28 |
