REPORT NUMBER: TWG-MGA-2016-004

**SIDE AIRBAG OUT-OF-POSITION INJURY
TECHNICAL WORKING GROUP**

**FCA ITALY S.P.A.
2016 Jeep Renegade Sport 5-Door SUV
NHTSA No.: M20160312TWG2**

FINAL REPORT

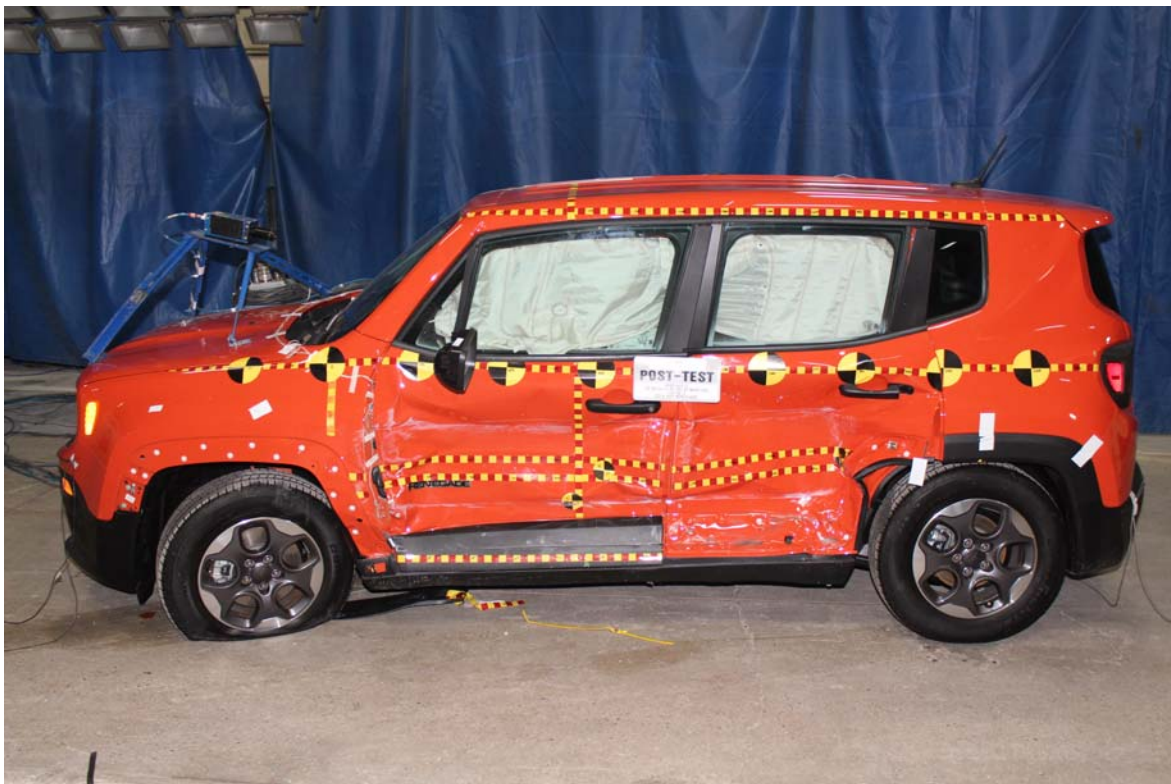
Photo No. 4. Post-Test Vehicle Left Side View

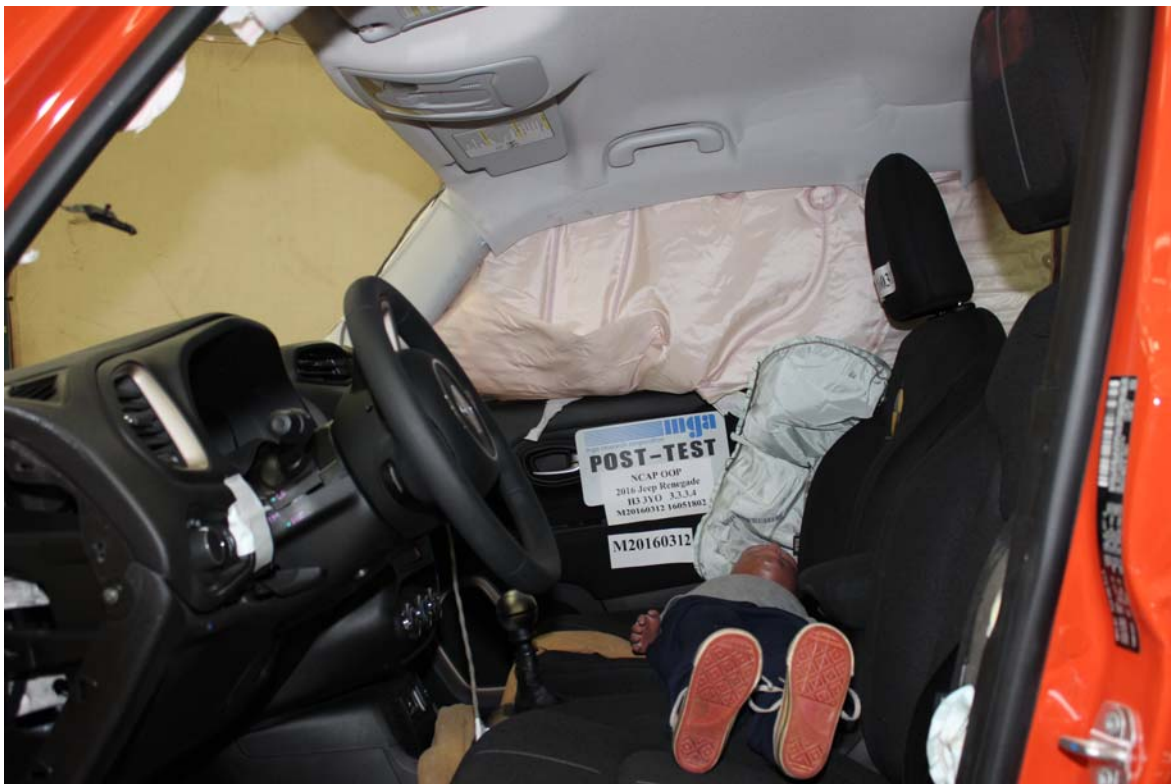
Photo No. 6. Post-Test 6-Year-Old Child Dummy Left Side View

- Torso/pelvis bag to top and left side of head

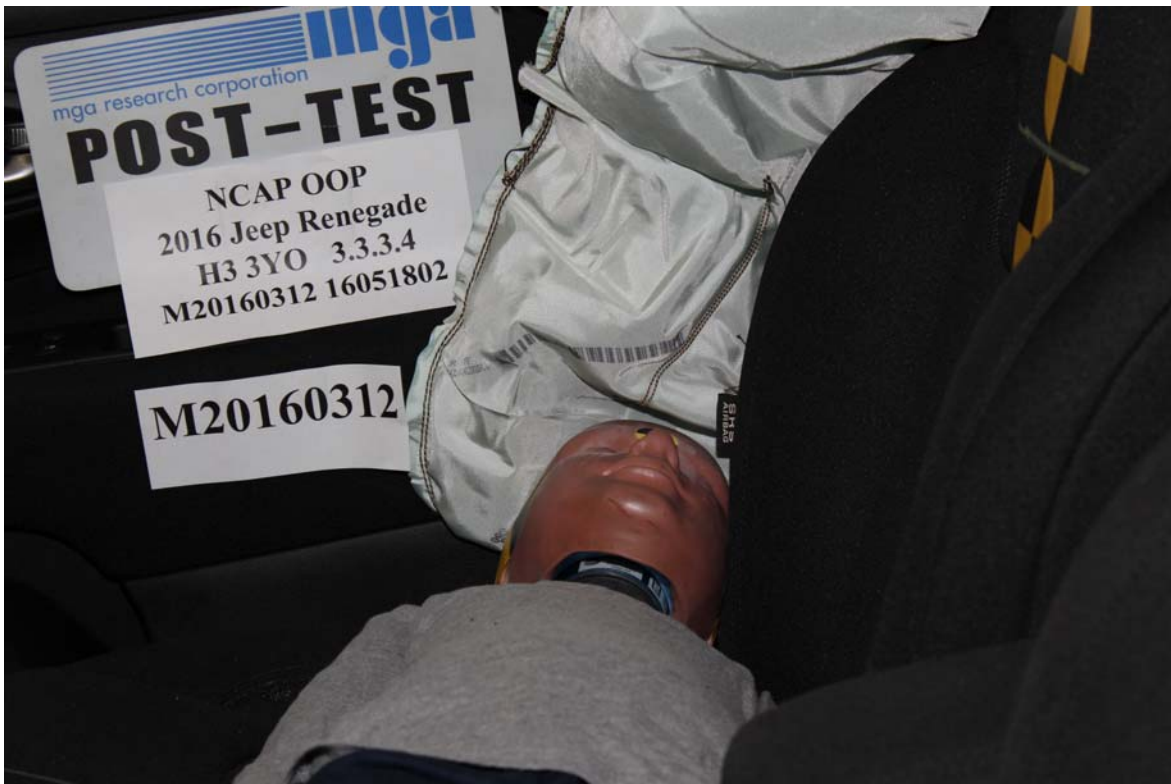
Photo No. 8. Post-Test 6-Year-Old Child Dummy Left Side Closeup View

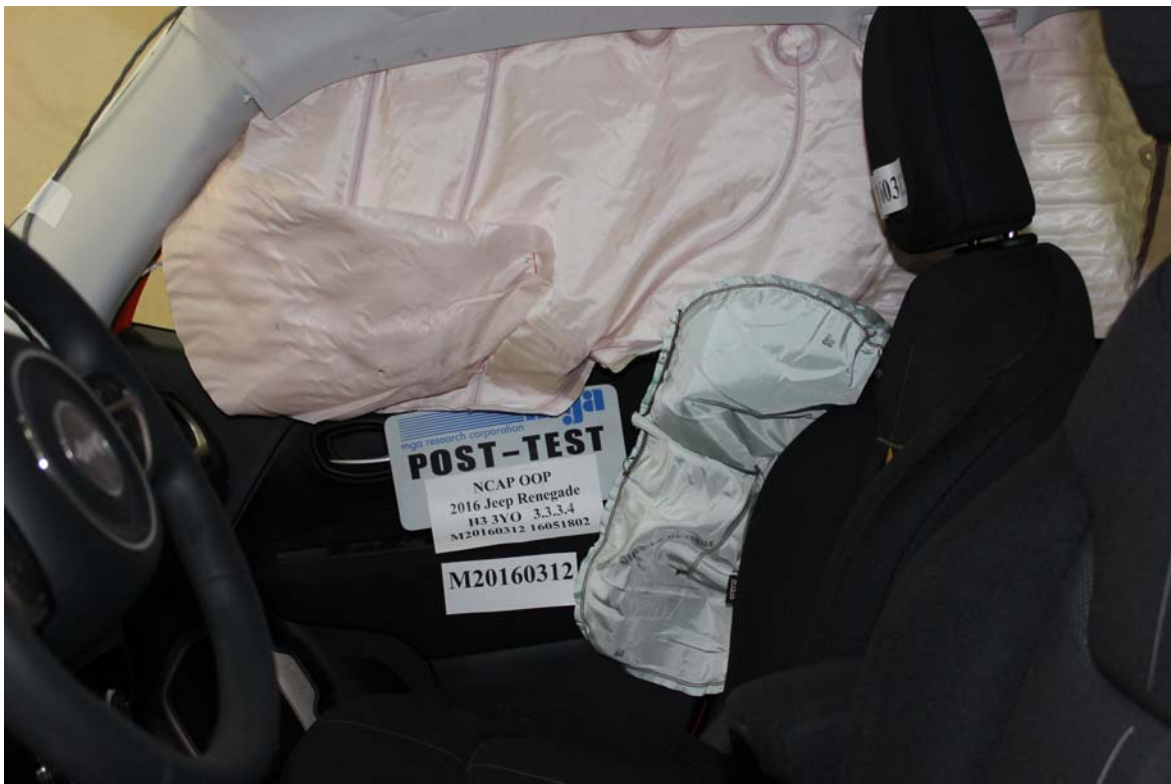
Photo No. 22. Post-Test Curtain Airbag Left Side View

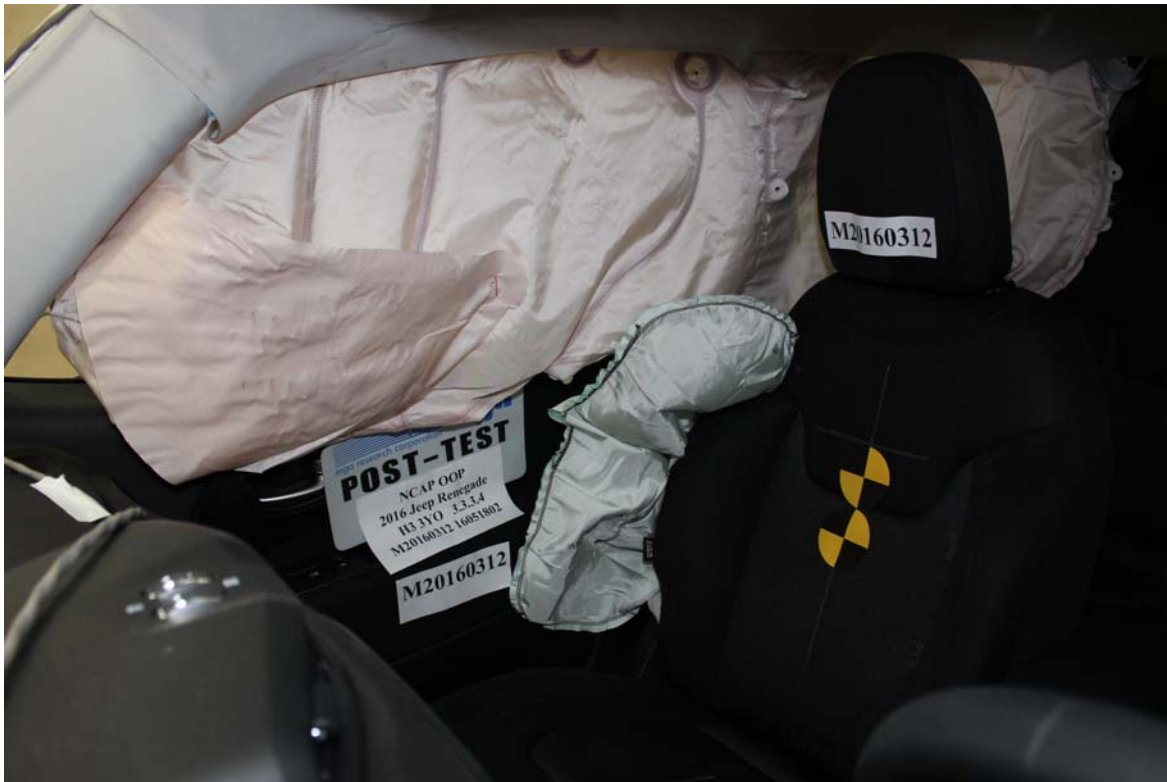
Photo No. 23. Post-Test Curtain Airbag Left $\frac{3}{4}$ Front View

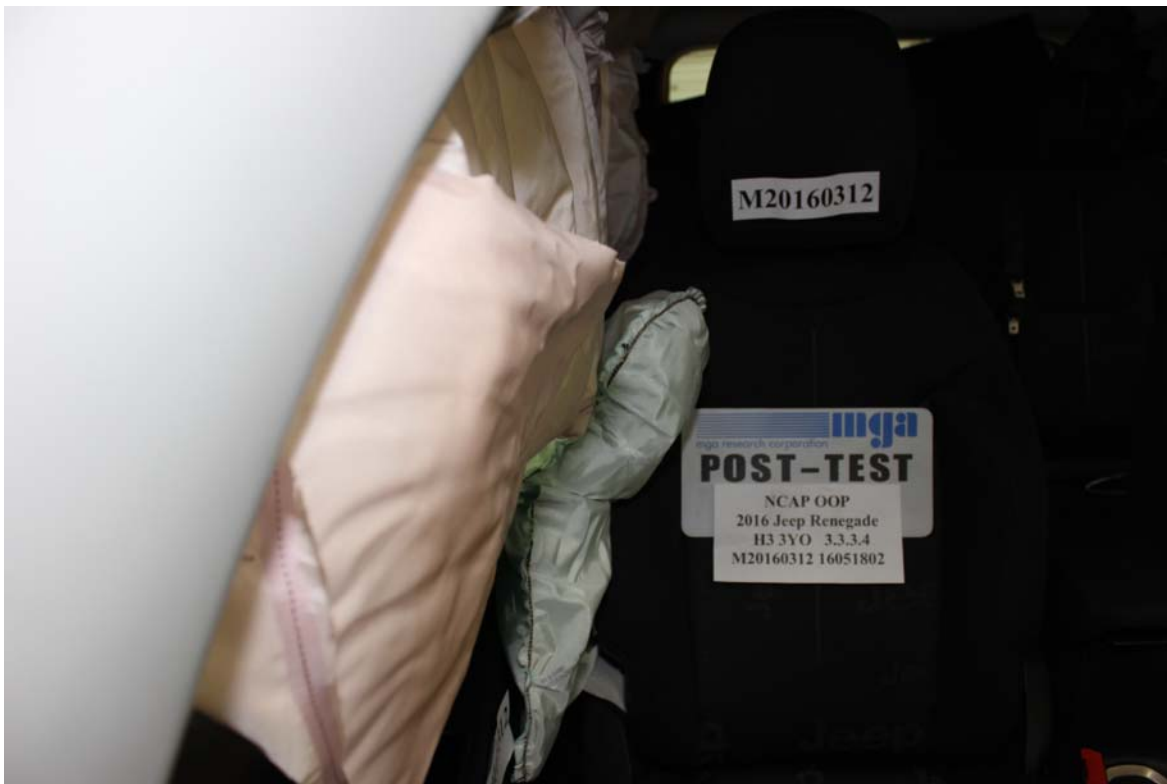
Photo No. 24. Post-Test Curtain Airbag Front View

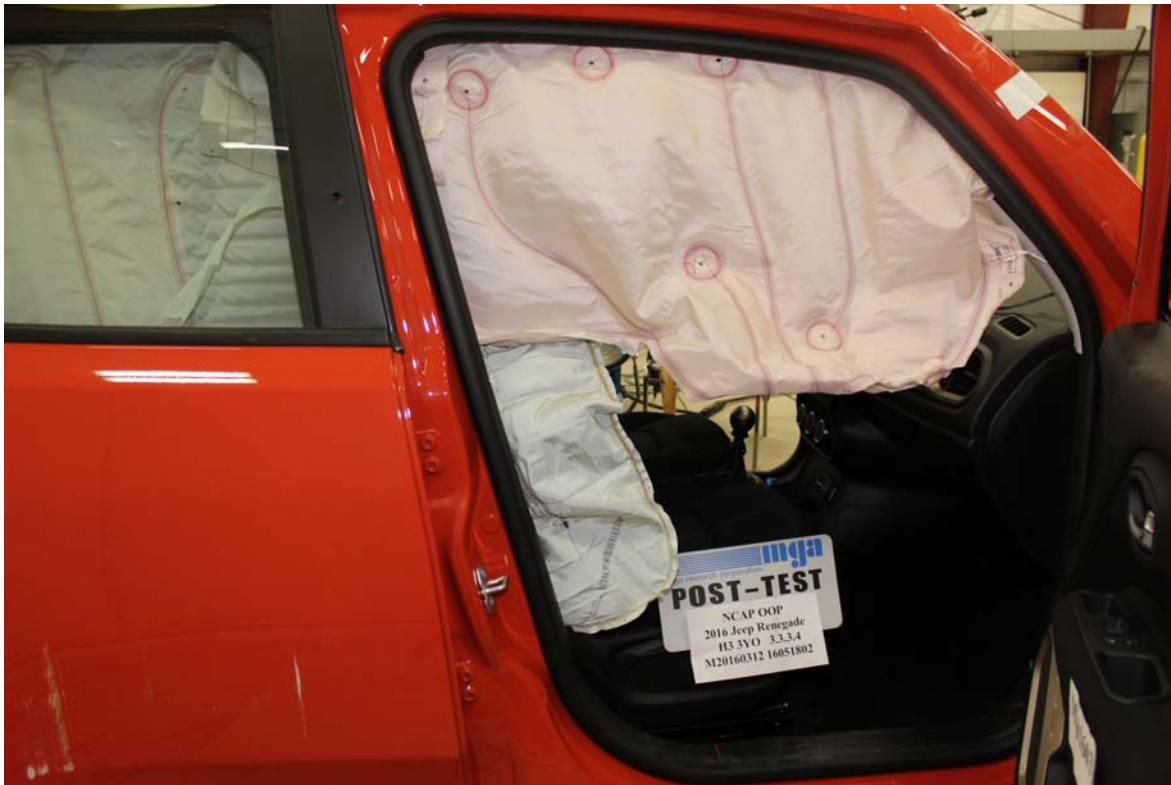
Photo No. 25. Post-Test Curtain Airbag Right Side View (Door Open)

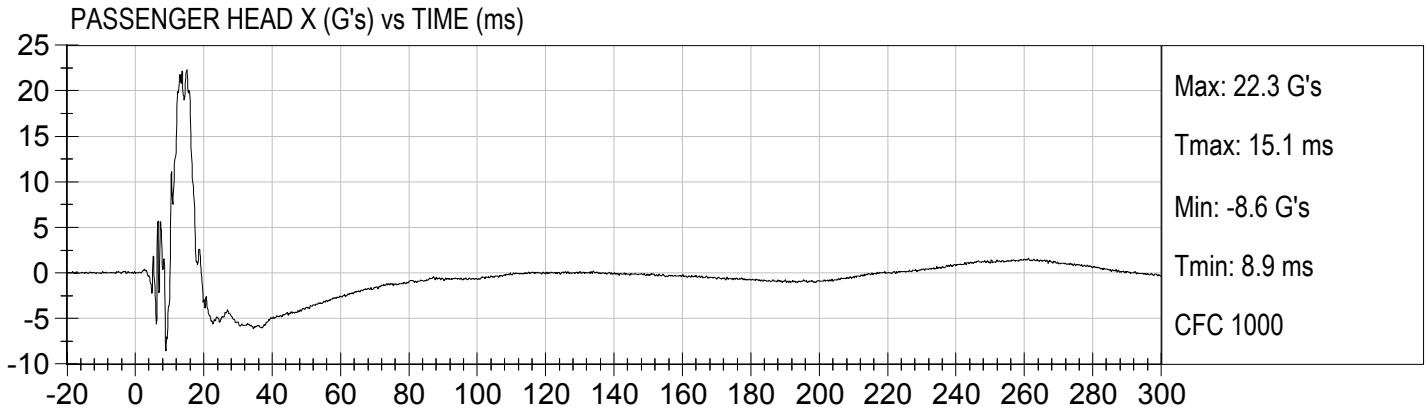
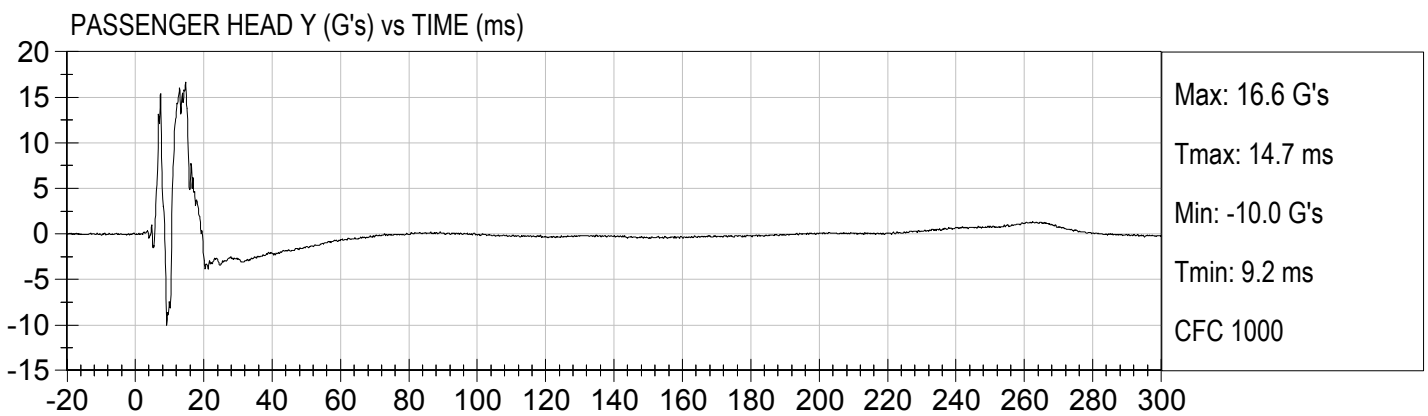
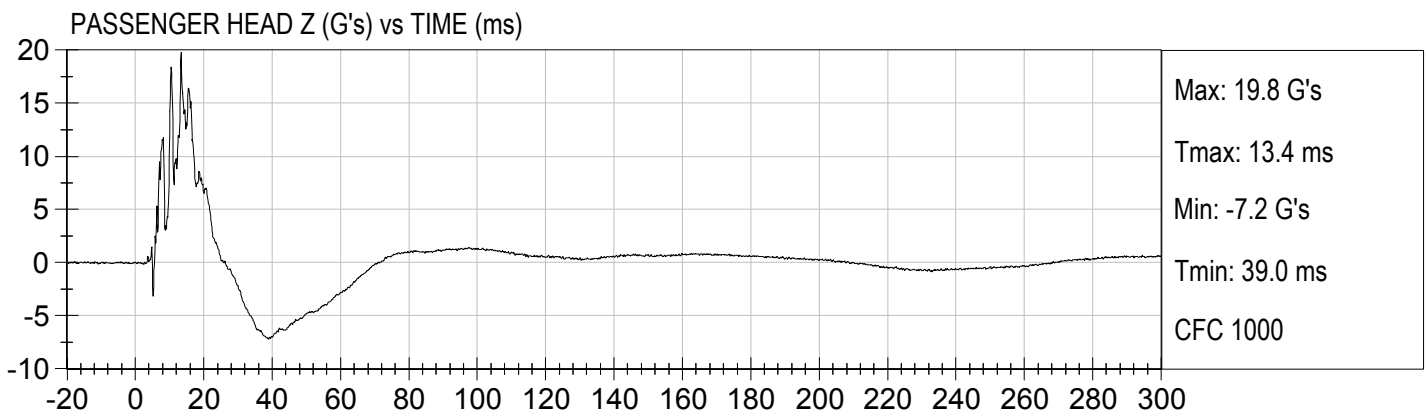
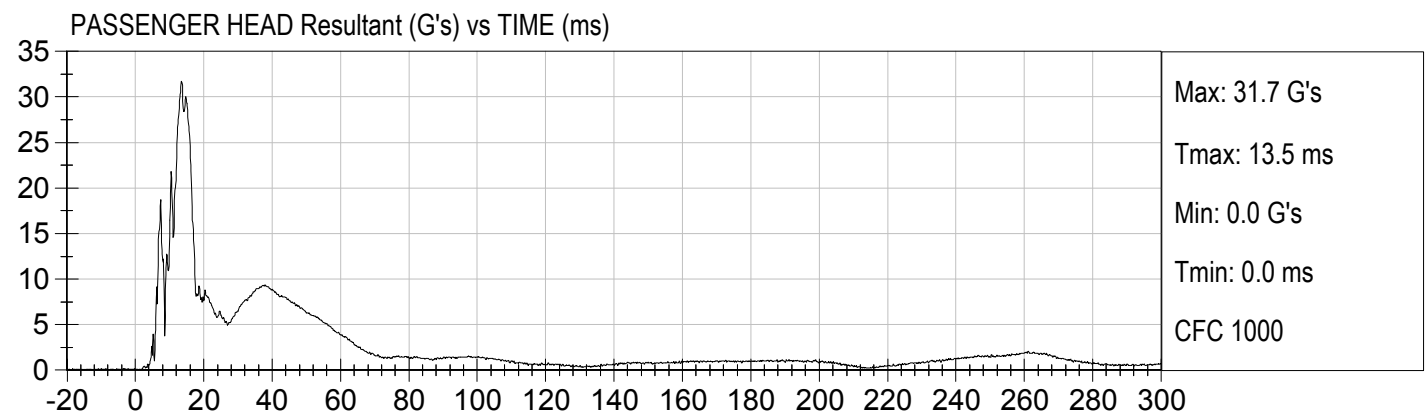
<u>Page No.</u>
Figure No. 1.	Passenger Head X Acceleration vs. Time	23
Figure No. 2.	Passenger Head Y Acceleration vs. Time	23
Figure No. 3.	Passenger Head Z Acceleration vs. Time	23
Figure No. 4.	Passenger Head Resultant Acceleration vs. Time	23
Figure No. 5.	Passenger Upper Neck X Force vs. Time	24
Figure No. 6.	Passenger Upper Neck Y Force vs. Time	24
Figure No. 7.	Passenger Upper Neck Z Force vs. Time	24
Figure No. 8.	Passenger Upper Neck Resultant Force vs. Time	24
Figure No. 9.	Passenger Upper Neck X Moment vs. Time	25
Figure No. 10.	Passenger Upper Neck Y Moment vs. Time	25
Figure No. 11.	Passenger Upper Neck Z Moment vs. Time	25
Figure No. 12.	Passenger Upper Neck Resultant Moment vs. Time	25
Figure No. 13.	Passenger Lower Neck X Force vs. Time	26
Figure No. 14.	Passenger Lower Neck Y Force vs. Time	26
Figure No. 15.	Passenger Lower Neck Z Force vs. Time	26
Figure No. 16.	Passenger Lower Neck Resultant Force vs. Time	26

MAXIMUM VALUE			
		Position No. 2			
DESCRIPTION	UNIT	MAXIMUM	TIME (ms)	MINIMUM	TIME (ms)
Head X	g	22.3	15.1	-8.6	8.9
Head Y	g	16.6	14.7	-10.0	9.2
Head Z	g	19.8	13.4	-7.2	39.0
Head Resultant	g	31.7	13.5		
Upper Neck Fx	N	220.9	13.9	-114.5	35.4
Upper Neck Fy	N	44.4	14.8	-95.4	25.0
Upper Neck Fz	N	62.7	266.6	-646.8	17.4
Upper Neck F Resultant	N	667.7	17.4		
Upper Neck Mx	Nm	4.2	10.5	-10.0	16.6
Upper Neck My	Nm	20.2	17.2	-2.7	124.2
Upper Neck Mz	Nm	2.2	265.1	-2.6	25.9
Upper Neck M Resultant	Nm	22.6	17.2		
Lower Neck Fx	N	221.8	17.0	-12.4	200.6
Lower Neck Fy	N	92.2	16.0	-53.3	10.7
Lower Neck Fz	N	49.5	268.0	-592.2	17.4
Lower Neck F Resultant	N	635.3	17.3		
Lower Neck Mx	Nm	3.5	259.7	-10.8	22.8
Lower Neck My	Nm	19.8	33.7	-6.3	12.9
Lower Neck Mz	Nm	2.0	261.3	-4.5	23.7
Lower Neck M Resultant	Nm	21.7	31.0
