**REPORT NUMBER: TWG-MGA-2016-005**

**SIDE AIRBAG OUT-OF-POSITION INJURY  
TECHNICAL WORKING GROUP**

**TOYOTA MOTOR MANUFACTURING CANADA, INC  
2016 Lexus RX 350 5-Door SUV  
NHTSA No.: M20165105TWG2**

**FINAL REPORT**

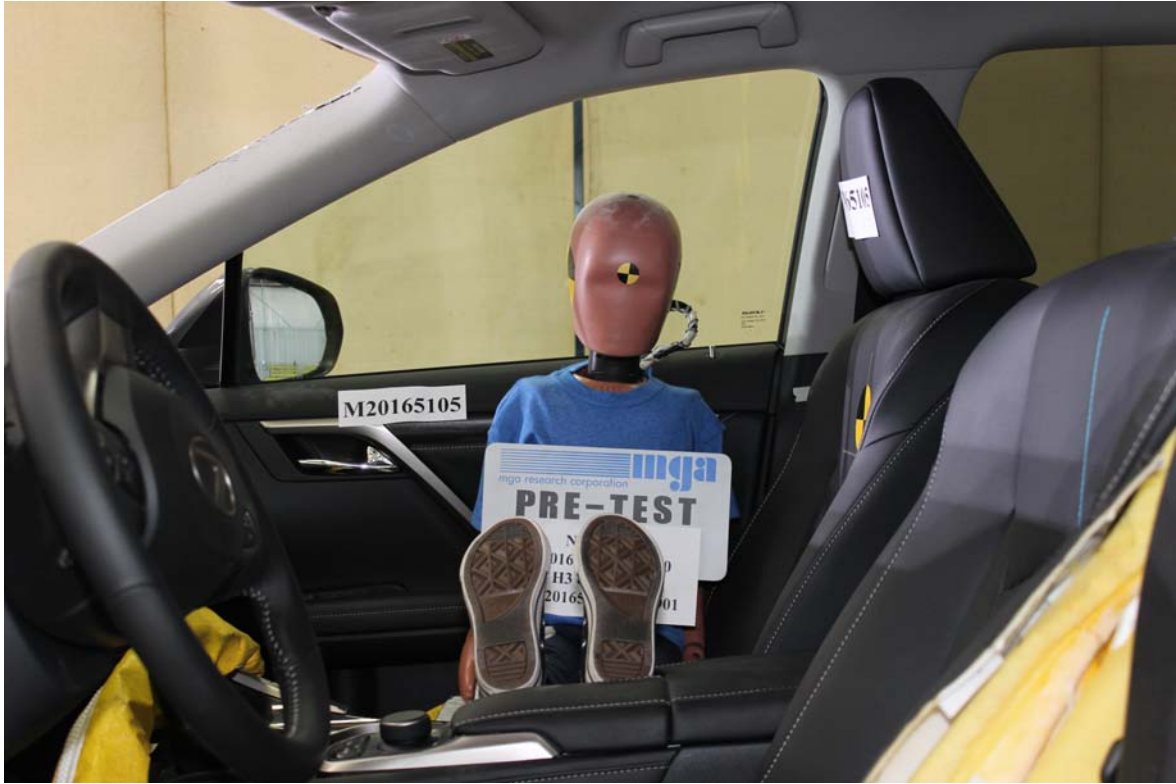
Photo No. 5. Pre-Test 6-Year-Old Child Dummy Left Side View

The Hybrid III 6-Year-Old child dummy was placed in the right front passenger seat along the outboard edge of the foam block, facing inboard with its legs extended and arms hanging at its sides. The seat track was positioned forward to maximize the cushion to head interaction. The dummy's pelvis was slid outboard until the dummy's back contacted the door trim panel or armrest and the center of gravity of the head was centered in the deployment trajectory of the airbag. The head remained in its neutral orientation. A vertical plane through the centerline of the dummy's shoulder bolts was parallel to the vehicle centerline. The dummy's arms were bent at the elbow until the fingertips contacted the foam block.

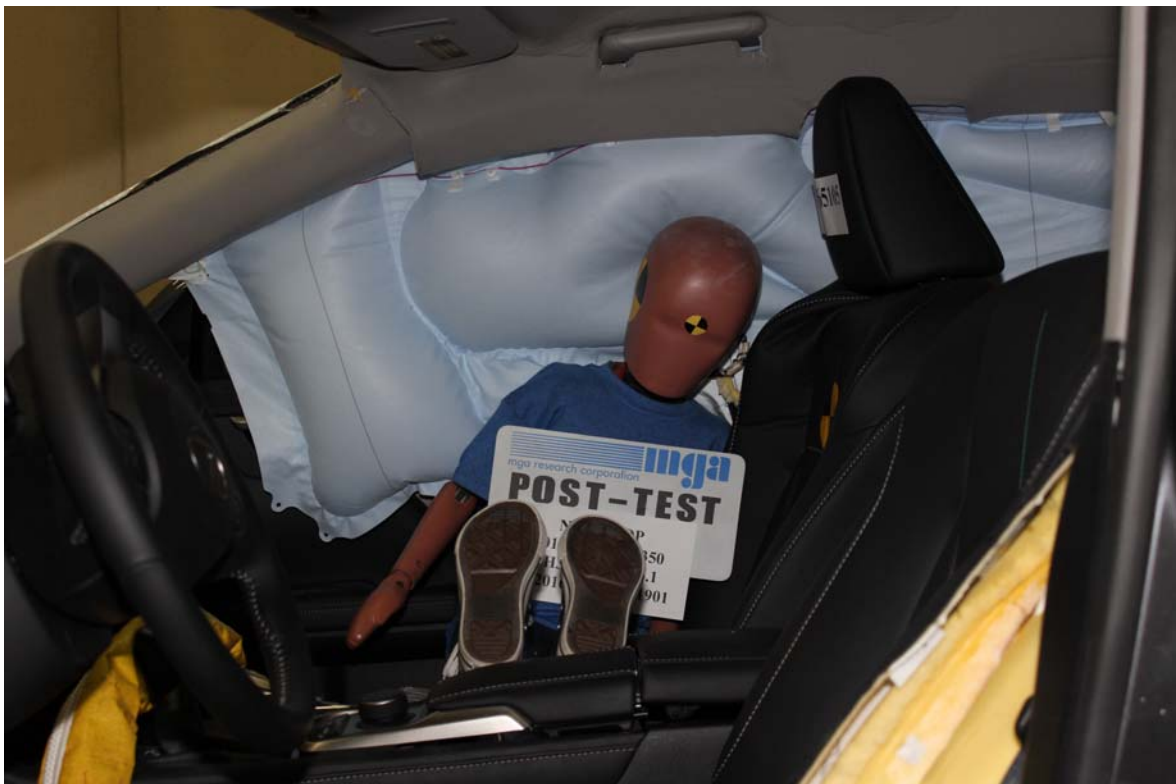
Photo No. 6. Post-Test 6-Year-Old Child Dummy Left Side View

- Curtain airbag to top and back of head
- Torso bag to left side of shoulder, torso, and pelvis

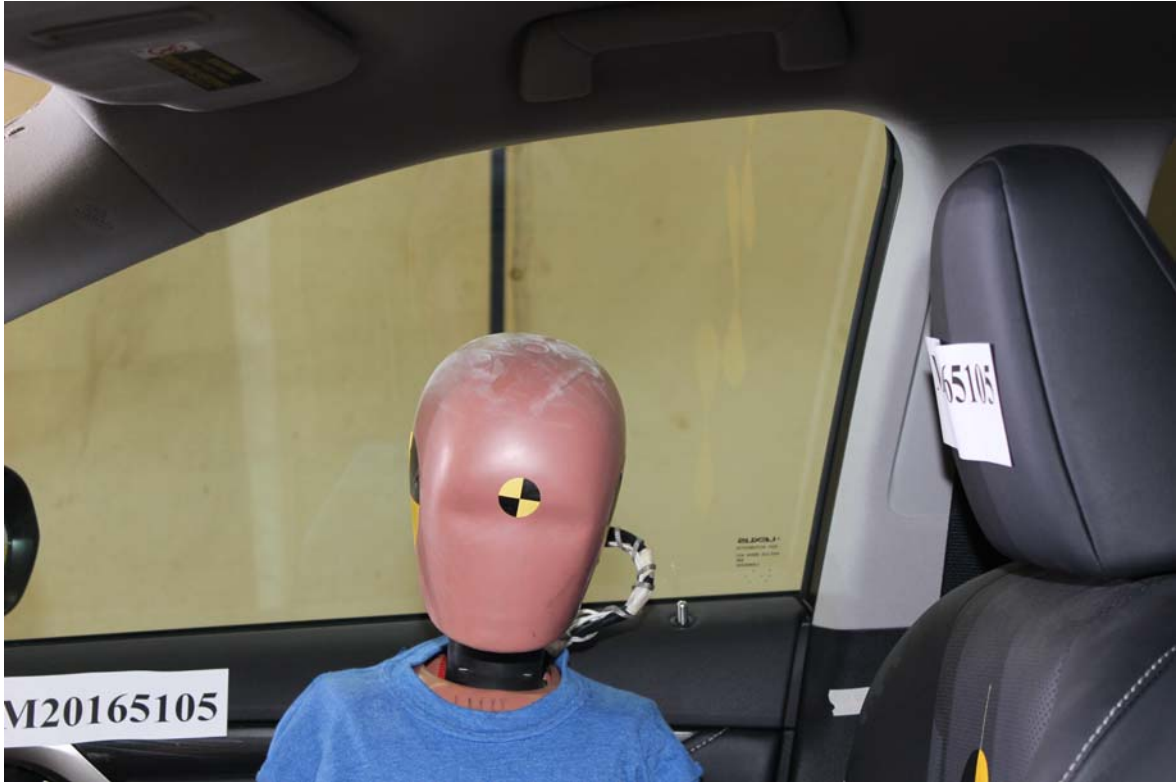
Photo No. 7. Pre-Test 6-Year-Old Child Dummy Left Side Closeup View

The dummy's skullcap seam was taped with 4mm electrical tape to prevent the airbag from getting caught in the seam. The dummy's headskin was cleaned with alcohol and dusted with baby powder to achieve acceptable frictional characteristics.

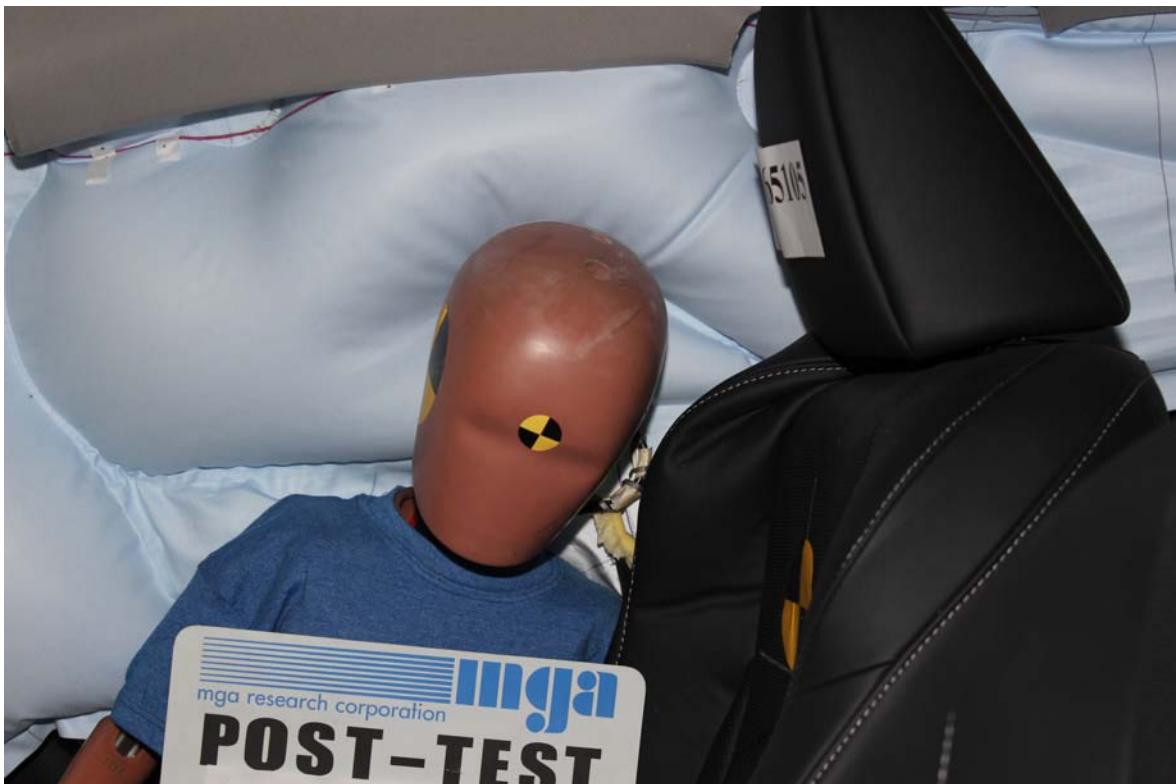
Photo No. 8. Post-Test 6-Year-Old Child Dummy Left Side Closeup View

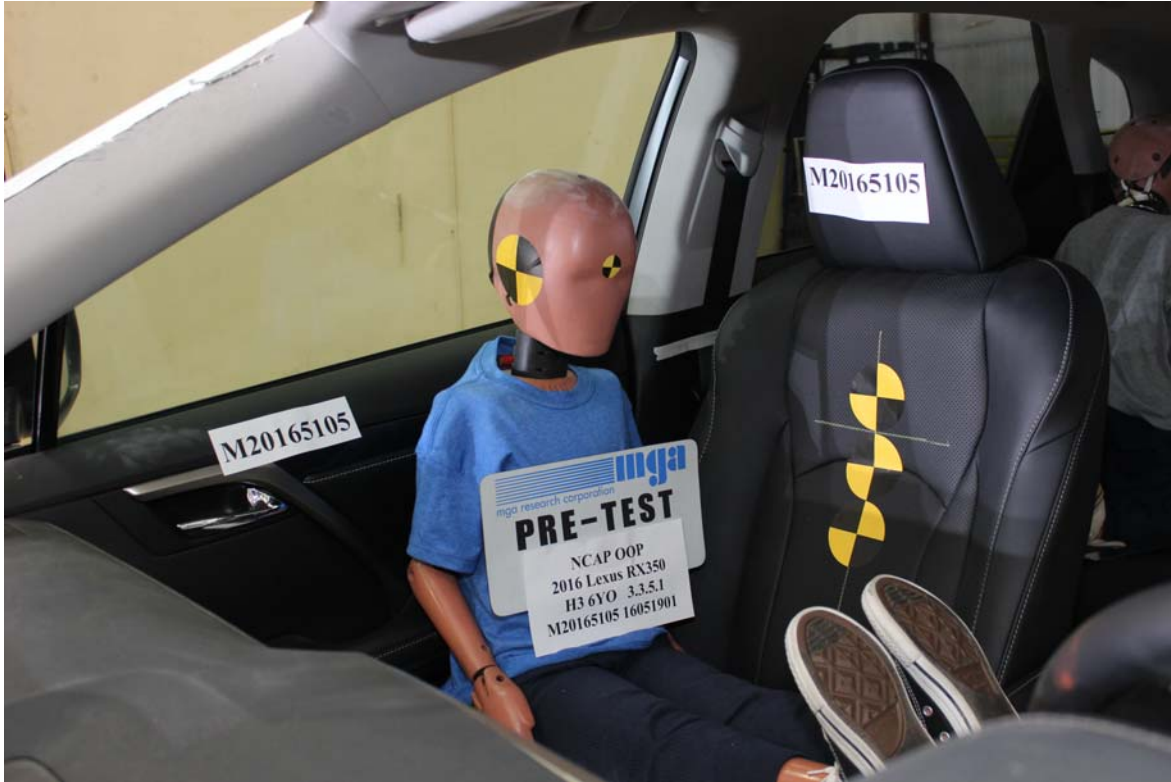
Photo No. 9. Pre-Test 6-Year-Old Child Dummy Left  $\frac{3}{4}$  Front View

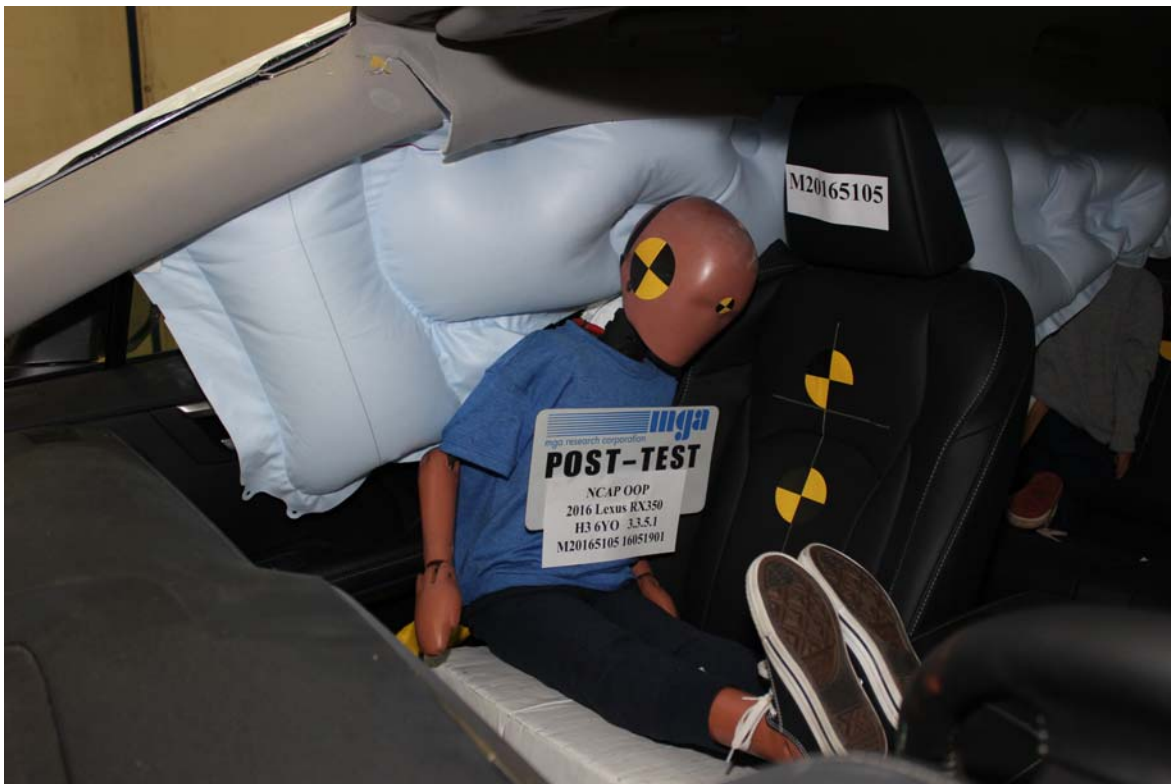
Photo No. 10. Post-Test 6-Year-Old Child Dummy Left  $\frac{3}{4}$  Front View

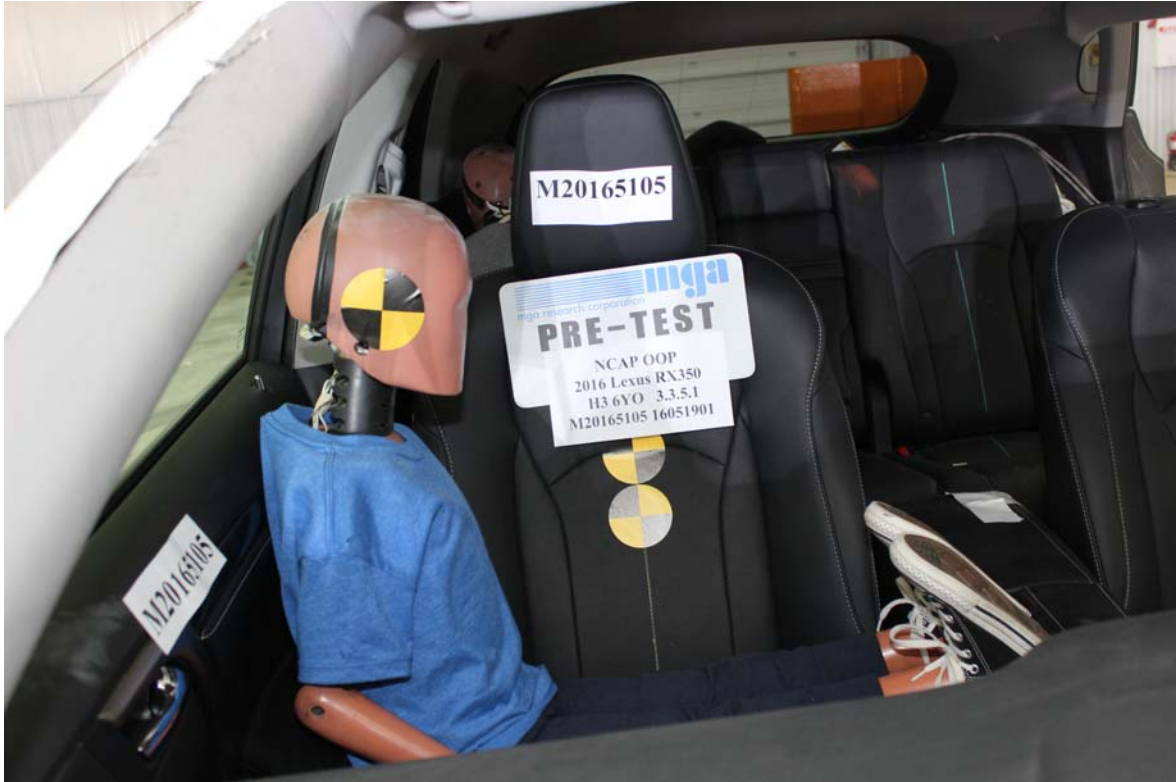
Photo No. 13. Pre-Test 6-Year-Old Child Dummy Front View

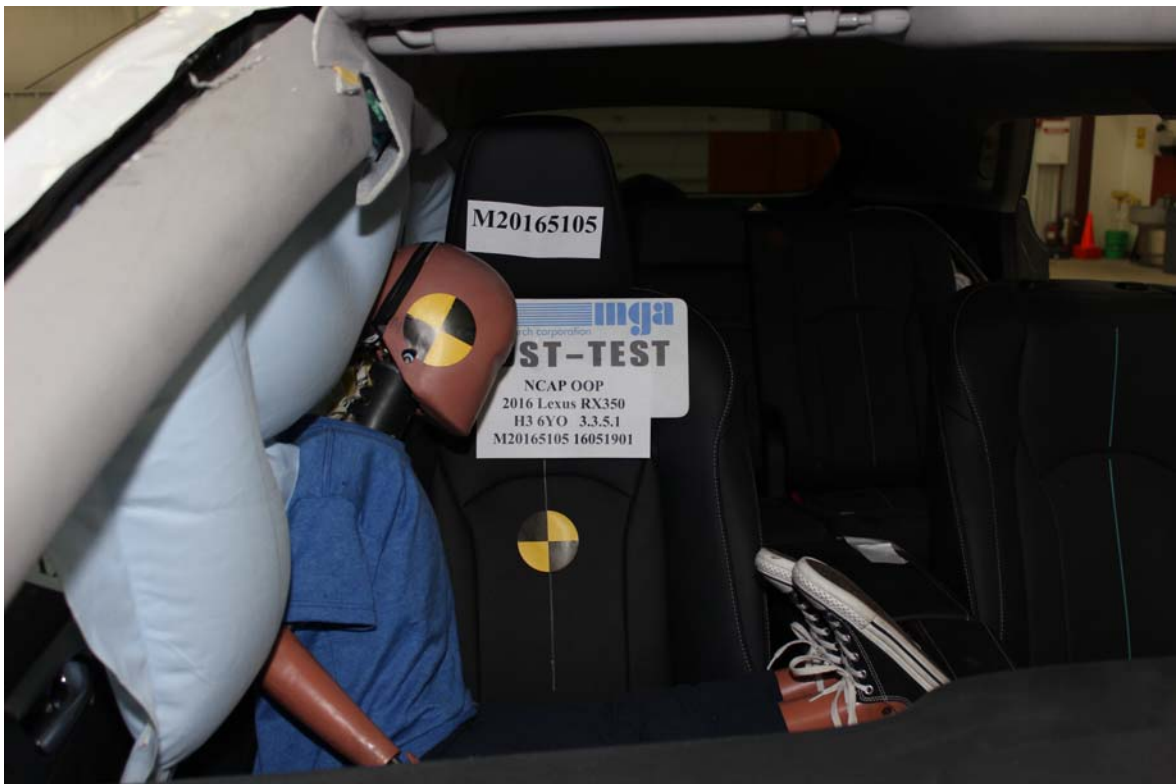
Photo No. 14. Post-Test 6-Year-Old Child Dummy Front View

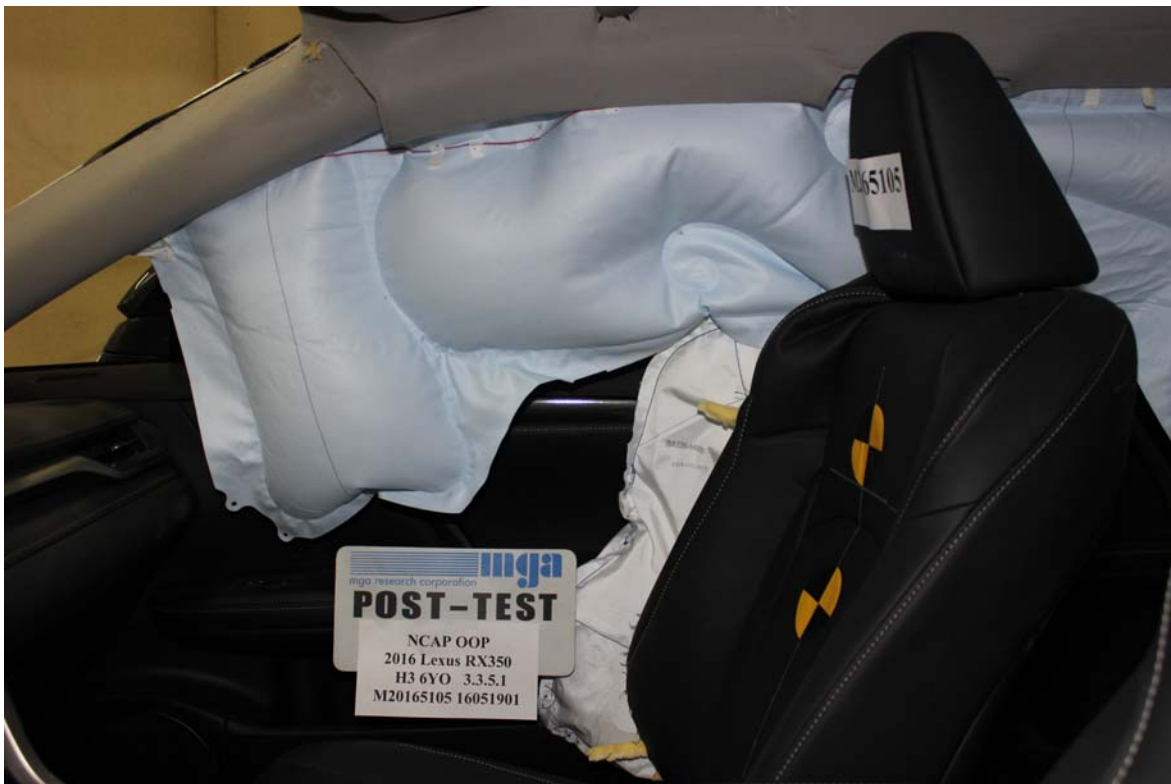
Photo No. 22. Post-Test Curtain Airbag Left Side View

| Visible Dummy Contact Points | |
|---|---|
| Head Contact | Curtain airbag to top and back of head |

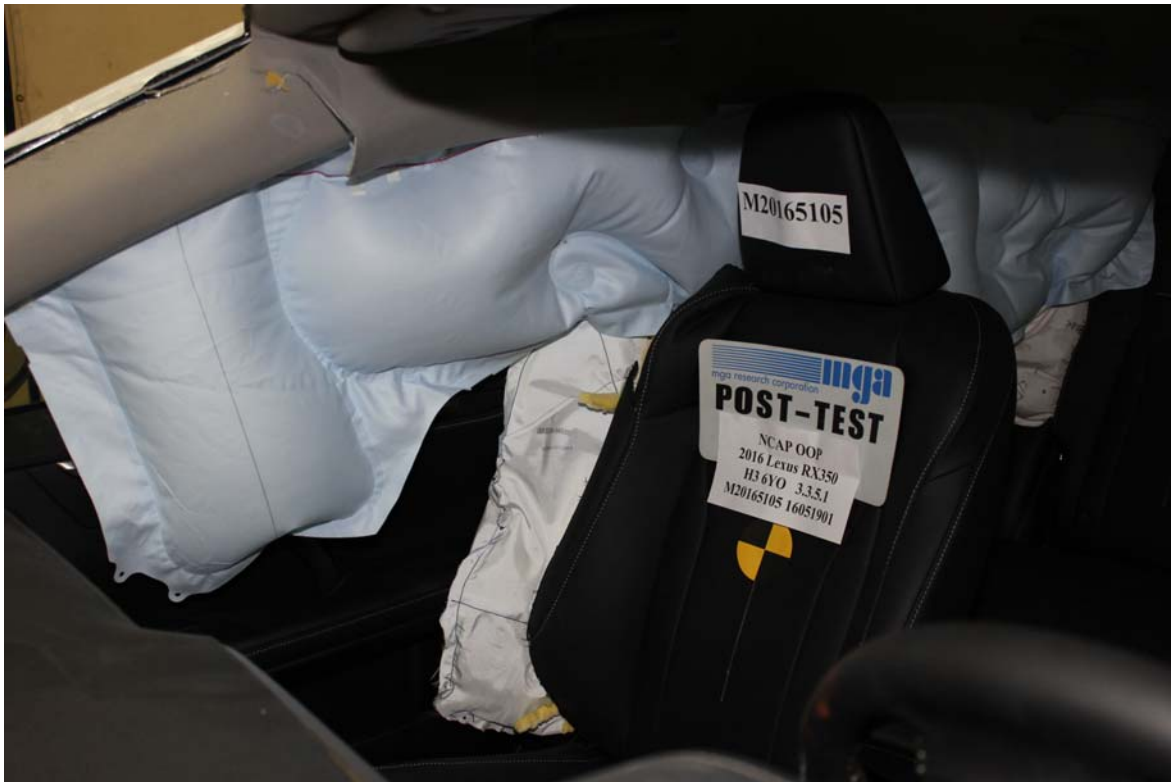
Photo No. 23. Post-Test Curtain Airbag Left  $\frac{3}{4}$  Front View

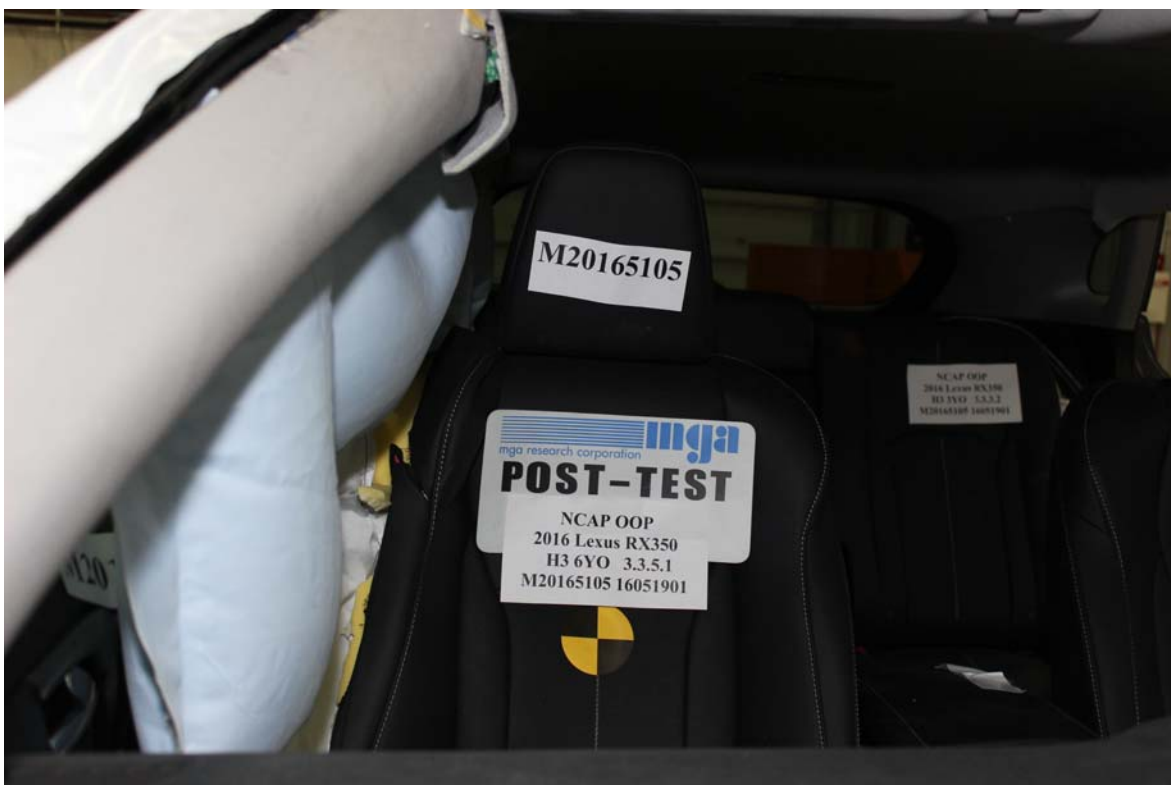
Photo No. 24. Post-Test Curtain Airbag Front View

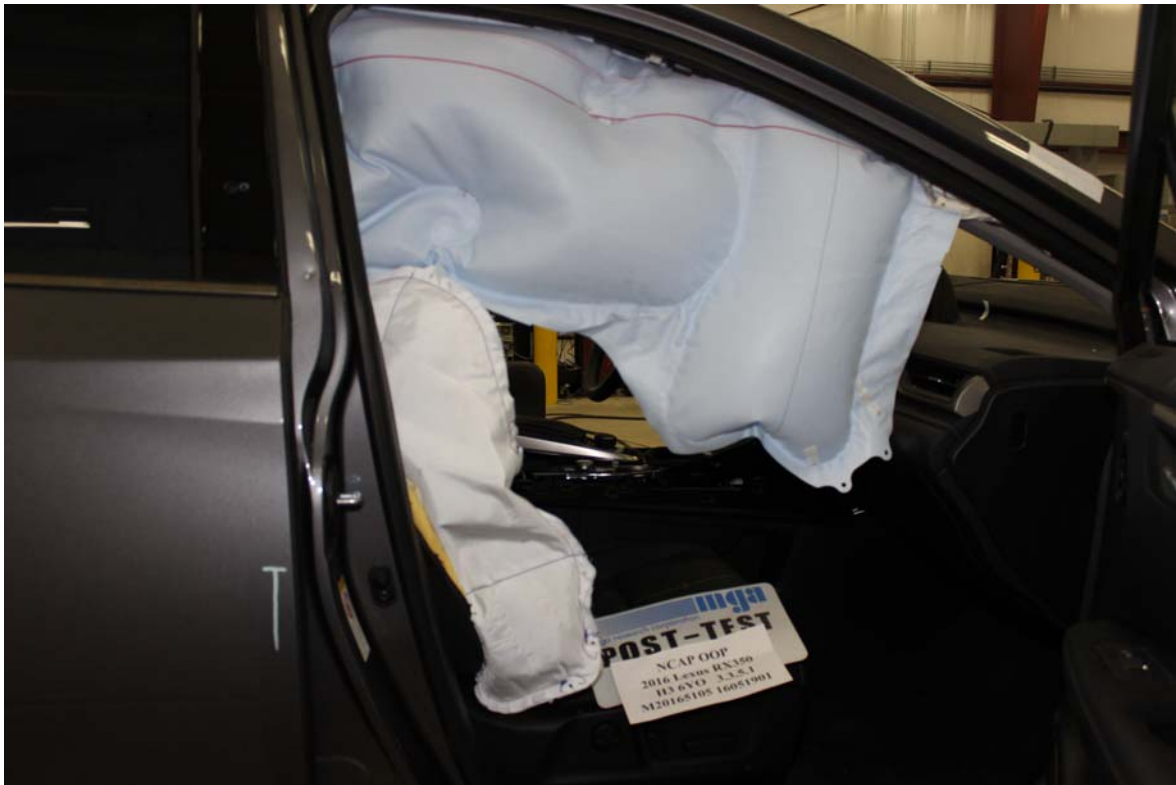
Photo No. 25. Post-Test Curtain Airbag Right Side View (Door Open)

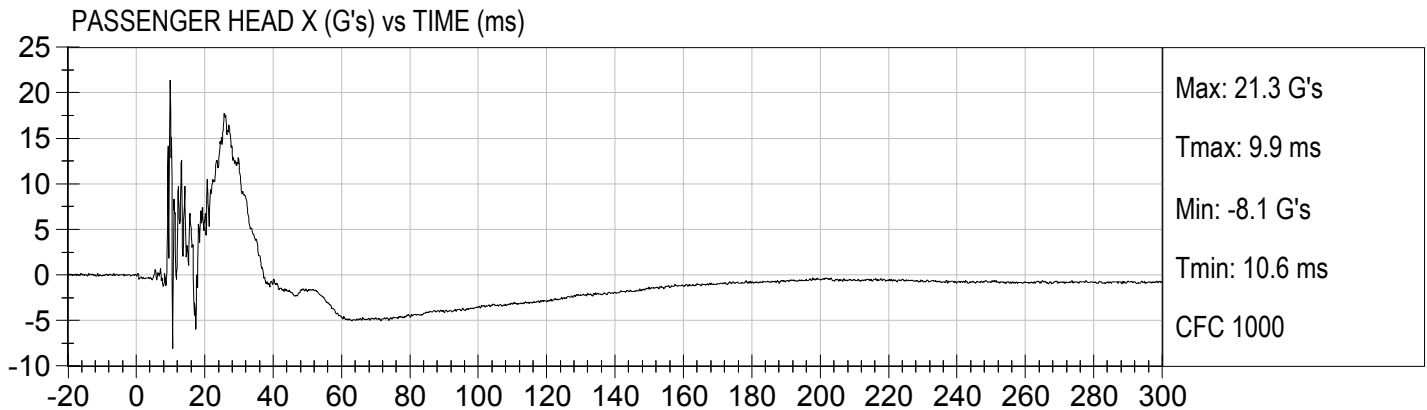
| | <u>Page No.</u> |
|---|---|
| Figure No. 1. Passenger Head X Acceleration vs. Time | 23 |

| | | MAXIMUM VALUE | | | |
|---|---|---|---|---|---|
| Head X | g | 21.3 | 9.9 | -8.1 | 10.6 |

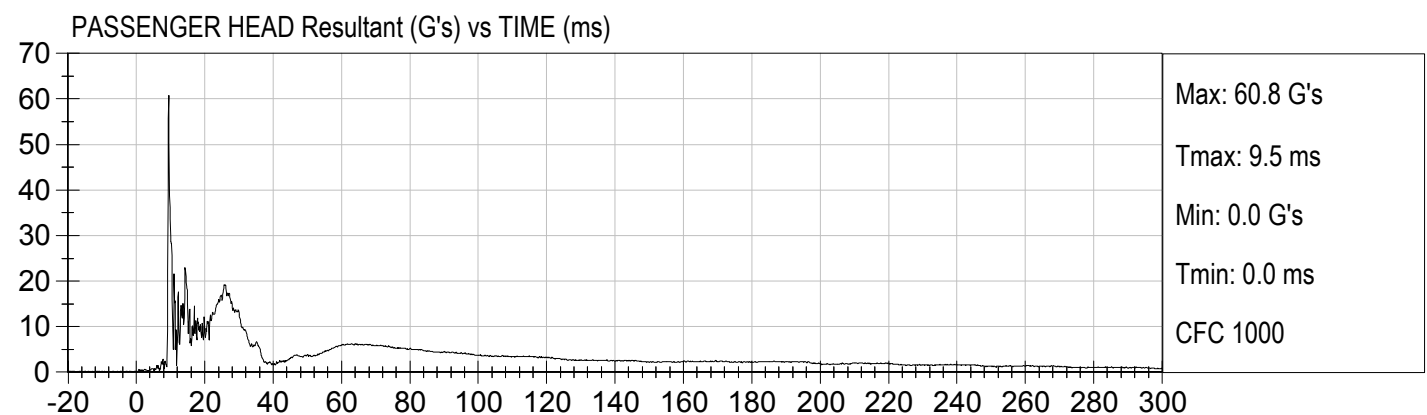
| | <u>Page No.</u> |
|---|---|
| Figure No. 4. Passenger Head Resultant Acceleration vs. Time | 23 |

| | | MAXIMUM VALUE | | | |
|---|---|---|---|---|---|
| Head Resultant | g | 60.8 | 9.5 | | |

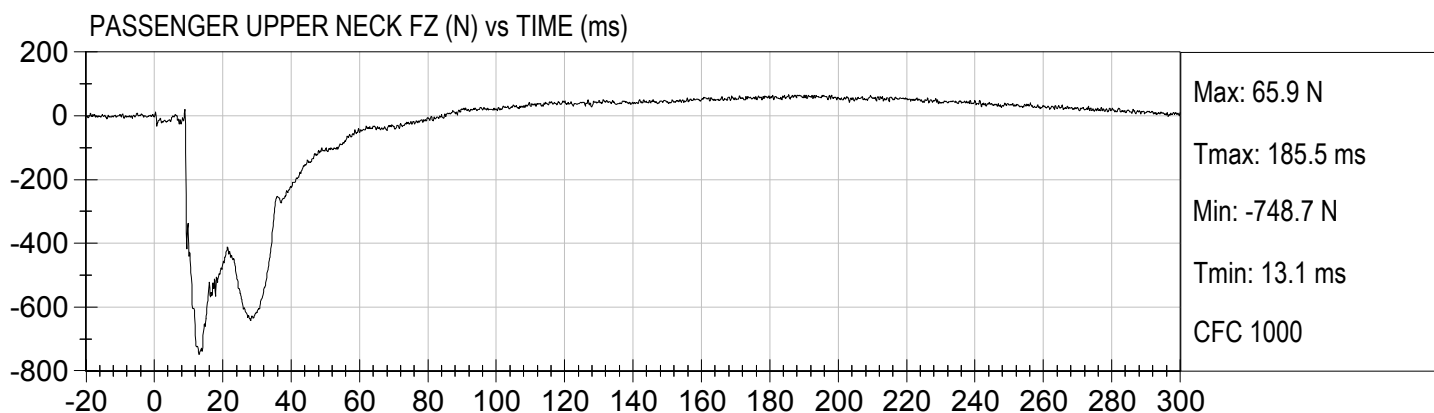
| | <u>Page No.</u> |
|---|---|
| Figure No. 7. Passenger Upper Neck Z Force vs. Time | 24 |

| | | MAXIMUM VALUE | | | |
|---|---|---|---|---|---|
| Upper Neck Fz | N | 65.9 | 185.5 | -748.7 | 13.1 |

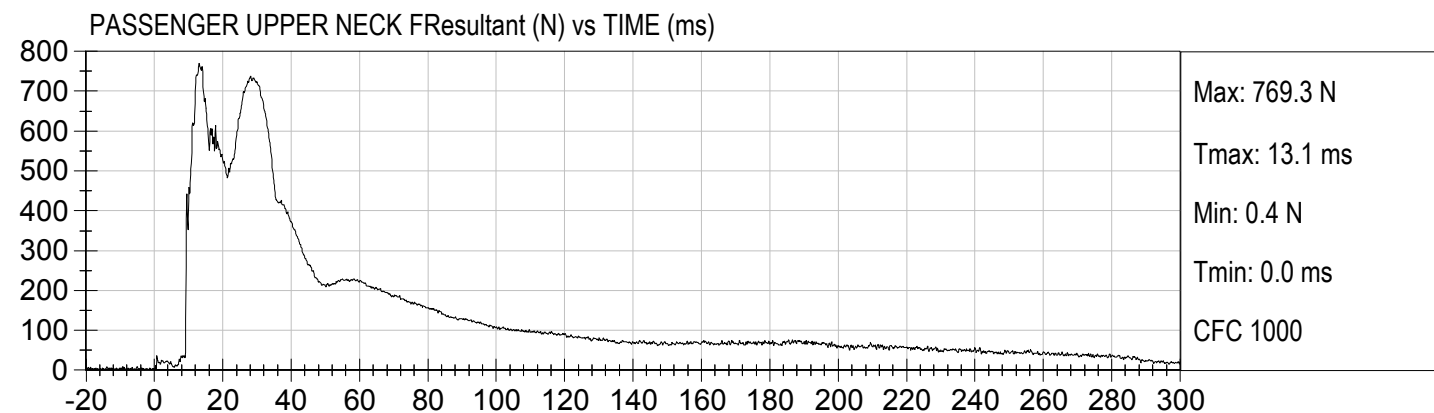
| | <u>Page No.</u> |
|---|---|
| Figure No. 8. Passenger Upper Neck Resultant Force vs. Time | 24 |

| | | MAXIMUM VALUE | | | |
|---|---|---|---|---|---|
| Upper Neck F Resultant | N | 769.3 | 13.1 | | |

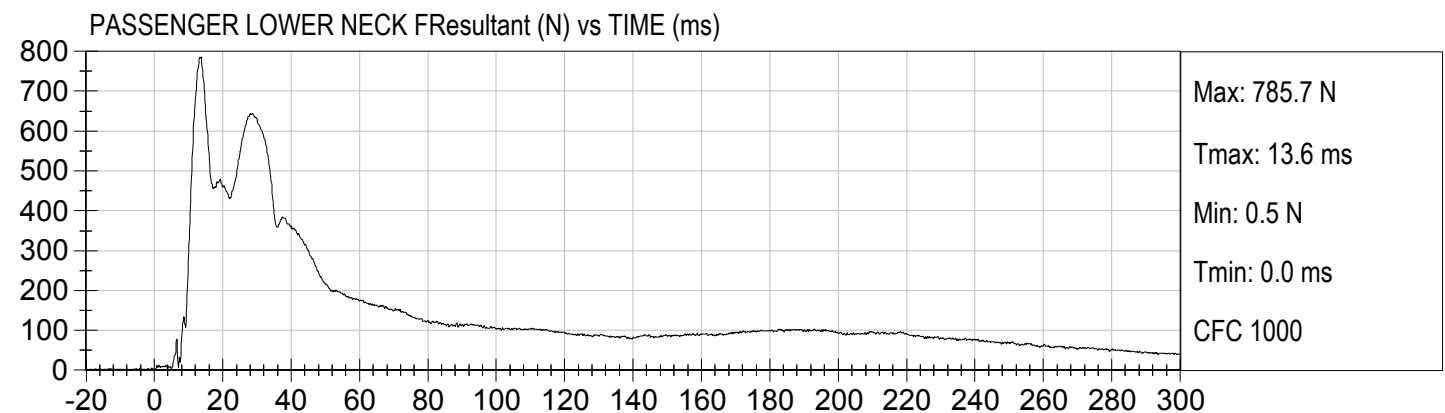
| | <u>Page No.</u> |
|---|---|
| Figure No. 16. Passenger Lower Neck Resultant Force vs. Time | 26 |

| | | MAXIMUM VALUE | | | |
|---|---|---|---|---|---|
| Lower Neck F Resultant | N | 785.7 | 13.6 | | |

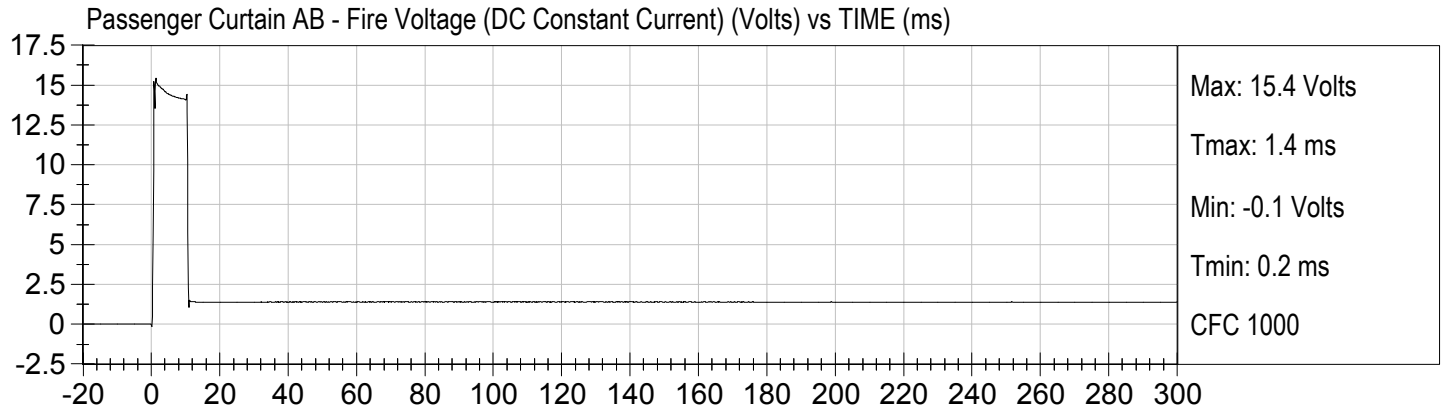
| | <u>Page No.</u> |
|---|---|
| Figure No. 21. Passenger Curtain Airbag – Fire Voltage vs. Time | 28 |

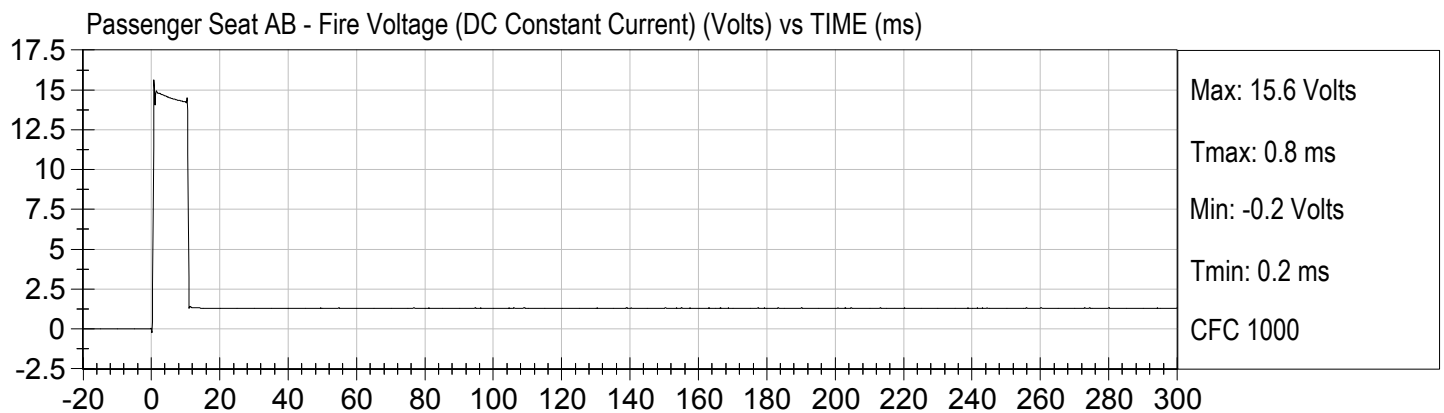
| | <u>Page No.</u> |
|---|---|
| Figure No. 23. Passenger Seat Airbag – Fire Voltage vs. Time | 28 |
