**REPORT NUMBER: TWG-MGA-2016-006**

**SIDE AIRBAG OUT-OF-POSITION INJURY  
TECHNICAL WORKING GROUP**

**TOYOTA MOTOR MANUFACTURING CANADA, INC.  
2016 Lexus RX 350 5-Door SUV  
NHTSA No.: M20165105TWG3**

**FINAL REPORT**

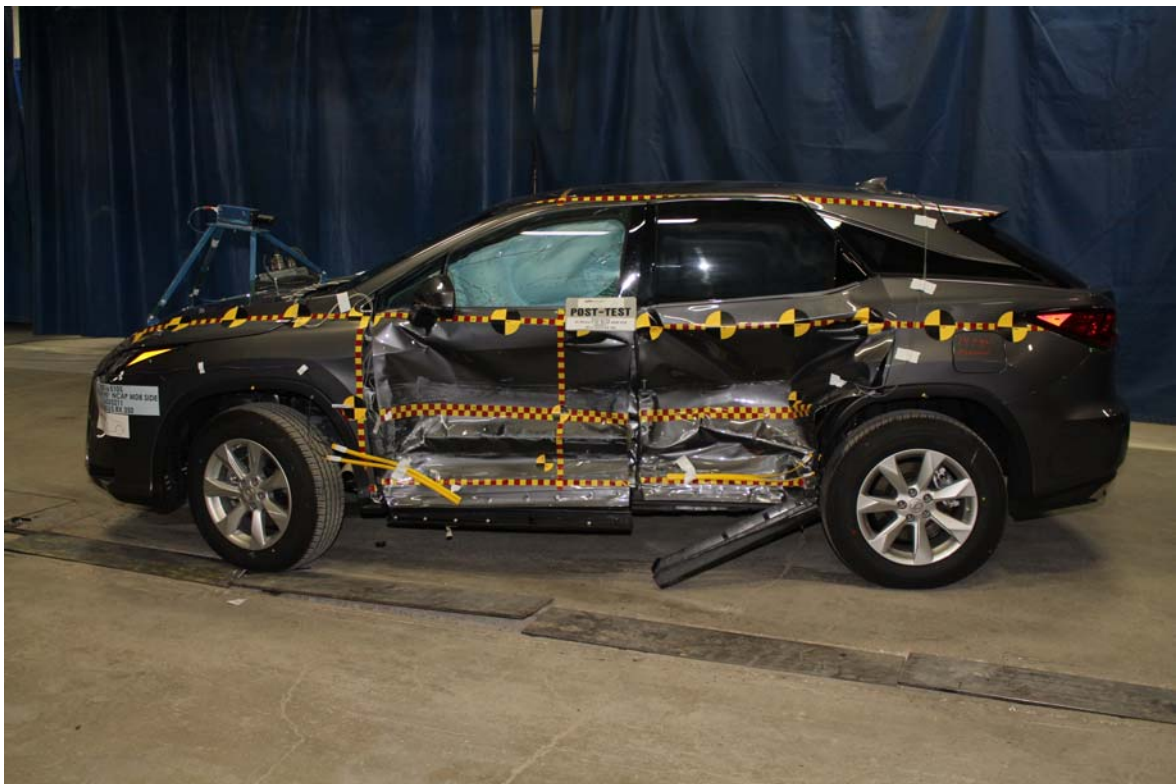
Photo No. 4. Post-Test Vehicle Left Side View

Please note that this vehicle had previously been tested in an  
NCAP MDB Side Impact on March 2, 2016.

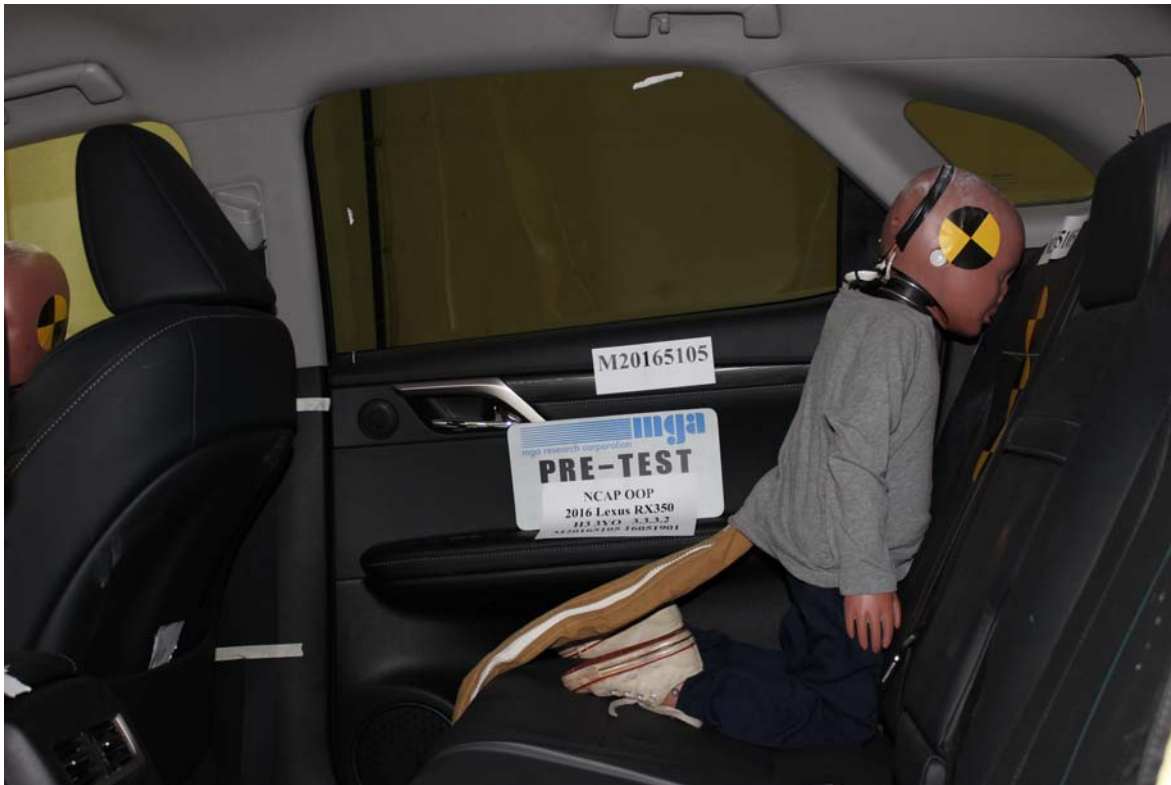
Photo No. 5. Pre-Test 3-Year-Old Child Dummy Left Side View

The Hybrid III 3-Year-Old child dummy was placed in the right rear passenger seat along the outboard edge of the seat cushion, kneeling and facing rearward. The vertical centerline of the dummy's sternum was aligned as close as possible with the leading edge of the seatback bolster. The sternum contacted with seat. The dummy's head was placed in between the seat bolster and pillar/side trim to maximize contact between the sternum and seatback. The head remained in its neutral orientation. The outboard leg was positioned at the outboard edge of the seat cushion and parallel to the seat centerline and remained on the cushion. The outboard knee and lower leg was slid toward the seatback/seat cushion junction until the top edge of the upper rib was aligned horizontally with the top edge of the airbag module. The inboard leg was aligned parallel to the centerline of the seat cushion. The inboard knee and lower leg was slid toward the seat bight until a line drawn through both shoulder bolts was perpendicular to the vehicle centerline. The inboard arm was rotated towards the seatback until the thumb contacts the seatback. The outboard arm and hand was rotated to hang down as close to vertical as possible.

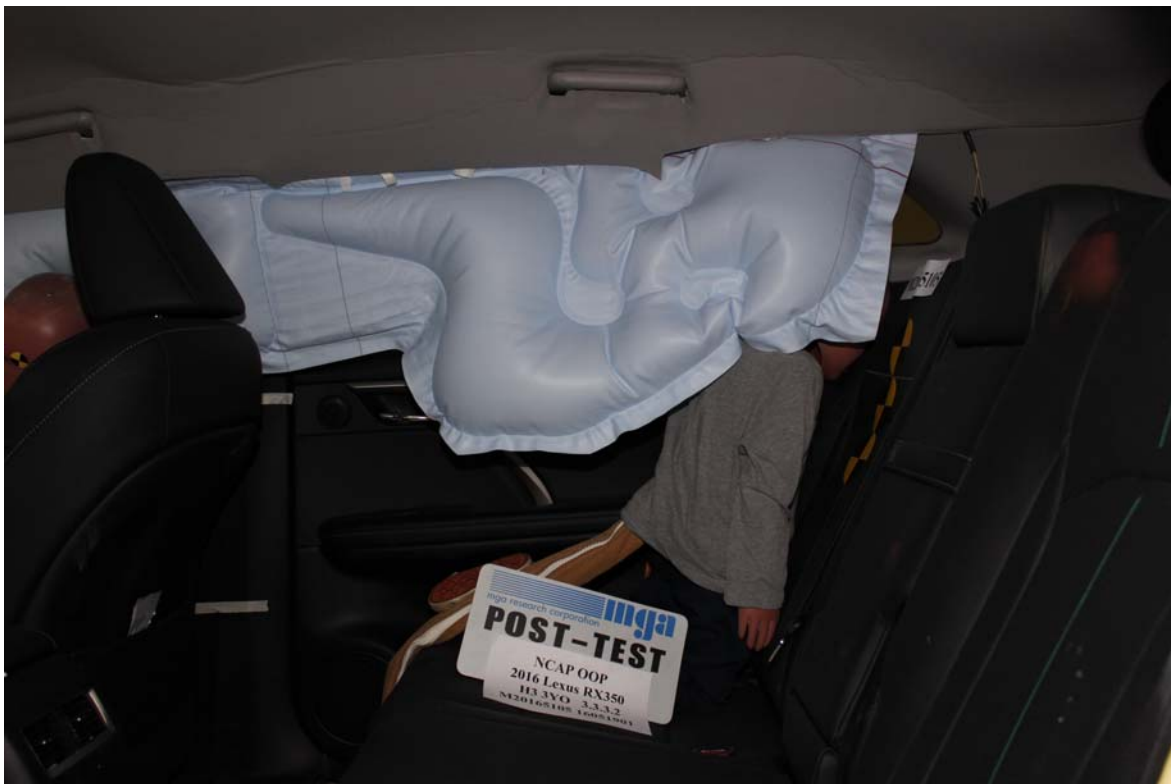
Photo No. 6. Post-Test 3-Year-Old Child Dummy Left Side View

- Curtain bag to back of head and back of dummy
- Torso bag to left side of head, left shoulder, left torso, and left pelvis

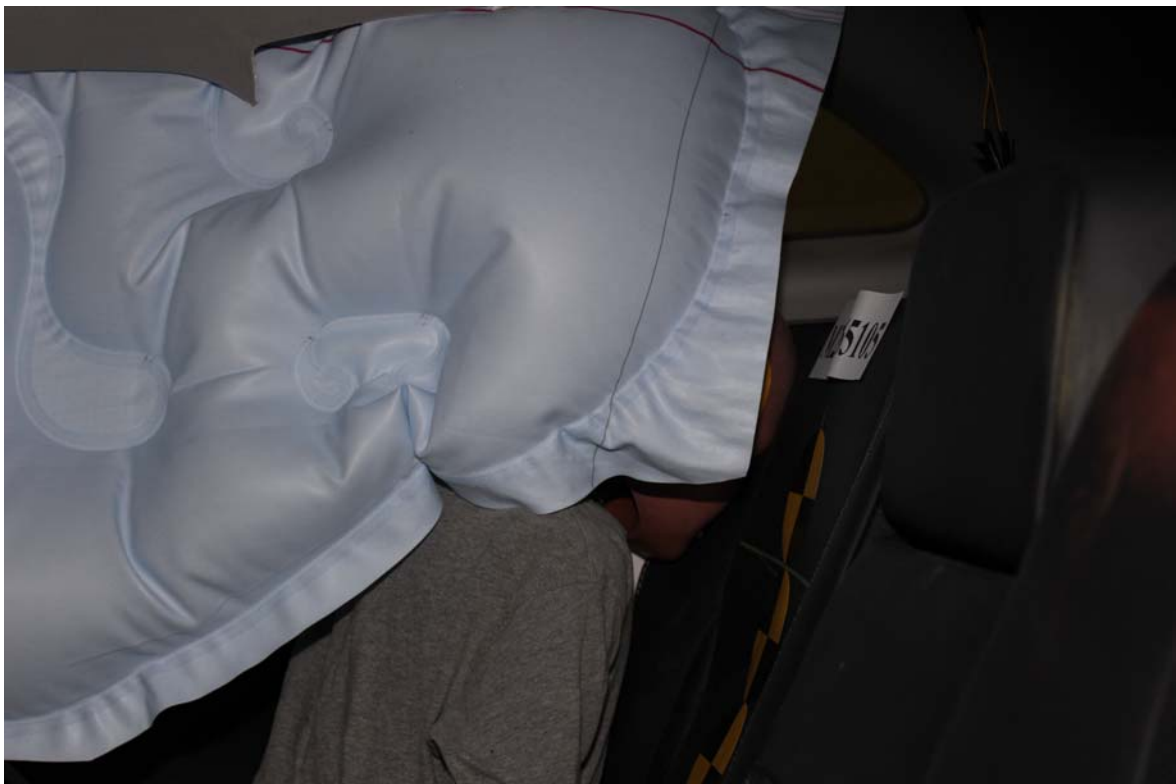
Photo No. 8. Post-Test 3-Year-Old Child Dummy Left Side Closeup View

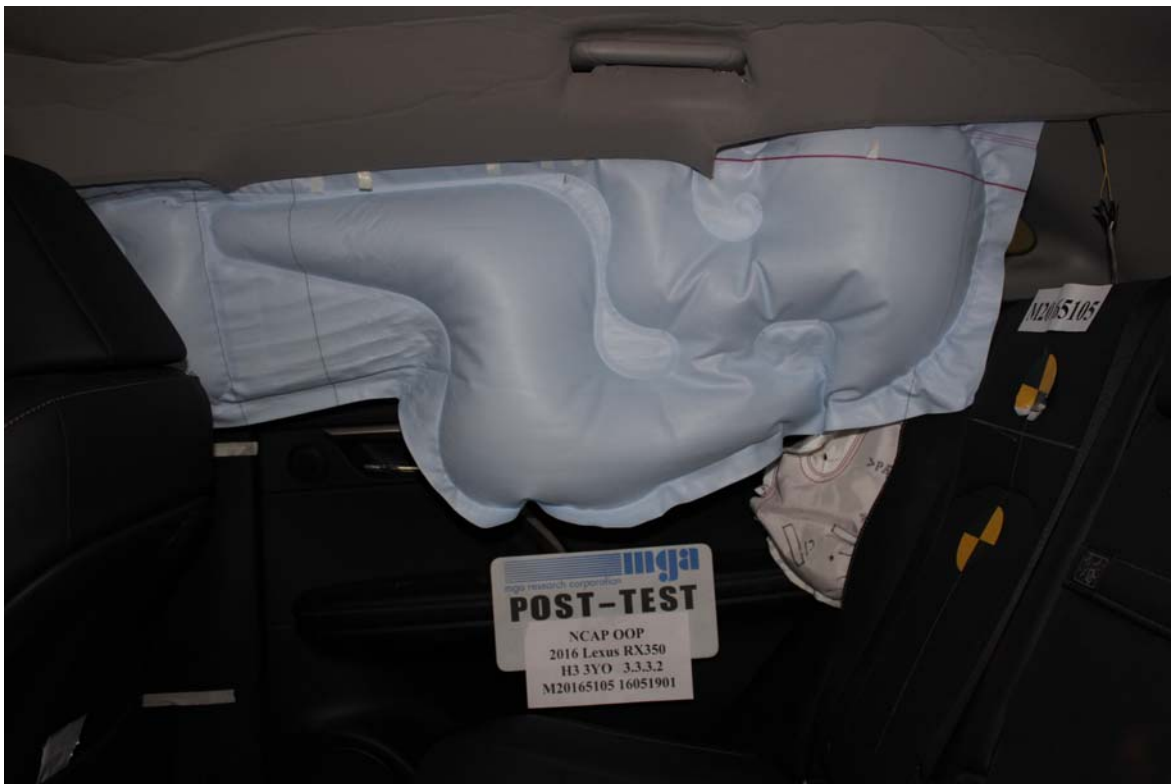
Photo No. 22. Post-Test Curtain Airbag Left Side View

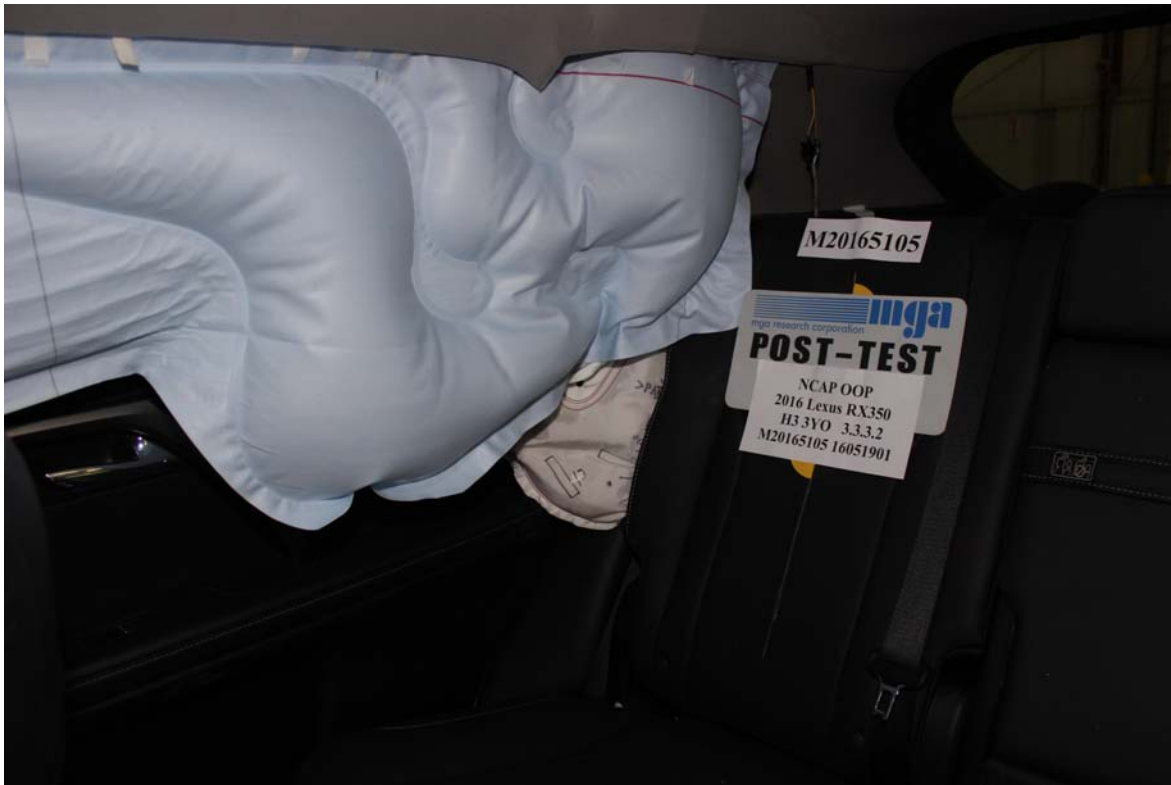
Photo No. 23. Post-Test Curtain Airbag Left  $\frac{3}{4}$  Front View

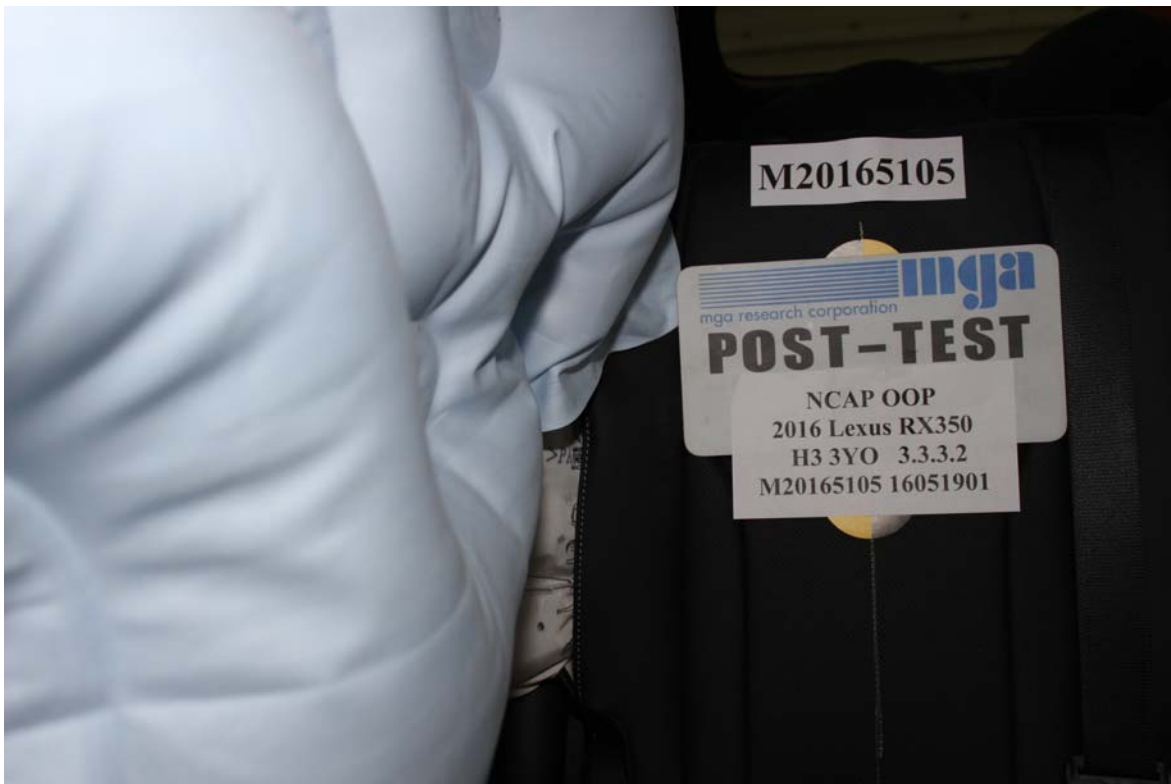
Photo No. 24. Post-Test Curtain Airbag Front View

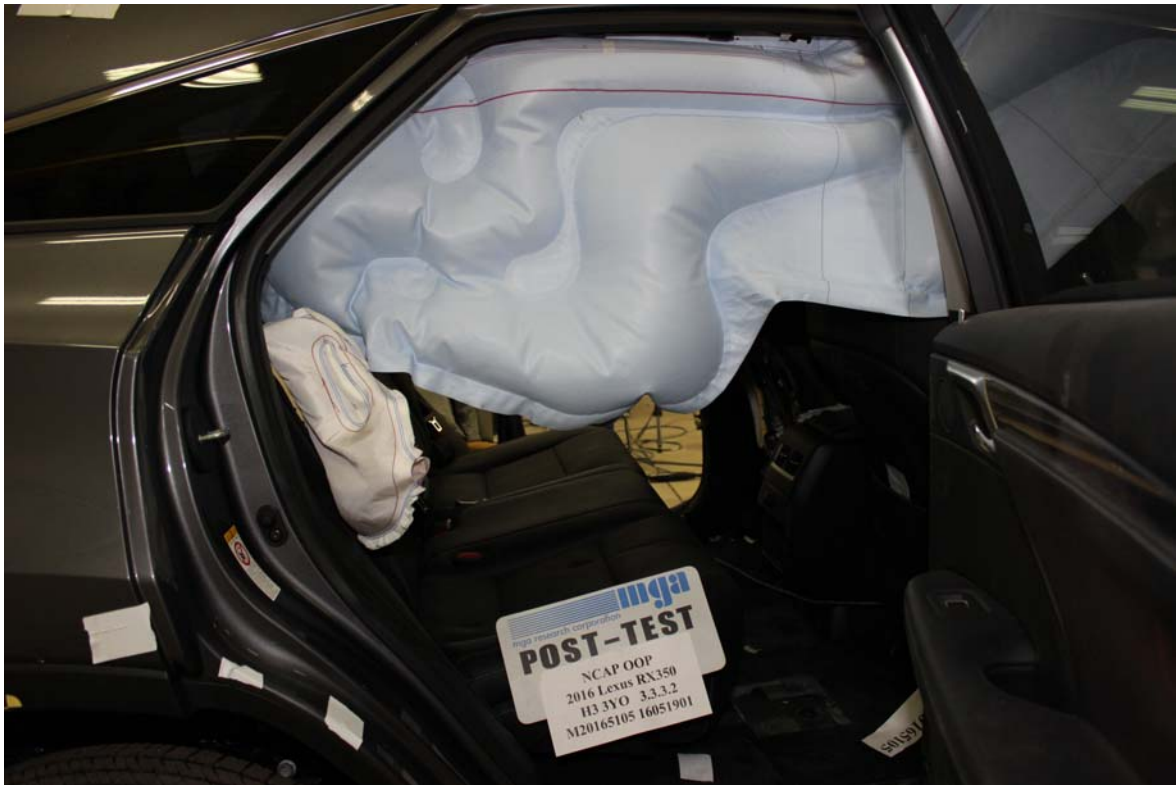
Photo No. 25. Post-Test Curtain Airbag Right Side View (Door Open)

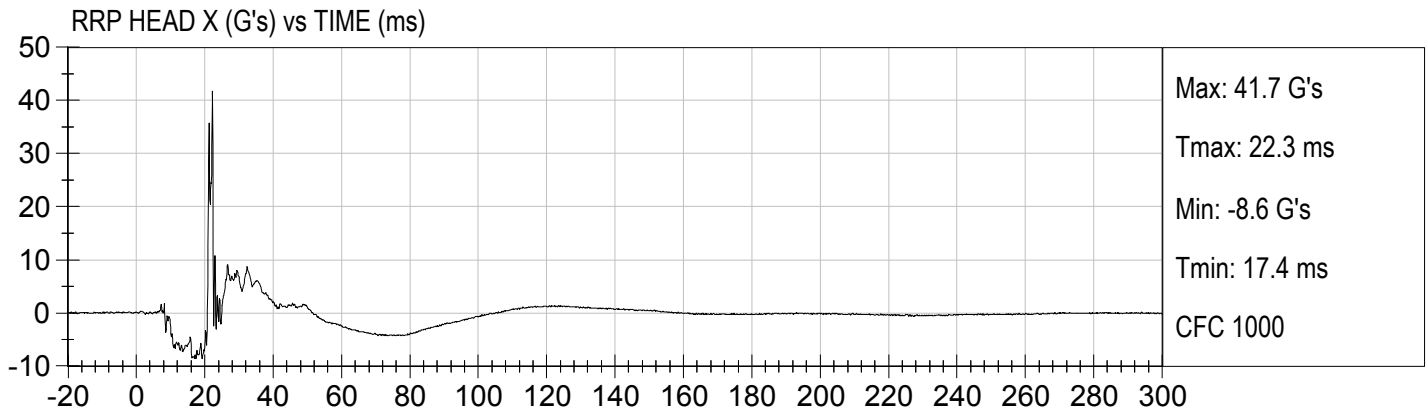
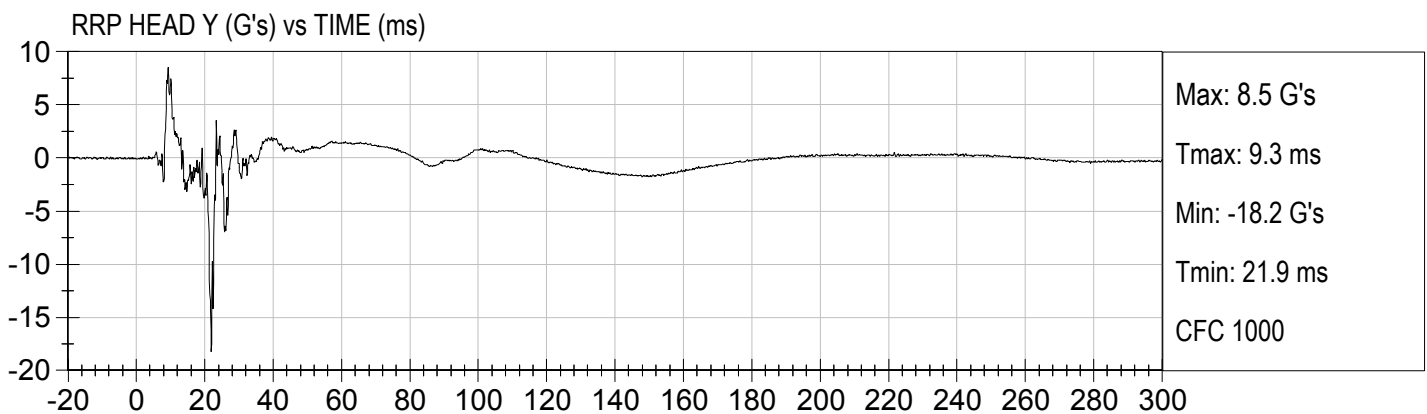
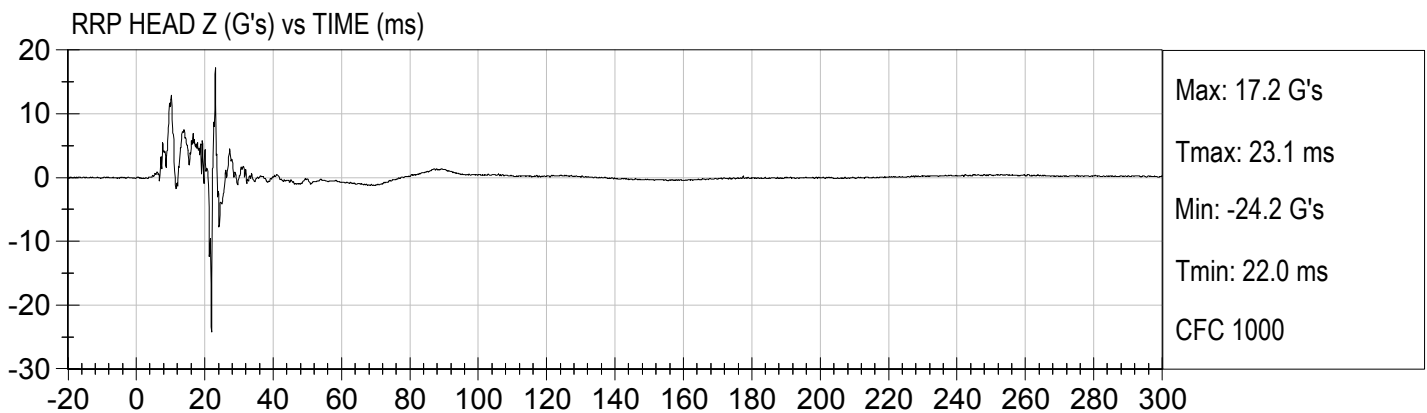
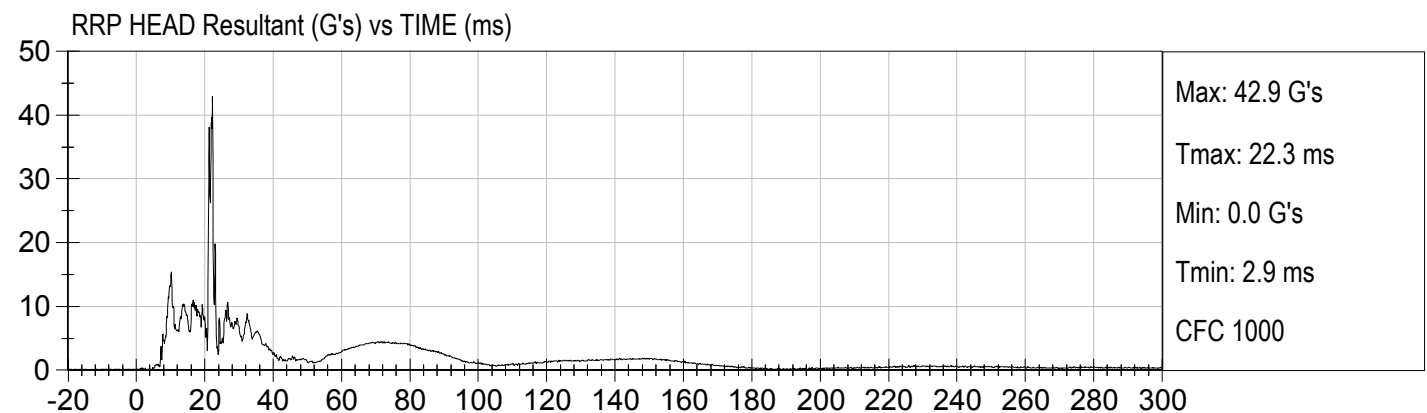
| | <u>Page No.</u> |
|---|---|
| Figure No. 1. RRP Head X Acceleration vs. Time | 24 |
| Figure No. 2. RRP Head Y Acceleration vs. Time | 24 |
| Figure No. 3. RRP Head Z Acceleration vs. Time | 24 |
| Figure No. 4. RRP Head Resultant Acceleration vs. Time | 24 |

| | | MAXIMUM VALUE | | | |
|---|---|---|---|---|---|
| Head X | g | 41.7 | 22.3 | -8.6 | 17.4 |
| Head Y | g | 8.5 | 9.3 | -18.2 | 21.9 |
| Head Z | g | 17.2 | 23.1 | -24.2 | 22.0 |
| Head Resultant | g | 42.9 | 22.3 | | |

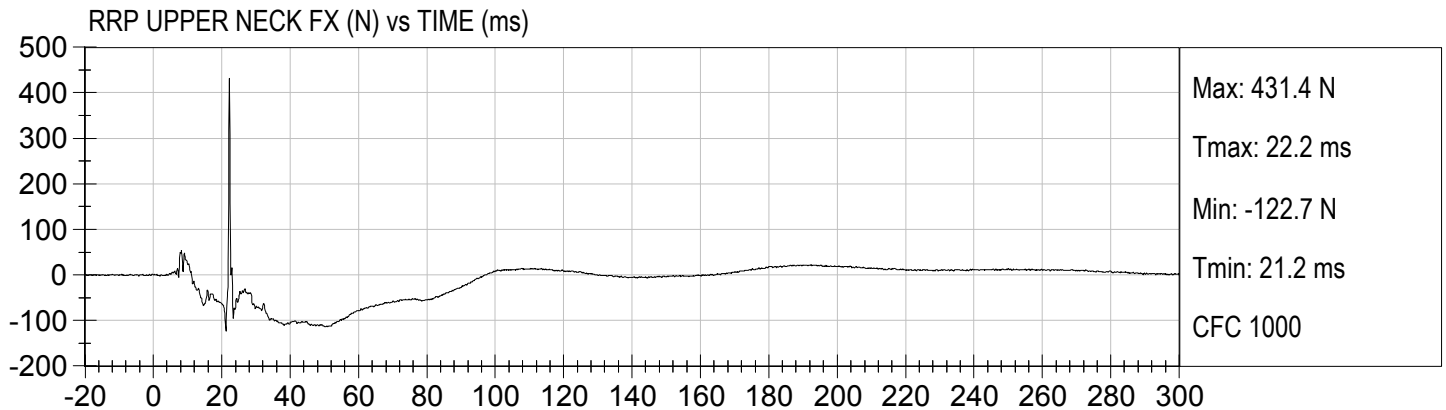
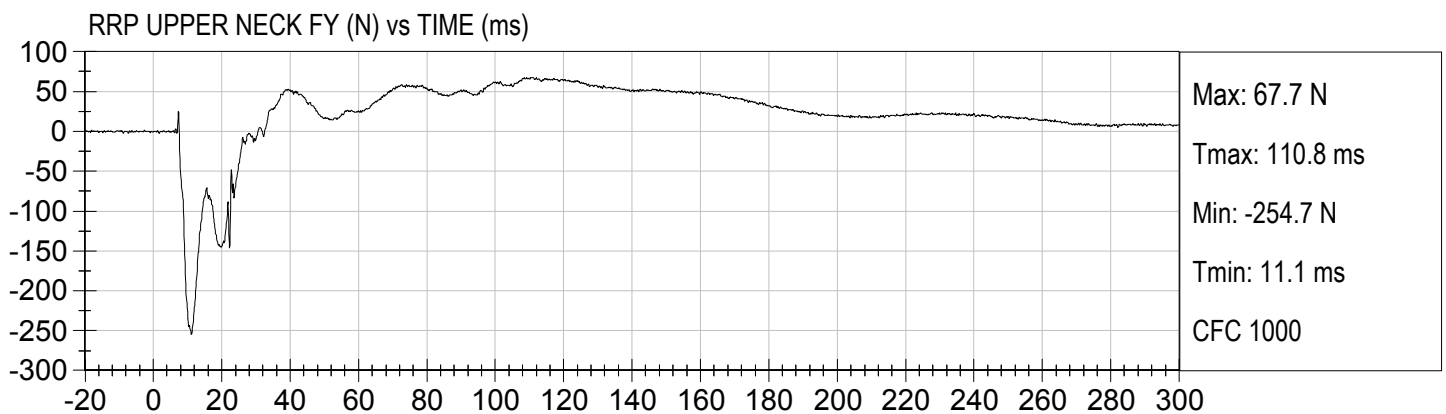
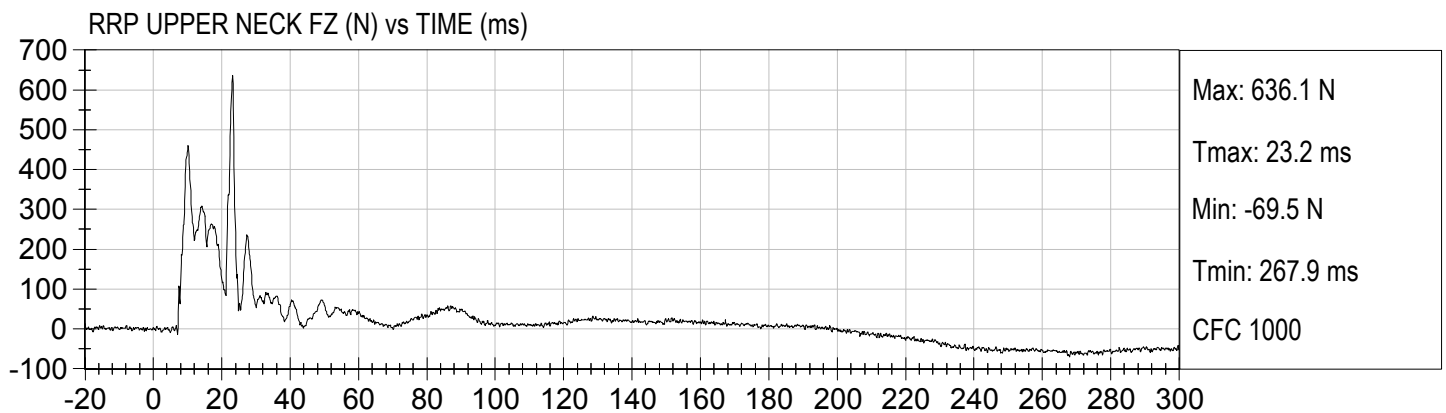
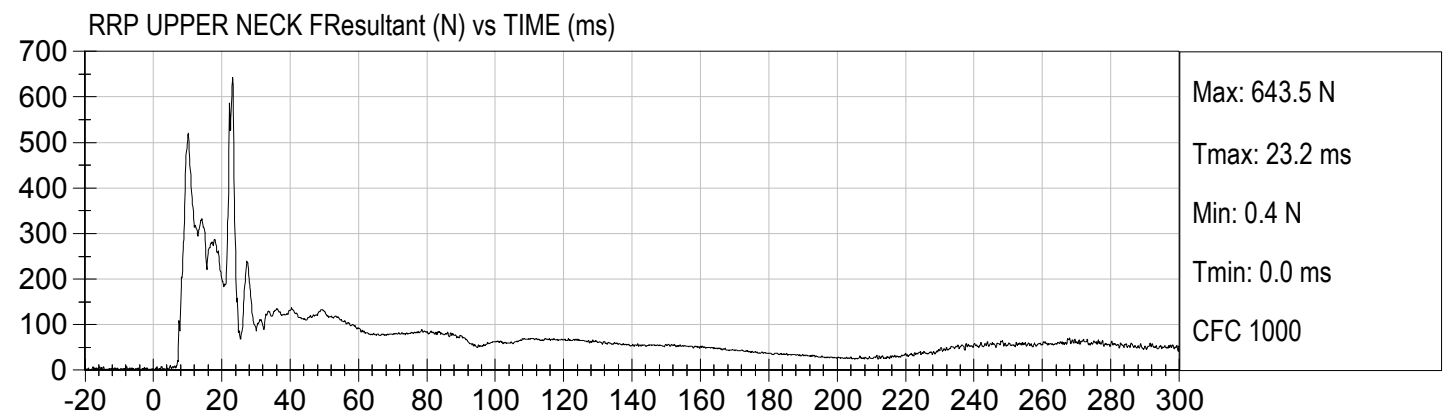
| | <u>Page No.</u> |
|---|---|
| Figure No. 5. RRP Upper Neck X Force vs. Time | 25 |
| Figure No. 6. RRP Upper Neck Y Force vs. Time | 25 |
| Figure No. 7. RRP Upper Neck Z Force vs. Time | 25 |
| Figure No. 8. RRP Upper Neck Resultant Force vs. Time | 25 |

| | | MAXIMUM VALUE | | | |
|---|---|---|---|---|---|
| Upper Neck Fx | N | 431.4 | 22.2 | -122.7 | 21.2 |
| Upper Neck Fy | N | 67.7 | 110.8 | -254.7 | 11.1 |
| Upper Neck Fz | N | 636.1 | 23.2 | -69.5 | 267.9 |
| Upper Neck F Resultant | N | 643.5 | 23.2 | | |
