REPORT NUMBER: TWG-TRC-16-03

**NEW CAR ASSESSMENT PROGRAM (NCAP)**  
SIDE AIRBAG OUT-OF-POSITION INJURY TESTING

FCA US LLC  
2016 Chrysler 300 4-Door Sedan

NHTSA NUMBER: M20160302TWG2  
TRC TEST NUMBER: 160525-2

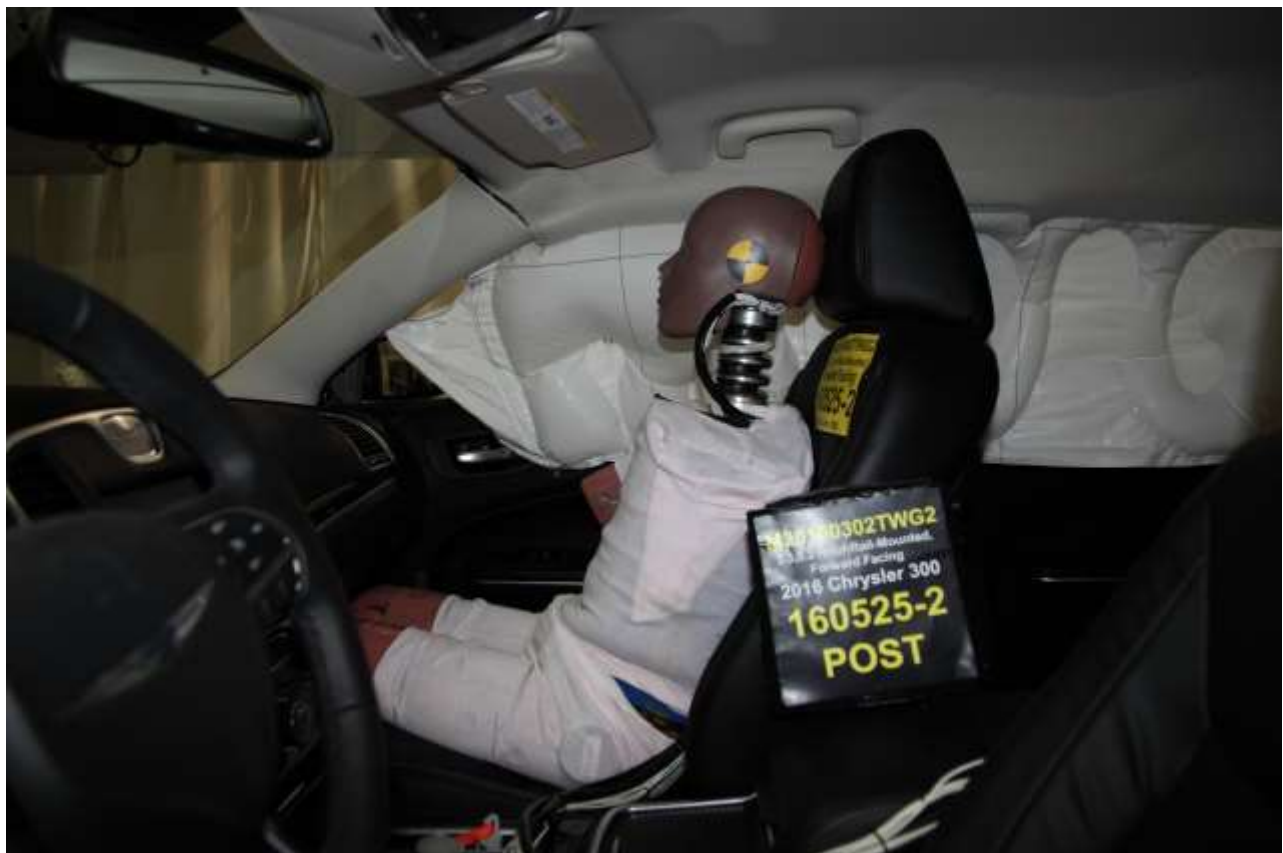
Figure A-10 Post-Test SIDIIs Dummy - Left Side View

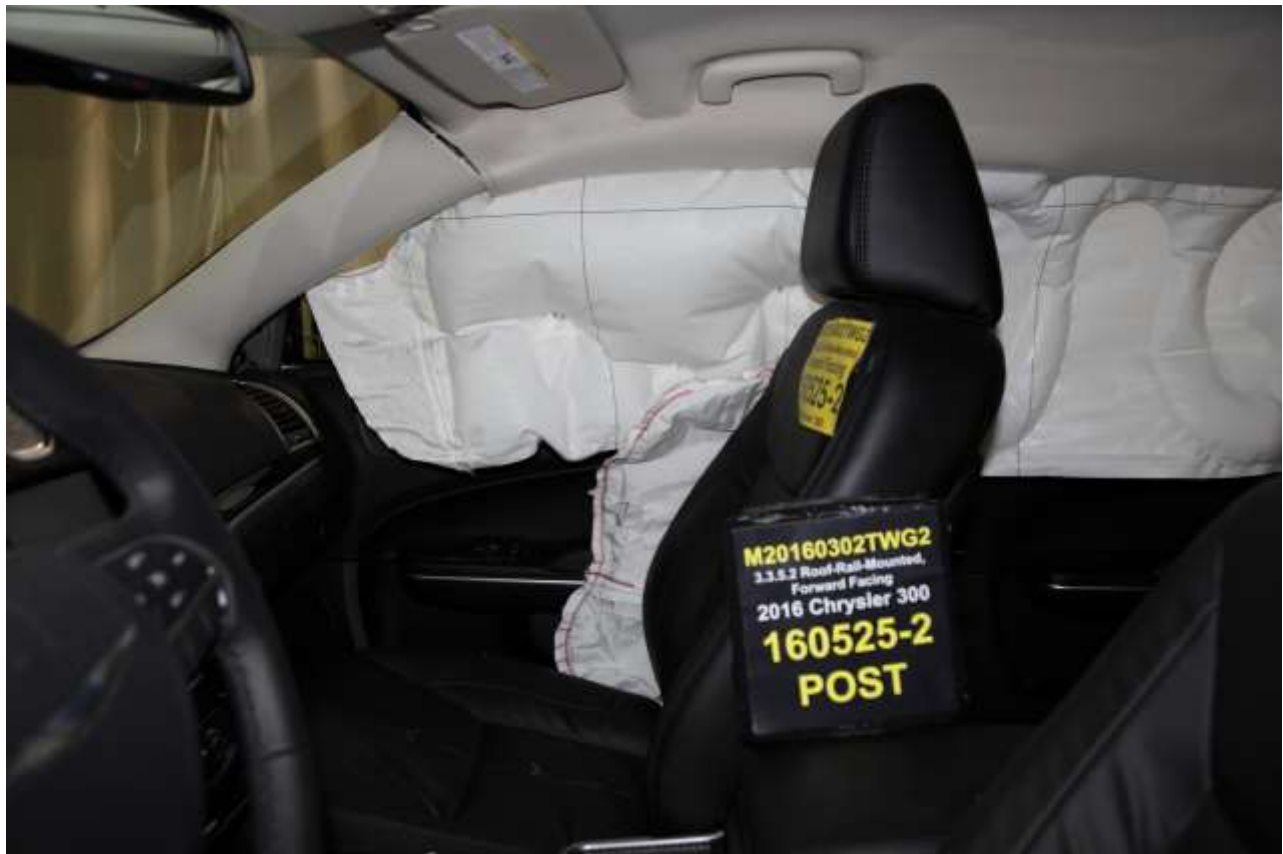
Figure A-26 Post-Test Curtain Airbag - Left Side View

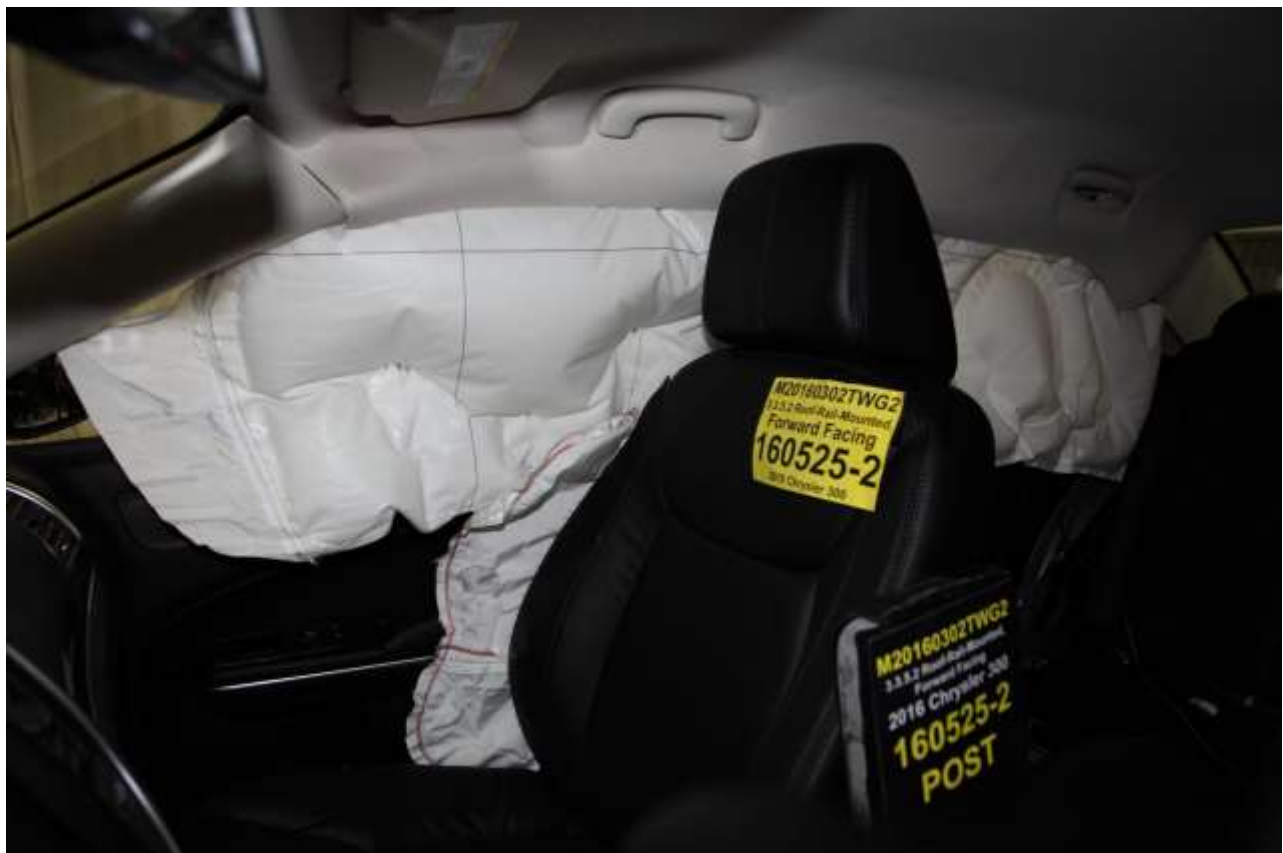
Figure A-27 Post-Test Curtain Airbag - Left Front 3/4 View

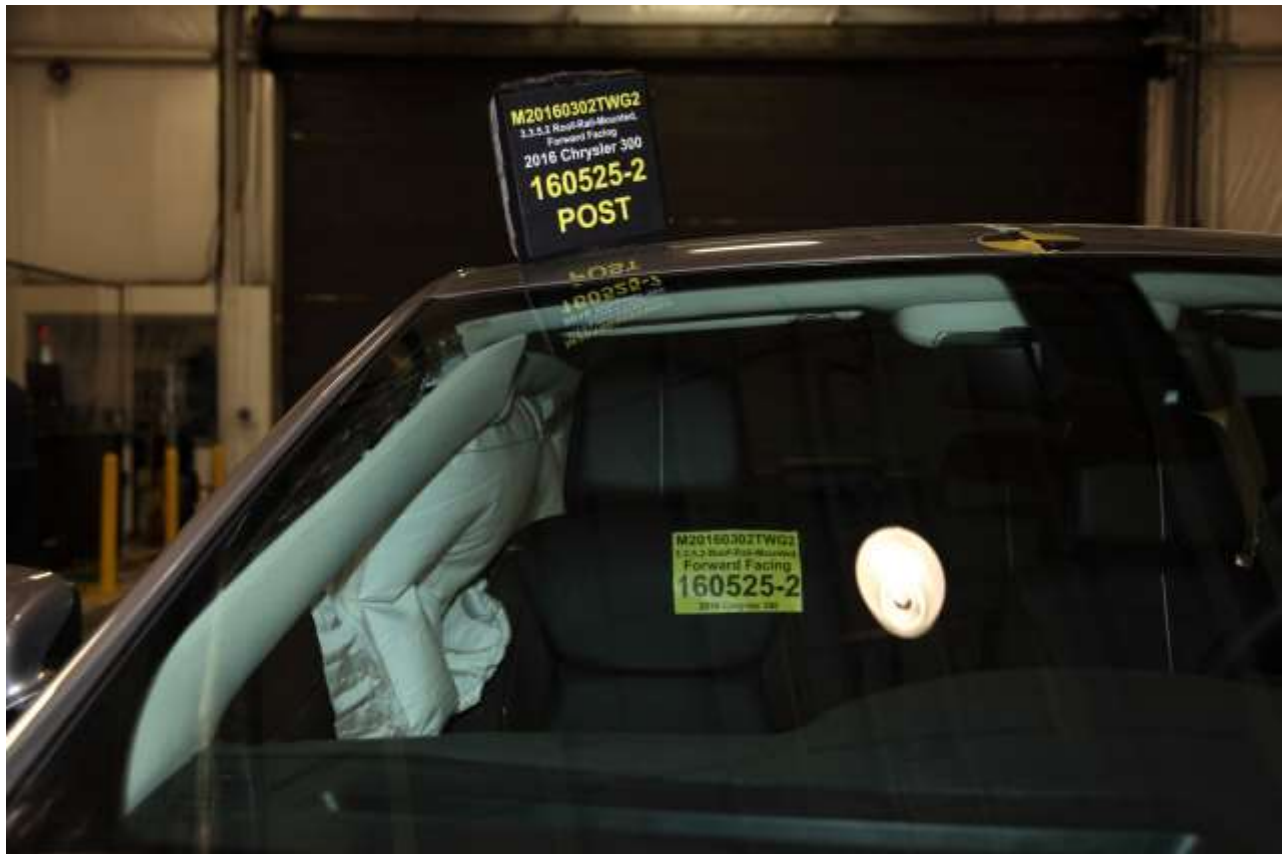
Figure A-28 Post-Test Curtain Airbag - Front View
