REPORT NUMBER: NCAP-MGA-2017-001

**NEW CAR ASSESSMENT PROGRAM (NCAP)
Frontal Barrier Impact Test**

**KIA MOTORS CORPORATION
2017 Kia Sportage LX AWD 5-Door SUV
NHTSA No.: O20174200**

**MGA RESEARCH CORPORATION
5000 Warren Road
Burlington, WI 53105**

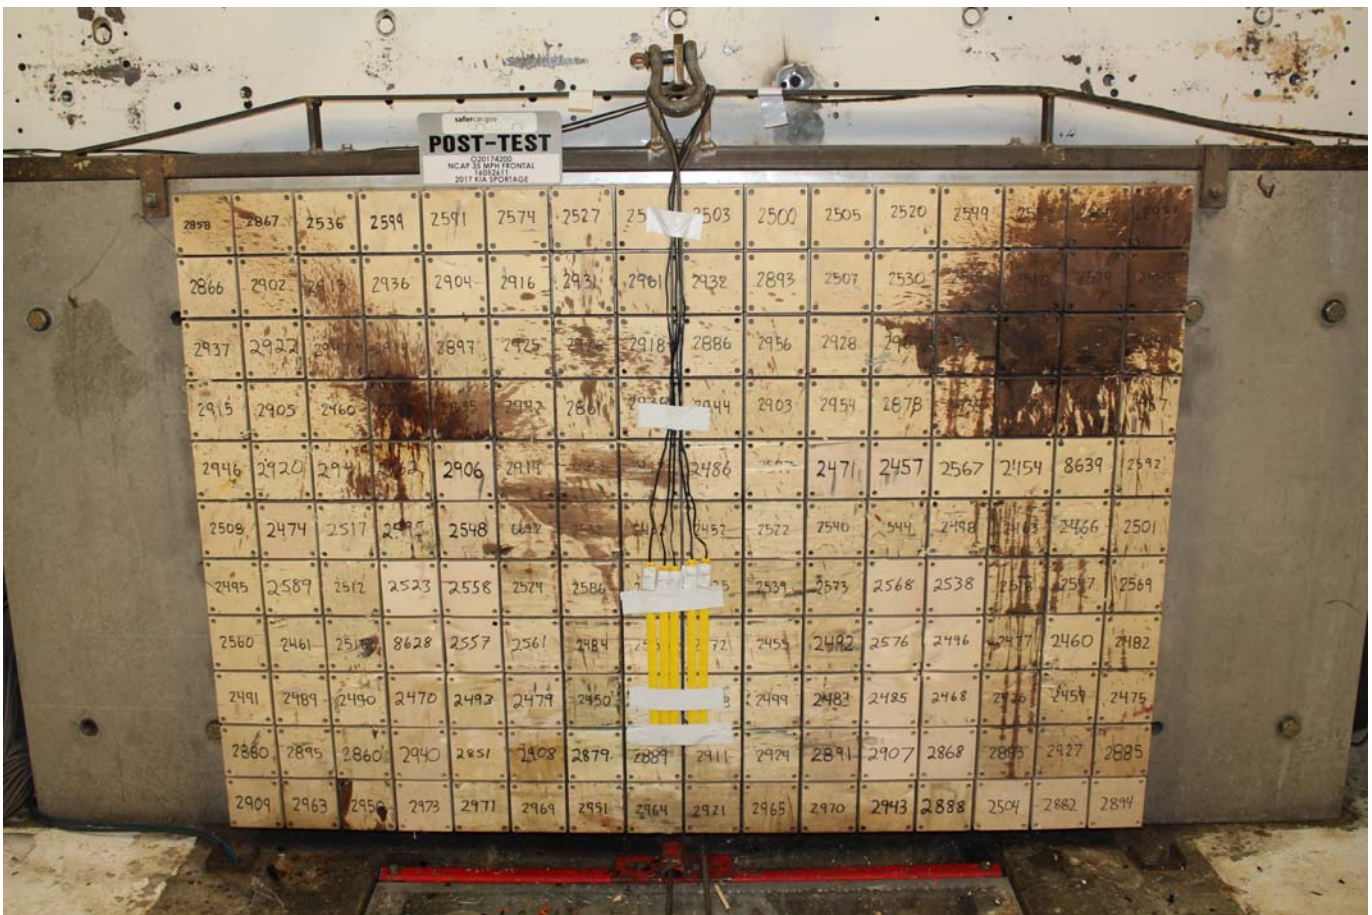
Photo No. 003 - Post-Test Load Cell Wall

Barrier K-16 My recorded no valid data.
 Barrier C-04 Fx recorded no valid data.
 Barrier C-04 My recorded no valid data.
 Barrier C-04 Mz recorded no valid data.

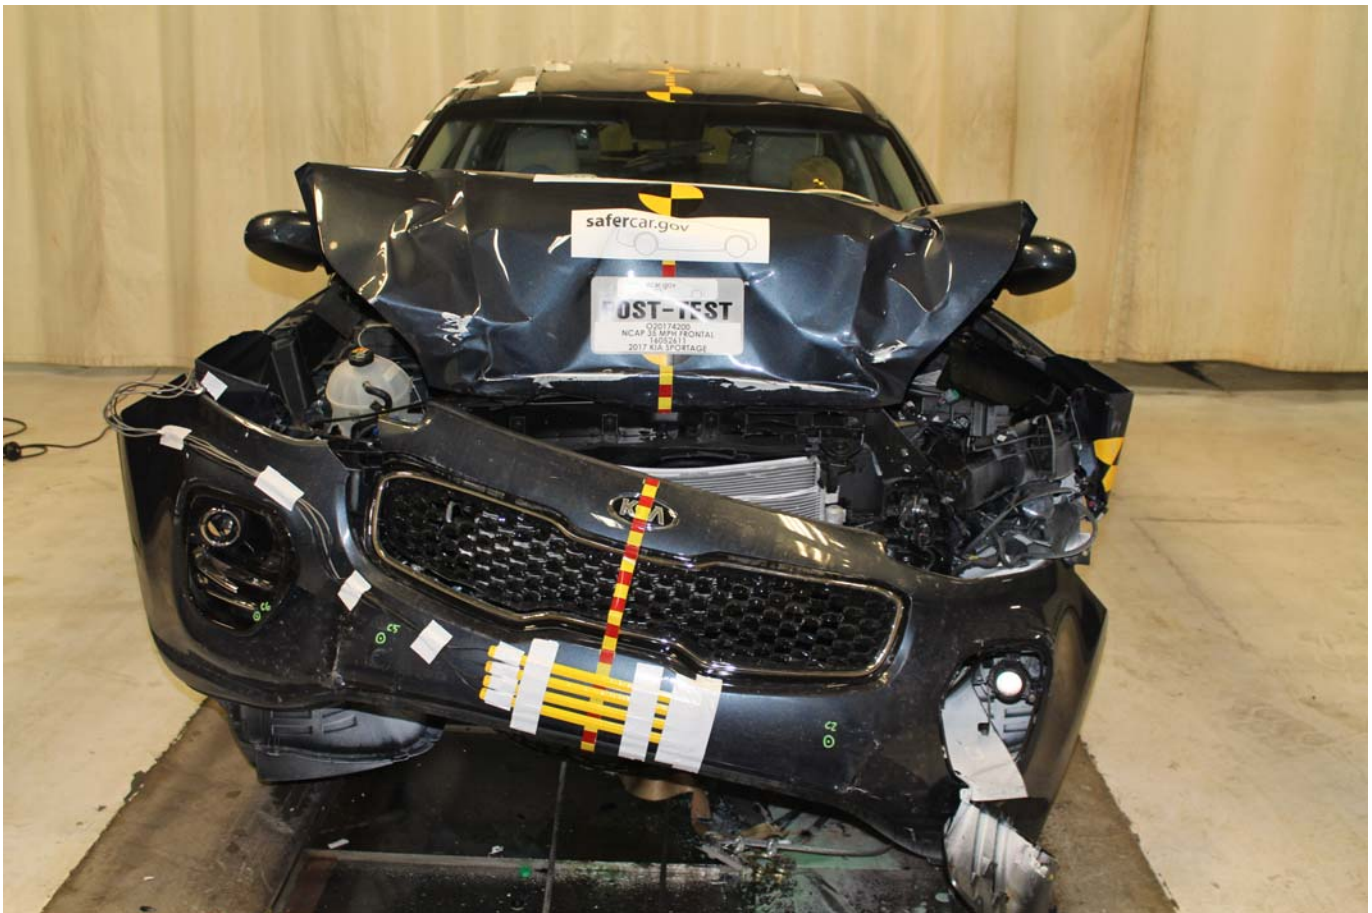
Photo No. 009 - Post-Test Front View of Test Vehicle

The maximum static crush of the vehicle was 452mm at the vehicle centerline and both the driver and passenger side doors remained closed during the impact event and were operable after the impact.

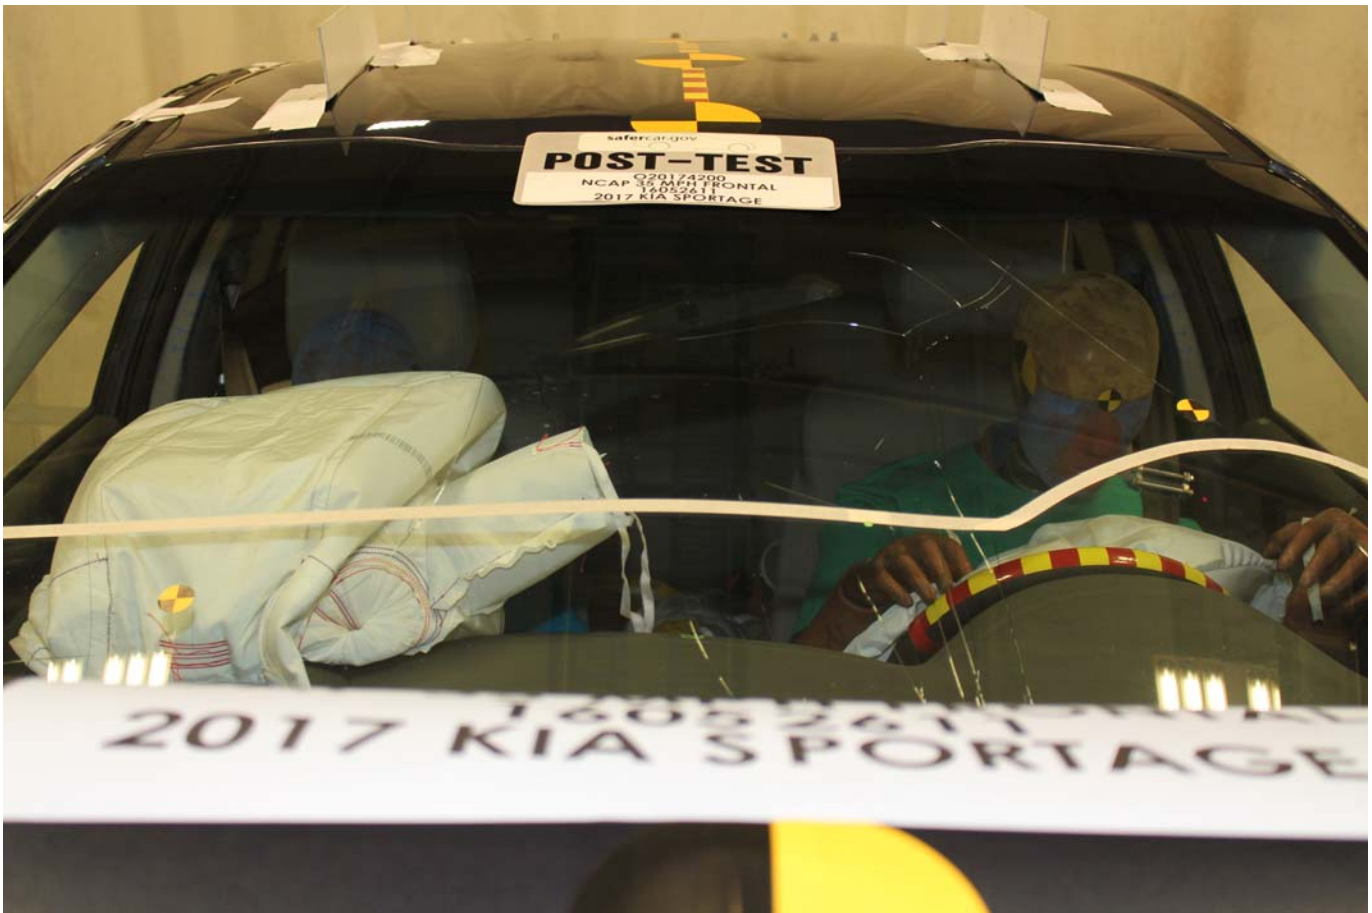
Photo No. 019 - Post-Test Windshield View

There was 100 percent windshield retention and no intrusion into the protected zone of the windshield during the event. There was no Stoddard Solvent leakage after the event or during any phase of the static rollover.

Critical Areas of Performance	Observations and Conclusions
Windshield Damage	Cracked
Window Damage	None
Other Notable Effects	None

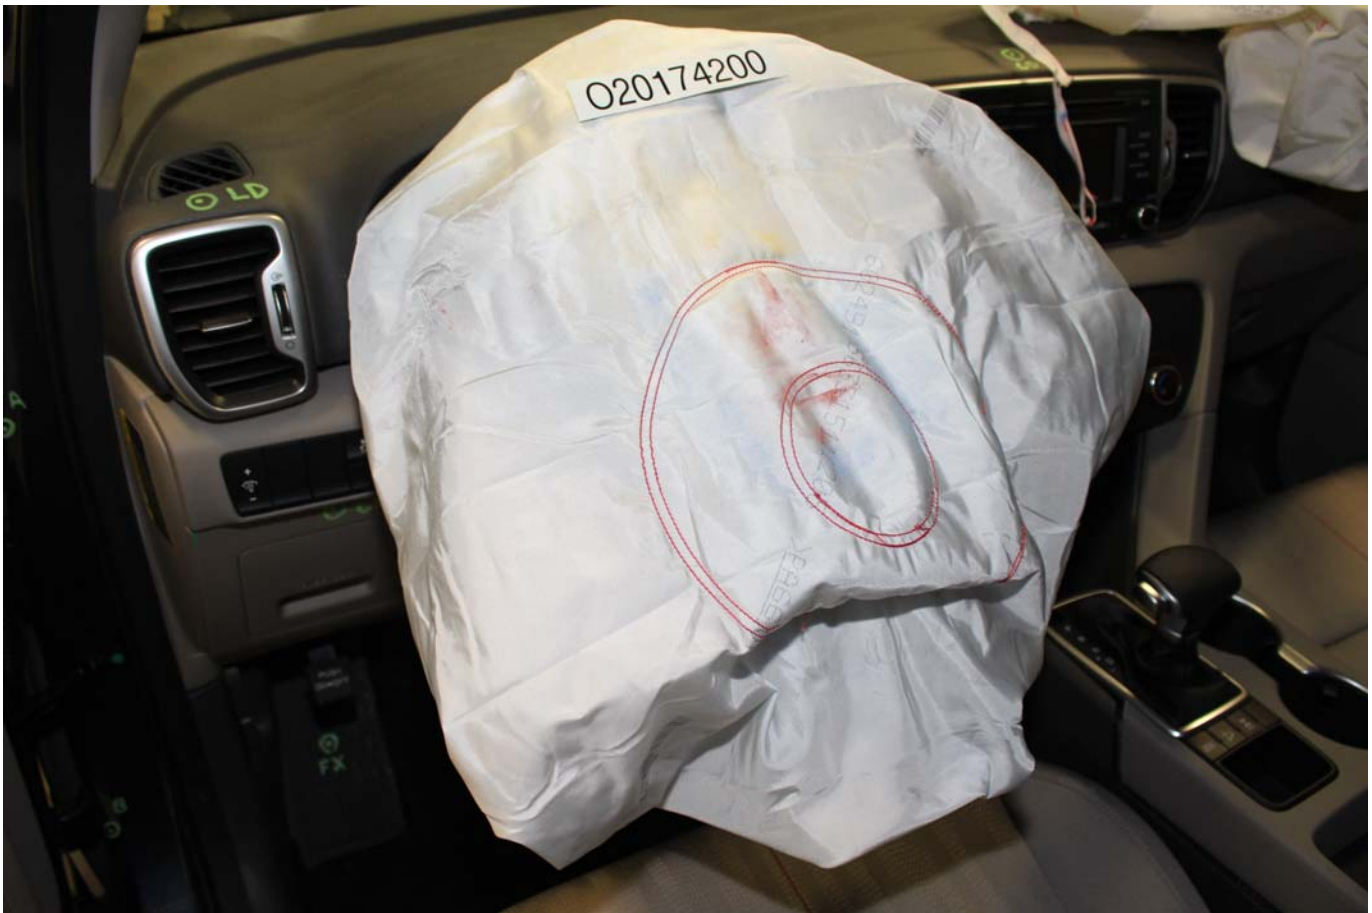
Photo No. 047 - Post-Test Driver Dummy Contact with Airbag

The driver's visible contact points were as follows: The driver's head contacted the airbag. The driver's head also contacted the headrest. The passenger's visible contact points were as follows: The passenger's head contacted the airbag. The passenger's head also contacted the headrest.

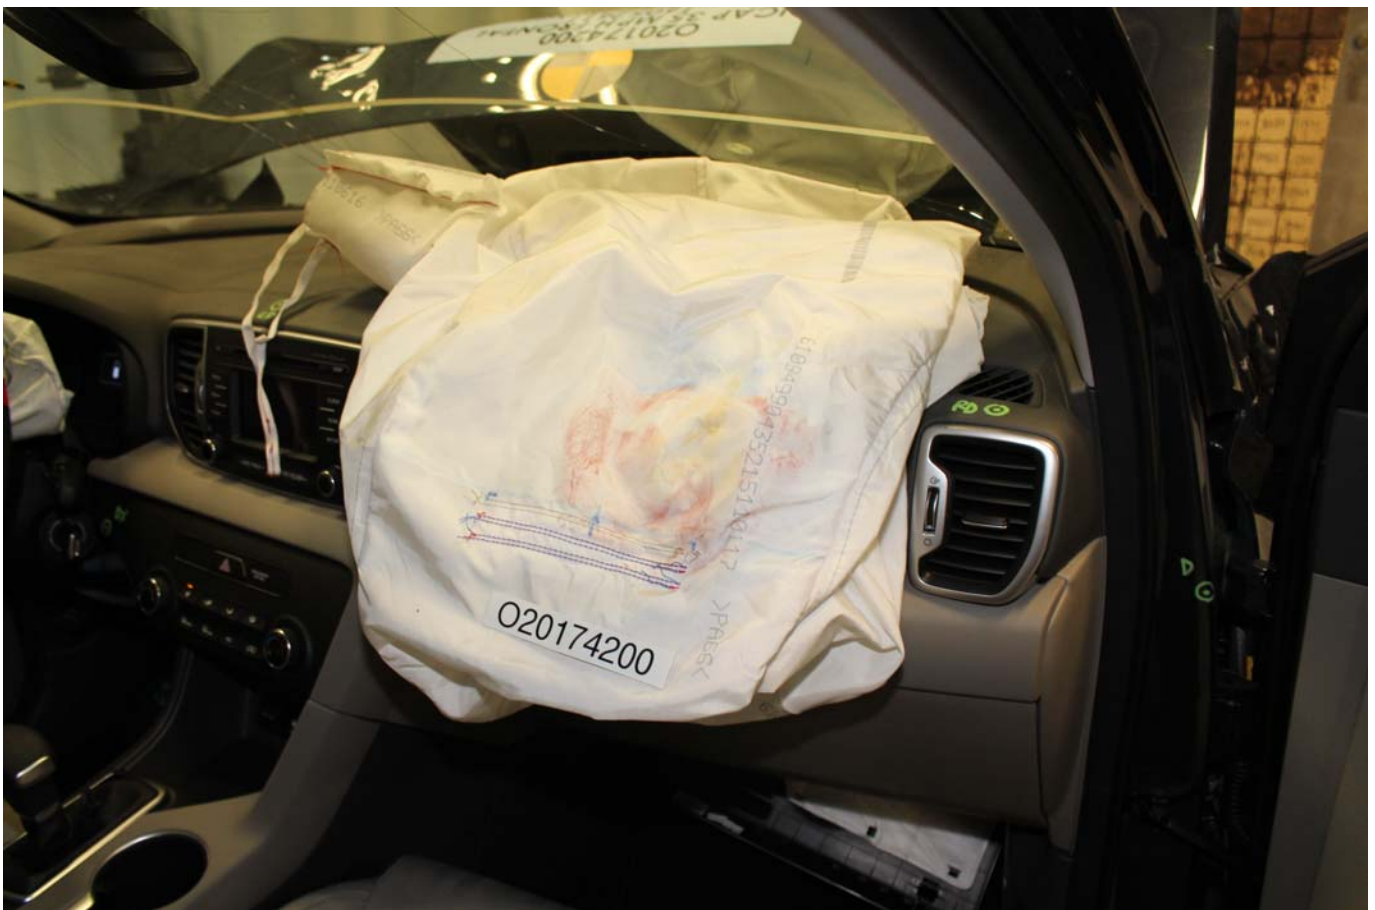
Photo No. 068 - Post-Test Passenger Dummy Contact with Airbag

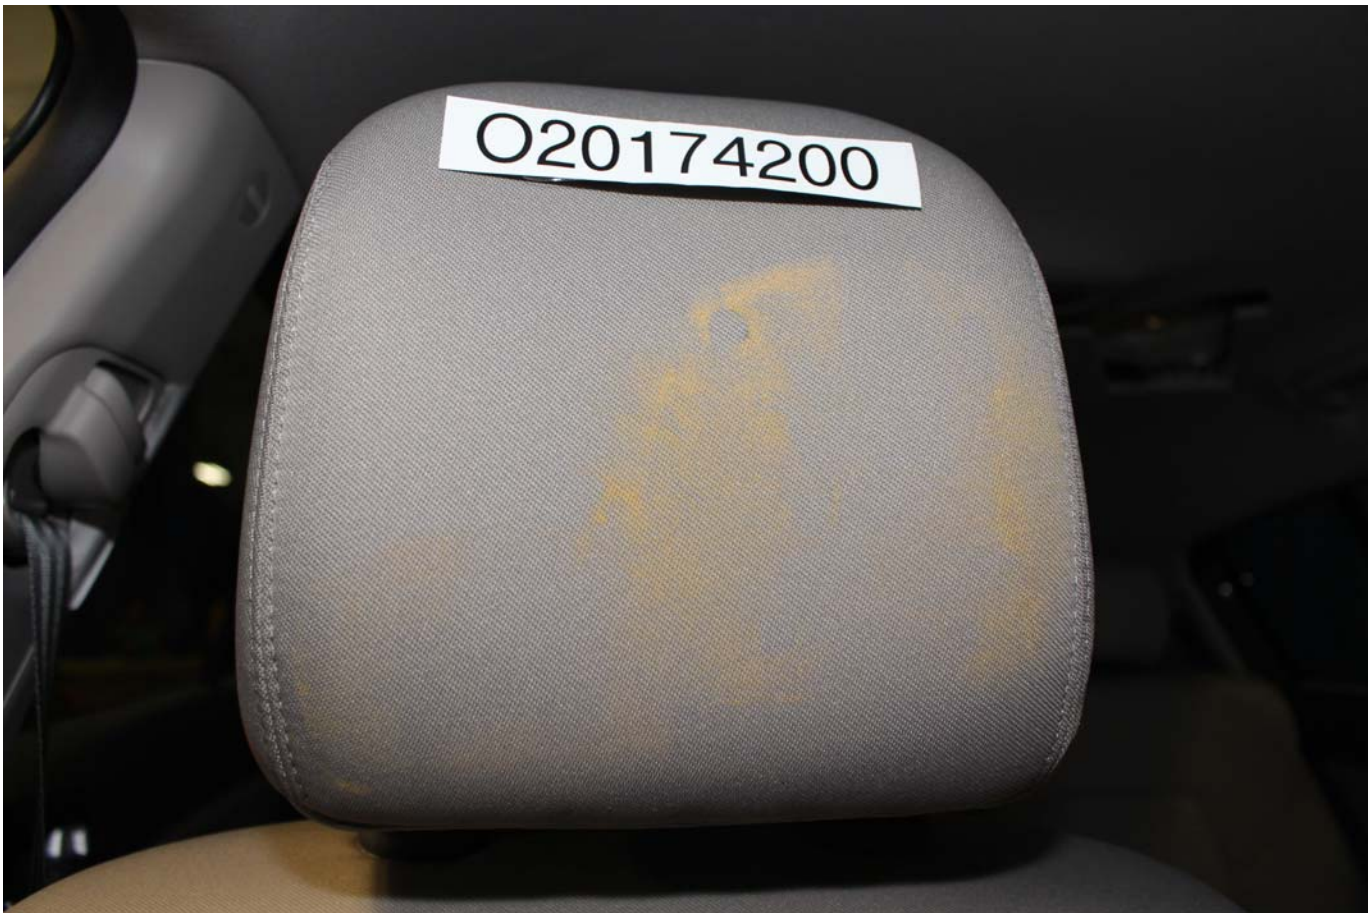
Photo No. 069 - Post-Test Passenger Dummy Contact with Headrest

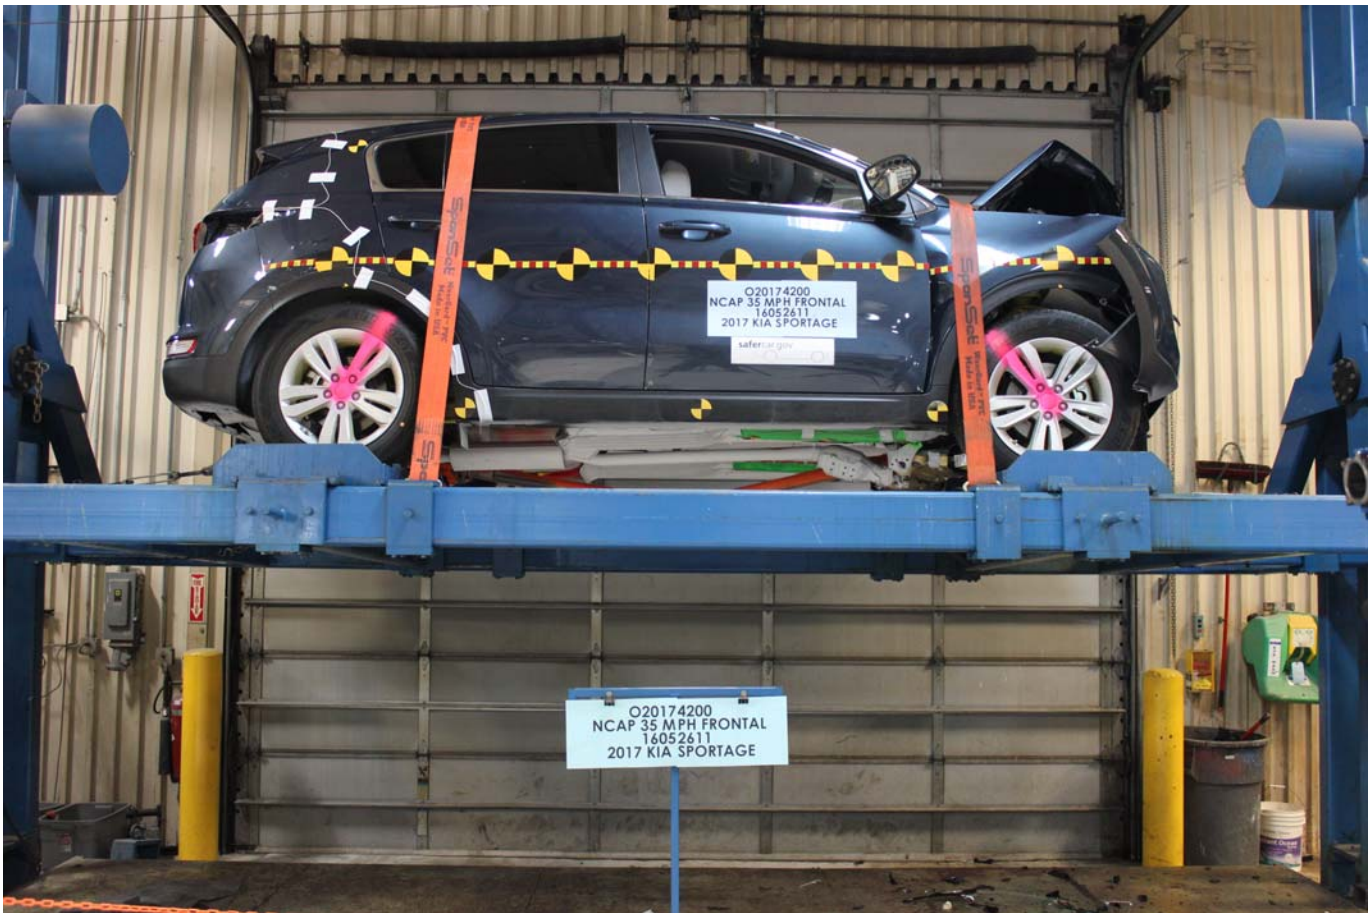
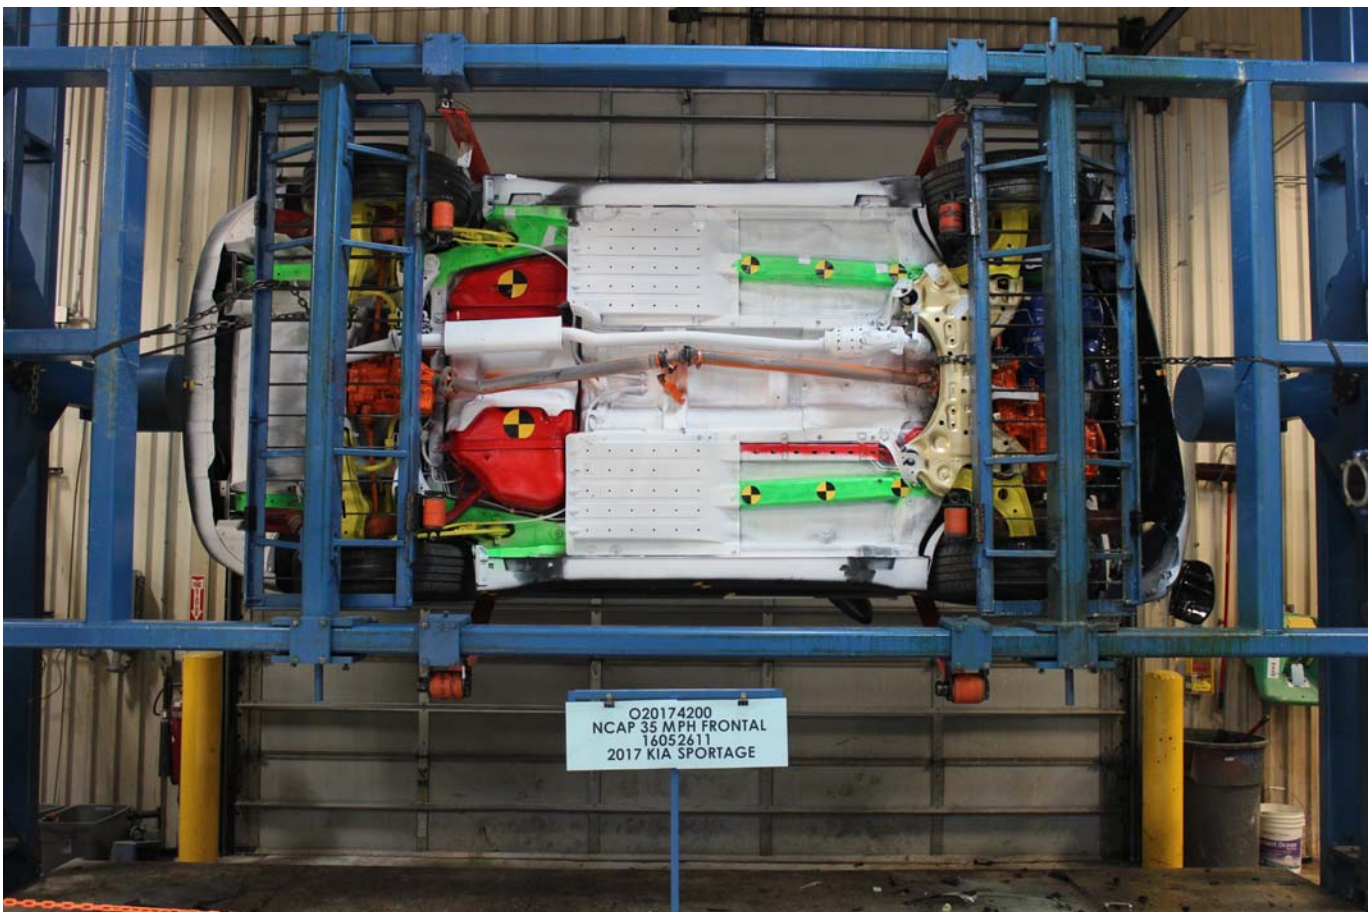
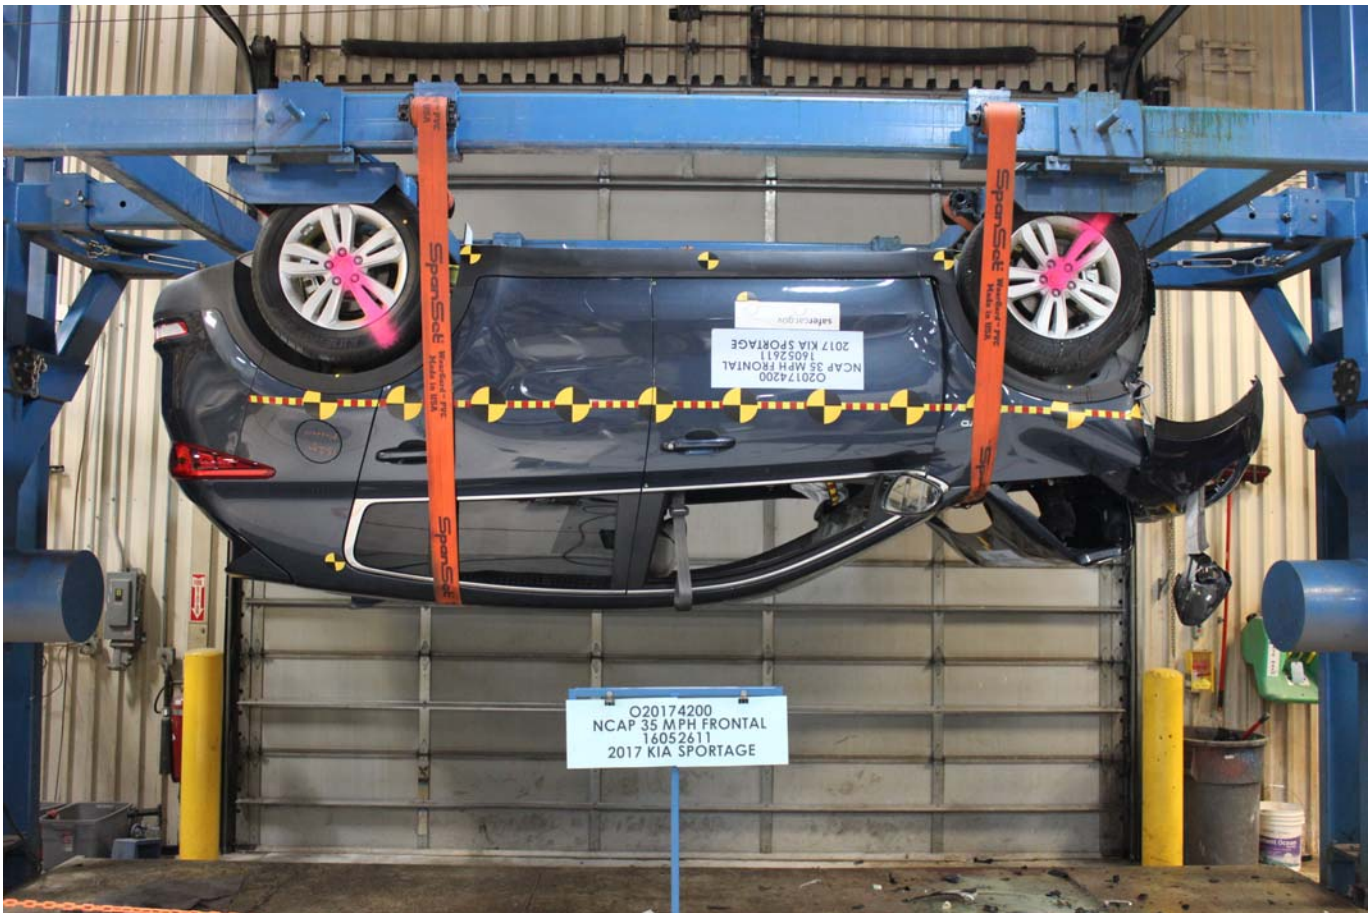
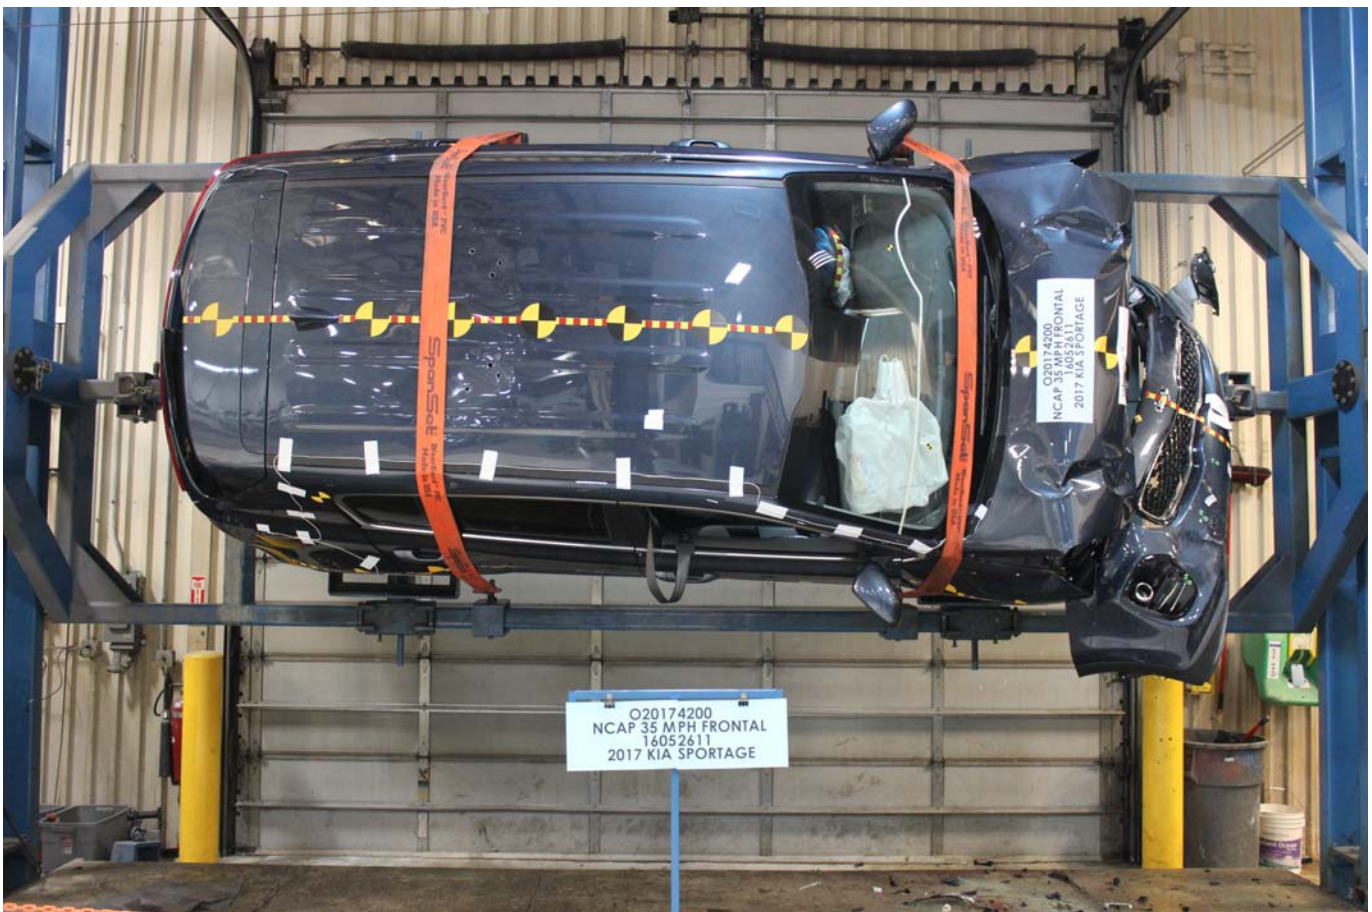
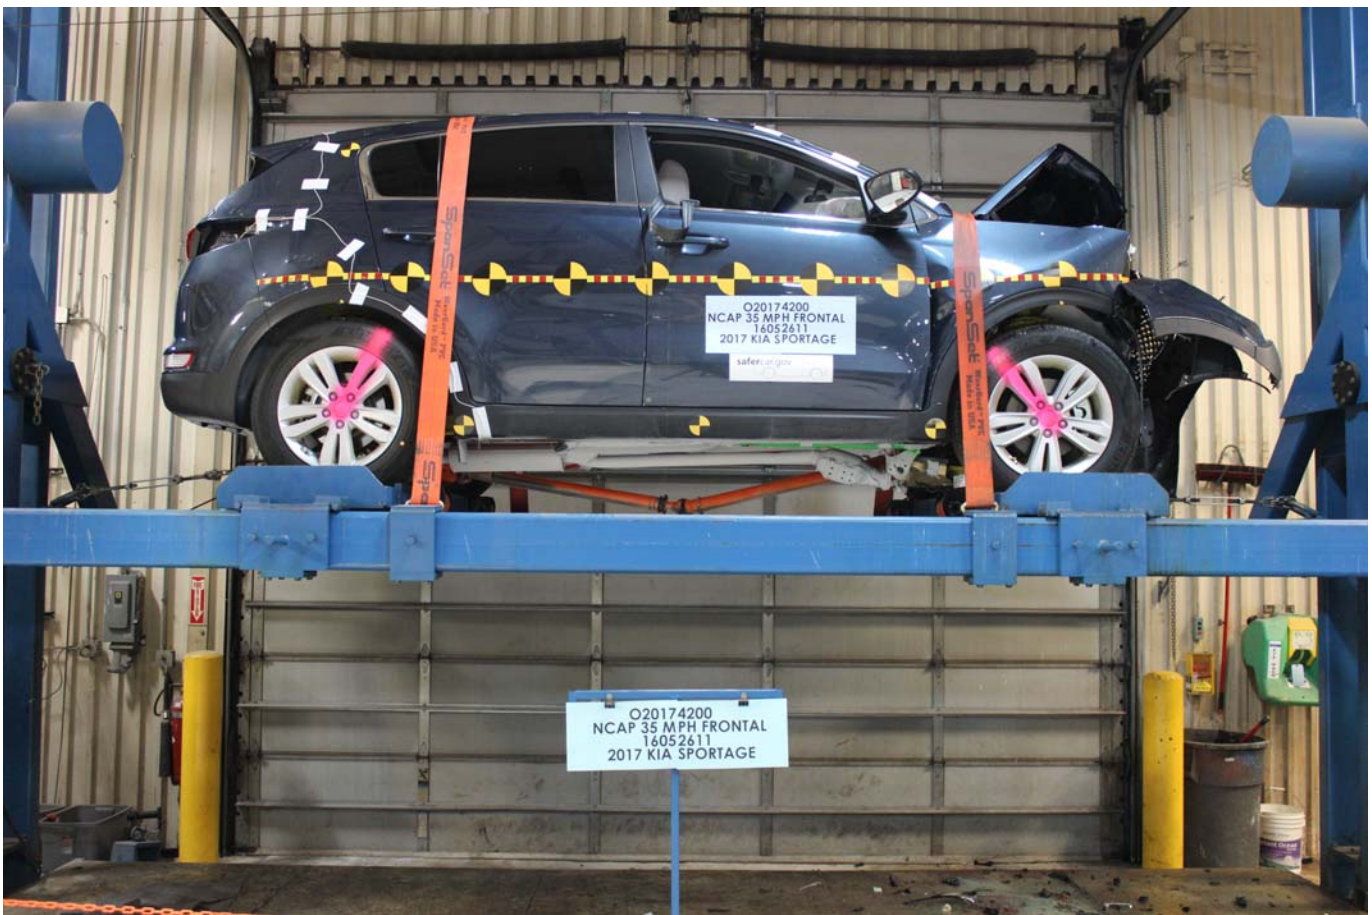
Photo No. 073 - Vehicle at 0 Degree on Static Rollover Device

Photo No. 074 - Vehicle at 90 Degrees on Static Rollover Device

Photo No. 075 - Vehicle at 180 Degrees on Static Rollover Device

Photo No. 076 - Vehicle at 270 Degrees on Static Rollover Device

Photo No. 077 - Vehicle at 360 Degrees on Static Rollover Device
