REPORT NUMBER: TWG-CAL-16-01

**NEW CAR ASSESSMENT PROGRAM (NCAP)**  
SIDE AIRBAG OUT-OF-POSITION INJURY TESTING

**Ford Motor Co.**  
**2016 Ford Fiesta**

NHTSA NUMBER: M20160205TWG2  
CALSPAN TEST NUMBER: CT2016-01

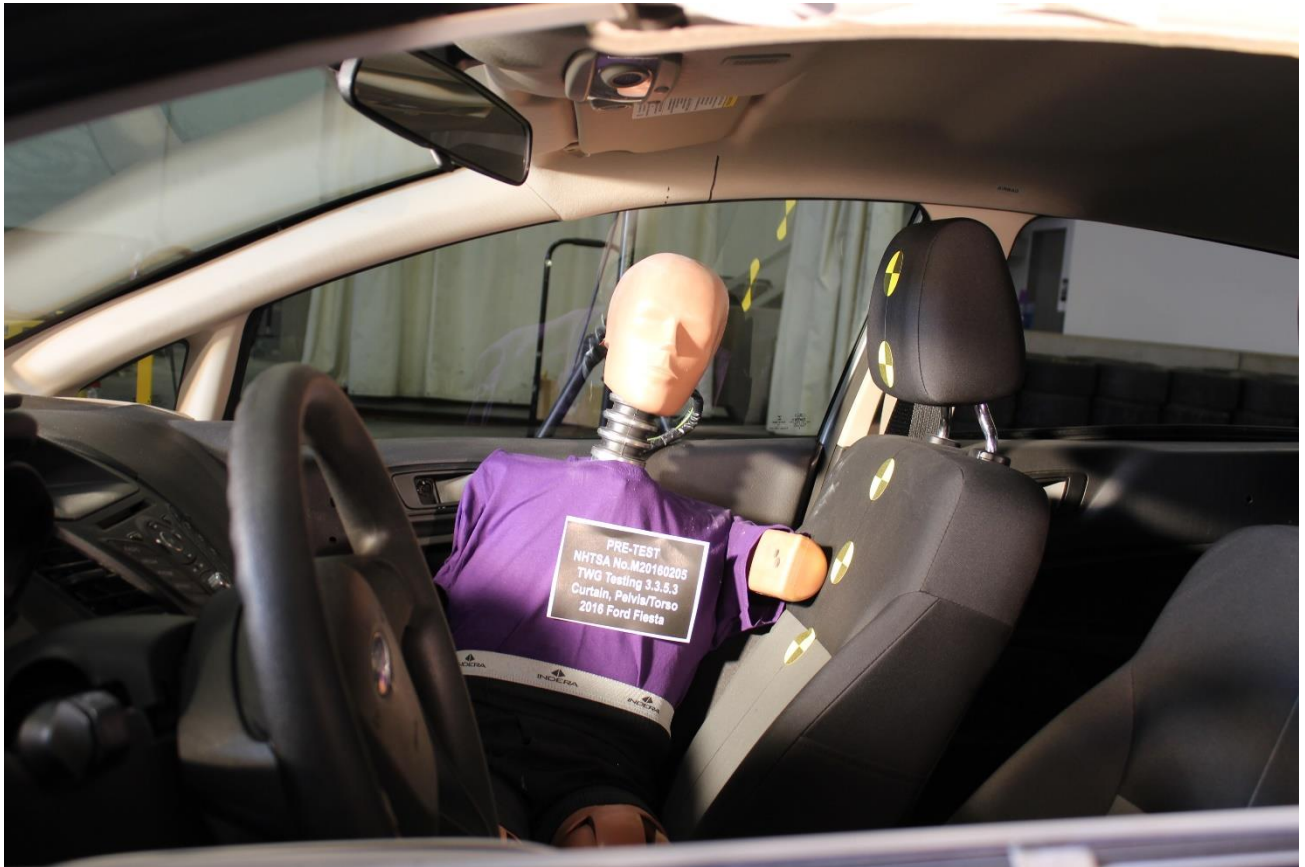
**Figure A-3: Pre-Test SID-IIs 5th Female Left Side View**

#### PRE-TEST VISIBLE DUMMY CONTACT POINTS

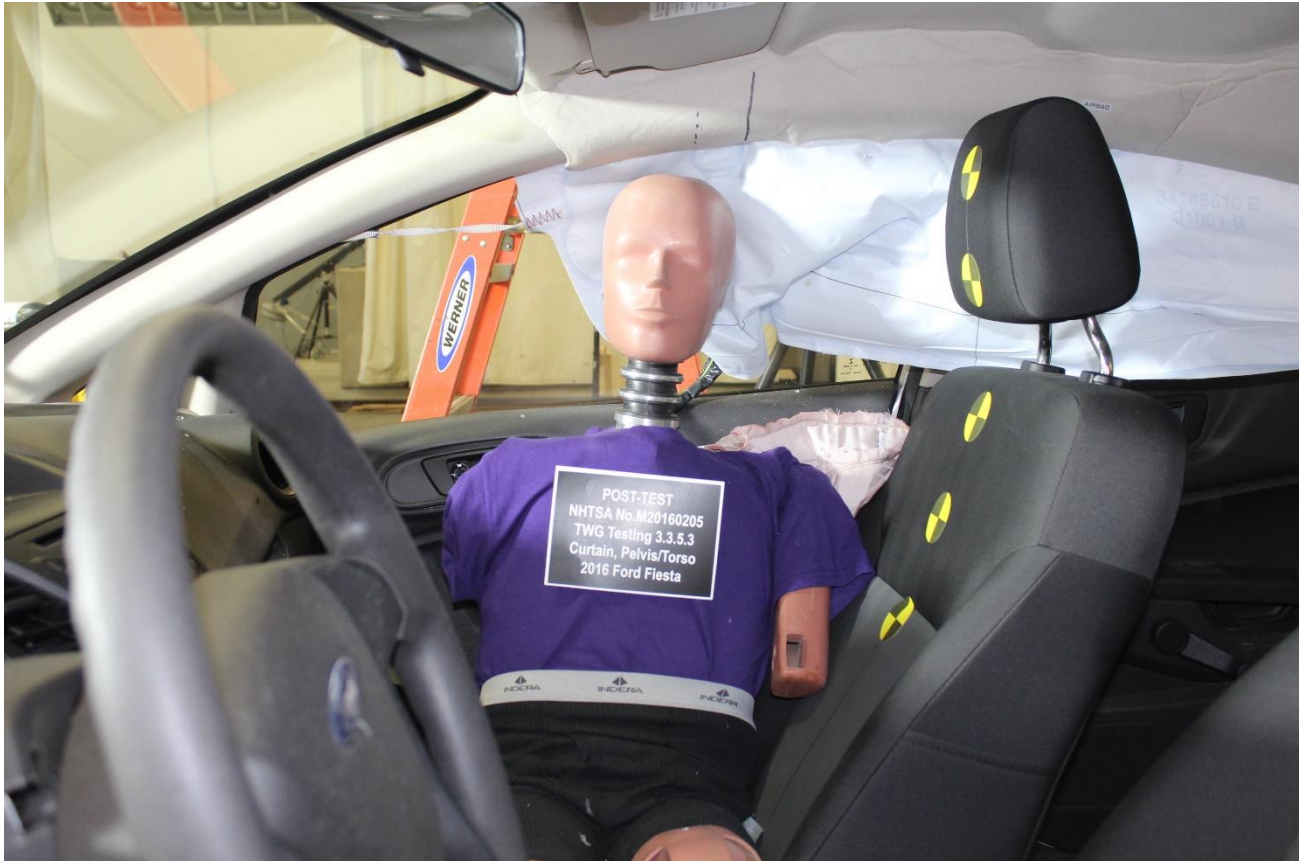
**Figure A-4: Post-Test SID-IIs 5th Female Left Side View**

#### POST-TEST VISIBLE DUMMY CONTACT POINTS

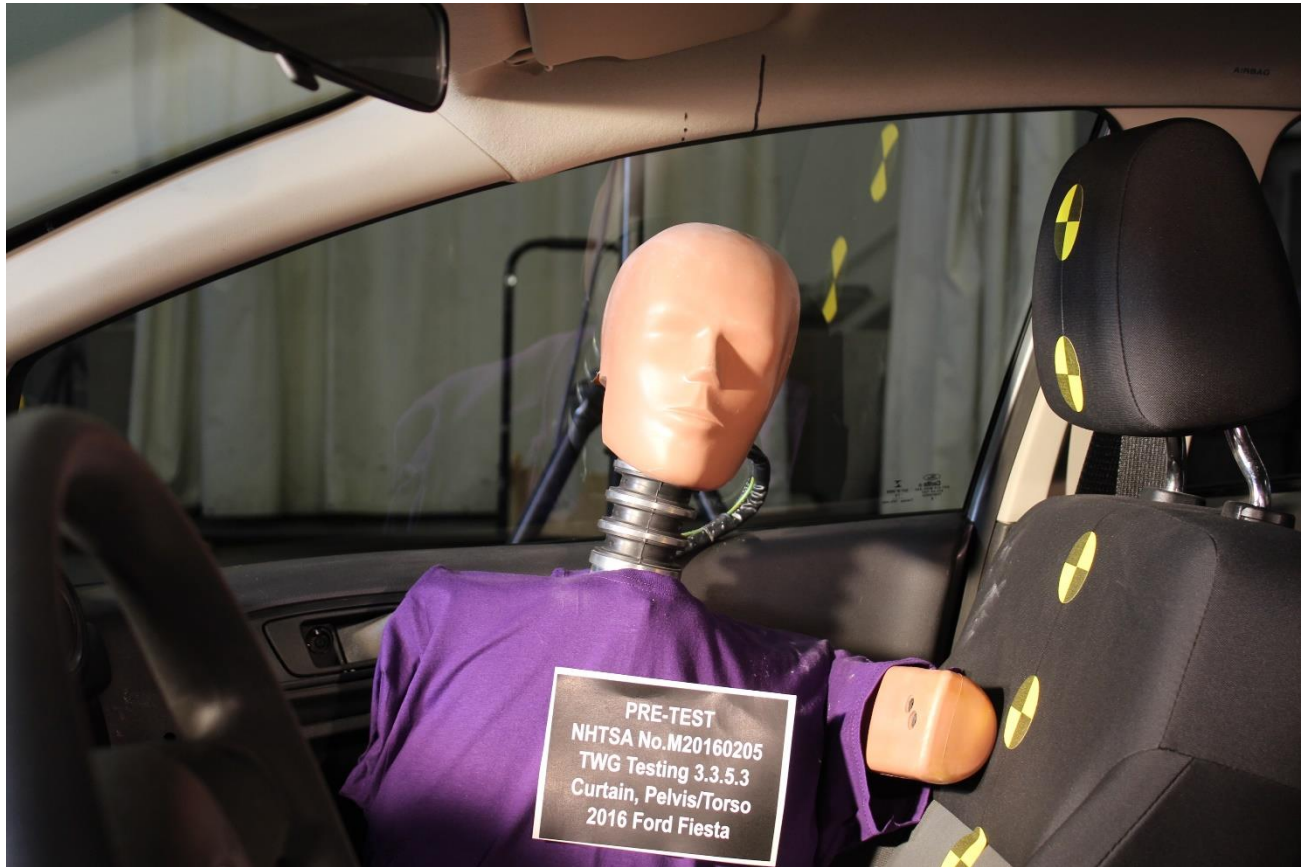
**Figure A-5: Pre-Test SID-IIs 5th Female Left Side Close-up View**

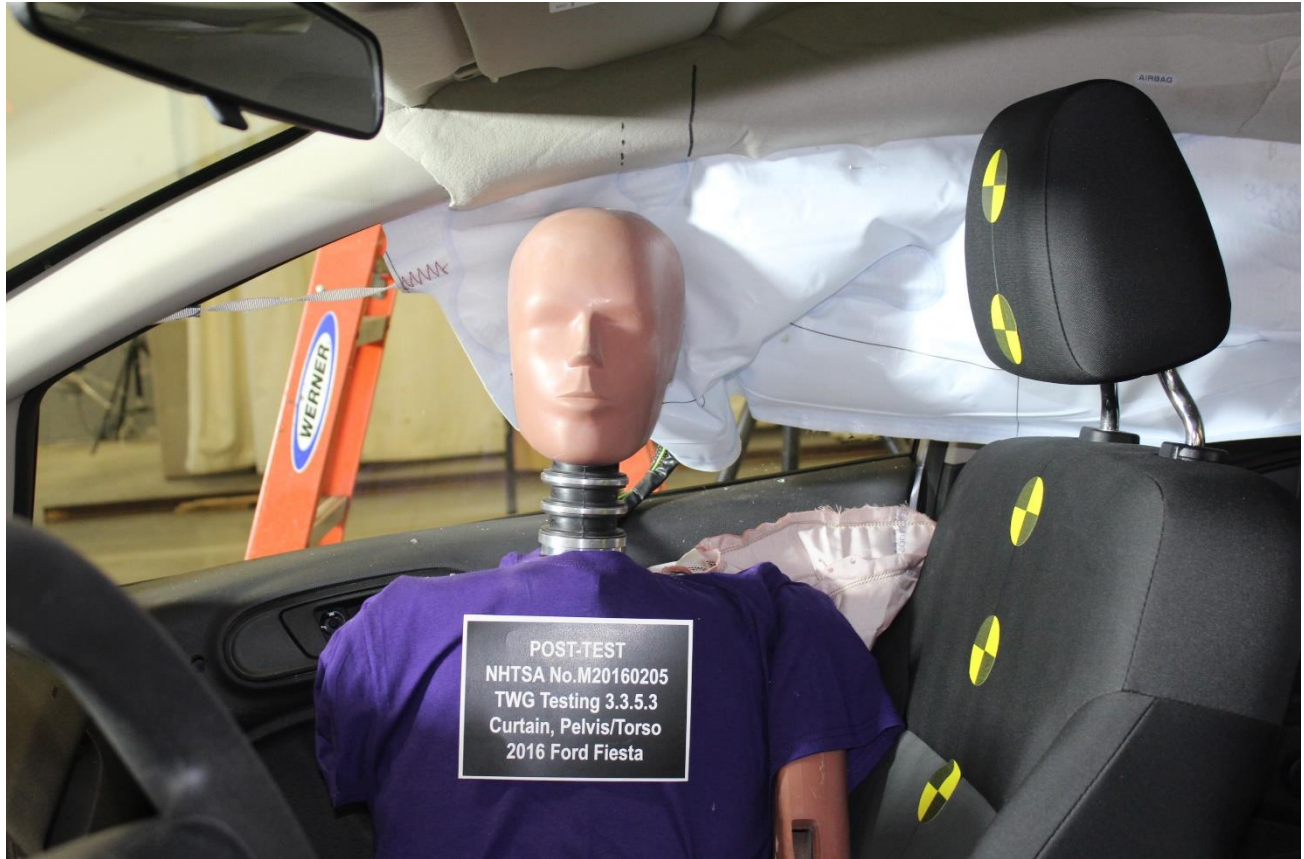
**Figure A-6: Post-Test SID-IIs 5th Female Left Side Close-up View**

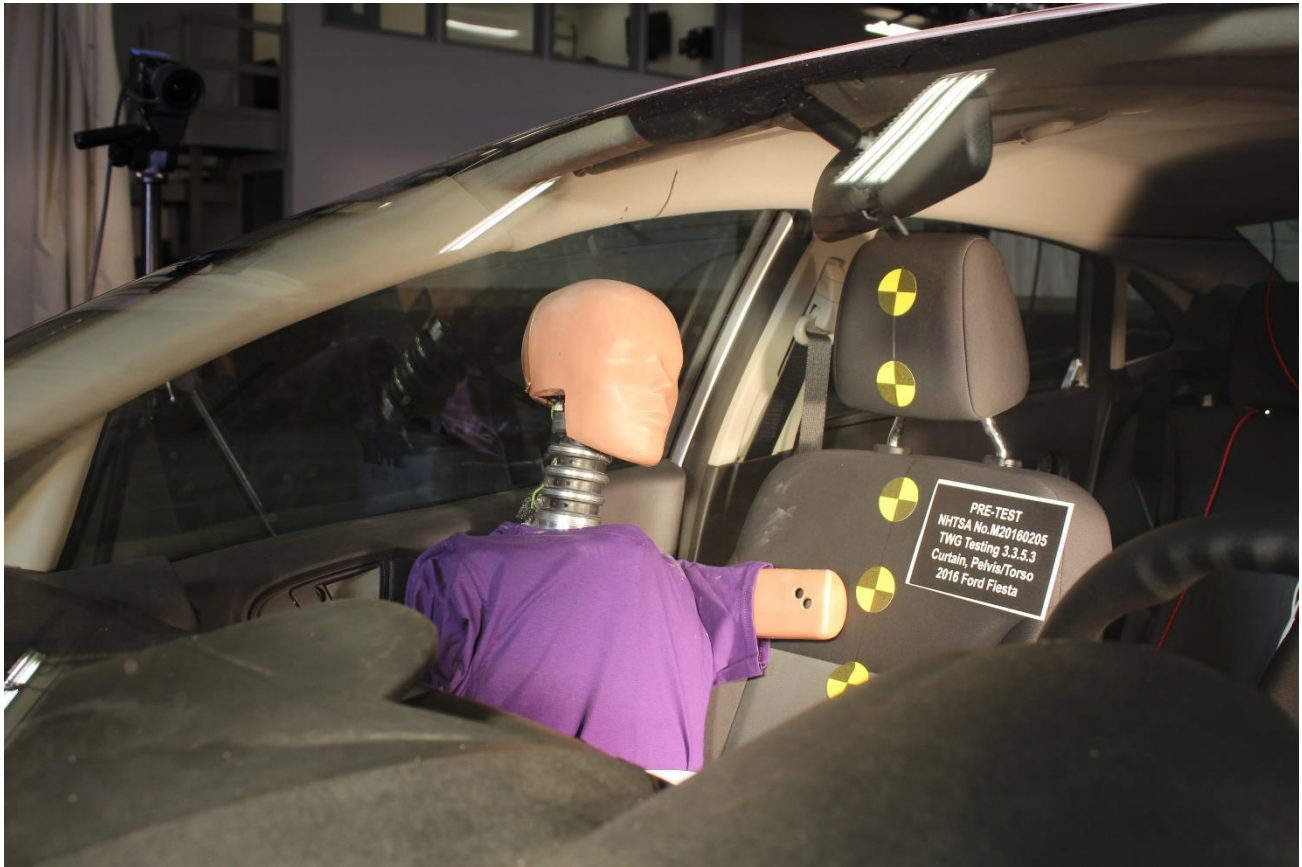
**Figure A-7: Pre-Test SID-IIs 5th Female Left  $\frac{3}{4}$  Front View**

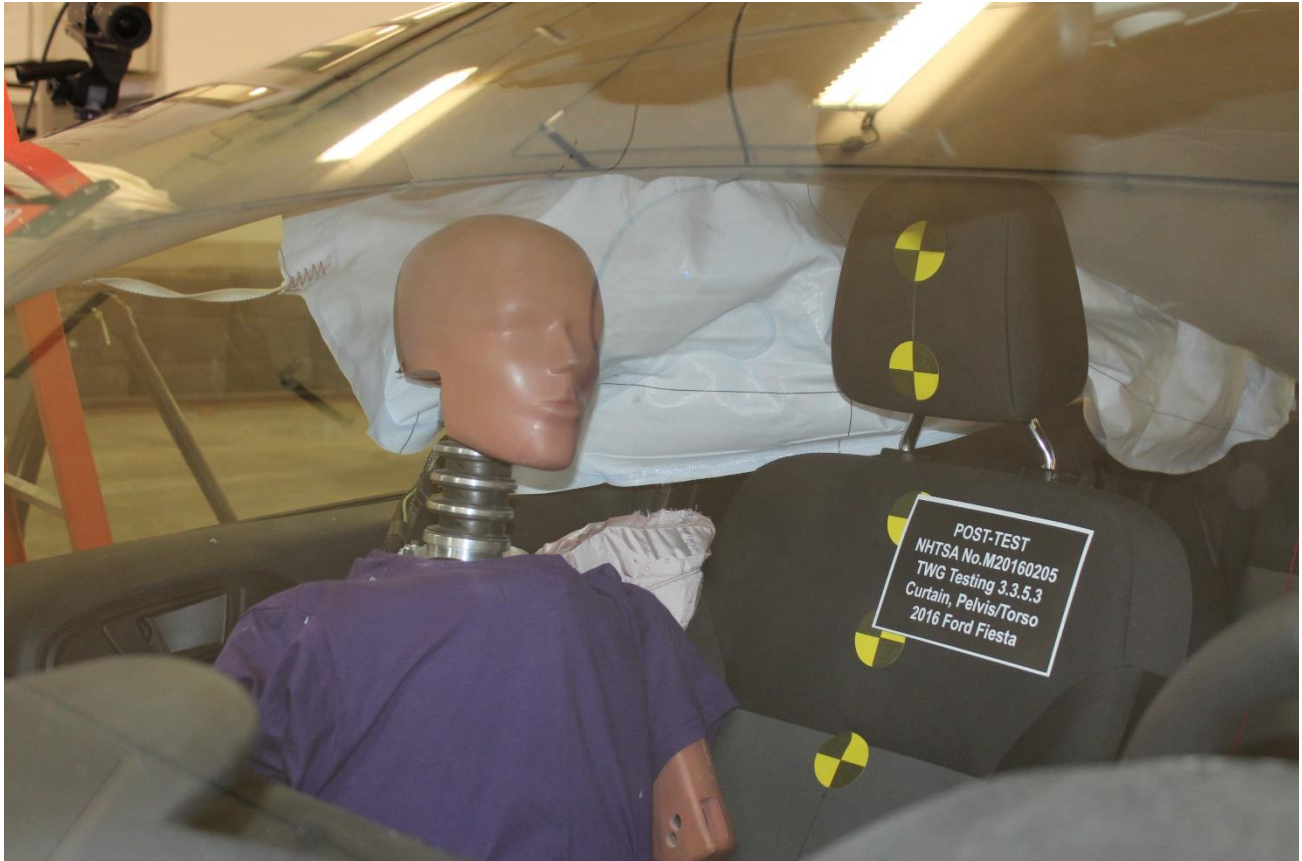
**Figure A-8: Post-Test SID-IIs 5th Female Left  $\frac{3}{4}$  Front View**

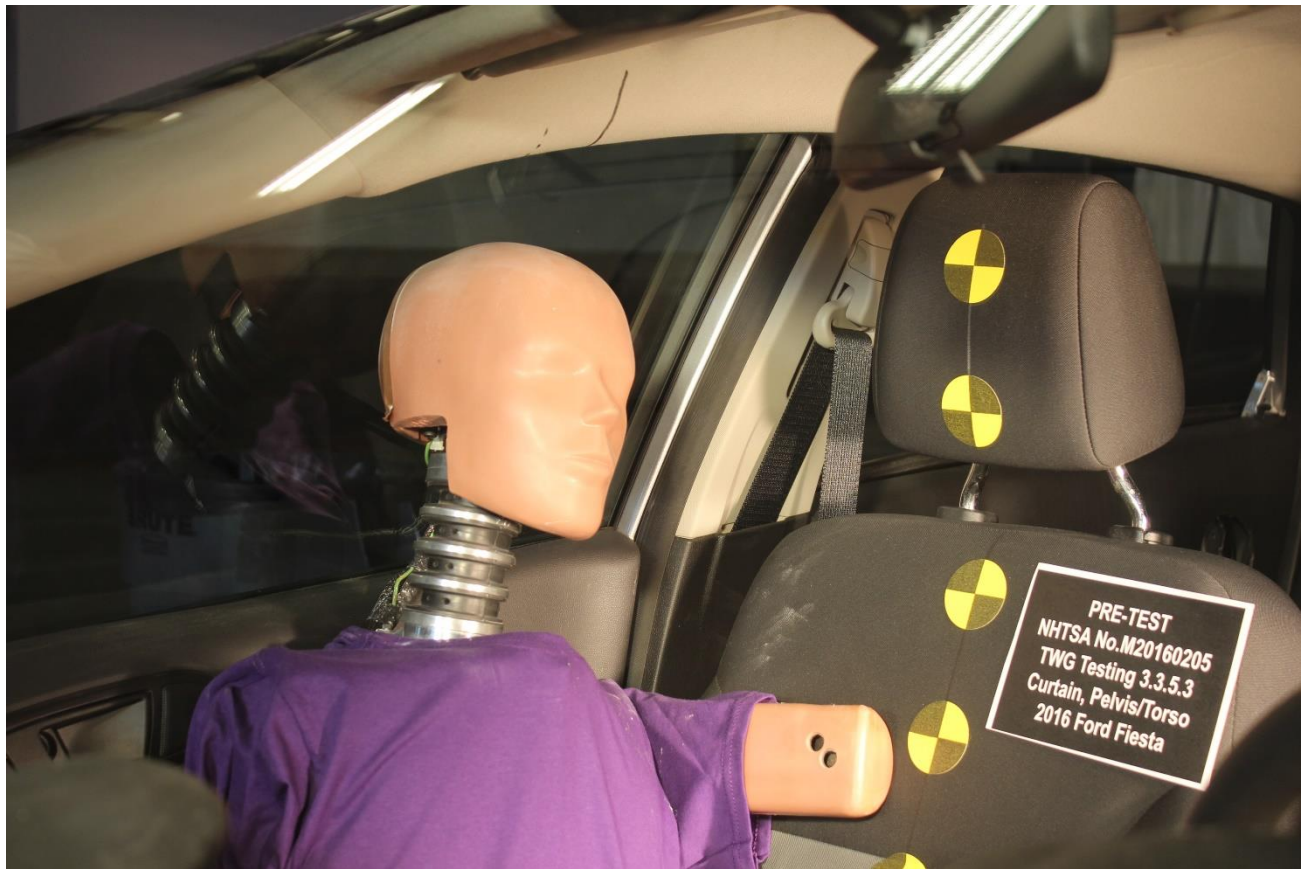
**Figure A-9: Pre-Test SID-IIs 5th Female Left  $\frac{3}{4}$  Front Close-up View**

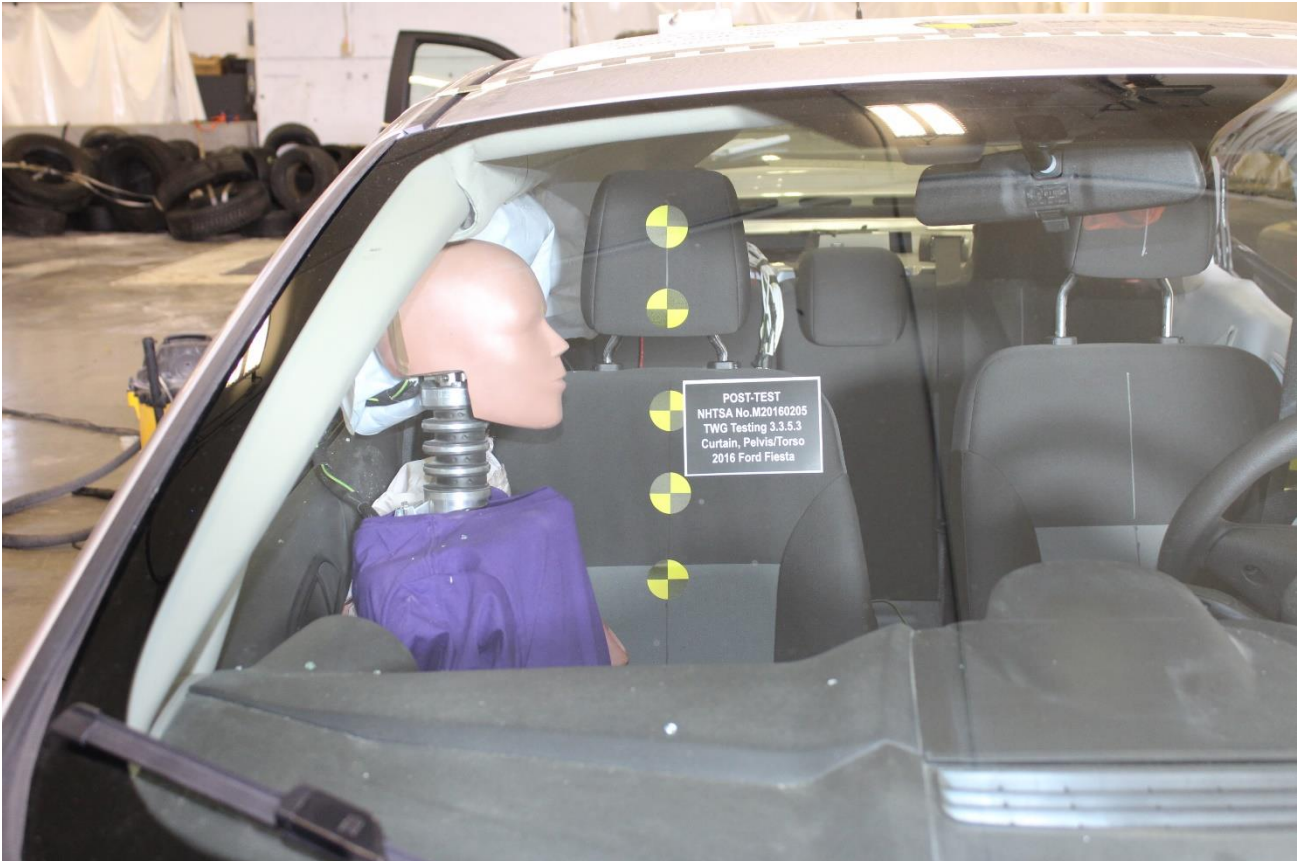
**Figure A-12: Post-Test SID-IIs 5th Female Front View**

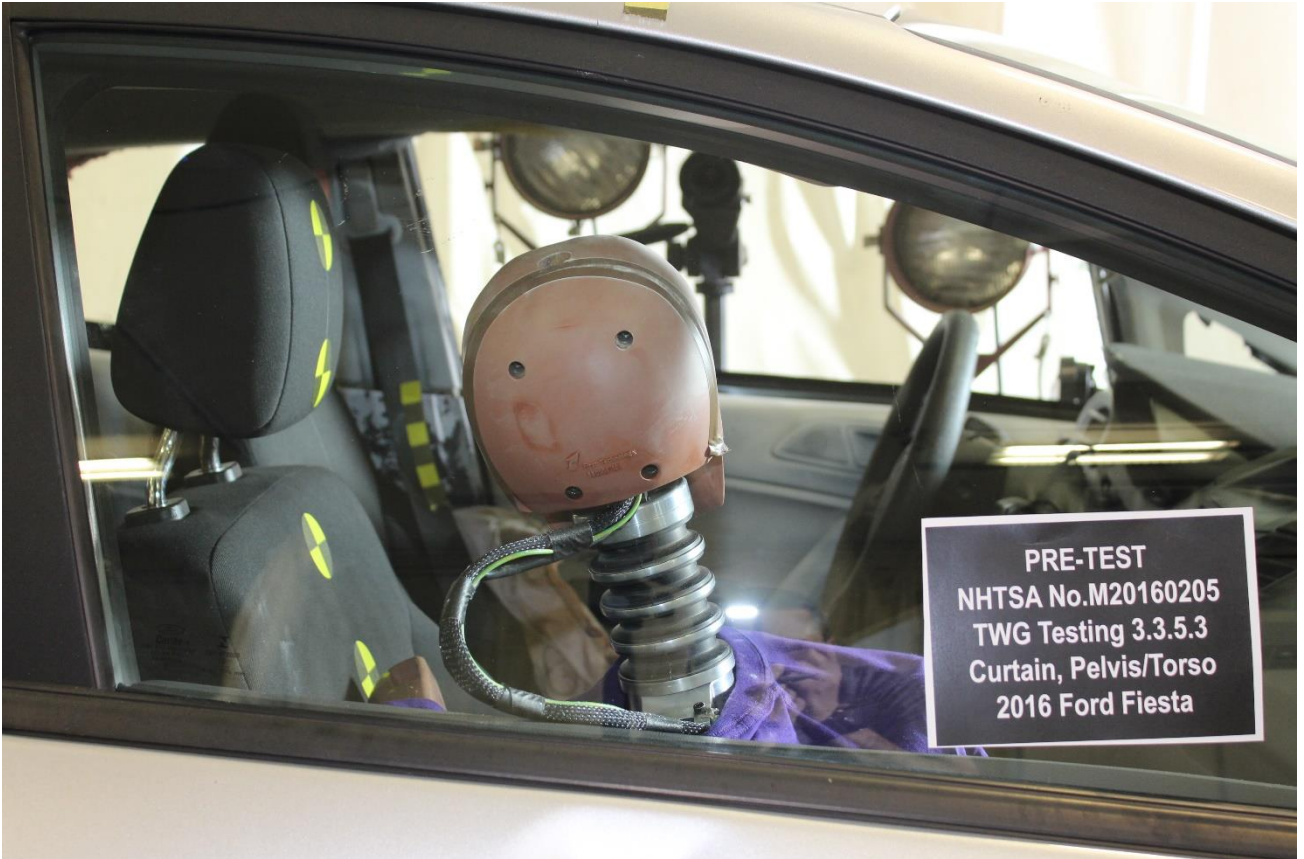
**Figure A-14: Pre-Test SID-IIs 5th Female Right Side View**

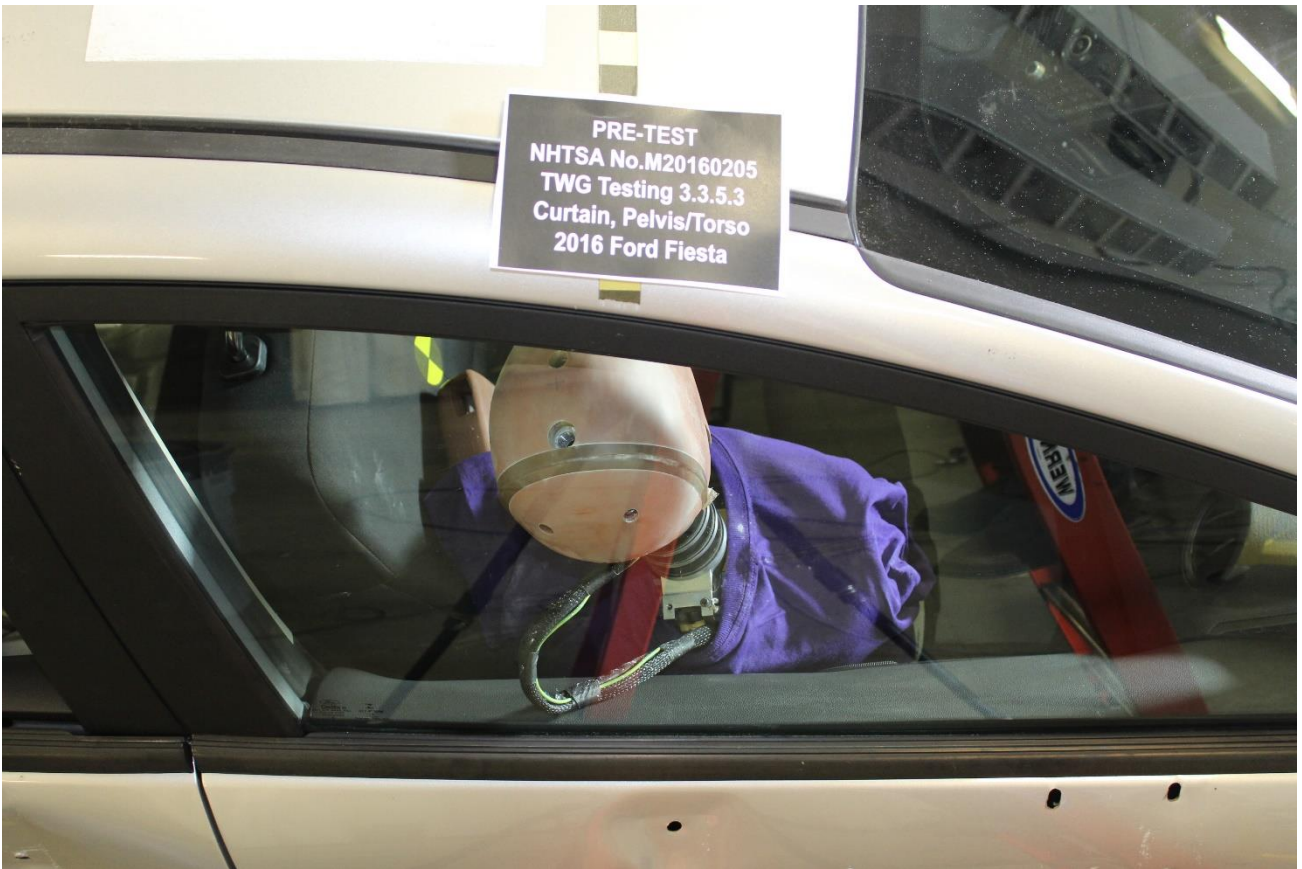
**Figure A-15: Pre-Test SID-IIs 5th Female Right Side Clearance View**

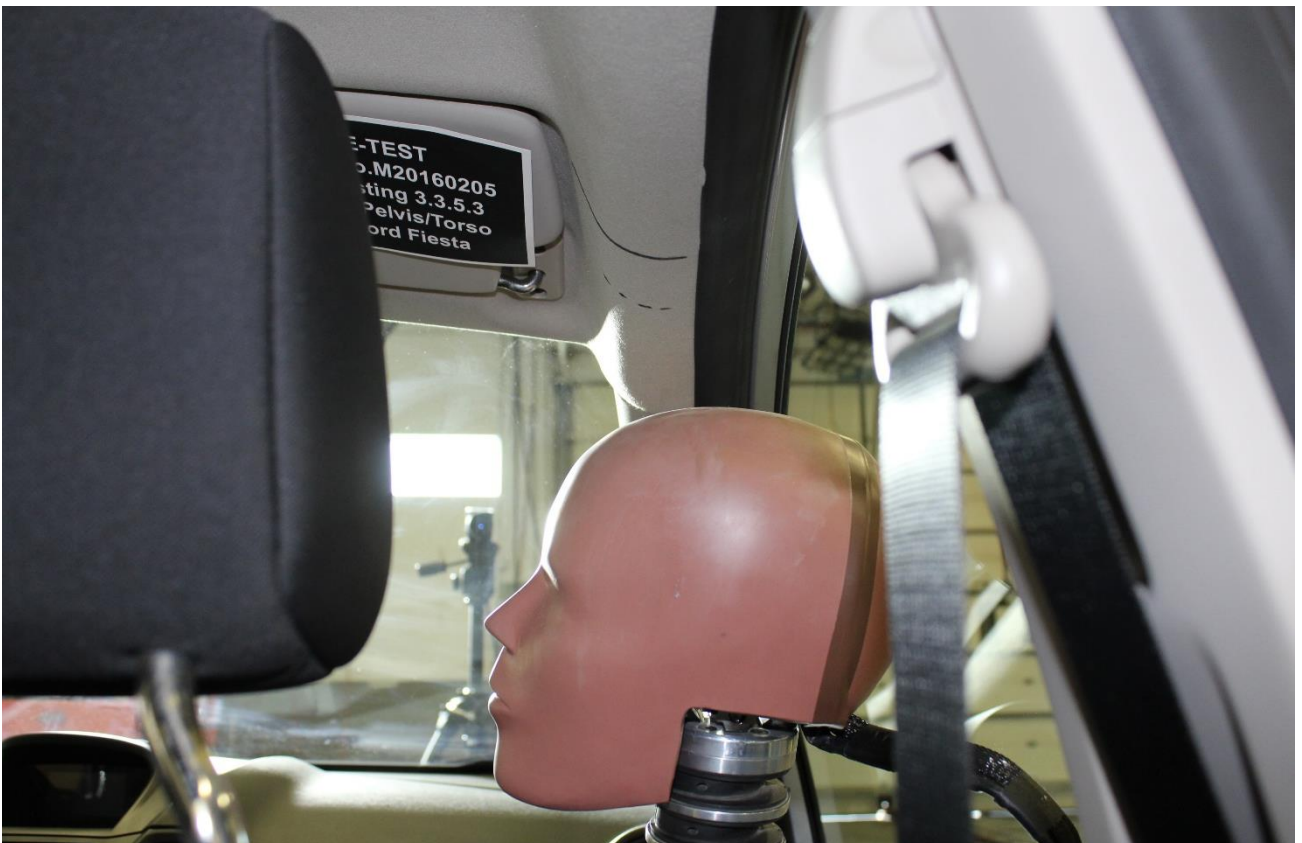
**Figure A-16: Pre-Test SID-IIs 5th Female Rear Clearance View**

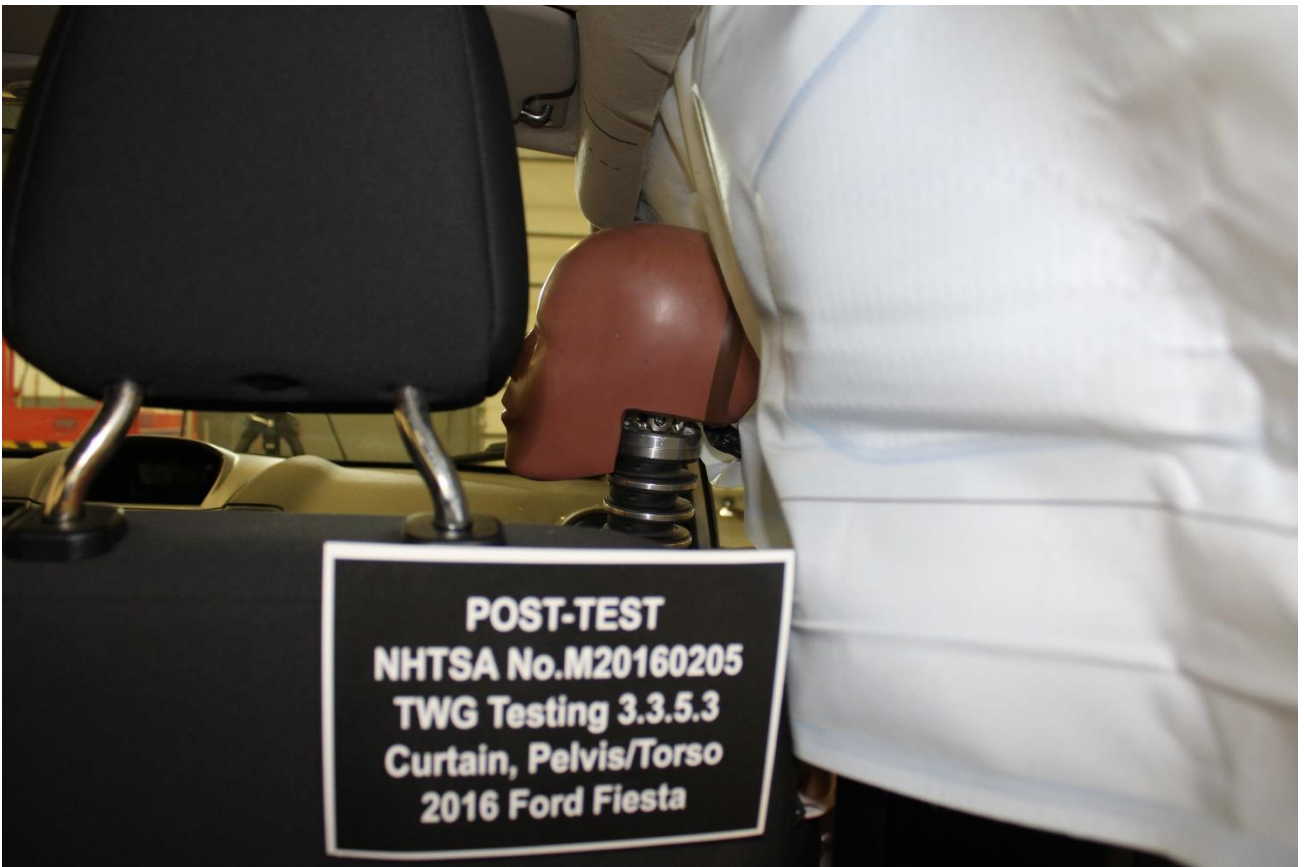
**Figure A-17: Post-Test SID-IIs 5th Female Rear Clearance View**

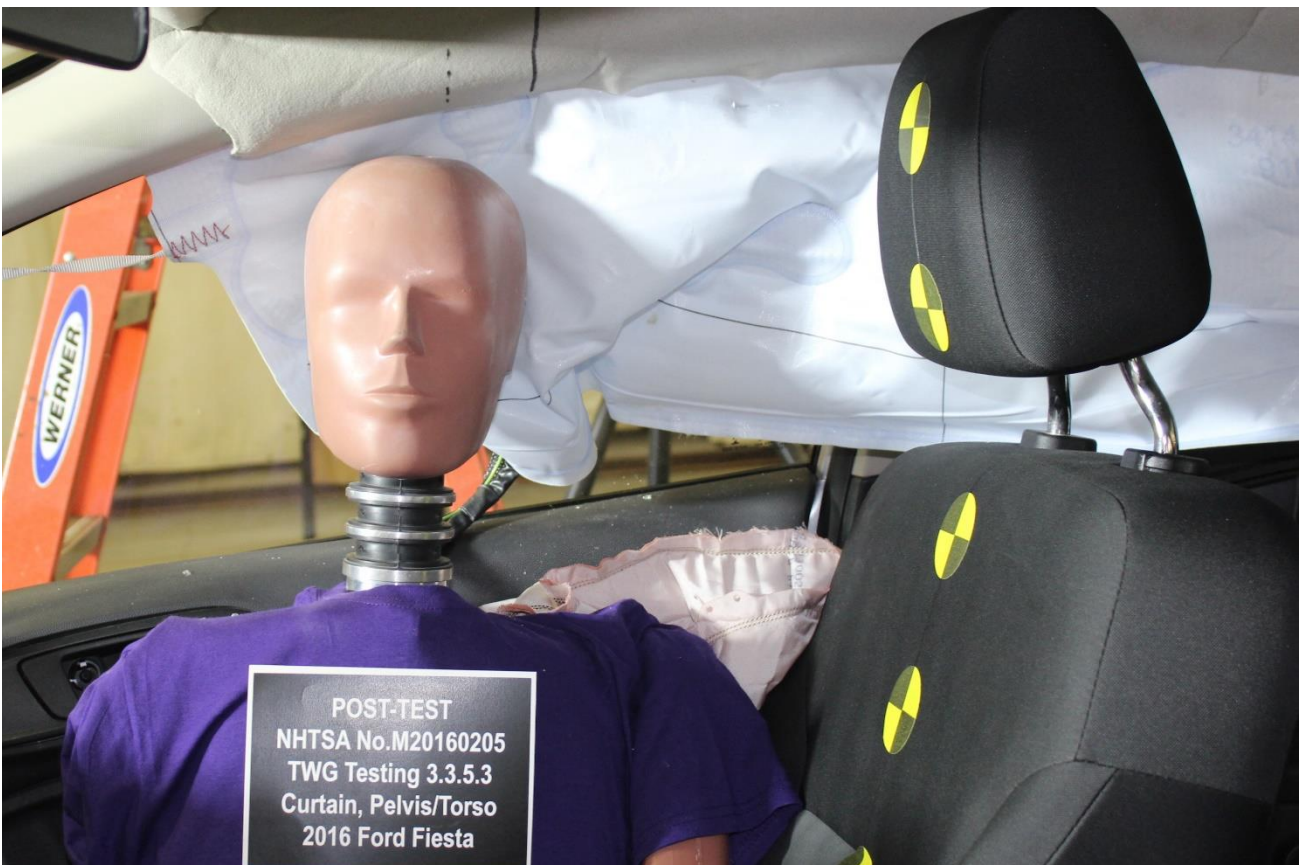
**Figure A-18: Post-Test Curtain Airbag Left Side View**

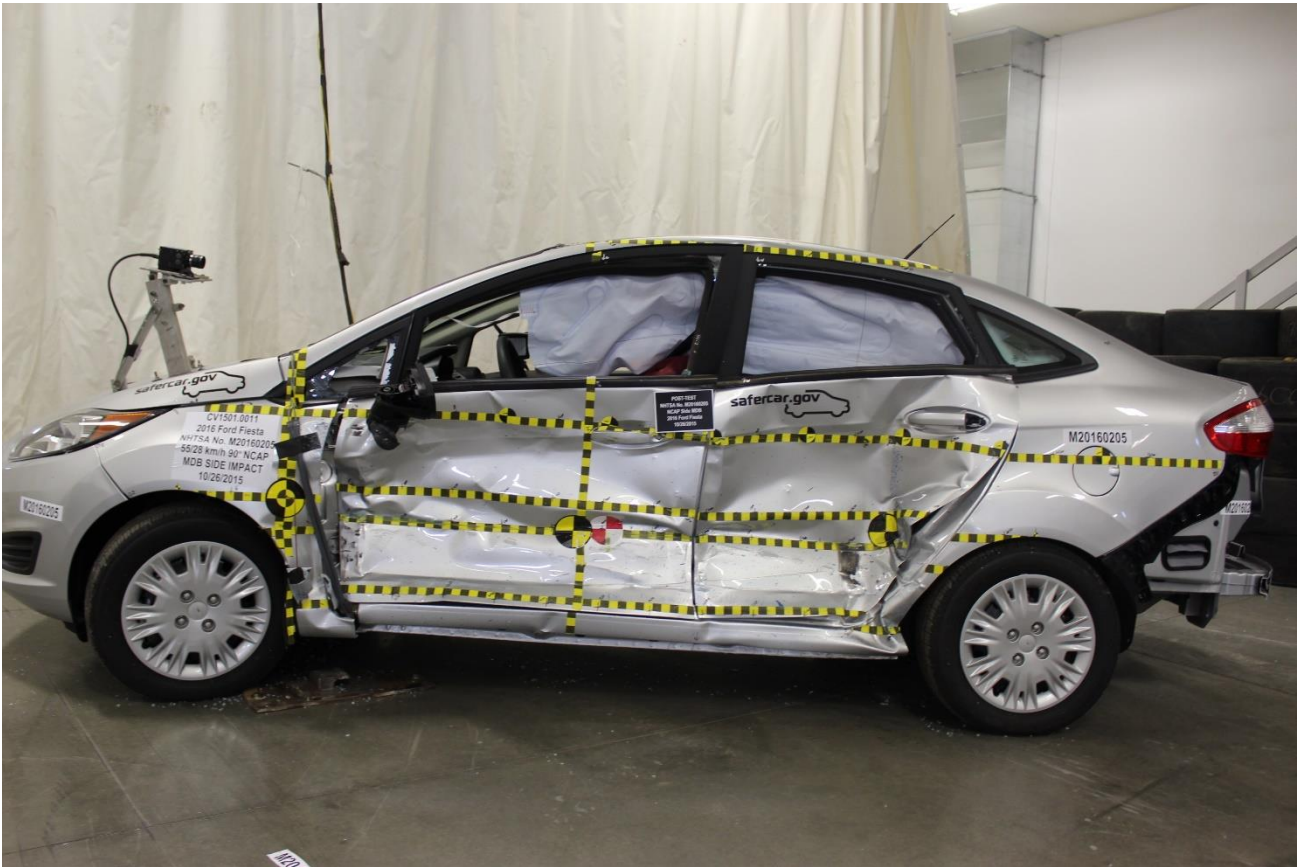
**Figure A-19: Post SNCAP Left Side View**

‡Vehicle had previously undergone a New Car Assessment Program Side NCAP Test.
