**REPORT NUMBER: SPNCAP-MGA-2017-005**

**NEW CAR ASSESSMENT PROGRAM (NCAP)  
Side Impact Pole Test**

**FORD MOTOR CO.  
2017 Ford Fusion SE 4-Door Sedan  
NHTSA No.: M20170202**

**MGA RESEARCH CORPORATION  
5000 Warren Road  
Burlington, WI 53105**

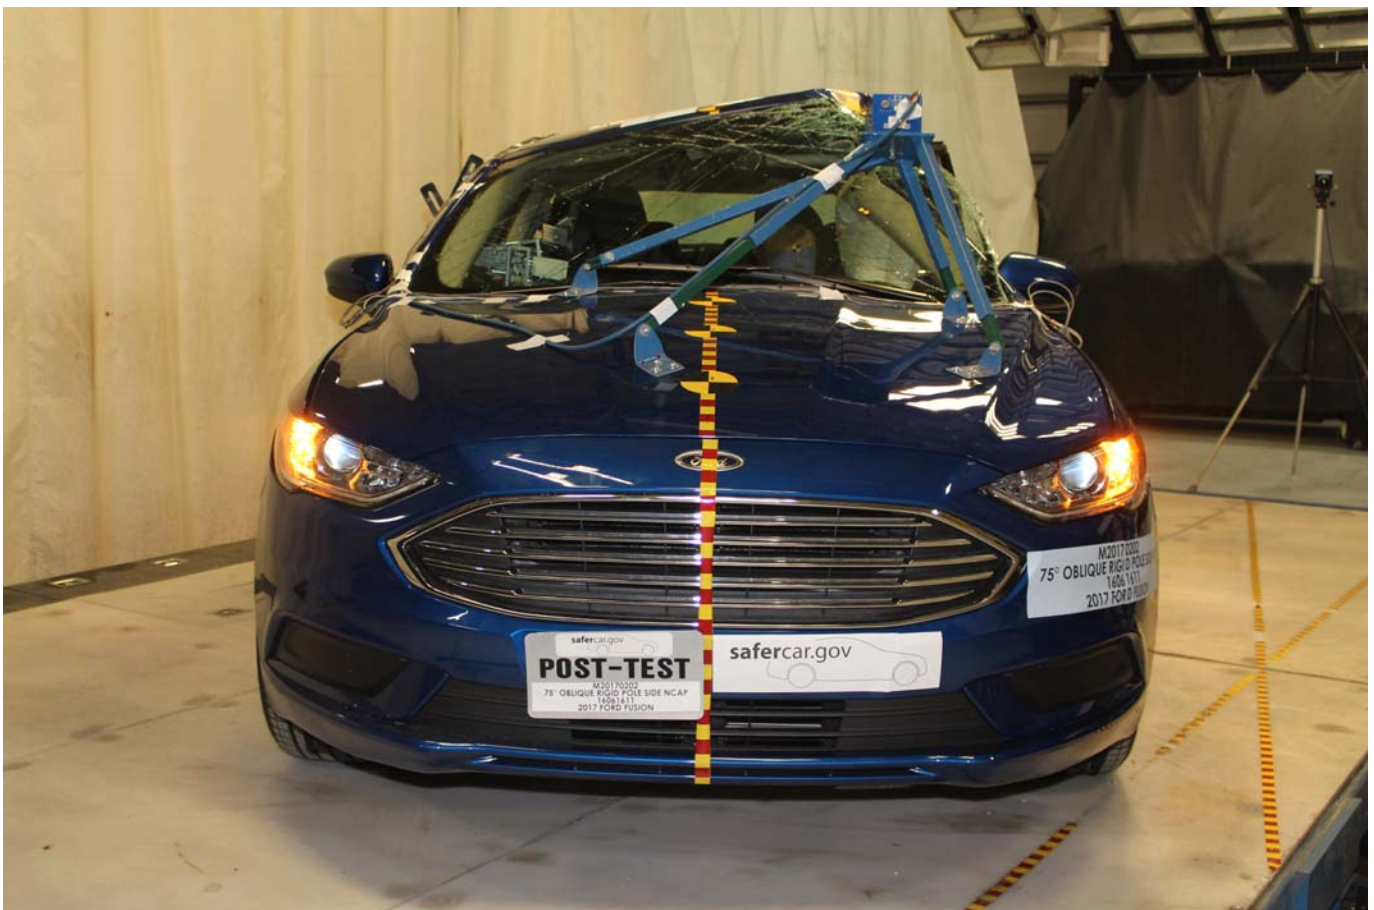
Photo No. 004 - Post-Test Frontal View of Test Vehicle

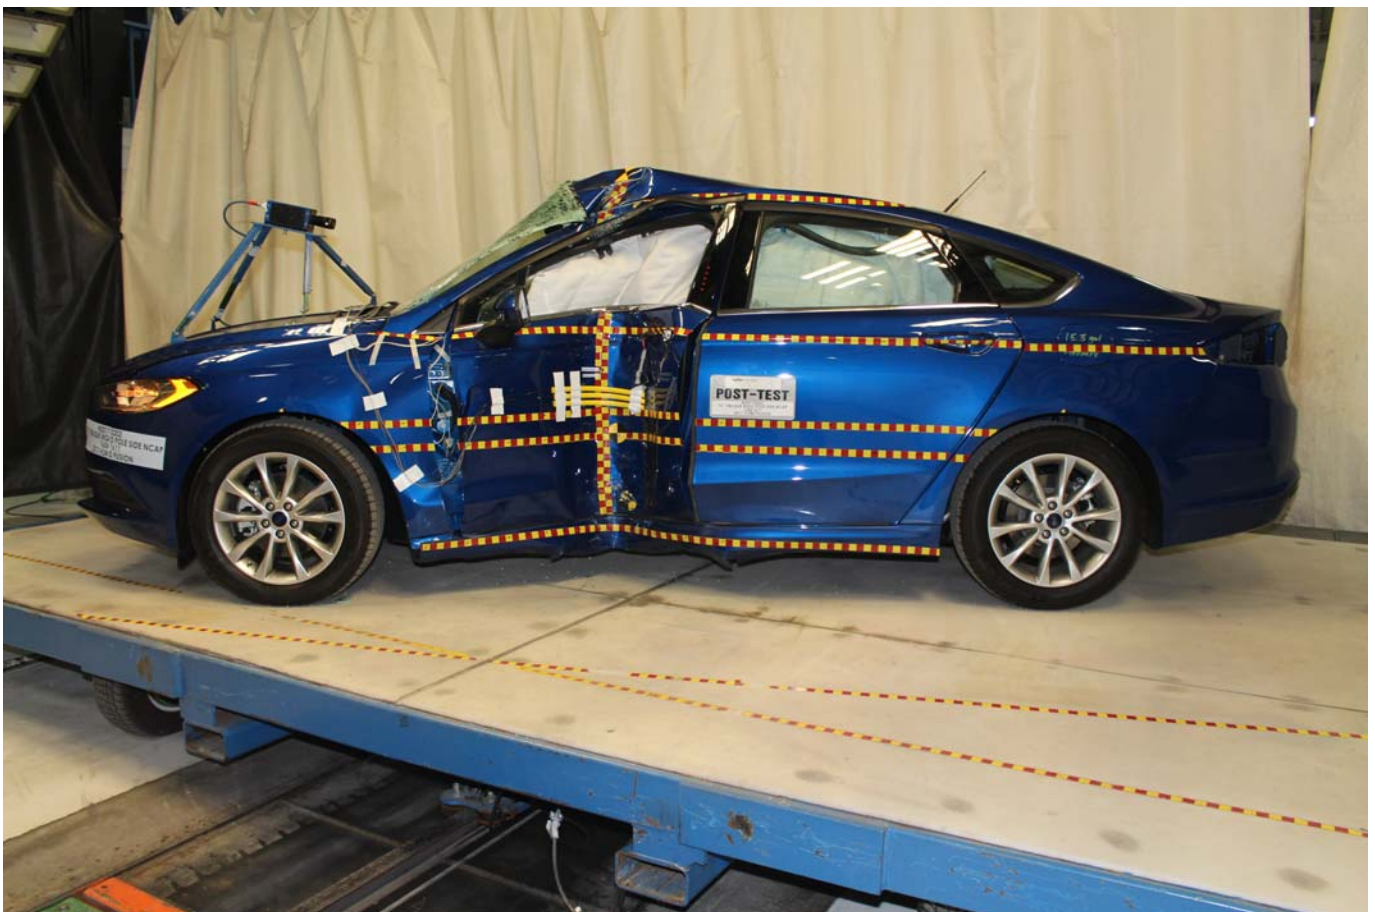
Photo No. 008 - Post-Test Left Side View of Test Vehicle

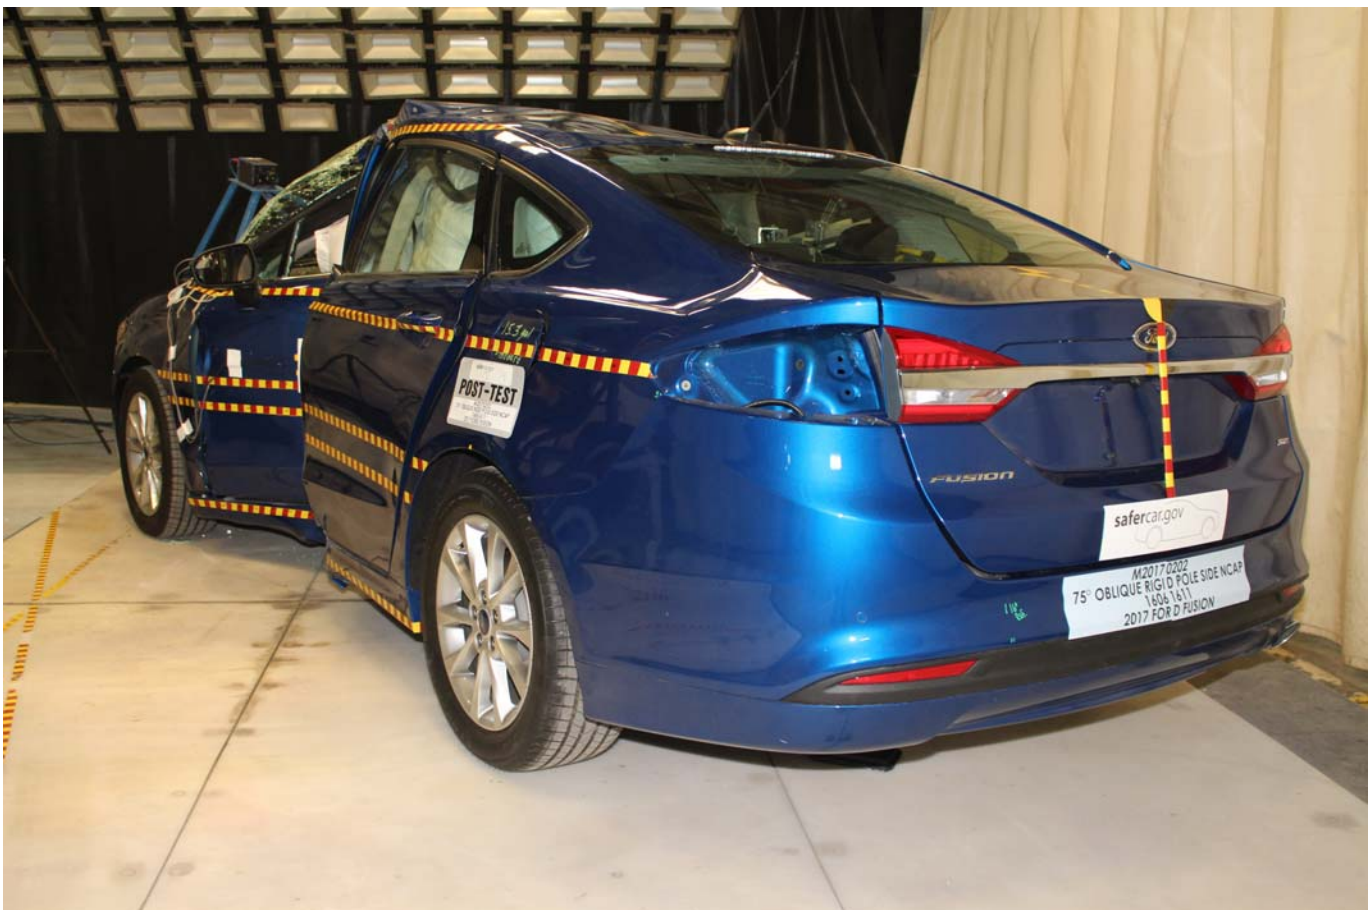
Photo No. 010 - Post-Test Left Rear  $\frac{3}{4}$  View of Test Vehicle

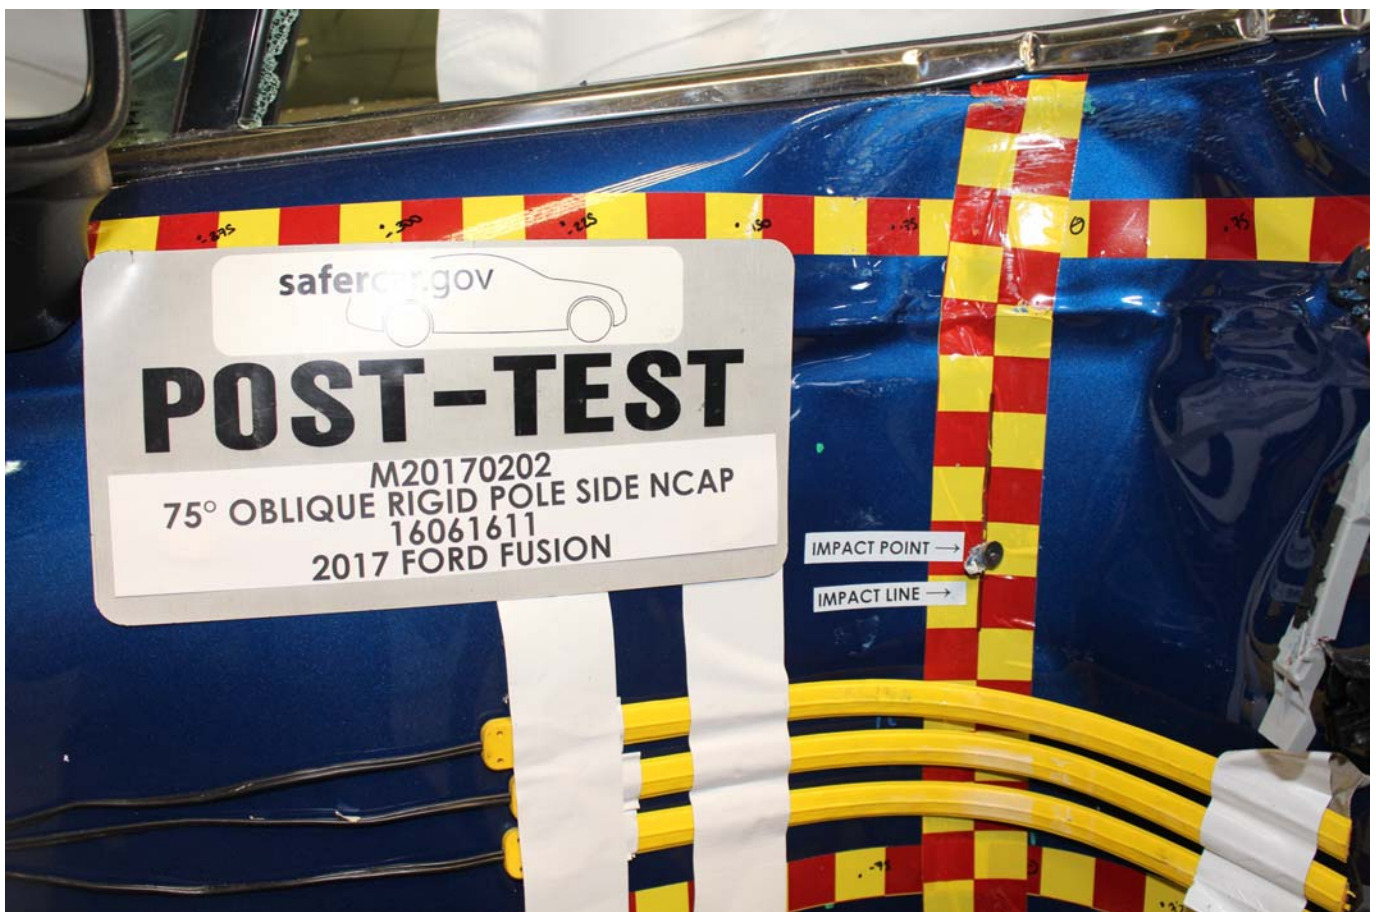
Photo No. 020 - Post-Test Close-Up View of Impact Point Target Showing Impact Location

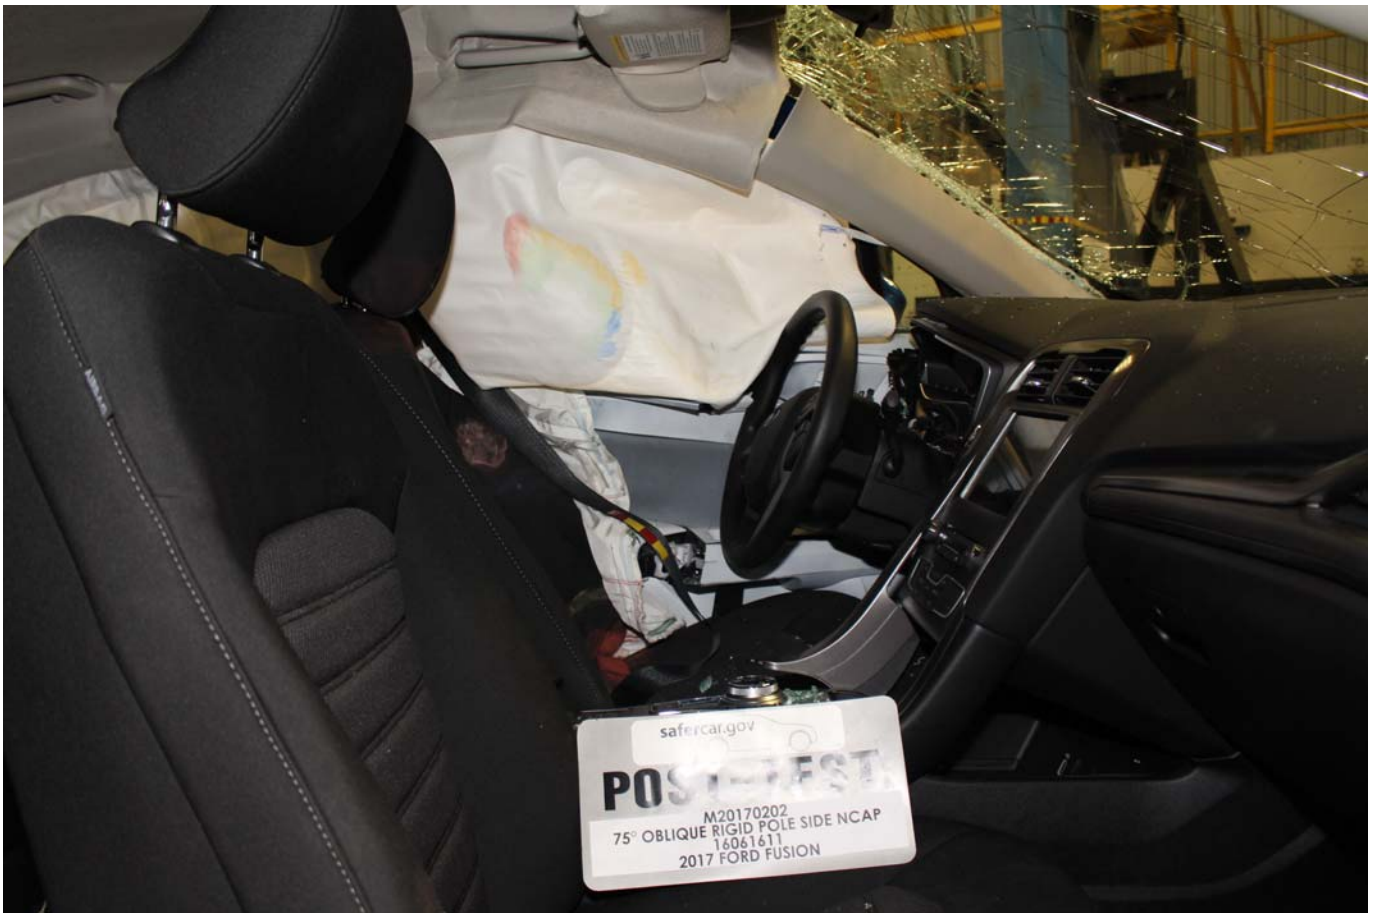
Photo No. 045 - Post-Test Inner Door Panel View Showing Dummy Contact Location

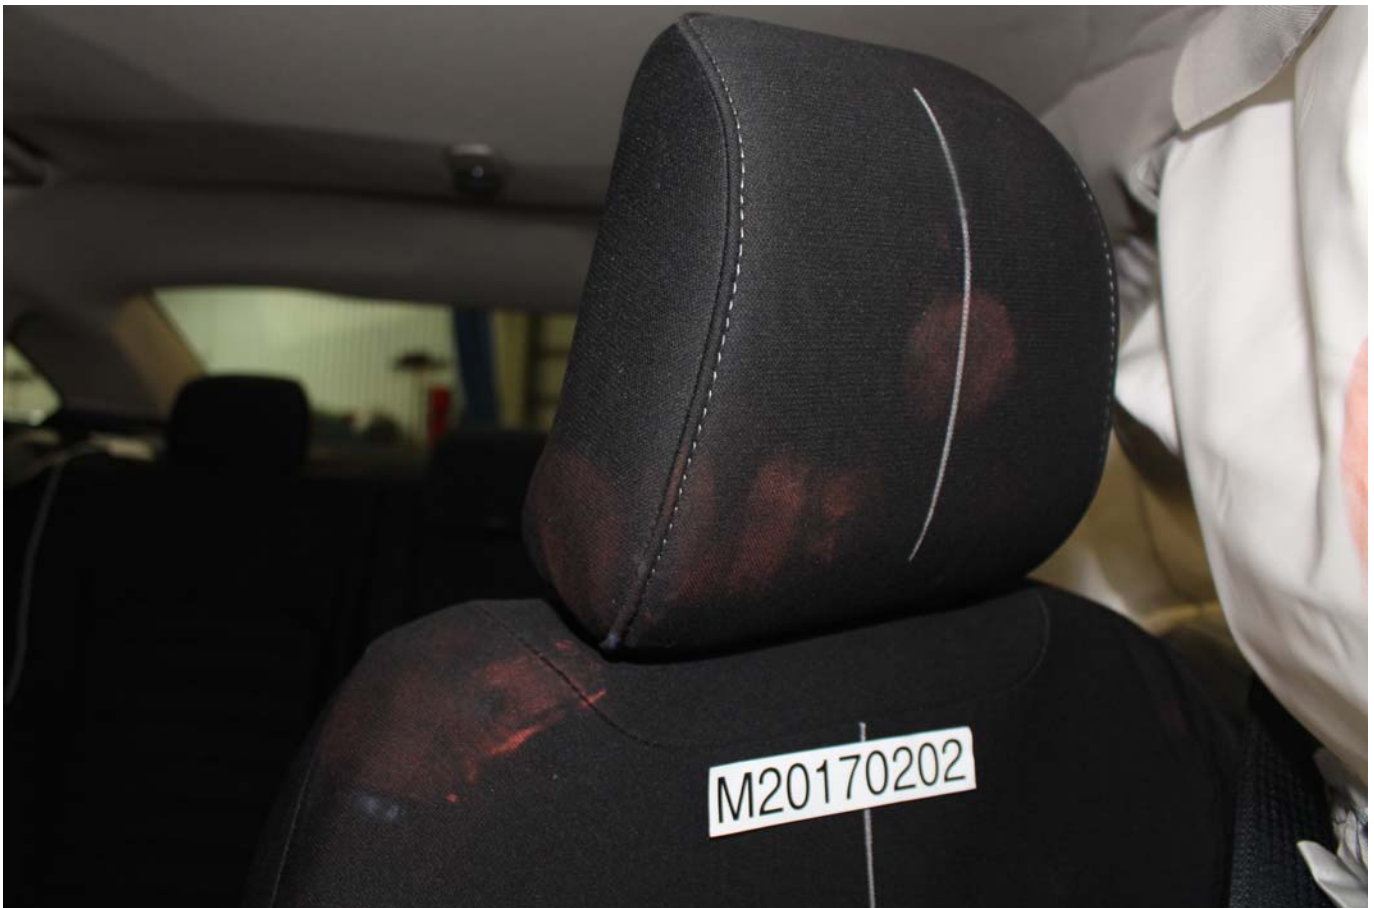
Photo No. 046 - Post-Test Dummy Close-Up Head Contact with Vehicle Interior View

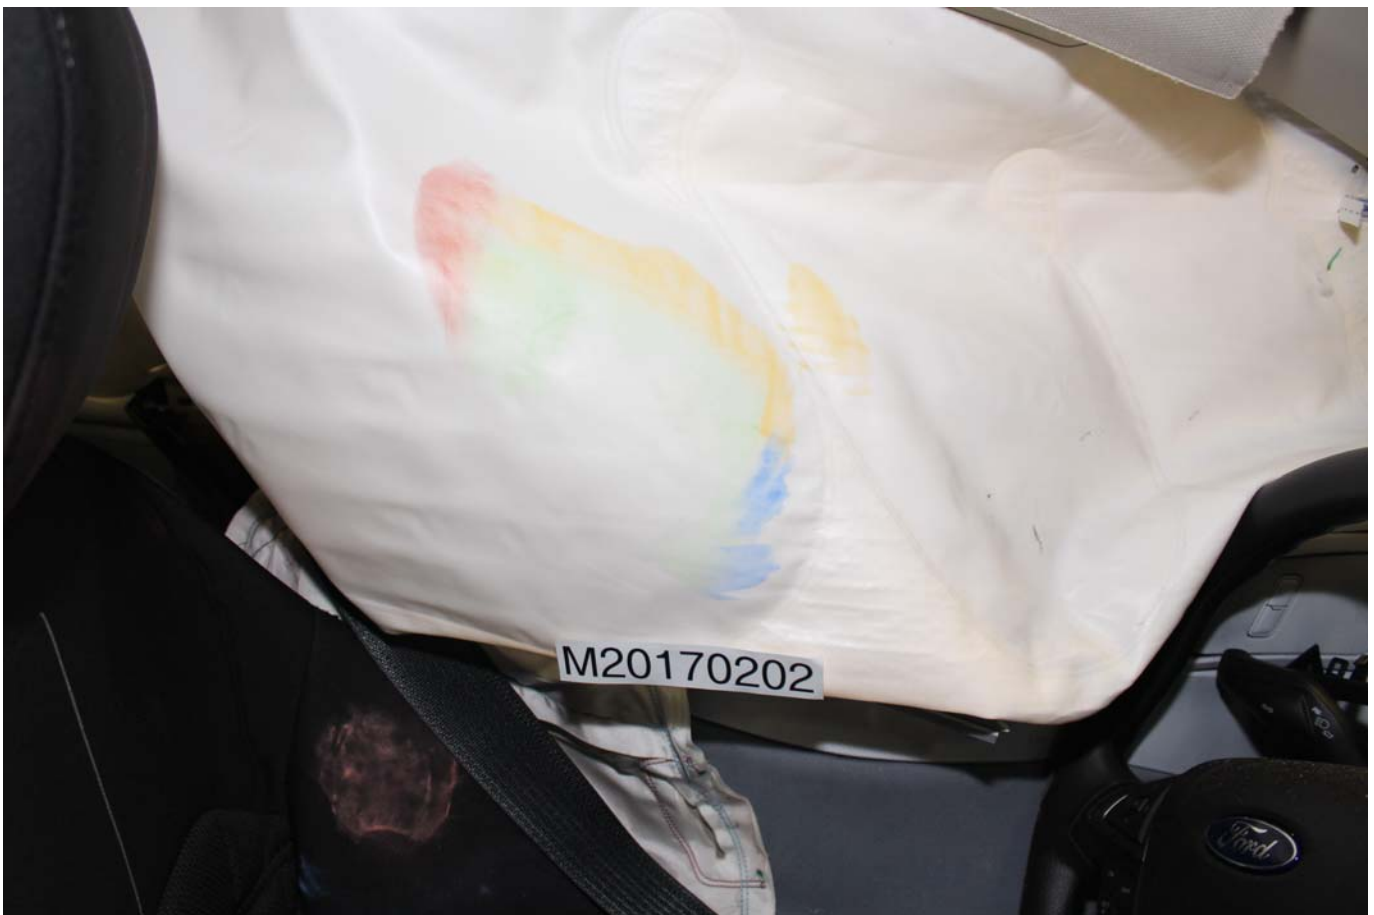
Photo No. 047 - Post-Test Dummy Close-Up Head Contact with Side Air Bag View

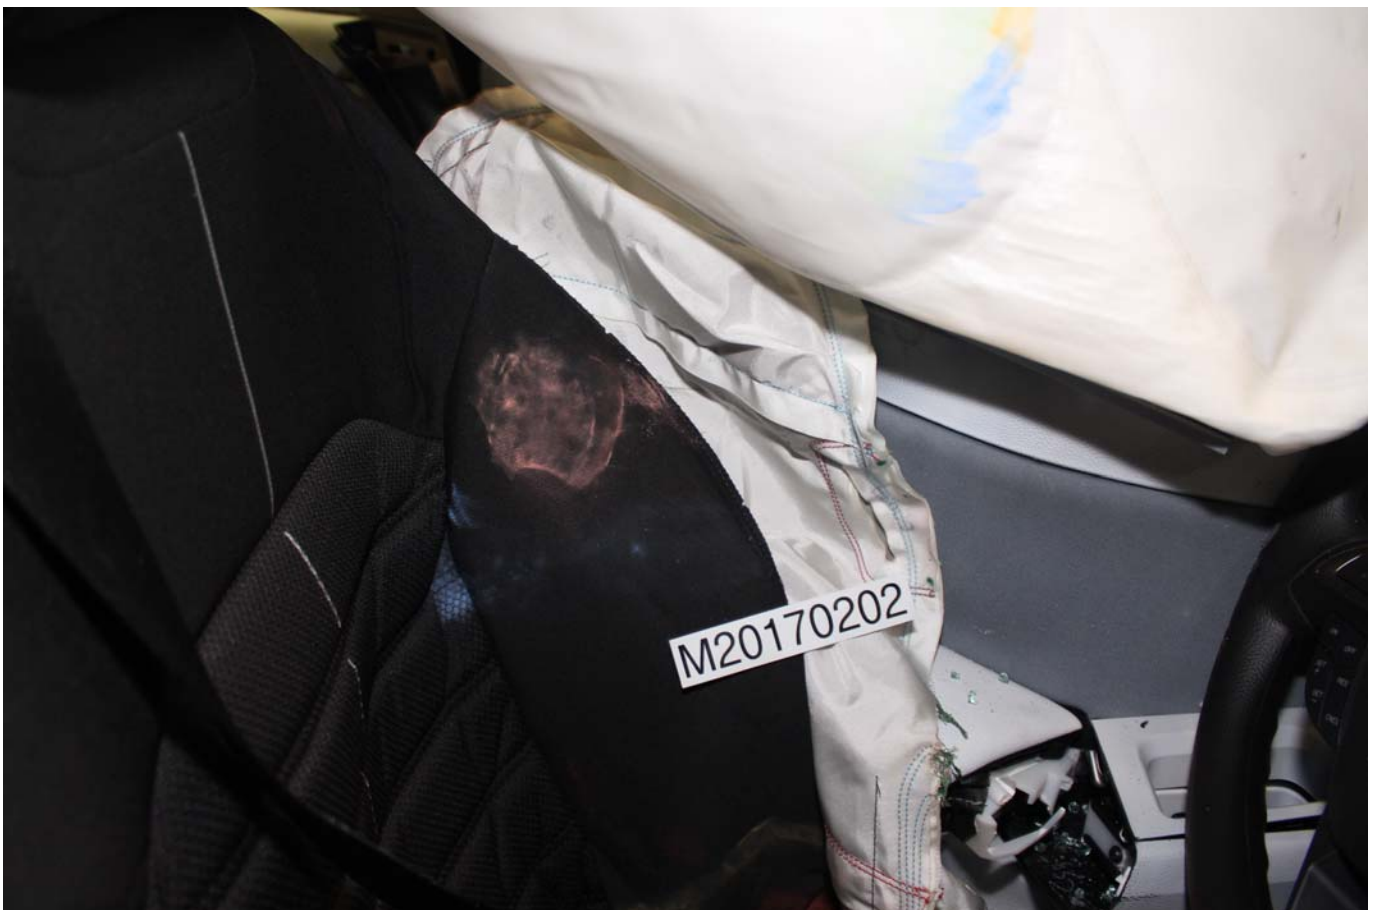
Photo No. 048 - Post-Test Dummy Close-Up Torso Contact with Vehicle Interior View

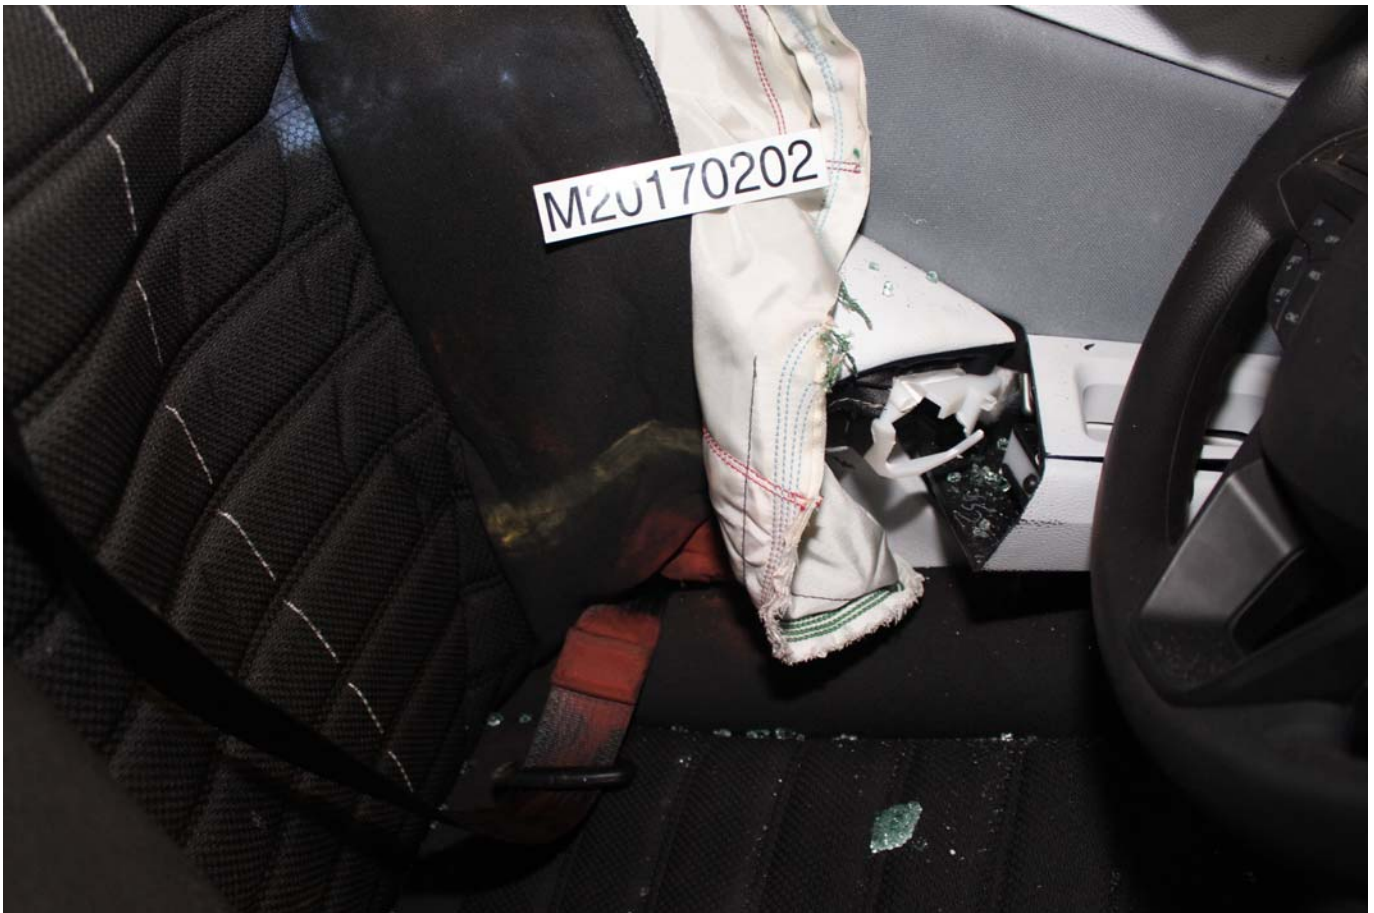
Photo No. 049 - Post-Test Dummy Close-Up Torso Contact with Side Air Bag View

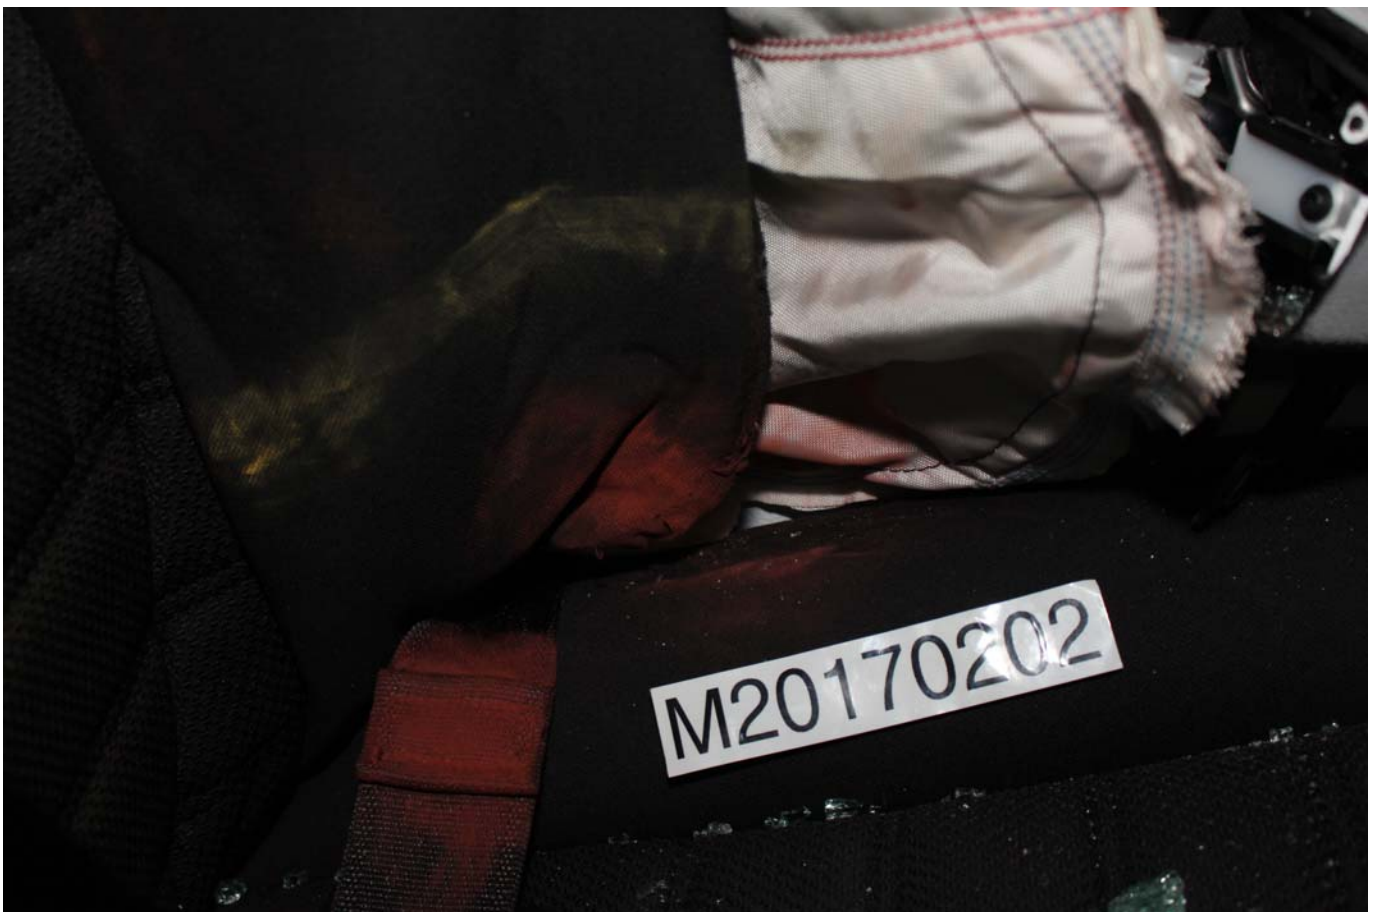
Photo No. 050 - Post-Test Dummy Close-Up Pelvis Contact with Vehicle Interior View

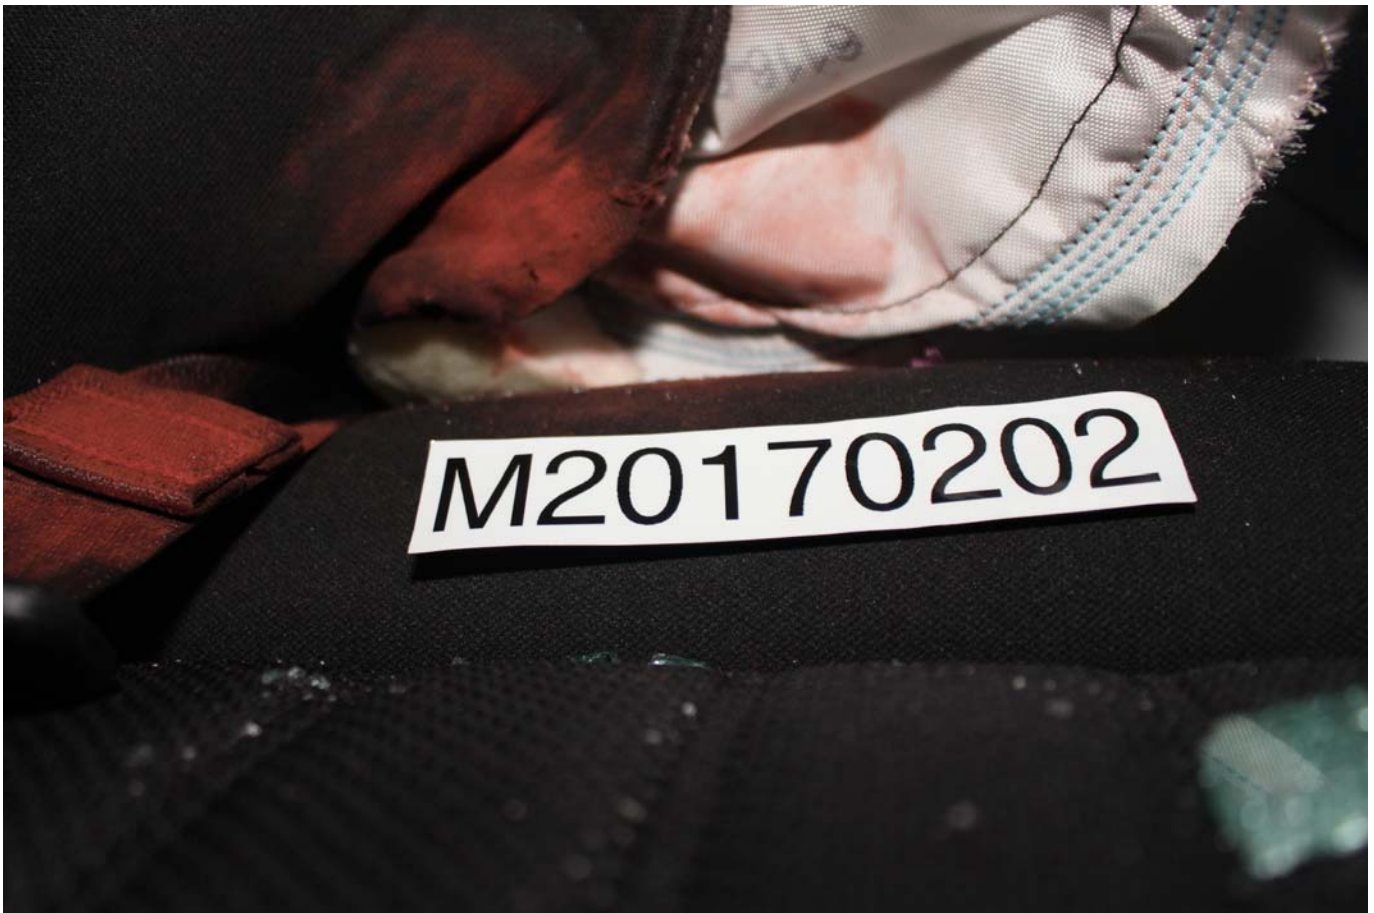
Photo No. 051 - Post-Test Dummy Close-Up Pelvis Contact with Side Air Bag View

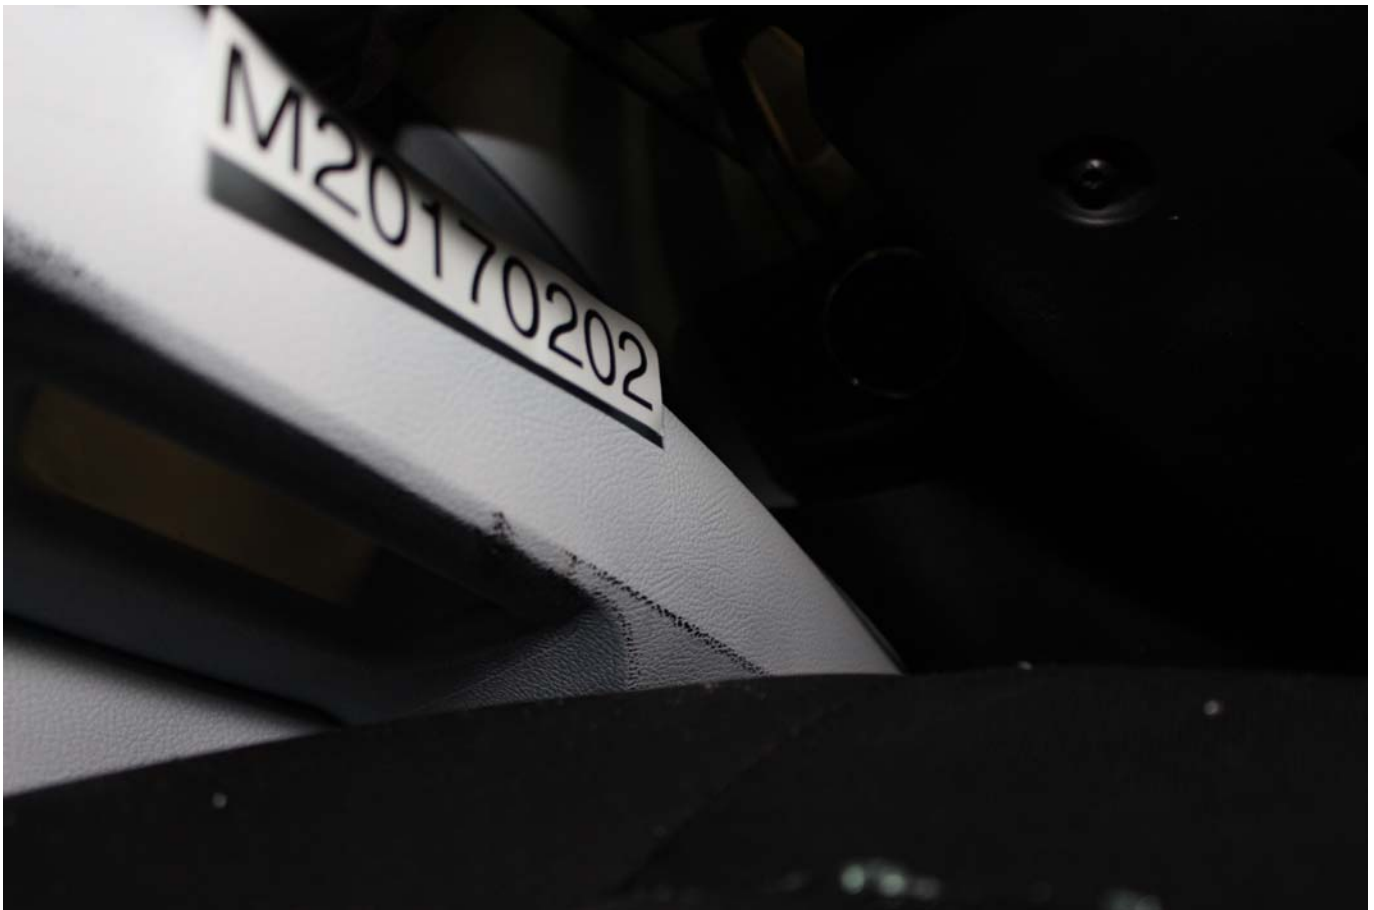
Photo No. 052 - Post-Test Dummy Close-Up Knee Contact with Vehicle Interior View

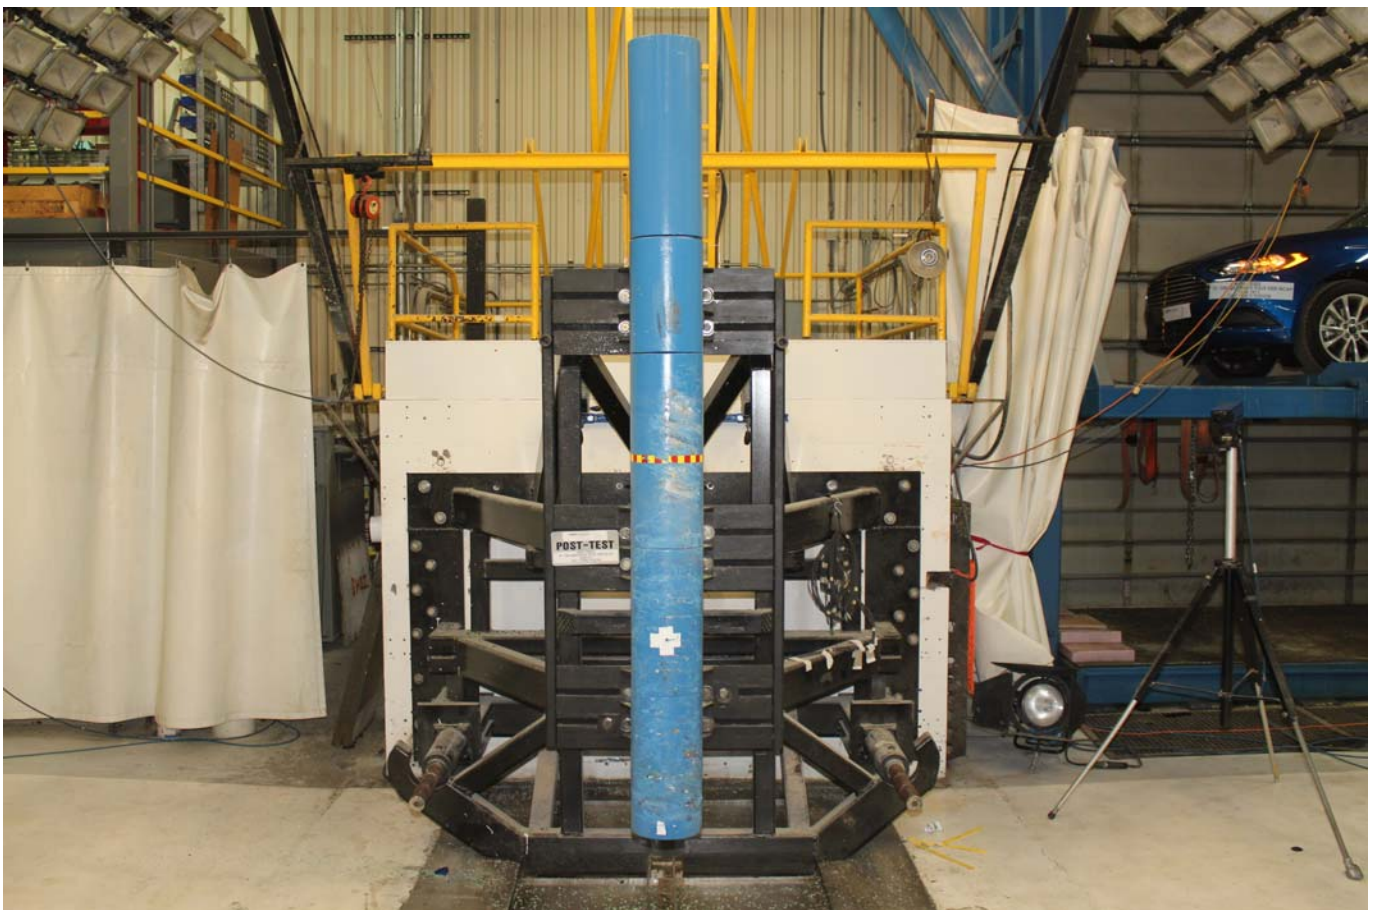
Photo No. 058 - Post-Test Pole Barrier Front View

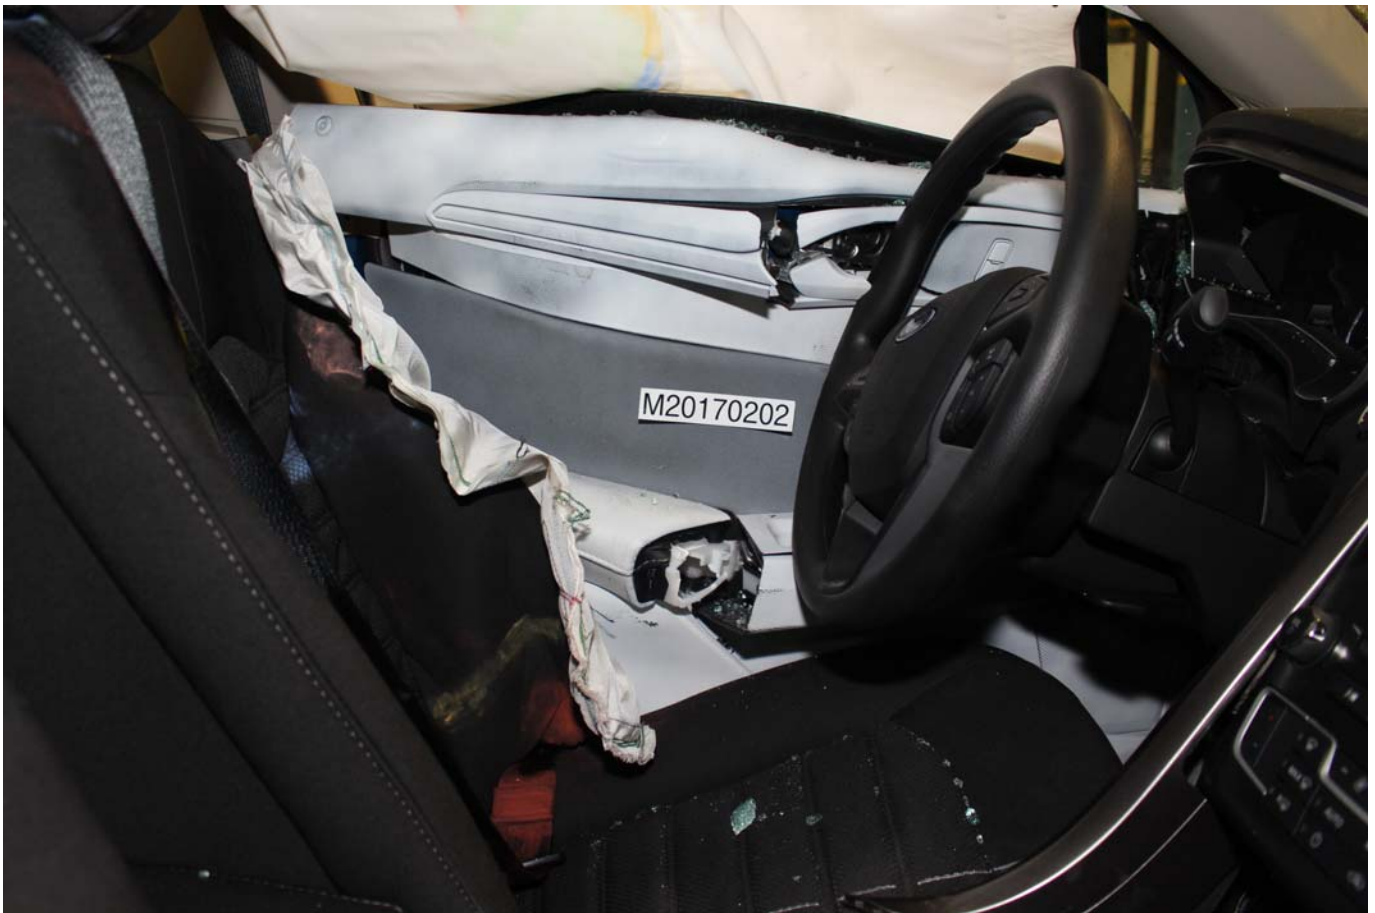
Photo No. 071 - Post-Test View of Shattered Vehicle Inner Door Panel
