**REPORT NUMBER: SINCAP-MGA-2017-006**

**NEW CAR ASSESSMENT PROGRAM (NCAP)  
Moving Deformable Barrier Side Impact Test**

**FORD MOTOR CO.  
2017 Ford Fusion SE 4-Door Sedan  
NHTSA No.: M20170203**

**MGA RESEARCH CORPORATION  
5000 Warren Road  
Burlington, WI 53105**

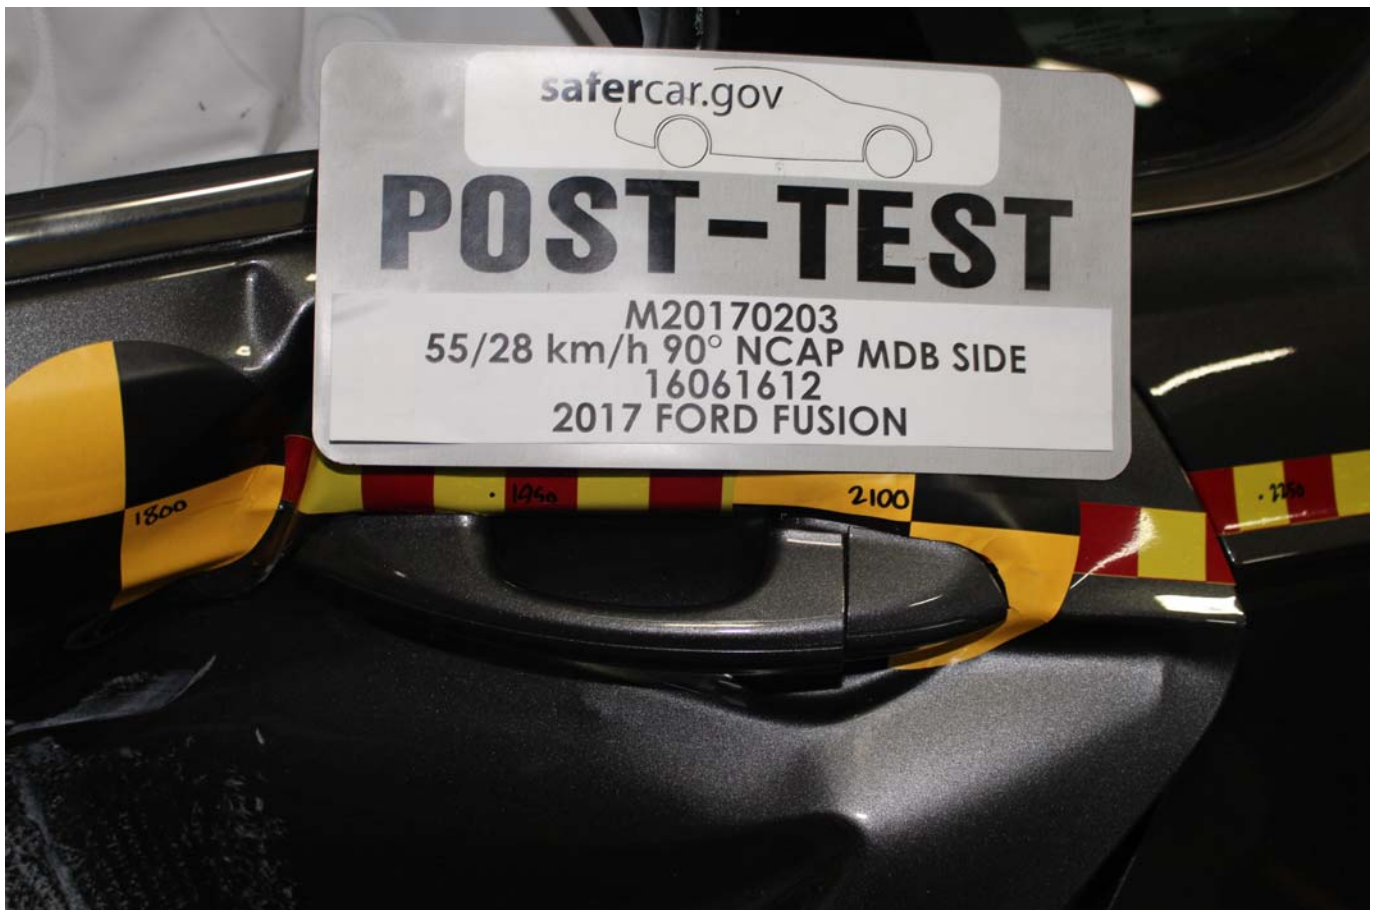
Photo No. 024 - Post-Test Left Rear Door Latch Close-Up

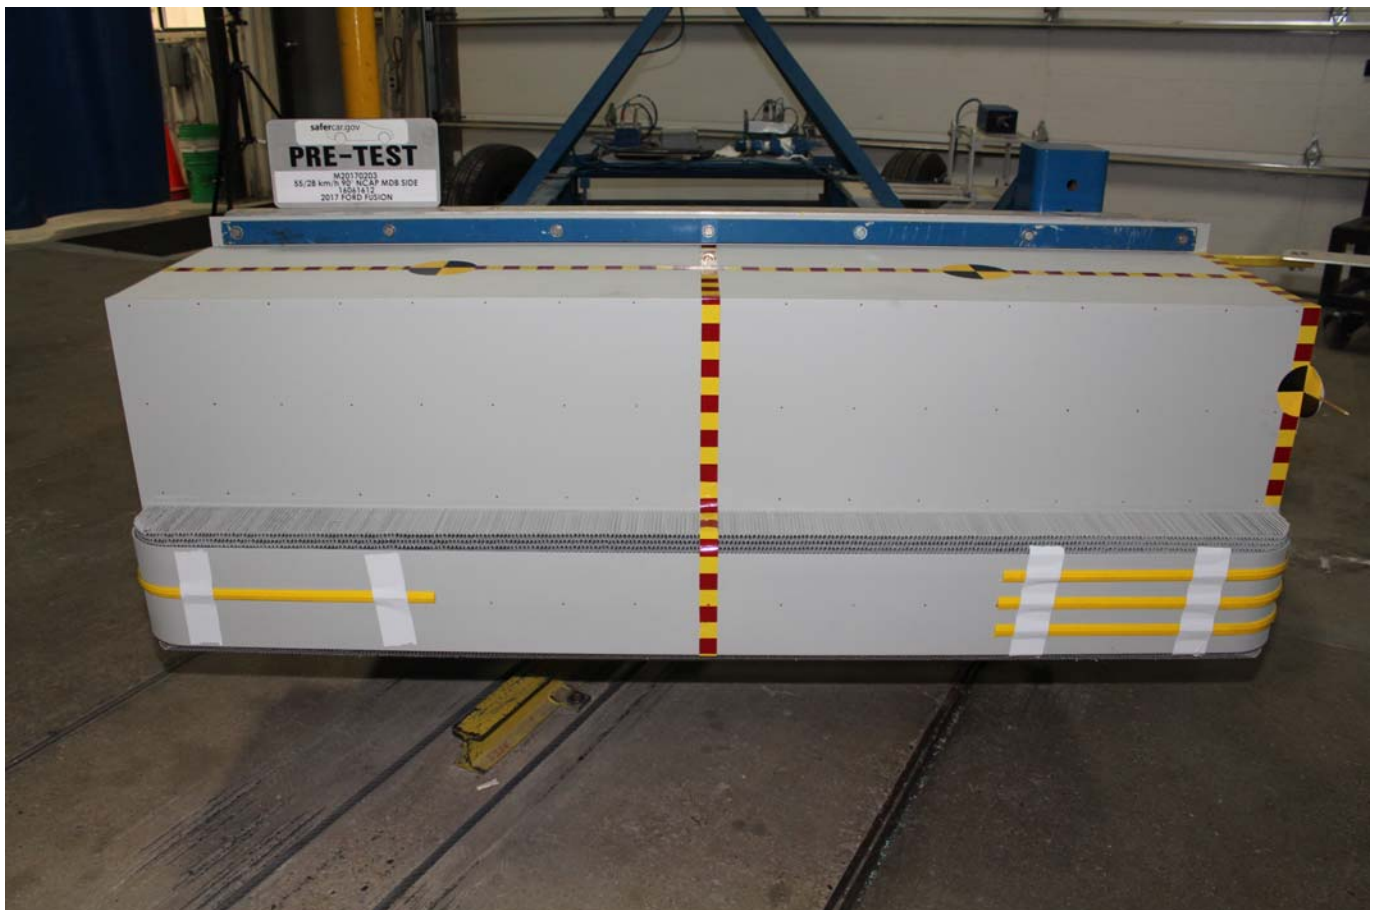
Photo No. 084 - Pre-Test Front View of MDB Impactor Face
