**FINAL REPORT NUMBER: SPNCAP-TRC-16-007**

**NEW CAR ASSESSMENT PROGRAM (NCAP)  
SIDE IMPACT POLE TEST**

**General Motors LLC  
2016 Chevrolet Cruze  
NHTSA NUMBER: M20160104**

**PREPARED BY:  
Transportation Research Center Inc.  
10820 State Route 347  
P. O. Box B-67  
East Liberty, OH 43319**

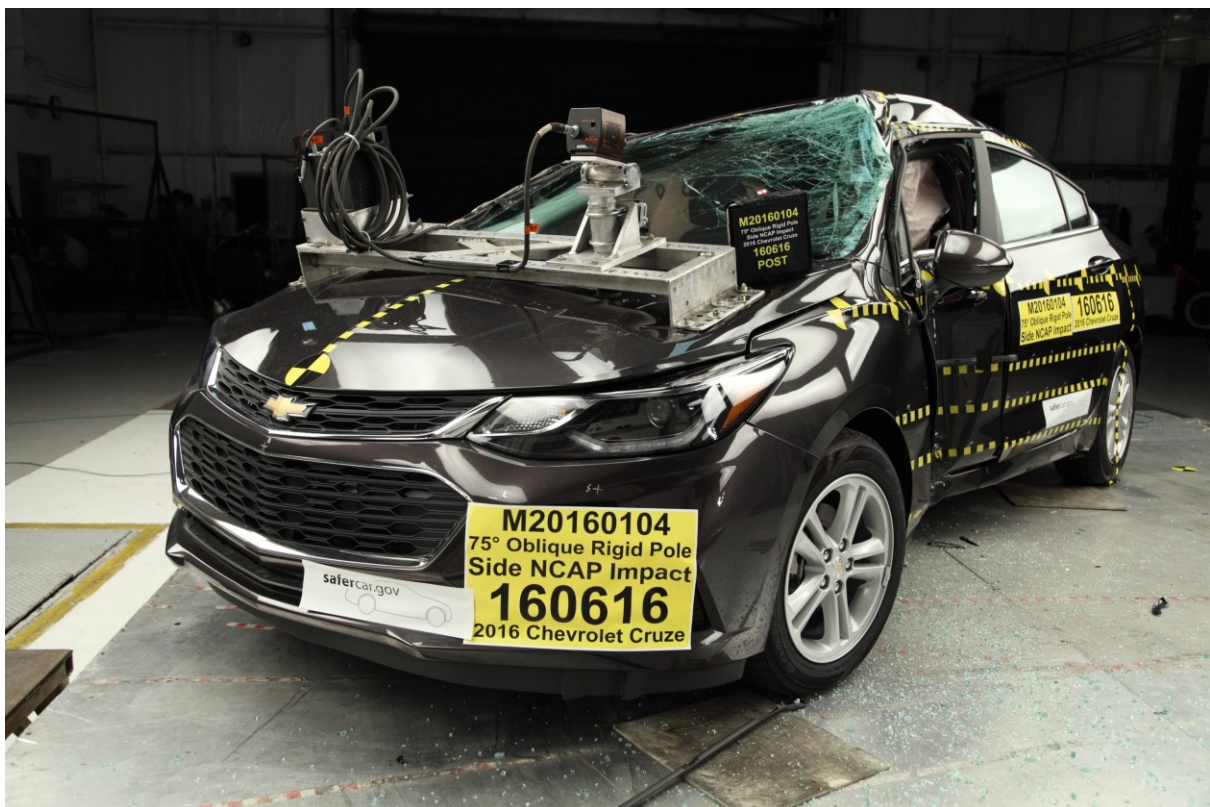
**No. 006 Post-Test Left Front  $\frac{3}{4}$  View of Test Vehicle**

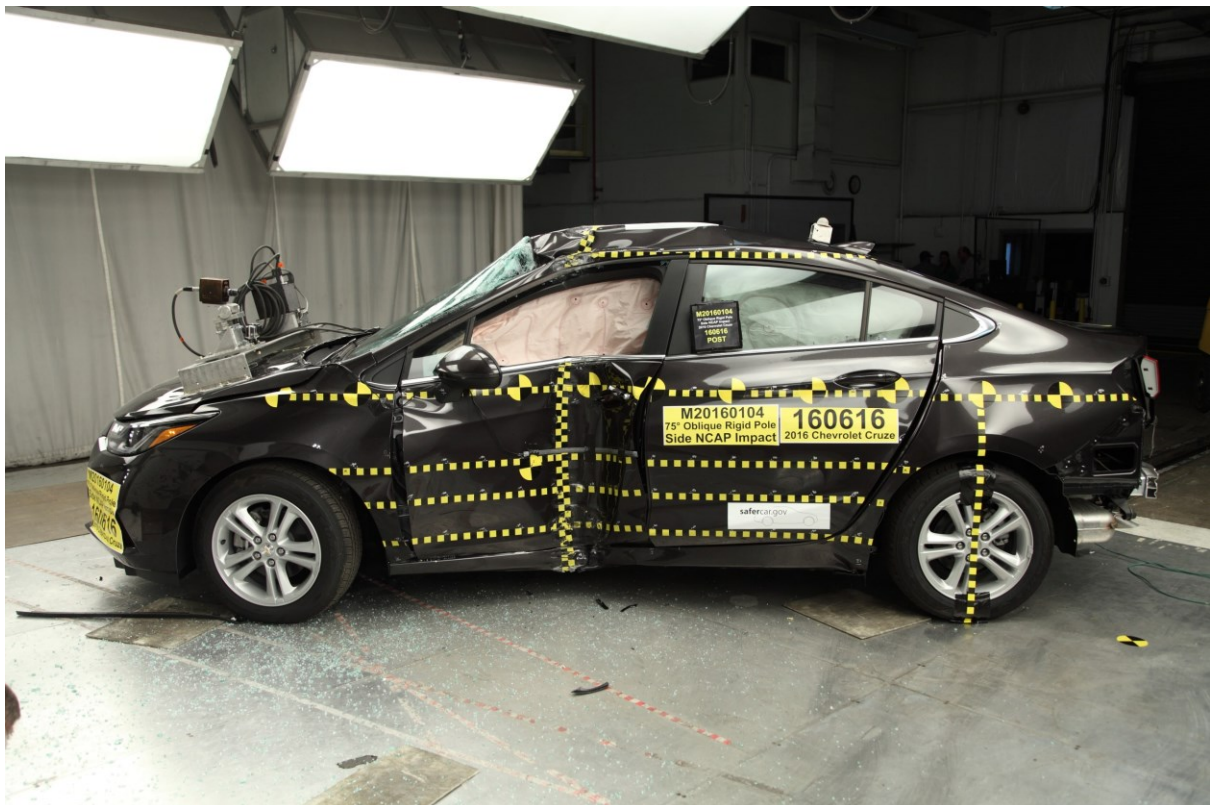
**No. 008 Post-Test Left Side View of Test Vehicle**

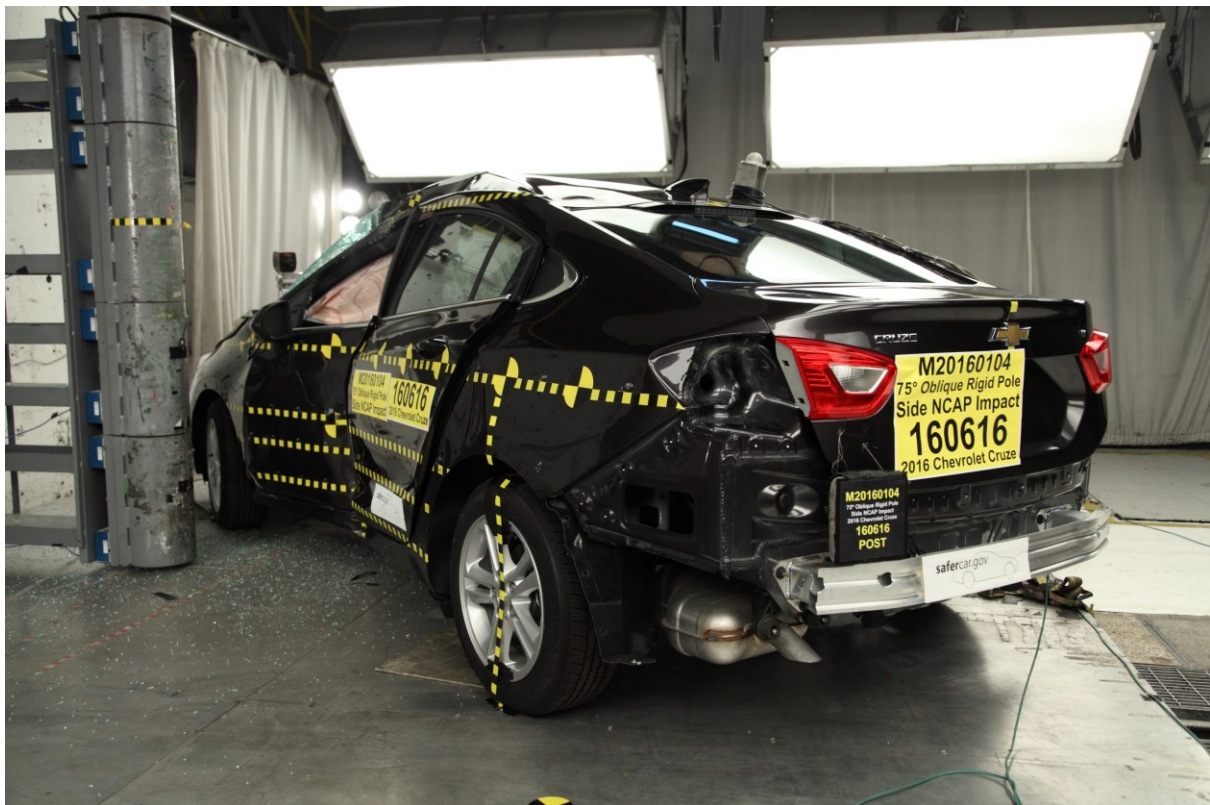
**No. 010 Post-Test Left Rear  $\frac{3}{4}$  View of Test Vehicle**

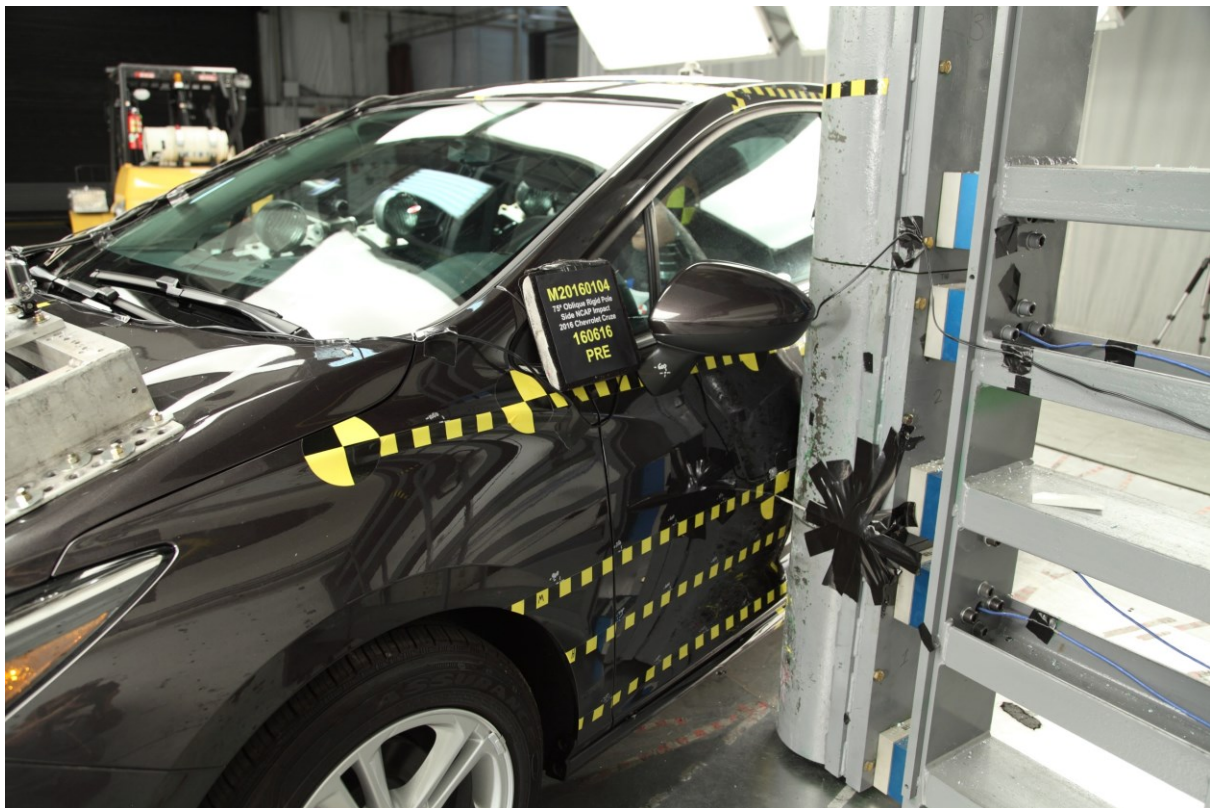
**No. 017 Pre-Test Left Side View of Pole Positioned Against Side of Vehicle**

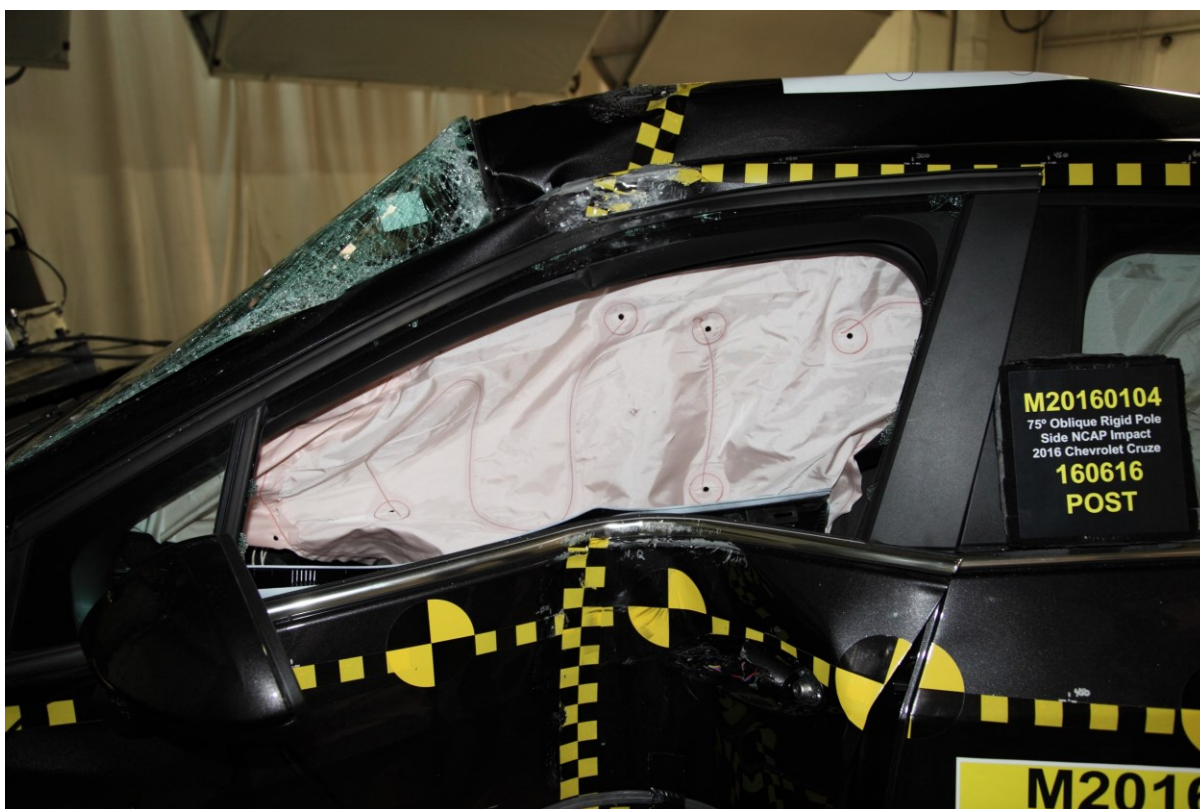
**No. 025 Post-Test Left Side View of Dummy Shoulder and Door Top View**

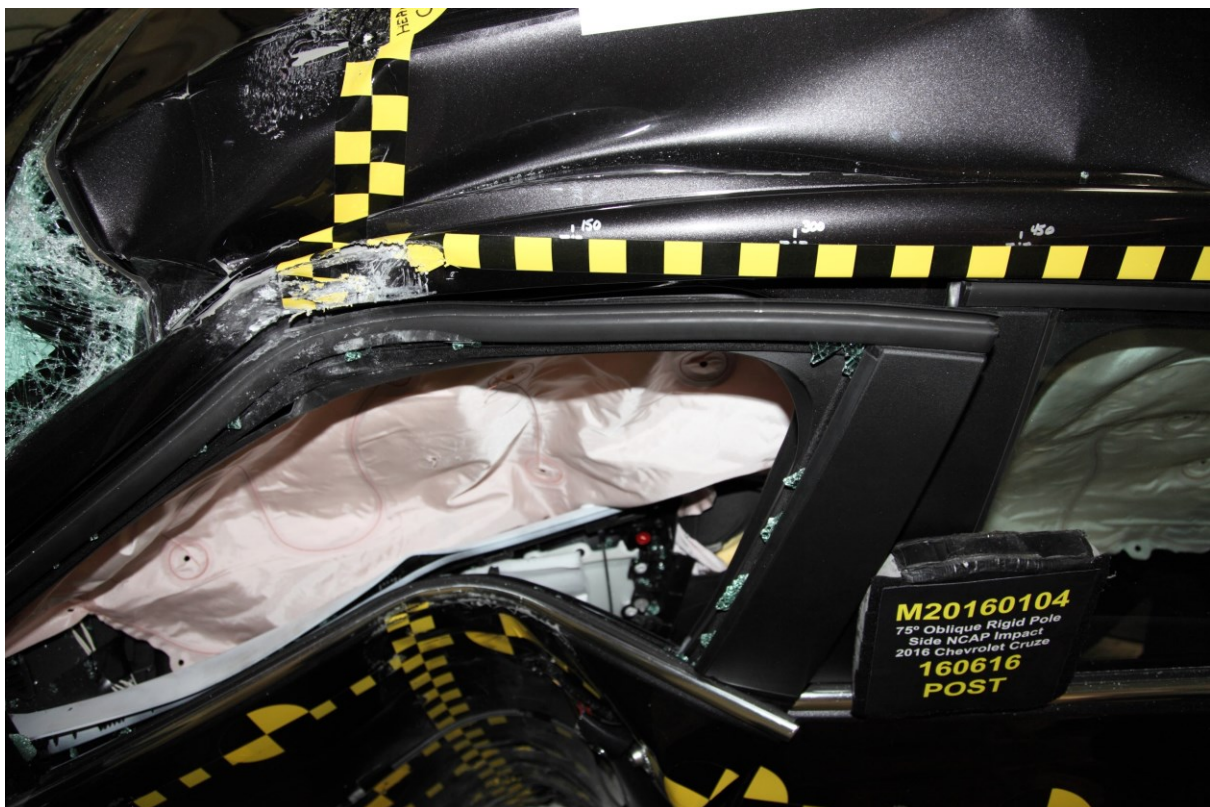
**No. 041 Post-Test Dummy and Door Clearance View**

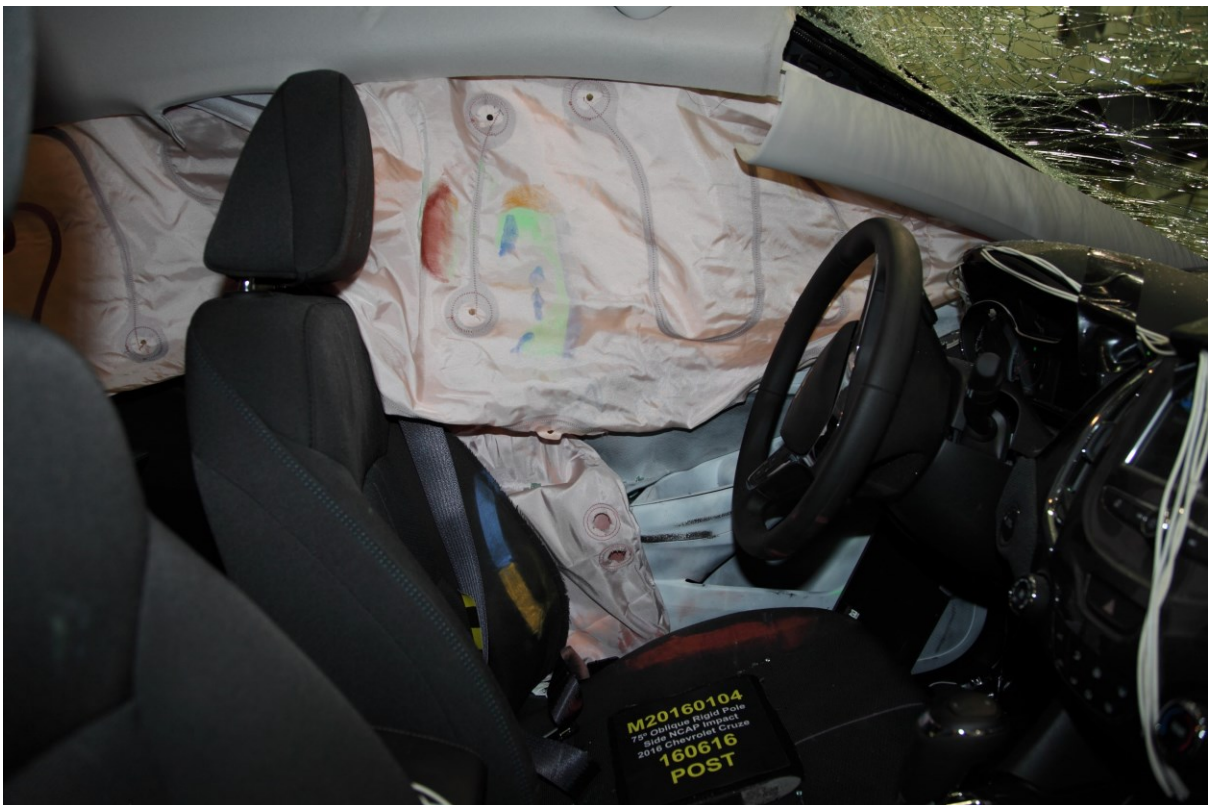
**No. 045 Post-Test Inner Door Panel View**

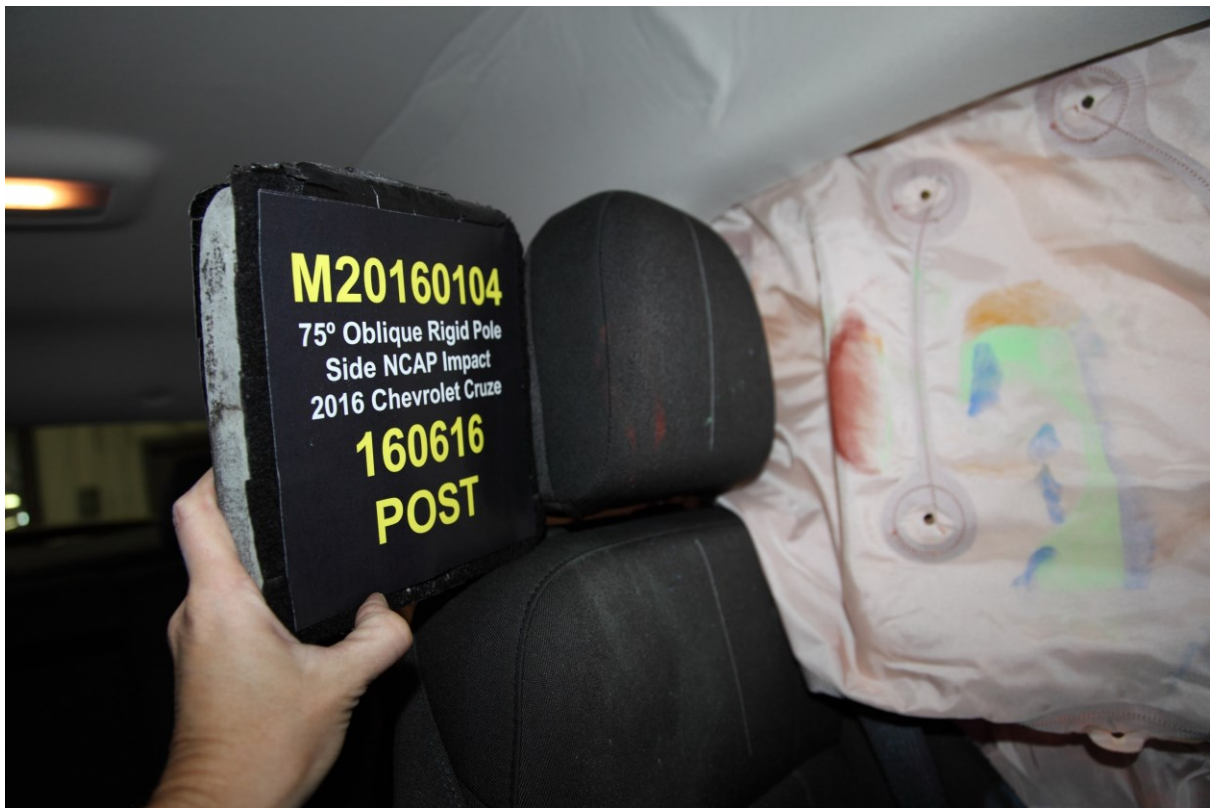
**No. 046 Post-Test Dummy Close-Up Head Contact with Vehicle Interior View**

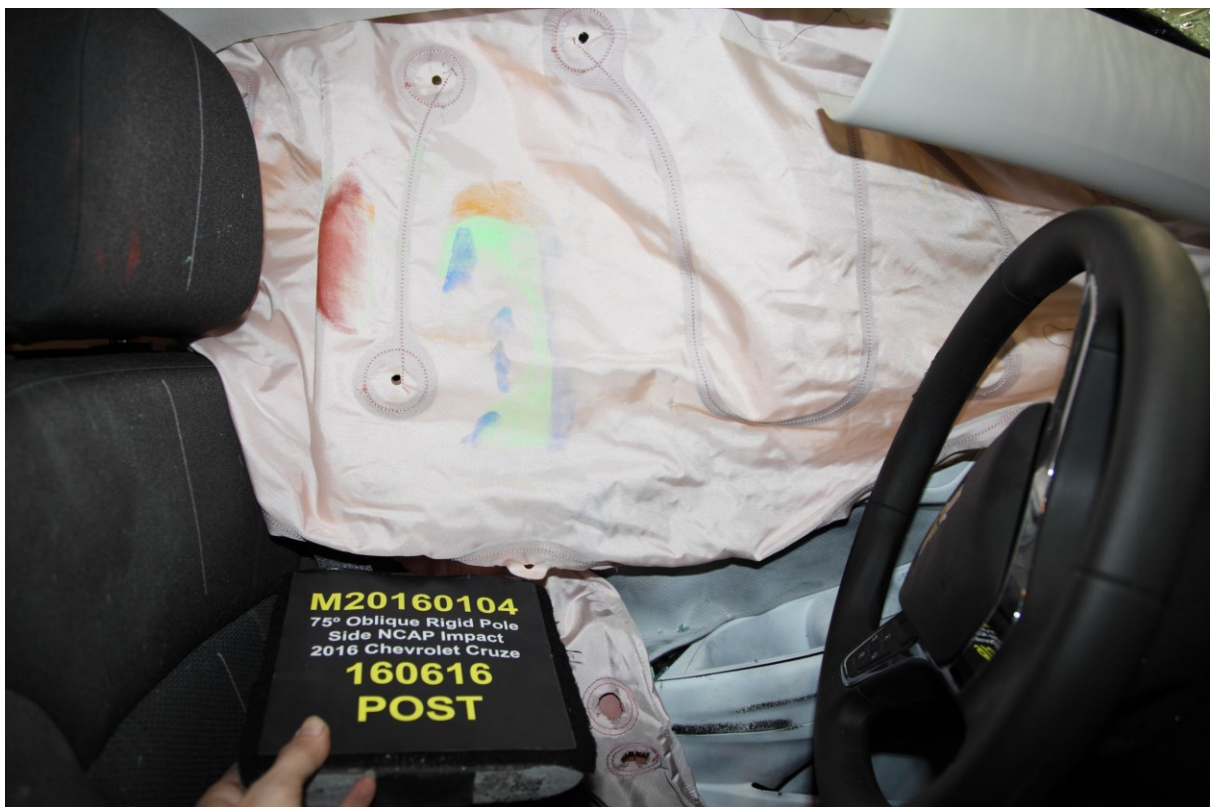
**No. 047 Post-Test Dummy Close-Up Head Contact with Side Airbag View**

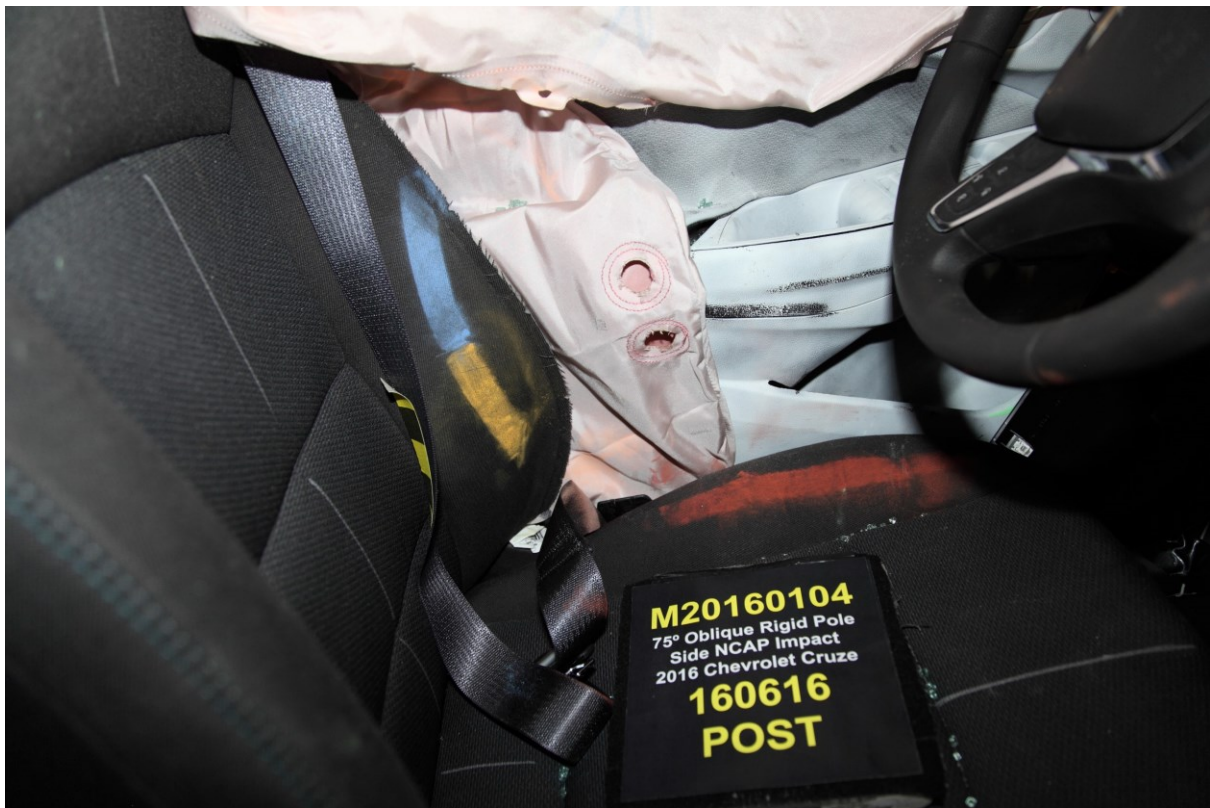
**No. 048 Post-Test Dummy Close-Up Torso Contact with Vehicle Interior View**

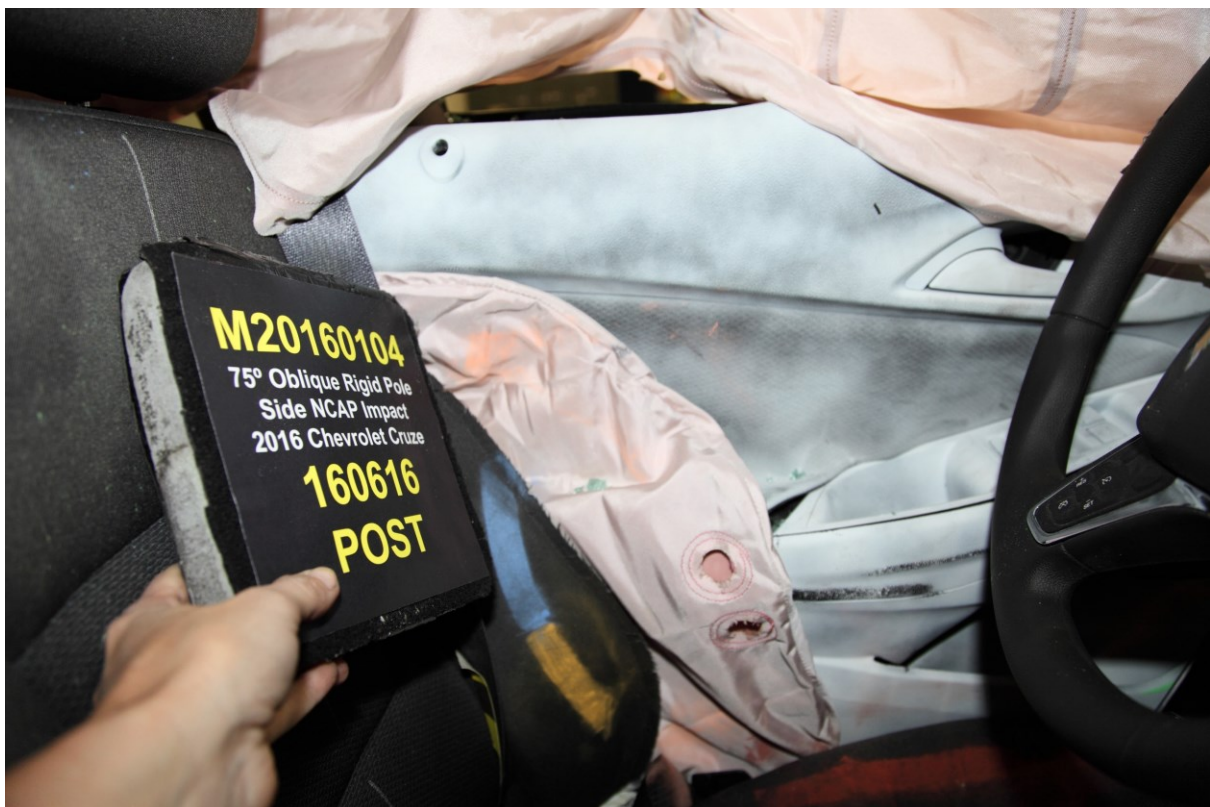
**No. 049 Post-Test Dummy Close-Up Torso Contact with Side Airbag View**

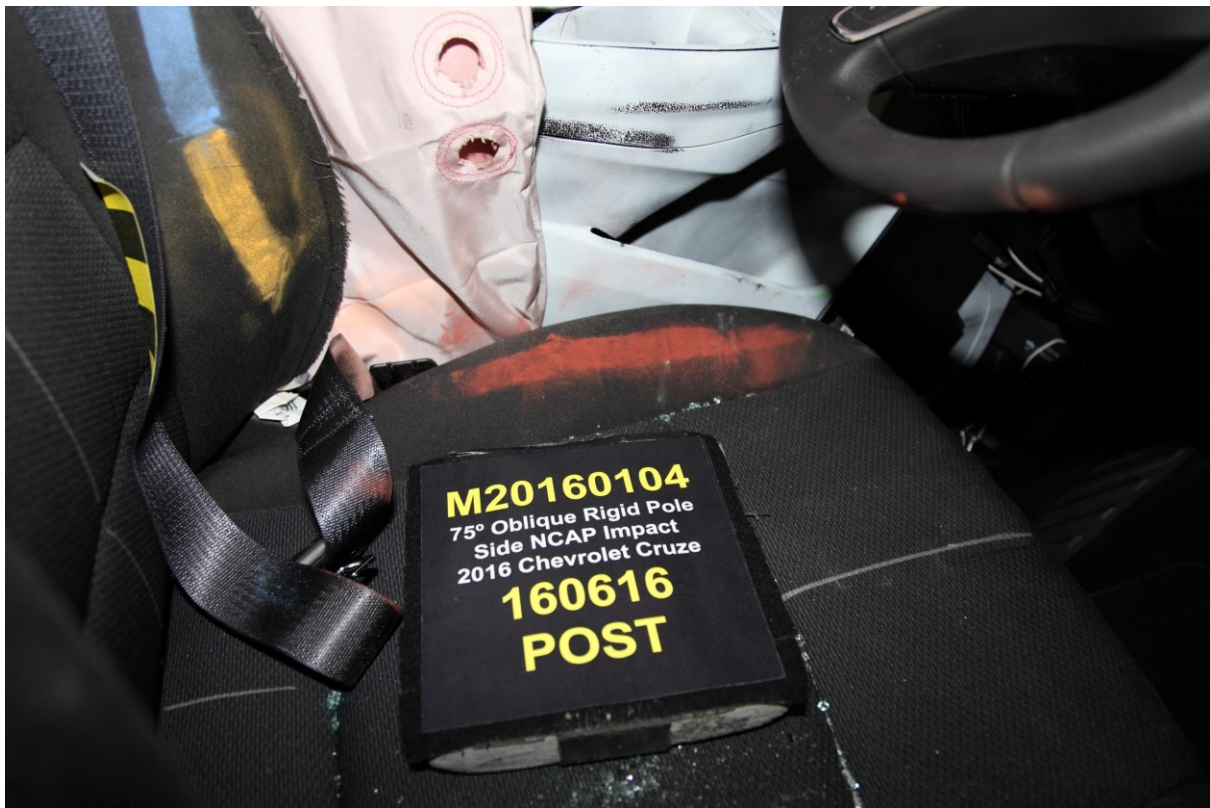
**No. 050 Post-Test Dummy Close-Up Pelvis Contact with Vehicle Interior View**

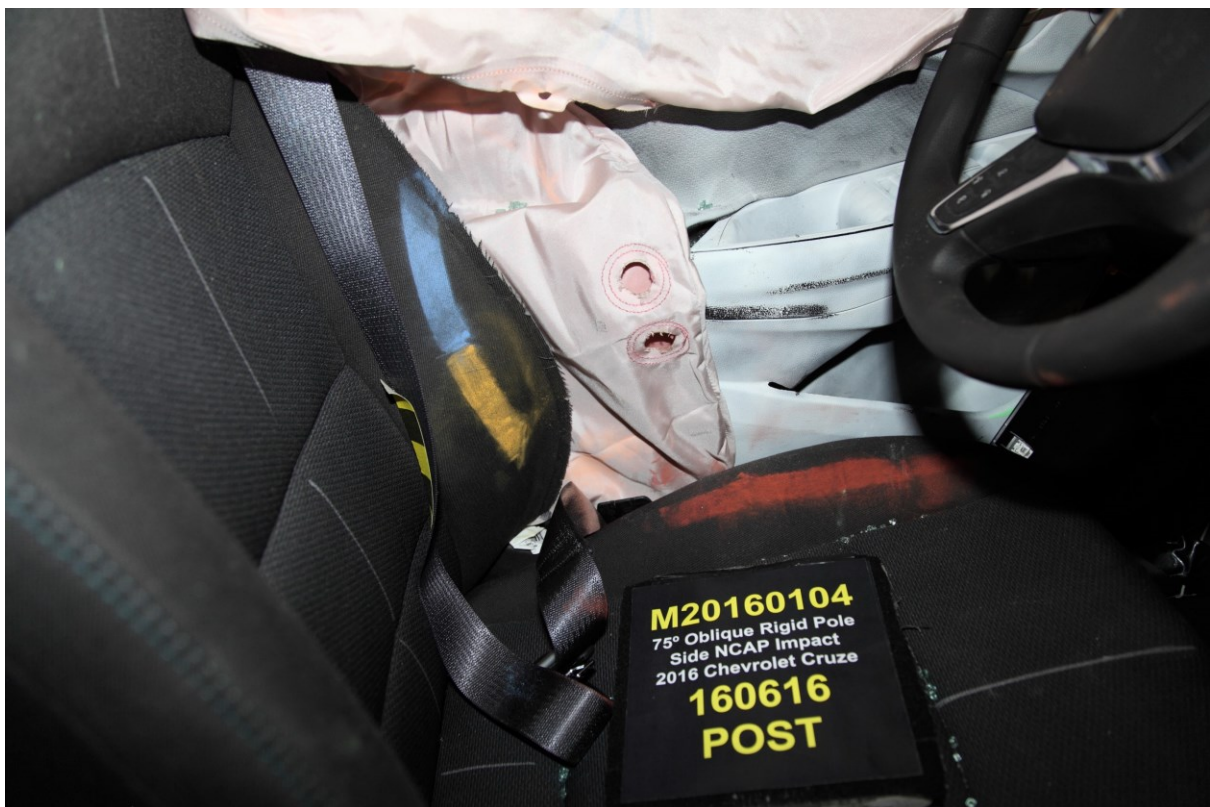
**No. 051 Post-Test Dummy Close-Up Pelvis Contact with Side Airbag View**

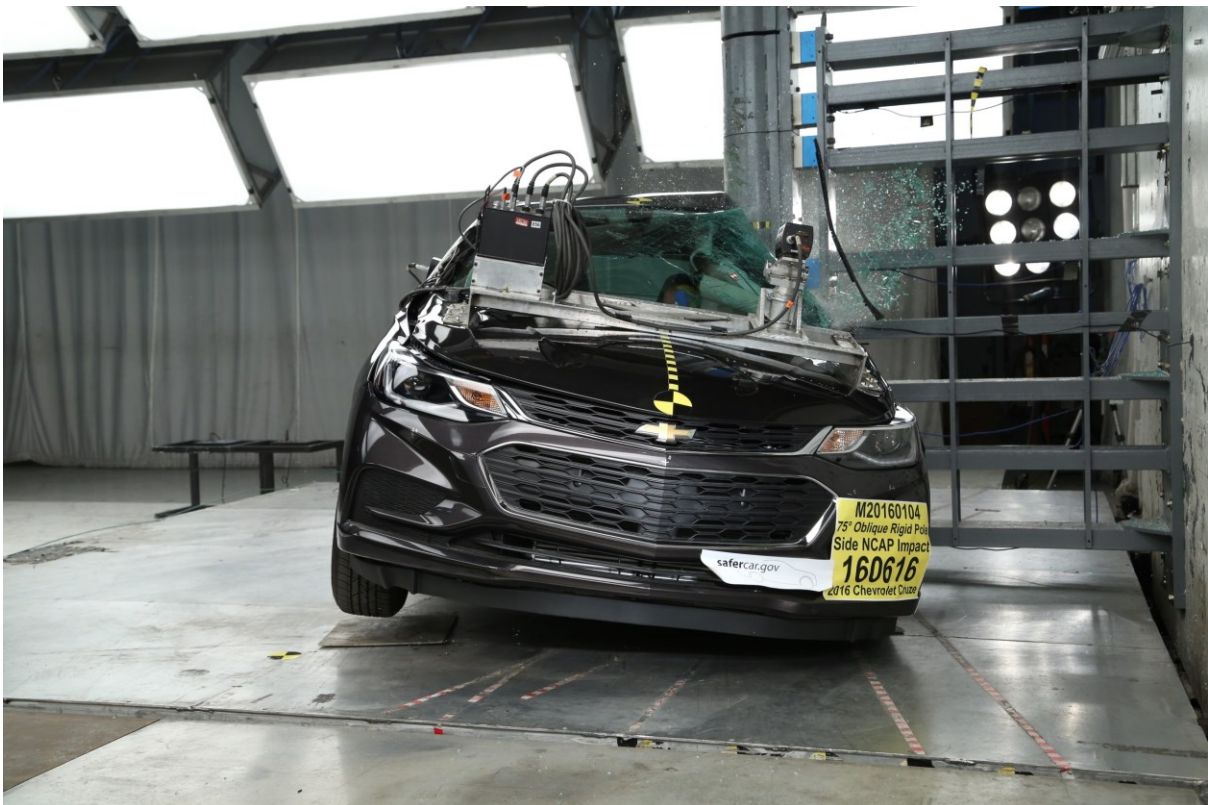
**No. 068 Impact Event**
