**NEW CAR ASSESSMENT PROGRAM (NCAP)  
SIDE IMPACT POLE TEST**

**Toyota Motor Manufacturing, Inc.  
2015 Toyota Sienna**

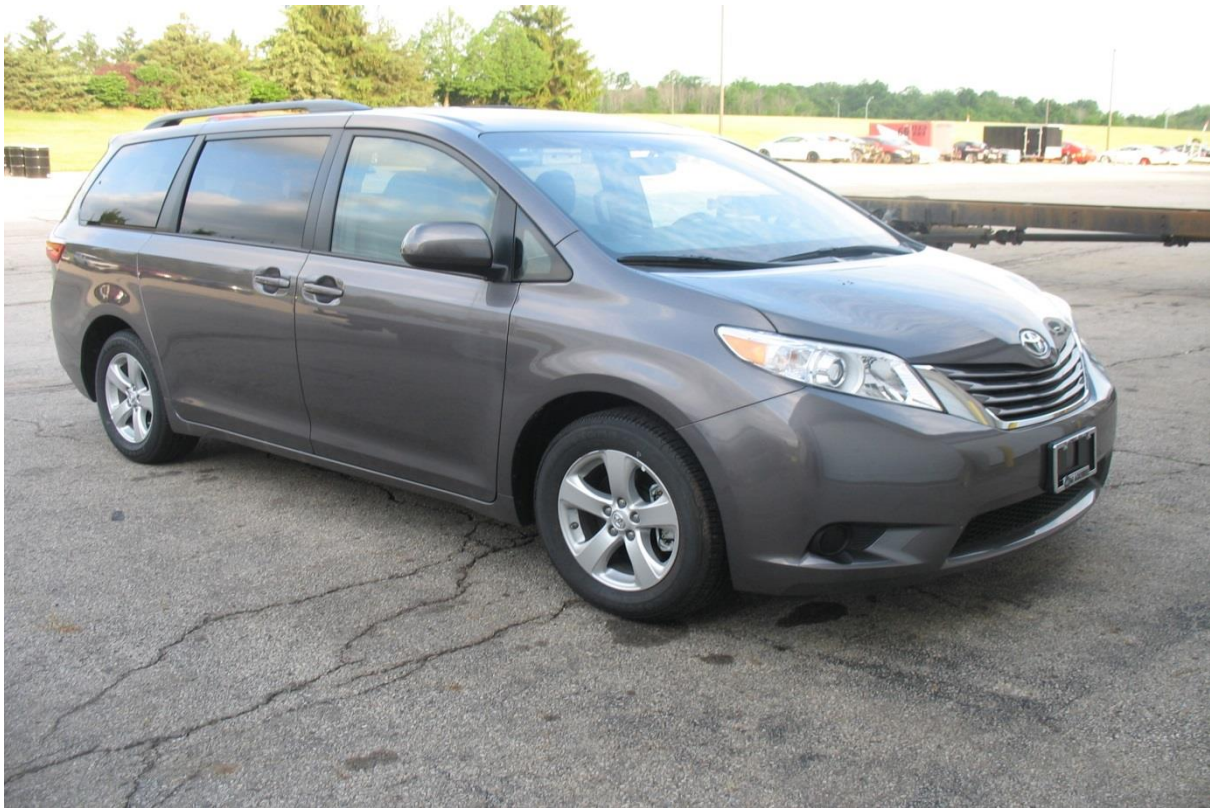
**Figure A-1 As Delivered Right Front  $\frac{3}{4}$  View of Test Vehicle**
