**REPORT NUMBER: SPNCAP-CAL-17-001**

**NEW CAR ASSESSMENT PROGRAM (NCAP)  
SIDE IMPACT POLE TEST**

**Hyundai Motor Company  
2017 Hyundai Elantra  
Four Door Sedan**

**FINAL REPORT**

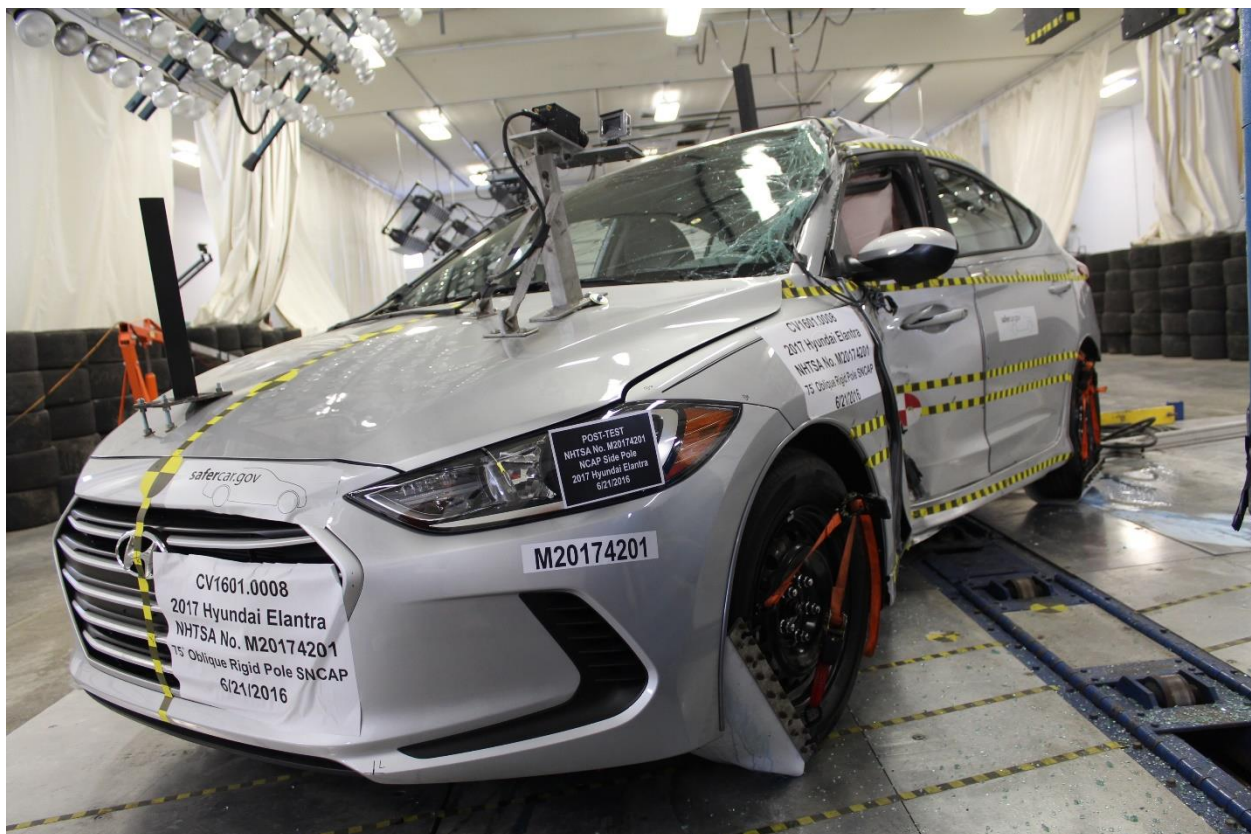
**Figure A-6: Post-Test Left Front  $\frac{3}{4}$  View of Test Vehicle**

| Critical Areas of Performance | Observations and Conclusions |
|---|---|
| Windshield Damage | Cracks throughout with separation along driver's A-Pillar |
| Side Window Damage | Driver's window shattered |

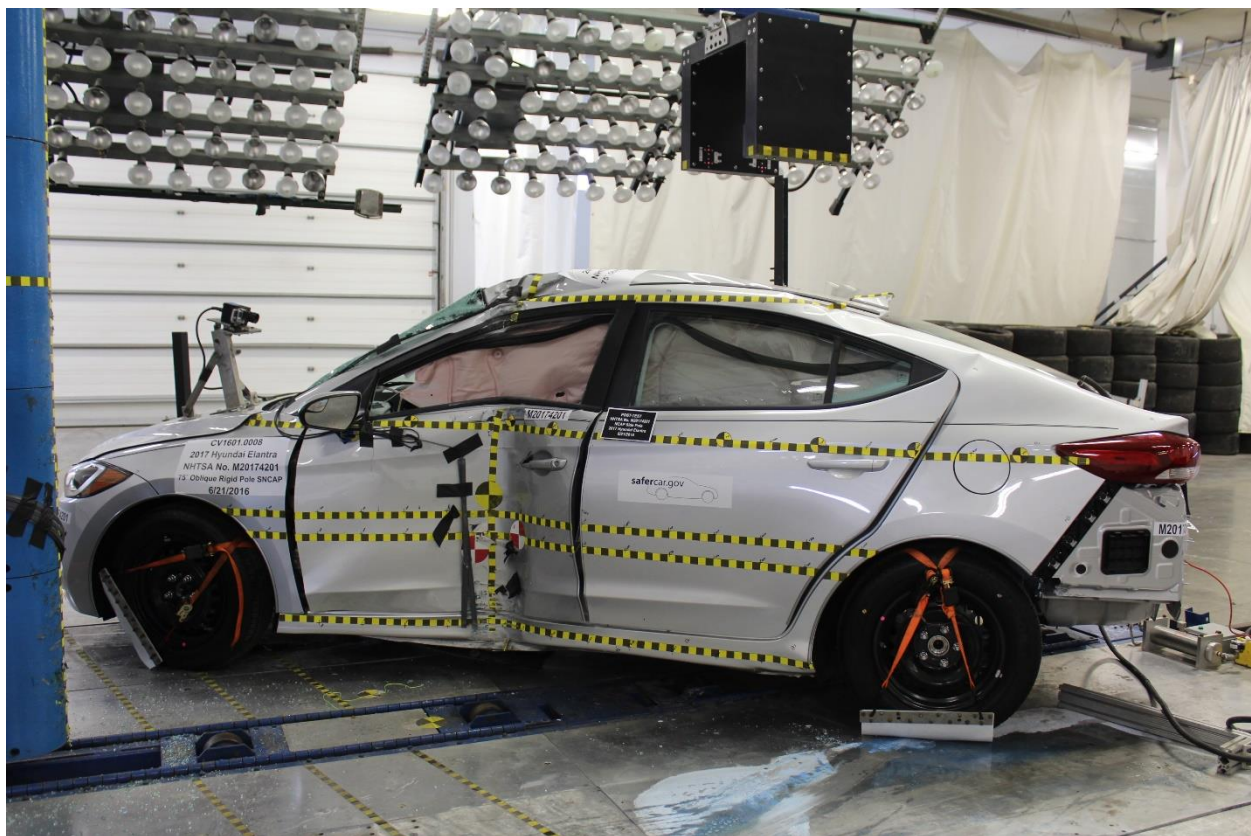
**Figure A-8: Post-Test Left Side View of Test Vehicle**

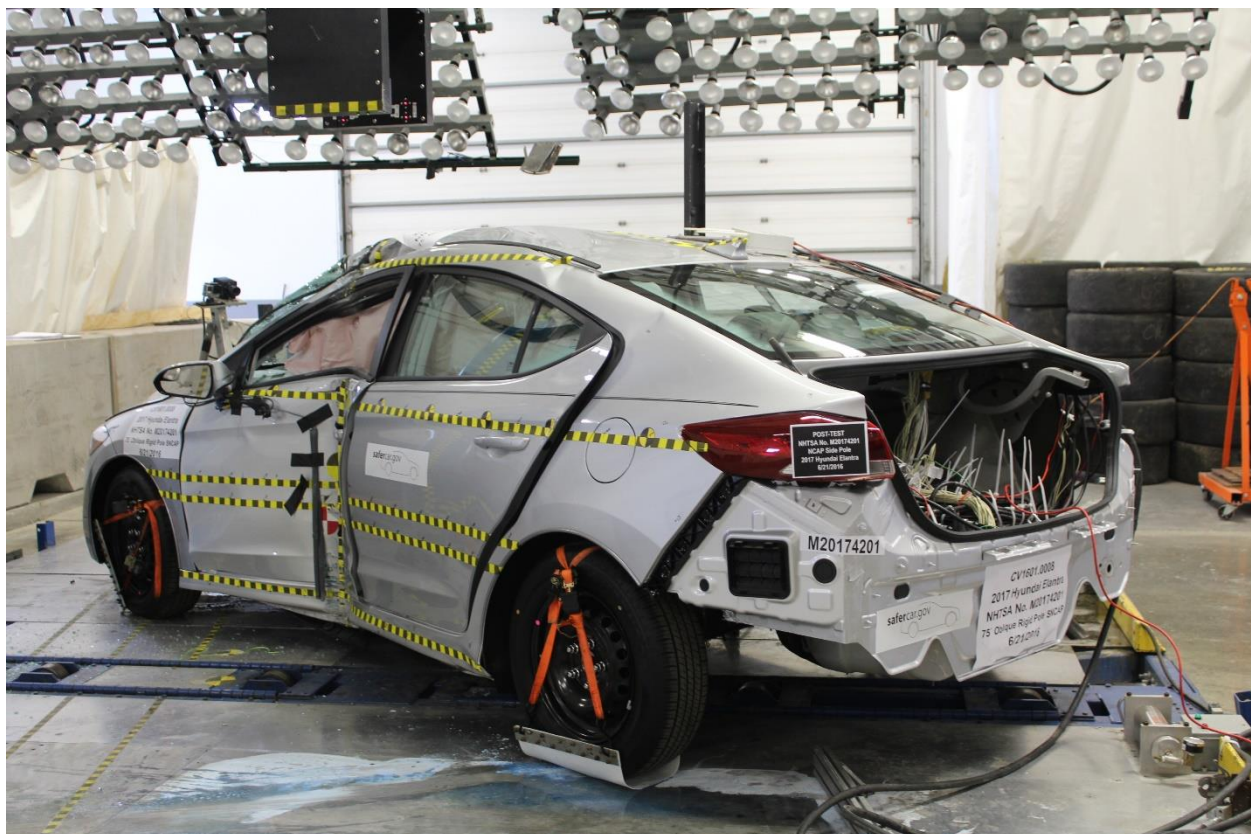
**Figure A-10: Post-Test Left Rear  $\frac{3}{4}$  View of Test Vehicle**

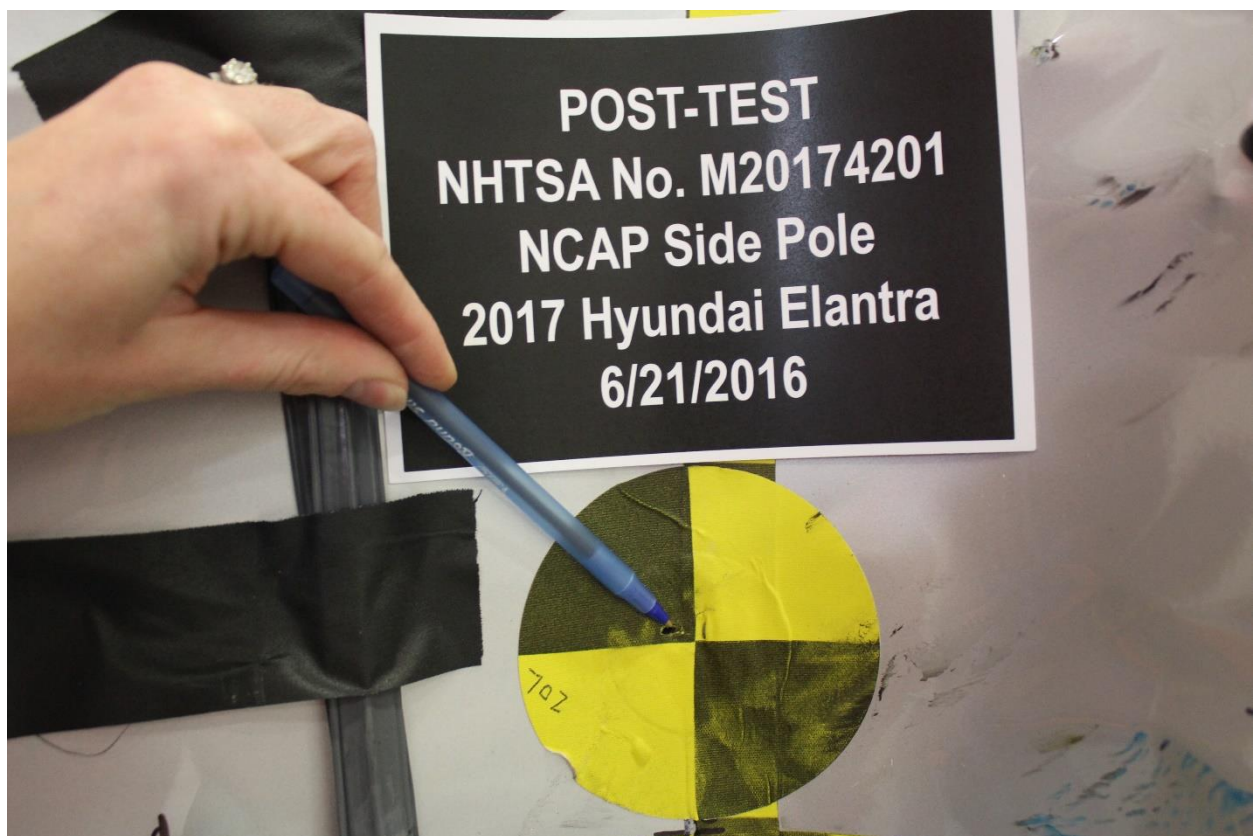
Figure A-20: Post-Test Close-Up View of Impact Point Target Showing Impact Location

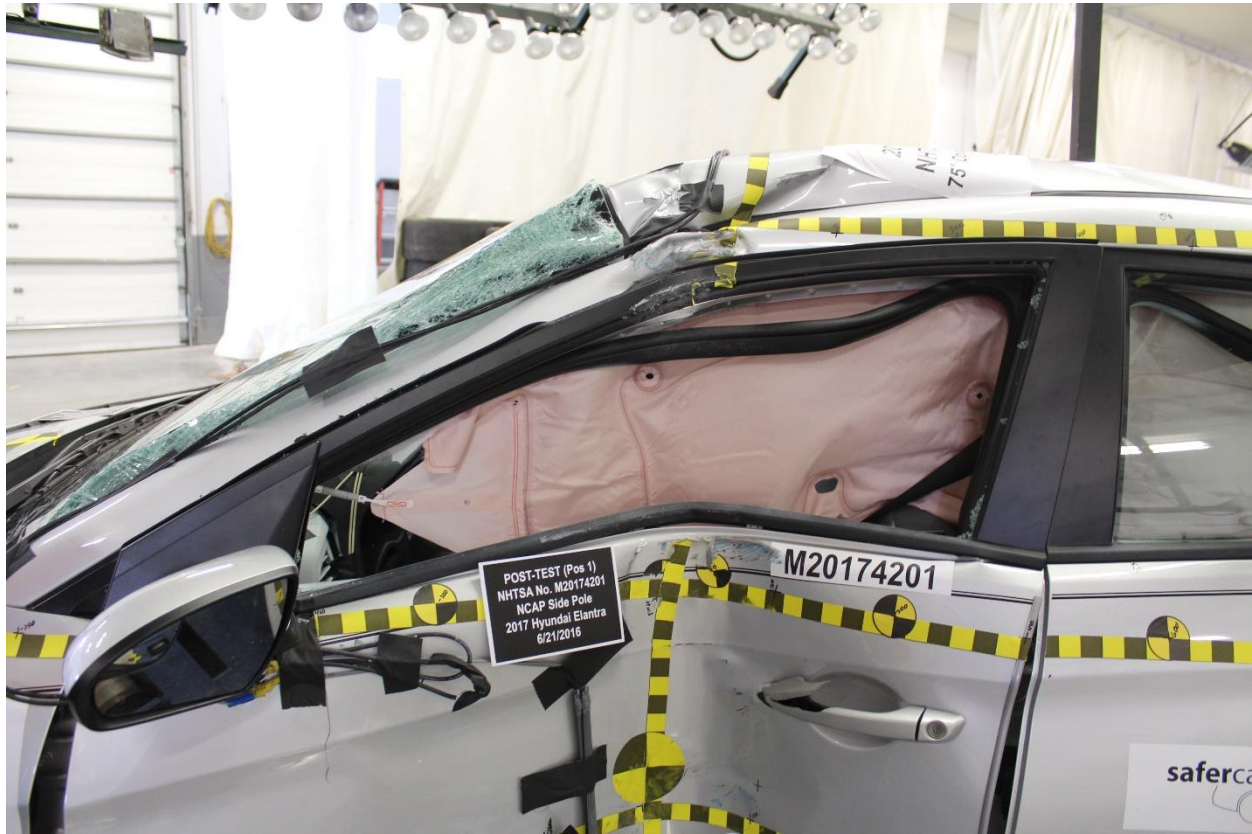
**Figure A-25: Post-Test Left Side View of Dummy Shoulder and Door Top View**

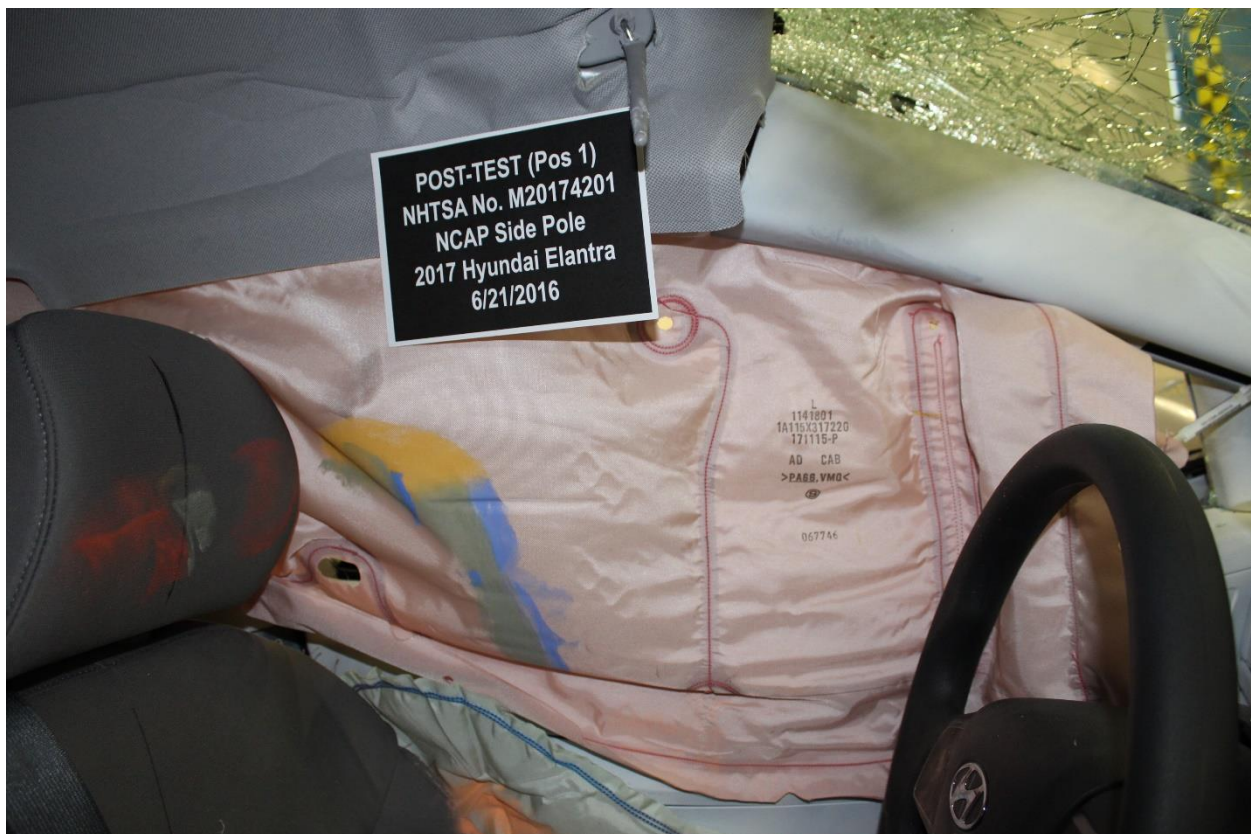
**Figure A-46: Post-Test Dummy Close-Up Head Contact with Vehicle Interior View**

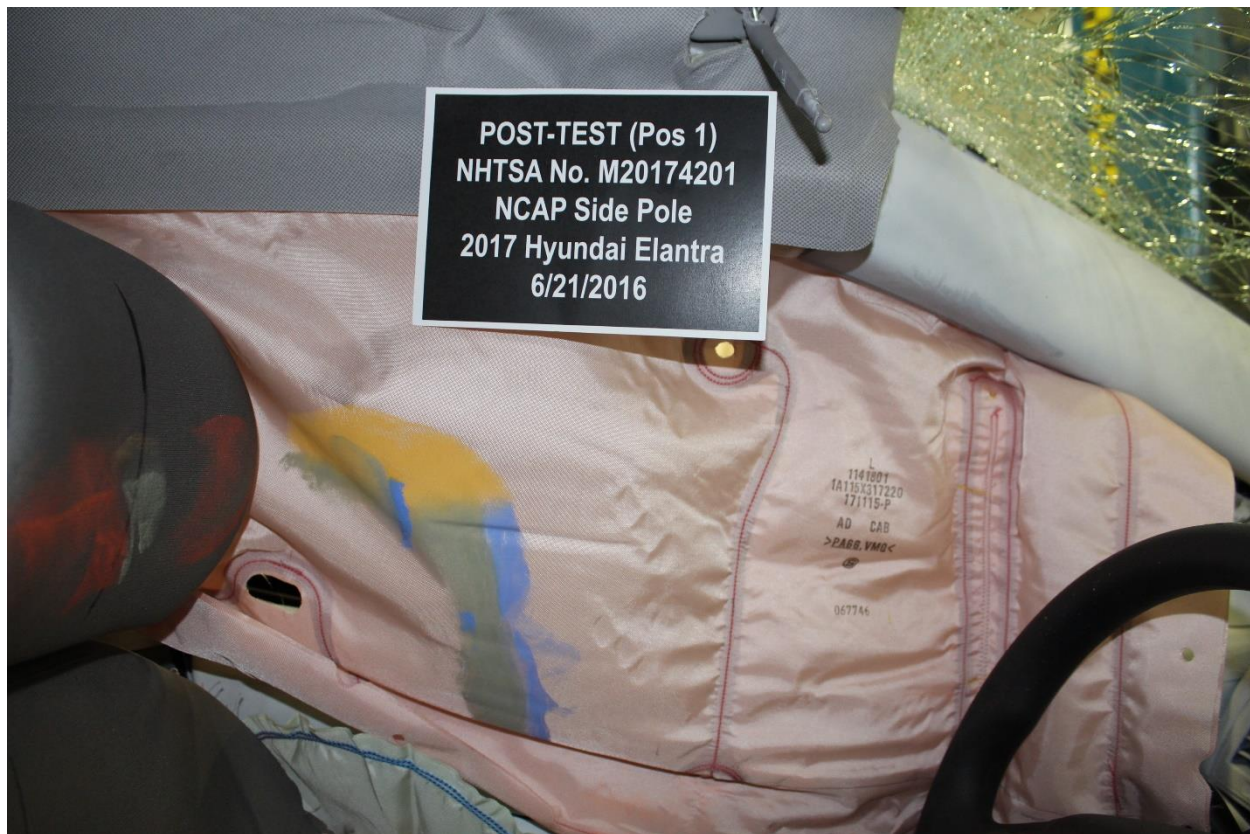
**Figure A-47: Post-Test Dummy Close-Up Head Contact with Side Airbag View**

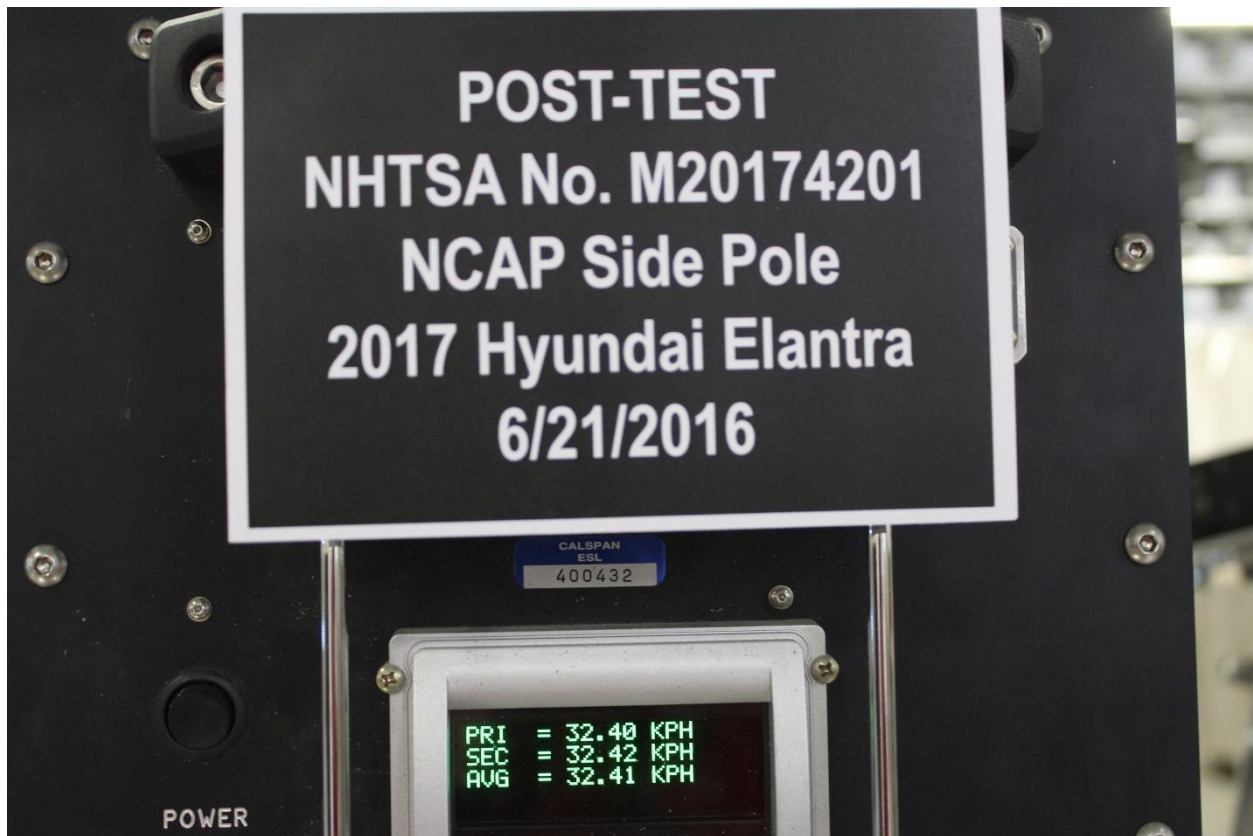
Figure A-62: Post-Test Primary and Redundant Speed Trap Read-Out
