REPORT NUMBER: NCAP-CAL-17-001

**NEW CAR ASSESSMENT PROGRAM (NCAP)
FRONTAL BARRIER IMPACT TEST**

**Hyundai Motor Company
2017 Hyundai Elantra
Four Door Sedan**

NHTSA No: M20174200

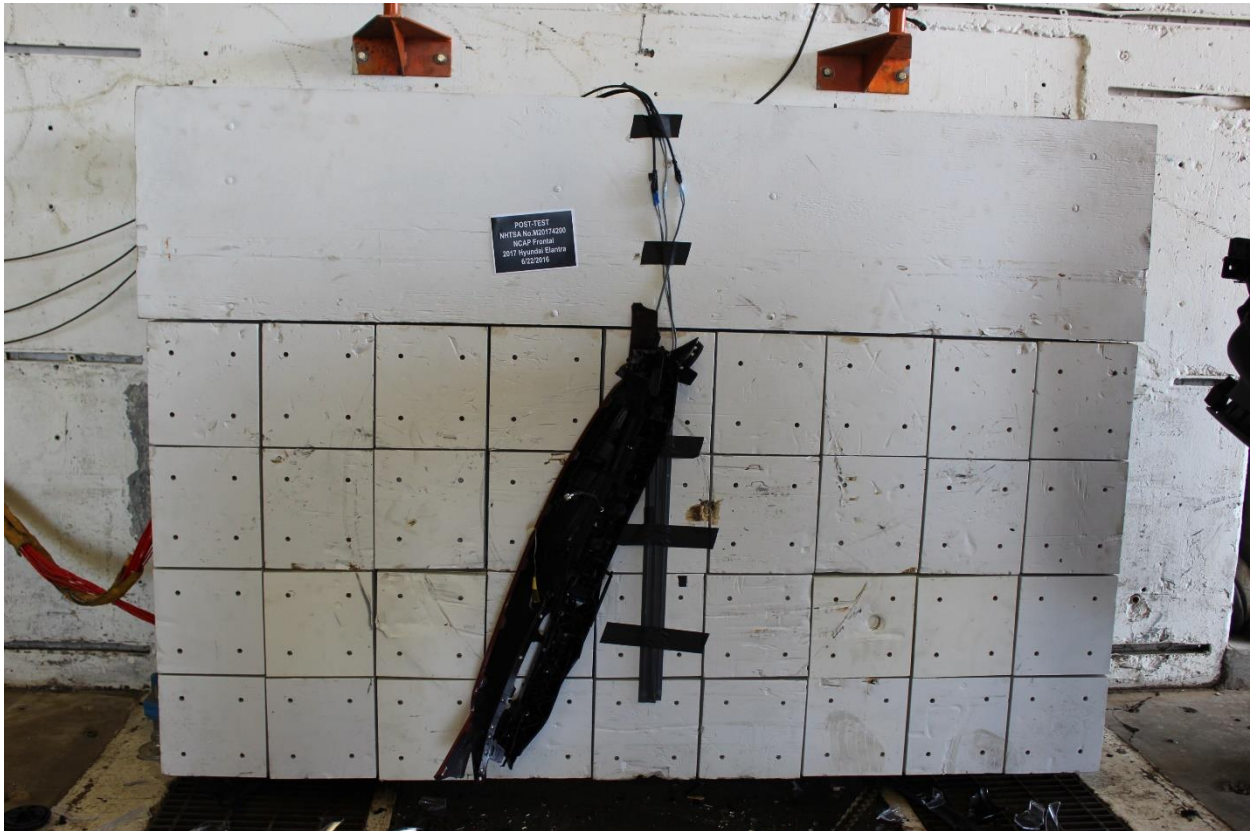
Figure A-3: Post-Test Load Cell Wall

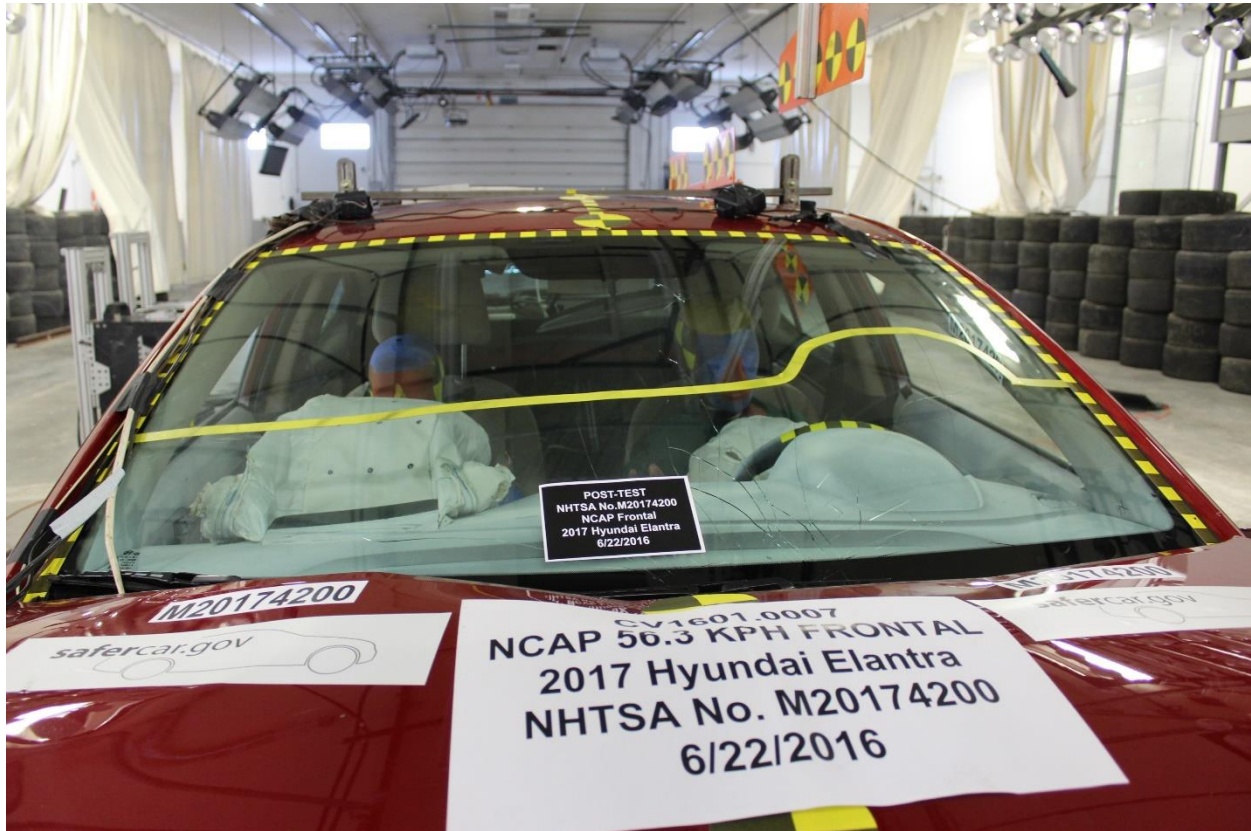
Figure A-19: Post-Test Windshield View

Critical Areas of Performance	Observations and Conclusions
Windshield Damage	Minor Cracks
Window Damage	None
Other Notable Effects	None

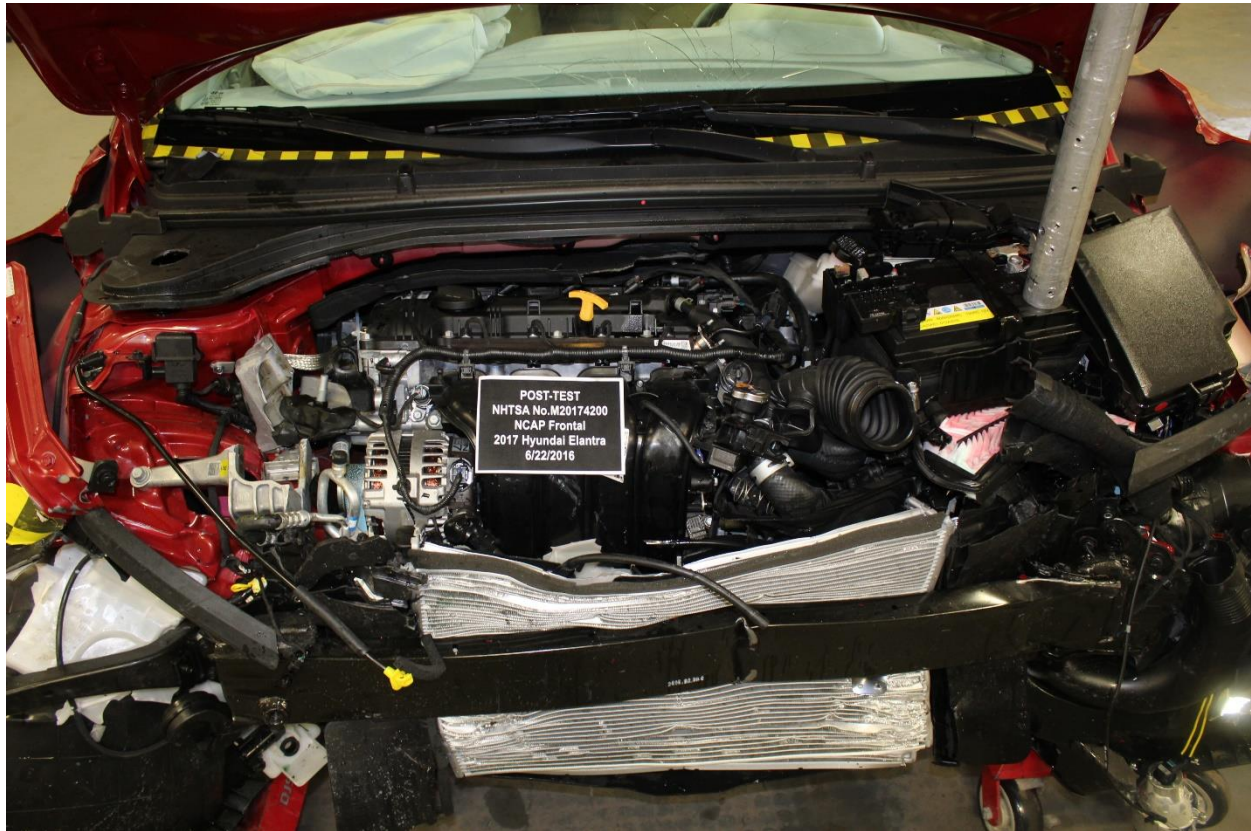
Figure A-21: Post-Test Engine Compartment View

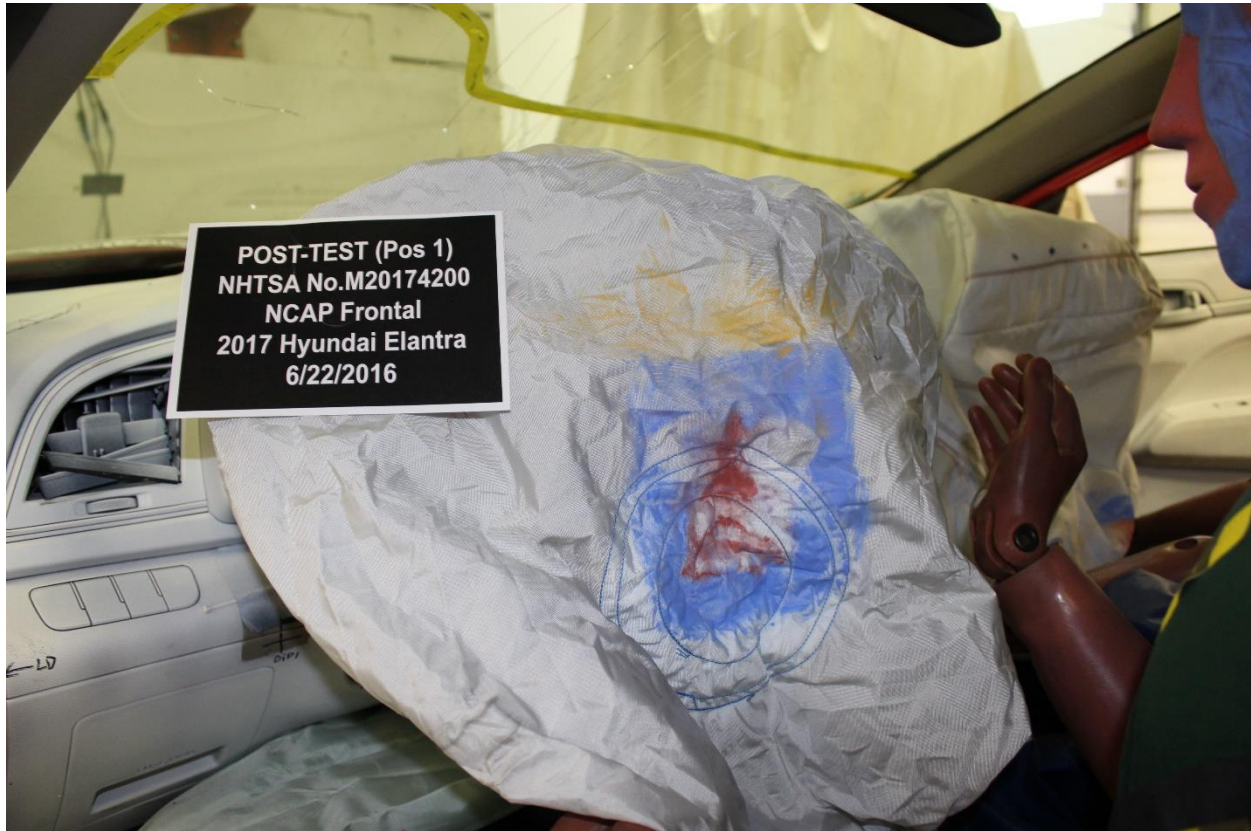
Figure A-47: Post-Test Driver Dummy Contact With Airbag

The driver's visible contact points were as follows: The driver's head contacted the frontal airbag and then the head restraint. The upper torso contacted the frontal airbag. Both knees contacted the knee air bag.

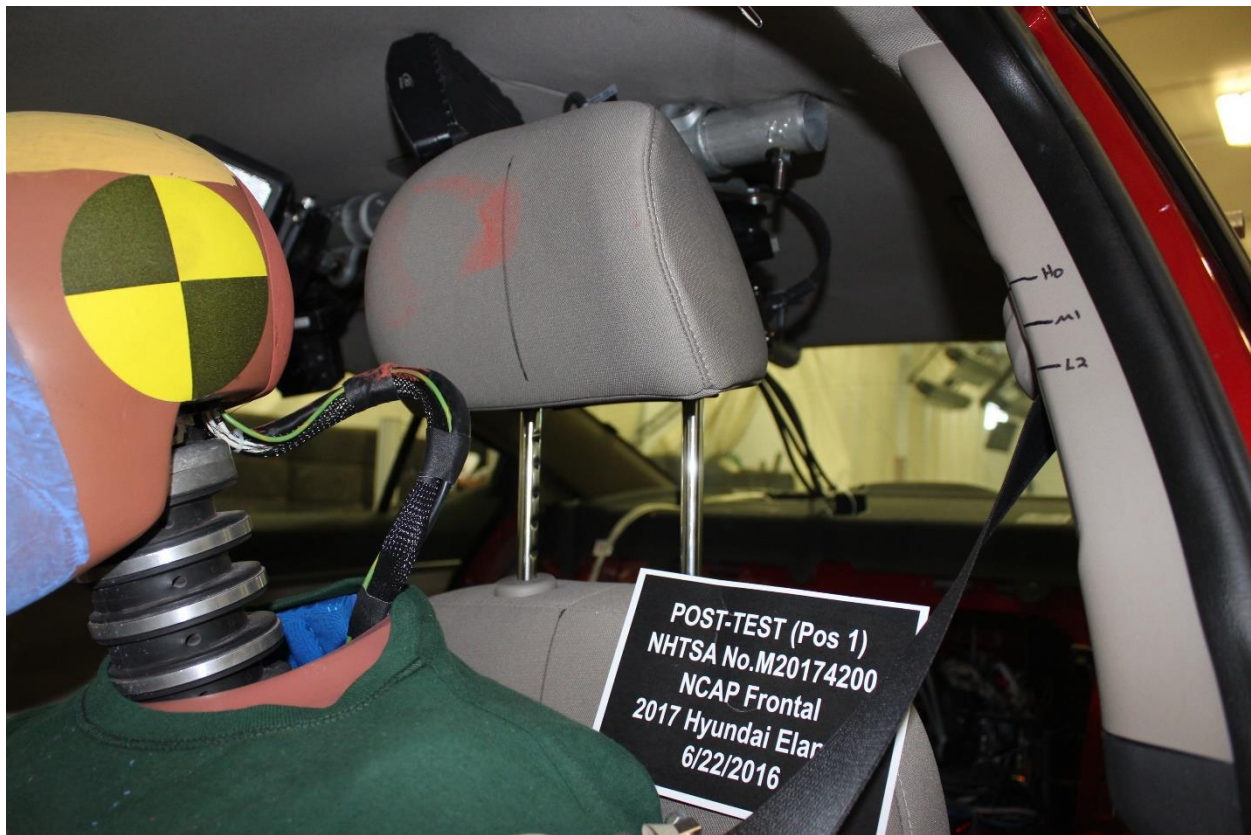
Figure A-48: Post-Test Driver Dummy Contact With Headrest

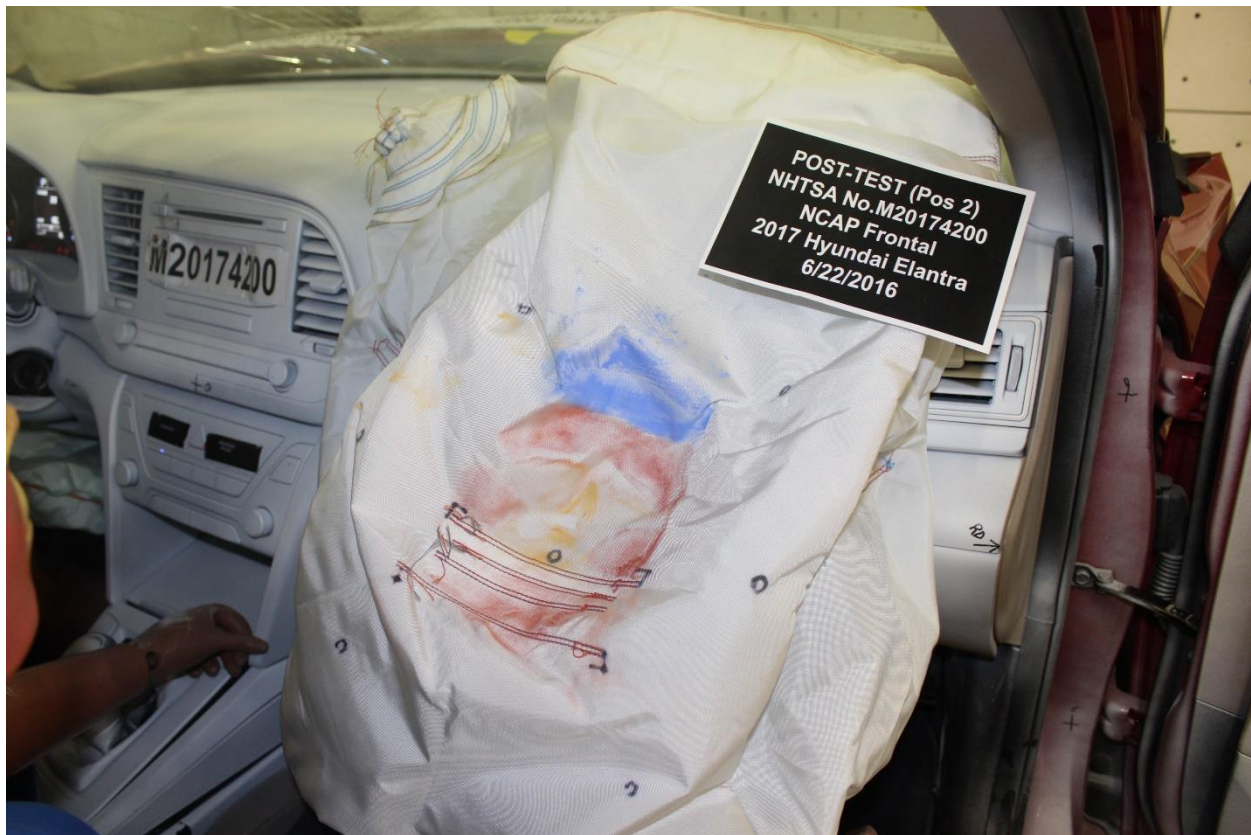
Figure A-68: Post-Test Passenger Dummy Contact With Airbag

The passenger's visible contact points were as follows: The passenger's head contacted the frontal airbag and then the head restraint. The upper torso contacted the frontal airbag. The Left knee contacted the glove box.

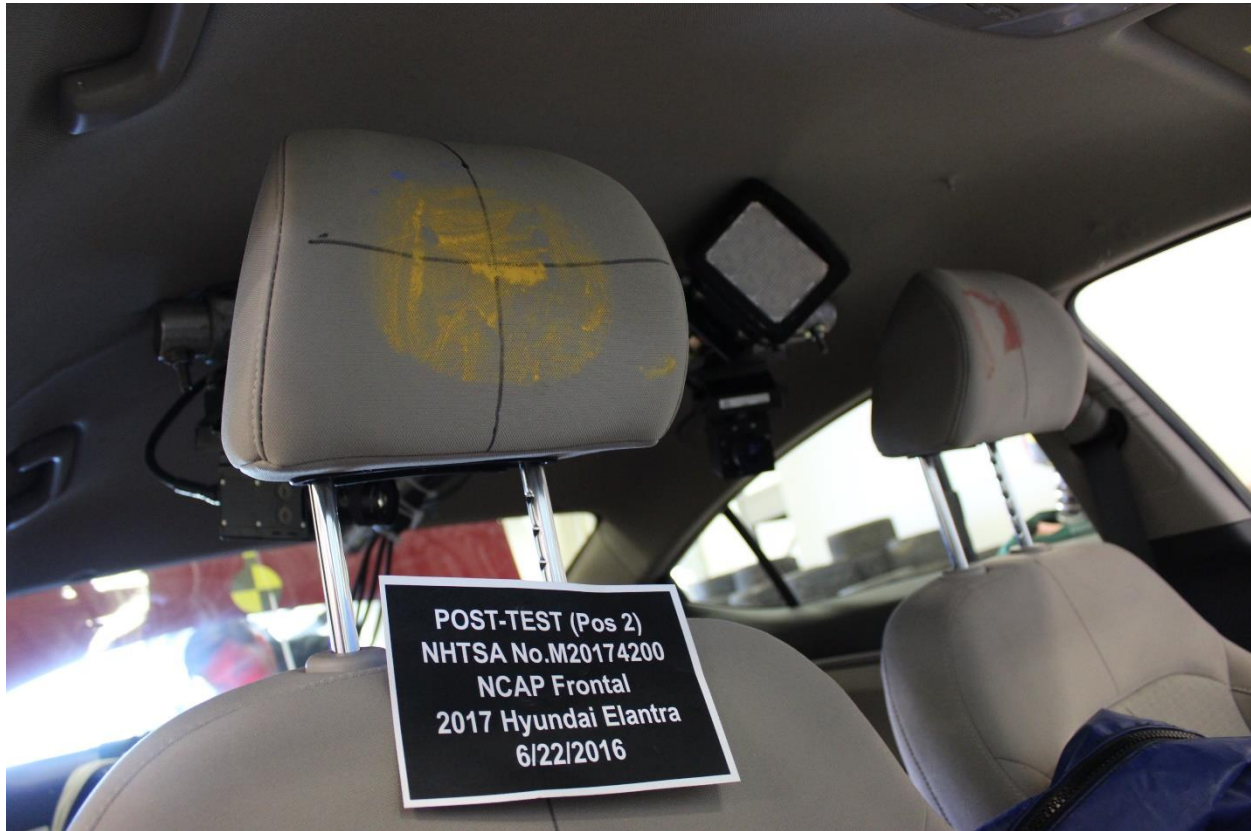
Figure A-69: Post-Test Passenger Dummy Contact With Headrest

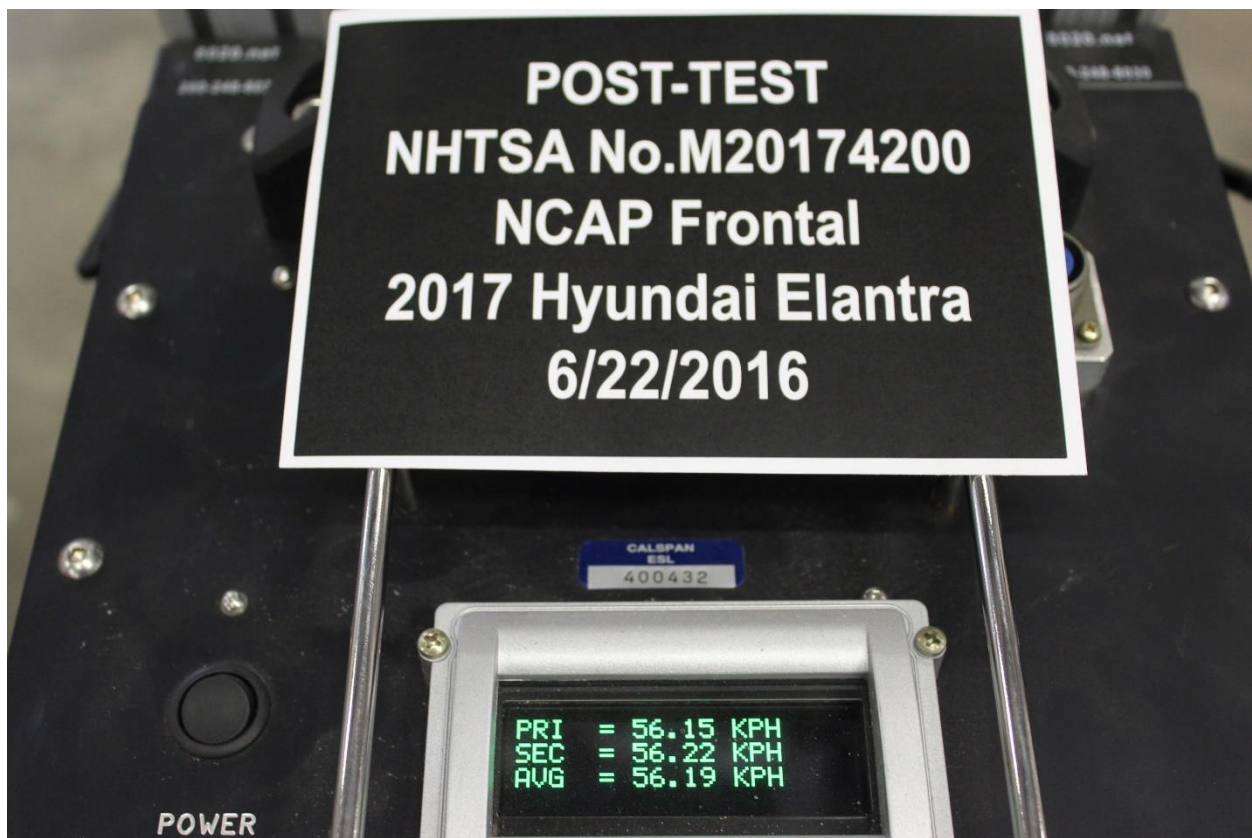
Figure A-72: Post-Test Speed Trap Read-Out

A ridged fixed barrier was impacted by a 2017 Hyundai Elantra four door sedan at a velocity of 56.15 km/h. The test was performed at Calspan Corporation's Transportation Test Operations facility in Buffalo, New York on June 22, 2016. Pre- and post-test photographs of the vehicle and dummies to document the test can be found in Appendix A. One real-time camera and 14 high-speed cameras were used to document the frontal barrier impact event. Camera locations and other pertinent camera information can be found in Data Sheet 6 of this report.
