**REPORT NUMBER: SINCAP-CAL-17-001**

**NEW CAR ASSESSMENT PROGRAM (NCAP)  
MOVING DEFORMABLE BARRIER SIDE IMPACT TEST**

**Hyundai Motor Company  
2017 Hyundai Elantra  
Four Door Sedan**

**NHTSA No: M20174202**

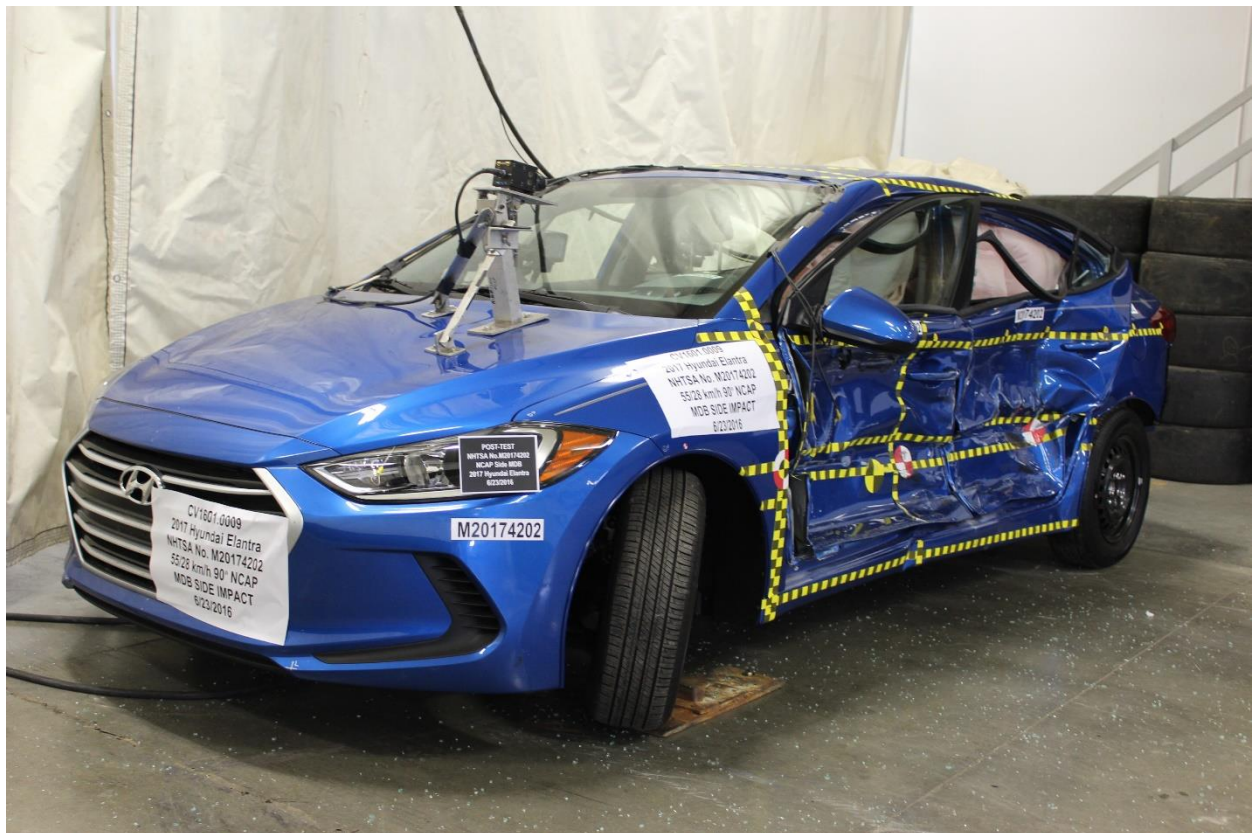
**Figure A-6: Post-Test Left Front ¾ View of Test Vehicle**

Critical Areas of Performance	Observations and Conclusions
Pillar Performance	B Pillar & C Pillar Buckled
Sill Separation	None
Windshield Damage	None
Side Window Damage	Rear Passenger Window Shattered
Other Notable Effects	None

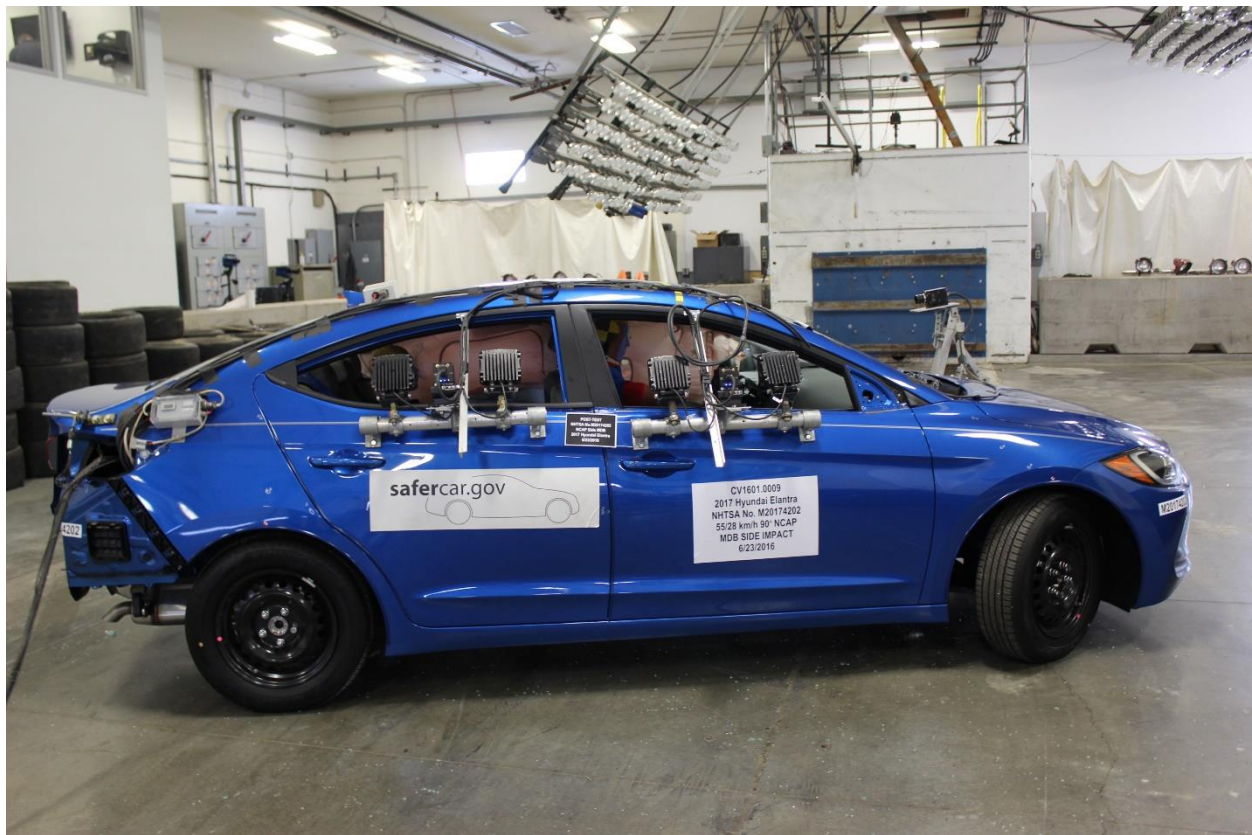
**Figure A-14: Post-Test Right Side View of Test Vehicle**

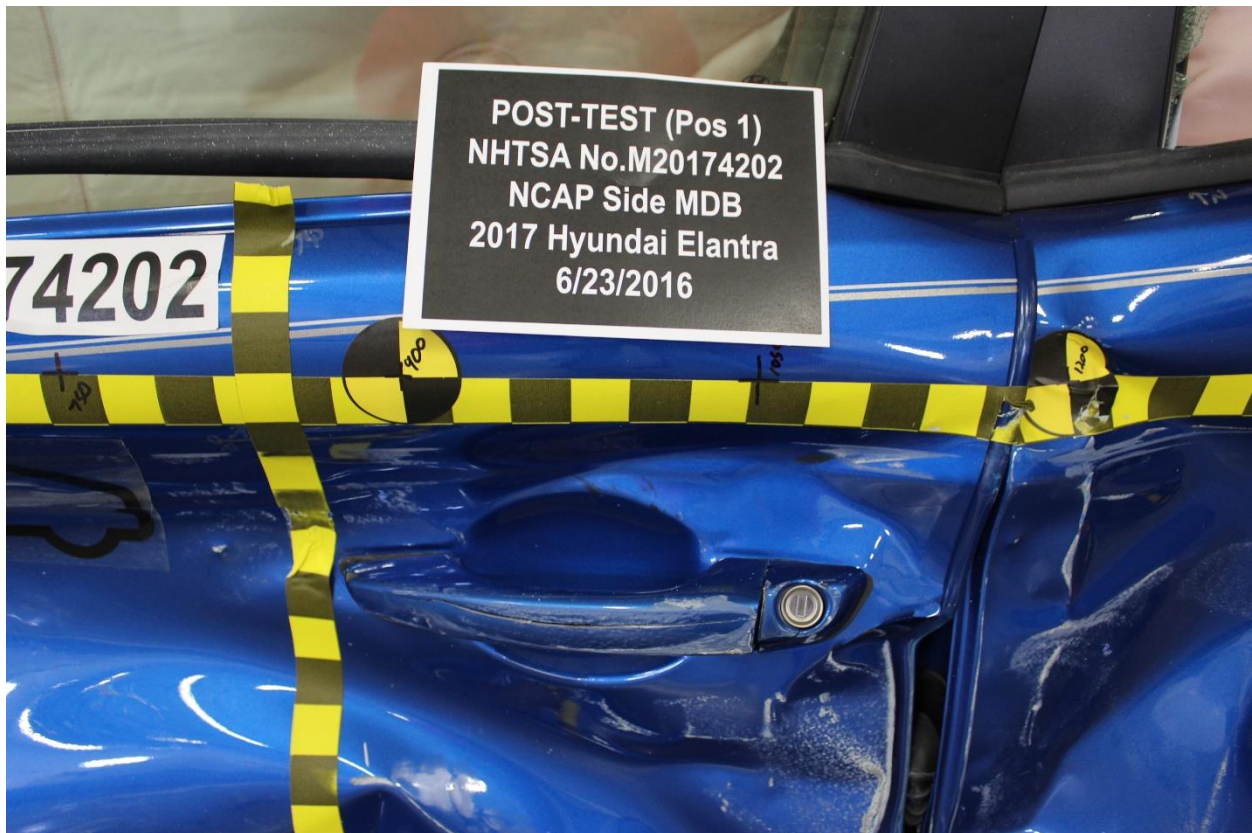
**Figure A-22: Post-Test Left Front Door Latch Close-Up**

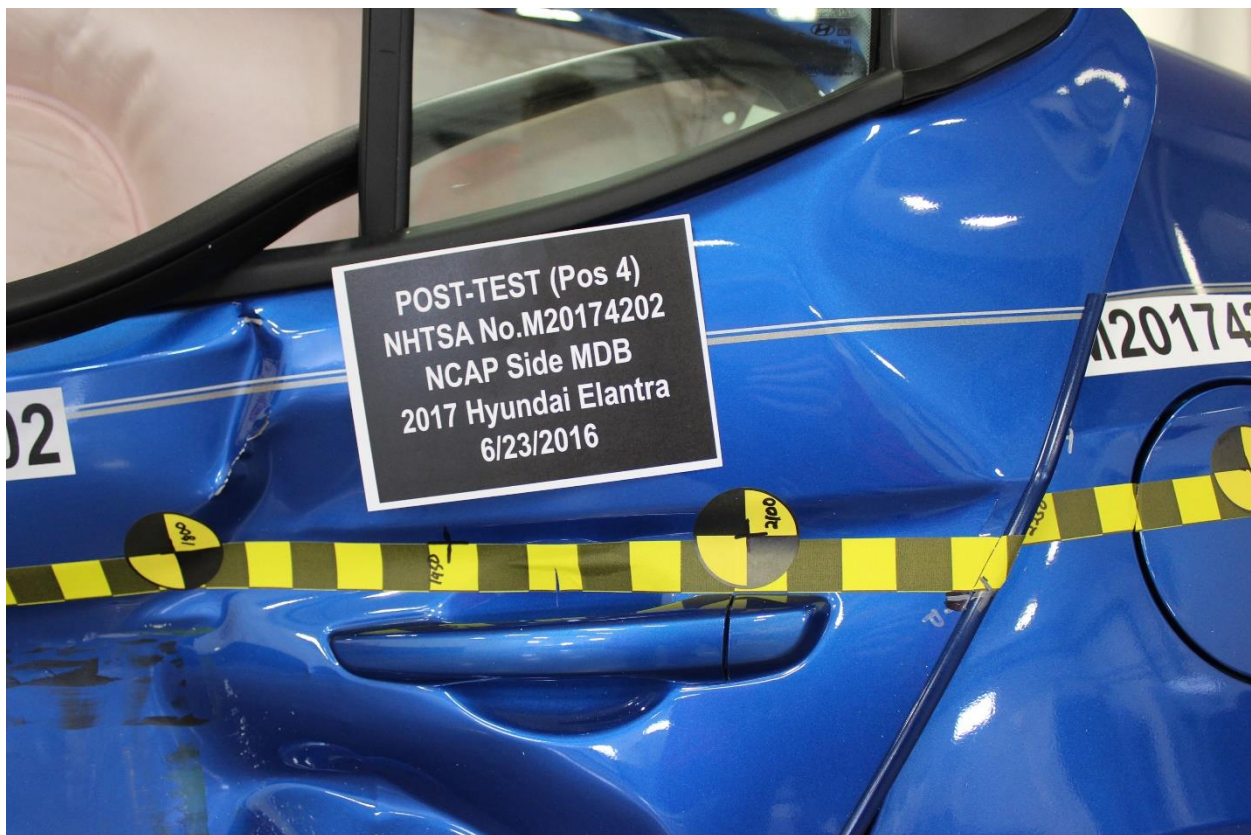
Figure A-24: Post-Test Left Rear Door Latch Close-Up

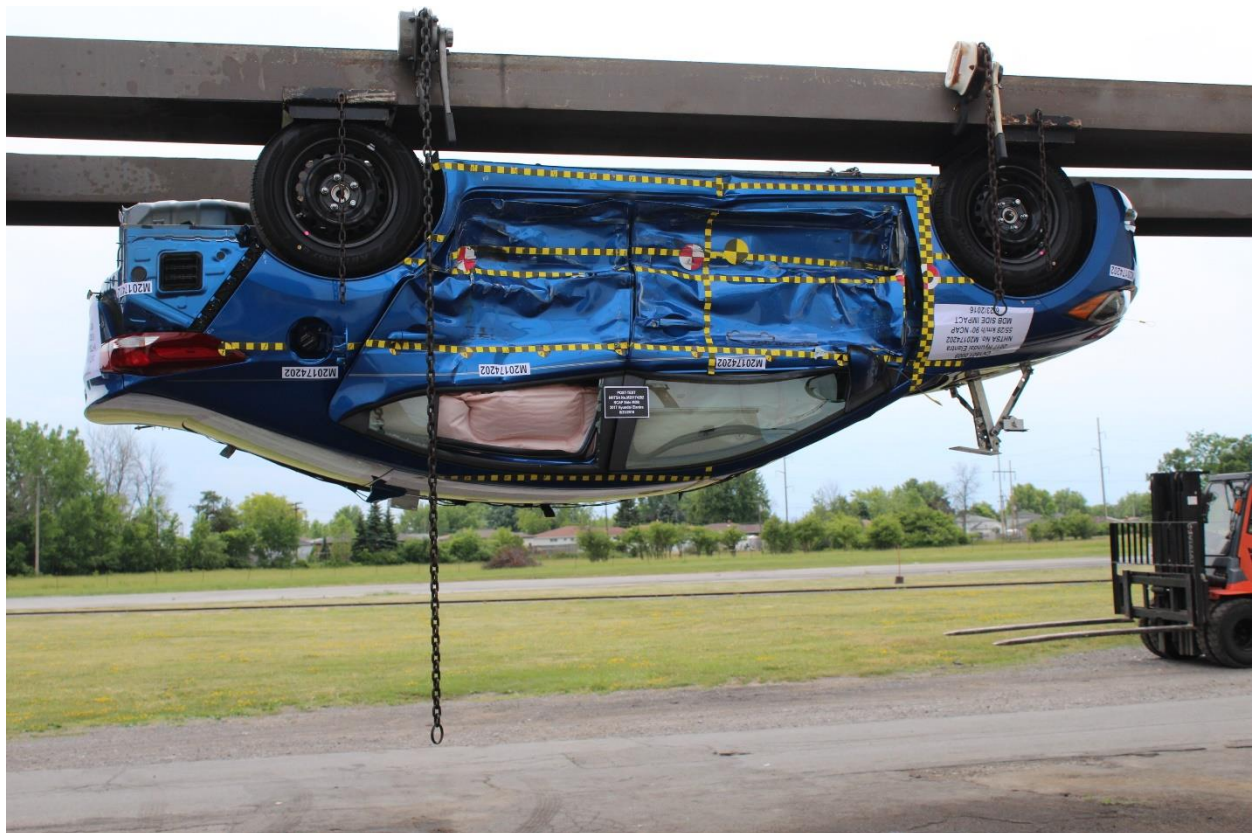
**Figure A-98: FMVSS No. 301 Static Rollover 180 Degrees**
