REPORT NUMBER: R&D-KAR-16-006

**OBLIQUE MOVING BARRIER INTO ANGLED STATIONARY VEHICLE CRASH TESTING IN
SUPPORT OF NHTSA'S FRONTAL OBLIQUE PROGRAM**

**OBLIQUE MOVING DEFORMABLE BARRIER INTO LEFT FRONT OF A MOVING
CONTOURED BARRIER**

60 KM/H, 15 DEGREE ANGLE, 35% OVERLAP

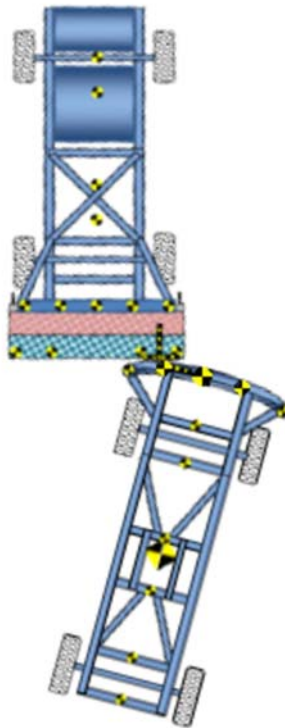
A Moving Contoured Barrier (MCB) was impacted on the left front corner by an Oblique Moving Deformable Barrier. The MCB was stationary and positioned at a target angle of 15° and a target offset of 35% to the line of forward motion of the OMDB. The OMDB was towed down the test track in a full forward direction, without any crabbing, and the targeted impact velocity of 60.0 km/h (37.3 mph) into the MCB.

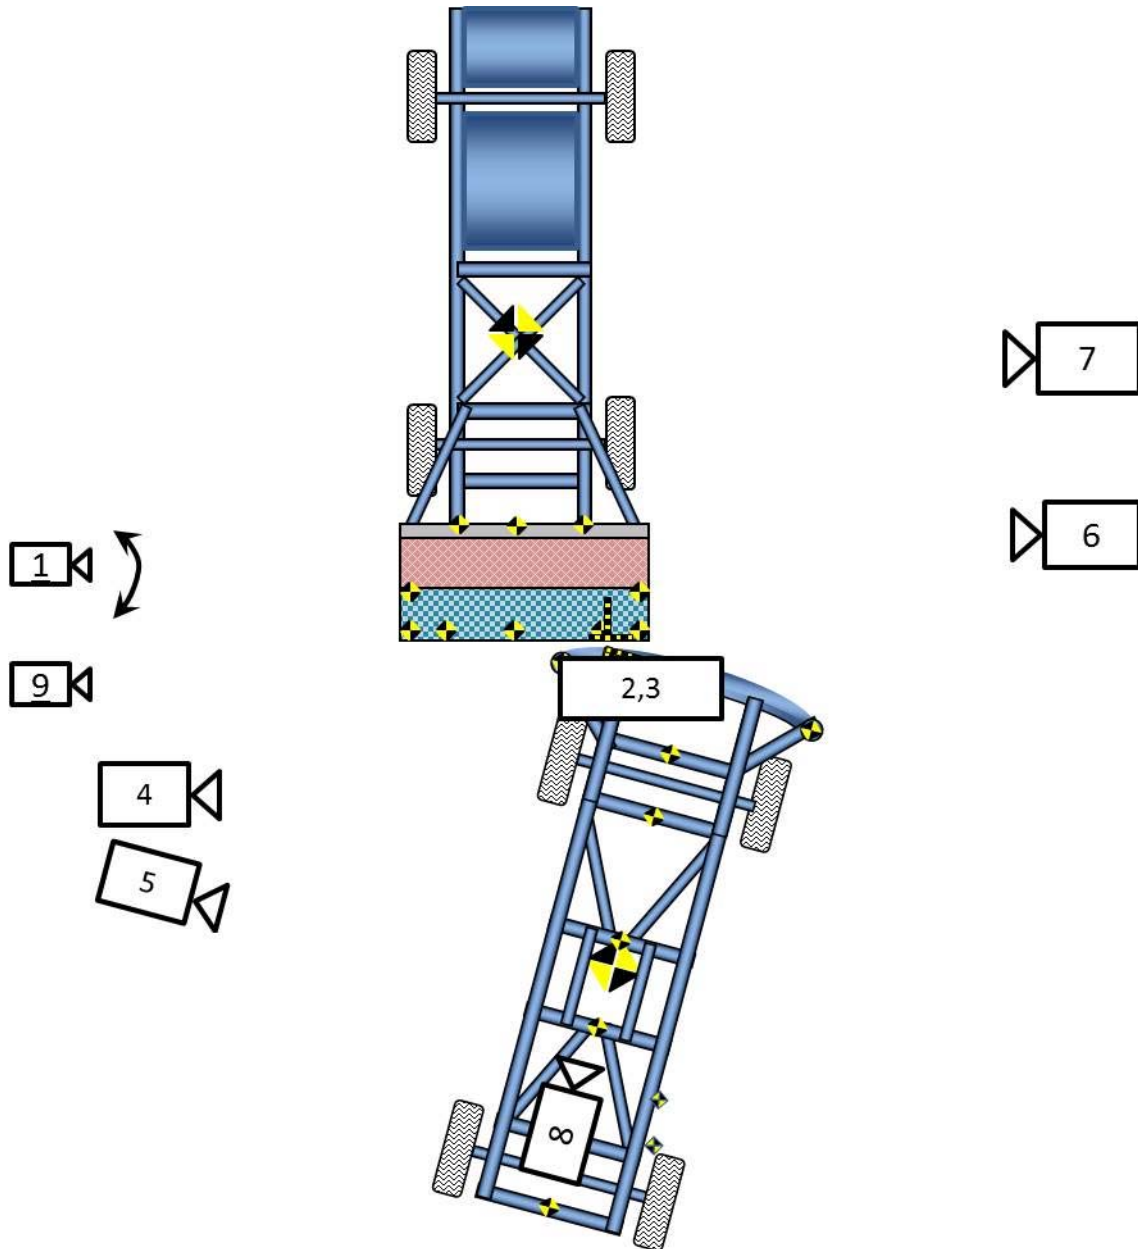
DATA SHEET NO. 1

HIGH SPEED CAMERA LOCATIONS AND DATA

No.	Camera View	Location (mm)			Lens (mm)	Speed (fps)
		X	Y	Z		
1	Real-Time Left Side Panning View	N/A	N/A	N/A	N/A	29.97
2	Overall Top View	3974	-561	11918	20	1000
3	Zoomed Top View	4081	-558	11966	50	1000
4	Overall Left Side	5011	11691	549	35	1000
5	MCB Left Side	901	16056	365	50	1000
6	Overall Right Side	3122	-9775	115	50	1000
7	OMDB Right Side	875	-14062	985	85	1000
8	Onboard MCB	N/A	N/A	N/A	12	1000
9	Real-Time Left Side View	2389	15374	725	N/A	29.97

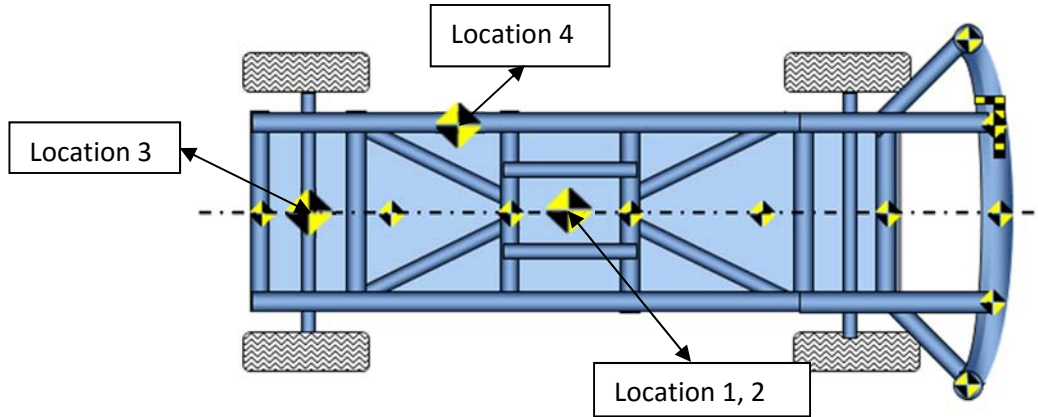
DATA SHEET NO. 2

MCB ACCELEROMETER LOCATIONS

No.	Accelerometer Location	Axes	Units	Location (mm)		
				X	Y	Z
1	Vehicle CG Accelerometers	X, Y, Z	g's	1965	0	324
2	Vehicle CG ARS	X, Y, Z	deg/s	1965	0	324
3	Rear C/L Axle	X, Y, Z	g's	267	0	419
4	Left Rear Frame	X, Y, Z	g's	1437	-498	522

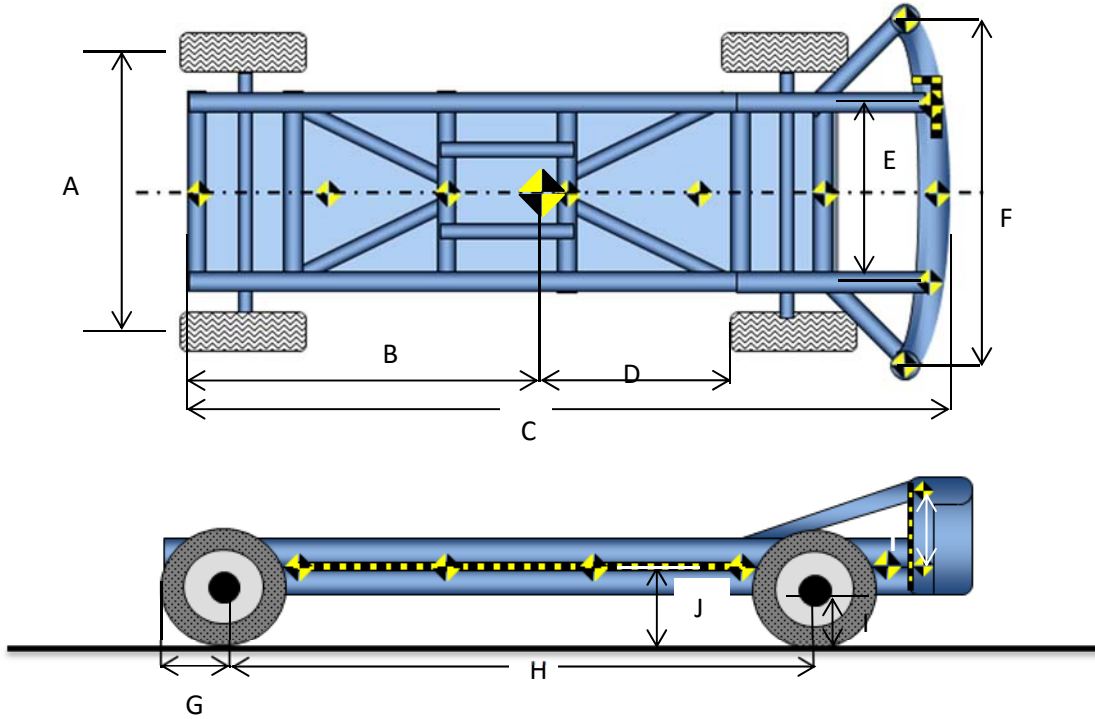
DATA SHEET NO. 3

MCB PHOTOGRAPHIC REFERENCE TARGET LOCATIONS

Item	Value	Item	Value
A	1495	F	1965
B	1970	G	312
C	4135	H	3048
D	1072	I	207
E	1040	J	355

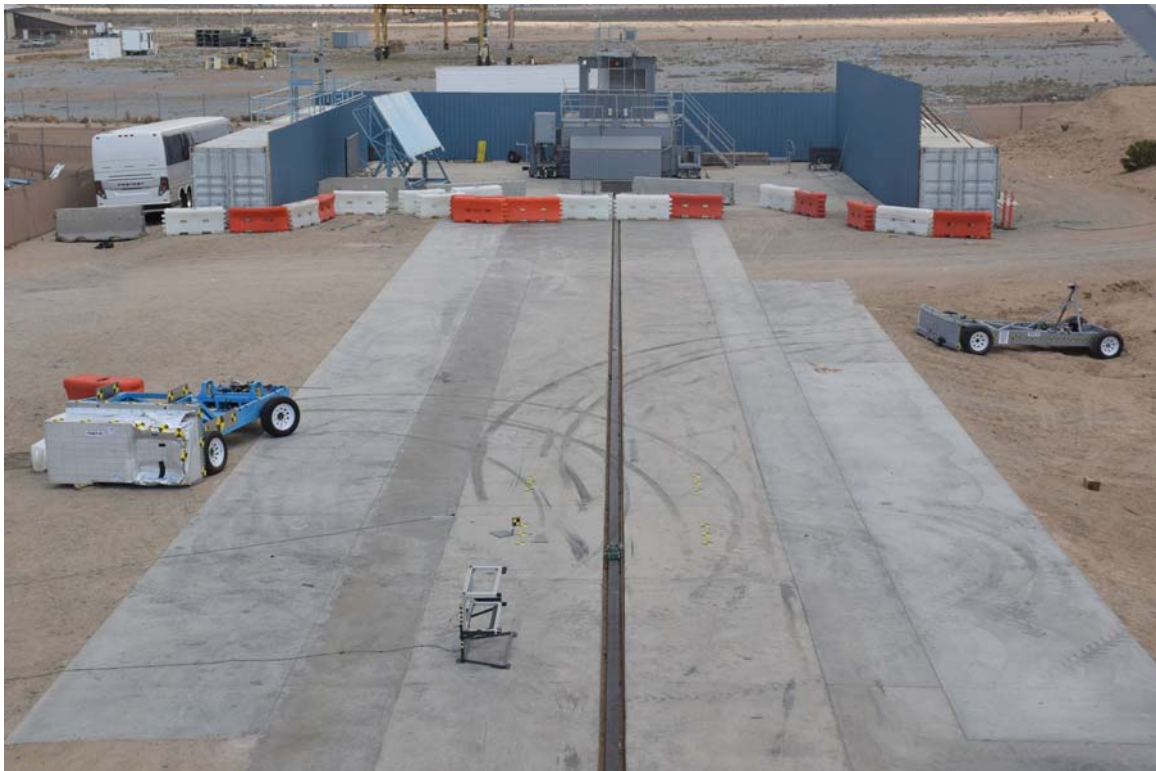
FIGURE 4. Post-Test Top View of OMDB and MCB

The OMDB impacted the MCB at a speed of 59.71 km/h. After impact the OMDB rotated 165.2°, coming to rest 4.40 m forward and 4.95 m left of its initial position. As a result of the impact, three M10x1.5 x 90 mm SHCS bolts on the left rear axle mount sheared causing the wheel assembly to rotate about the axle adapter. After the impact the MCB rotated 60.4° and traveled 14.43 m rearward and 8.15 m left of its initial position.

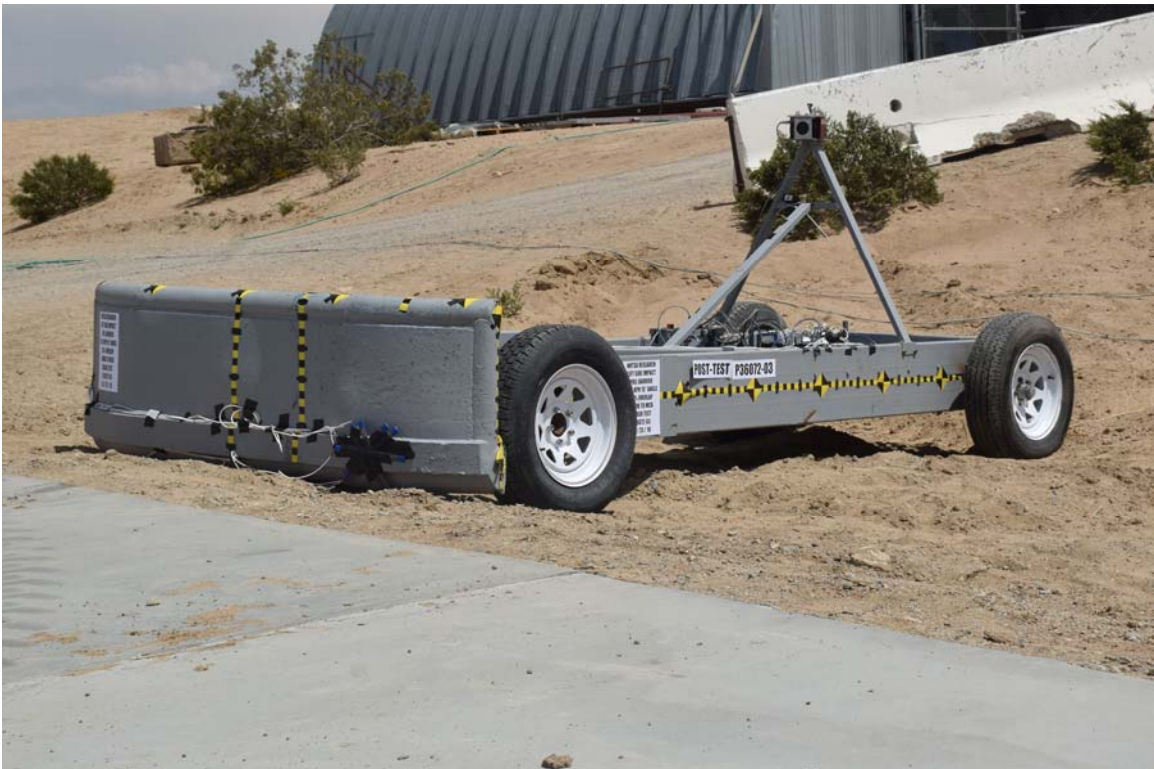
FIGURE 14. Post-Test Left Front $\frac{3}{4}$ View of MCB

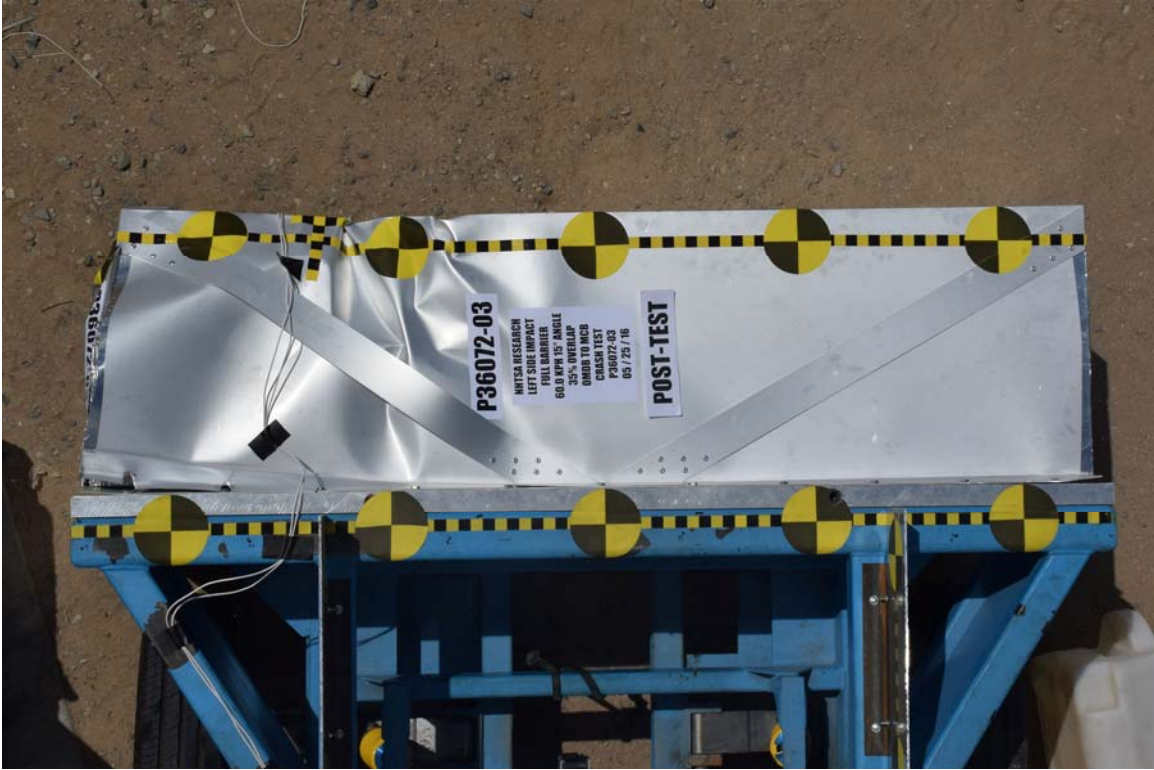
FIGURE 22. Post-Test Top View of OMDB Impactor Face

Report No. R&D-KAR-16-006	Government Accession No.	Recipient's Catalog No.	
Title and Subtitle Report for Frontal Oblique Offset Program Testing of a OMDB to MCB		Report Date July 18, 2016	
		Performing Organization Code KAR	
Author(s) Mr. Robert S. Ramos, Project Engineer, KARCO Mr. Frank Richardson, Program Manager, KARCO		Performing Organization Report No. TR-P36072-03-NC	
		Work Unit No.	
Performing Organization Name and Address KARCO Engineering, LLC. 9270 Holly Rd. Adelanto, CA 92301		Contract or Grant No. DTNH22-14-D-00360	
		Type of Report and Period Covered Final Test Report, May 25 – July 18, 2016	
Sponsoring Agency Name and Address DOT / National Highway Traffic Safety Administration Office of Vehicle Safety Research 1200 New Jersey Ave., SE, Room W46-446 Washington, D.C. 20590		Sponsoring Agency Code NSR210	
Supplementary Notes			
Abstract A test was conducted in accordance with Contract DTNH22-14-D-00360, Task Order #0002. The Test consisted of an Oblique Moving Deformable Barrier (OMDB) traveling at a target speed of 60 km/h into a stationary FMVSS 301 Moving Contoured Barrier (MCB). The struck vehicle was positioned 15 degrees clockwise relative to the moving barrier which impacted 35% of the left side of the vehicle. The test was conducted to obtain performance of the full-barrier face in an oblique test. The test was conducted at KARCO Engineering, LLC. facility in Adelanto, California on May 25, 2016. The OMDB impact velocity was 59.71 km/h and the ambient temperature at the test vehicle at the time of impact was 24.0°C. The OMDB maximum static crush was 249.2 mm.

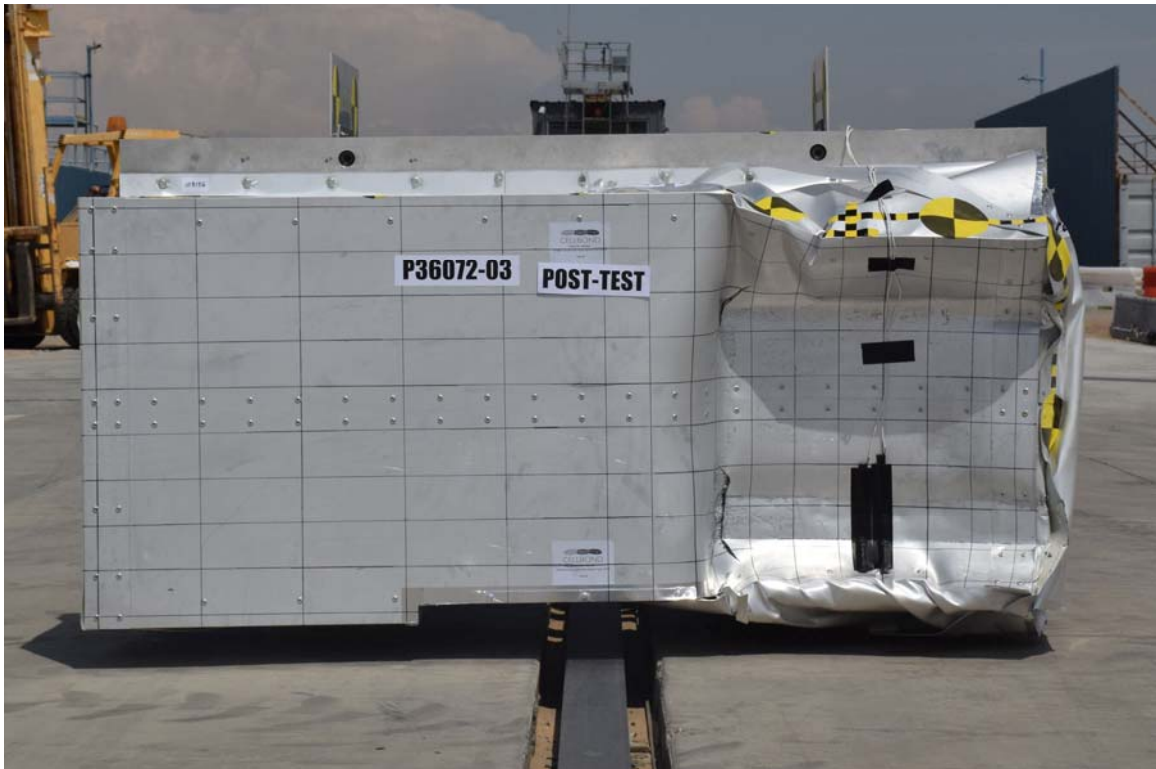
FIGURE 24. Post-Test Front View of OMDB Impactor Face

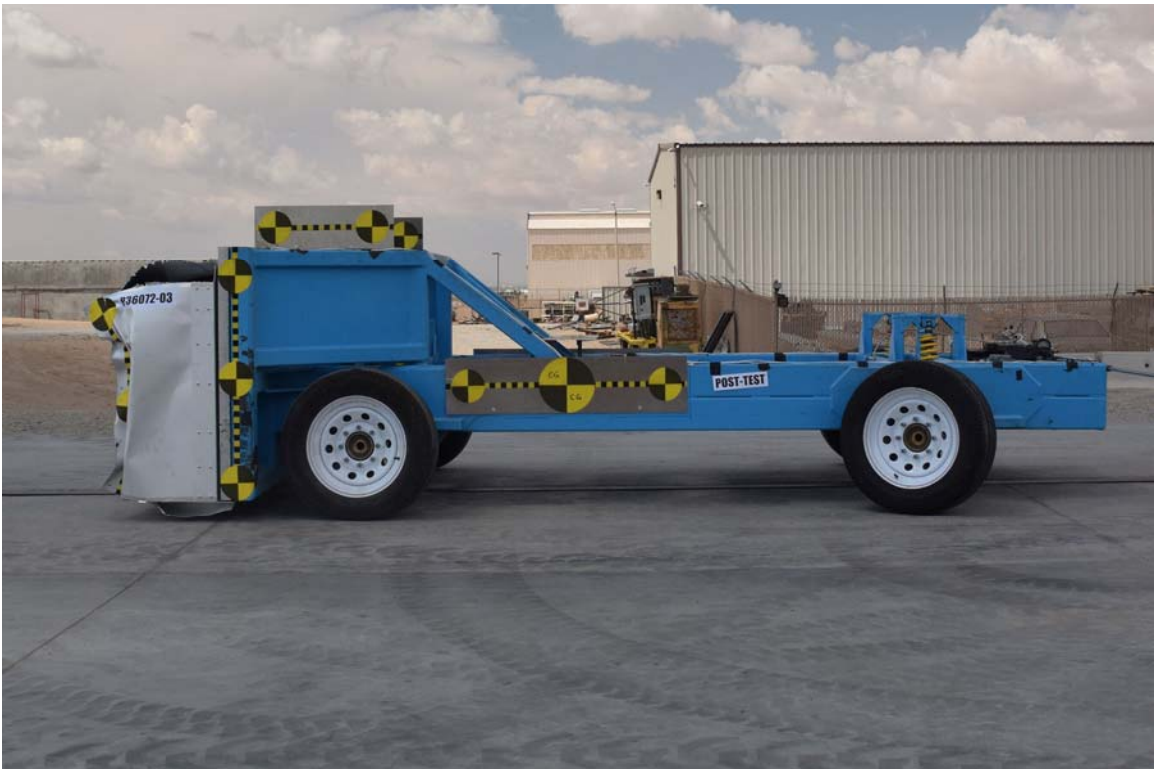
FIGURE 28. Post-Test Left View of OMDB
