**REPORT NUMBER: NCAP-MGA-2016-050**

**NEW CAR ASSESSMENT PROGRAM (NCAP)  
Frontal Barrier Impact Test**

**ADAM OPEL AG  
2016 Buick Cascada Premium 1SP 2-Door Convertible  
NHTSA No.: O20160100**

**MGA RESEARCH CORPORATION  
5000 Warren Road  
Burlington, WI 53105**

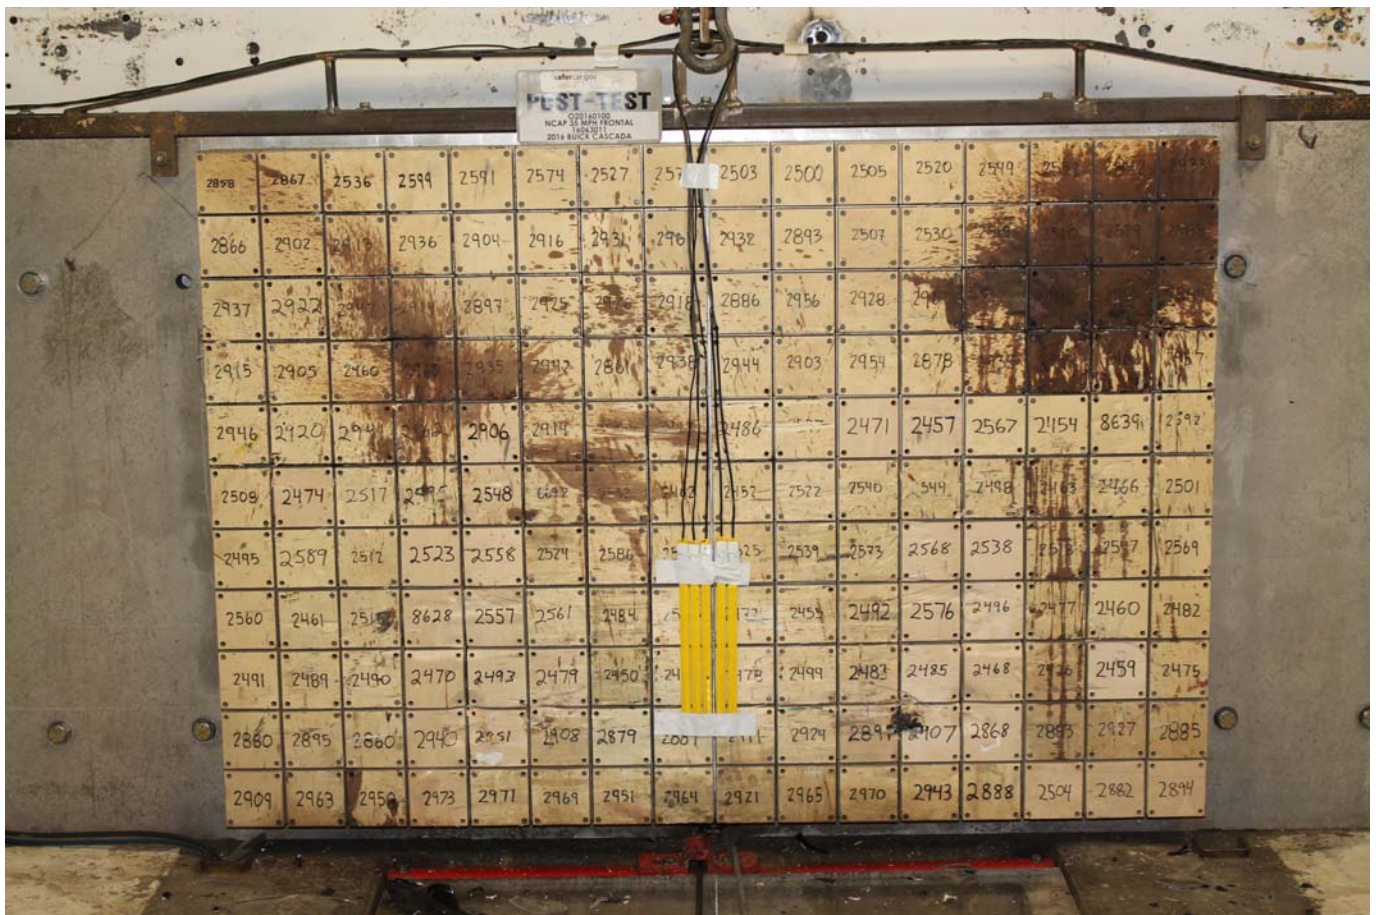
Photo No. 003 - Post-Test Load Cell Wall

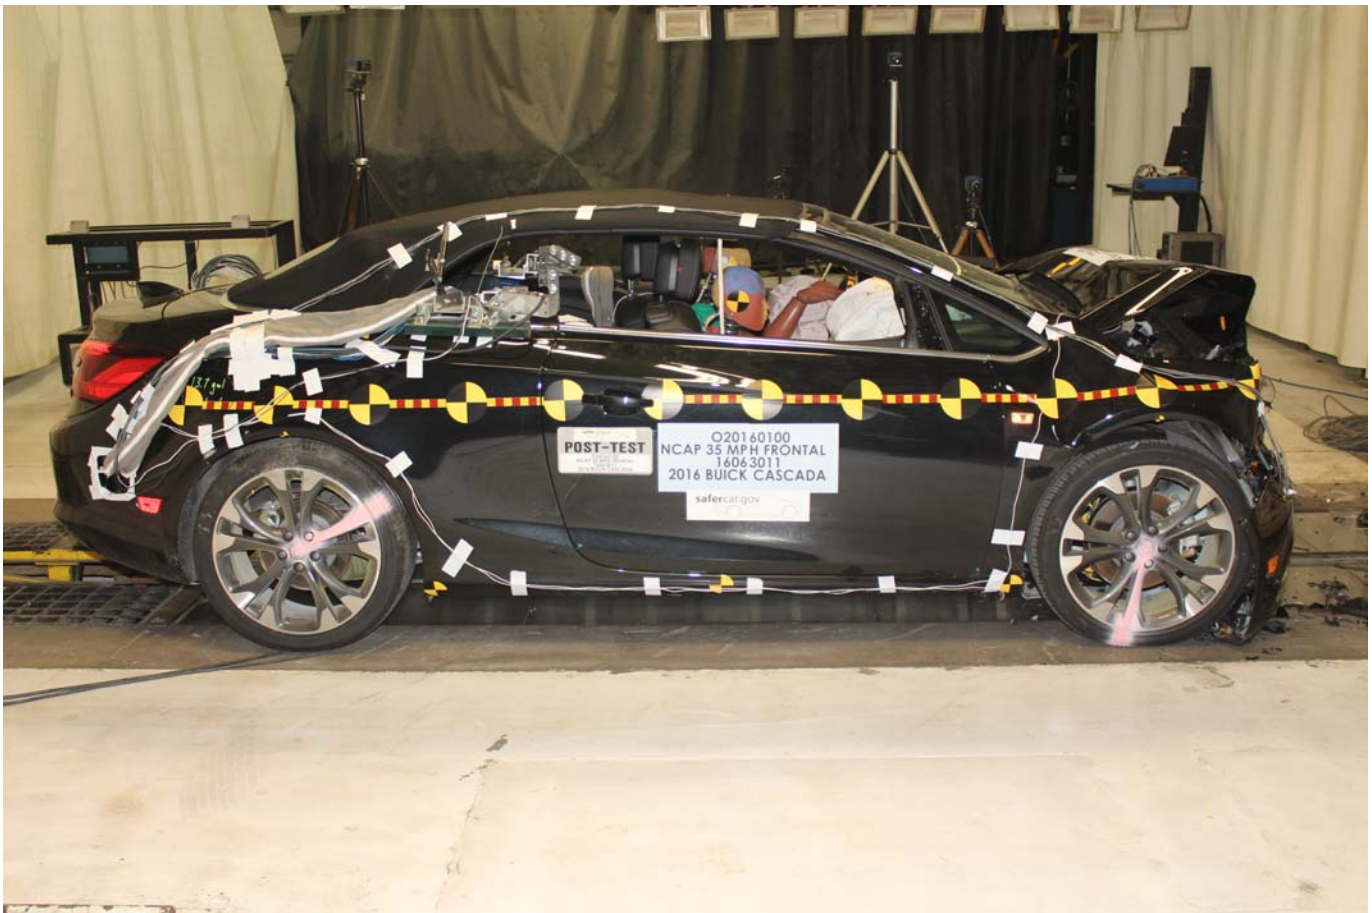
Photo No. 013 - Post-Test Right View of Test Vehicle

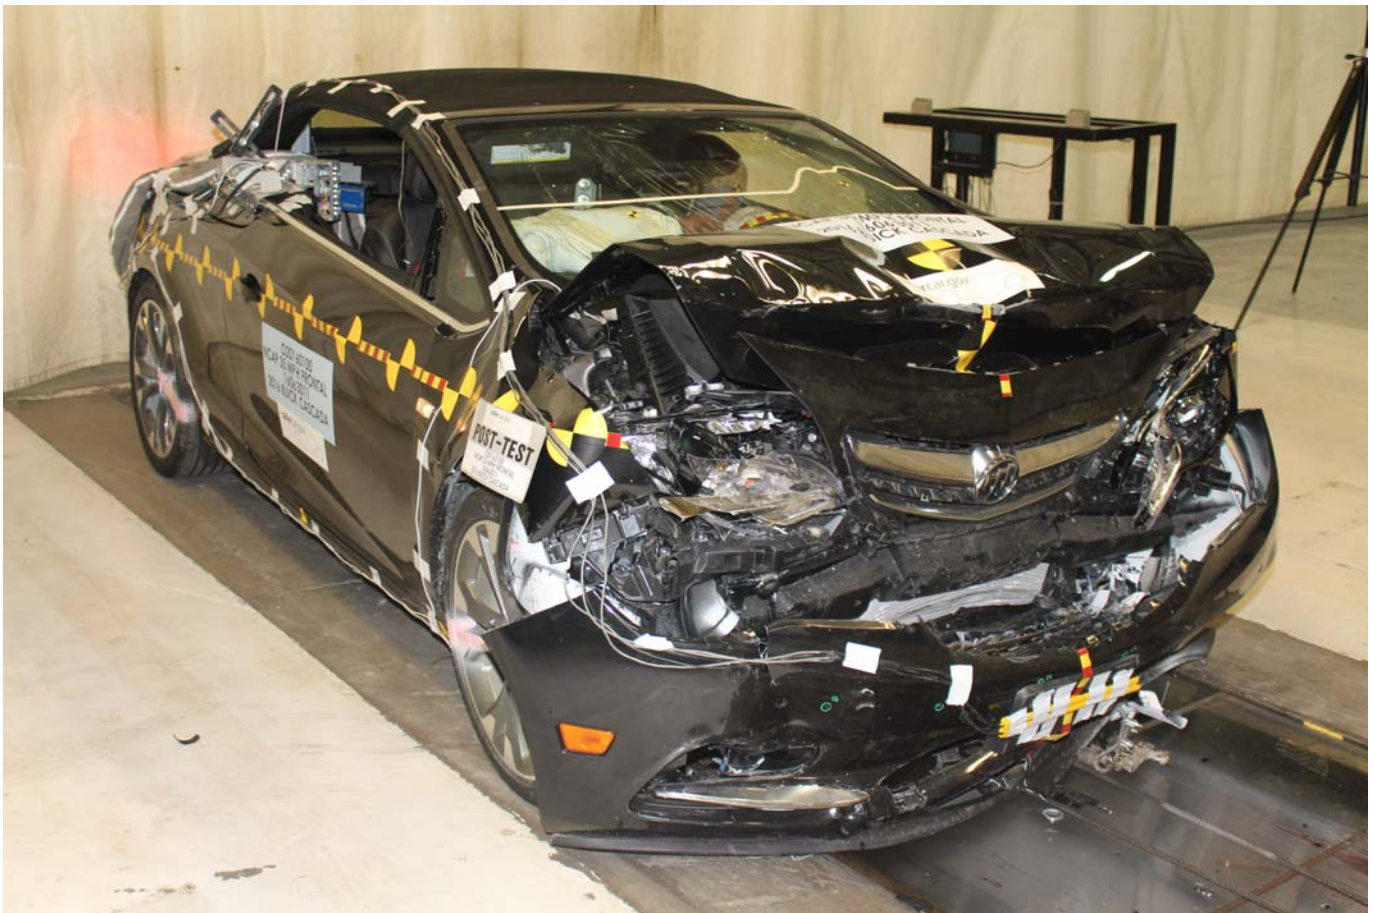
Photo No. 015 - Post-Test Right Front 3-4 View

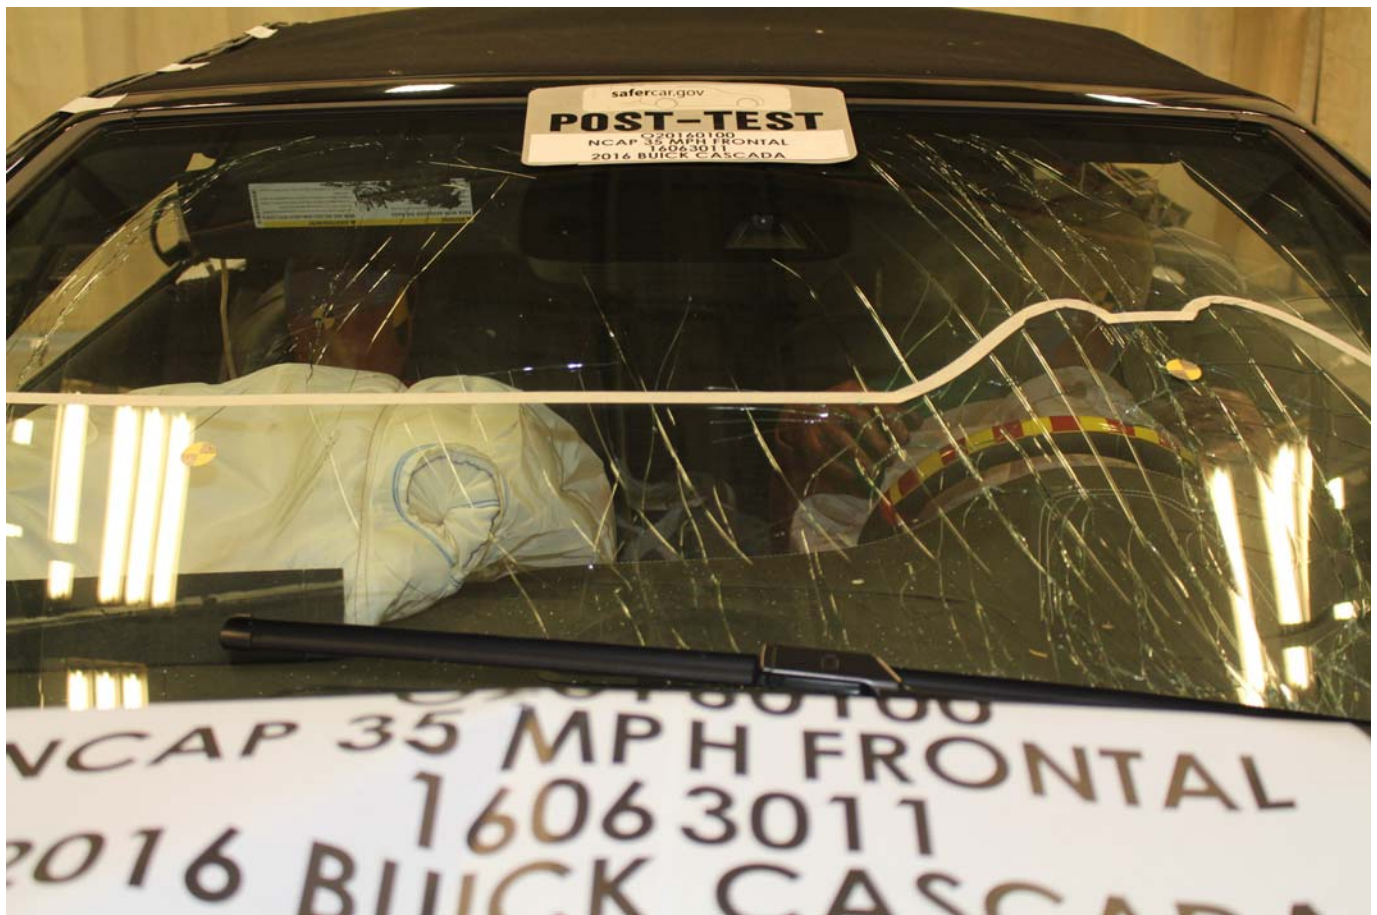
Photo No. 019 - Post-Test Windshield View

There was 100 percent windshield retention and no intrusion into the protected zone of the windshield during the event. There was no Stoddard Solvent leakage after the event or during any phase of the static rollover.

| Critical Areas of Performance | Observations and Conclusions |
|---|---|
| Windshield Damage | Cracked |

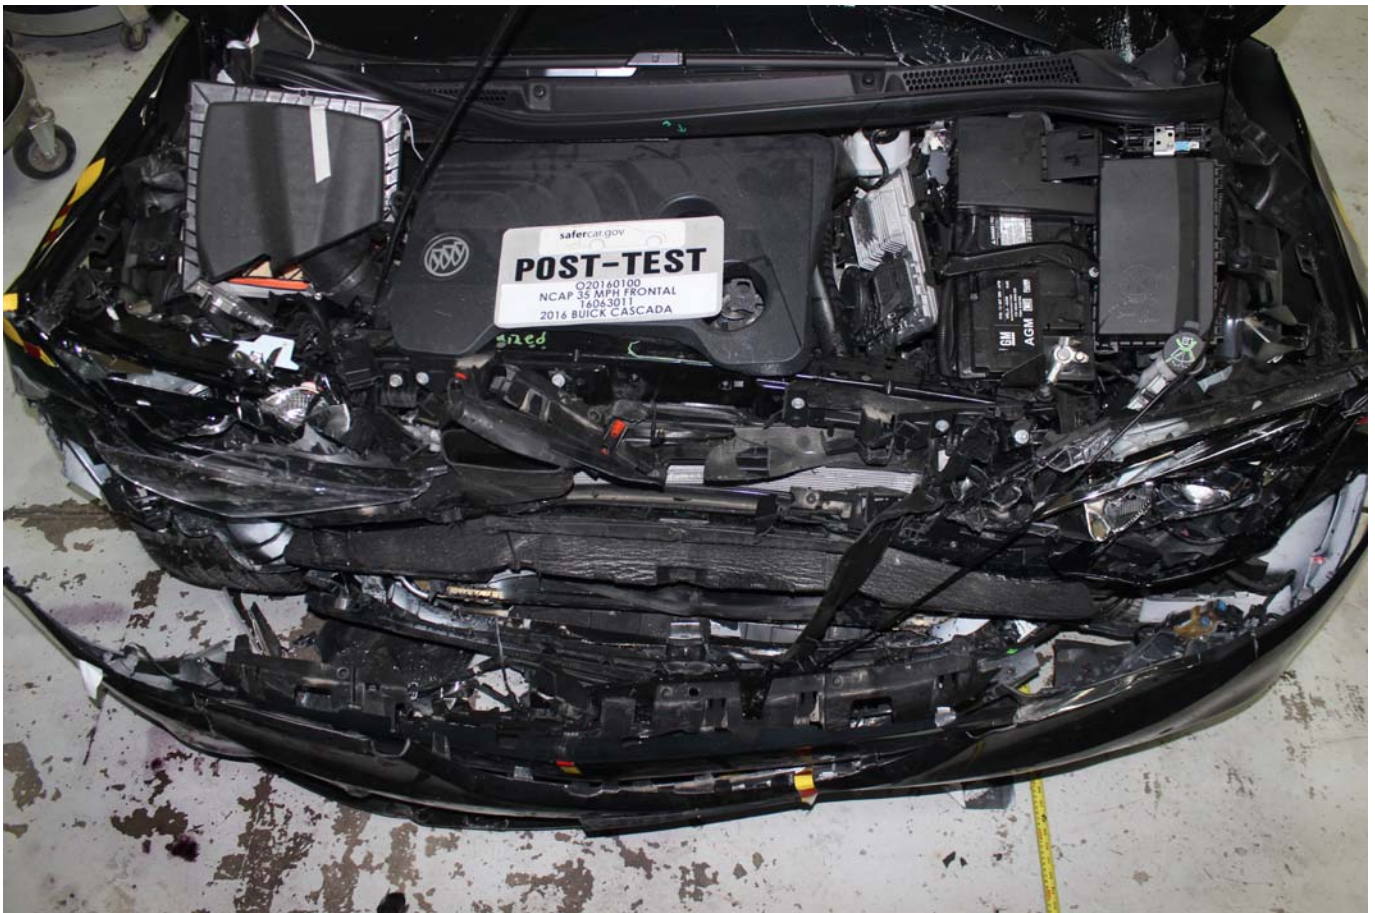
Photo No. 021 - Post-Test Engine Compartment View

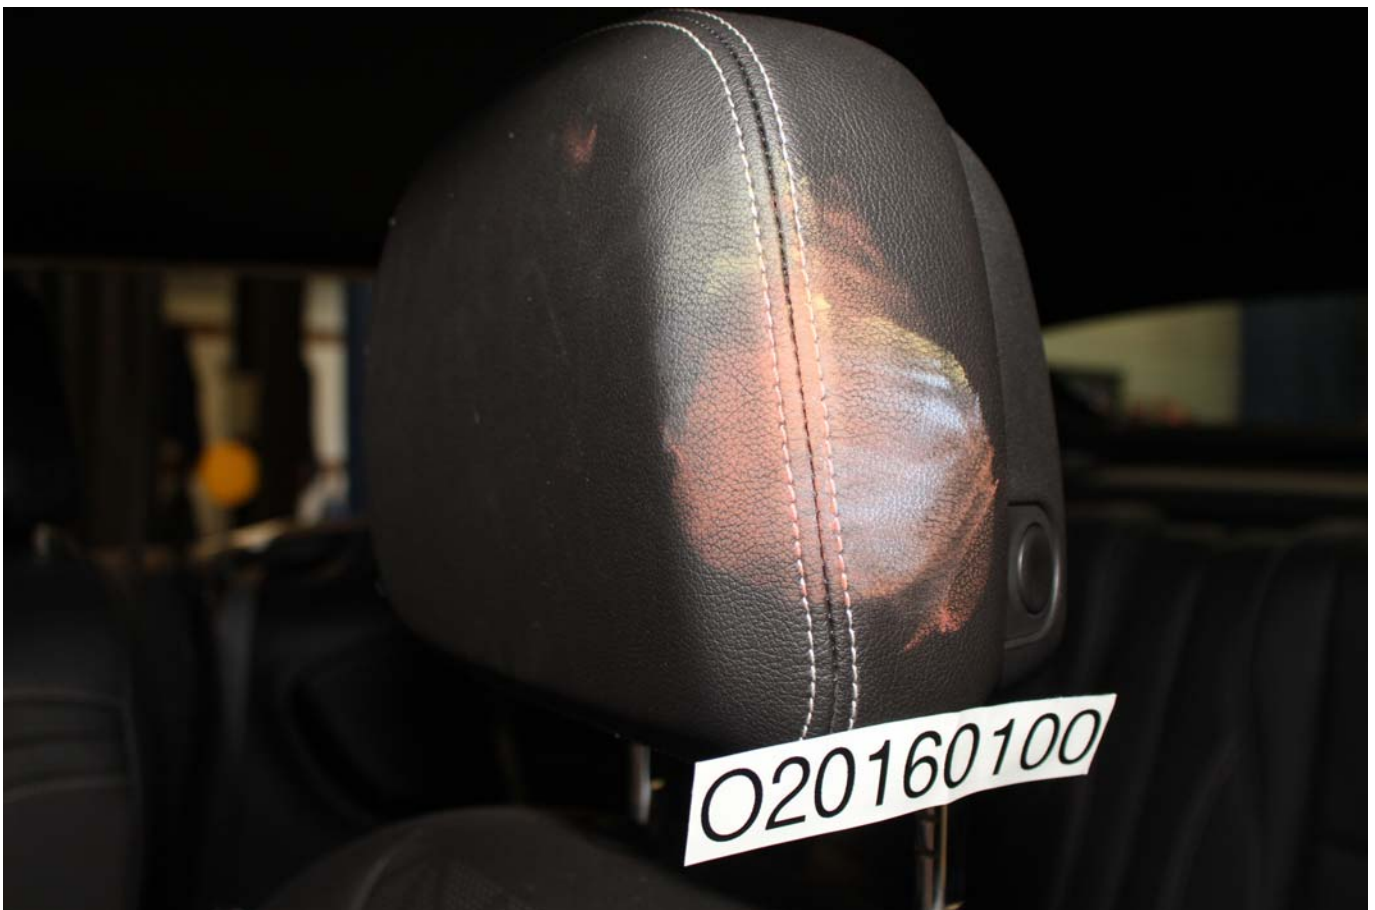
Photo No. 048 - Post-Test Driver Dummy Contact with Headrest

The driver's visible contact points were as follows: The driver's head contacted the airbag. The driver's head also contacted the headrest. The driver's knees contacted the knee airbag. The passenger's visible contact points were as follows: The passenger's head contacted the airbag. The passenger's head also contacted the headrest. The passenger's knees contacted the knee airbag.

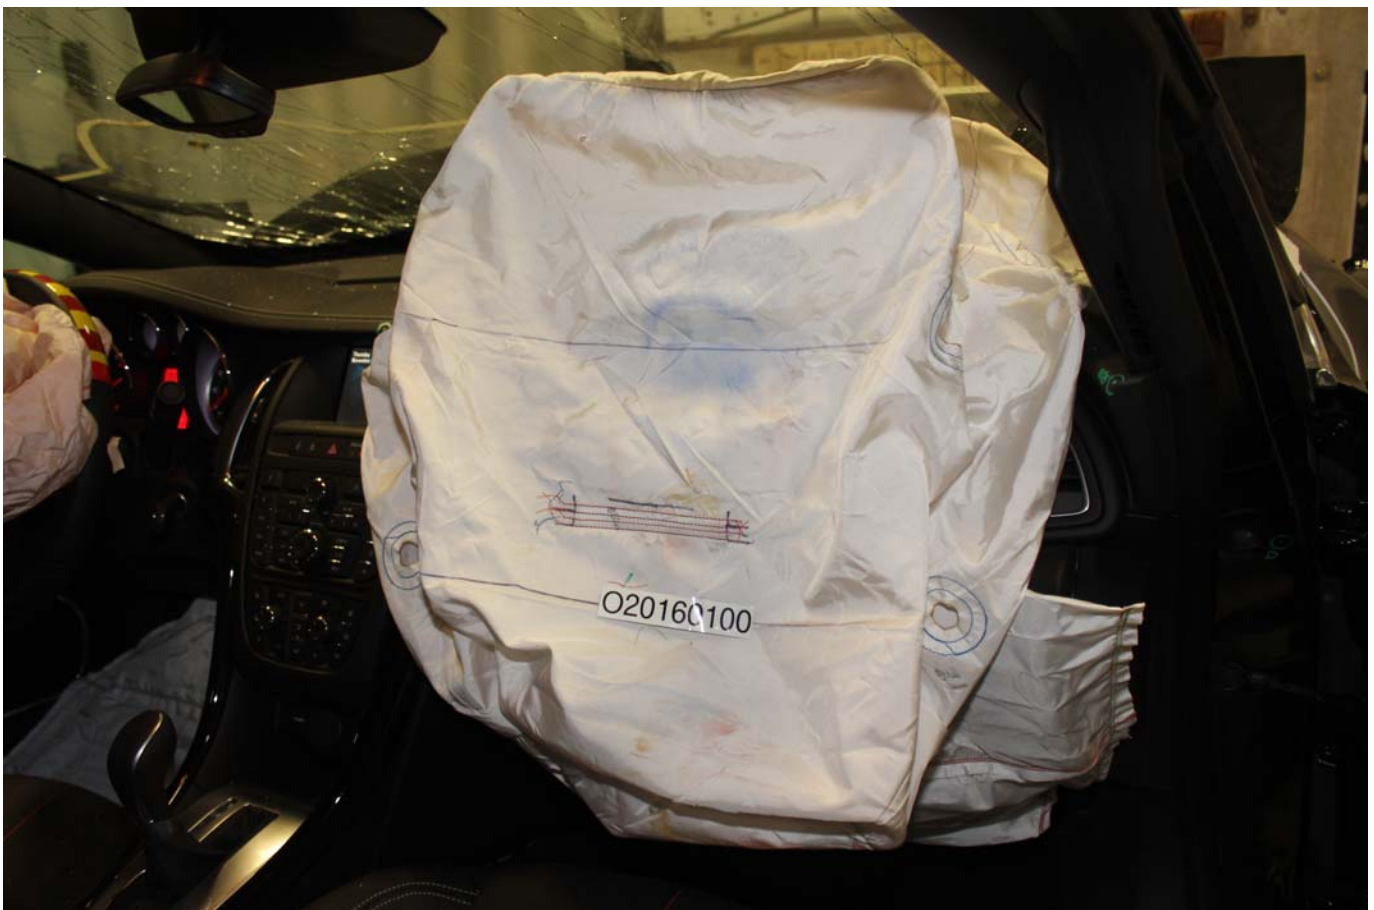
Photo No. 068 - Post-Test Passenger Dummy Contact with Airbag

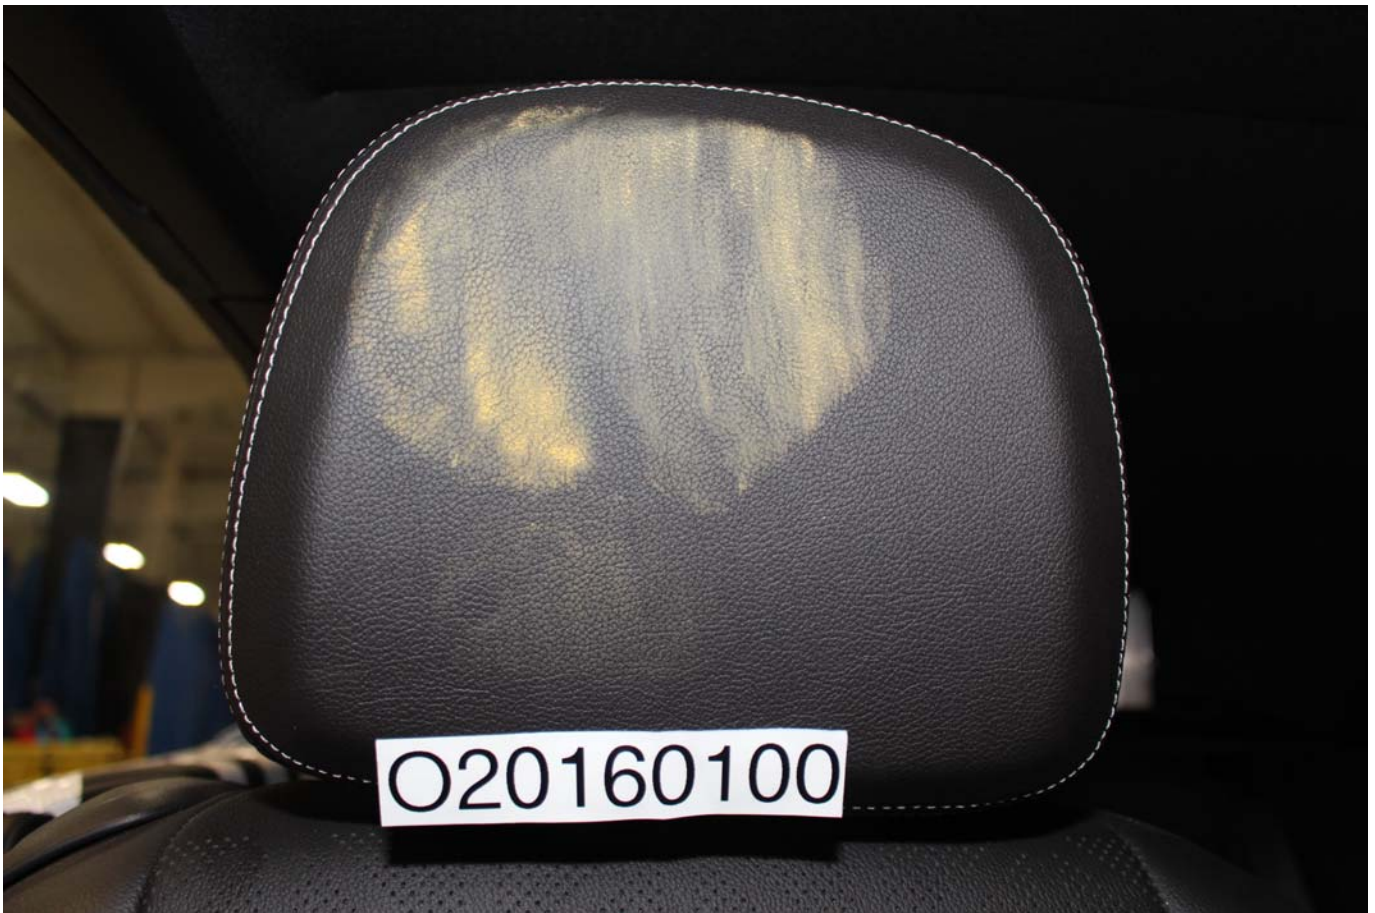
Photo No. 069 - Post-Test Passenger Dummy Contact with Headrest

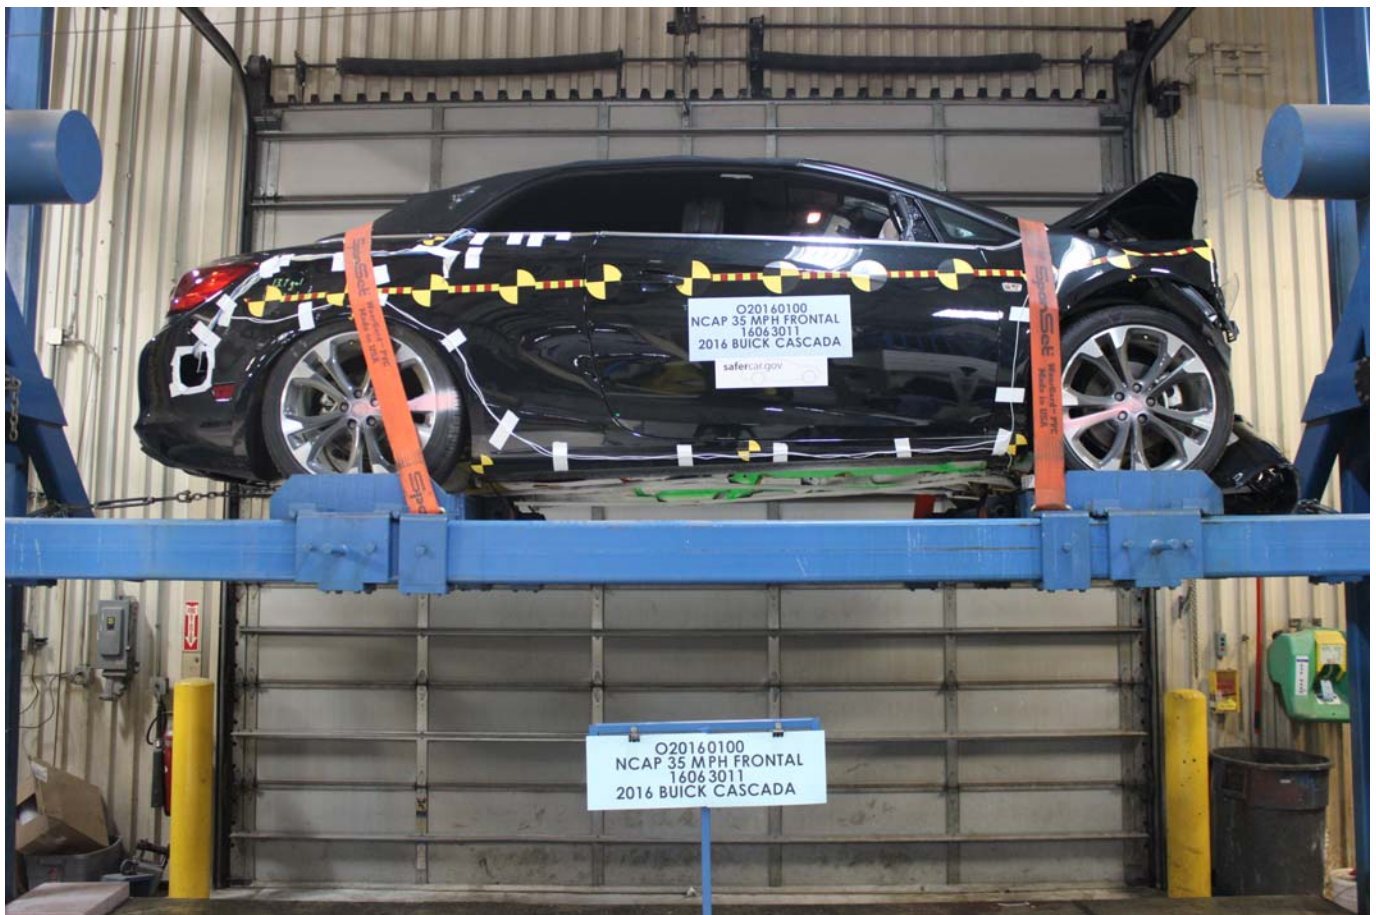
Photo No. 073 - Vehicle at 0 Degree on Static Rollover Device

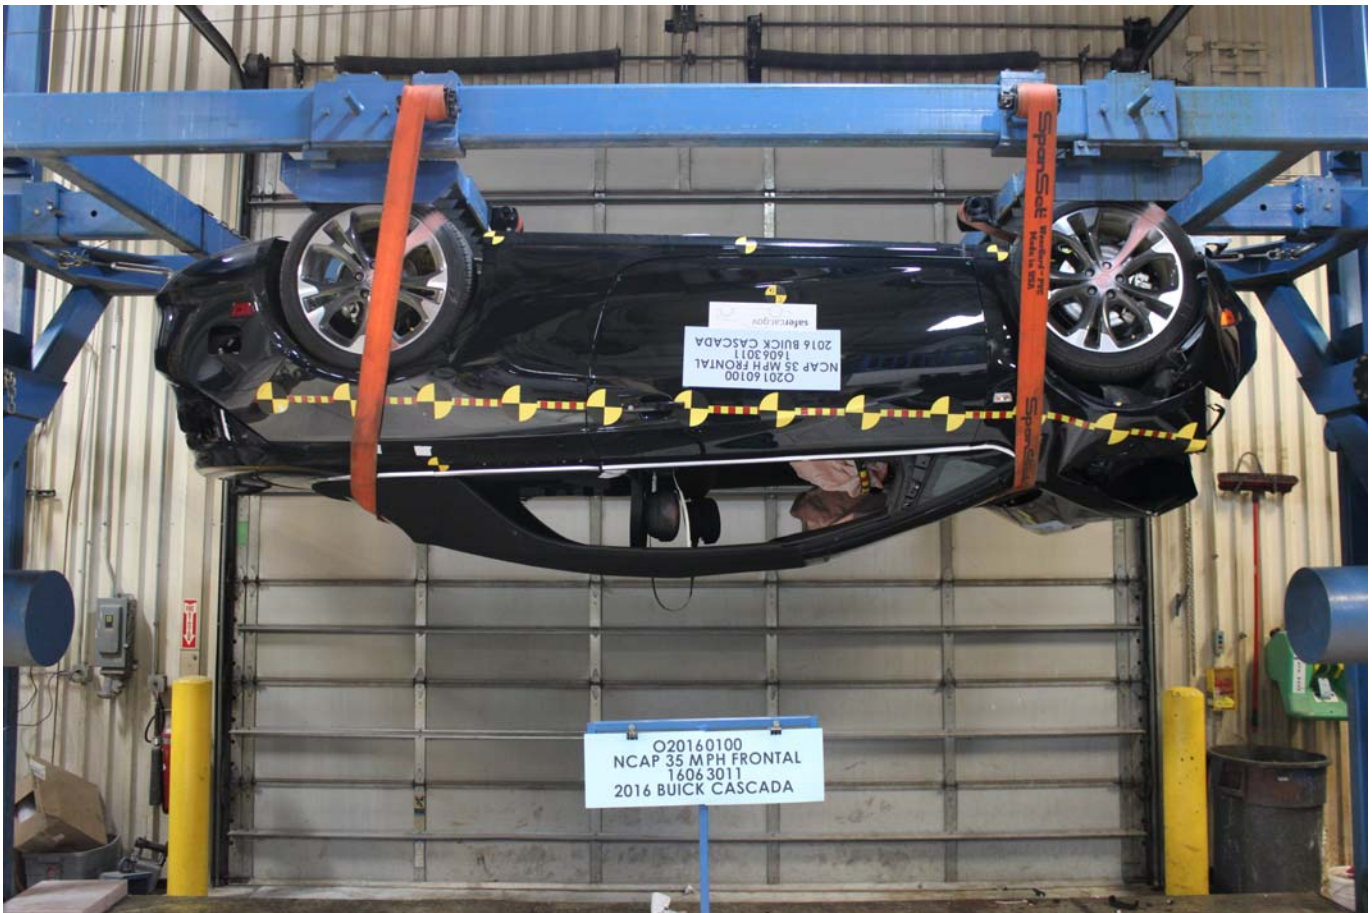
Photo No. 075 - Vehicle at 180 Degrees on Static Rollover Device

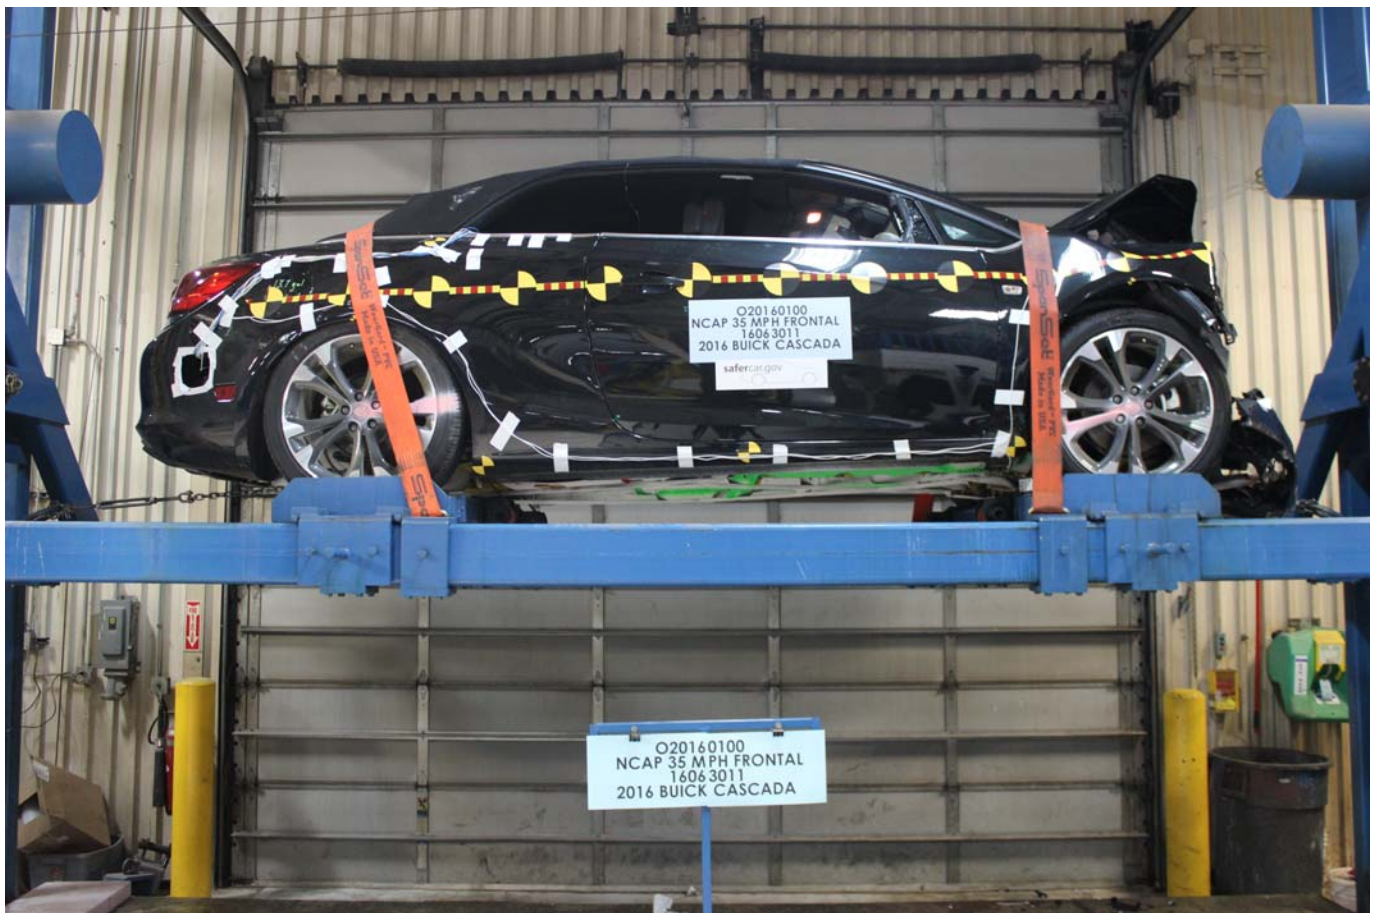
Photo No. 077 - Vehicle at 360 Degrees on Static Rollover Device

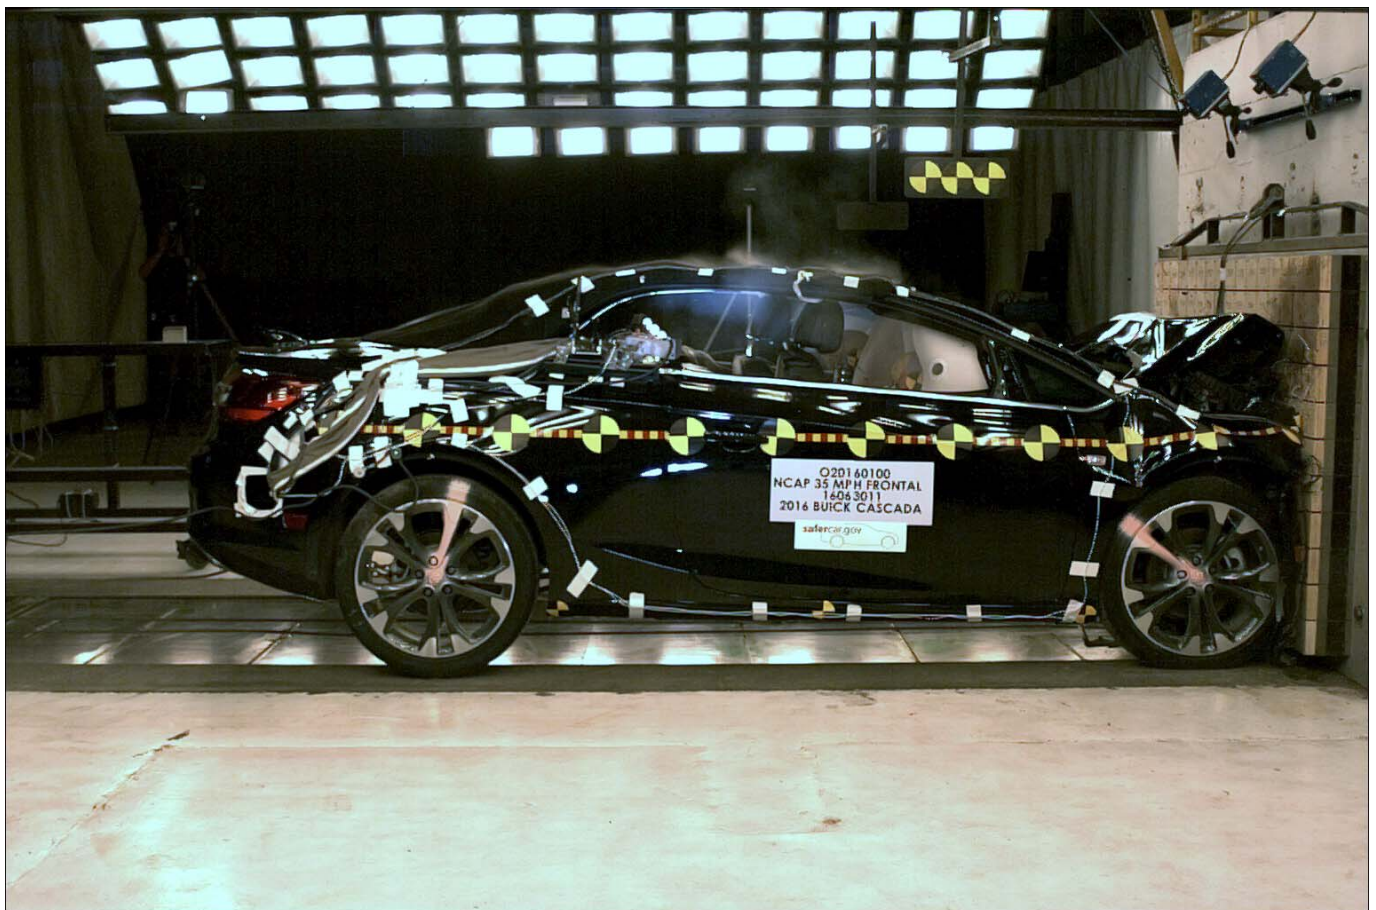
Photo No. 078 - 2016 Buick Cascada Frontal Impact Event

A load cell barrier consisting of 176 load cells was impacted by a 2016 Buick Cascada Premium 1SP 2-Door Convertible at a velocity of 56.21 km/h. The test was performed at MGA Research Corporation on June 30, 2016. Pre-test and post-test photographs of the vehicle and dummies can be found in Appendix A.
