**REPORT NUMBER: NCAP-MGA-2016-052**

**NEW CAR ASSESSMENT PROGRAM (NCAP)  
Frontal Barrier Impact Test**

**HONDA OF CANADA MFG.  
2016 Honda Civic LX 2-Door Coupe  
NHTSA No.: O20165313**

**MGA RESEARCH CORPORATION  
5000 Warren Road  
Burlington, WI 53105**

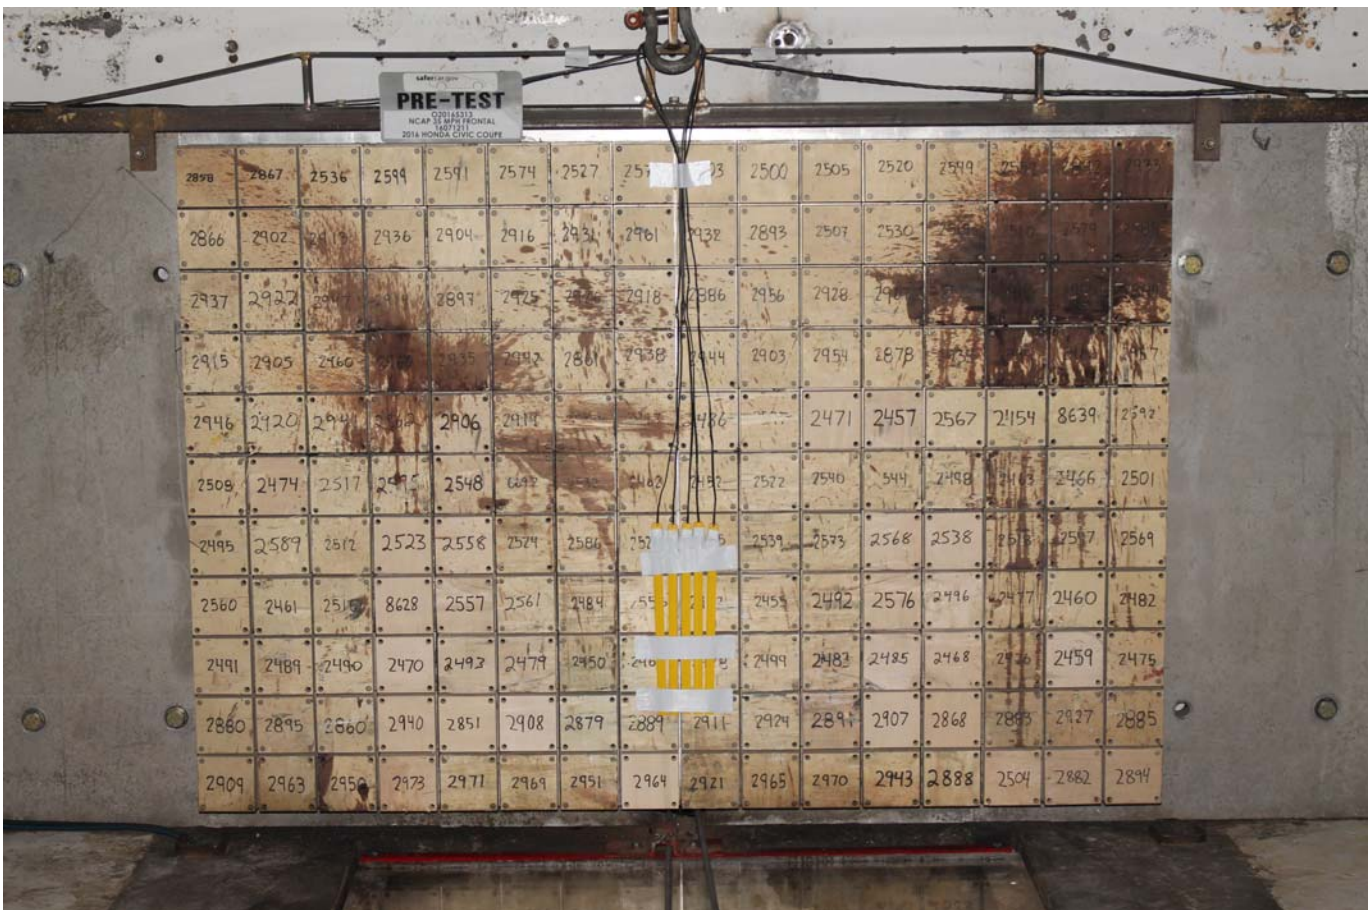
Photo No. 002 - Pre-Test Load Cell Wall

A load cell barrier consisting of 176 load cells was impacted by a 2016 Honda Civic LX 2-Door Coupe at a velocity of 56.17 km/h. The test was performed at MGA Research Corporation on July 12, 2016. Pre-test and post-test photographs of the vehicle and dummies can be found in Appendix A.

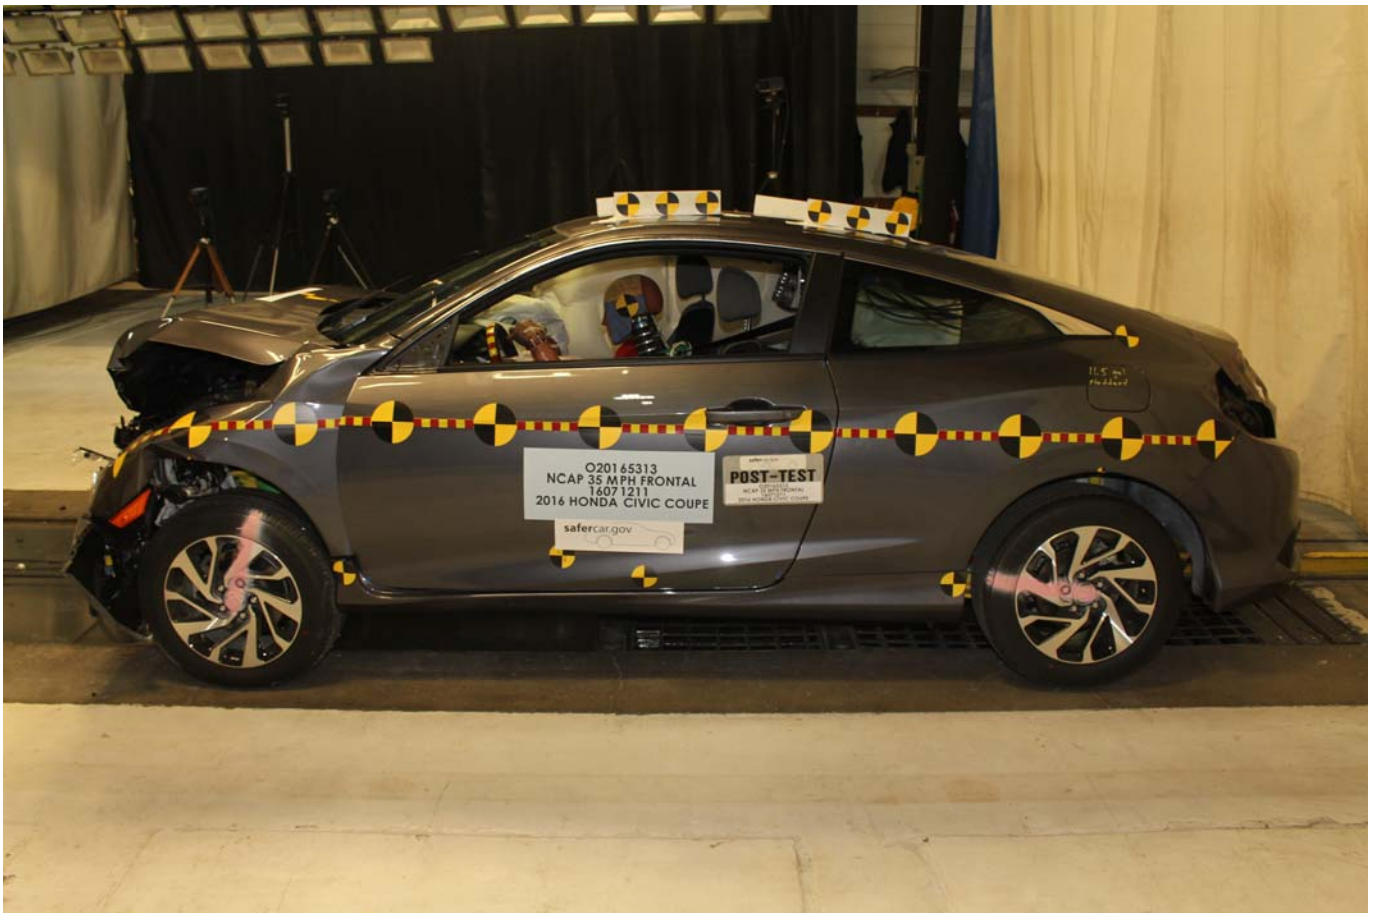
Photo No. 011 - Post-Test Left View of Test Vehicle

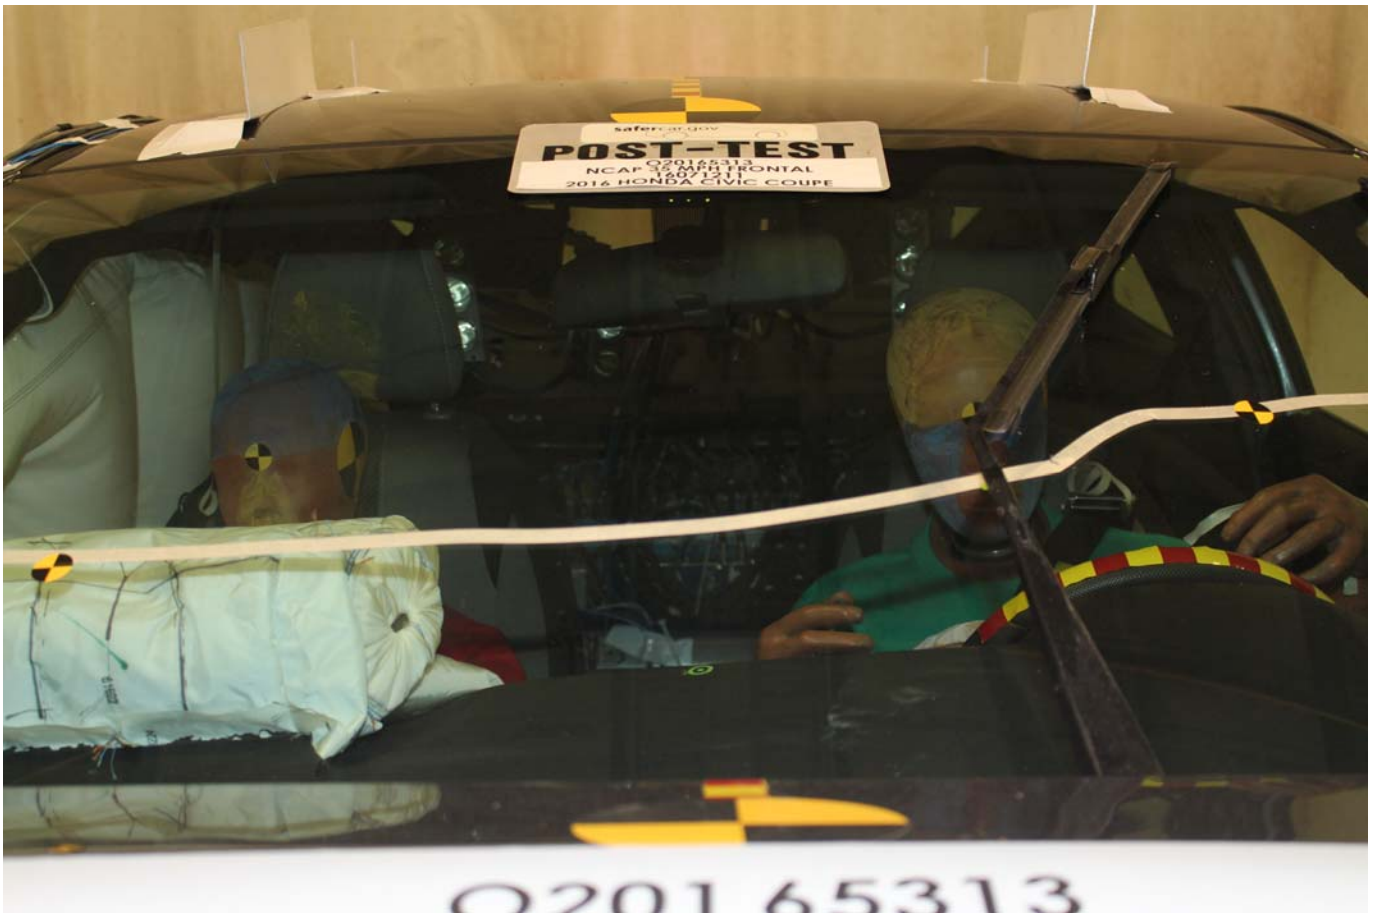
Photo No. 019 - Post-Test Windshield View

There was 100 percent windshield retention and no intrusion into the protected zone of the windshield during the event. There was no Stoddard Solvent leakage after the event or during any phase of the static rollover.

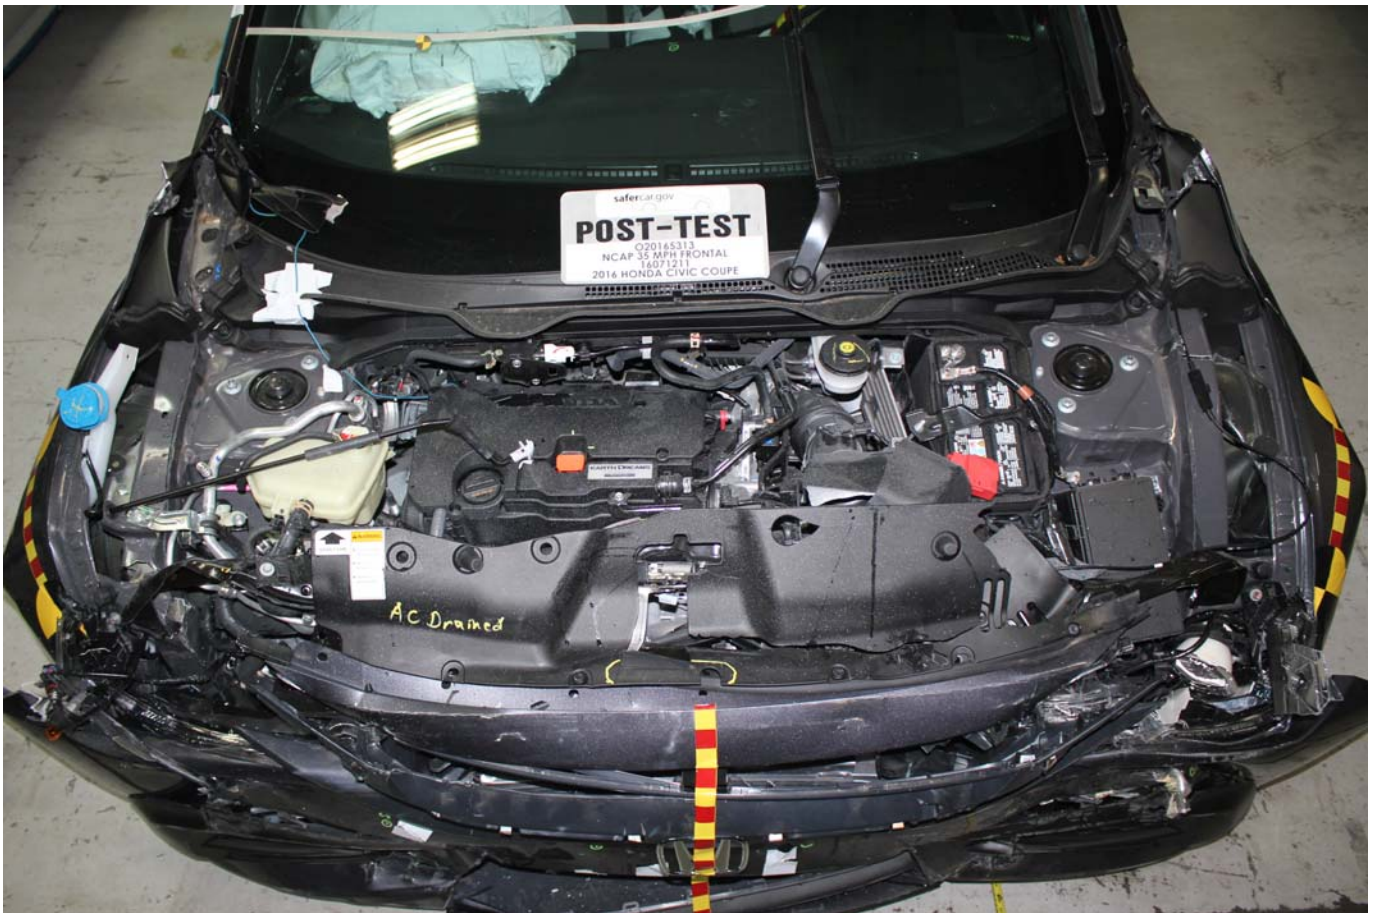
Photo No. 021 - Post-Test Engine Compartment View

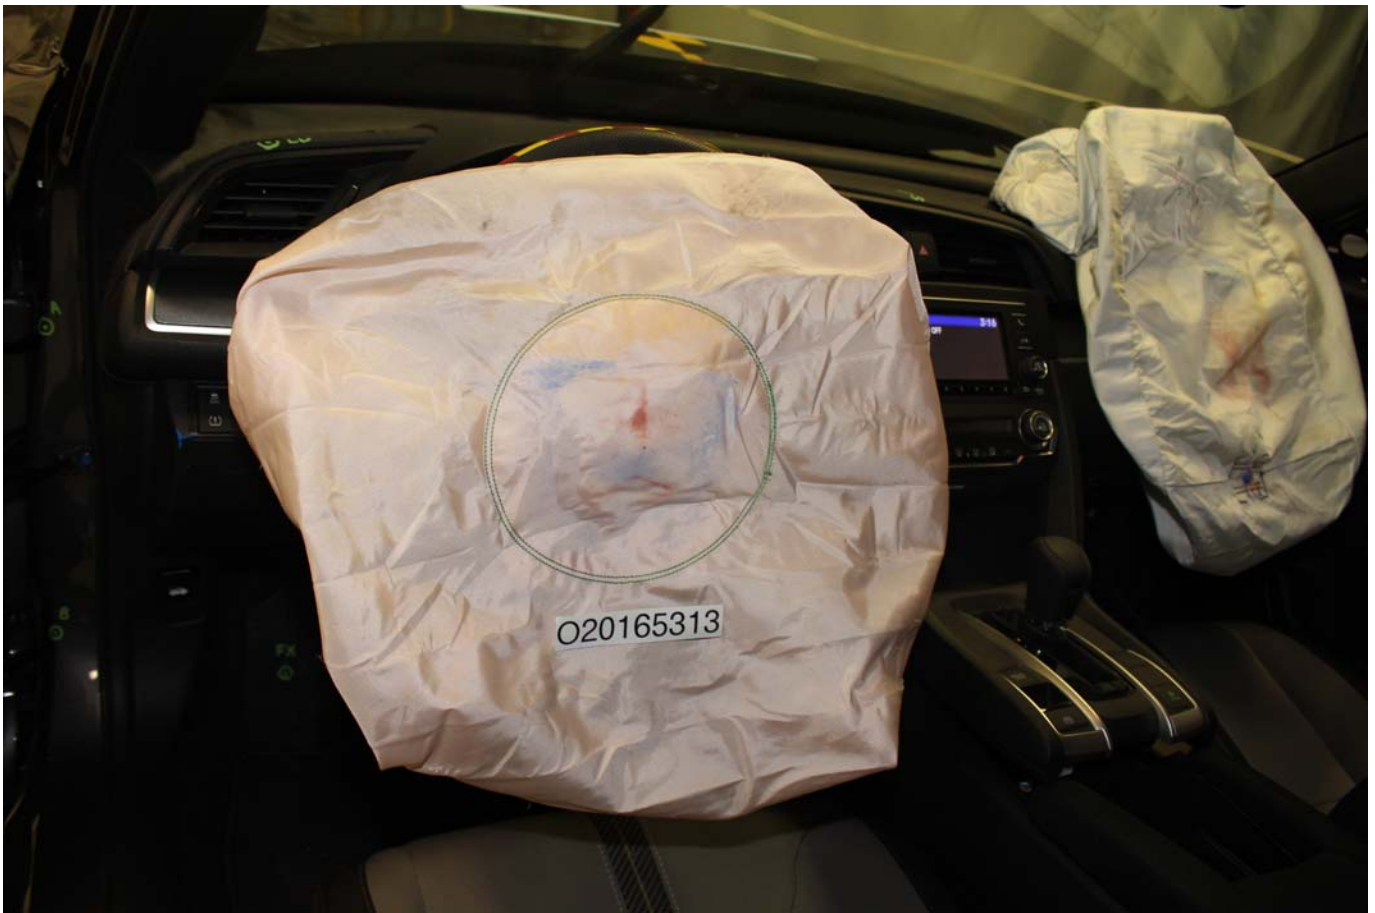
Photo No. 047 - Post-Test Driver Dummy Contact with Airbag

The driver's visible contact points were as follows: The driver's head contacted the airbag. The driver's head also contacted the headrest. The driver's knees contacted the steering column shroud. The passenger's visible contact points were as follows: The passenger's head contacted the airbag. The passenger's head also contacted the headrest. The passenger's knees contacted the glovebox.

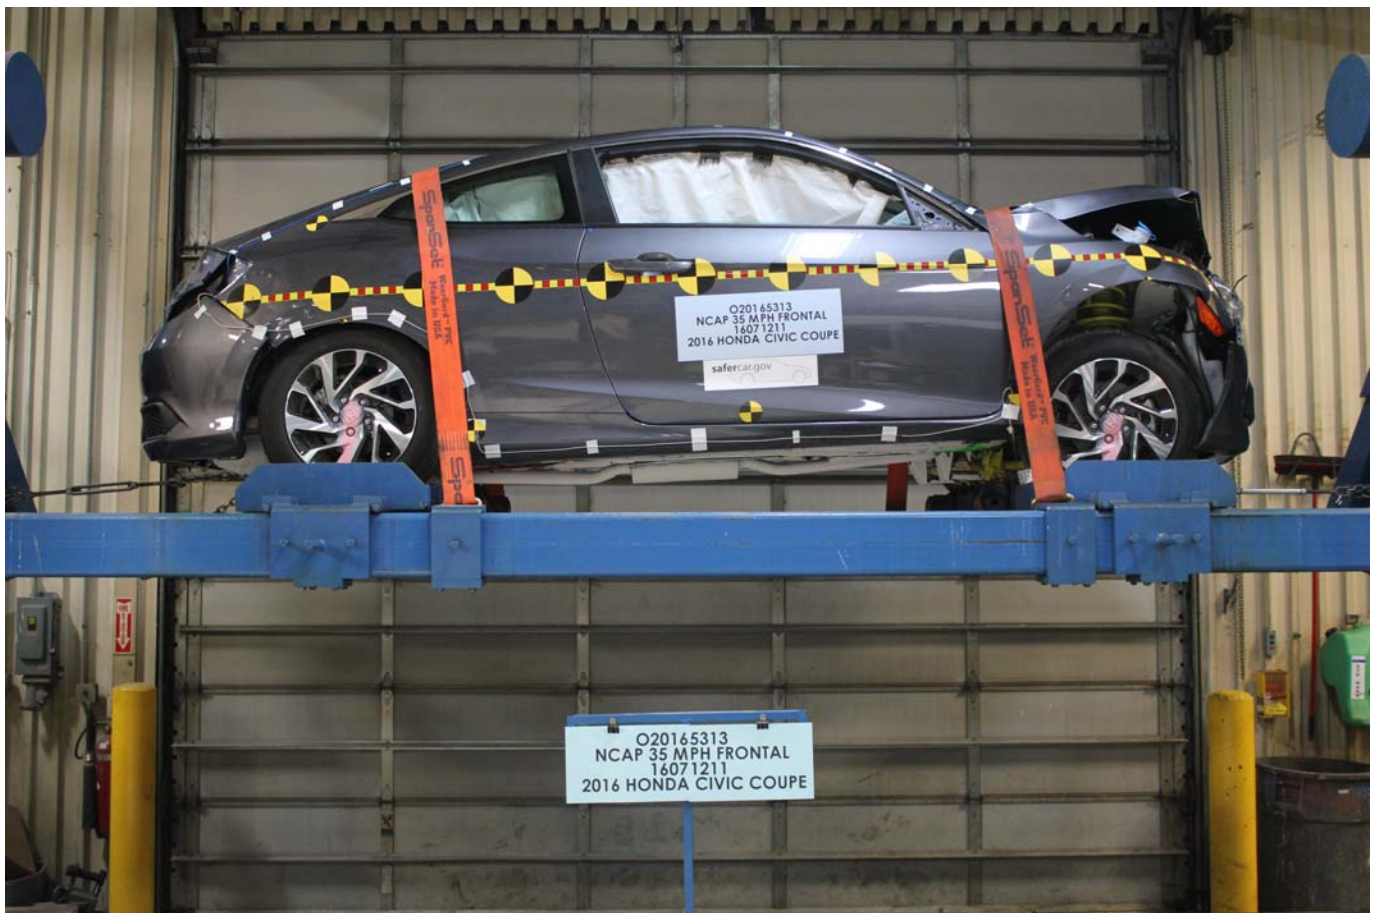
Photo No. 073 - Vehicle at 0 Degree on Static Rollover Device

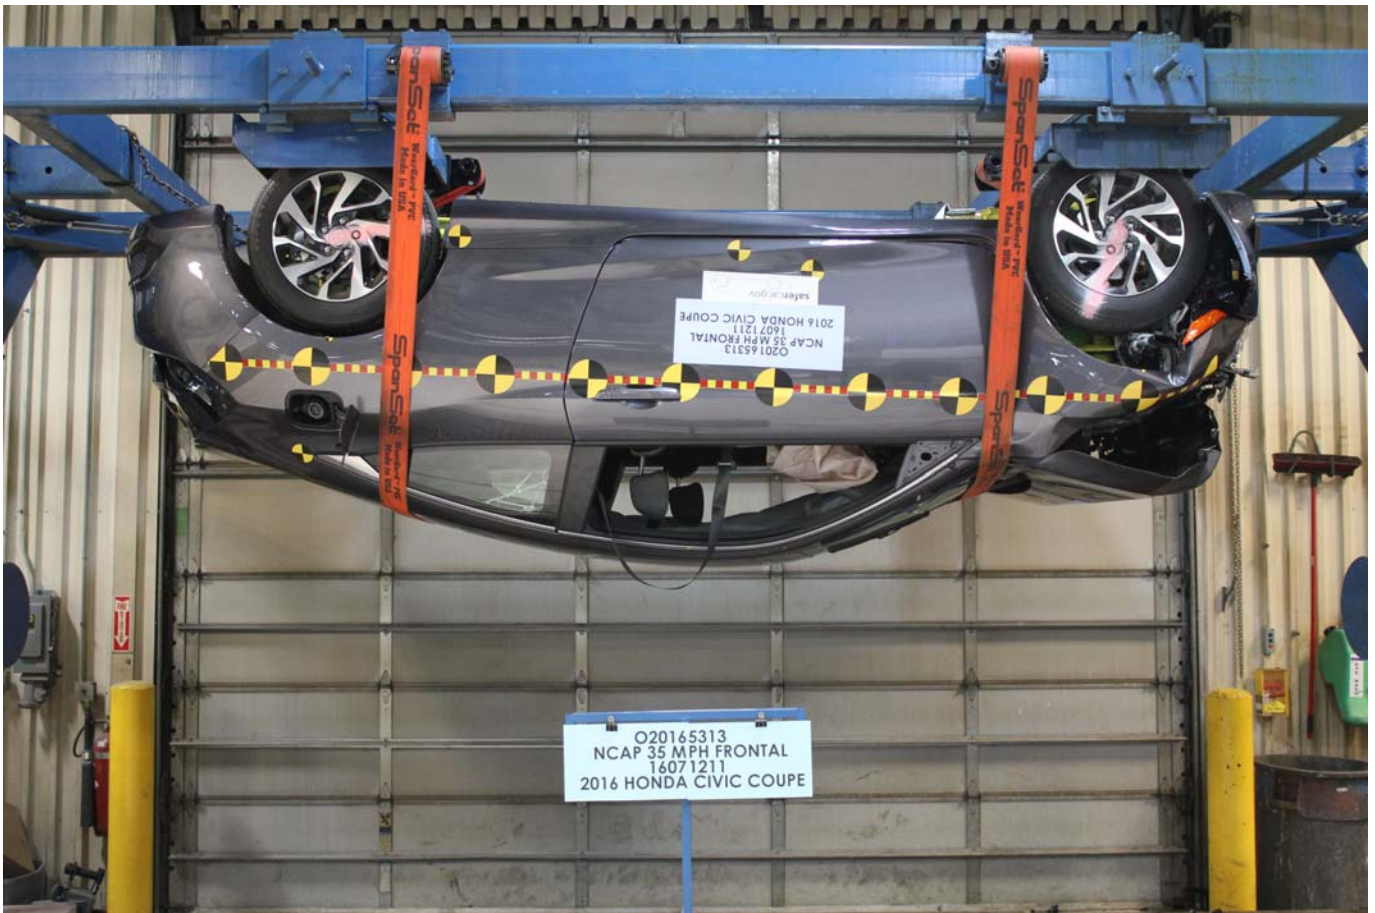
Photo No. 075 - Vehicle at 180 Degrees on Static Rollover Device

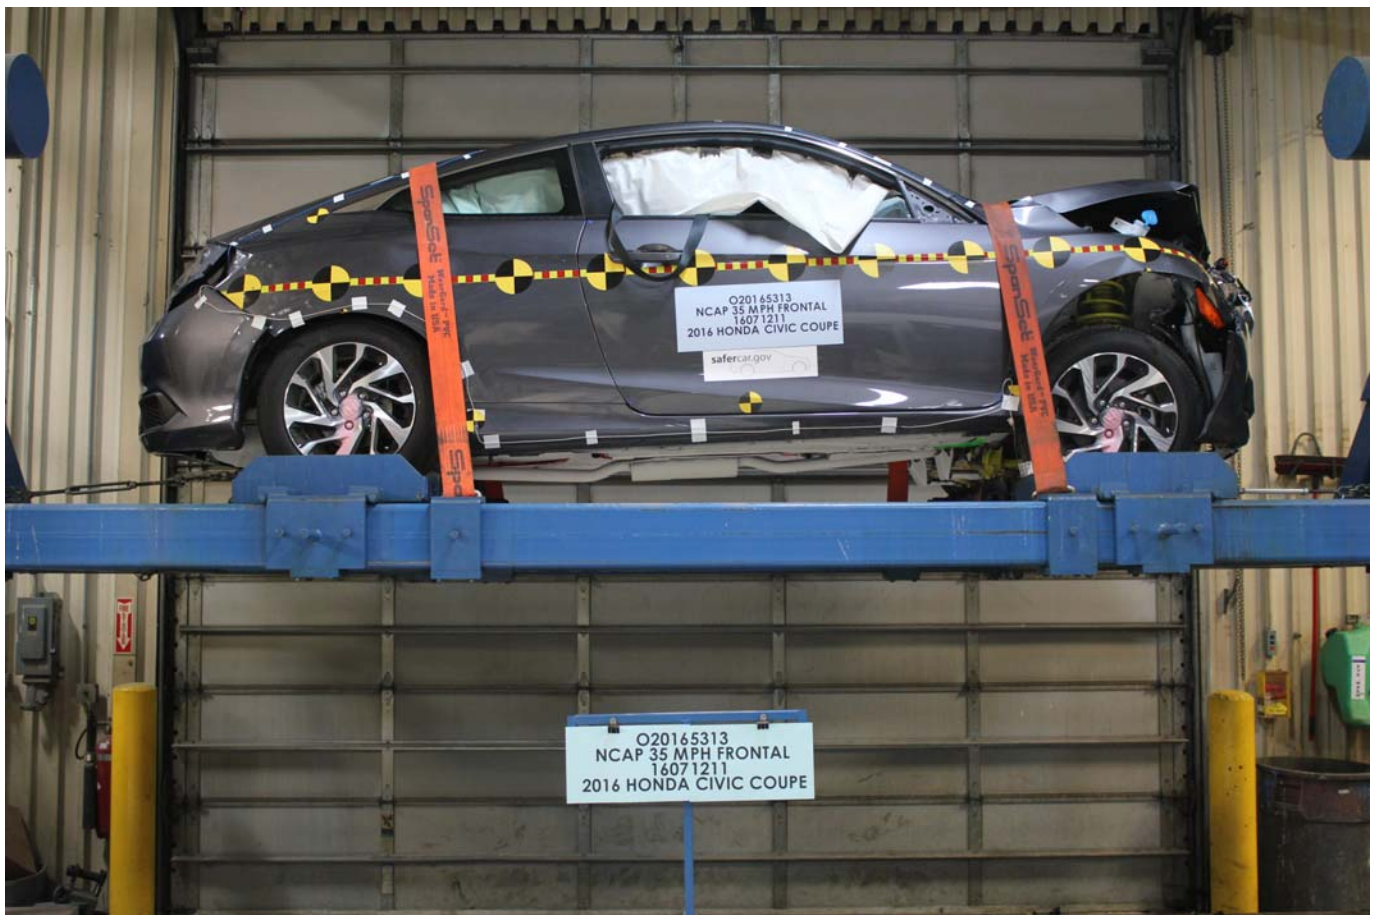
Photo No. 077 - Vehicle at 360 Degrees on Static Rollover Device
